Solid wall heat losses and the potential for energy saving

In situ U-value measurement method review

Date: 06 July 2016

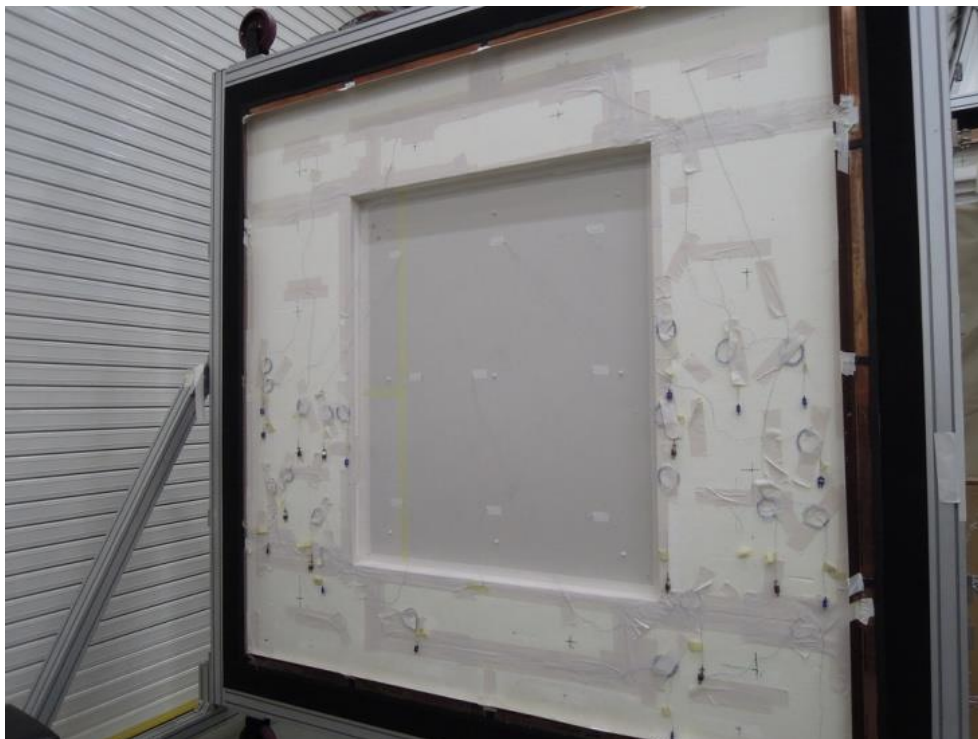
Figure 1 - 'Cold-side' of NPL hot-box test element showing the inserted test panel

The test panel, which measured 1.48m high x 1.23m wide, was inserted into the test opening in the expanded polystyrene surround of the hot-box testing element. The cold-side of the hot-box test element is shown in Figure 1. The recess depth of the test panel on the hot-side is identical to that of the cold side. The test panel consists of a 13mm thick layer of high density expanded polystyrene with 12.5mm plasterboard bonded to each face using PVA wood glue and an array of nine 6mm diameter nylon bolts. The thermal resistance of the test panel, the detail of which is given in Appendix A, plus standard surface resistances, gives a calculated U-value of 1.41 W/m²K. Figure 2 shows the dimensions of the test panel and the locations of the constructional nylon bolts and the five heat flux plates. Figure 3 shows a cross section schematic of the test panel in the hot-box with the HFPs installed and held in place by means of the pressure fixing arrangement. The detail of the pressure fixing of the heat flux plates can be seen more clearly in the images in Figure 4.

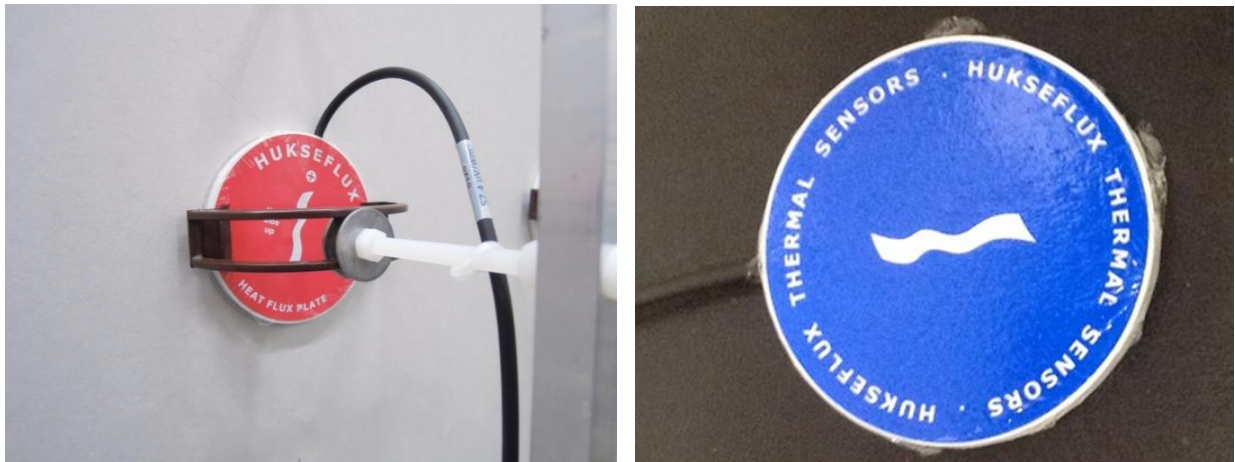
The image of the underside of the HFP on removal from the plasterboard surface (right hand image of Figure 5), shows the relatively small indents in the plasterboard surface, indicating that there is complete thermal contact between the wall surface and the cling-film and hence the HFP.

Figure 5 - Image of a HFP pressure-fixed to the plasterboard surface of the test panel and image of the underside of the sensor when removed

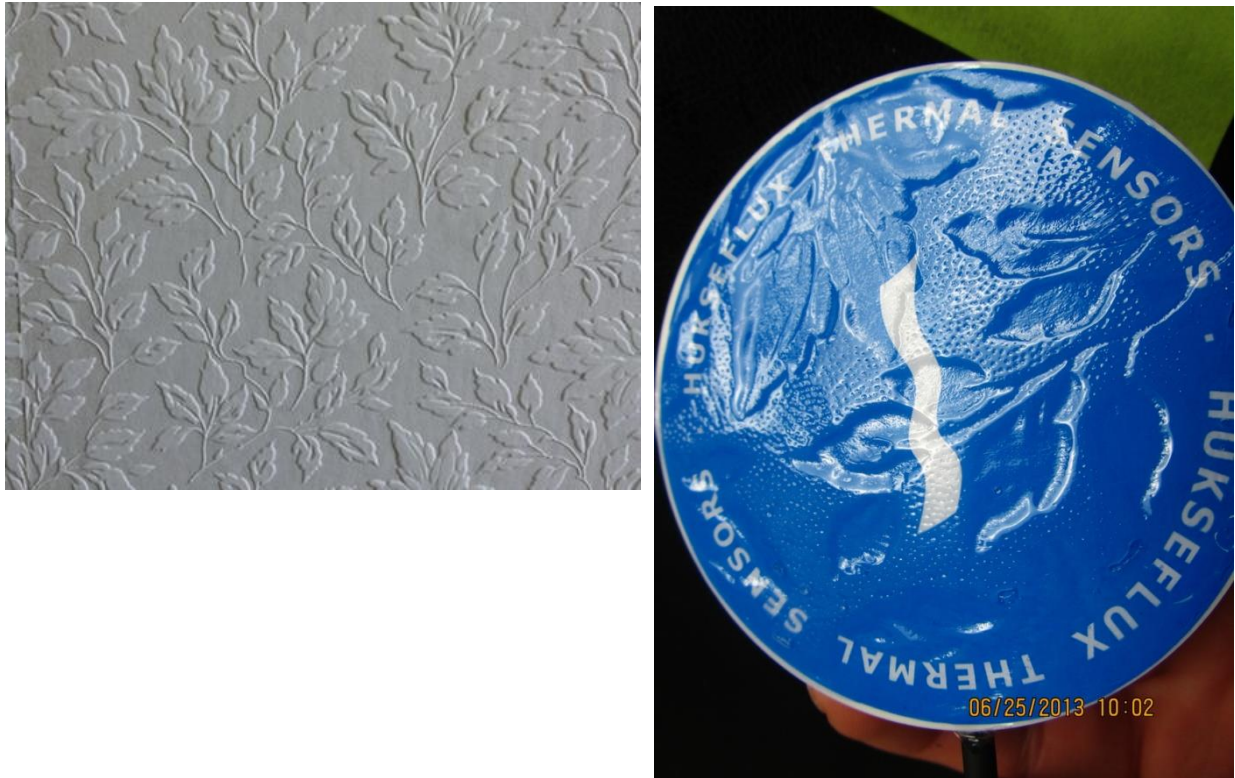
Figure 7 - Image close-up of embossed wallpapered surface of the test panel for Runs 4 and 5 and an image of the underside of the HFP after removal

Thus, for the pressure-fix system used, there is good thermal contact between both smooth (plasterboard) and embossed (or indented) surfaces and the cling-film and HFP.

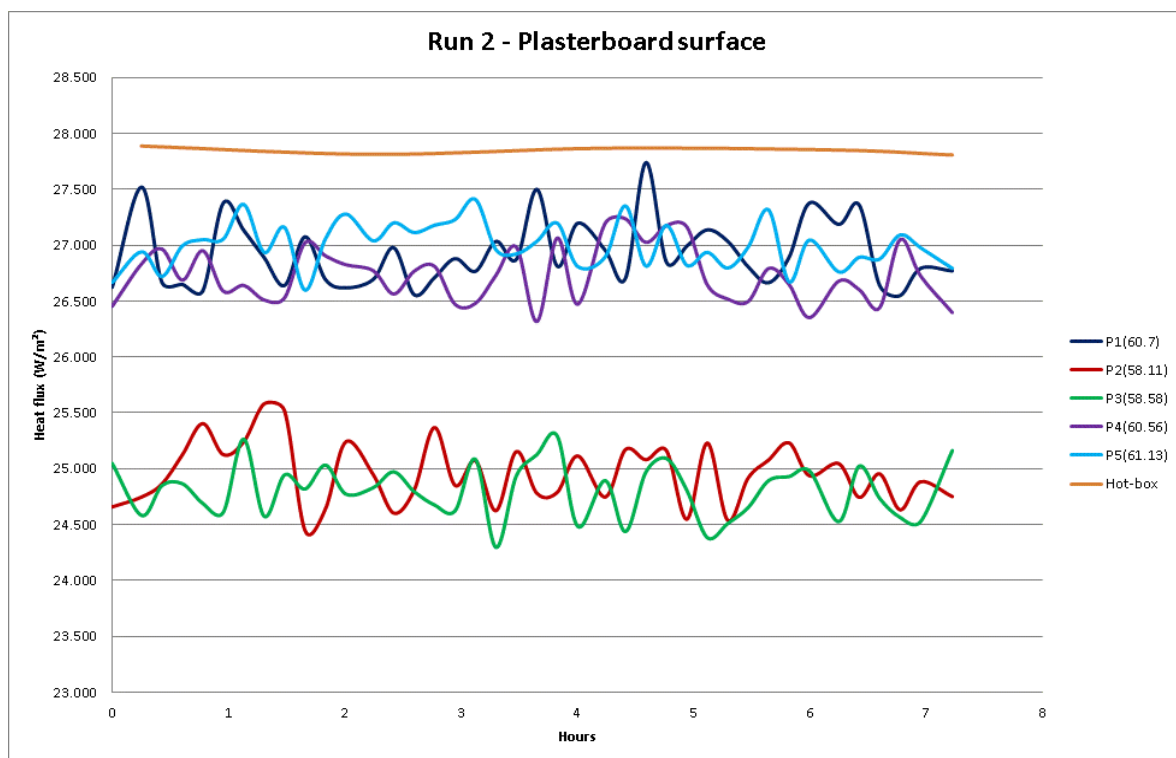
Figure 8 - ‘Raw’ heat fluxes (through test panel) for Run 2 (Plasterboard surface)

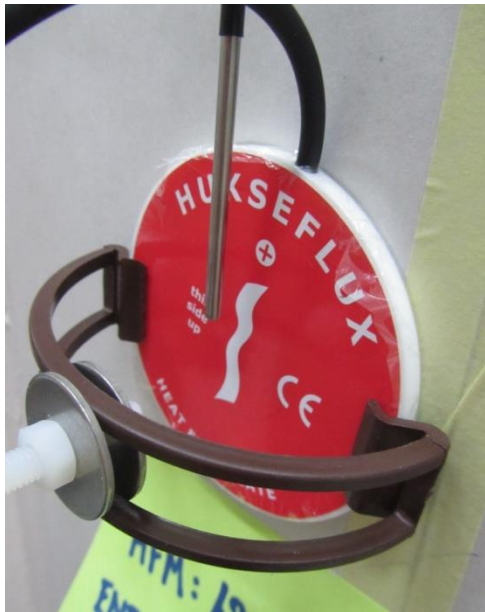
Thermistor air temperature sensors (as used for in situ measurements) were also installed close (~20 mm) to the surface at each of the five heat flux plates in Runs 2 and 5. The thermistor sensors are encased in a polished metal tube. A close-up of the sensor (as mounted for Run 2) is shown in Figure 11. This thermistor sensor will normally respond to a particular mixture of the air temperature and the mean radiant temperature of the surrounding surfaces. The low emissivity of the polished metal tube of the sensor will significantly reduce the effect of any radiant temperatures, such that the temperature sensed by the thermistor should be close to the actual air temperature.

Figure 11: Thermistor sensor (metal-tube) mounted close to the HFP surface

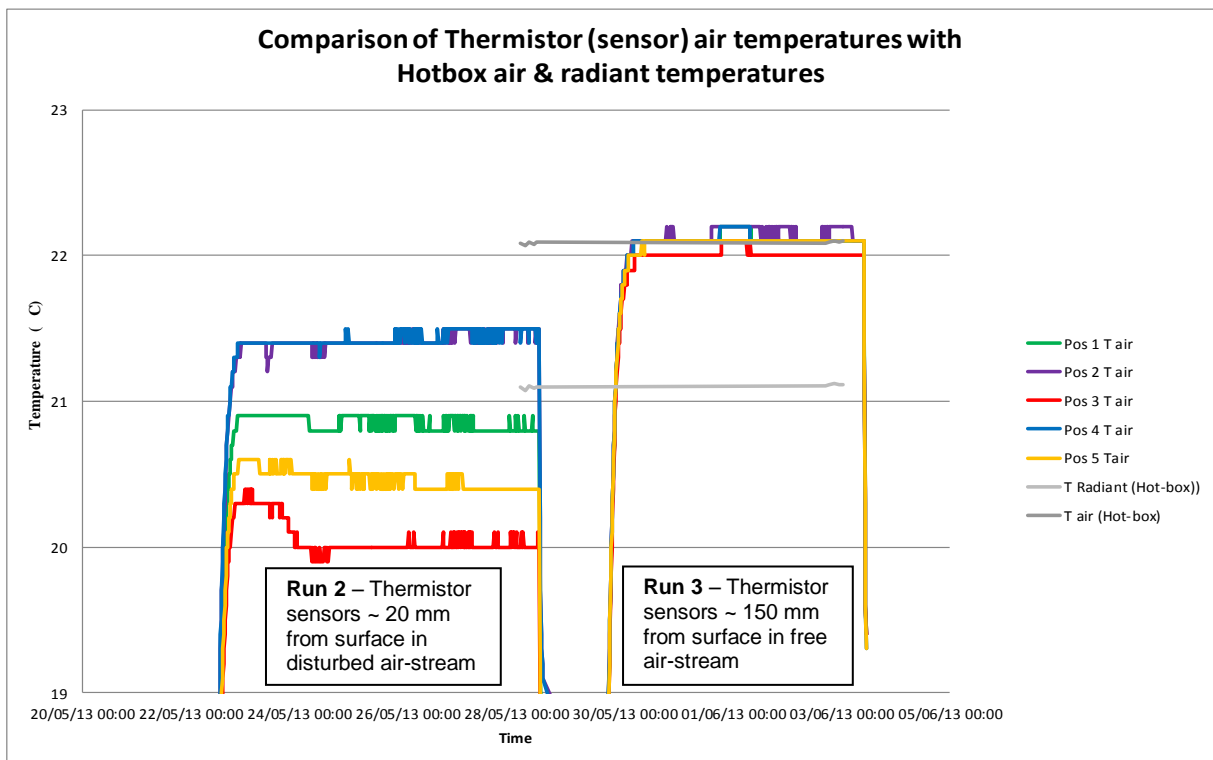
In Figure 12, comparing the five thermistor 'air' temperatures to (a) the air temperature and (b) the radiant temperature measured by the hot-box in Run 2, it can be seen that the measured 'air' temperatures are all lower than the hot-box air temperature, but also that the 'air' temperatures measured by the different HFPs also vary somewhat from location to location. For Run 3 however, the thermistor 'air' temperature sensors were positioned in the undisturbed air stream, and it can be seen that all the 'air' temperatures measured by the thermistor sensors hardly vary at all and that the mean of the five thermistor temperatures also now agrees with the hot-box air temperature. The important conclusion from this test is that the thermistor temperature sensor with its polished metal tube measures very close to air temperature.

Figure 12 - Variation in air temperature close to the test-panel surface as measured by the thermistor sensors

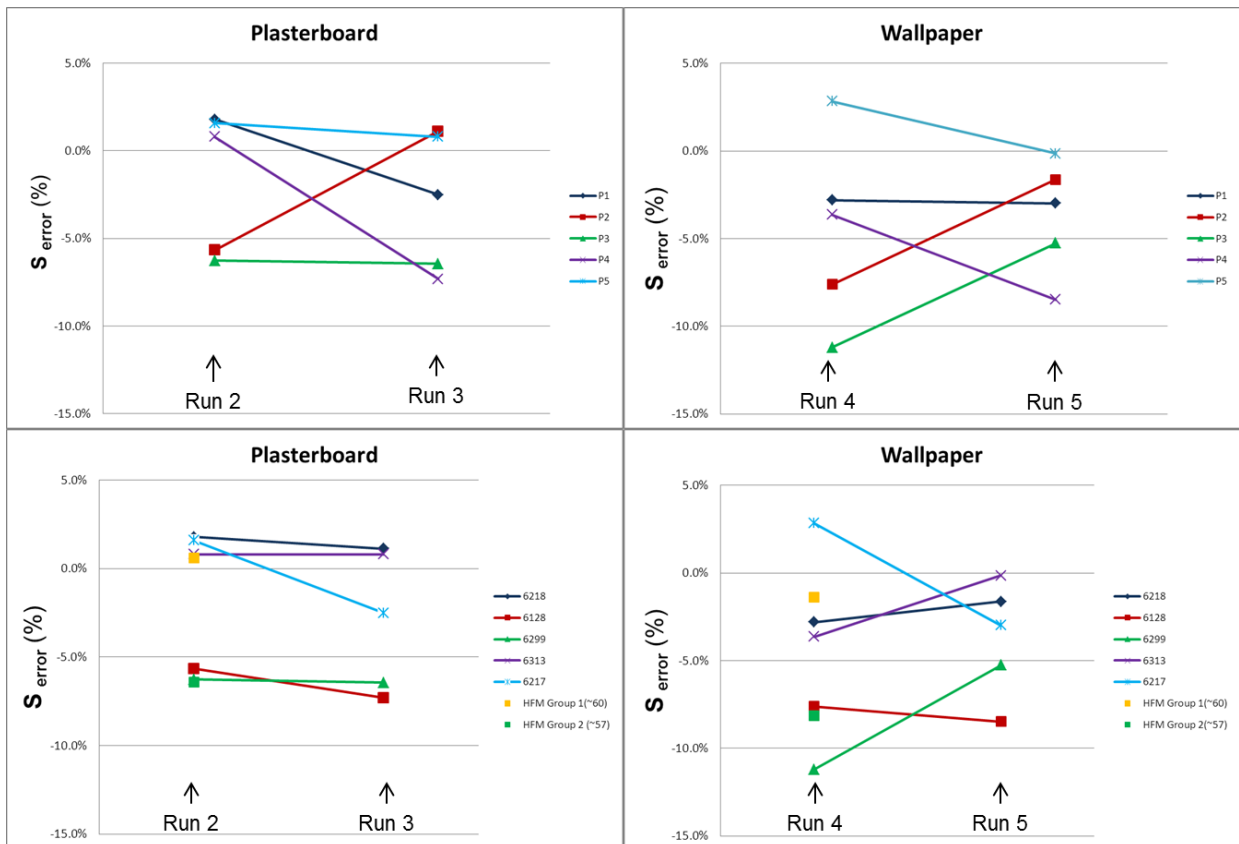
Considering the plasterboard surface (top left hand plot) and the unmoved HFP (green line), the systematic error is constant (hence a horizontal line). This is what is expected if the HFP and location are behaving consistently. For this particular HFP the systematic error is around -7%. By contrast, for the wallpaper (embossed) surface (top right plot), the systematic error for the unmoved HFP (green line) is not as constant between runs. In the first run the systematic error is about -11% and in the second it is just less than -5%. Also the *variation in systematic error* (as defined) for all HFPs is greater for the first wallpaper run compared to the second. It is not clear why that should be. One possible explanation is that the first wallpaper run was carried out only a day or so after the wallpapering of the test-panel (when the wallpaper may not have fully dried out and stabilised, whereas the second run would have been several days later when the wallpaper had more fully dried out.

Figure 13 - Plots of the systematic error (as a percentage) between the heat flux as measured by the HFP and that measured by the Hot-box

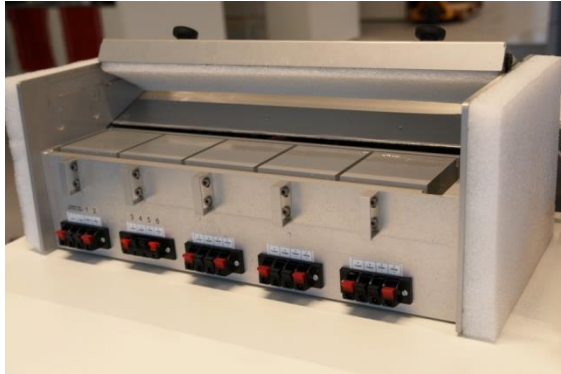
Figure 16 - Hukseflux Calibration apparatus showing locations for up to five HFP to be calibrated

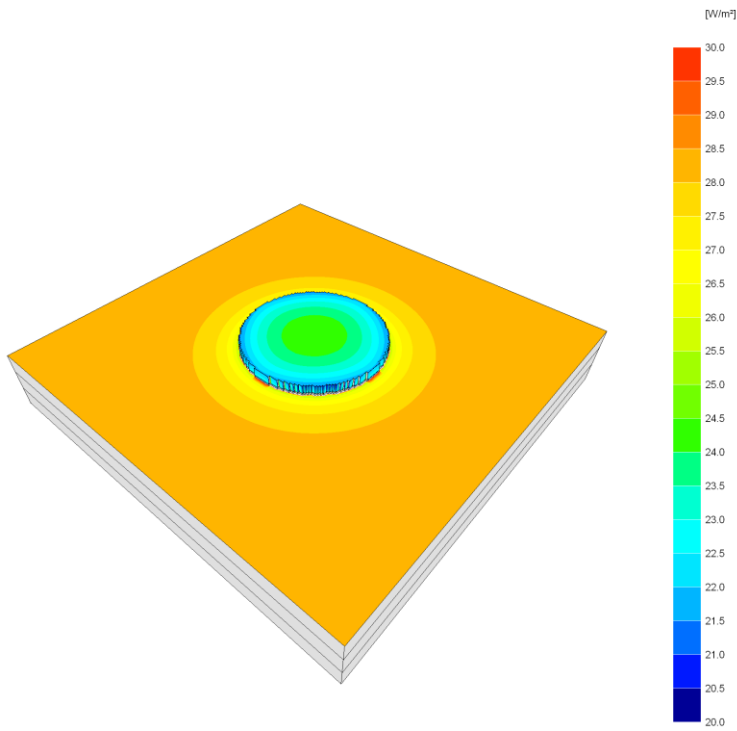
The HFP pressure-fixed to the hot-side surface of the test panel in the hot box and those used in situ on a brick wall are very similar in their thermal behaviour. Figure 21 shows the heat flux through the HFP (pressure-fixed to the Test Panel) and that through the test panel itself and Figure 22 shows this for the HFP pressure-fixed to a solid brick wall. The images show clearly the reduction in heat flux (due to the presence of the HFP) together with the area around the edges of the HFP, where the heat flux continues to be disturbed.

Figure 21 - Image of the heat flux through the HFP and the Test Panel

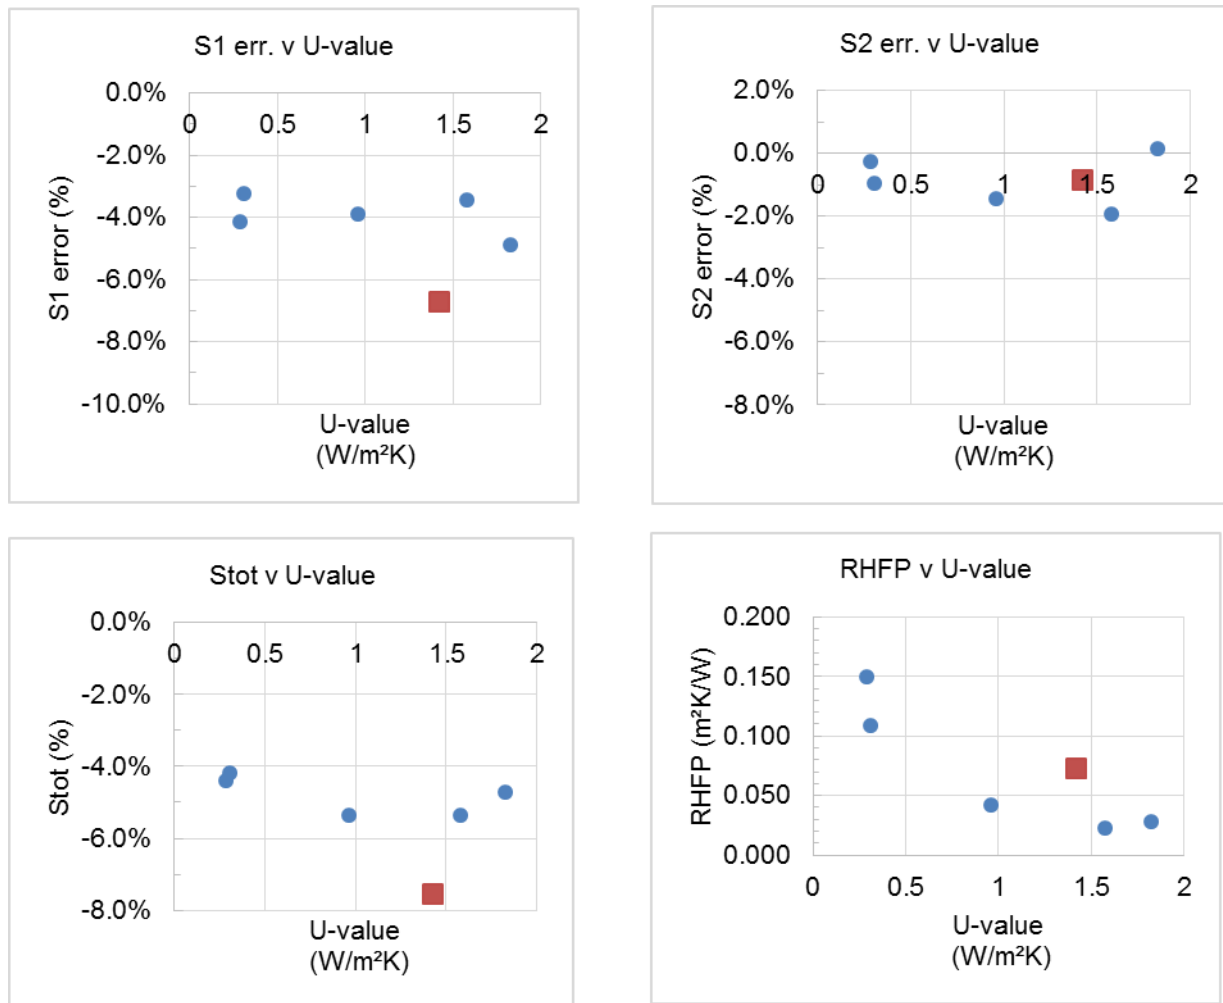
Various plots of the systematic errors (plus a plot of R_{HFP}) against the variation in U-value are shown in Figure 24

Figure 24: Plots of the sensitivity of the systematic error with U-value

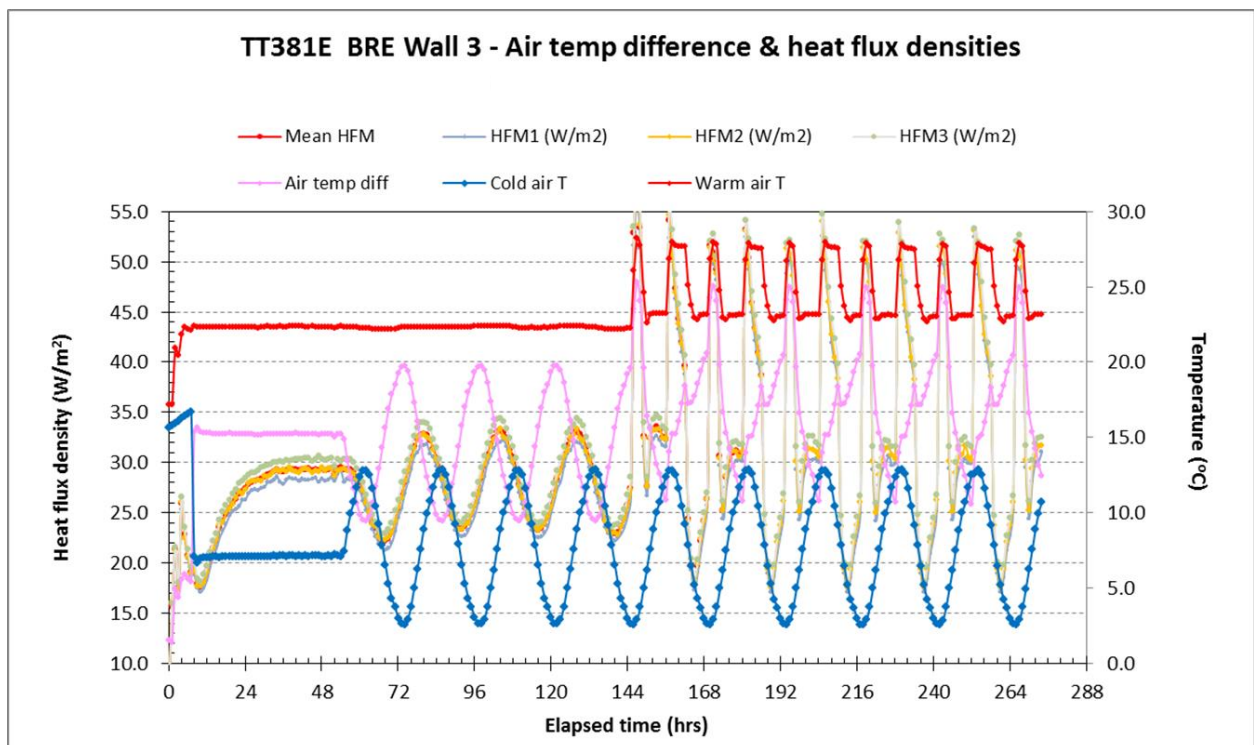
Figure 25: Steady-state and dynamic temperatures and measured heat flux from the HFP01 HFPs

The first main period shown in Figure 25, (following a brief set up period of a few hours which shows the creation of the initial conditions) runs up until approximately 50 hours of elapsed time and represents the steady-state period with the hot-side air temperature (Warm air T) steady at about 22.5 °C and with the cold-side temperature steady at about 7.0 °C. The middle period, running between approximately 50 hours and 144 hours, has the warm-side temperature steady as previously but with the cold side temperature cycling between about 2.5 °C and 13 °C (this was to simulate the generality of the diurnal

As part of the overall Solid Wall Insulation project, a number of solid brick walls were built in the laboratory and installed for testing in a separate NPL hot-box. These walls are described in the report on this project “Understanding the thermal performance of solid walls”. The tests carried out were mostly steady-state, however one built-wall, Wall 3, also underwent some dynamic assessment in order to confirm (or not) that U-value measurements carried out under steady-state conditions produced the same result when carried out under varying internal and external temperature conditions. The heat-fluxes (and hence measured U-values) are not determined from the hot-box measured heat-flux but from the heat-flux as measured by three HFP01 HFPs located near to the centre position on the hot-side wall surface. The typical steady-state and dynamic conditions for these runs in the hot-box are shown in Figure 25.

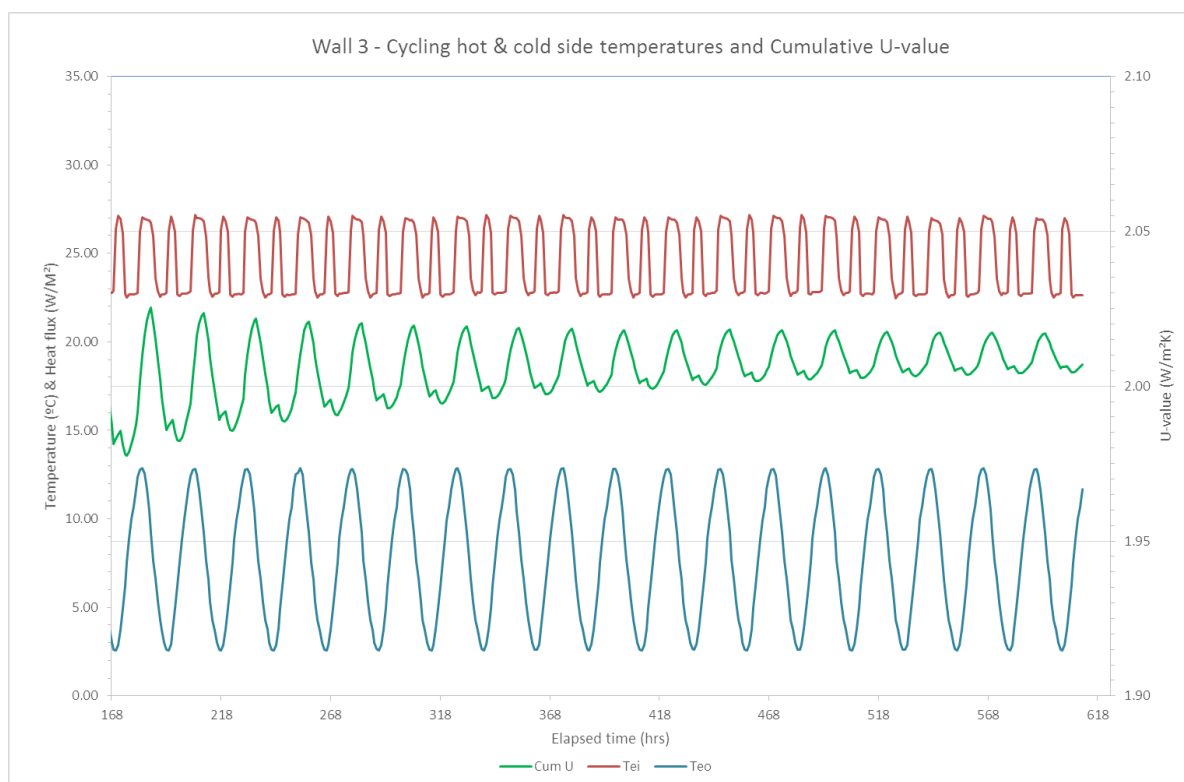
Figure 26 shows an extended period of hot-side and cold-side cycling temperatures (from elapsed time 168 hours onwards) and the resulting cumulative U-value for the uninsulated Wall 3. The cumulative U-value is determined from the sum of the average heat-flux (as measured by the three HFP) divided by the sum of the temperature difference over the relevant period of the test run.

Figure 26: Wall 3 (uninsulated) – Hot-side and Cold-side temperature cycling and the resulting cumulative U-value as measured by the HFP01 HFPs.

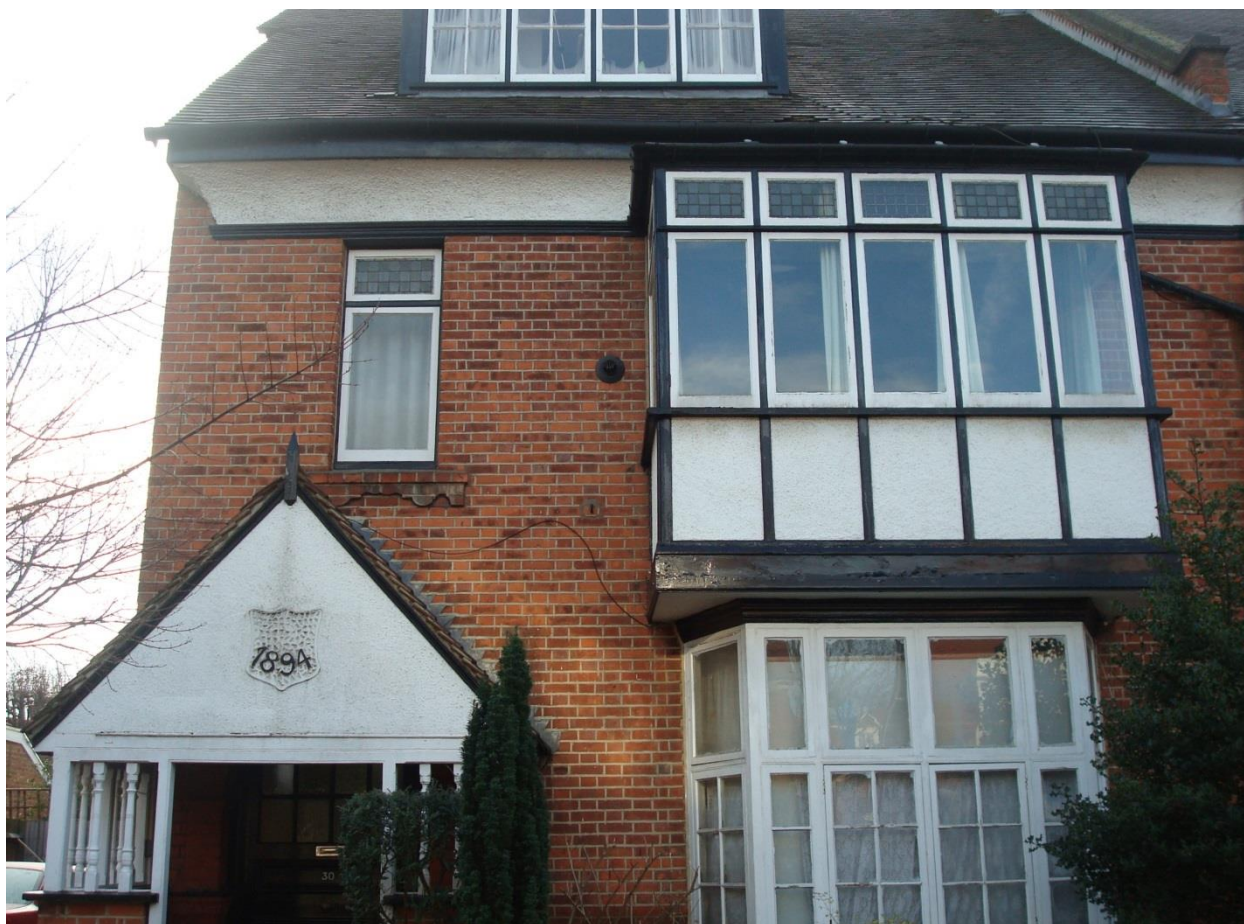
Figure 27 - Front view of dwelling

The field tests (ie Test 3 to Test 7) were conducted in a vacant dwelling in West London between February and June 2014. The dwelling was a first floor flat in a semi-detached block and the front view of the dwelling is shown below. Owing to its unusual shape, it had exposed facades on all four sides, making it particularly suitable for these experiments. The north façade had a 1.5 or 2 brick thick wall with a thickness of around 13.5” while the other facades were 1 brick (i.e. 9 inches) thick. The east and west walls were relatively free of sunlight in the winter due to the urban location and proximity of other buildings. The walls were wallpapered however permission was granted by the owner for the wallpaper to be stripped because a major refurbishment was anticipated. The plan drawing in Figure 28 gives some idea of the configuration of the dwelling.

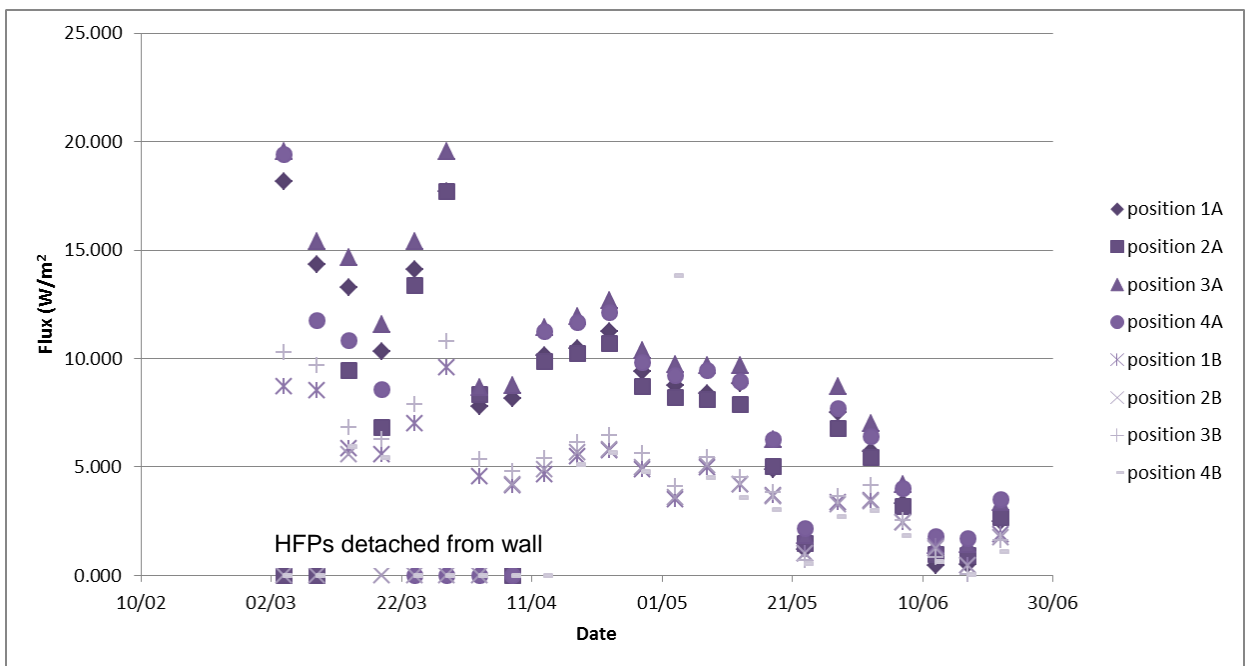
Figure 30 - Heat flux for each time period at each measurement location

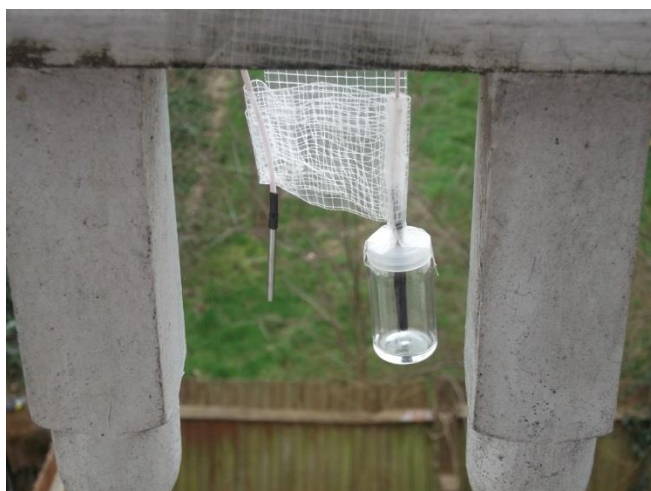
The temperature of the black thermistor within a glass vial (T_{bv}) was compared with the temperature recorded by the silvery thermistor (T_s). A preliminary examination of the data quickly revealed that the black thermistor in the vial was generally warmer than the silver thermistor during the day, but at night the black thermistor in the vial was at a slightly lower temperature than the silvery thermistor. Figure 32 shows the setup of these two sensors.

Figure 32 - Silvery thermistor and black thermistor in a glass vial

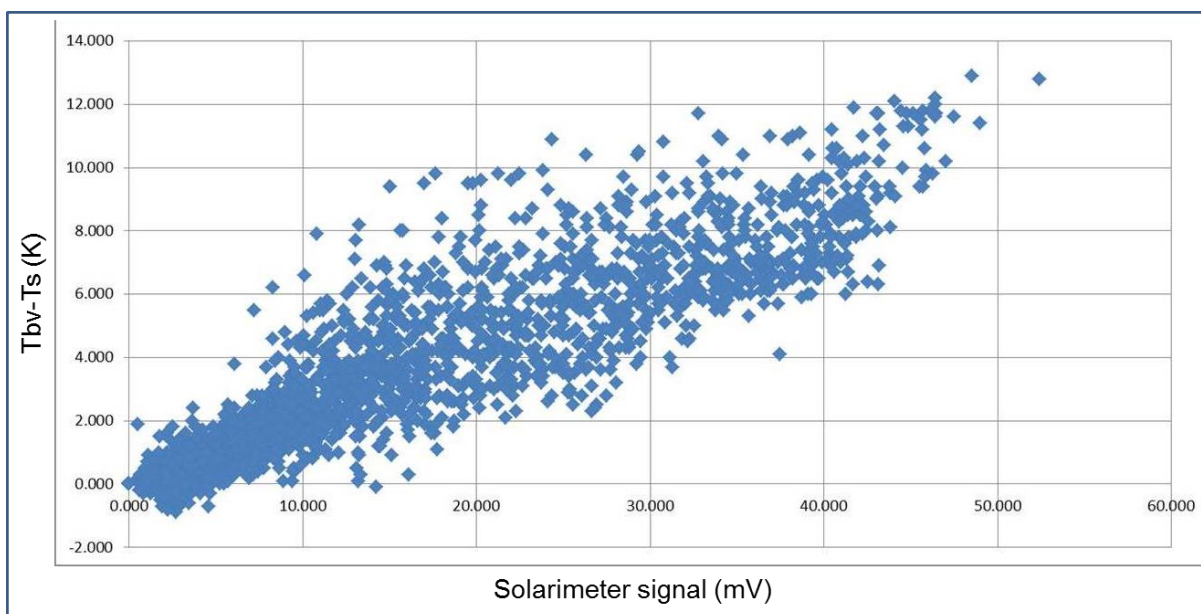
The following scatter plot (Figure 33) shows the data underlying the correlation between $T_{bv} - T_s$ (the temperature of the black sensor in the vial and that of the silvery sensor) and the signal from the solarimeter.

Figure 33 - Relationship between the vial setup and the solarimeter

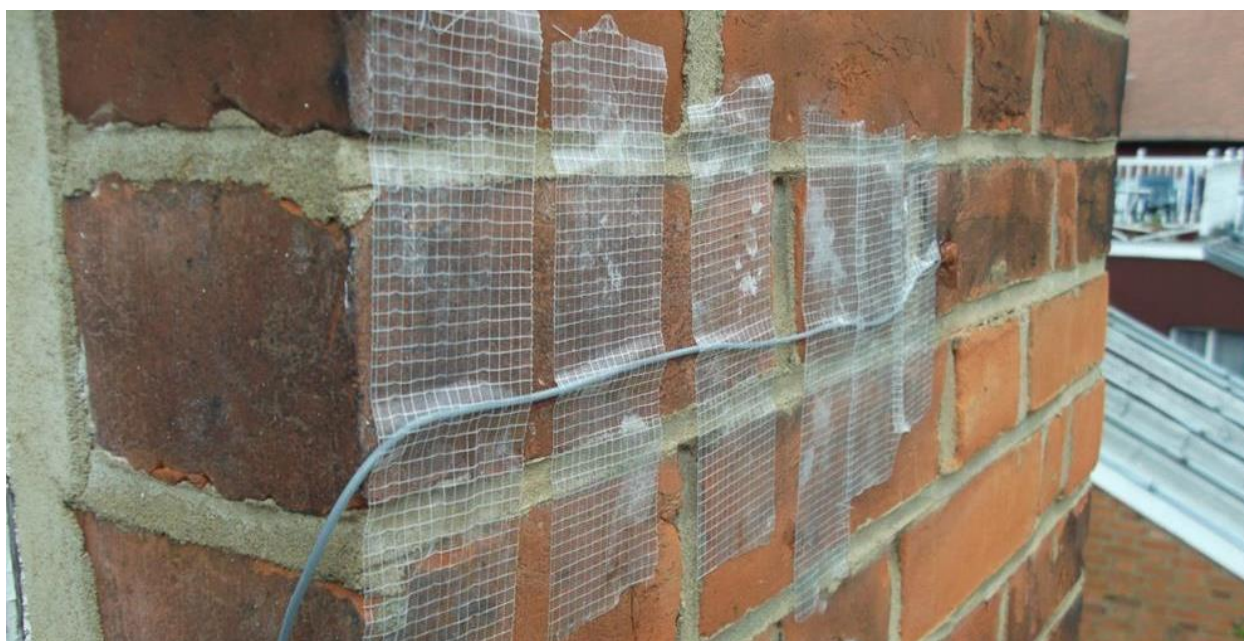
An external surface temperature sensor was glued to the south wall. Brick dust was glued to the surface sensor in order to provide it with a similar albedo and emissivity as the surface of the wall. The cable was taped along the surface of the wall to minimise heat conduction along the cable.

Figure 35 - The external surface sensor

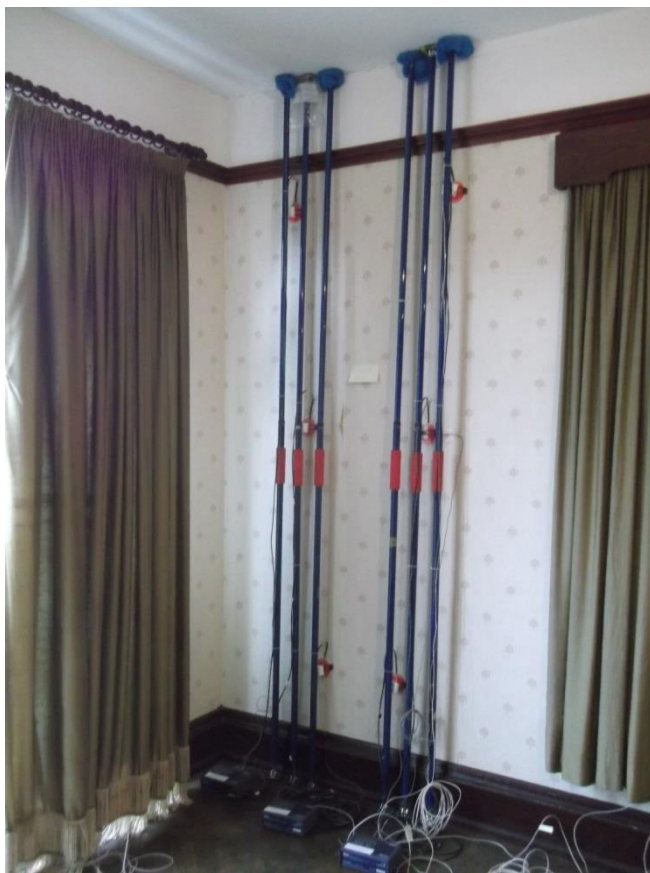
This test was conducted in response to some discussion regarding the appropriate positioning of heat flux plates in relation to height above the floor, or distance below the ceiling. For this test, U-values were measured at various heights. The HFPs were placed at different heights on the west wall of the test dwelling as in Figure 36 below.

Figure 36 - Vertical stratification test setup

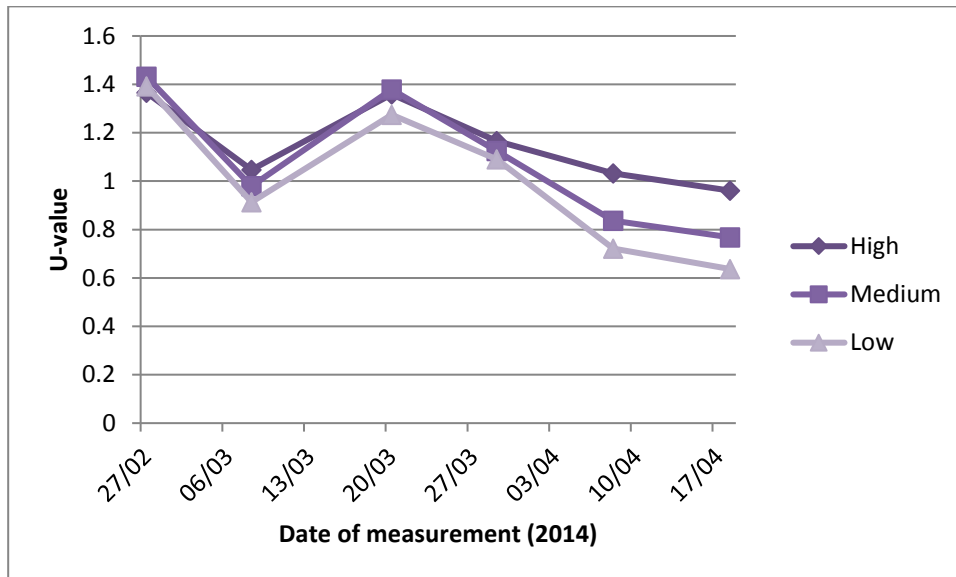
individual periods of monitoring; confirming that the U-values vary little vertically in the colder months. The three series; “high”, “medium” and “low” refer to the positioning of the groups of HFPs on the wall.

Figure 37 - U-value over time as measured at different heights on the wall

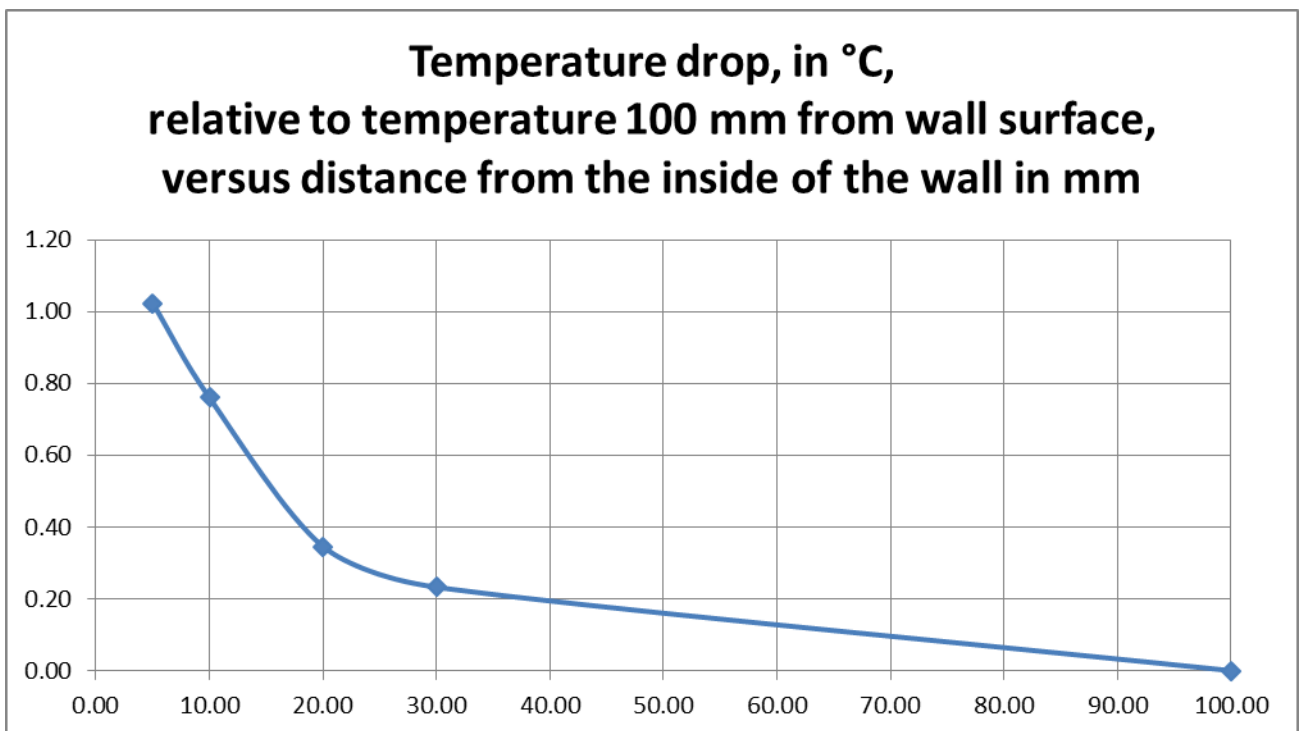
Figure 40 shows the results of an additional test which was carried out in early 2015, in a different property, showing the trend between air temperature and distance from a wall, showing that although a significant drop in temperature is seen close to the surface of an external wall, the distortion to the temperature is much less if the distance of the temperature sensor from the wall is at least 20 mm.

Figure 40 - The drop in air temperature in relation to distance from a wall

Test 7 asked whether there is an ideal distance from the wall at which to measure the internal air temperature. It looked at the U-values resulting from temperatures measured at 10mm, 100mm and 500mm from the wall surface. The results suggested that in colder months, the temperature could be as much as 2% lower at a distance of 10mm which would lead to a 2% overestimation of U-value. It is therefore recommended that temperatures are measured at least 20mm from the wall surface.
