LEMAN BH DECOMMISSIONING PROGRAMME (LBT-SH-AA-7180-00001-001, REV A10)

CLOSE OUT REPORT

Project	Leman BH Decommissioning
Originating company	Shell UK Limited
Document type	Close Out Report
Document number	EP201712203007
Security Classification	Unrestricted
Issue Date	19 th March 2019

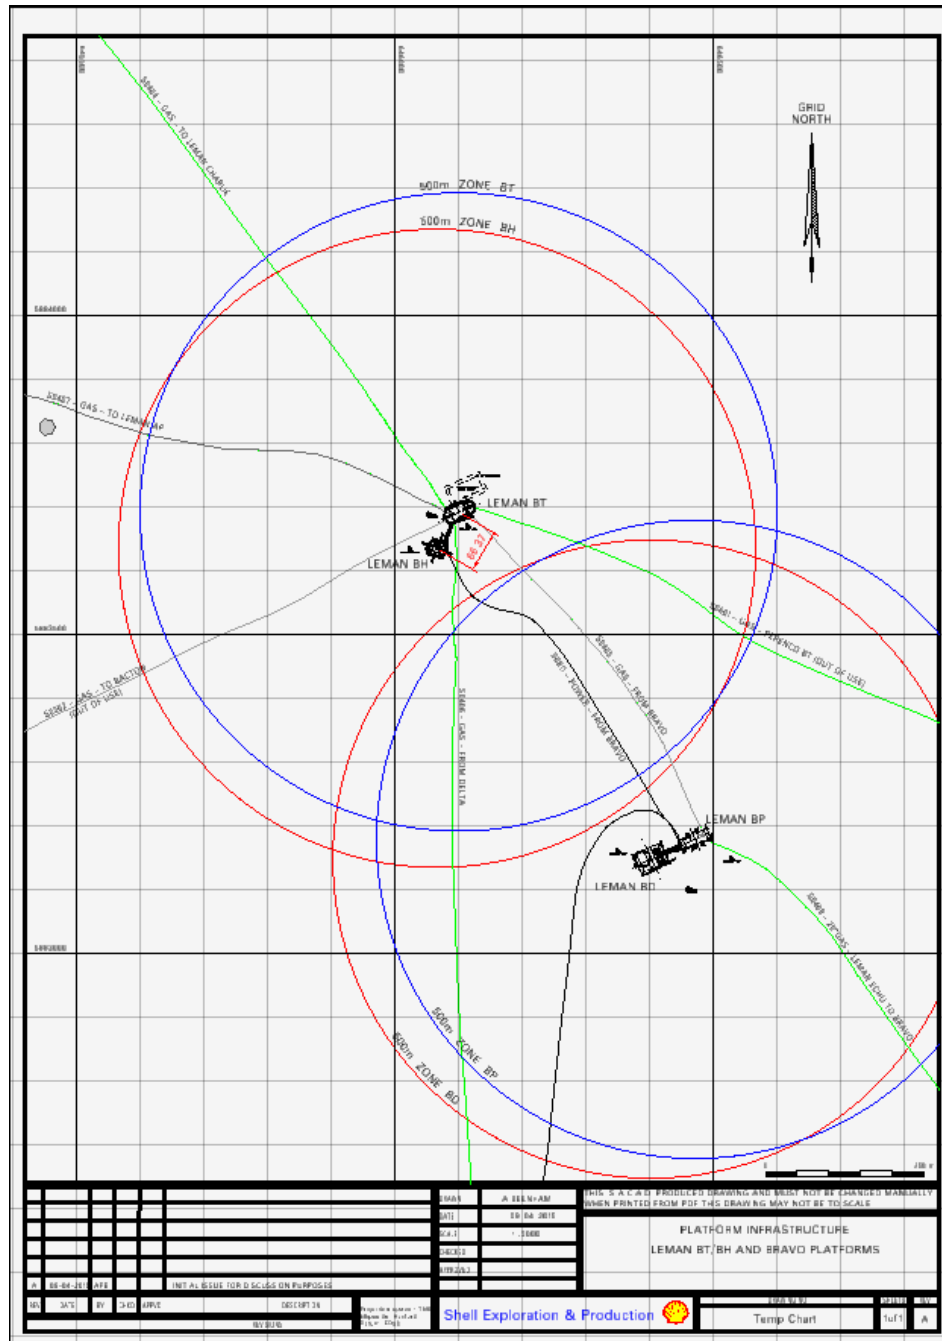
Figure 4-1 Leman BH and BT 500 m zones

A post decommissioning survey will not be performed as part of the Leman BH Decommissioning programme because the 500 metre (m) zones of Leman BH and Leman BT overlap each other to a great extent (the distance between the centre points of the two platforms is 66 m, as shown

A post decommissioning site survey will be carried out within the 500 m radius of the Leman BH installation as part of the Leman BT decommissioning in the future. Following this survey, seabed debris will be recovered for onshore disposal or recycling in line with existing disposal methods. Independent verification of seabed state will then be obtained by trawling the platform area. This will be followed by a statement of clearance to all relevant governmental departments and non-governmental organisations.

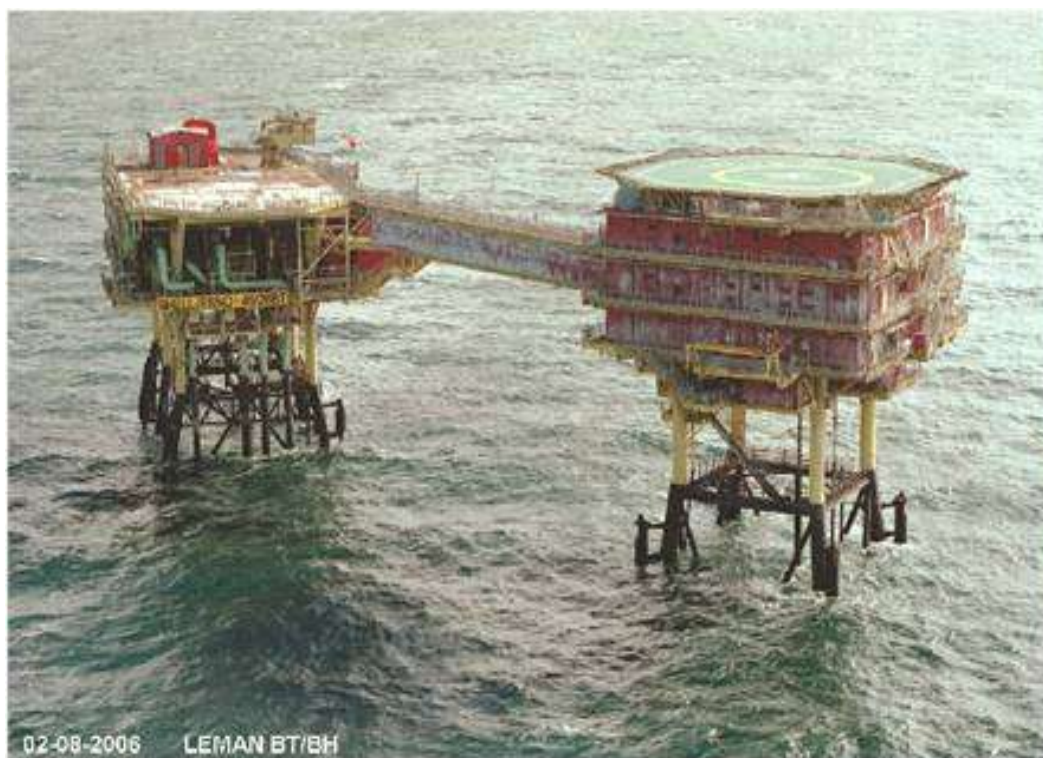
Photo 1 – Leman BT (left) and BH (right) platforms (August 2006)

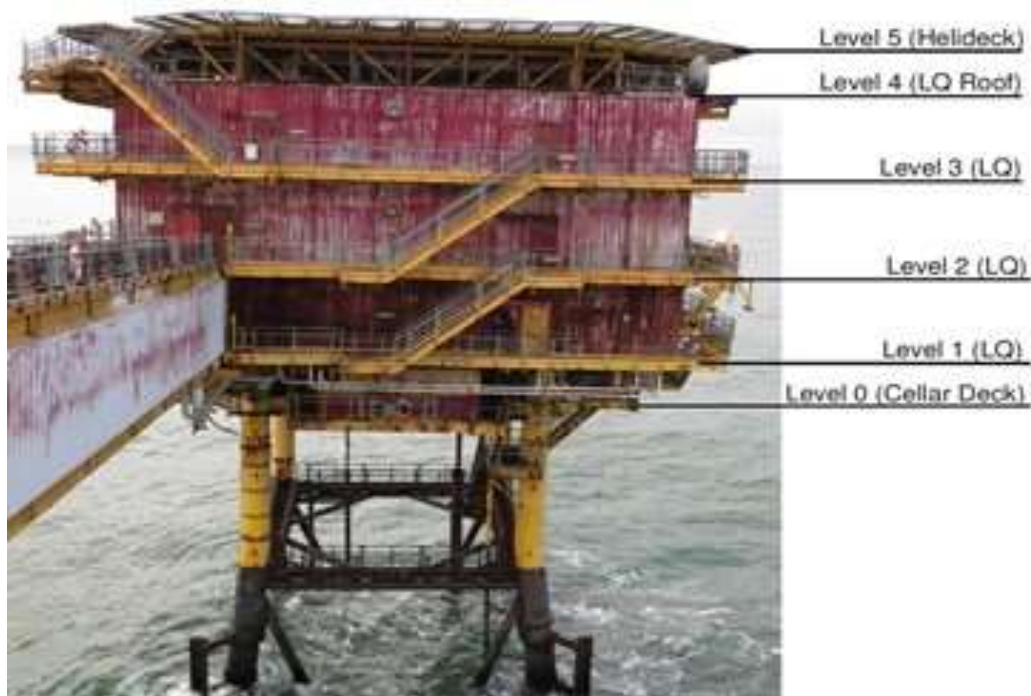
Photo 2 – Leman BH Platform (August 2006)

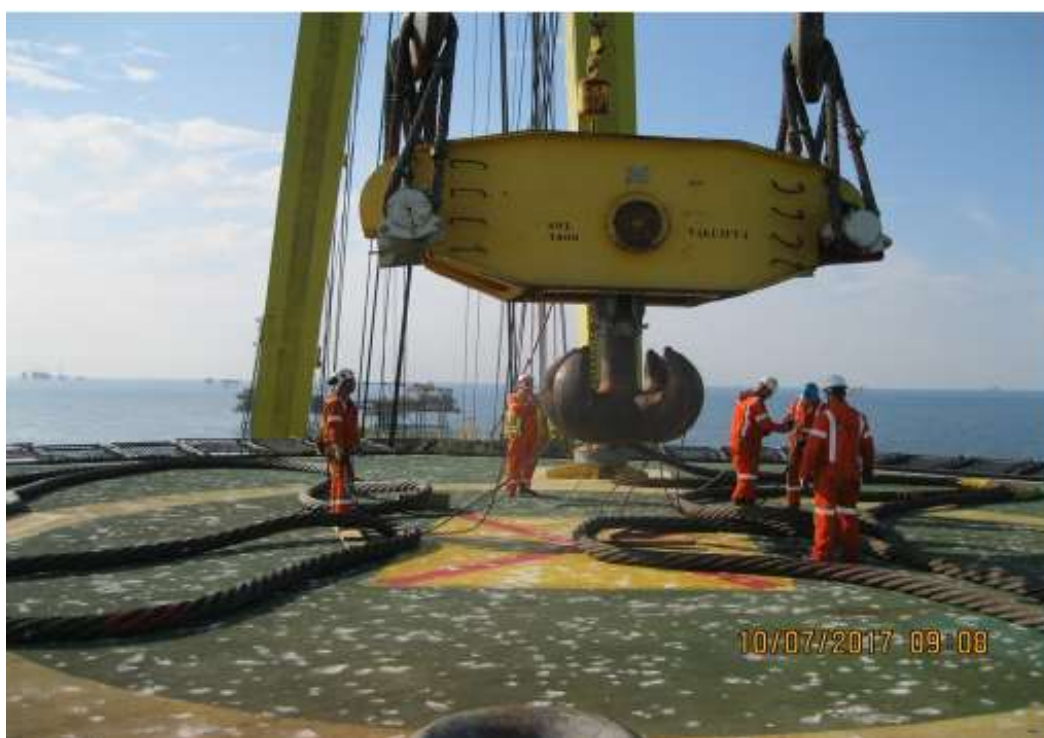
Photo 3 – Leman BH topside being prepared for lift (July 2017)

- Completed final enabling work scopes on Leman BH, including:
 - Installation of leg scaffold for final leg cut
 - Removal of stair access from cellar deck to spider deck
 - Fit lifting of rigging equipment for Topsides lift
- Cut the 4 legs above spider deck
- Lift topsides with heavy lift vessel Taklift4
- Deliver Topsides to decommissioning facility
- Return to Leman BH
- Dredge sand plug (4 legs) in preparation to cut at the 3 meter below seabed level
- Cut piles at 3 meter below seabed level
- Insert lifting pins
- Lift jacket
- Deliver Jacket to decommissioning facility
- Soft strip of the topside
- Felling, dismantling and disposal of the jacket
- Dismantling and disposal of the topside.

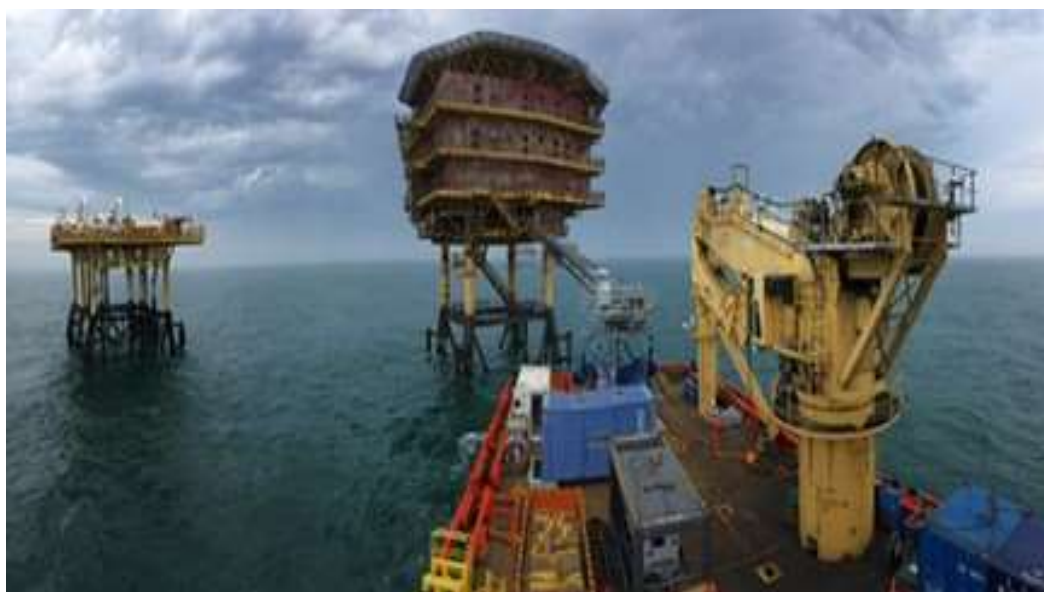
Photo 4 – Preparation work on Leman BH topside (July 2017)

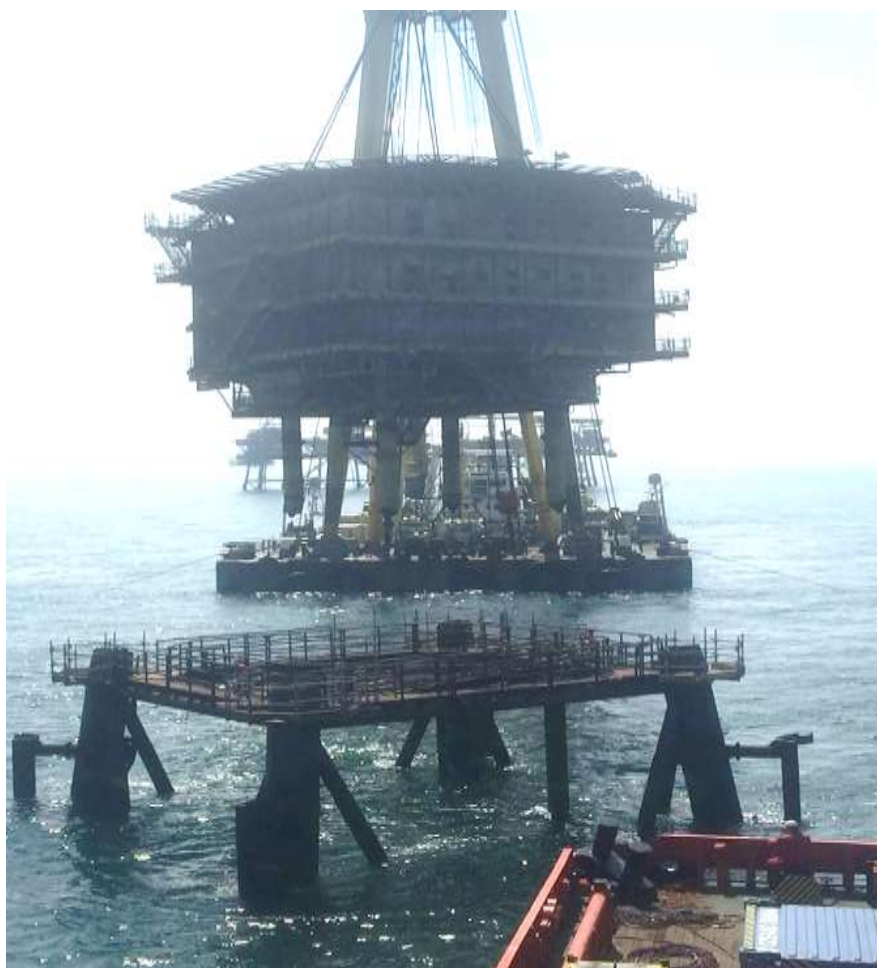
Photo 5 – Leman BH topside being lifted (July 2017)

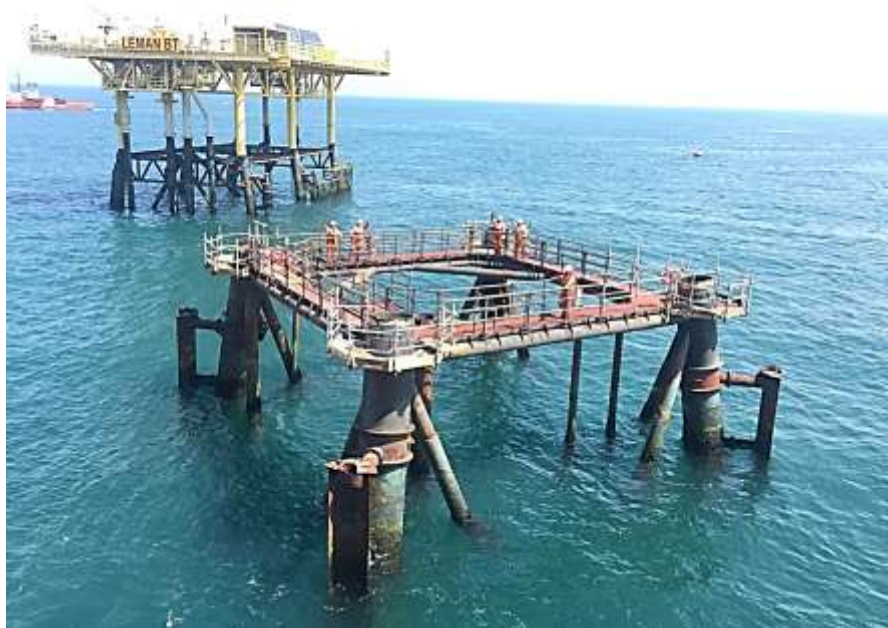
Photo 6 – Tidying up of Leman BH jacket (July 2017)

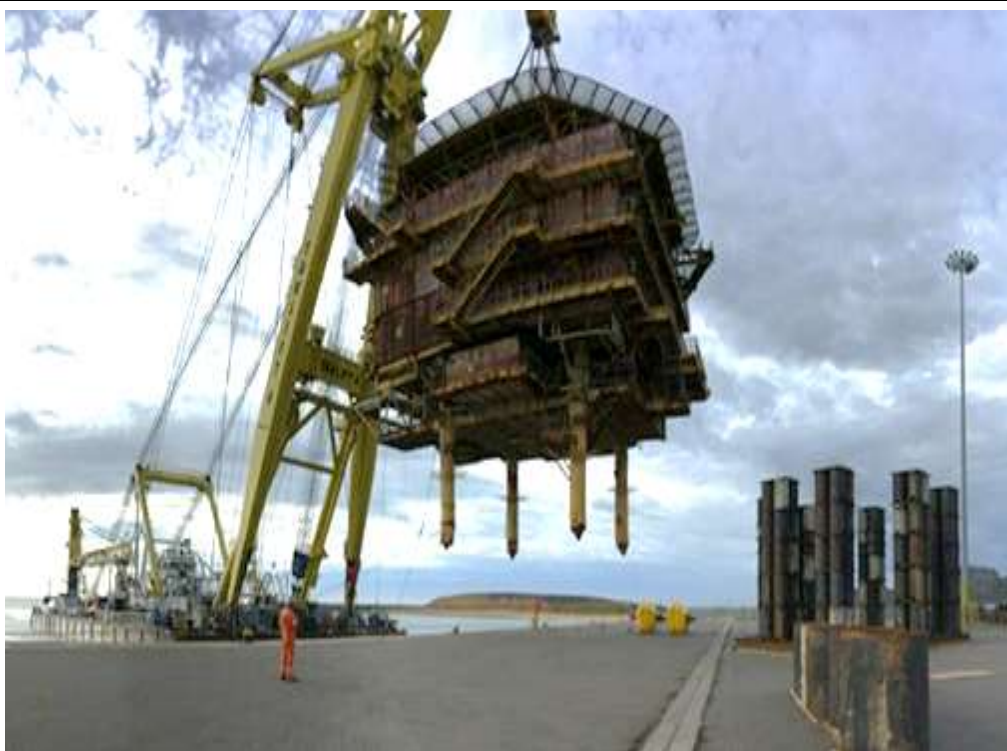
Photo 7 – Leman BH topside arriving at GTY (July 2017)

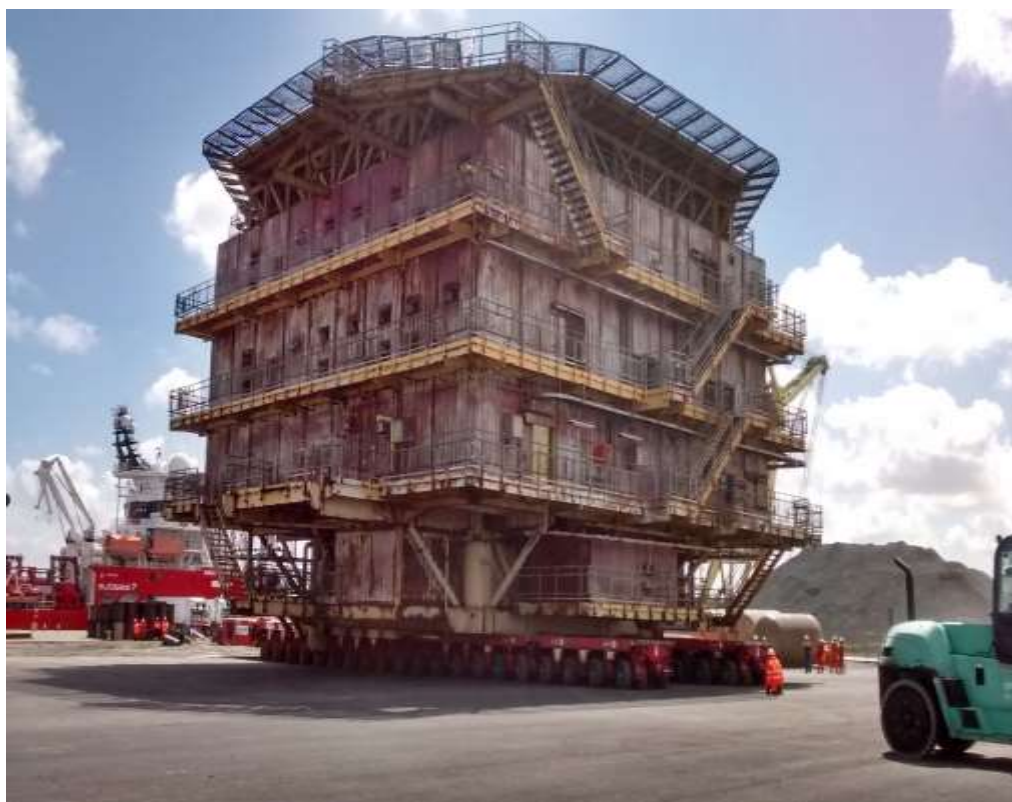
Photo 8 – Transfer of Leman BH topside to decommissioning yard (July 2017)

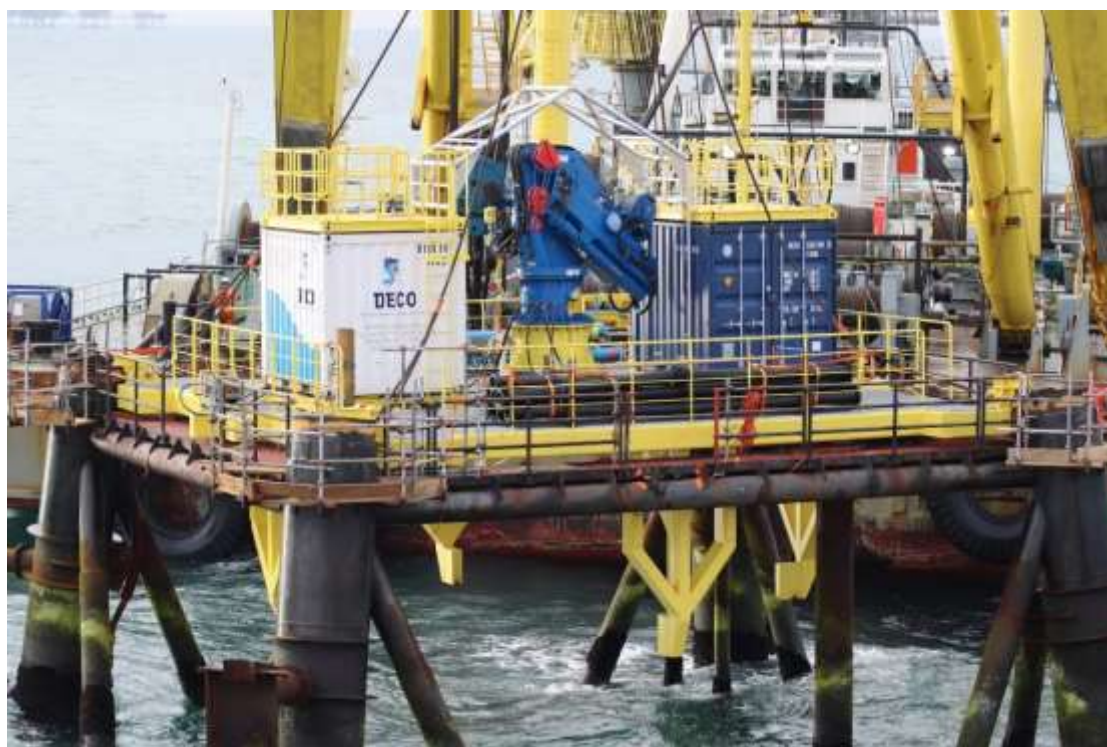
Photo 9 – Installation of rigging platform on Leman BH jacket (July 2017)

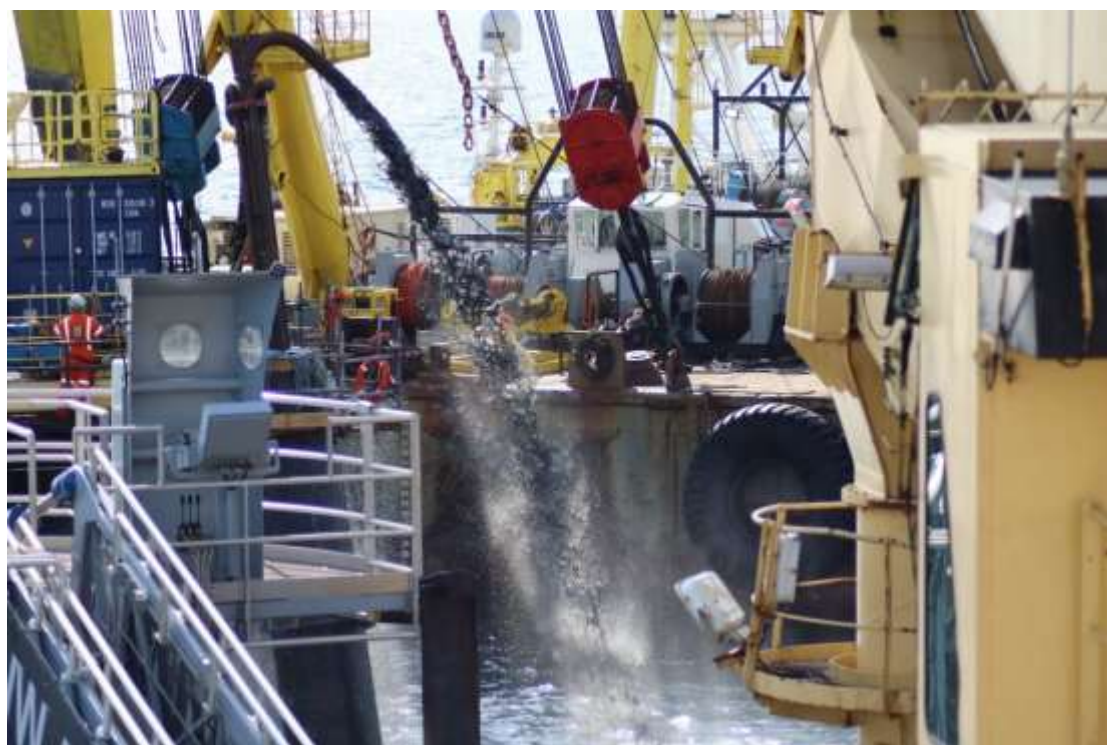
Photo 10 – Dredging of jackets at Leman BH (July 2017)

A marine licence (reference ML/232/0 (Version 2)) was obtained for the removal and placement of the sediments within the jacket legs. The marine licence was issued on 13th June 2017, and remained valid until 30th September 2017, within which period all offshore activities associated with the Leman BH decommissioning were completed. No other consents, licenses and/or permits were required for completion of the decommissioning activities at Leman BH.

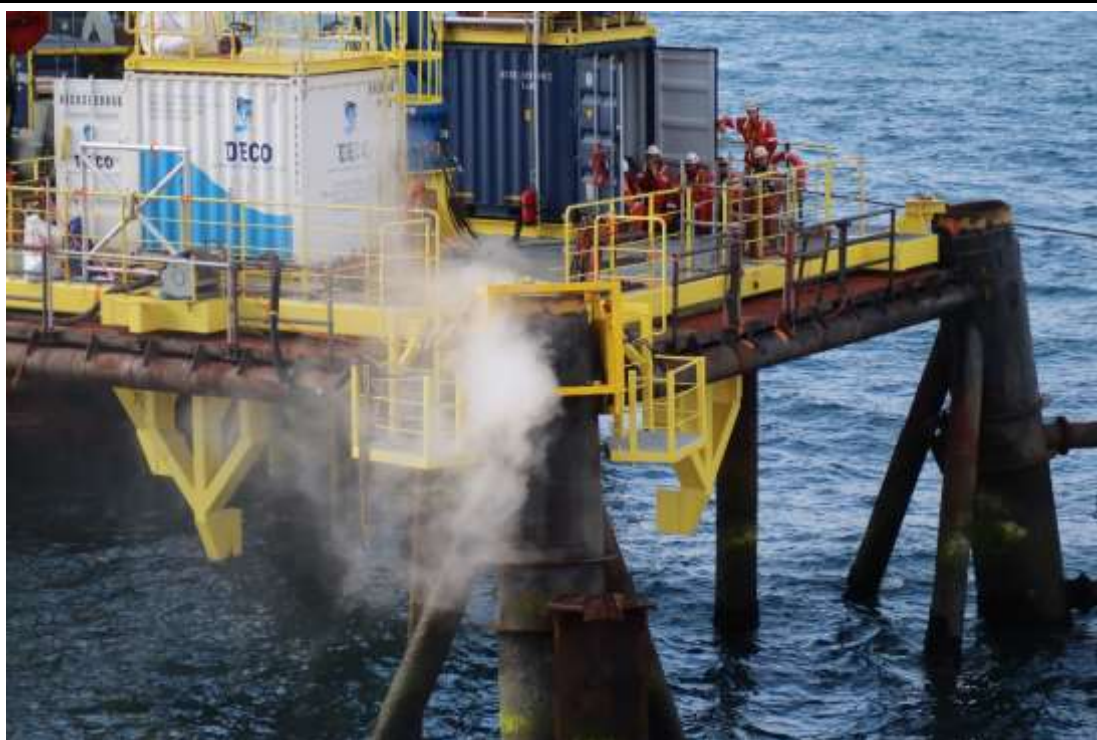
Photo 11 – Cutting holes for the lifting pins (July 2017)

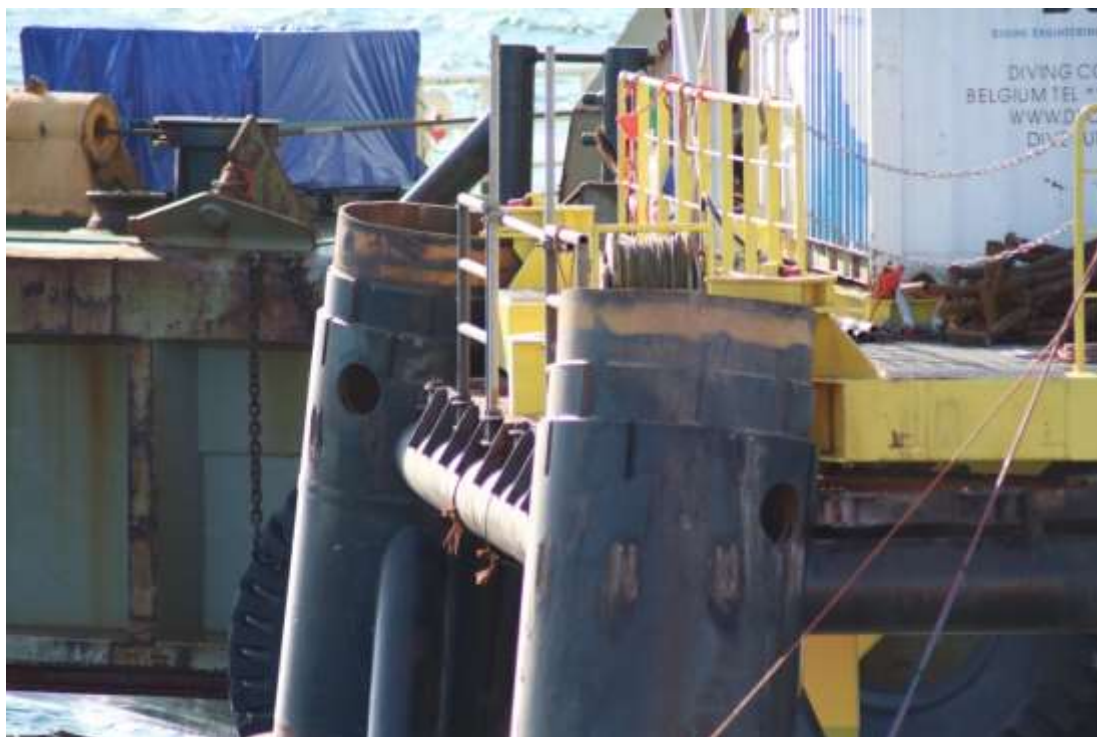
Photo 12 – Holes cut for lifting pins (July 2017)

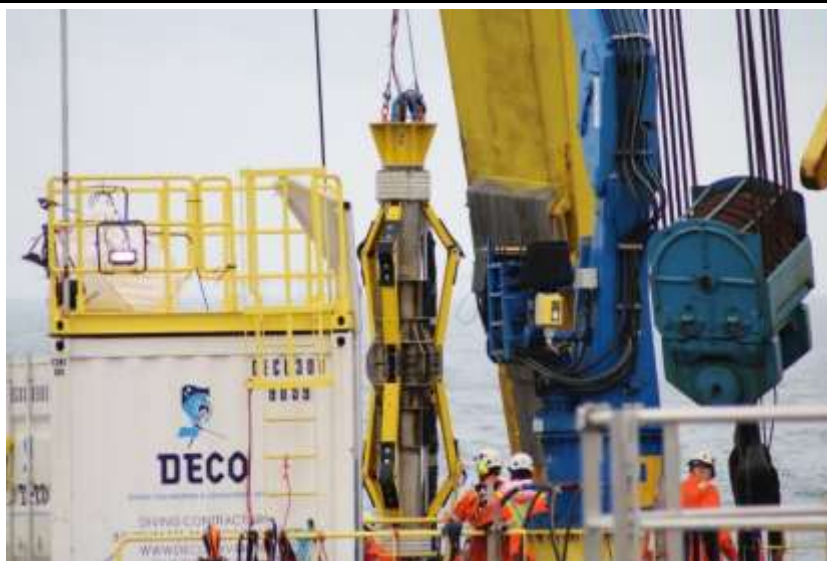
Photo 13 – Cutting of jacket piles (July 2017)

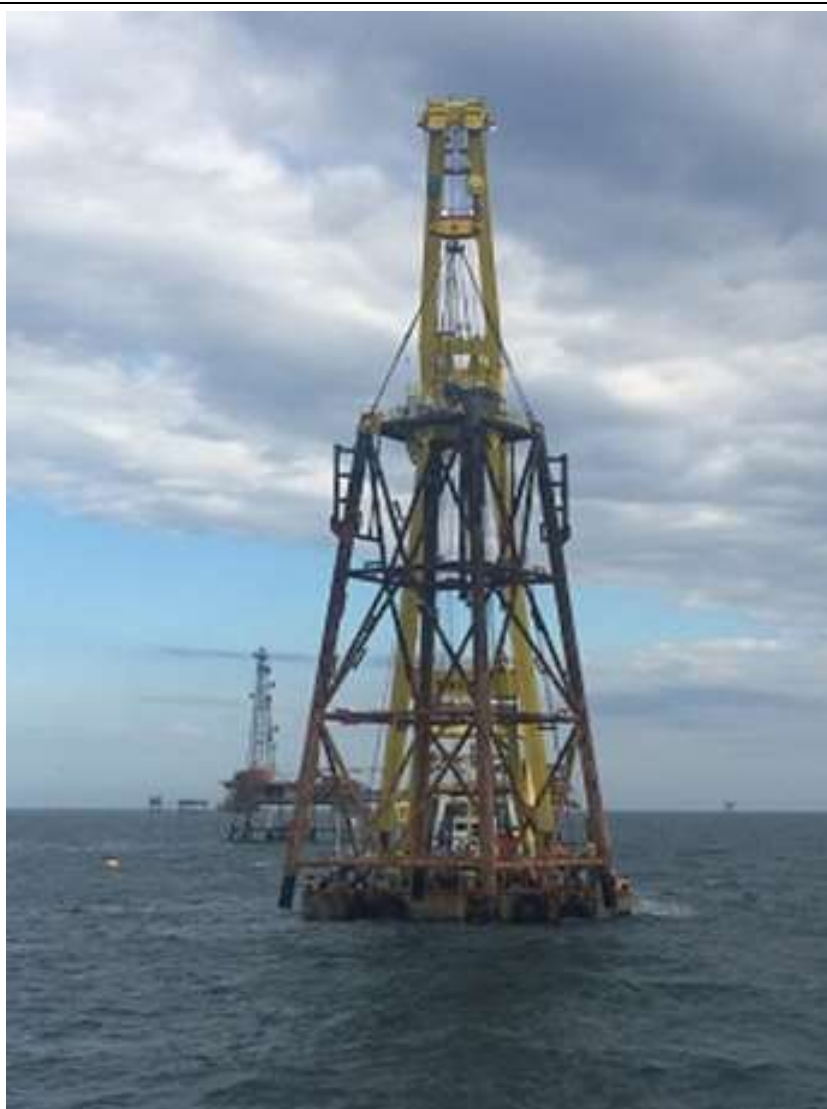
Photo 14 – Lifting of jacket (August 2017)

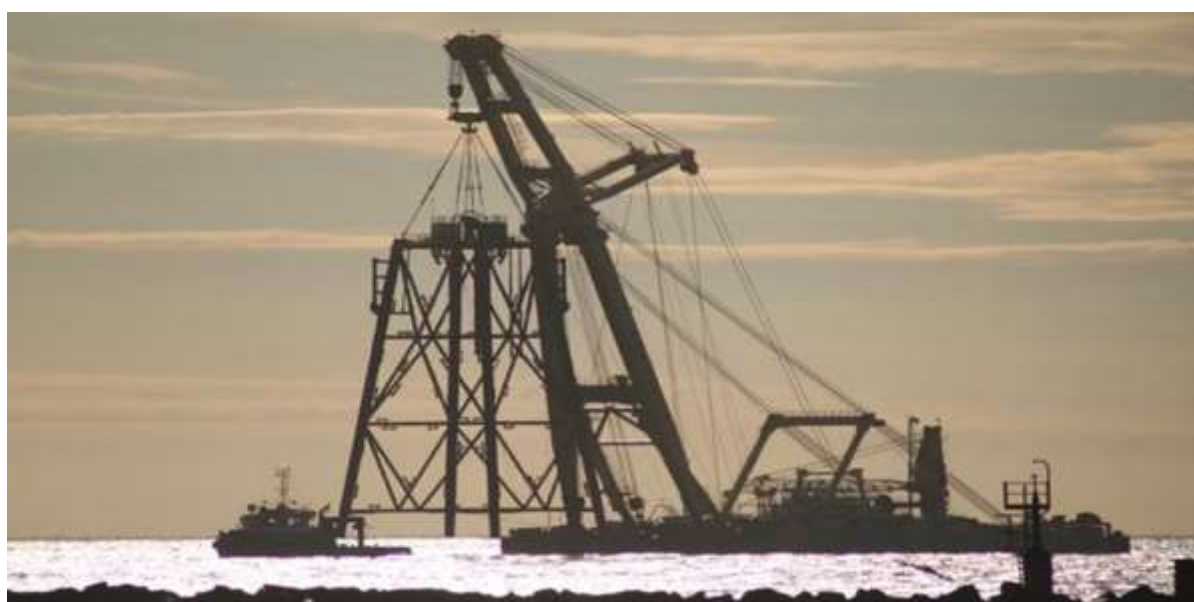
Photo 15 – Arrival of Leman BH jacket at GTY (August 2017)

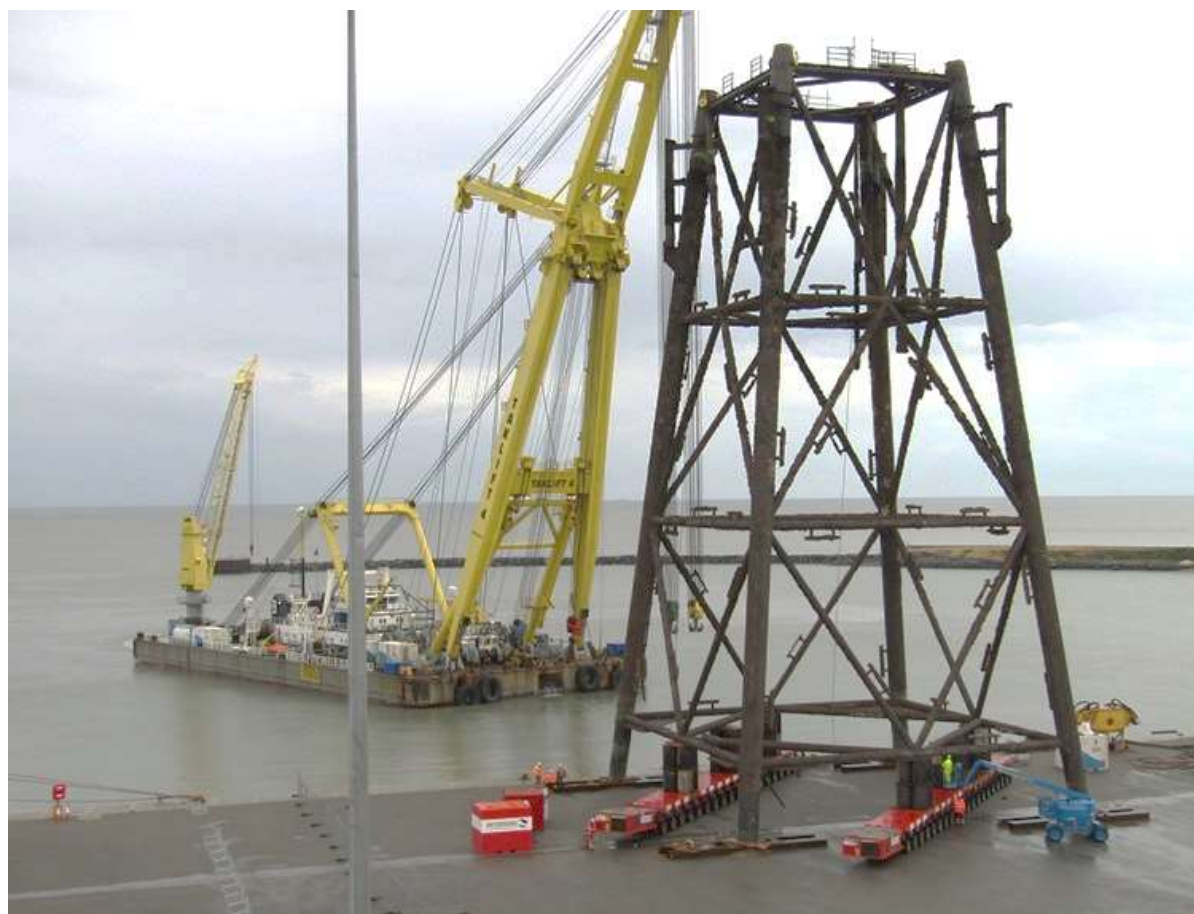
Photo 16 – Moving jacket to decommissioning site (August 2017)

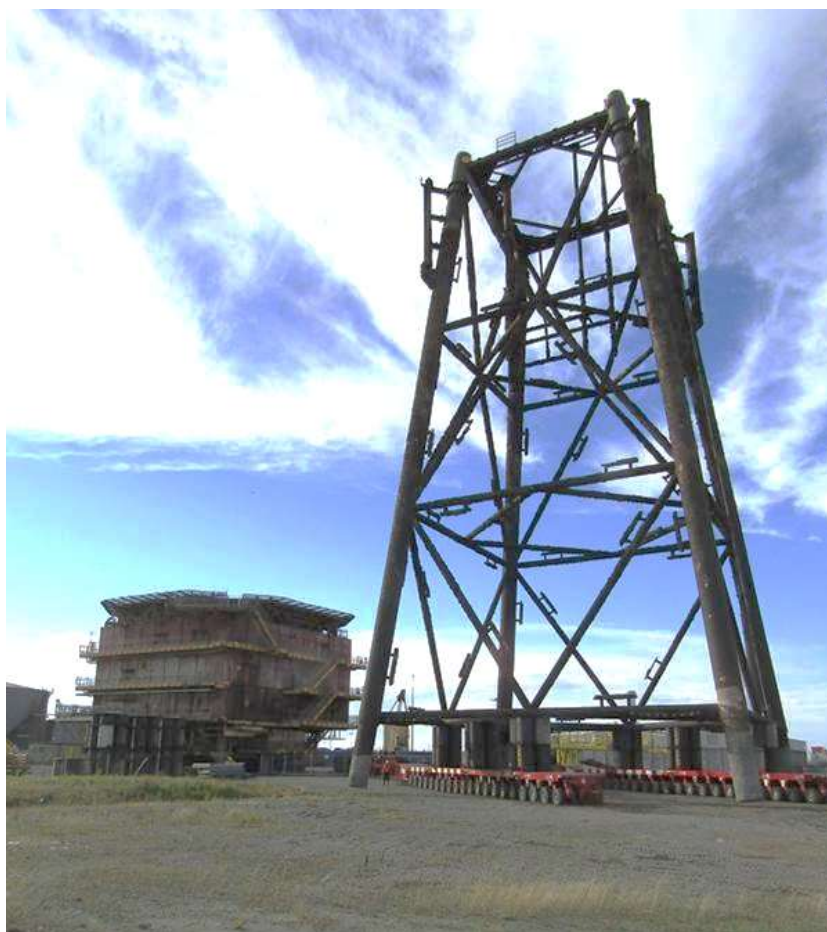
Photo 17 – Arrival of Leman BH jacket at decommissioning site (August 2017)

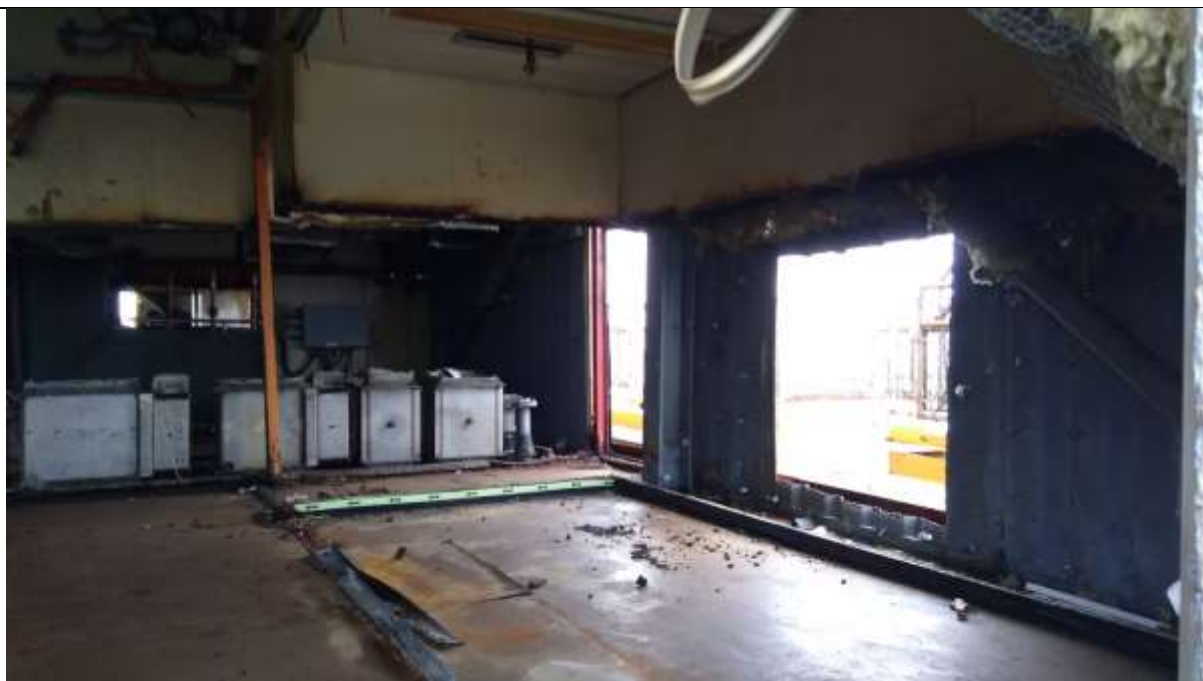
Photo 18 – Soft strip of the topside (August 2017)

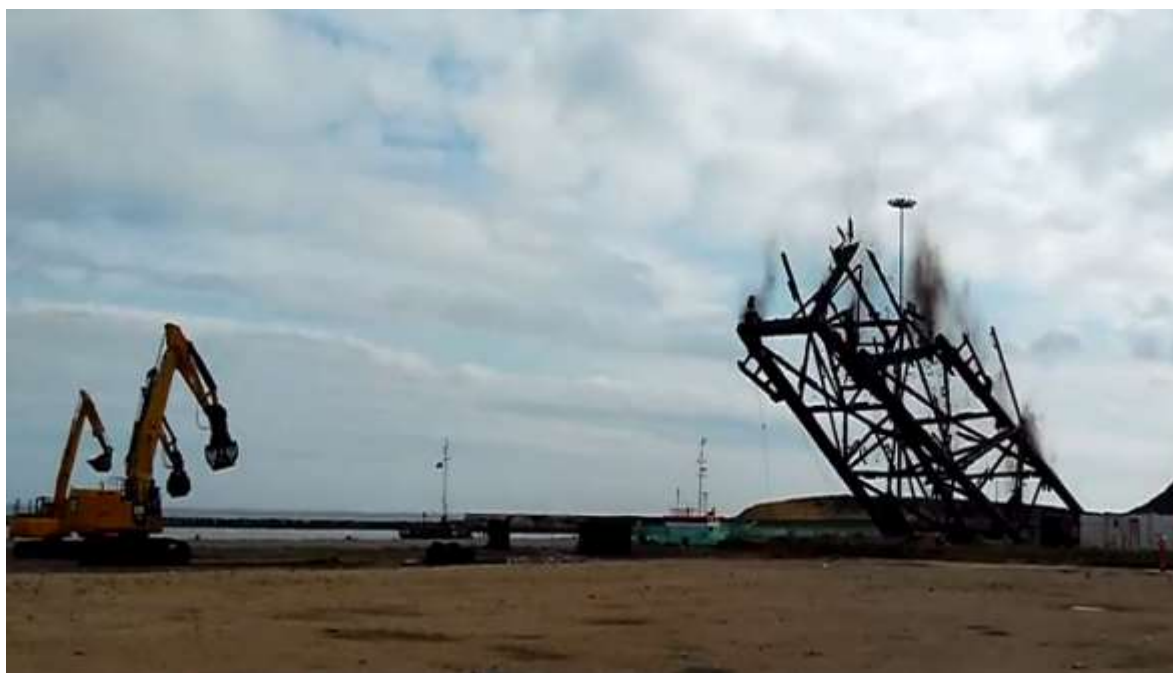
Photo 19 – Jacket Felling (September 2017)

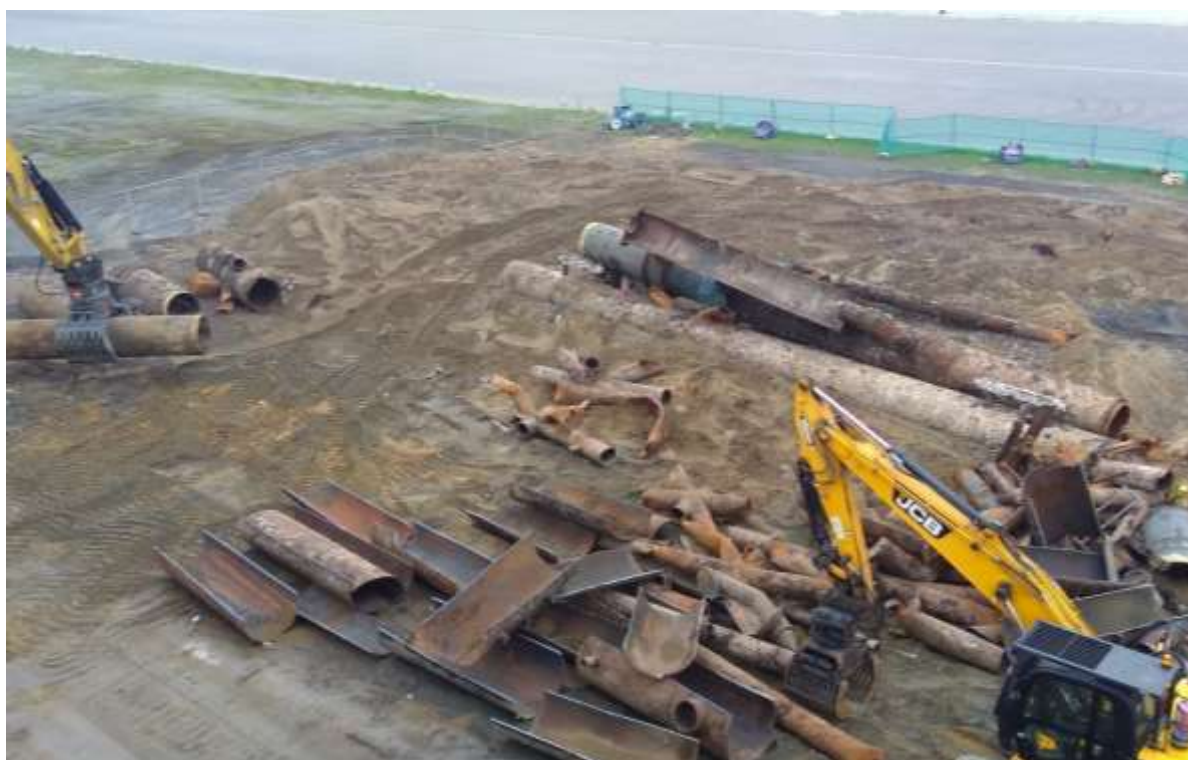
Photo 20 – Jacket Dismantling (September 2017)

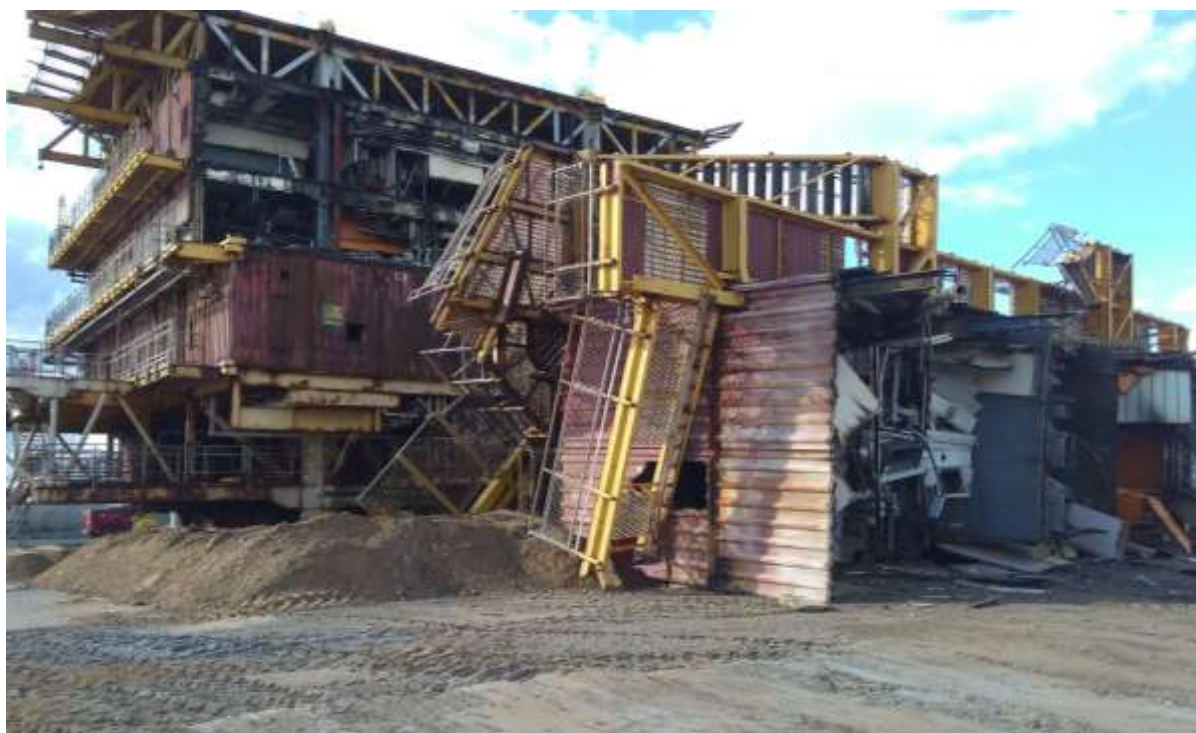
Photo 21 – Topside dismantling (October 2017)

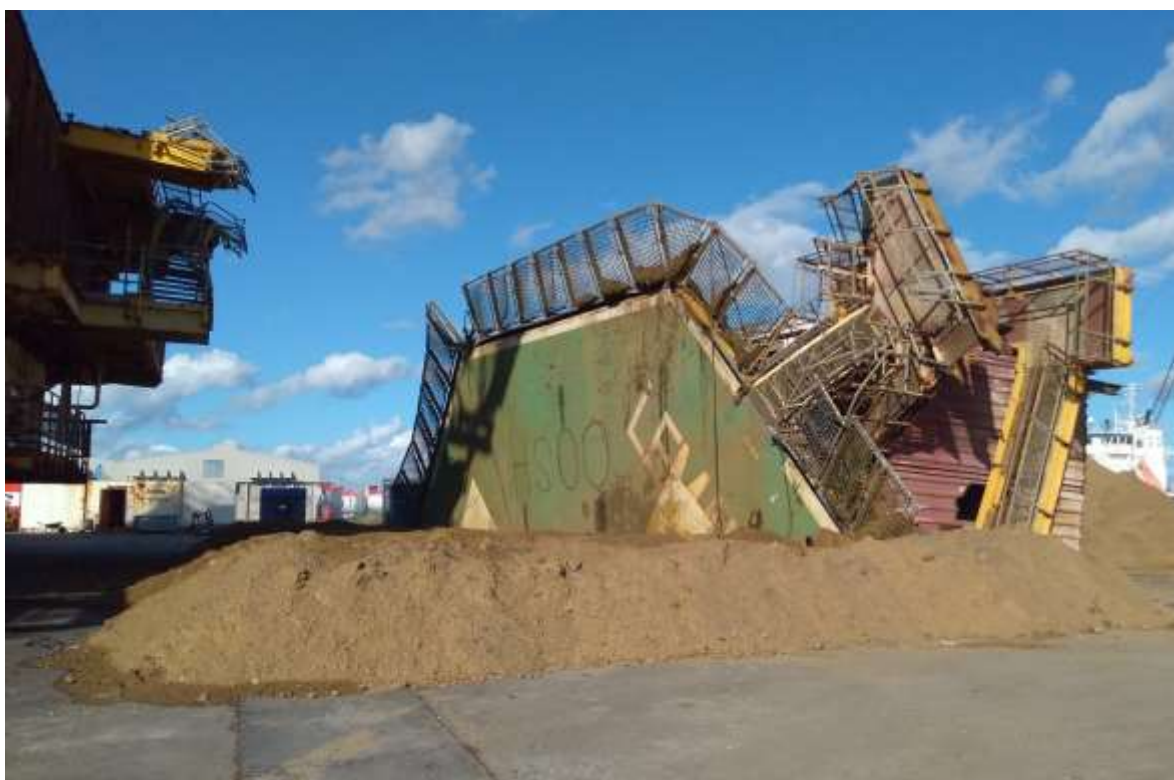
Photo 22 – Topside dismantling (October 2017)

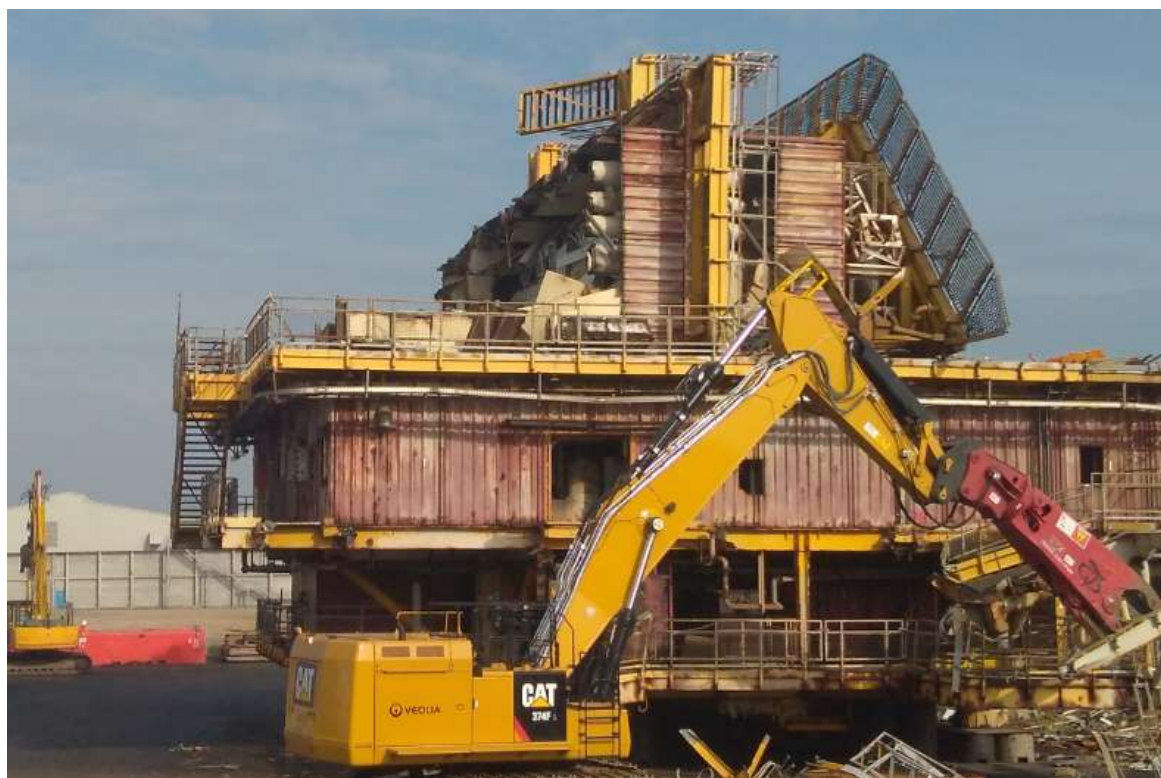
Photo 23 – Topside dismantling (November 2017)

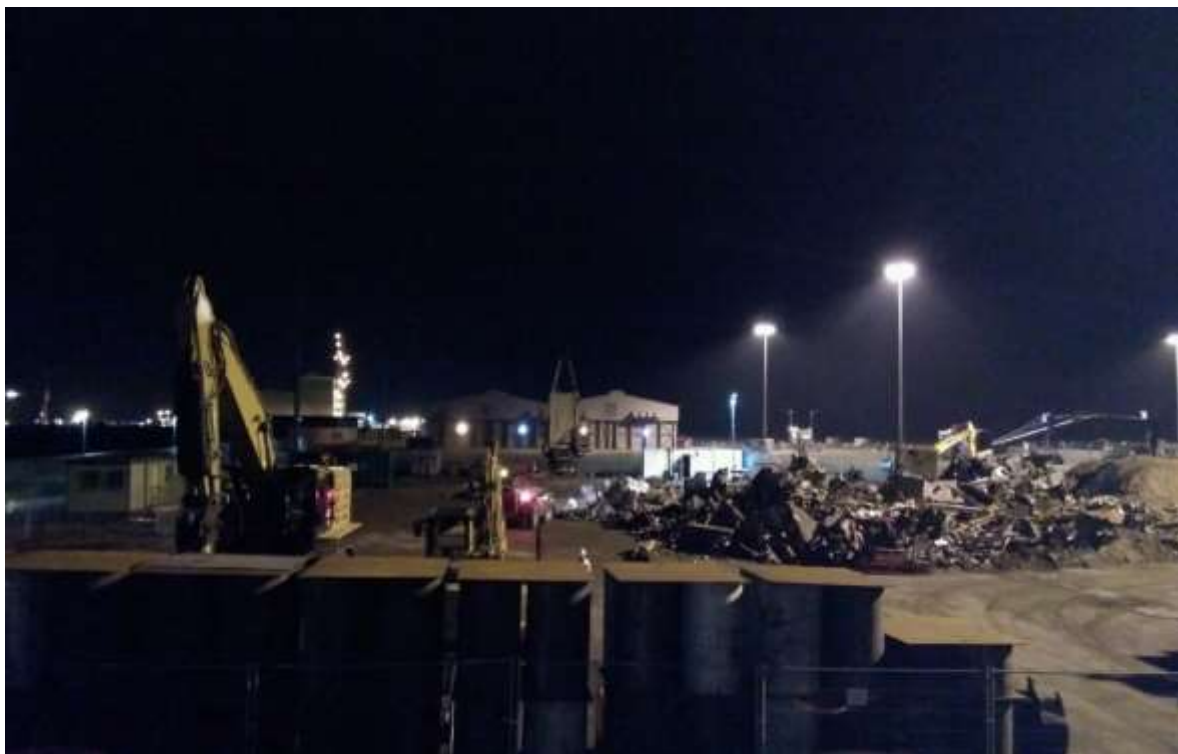
Photo 24 – Topside dismantling (November 2017)

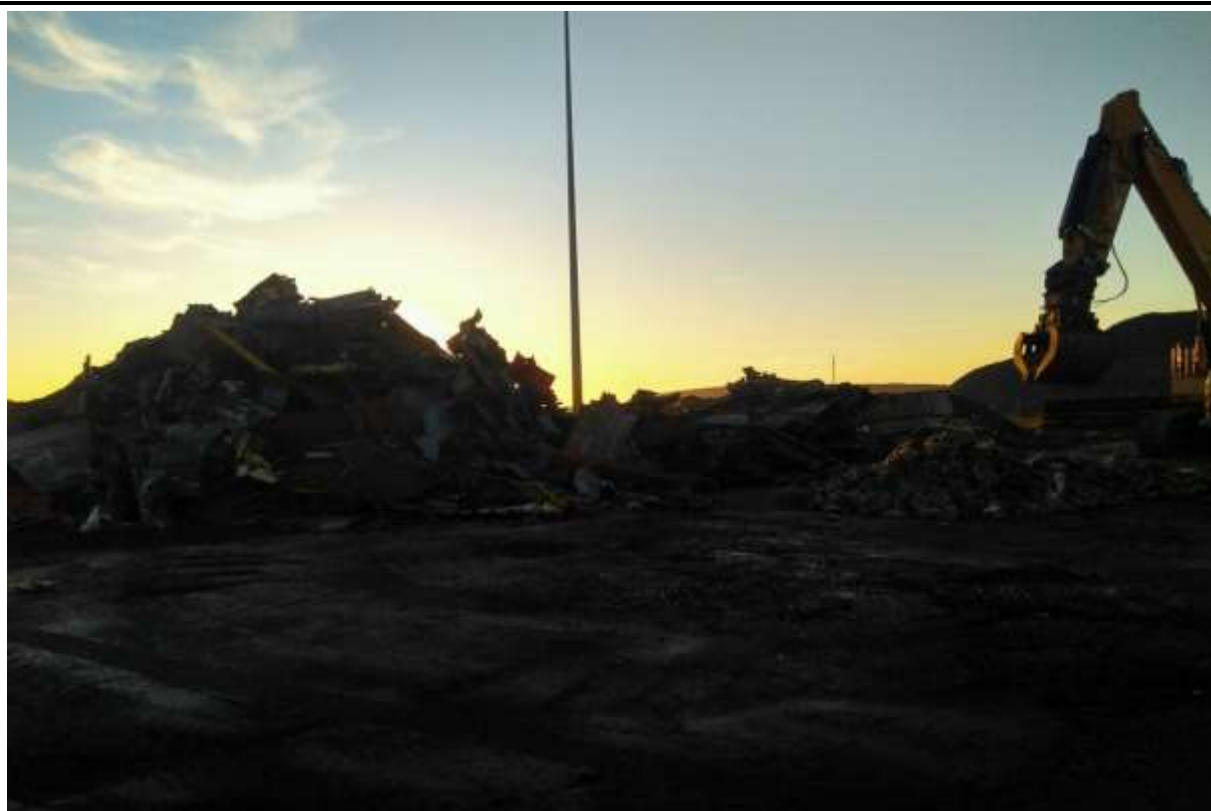
Photo 25 – Topside waste segregation (November 2017)

- Structural material (metals and cables) – 1376.9 tonnes
- Non-hazardous waste (mixed demolition waste/general waste) – 113.2 tonnes
- Hazardous waste (asbestos and fluorescent tubes) – 0.2 tonnes

- Recovered – 101.6 tonnes
- Recycled – 1386.8 tonnes
- Landfilled – 1.9 tonnes
