LEMAN BH DECOMMISSIONING PROGRAMME (LBT-SH-AA-7180-00001-001, REV A10)

CLOSE OUT REPORT

Project	Leman BH Decommissioning
Originating company	Shell UK Limited
Document type	Close Out Report
Document number	EP201712203007
Security Classification	Unrestricted
Issue Date	19 th March 2019

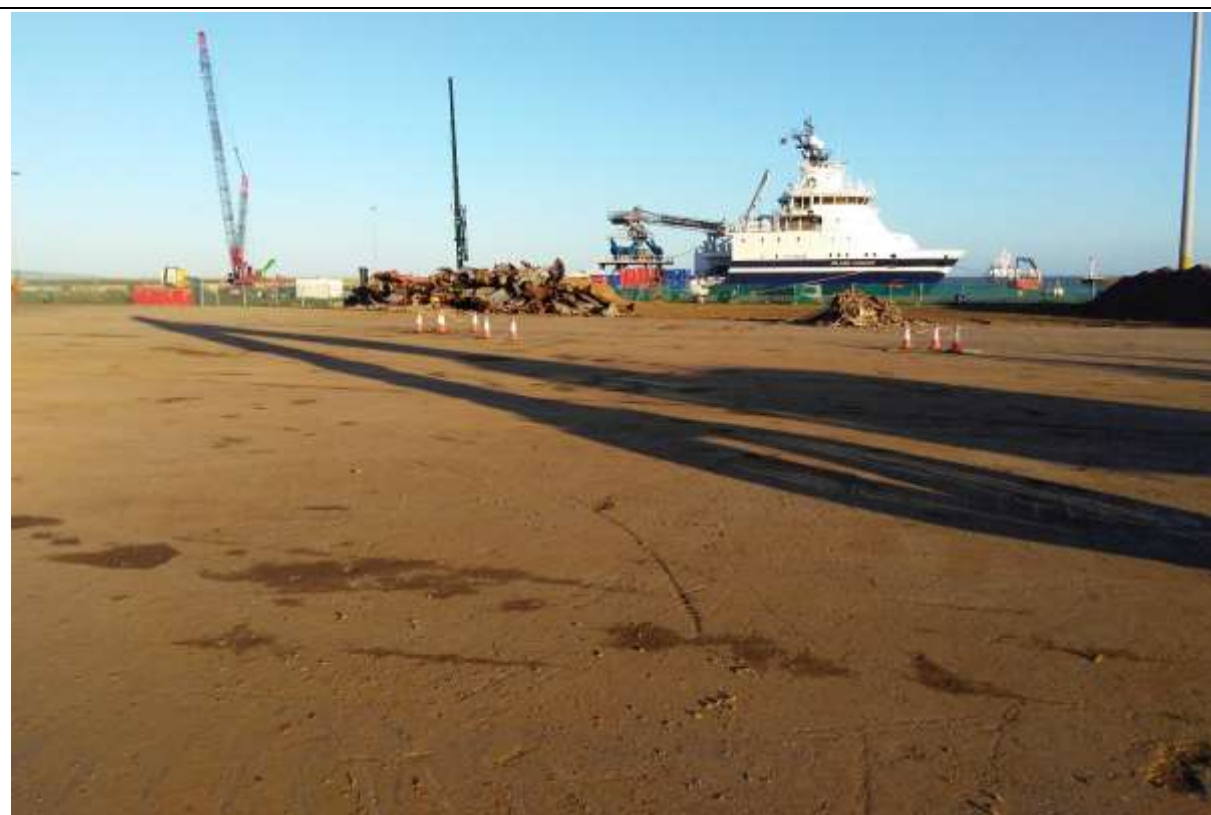
Photo 26 – Dismantling yard following demolition of topside (November 2017)
