PROJECT REPORT 115

DEVELOPMENT OF A REDUCED SPECIFICATION FOR SURFACING AGGREGATE ON LOW TRAFFIC ROADS IN BOTSWANA

By Martin E Woodbridge (TRL)
and Carl W N Slater (Stats Geotechnical Ltd)

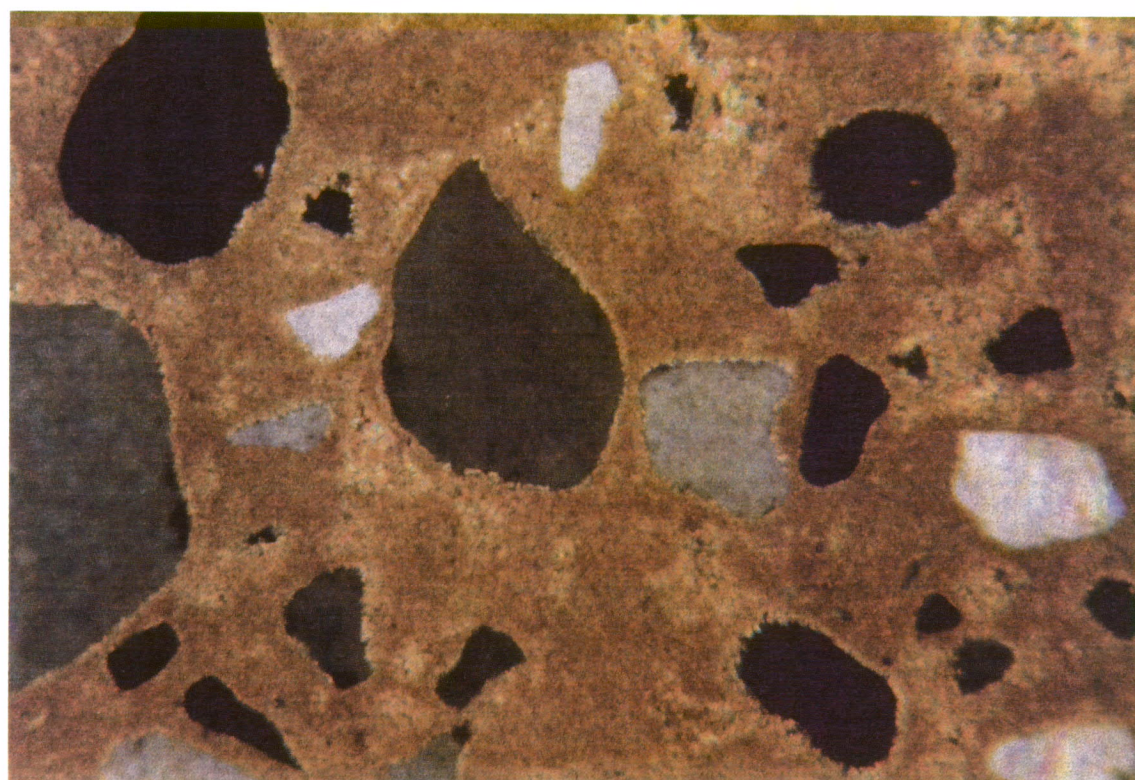
Plates 1 (c) & (d) Photomicrographs of Duricrusts

(d) MN2 Aggregate: sand particles in very fine grained (brown) calcite matrix.
Photo taken under crossed polarised light.

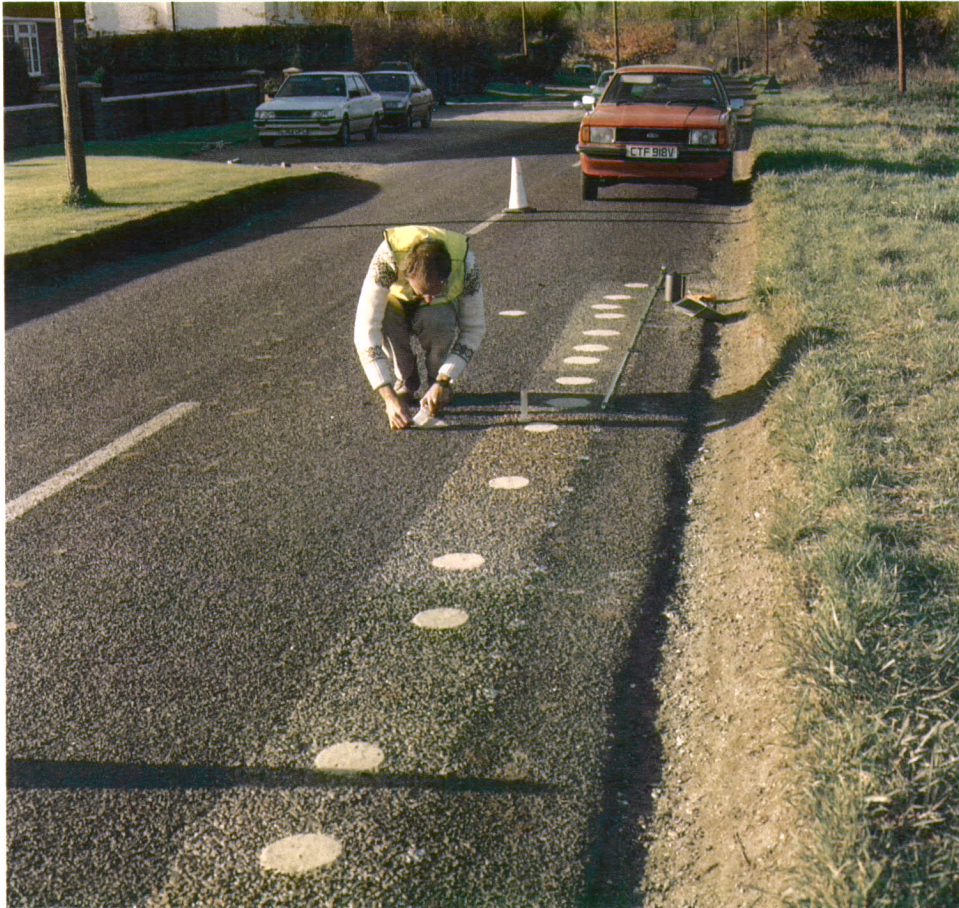
Plate 2 Measuring texture depth of trial panels by sand patch method

The trial sections were monitored regularly for three years until the road was overlaid. During each visit the sections were visually examined to detect the condition of the stone, and a traffic count obtained. Sand patch measurements (BS 598: Part 3:1985) were taken to determine texture depth (see Plate 2).

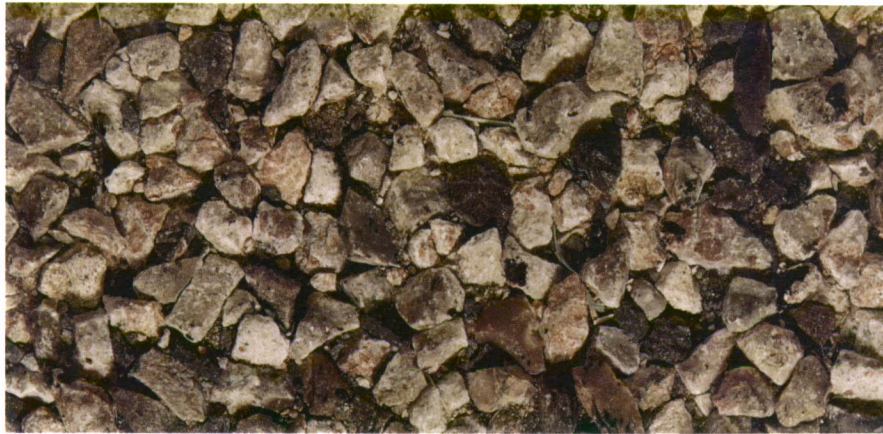
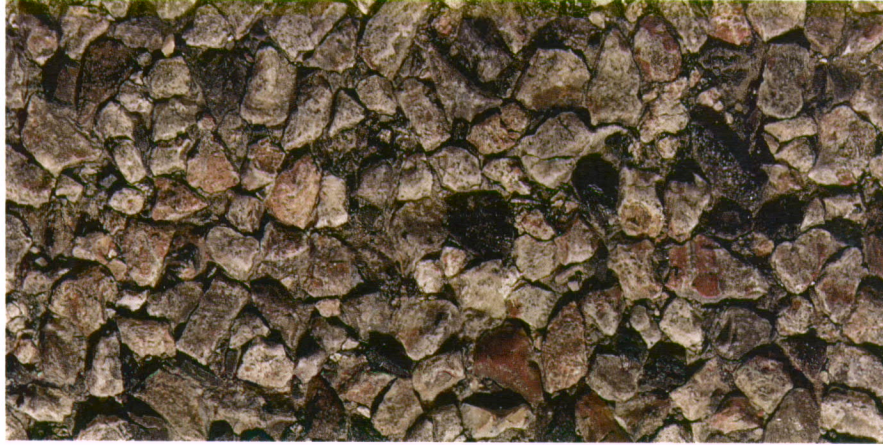
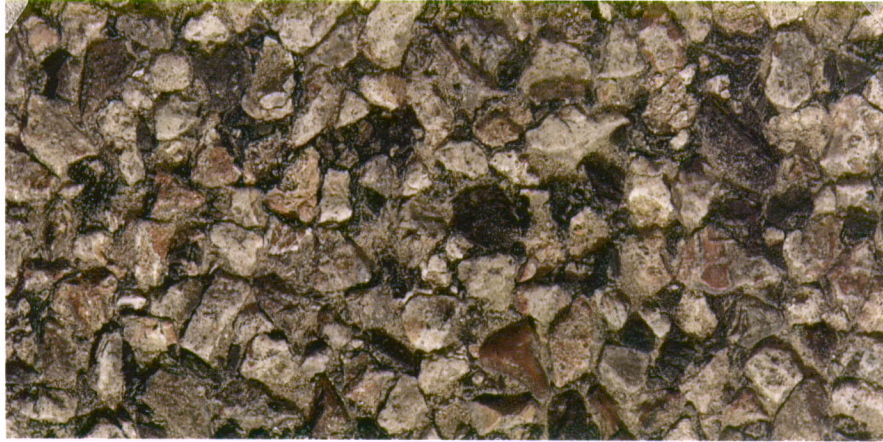
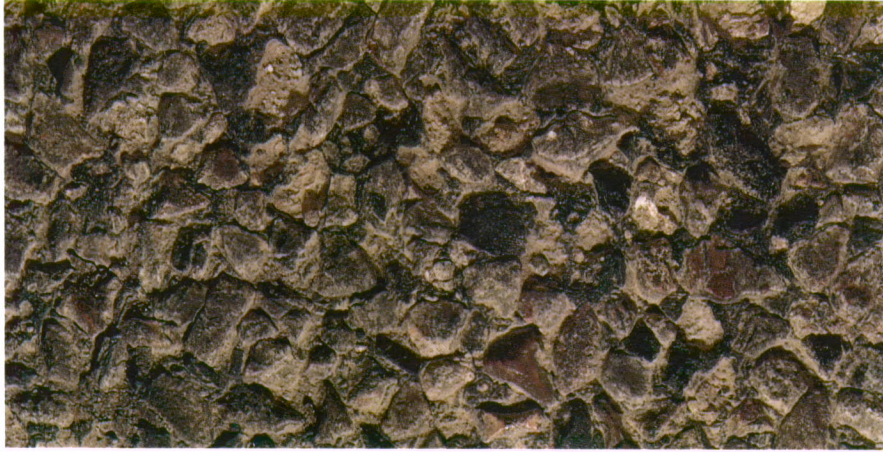
Plate 4 Sekoma calcrete, passing 13.2mm: Panel 18

About 140 chippings in plate. The larger size aggregate has performed better than the smaller size (i.e. passing 9.5mm: Plate 5) but there is nevertheless progressive cracking and whip-off of the light-coloured calcrete after 10 days. Aggregate surfaces also become quite polished. The dark coloured silcrete has performed well although there has been some loss where individual chippings were surrounded by calcrete.

The calcrete panels performed poorly. This is exemplified by the Sekoma aggregate shown in Plates 4 (larger size aggregate) and Plate 5 (smaller size aggregate). They were subject to initial cracking caused by rolling and also thereafter by traffic, so that by 300,000 vehicle passes, roughly equivalent to 350 days, a substantial amount of cracking and stone loss had occurred. The cracking was much more pronounced for the smaller size aggregate than the larger size. Thereafter the calcretes softened and became susceptible to further deterioration, probably assisted by the wetting and drying cycles and the freezing and thawing of the British winter, so that eventually many of the individual chippings became seriously abraded. The MN2 calcrete-rich aggregate, shown in Plate 6, showed similar early deterioration and eventual disintegration owing to softening.

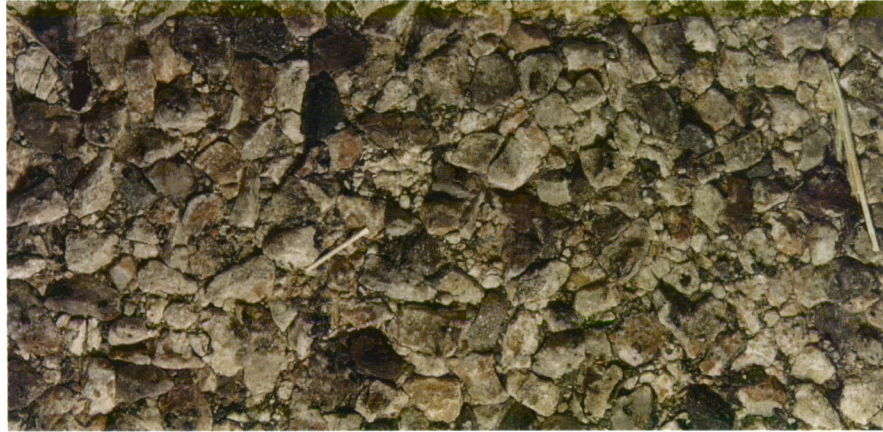
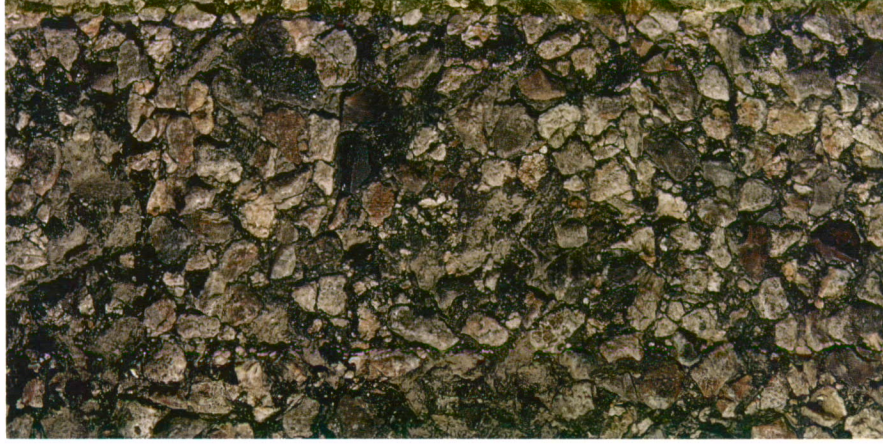
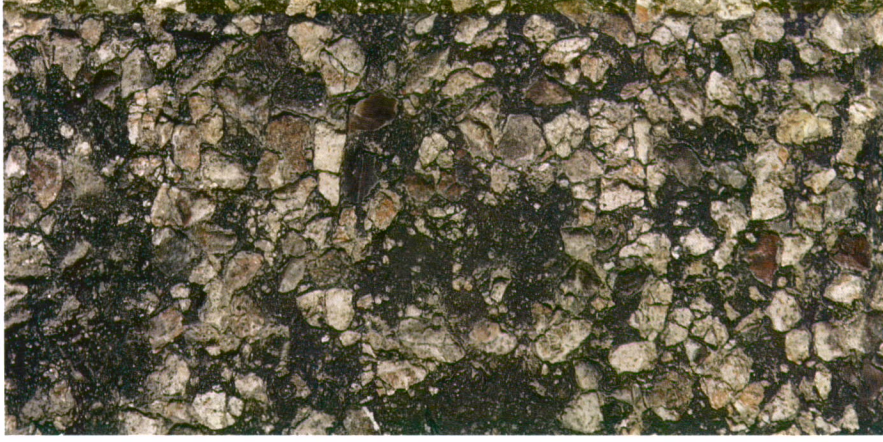
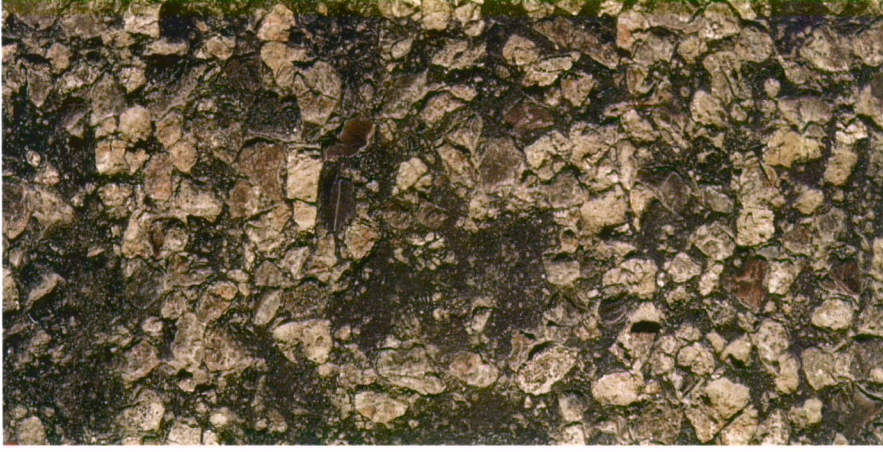
Plate 5 Sekoma calcrete, passing 9.5mm: Panel 7

About 225 chippings in plate. Much early cracking and loss of the light coloured calcrete. Bitumen fills the gaps created by lost chippings. At 800 days nearly 50% of the calcrete lost. Apart from cracking also progressive abrasion of the calcrete caused by softening due to wetting/drying cycles. The dark-coloured silcrete chippings have performed well. This section had failed by 350 days.

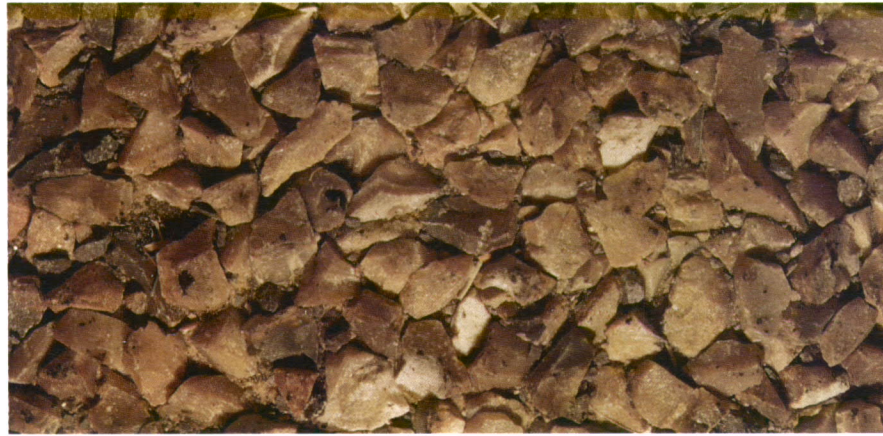
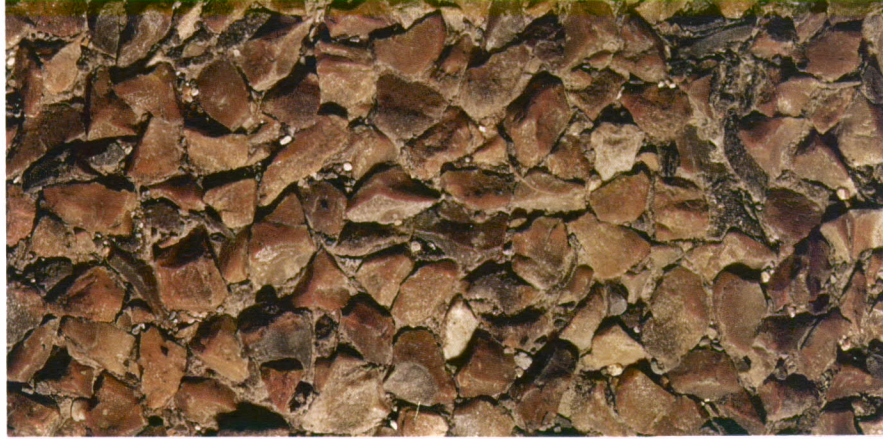
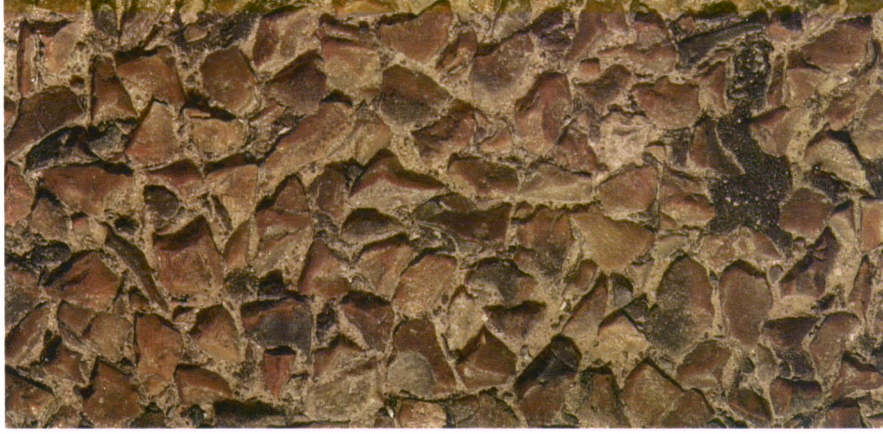
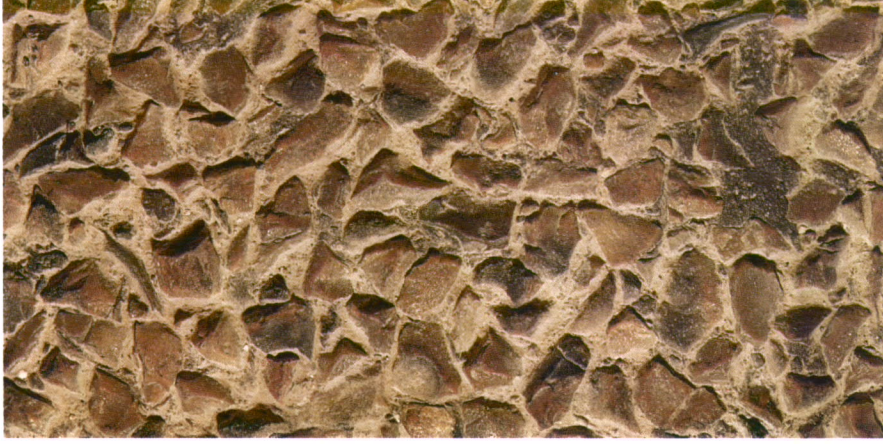
Plate 7. Samedupe silcrete, passing 13.2mm: Panel 19

About 145 chippings in plate. The pronounced flakiness (Fl, 50%) of the aggregate is evident from the shape. Some chippings lost early in the trial; their strength (TFV, 240 kN) indicated by little subsequent cracking. Apart from embedment, there has been little change. The size of the chippings has resulted in good residual texture although their smooth faces are evident.

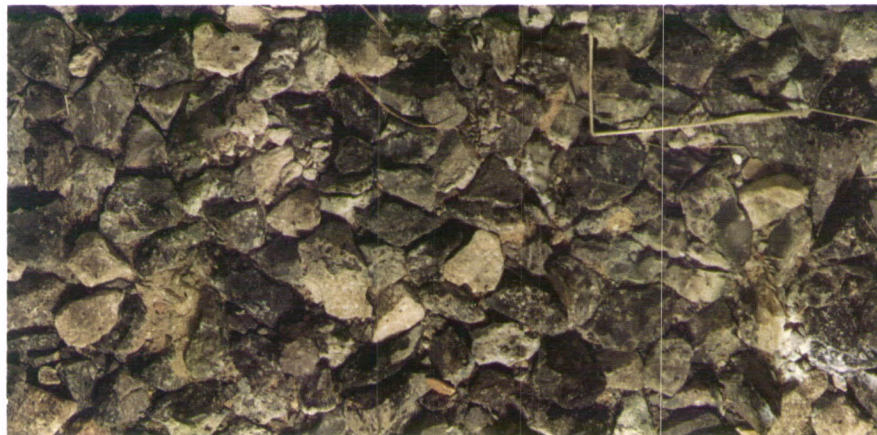
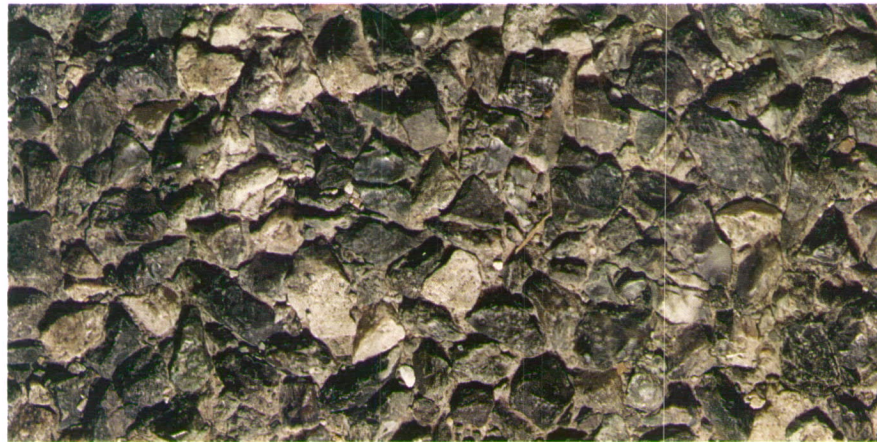
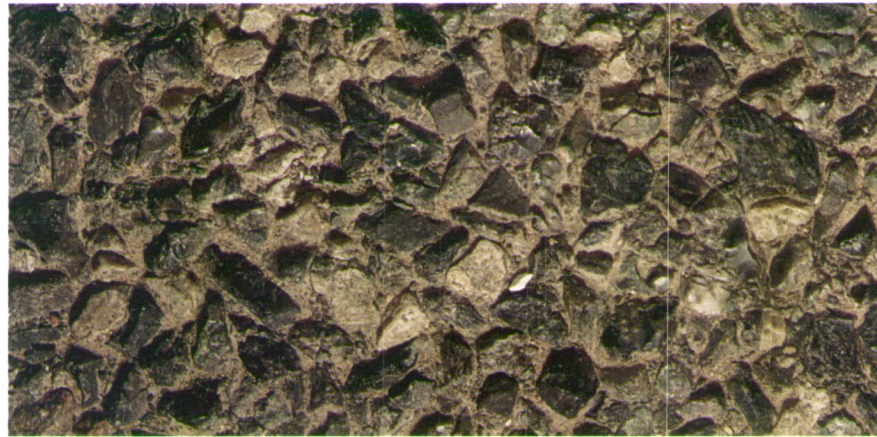
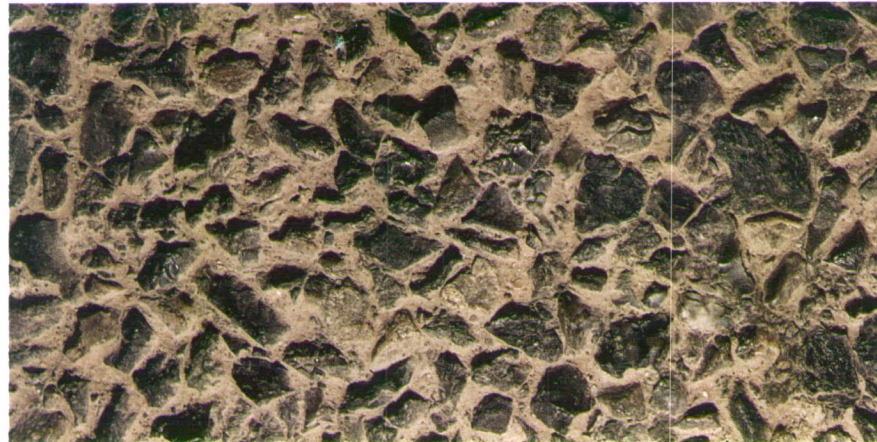
Plate 8 MN2 aggregate, silcrete-rich, passing 13.2mm: Panel 15

About 142 chippings in plate. Good performance, little cracking and good retention of texture. Observation at 1000 days difficult due to blanketing of section with chalk dust.

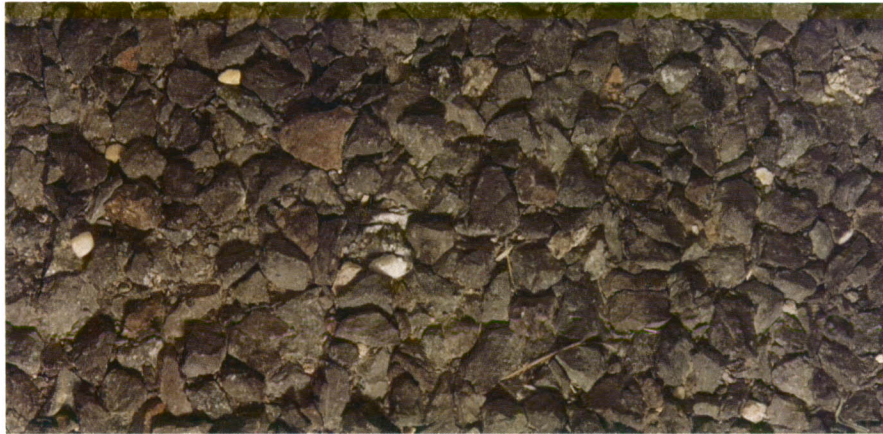
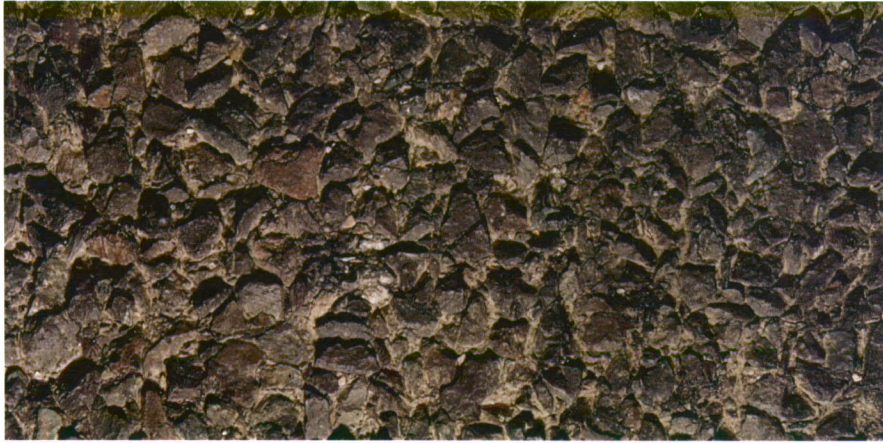
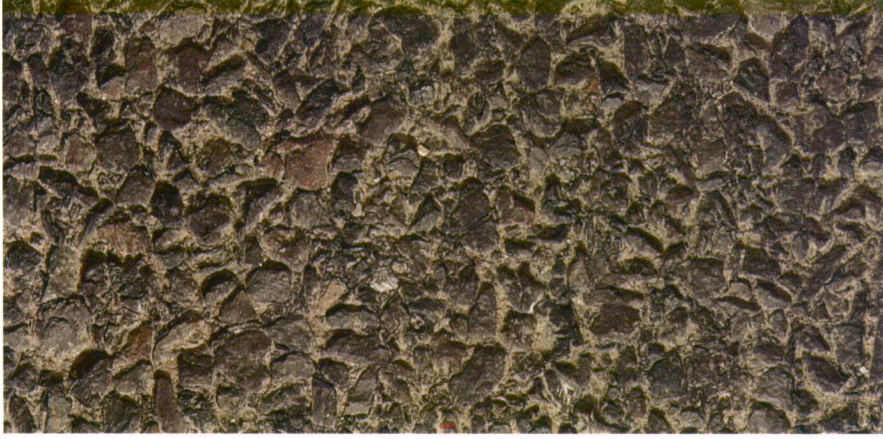
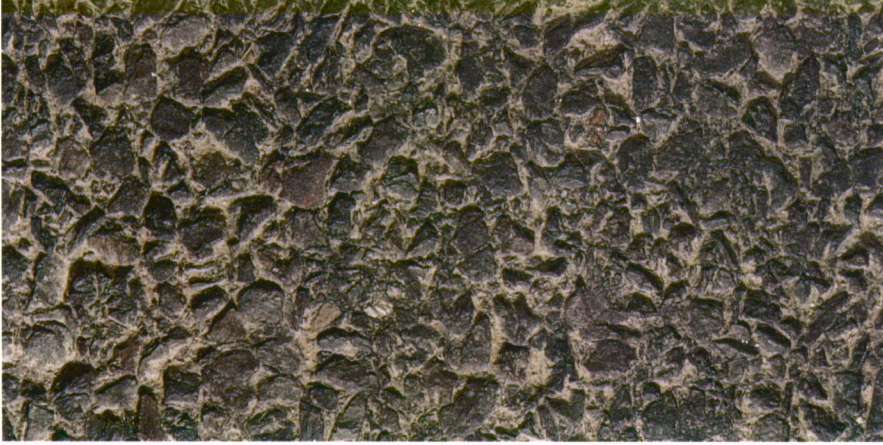
Plate 9 UK basalt, passing 10mm: Panel 20

About 250 chippings in plate. A very strong aggregate (TFV, 360 kN): some chippings cracked during construction but none during the trial. Good interlock developed. Apart from gradual embedment resulting in loss of texture depth, the aggregate performed well.

still in good condition after 1000 days, corresponding to about 1 million vehicle passes. Their performance was as good as the basalt control aggregate (Plate 9), for this level of traffic.

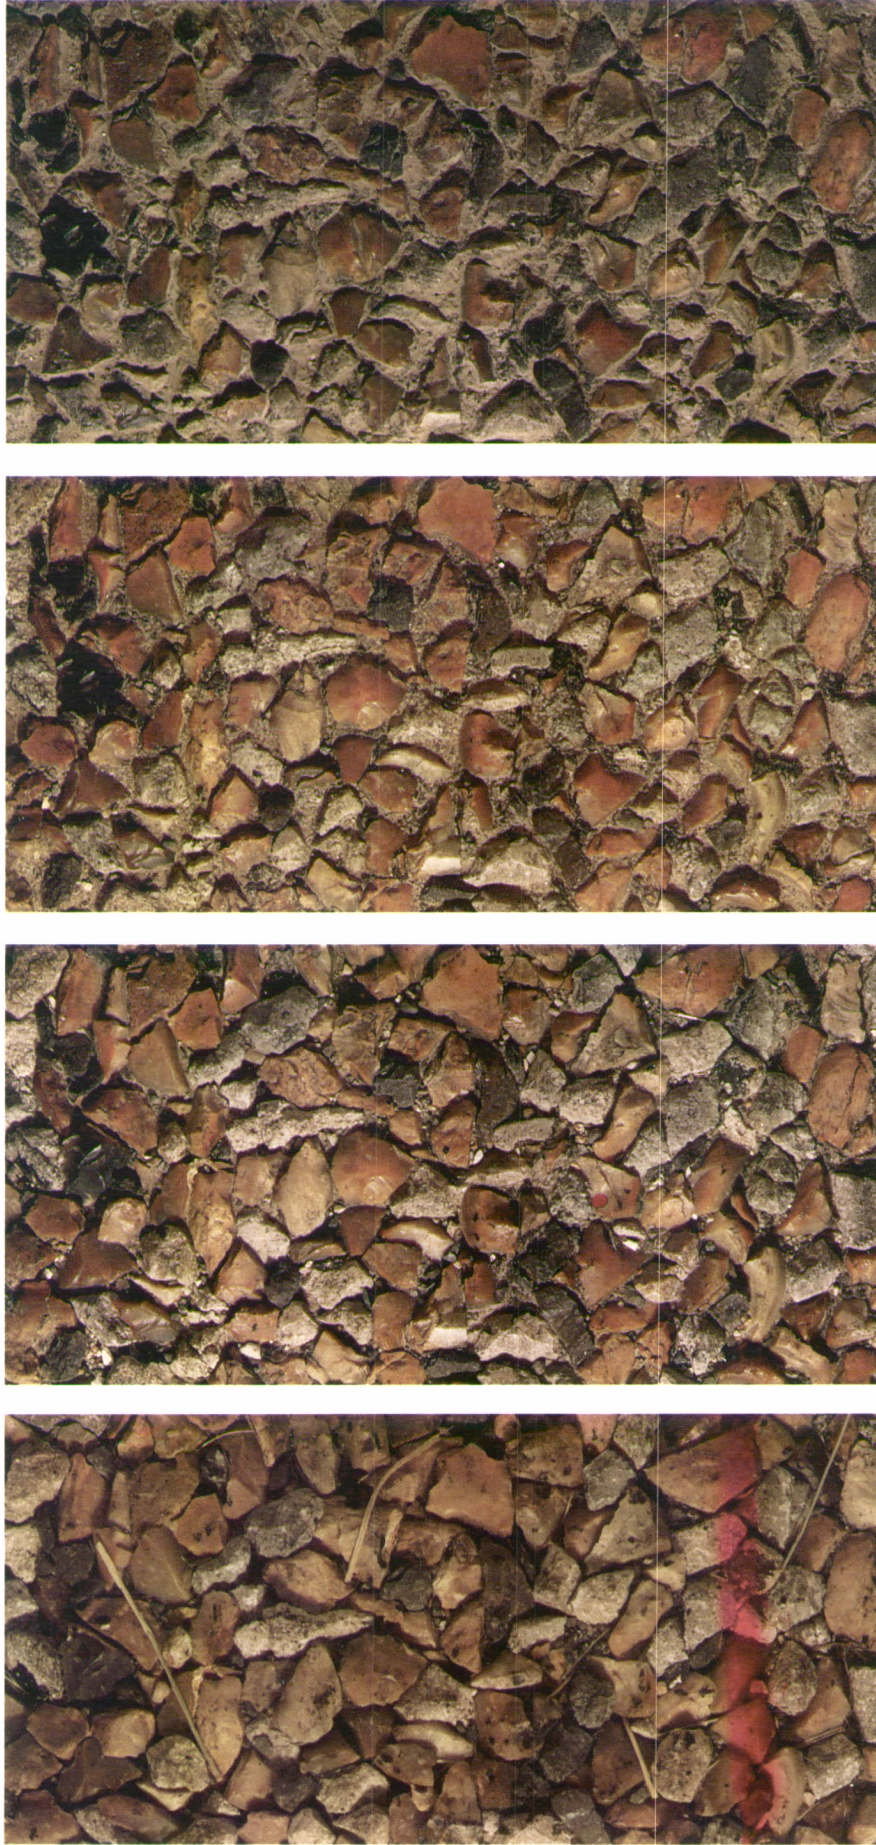
Plate 10 UK aggregate, 25% limestone/75% flint, passing 14mm: Panel 11

About 135 chippings in plate. Both aggregates performed well during the trial; the development of smooth polished surfaces is noticeable on the limestone by 800 days but there is negligible cracking. Good residual texture due to large initial aggregate size.

The panels containing the combinations of flint and soft oolitic limestone performed well and all were in good condition at the end of the trial (Plates 10 and 11). Although there was initial cracking of the limestone, there was virtually no loss. In this respect, the UK aggregates performed differently (better) than the duricrusts even though their engineering test results are comparable.

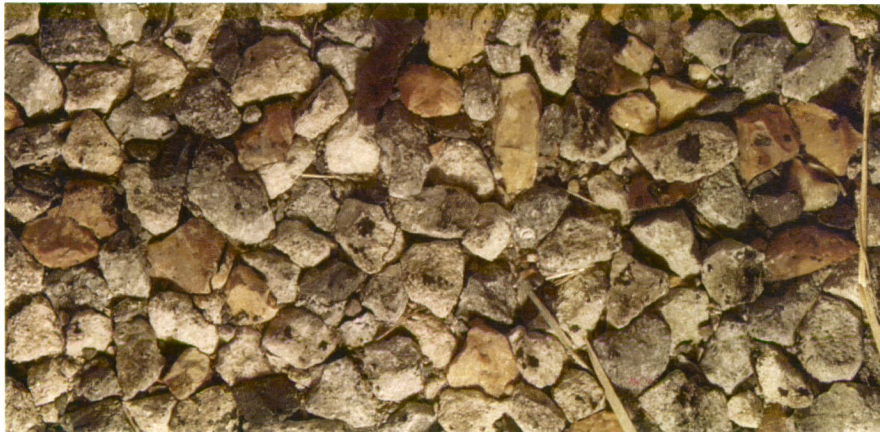
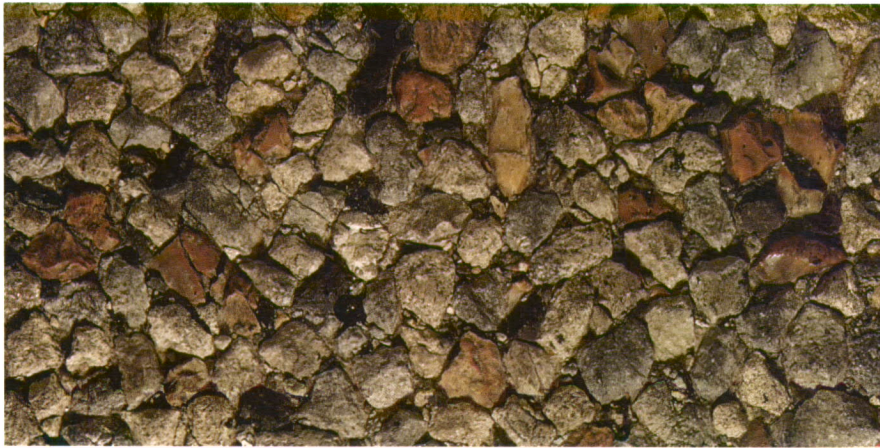
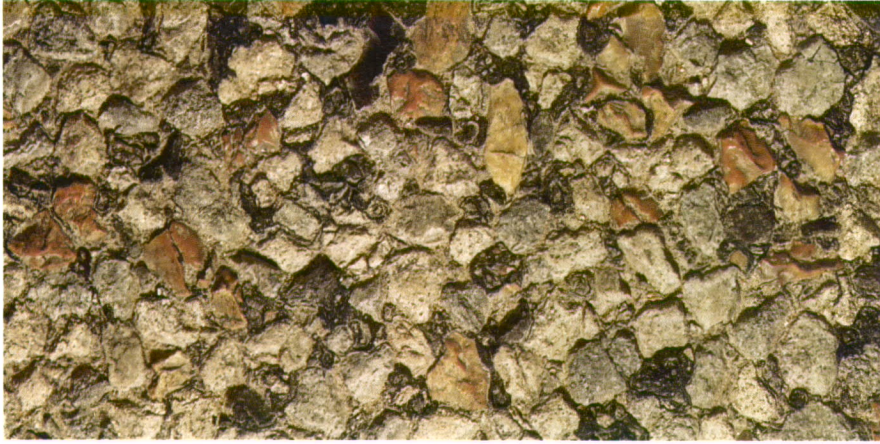
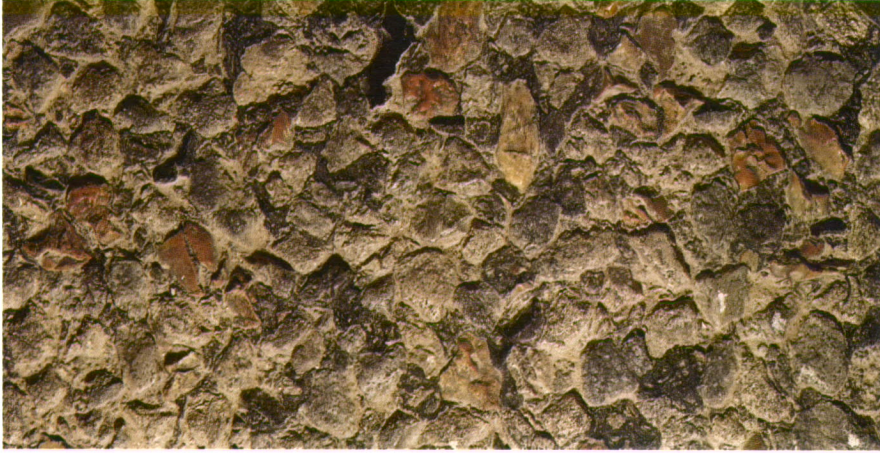
About 133 chippings in plate. Cracking of 6 limestones by 350 days but no chipping loss; by 800 days the polishing (and abrasion?) of the limestone is severe. This is also possibly reflected in the degree of embedment. The flint has performed well.
