HMS Daedalus

Land Quality Assessment

Radiological Survey Report
Project No 05002

Final Report

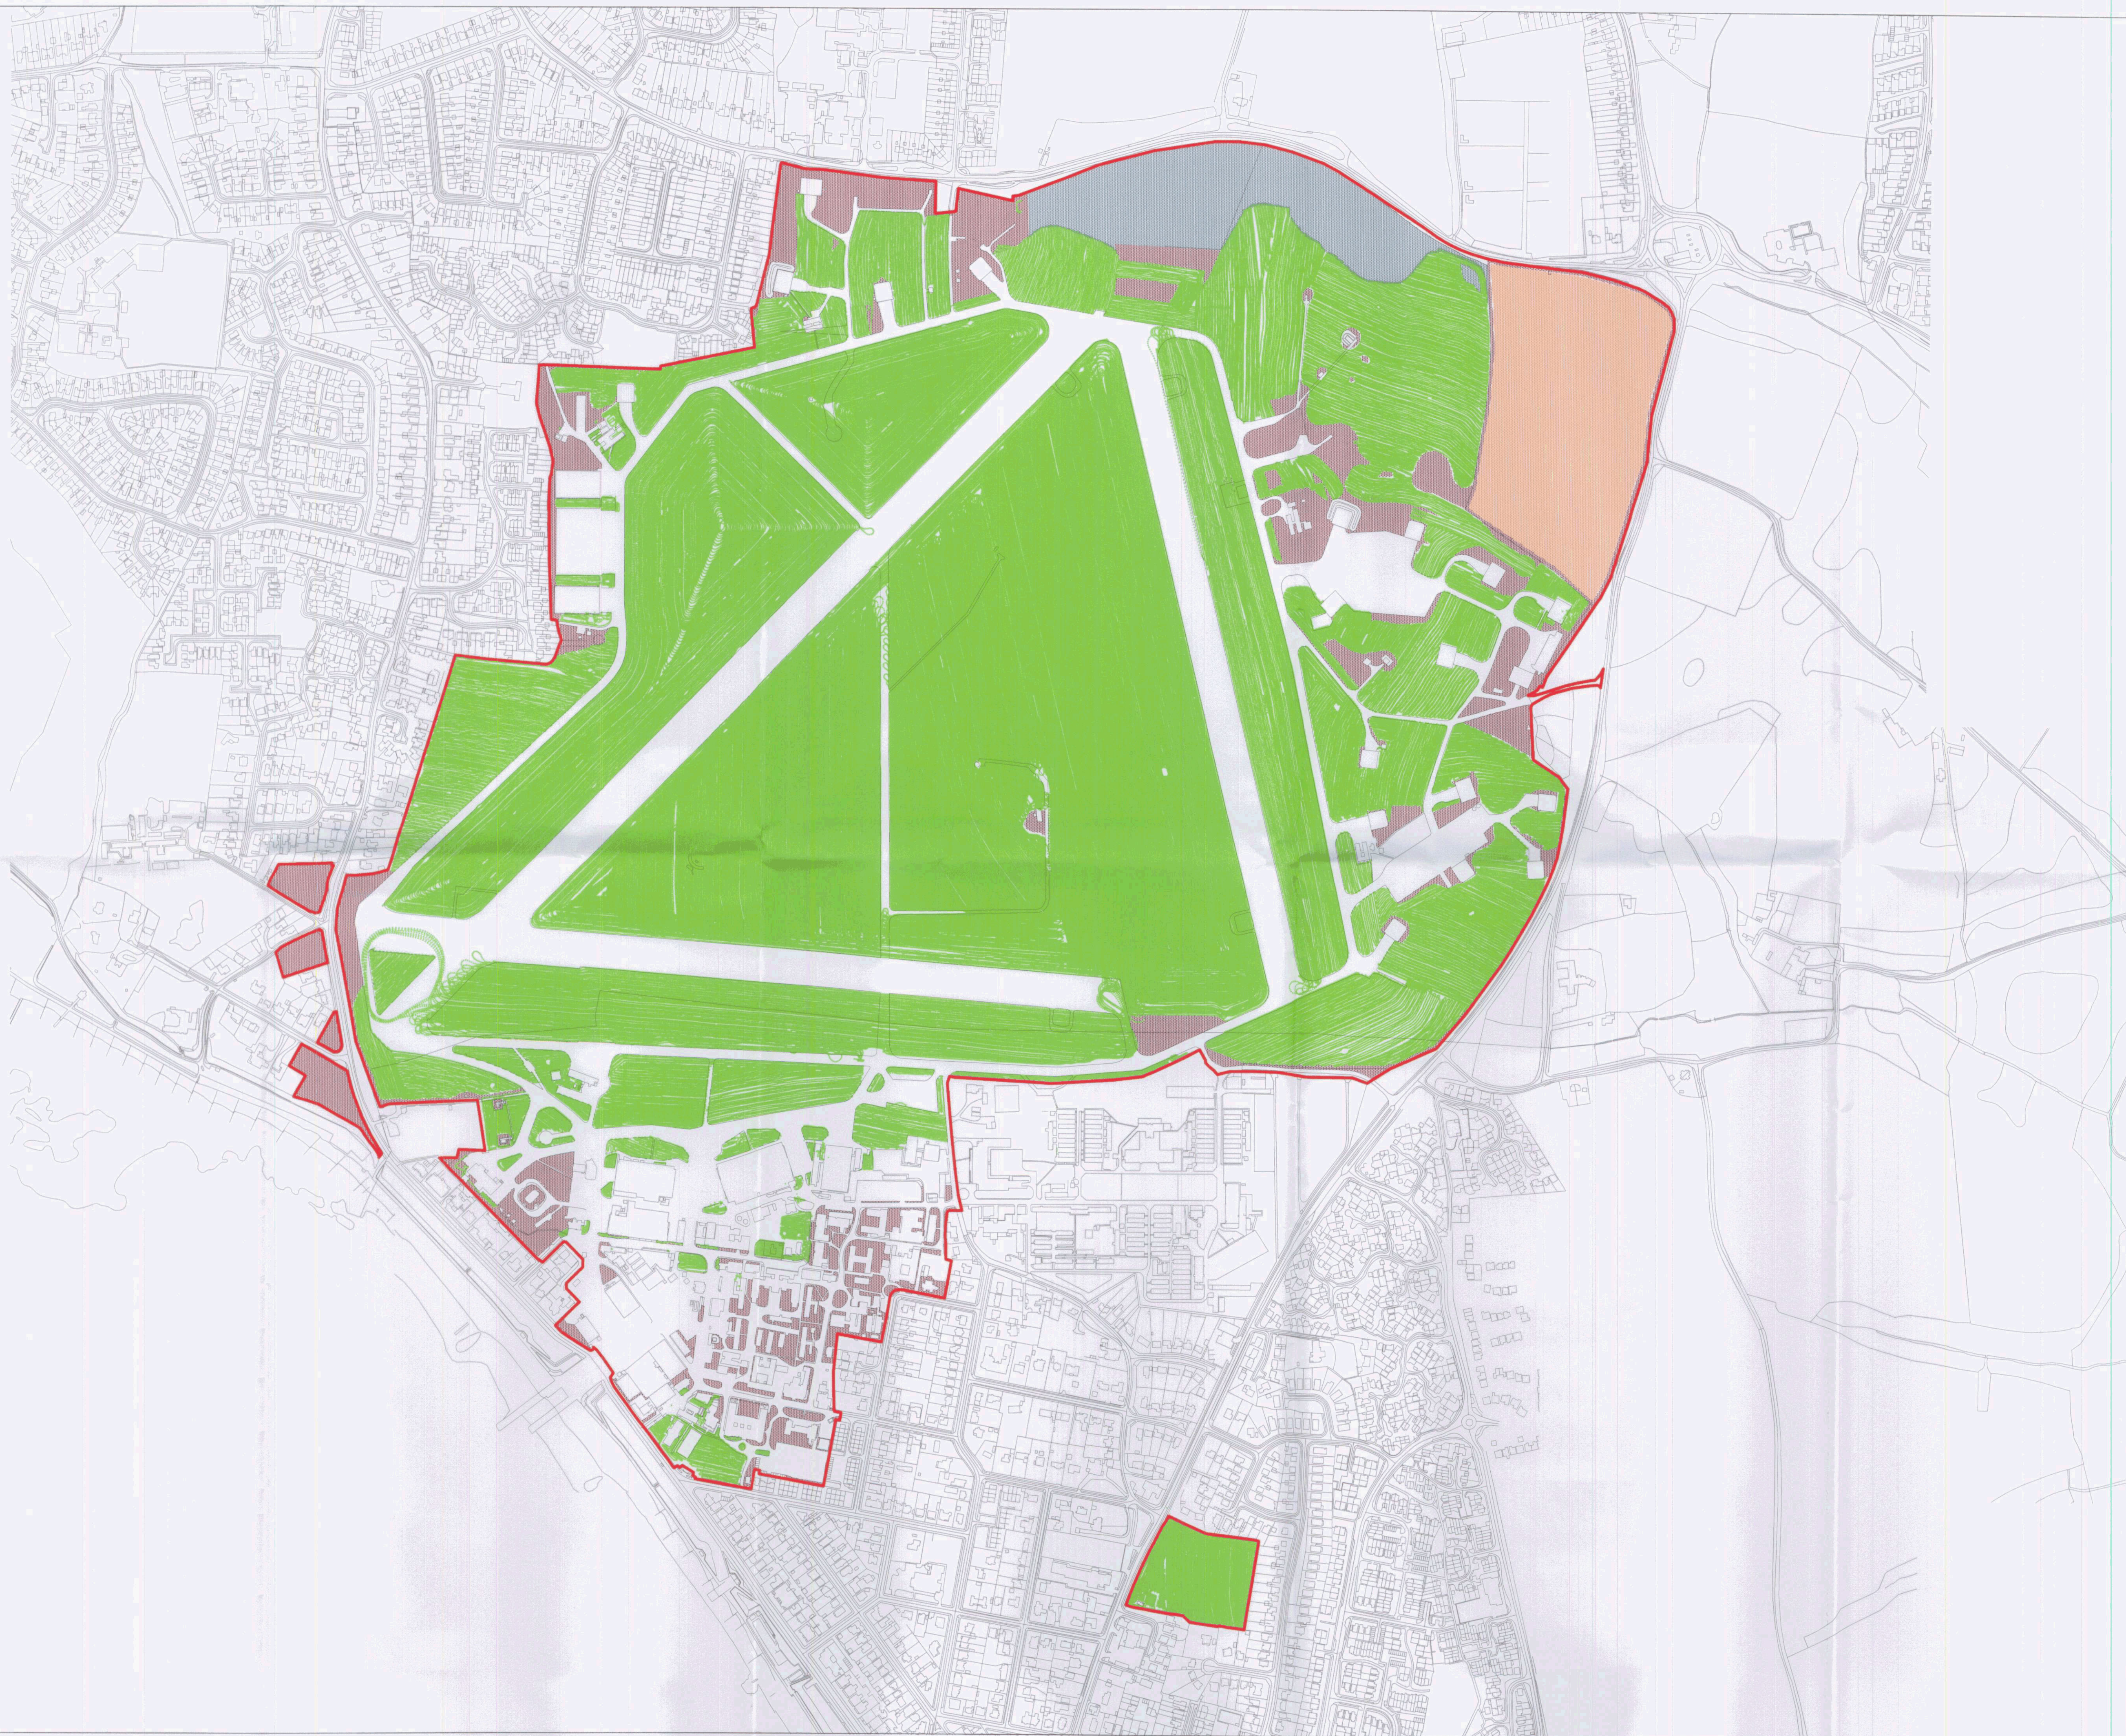
By examining the displayed survey output during or at the end of each day's work, field operators can monitor the extent of their coverage and check for any gaps due to having travelled too fast or strayed off line. Any gaps can then be filled in the following day. If a gap is caused by an area being inaccessible to the trailer-mounted equipment, or the GPS signal being obscured (e.g. by trees) the fill-in is completed using non-GPS equipment with the

- Key:
- Site boundary
 - Surveyed areas
 - Surveyed areas (non GPS)
 - Excluded areas
 - Overgrown area

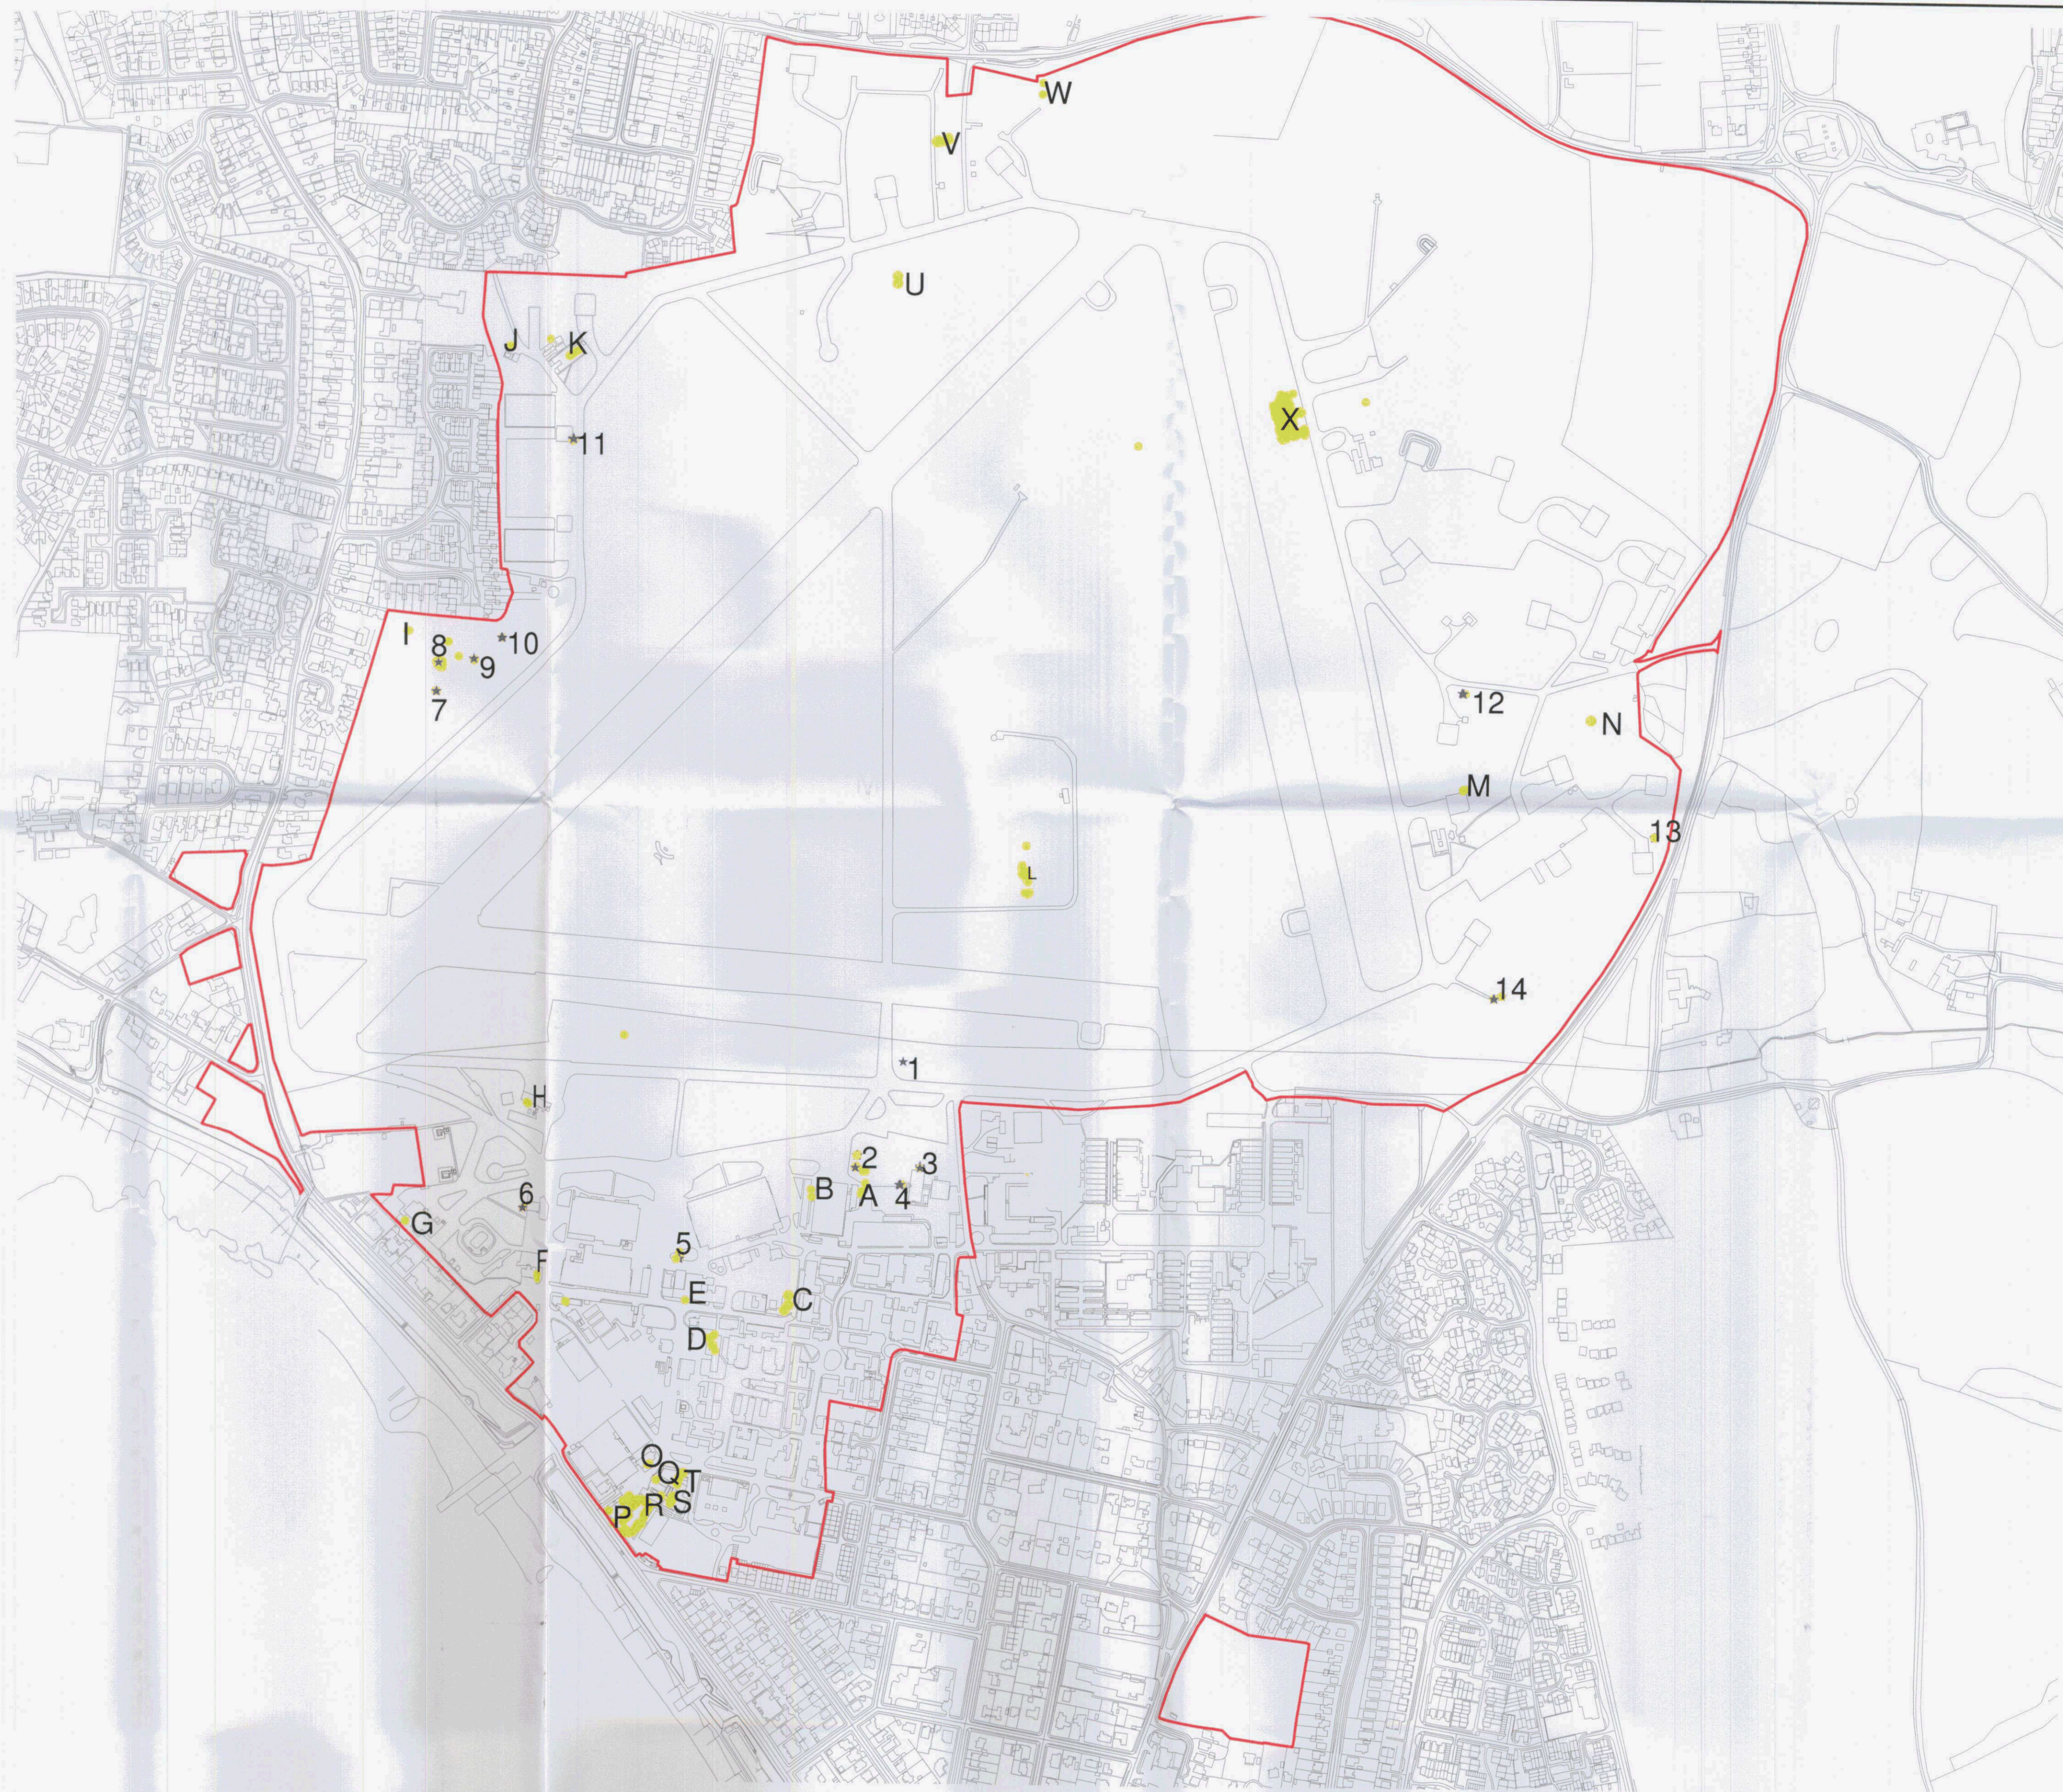
Of the sources greater than 0.34 Bq/g, which are individually quite small in extent, numbers 1 to 6 were found within the Technical Area, in the vicinity of former workshops and hangars. Most of these were already known from the 2003 survey. Numbers 7 to 11 were near to the buildings on the western fringe of the airfield. These were new finds, in an area not previously surveyed. Numbers 12, 13 and 14 are previously-known sources in the vicinity of hangars in the east of the airfield.

It should be noted that the anomalies shown on Figure 3 are based on the walkover survey. Further intrusive investigation was undertaken to confirm the nature of the contamination (artefacts or ash) and its spatial extent.

Many of the radioactive sources shown in the technical area and around the eastern hangars were already known from the 2003 survey. They are denoted by an asterisk in Table 4.2. Those elsewhere on the site are new finds. All of the sources detected in 2003 were found independently in the more recent survey.

A further 40 excavations were undertaken to investigate the 24 alphabetically denoted zones shown on Figure 3, together with 15 additional minor anomalies (denoted AN01-AN16) and the off site-field anomaly. Table 4.4 summarises additional radiological contamination, based upon excavated averaging volumes. No material determined as LLW was found in any of these trial pits.
