September 2019

# **Construction noise and vibration Monthly Report – July 2019**

**London Borough of Camden**

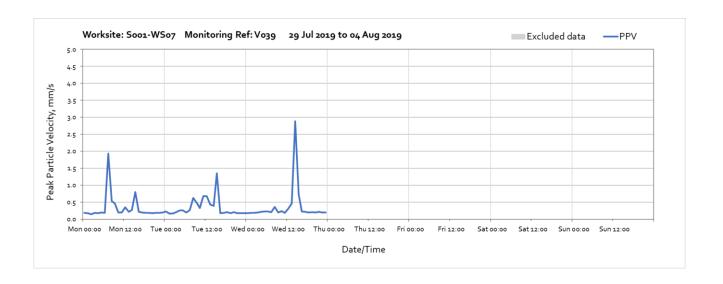
### Worksite: S003-WS07 - Monitoring Ref: V039

Note: Vibration monitoring was started at 00:00 on Wednesday the 3<sup>rd</sup> of July.

Note: High vibration levels at 15:00 on Tuesday 9<sup>th</sup> of July were due to local disturbance of the vibration monitor and are not representative of HS2 vibration levels.
