Measurement of the in-situ performance of solid biomass boilers

Annex F: Case Studies

Biomass boiler field trial Case studies – B046

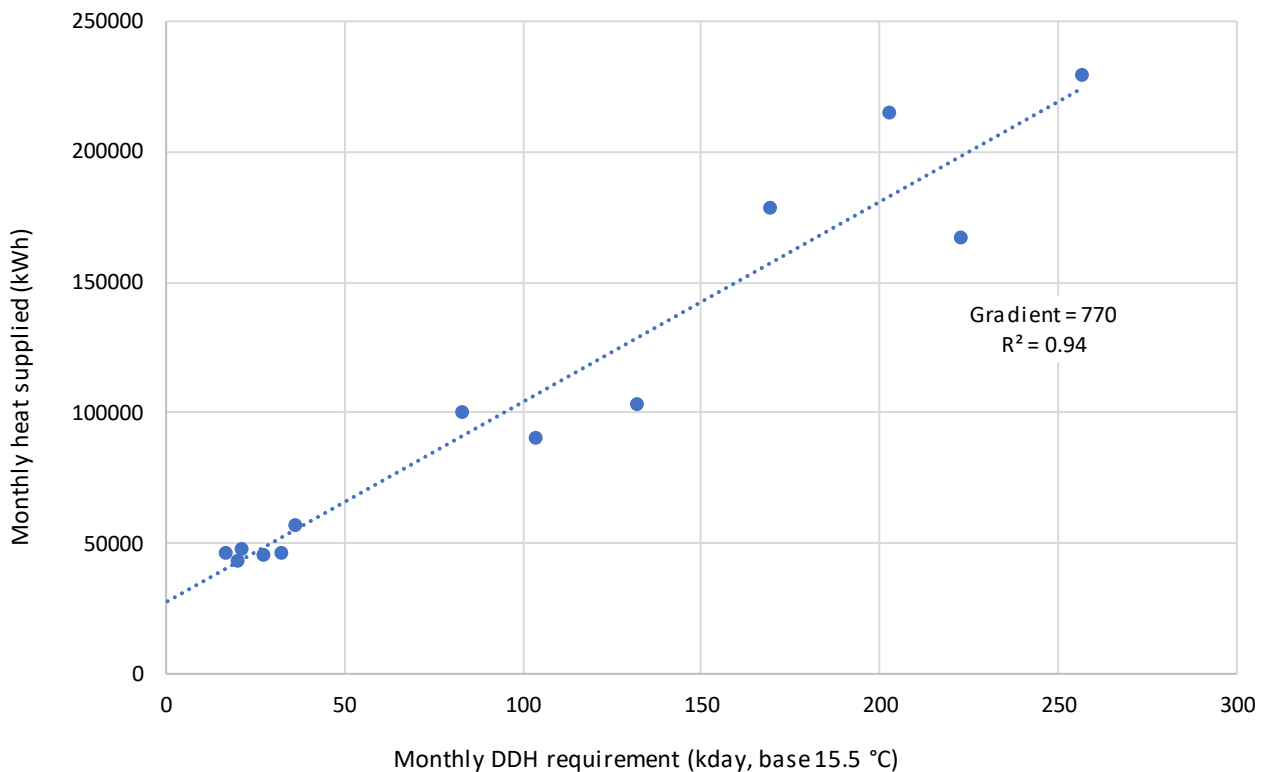
Figure 2: Graph showing heat delivered by the boiler and monthly degree day heating requirement

Figure 2 is a plot of monthly heat output from the boiler against monthly degree day heating requirement. Degree day analysis is a useful way to compare how much heat was delivered by a boiler at different times of the year or between different years, where the prevailing weather conditions may be different - the higher the number of degree days, the colder the outside temperature. It allows a judgement to be made of how well the system responds to temperature.

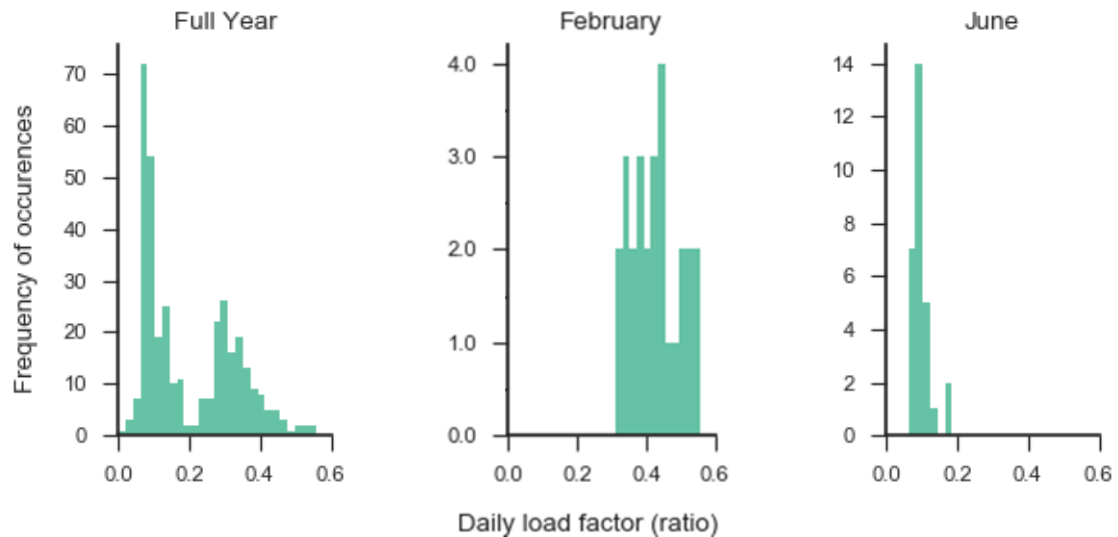
Figure 4: Daily load factors B046 for a full year, the month of February and June

In the summer, space heating was no longer required, and domestic hot water production became the major use of the boiler which provided a significantly lower demand. Figure 4 shows the reduction in daily load factor that occurred in summer (June) compared with winter (February). The distribution in the histogram for the full year shows the variation between the seasons as two distinct areas on the graph either side of the 20% daily load factor. The reduced load factors in summer months may also have been caused by the boiler modulating down its output as heat demand reduced. This modulation was seen during testing of the boiler where the boiler limited its fuel input to modulate down to around 40% of its rated output.

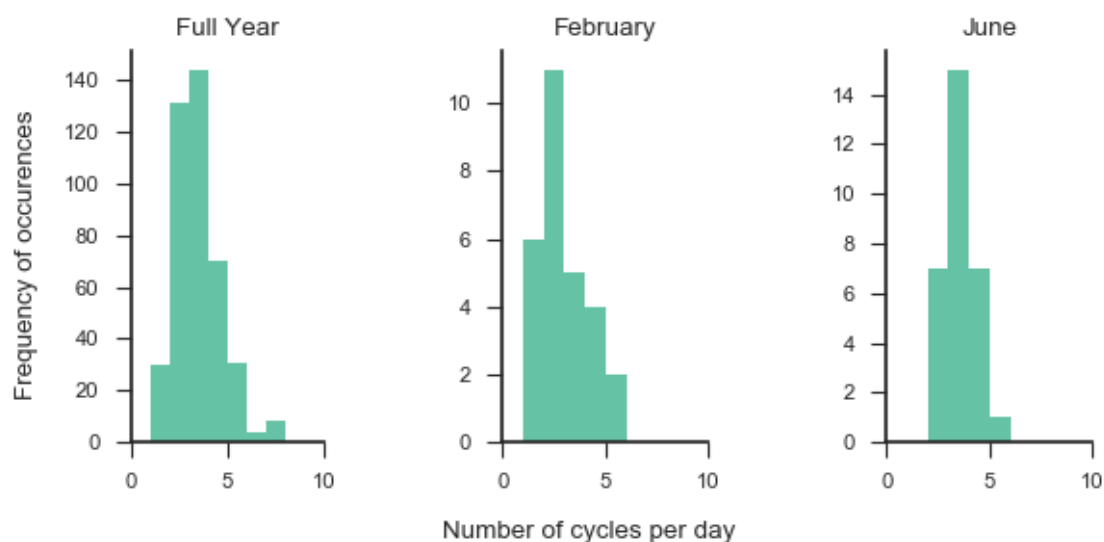
Figure 5: Number of cycles per day at B046 for a full year, the month of February and June

The number of cycles the boiler completed per day did not change much over the year as load factor changed (Figure 5). There was only a small difference between summer and winter, with fewer cycles in the winter months. The main effect of the seasonal variations on the boiler was the reduction of cycle length as average cycle length in summer fell to a quarter of the run time it was in winter. We have already shown the cause of this was due to the much lower demand for heat in the summer where the boiler was required to operate for just 2 hours per day (at full output) to meet demand. The efficiency was therefore reduced during summer months as the boiler modulated its output and operated for shorter periods of time, where it no longer remained warm between runs.

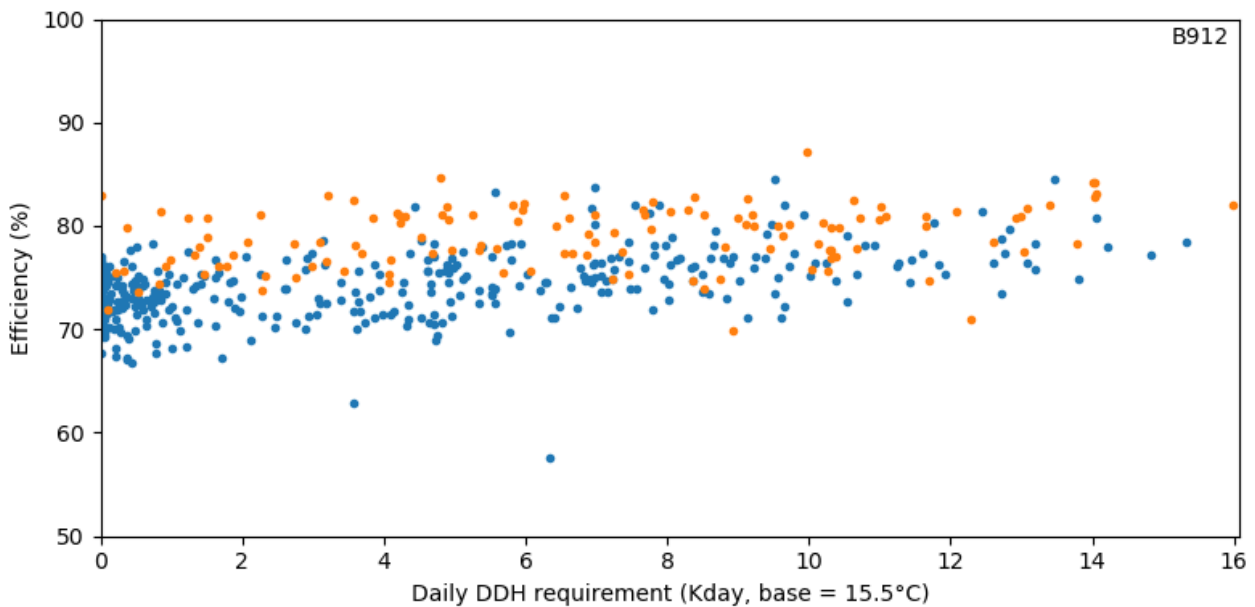
Figure 7: Daily efficiencies against daily degree days (blue before intervention, orange after intervention)

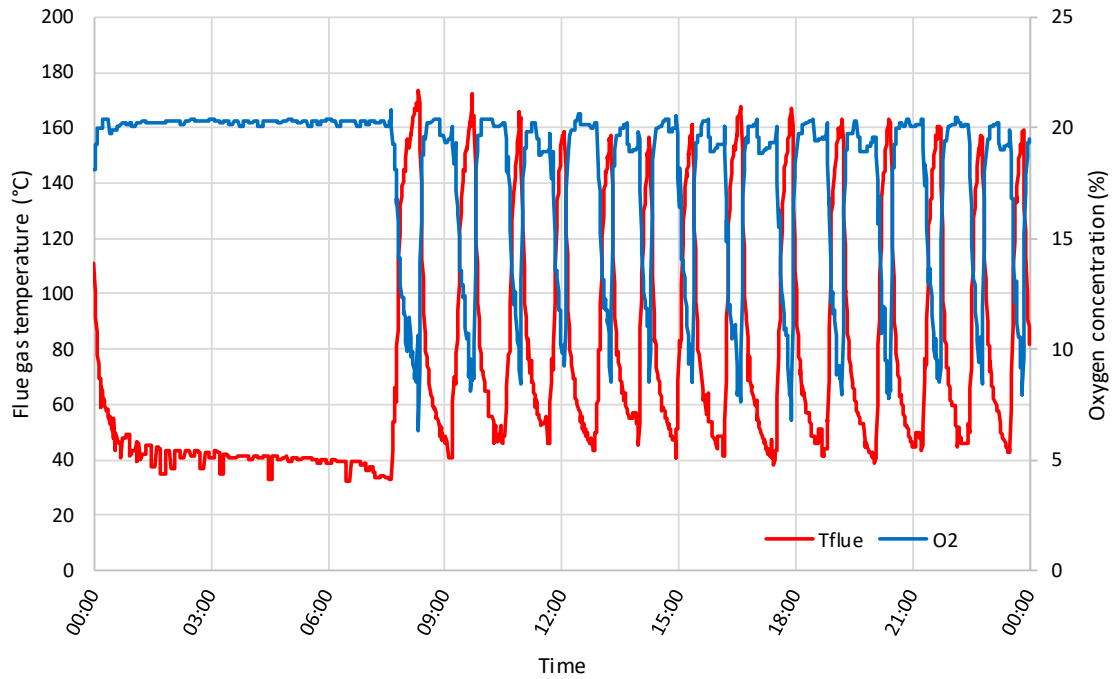
Figure 5: Boiler cycling during a typical day in March

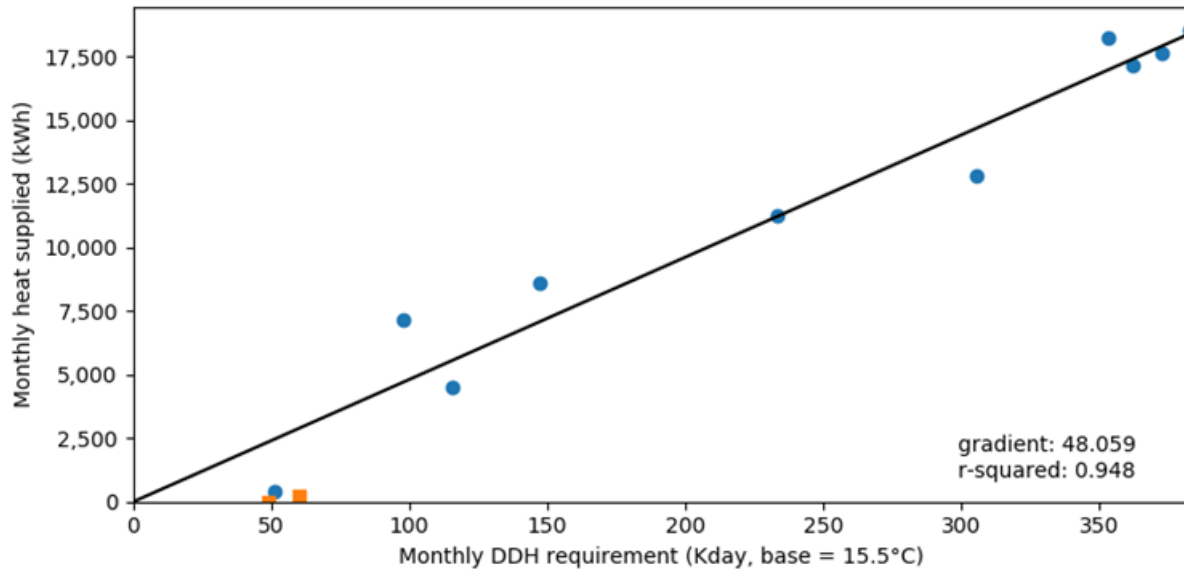
Figure 2: Graph showing heat delivered by the boiler and monthly degree day heating requirement
