Interim report on the investigation of the explosion and fire on board the chemical tanker *Stolt Groenland* on 28 September 2019, Ulsan, Republic of Korea

NARRATIVE

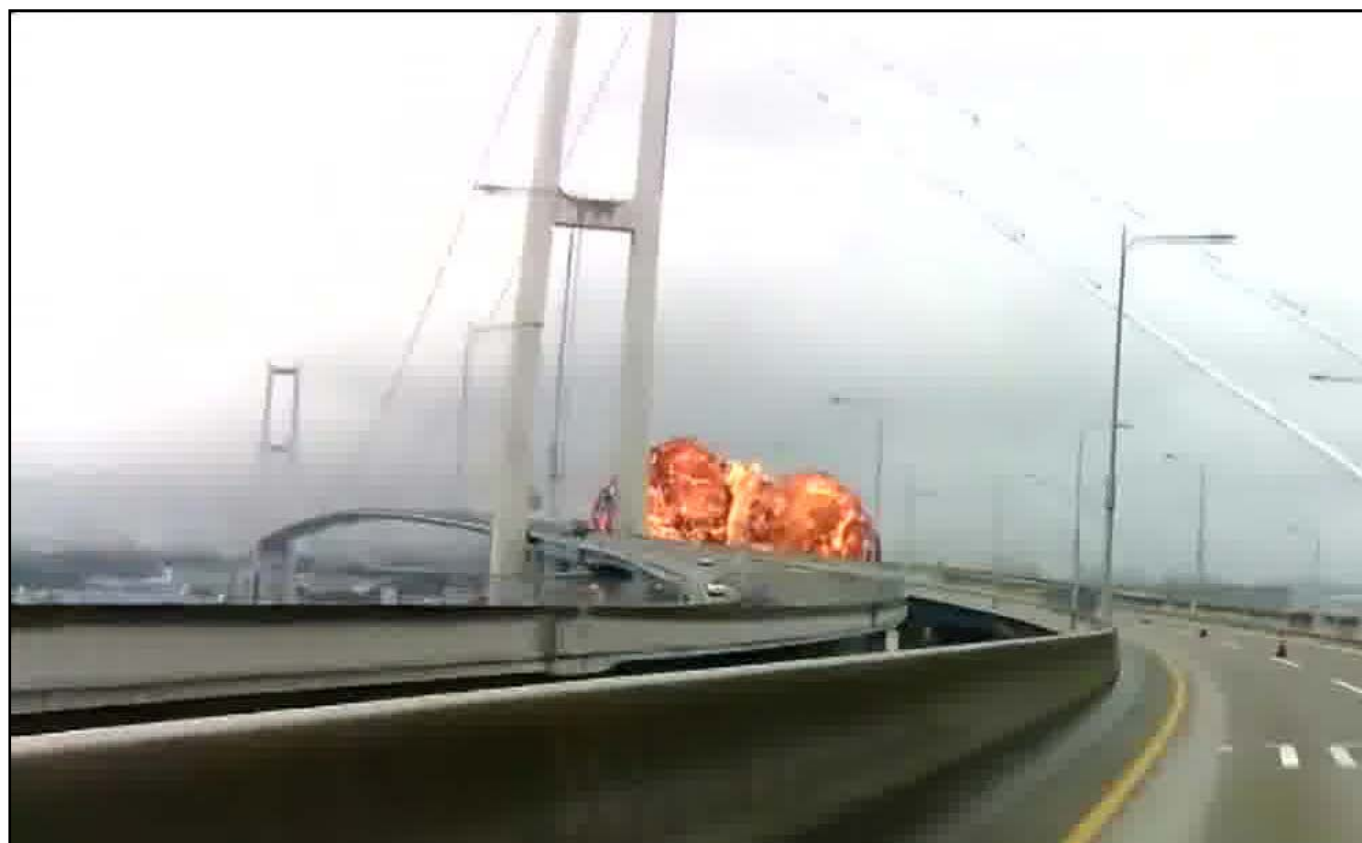
Figure 2: Fireball viewed from the Ulsan bridge

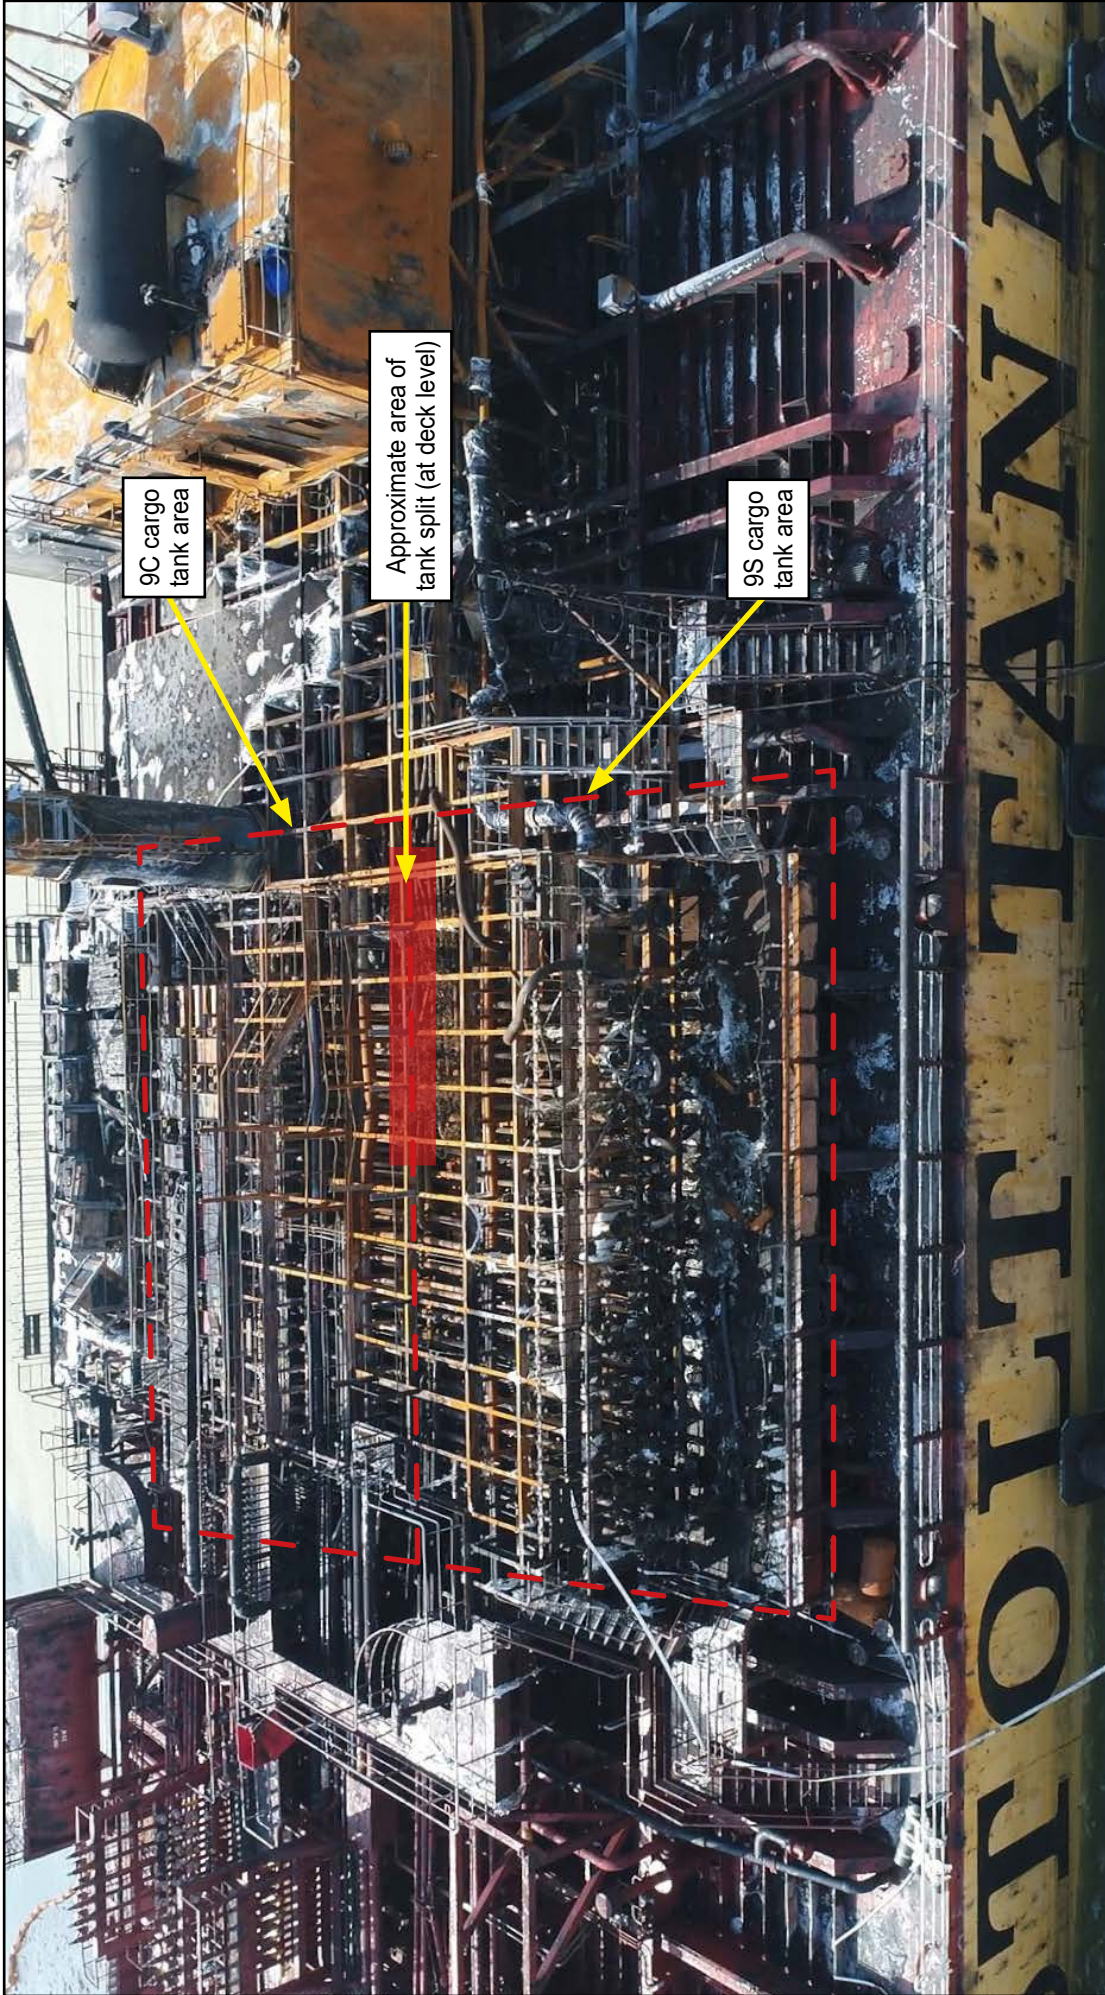
The fire was fought from the shore and from the water and lasted until early the following morning. The damage in way of *Stolt Groenland's* cargo manifold and accommodation block was extensive (**Figure 3**). The following persons were injured: *Stolt Groenland's* gangway watchkeeper, who was blown over the guardrails by the force of the explosion; a deck rating on board *Bow Dalian*; and, a number of shore workers, including firefighters and police during the emergency response.

Figure 3: Stolt Groenland starboard cargo manifold
