THE WRECK OF
THE SS
RICHARD MONTGOMERY

A SUMMARY REPORT
The COASTGUARD Agency
an Executive Agency of the
Department of Environment, Transport and the Regions

29 September 1997

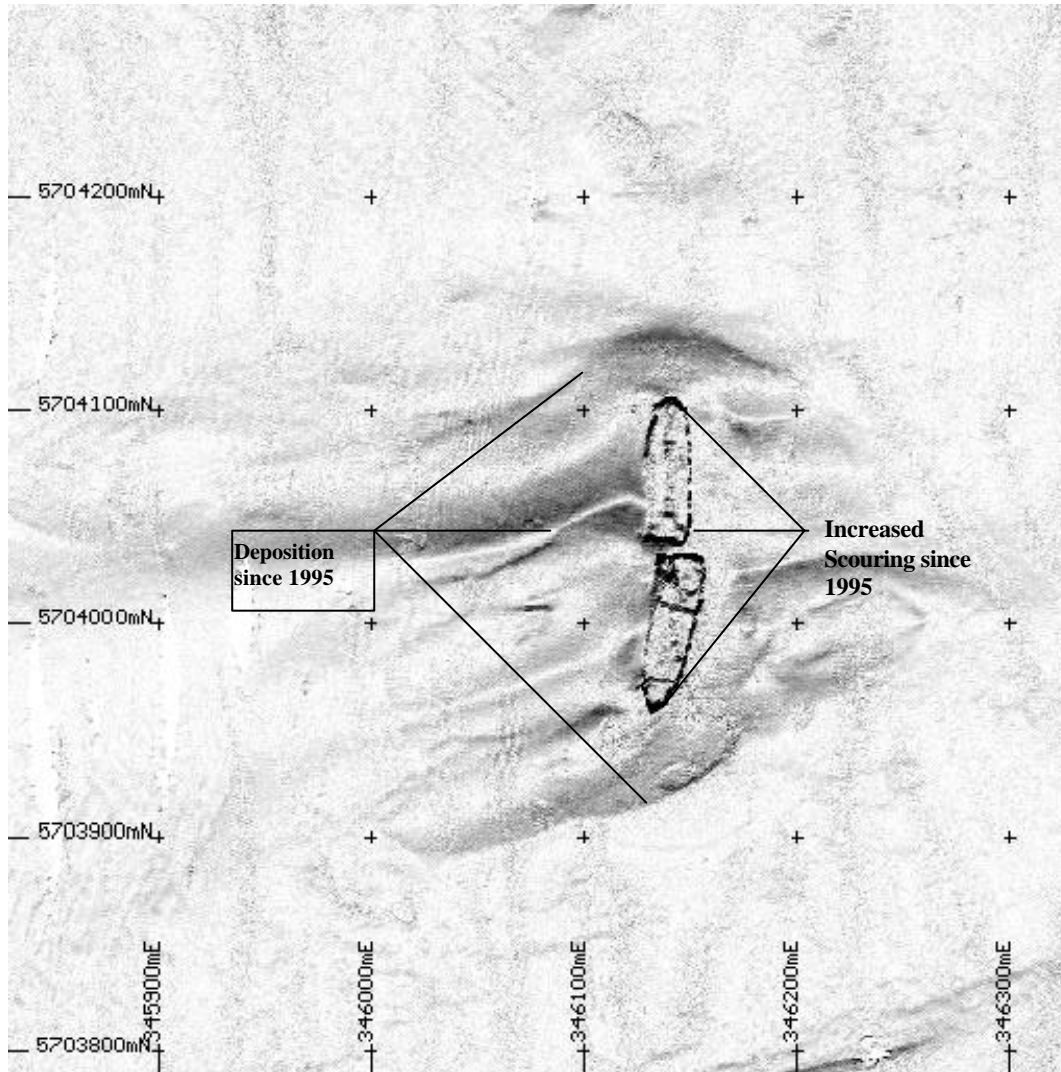
MONOCHROMATIC GRADIENT PLOT

A monochromatic gradient plot at ANNEX C reveals details of the ship's structure. This plot also reveals details of small seabed topographical features such as sand ripples over the area.
