Design, Construction Supervision and Baseline Monitoring of Trial Sections on Low Volume Roads in Zambia

Experimental Design and Research Matrix Report

AFCAP Project Reference Number ZAM2097A

October 2017

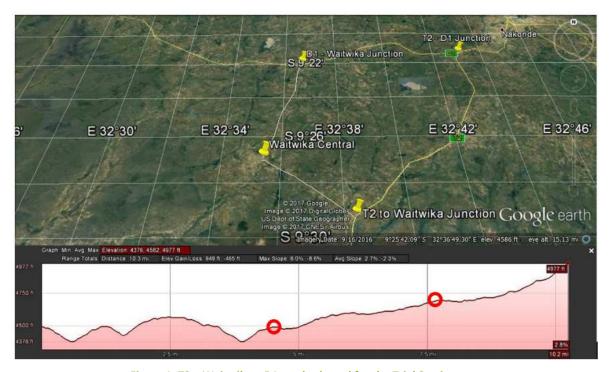
Figure 1: T2 – Waitwika – D1 road selected for the Trial Sections

During the Project Inception stage, the road T2 – Waitwika – D1 in Nakonde District of Muchinga Province as shown in Figure 1 below, was identified among 19 candidate roads and agreed with the RDA as the most suitable location for construction of two 500 m Trial Sections.

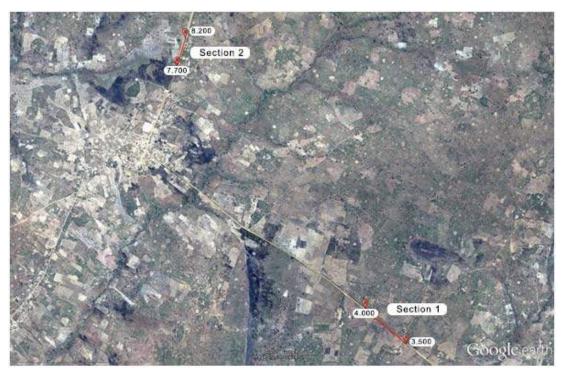
Figure 2: Location of Trial sections

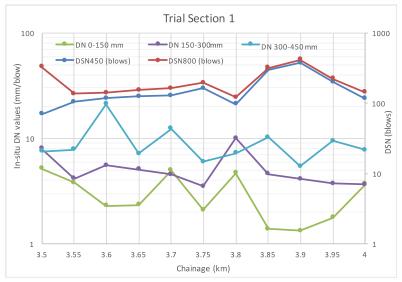
Figure 3: Trial Section 1 - In-situ DN and DSN values

A DCP survey was carried out at potential Trial section sites, based on a visual evaluation of the in situ soils and the general environment around the road (drainage, shape, etc.), and the traffic. The DCP survey showed that the in-situ subgrade material on the two Trial Sections is well-compacted silty sand exhibiting high strength at the prevailing moisture condition as shown in Figure 3 and Figure 4 below. Samples were collected from test pits along the two Sections to determine the current moisture content of the pavement for interpretation of the DCP soundings, and to obtain the engineering characteristics of the in-situ materials.

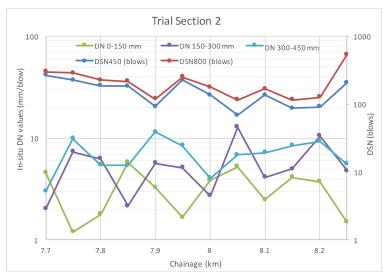
Figure 4: Trial Section 2 -In-situ DN and DSN values

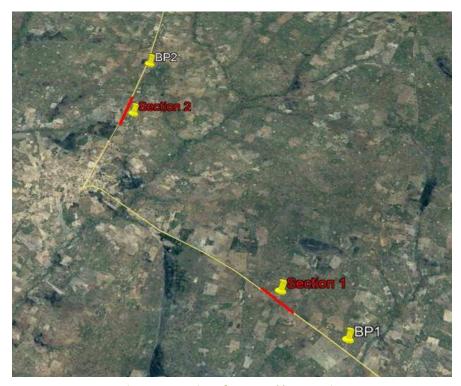
Figure 5: Location of proposed borrow pits

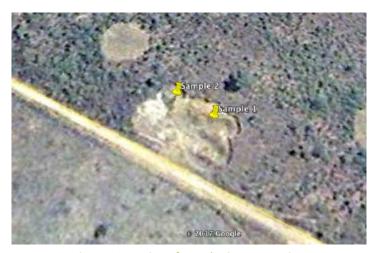
Figure 6: Location of samples in Borrow Pit 1

Two bulk samples (BP1-1 and BP1-2) of the hardpan laterite, each of about 150 kg in mass, were collected from recently excavated small stockpiles at the locations shown in Figure 6.

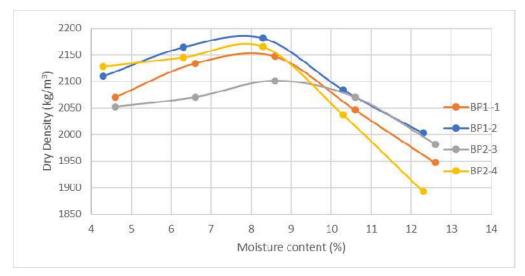
Figure 7: Compaction curves of borrow pit samples

DCP tests were undertaken on a range of compacted samples to evaluate moisture/strength/density relationships. The DN values of all moulds compacted for the MDD/OMC determination were determined and are shown in conjunction with the associated compaction curves in Figure 7 and Figure 8.

Figure 8 shows that for TLC 0.1 MESA, the operating moisture content must not exceed the range 7.5 – 9.0% to attain the required DN values. Figure 7 indicates that the OMCs do, in fact, fall within that range.

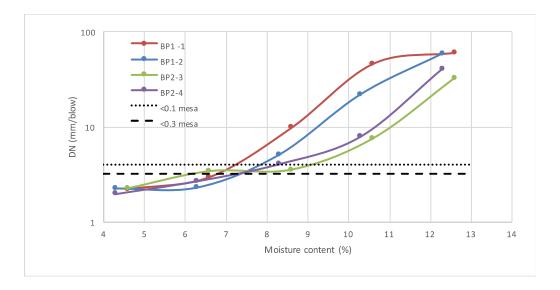
Figure 8: DN results from testing of compaction samples

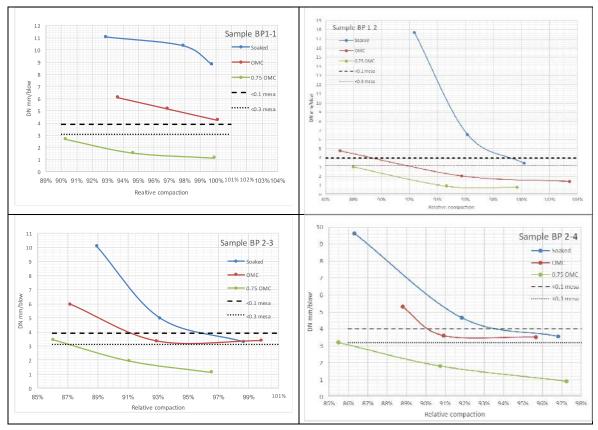
Figure 9: DN values of borrow pit samples at different moisture contents and densities

The borrow pit materials were tested at three compaction efforts and three moisture contents as shown in Figure 9. General classification tests were also routinely carried out to confirm that the grading is acceptable $(1.0 \le GM \le 2.3)$ and that the materials are not overly plastic.

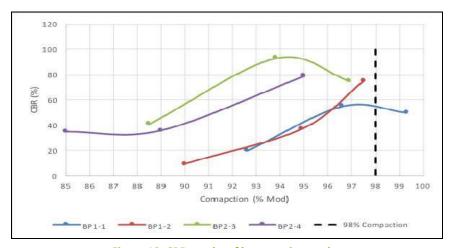
Figure 10: CBR results of borrow pit samples

The CBR results show that the laboratory testing has generally produced lower densities than expected. Although there is some unexplained variation (and possible spurious data) in the results, extrapolation of the strengths to 98% compaction indicates that the CBR will generally be above 60% for all the materials at 98% relative compaction.

Although the design is based on the measured shear strength of the materials indicated by their DN values, CBR tests were also undertaken for comparison with conventional design methods. The CBR results are summarised in Figure 10.

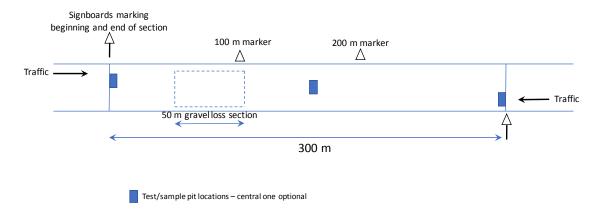
Figure 11: Layout of unpaved road control section

In order to make performance comparisons, unpaved road control sections are required. The T2-Waitwika-D1 road will be rehabilitated to full gravel standard under an AfDB funded project. The unpaved control sections to be chosen will need to be carefully set up according to the lay-out shown in Figure 11 and be as close to the paved Trial Sections with properties (traffic, subgrade, grade, etc.) as similar as possible to them. The sections should be 300 m long and include a 50-m section for regular gravel loss measurements. The construction cost of this 300-m section should be determined as a pro-rated part of the entire gravel road construction cost, excluding any drainage structures, i.e., the cost of forming, gravelling and constructing the road as well as the cost of the associated side-and mitre-drains. The exact locations of these sections will be chosen during construction based on the Contractor's progress and will be as similar as possible to the paved sections, particularly in terms of gradient.

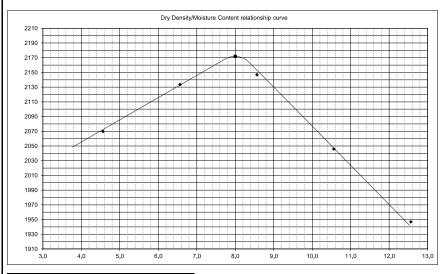
Optimum Moisture Content:
 OMC
 8.0 %

Maximum Dry Density:
 MDD
 2172 kg/m³

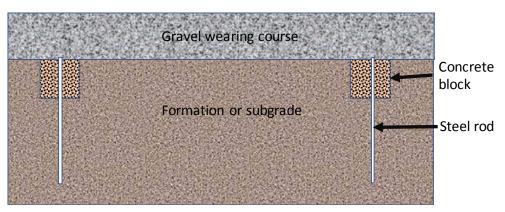
The setting of 500 mm steel roads (10 - 15 mm in diameter) in concrete blocks at subgrade level has been found to be satisfactory (Figure A-1).

Figure E-1: Placement of stable benchmarks

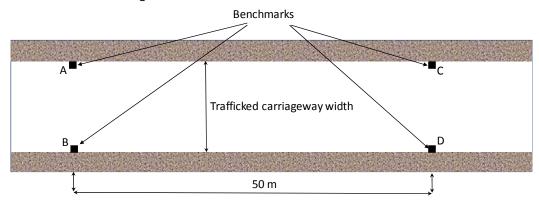
A gravel loss monitoring section will normally be 50 m long, on a flat and level section of road with no culverts or cross-drainage structures and should fit within the trafficked portion of the carriageway. The bench marks should be placed at each end of the section and at least 3 (preferably 4) should be installed as shown in Figure A-2.

Figure E-2: Location of stable benchmarks
