# Ground Improvement for Khulna Soft Clay Soil

Final Report

Mott MacDonald

AsCAP Project Reference Number. BAN2083A

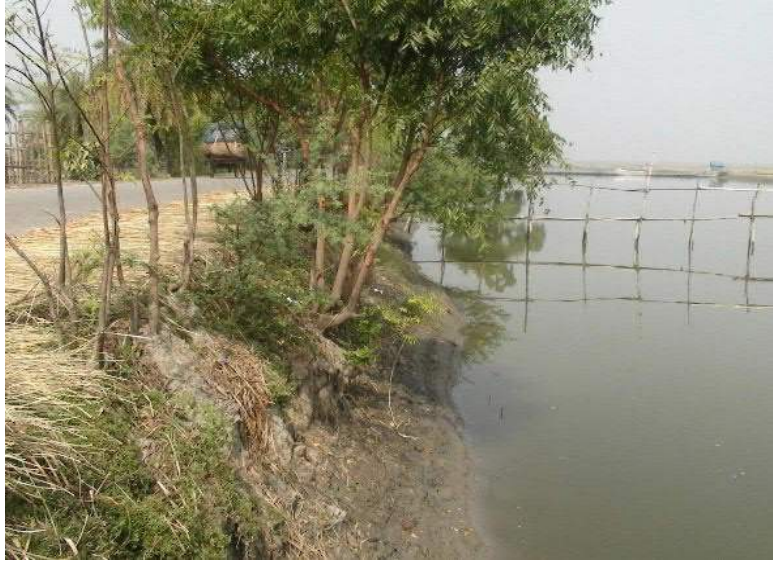
Erosion leading to over-steepening of the embankment slopes  
(Site 3 – 287042008)

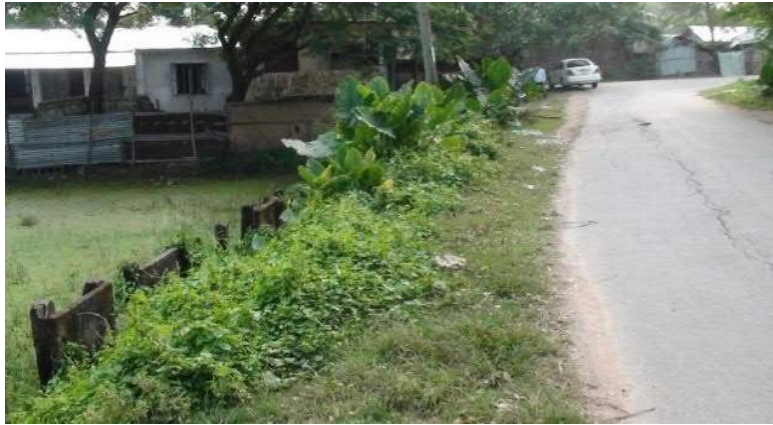
Longitudinal cracking towards the edge of the road pavement  
(Site 10 – 247302001)

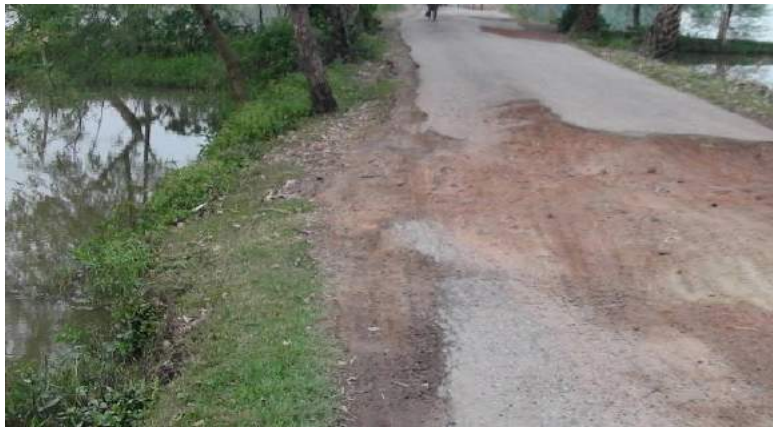
Lateral spreading of the embankments  
(Site 11 – 247303003)

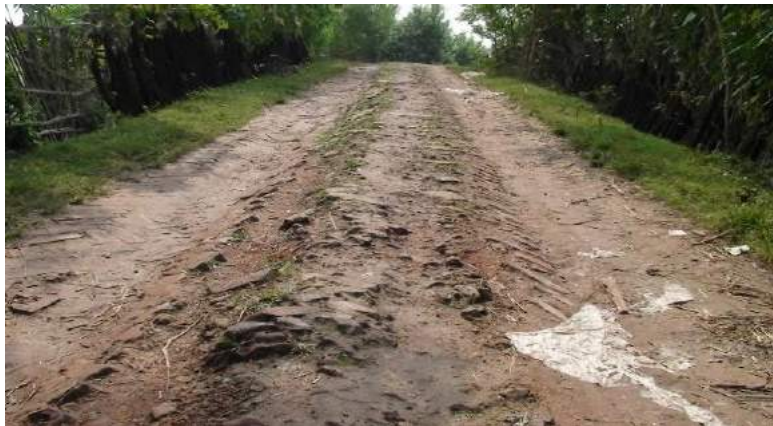
Poor road surface conditions / potholes are widespread  
(Site 6 – 247172001)

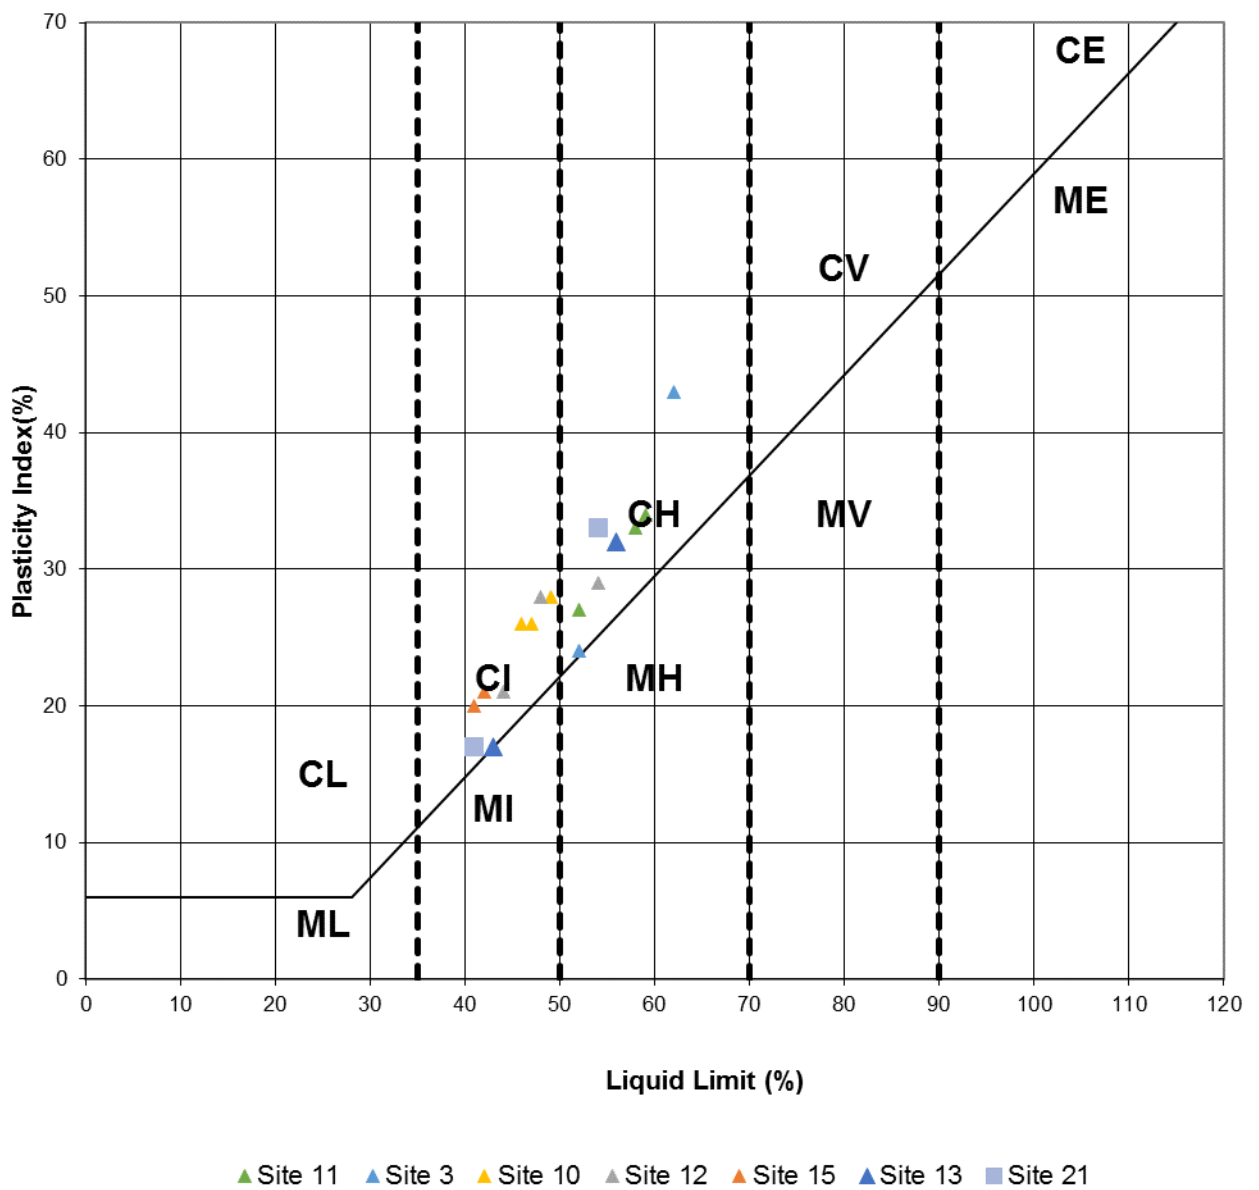
Figure 5.1: A-Line Plasticity Chart

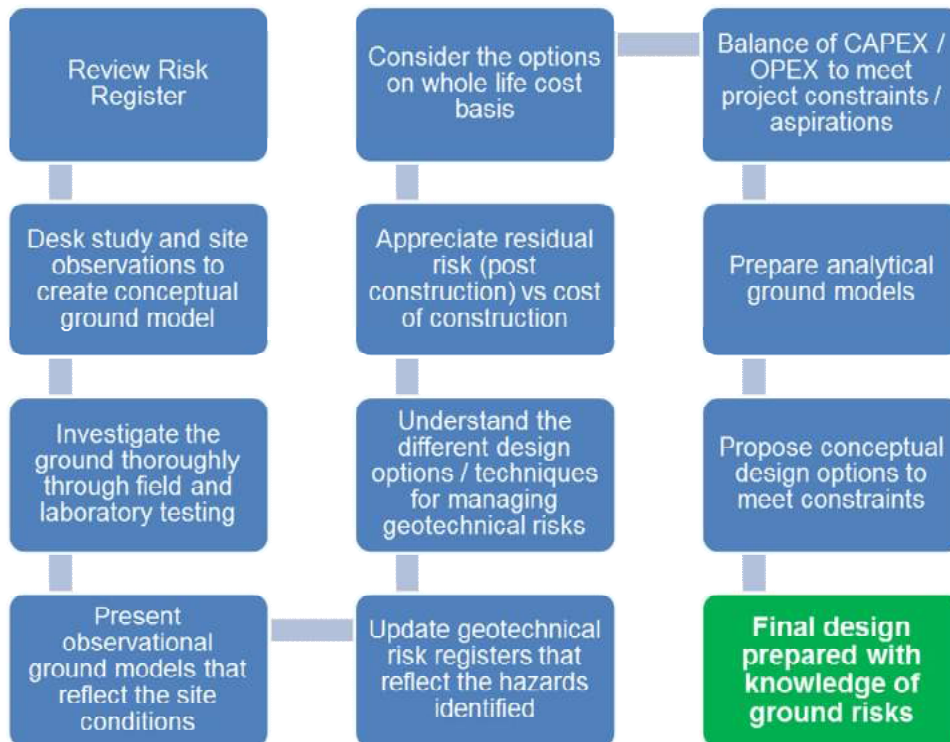
Figure 7.3: Design Phase – Management of Risks associated with Soft Ground

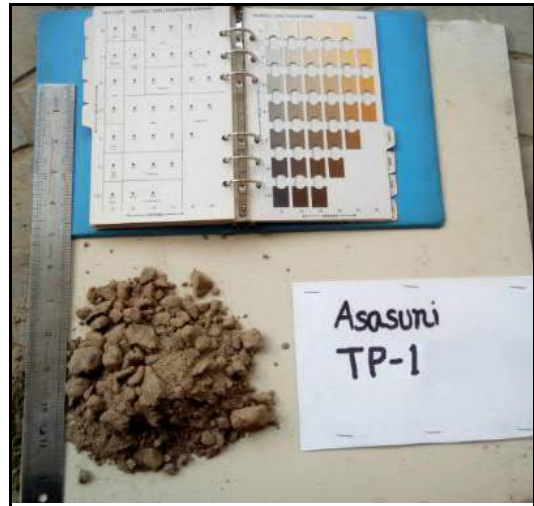
The soil sample contains Very Fine Sand of Reddish Brown colour. The Sand is Loose and contains sufficient amount of Gravels within it. But those gravels are may be mixed from the pavement material because some of them contain coats of Bitumen.

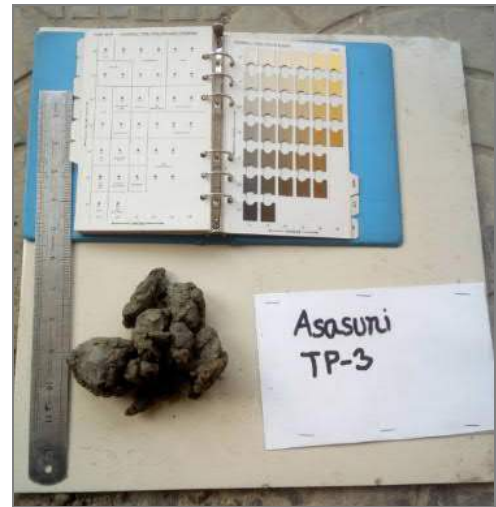
The soil sample is Gray in colour with High Plasticity, Occasional lines of ferruginous and spotted carbonaceous materials are present. Small lenses of Grayish Brown soil id also observed within the Gray soil. Soil sample contains plant roots.

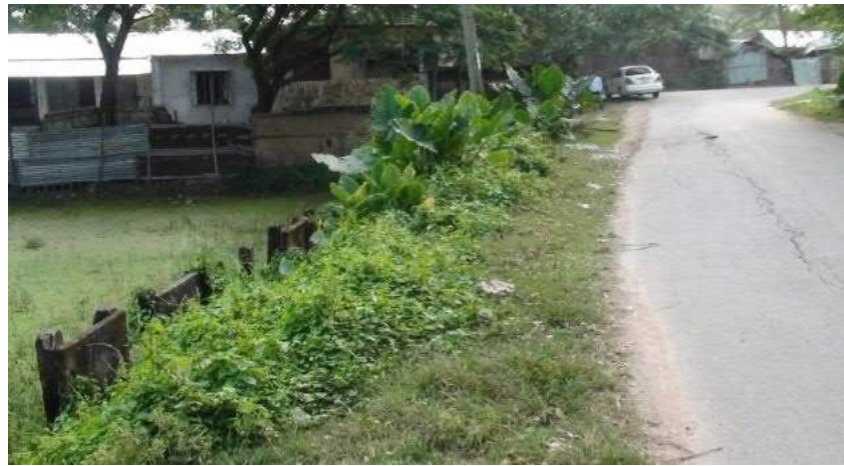
The main body of the embankment is composed of a Lean Clay and a Lean Clay with Sand. This placed embankment fill material generally has a cone resistance of 2.5 to 9.5 MPa. Resistance within the embankment fill drops from the more competent near surface layers and then increases towards the base of the embankment fill and into the foundation soil. This illustrates probable poor compaction of the fill material, leading to low strength and support characteristics.

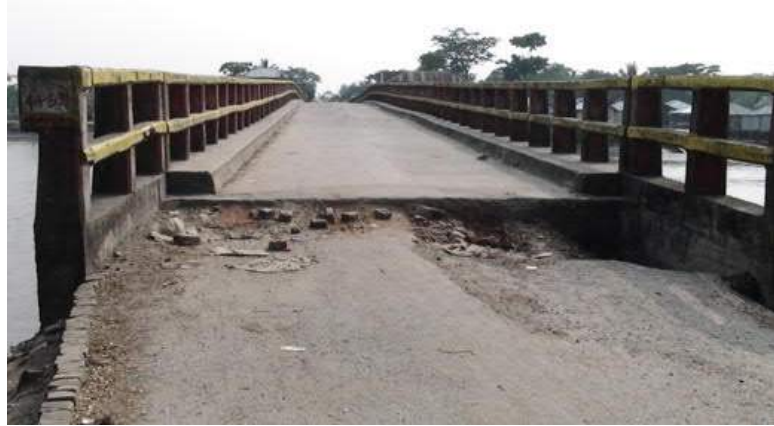
The road embankment is constructed predominantly from Lean Clay and Fat Clay with Sand. At Mongla A - the placed embankment fill material generally has a cone resistance of 1.5 to 4 MPa. At Mongla B - the placed embankment fill material generally has a cone resistance of 20 MPa near the surface, dropping to around 4 MPa, the higher values reflecting the influence of broken brick aggregate near the surface.
