Construction noise and vibration Monthly Report – November 2019

London Borough of Camden

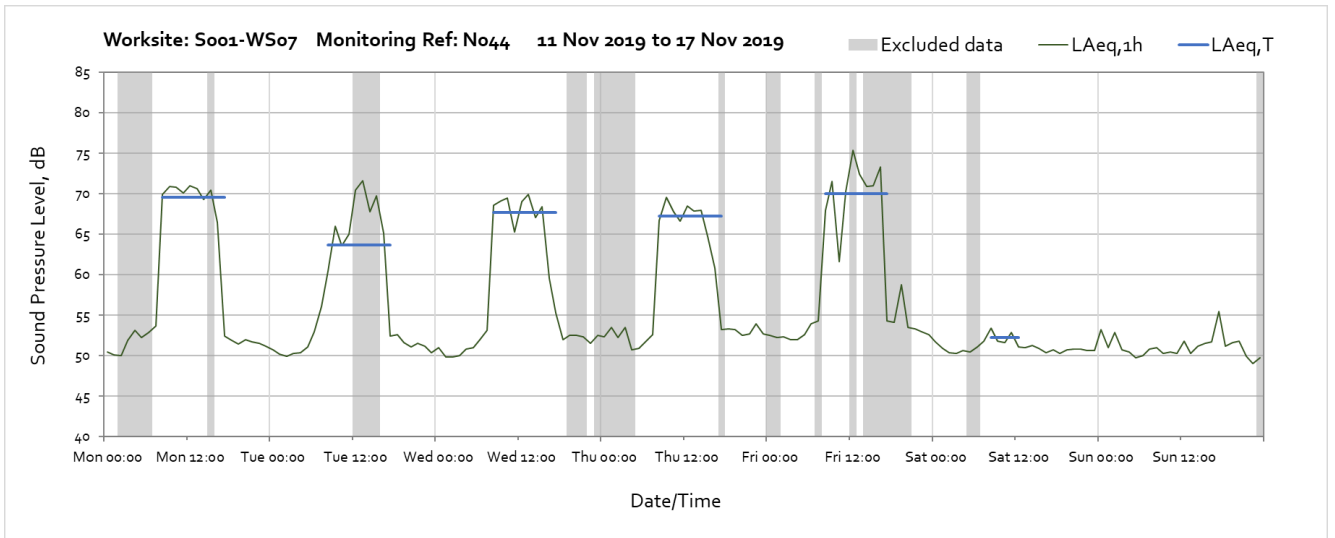
Worksite: S001-WS07 – Monitoring Ref: N044

Note: Missing data between 18:00 and 23:00 on Friday the 1st of November were due to a power failure at the construction site.

Note: Noise levels above the SOAEL on Tuesday the 19th and Thursday the 21st of November were due to noise from dust suppression equipment installed in proximity to the monitor. Considering distance attenuation noise levels would be below the SOAEL at the nearest receptors to the works.

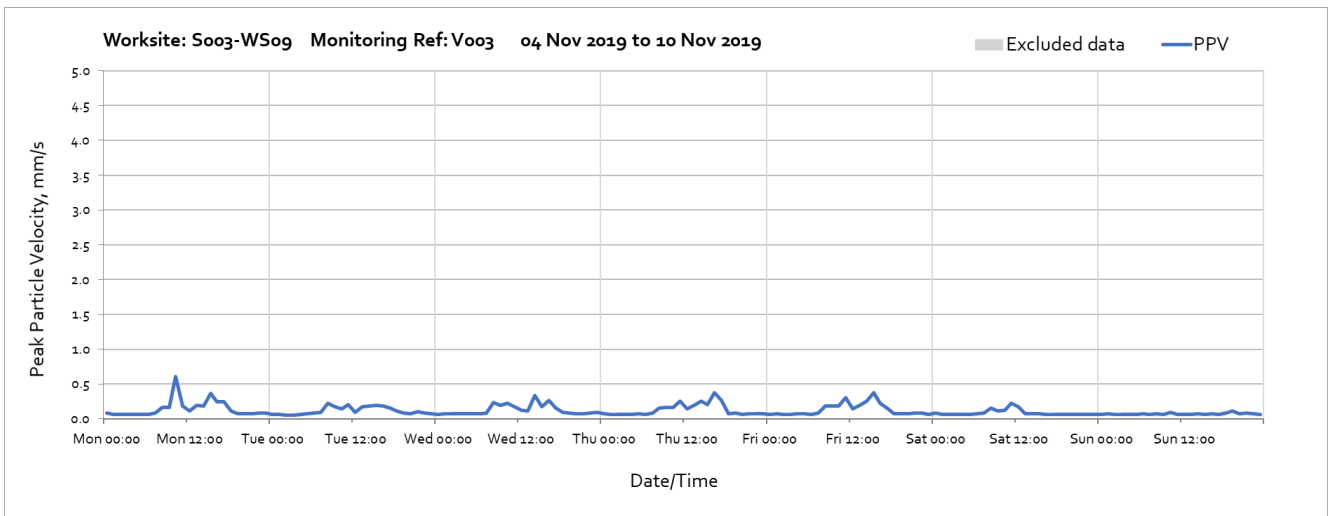
Worksite: S003-WS09 – Monitoring Ref: V003

Note: High vibration levels on Monday the 11th of November were due to local disturbance of the vibration monitor and are not representative of HS2 vibration levels.
