**Technical Assessment of Petroleum Road Fuel Tankers  
Work Package 1 - Full scale testing and associated modelling  
OVERALL SUMMARY**

**ES/14/39/00rev08**

### Technical Assessment of Petroleum Road Fuel Tankers

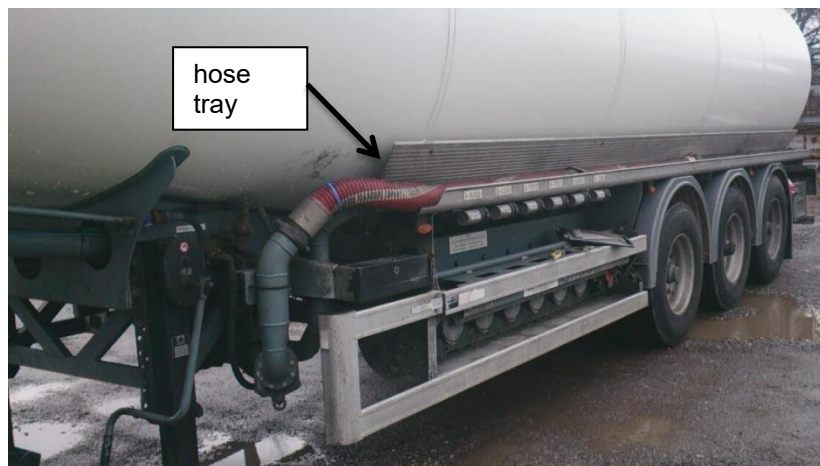
**Figure 4** Nearside of GRW tanker J2580 with hose tray  
Radiography of bands D/8 to H/8 started just above the top of the hose tray

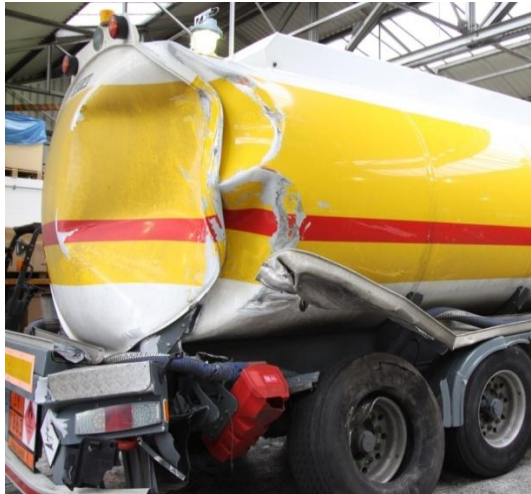
DfT IMG9444

GRW tanker J3217 was damaged at the rear offside by an impact from behind (Figure 5). It was laser scanned by HSL to provide dimensional information on the whole tanker, including the damage. Figure 6 is an image from the laser scan data. Physical samples of the damaged areas were taken for use in WP2.

**Figure 5** Damage to the rear of GRW tanker J3217

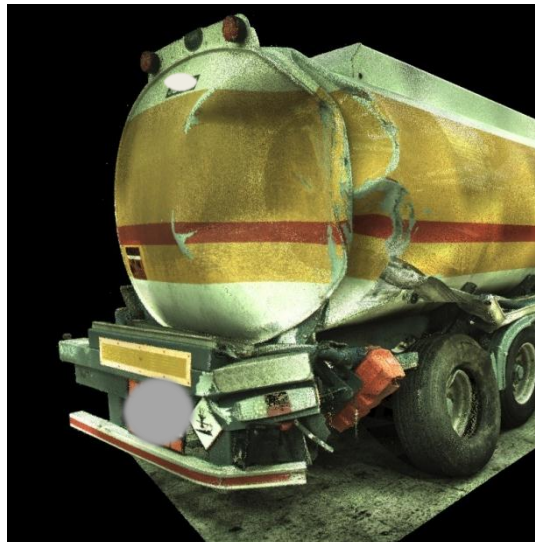
**Figure 6** Laser scan image of the rear of GRW tanker J3217

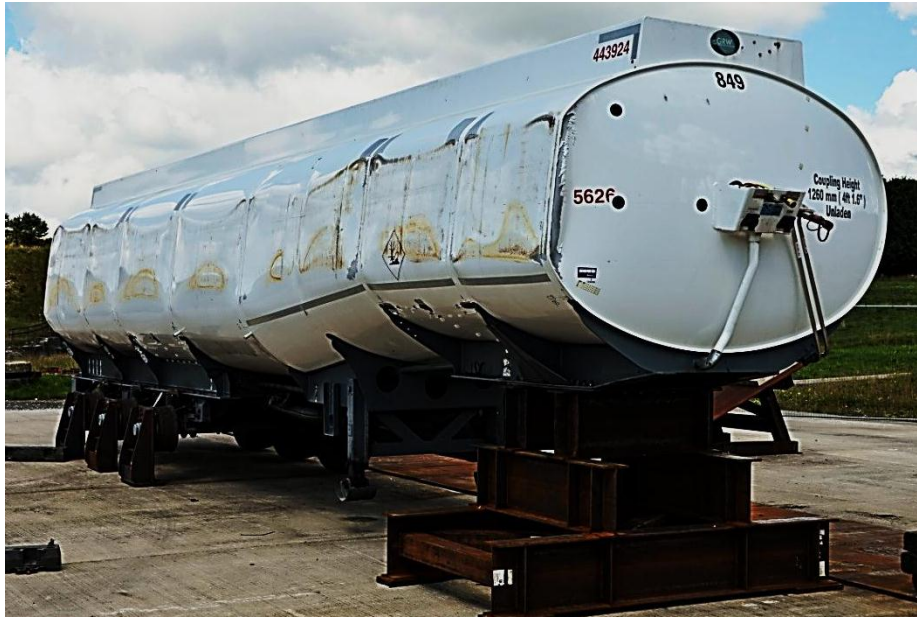
VPS 1407047\_006 - picture enhanced to make damage clearer

After the test, the offside (impact side) of all the tankers had a similar deformation shape with the impact area flattened - Figure 13 illustrates the damage to GRW tanker J3910. The deformation profile was similar along the length of the GRW tankers, with the level of deformation increasing from front to rear of the GRW tankers. The deformation data, both as a reduction in tanker diameter and as the length of the flattened impact chord, were similar for GRW tankers J2580 and J3910. Comparison of laser scan images taken before and after the tests showed that the impact had caused permanent reduction in tanker diameter of approximately 100 mm at the rear of the proof of concept tanker; of approximately 100 mm at the rear and 82 mm at the front of GRW tanker J2580; and of approximately 107 mm at the rear and 82 mm at the front of GRW tanker J3910.

**Figure 13** GRW tanker J3910 - impact damage viewed from front

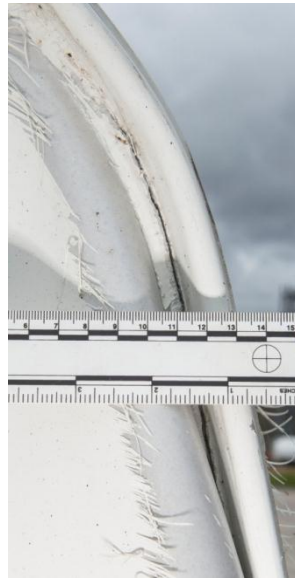
VPS 1408025\_017

**Figure 14** GRW tanker J2580 – rupture in the weld at top of impact zone

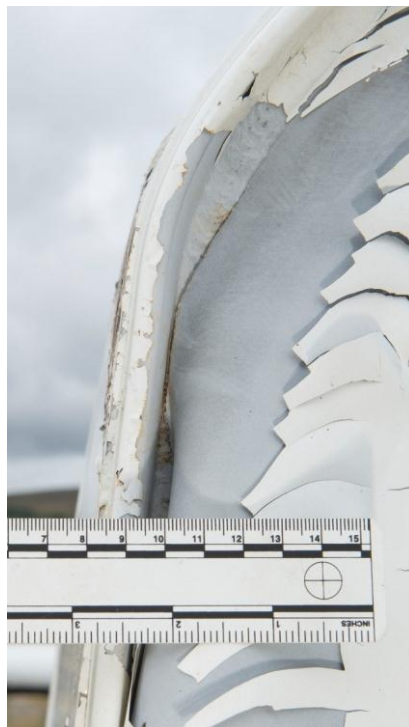
VPS 1408025\_025

**Figure 16** GRW tanker J3910 – rupture at toe of weld at top of impact zone

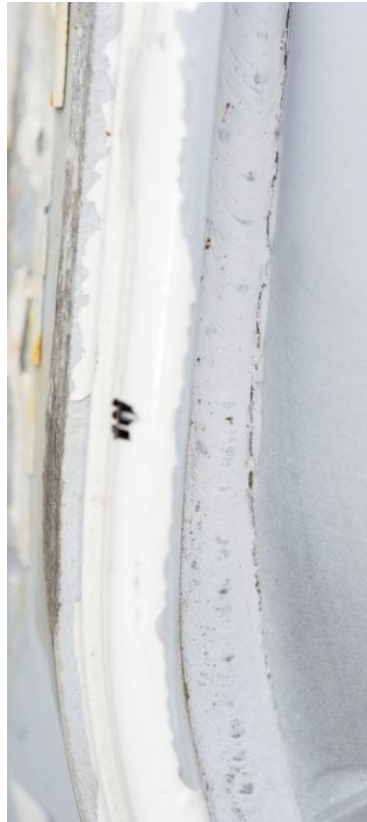
VPS 1408025\_006

**Figure 17** GRW tanker J3910 – crack at toe of weld at bottom of impact zone

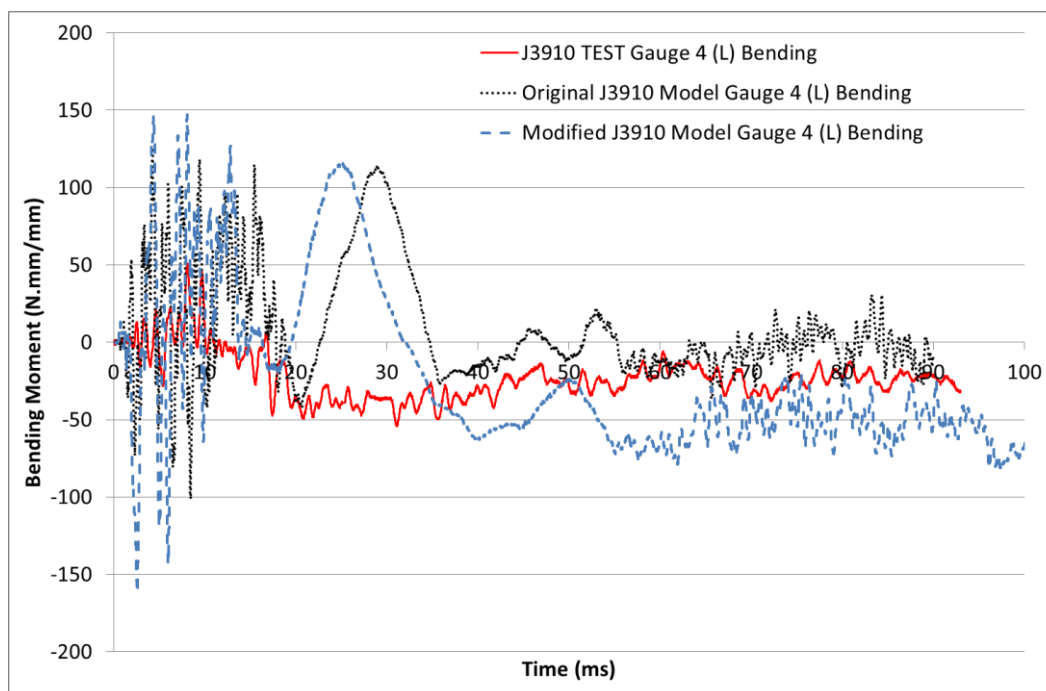
**Figure 24** Comparison of bending moments at centre of C1b for GRW tanker J3910 test and finite element models

Gauge location 4 (longitudinal direction gauge at centre compartment 1b); bending moment per unit length

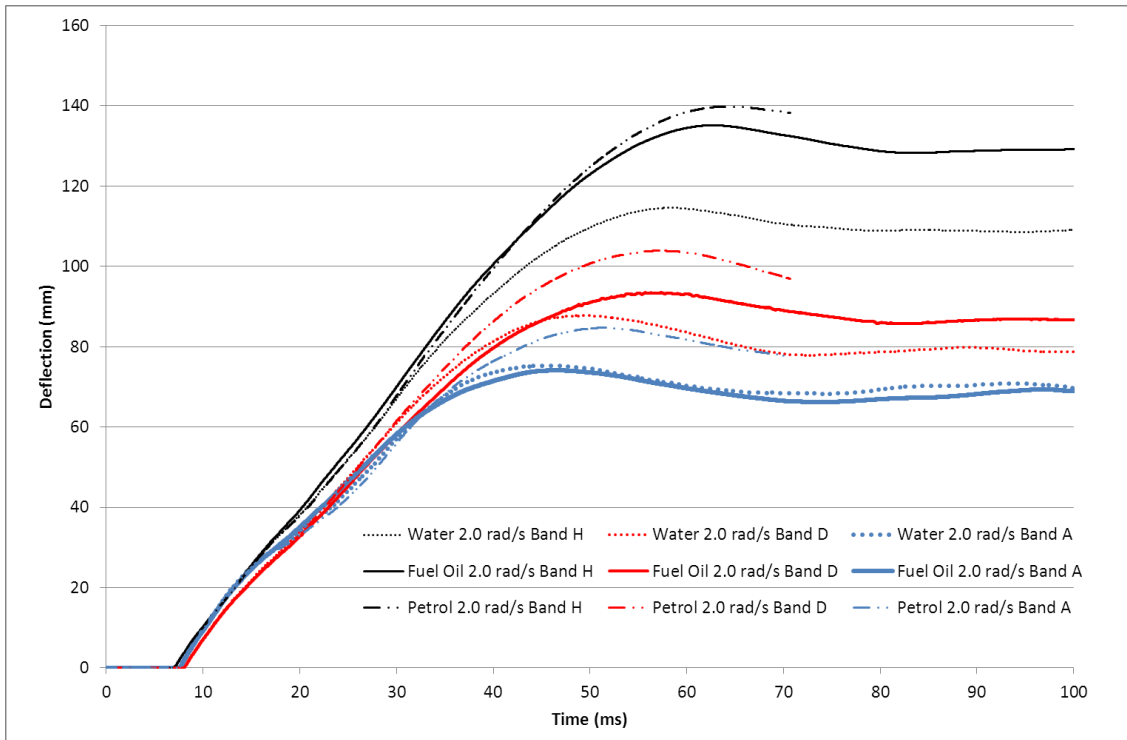
It is not clear why deflections of the tanker vary so much with different liquids when the overall mass, and therefore inertia and energy, are the same. The explanation is likely to involve the different fill levels and pressure gradients within the compartments for the different liquids, and the different fill levels changing the free space above the liquid, which varies the opportunity for sloshing movement.

**Figure 27** Effect of tanker load (fuel oil/water/petrol) on deformation (band deflections) at 2.0 rad/s impact velocity

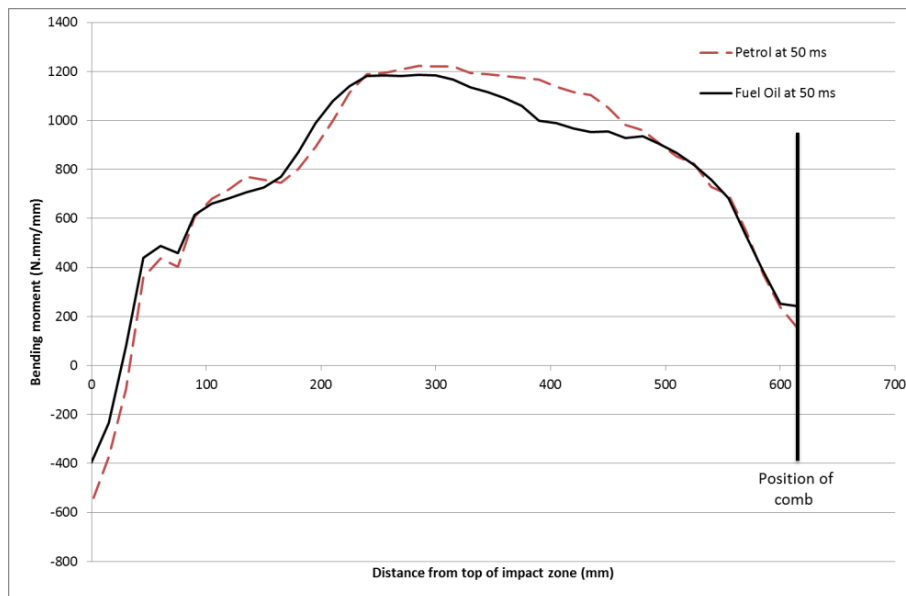
**Figure 33** Bending moments next to Band F/8+ - variation due to fuel (2.0 rad/s)

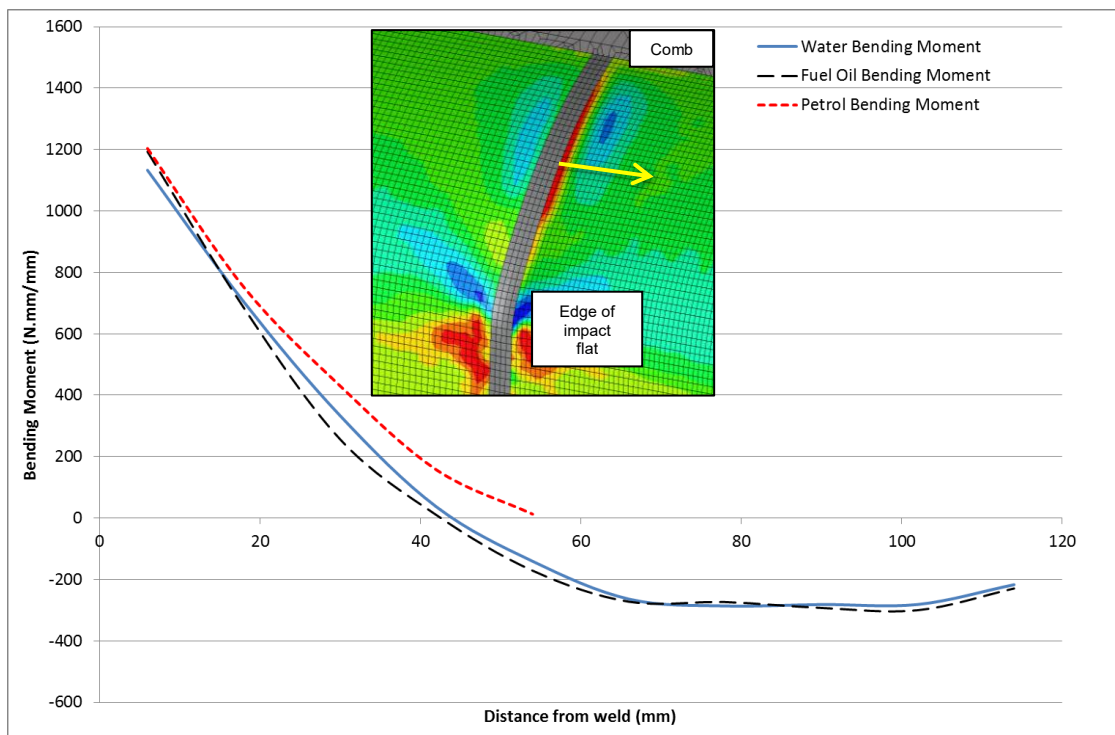
**Figure 34** Variation in bending moments with distance from the weld (Band F/8+) for water, fuel oil and petrol (all at 2.0 rad/s)

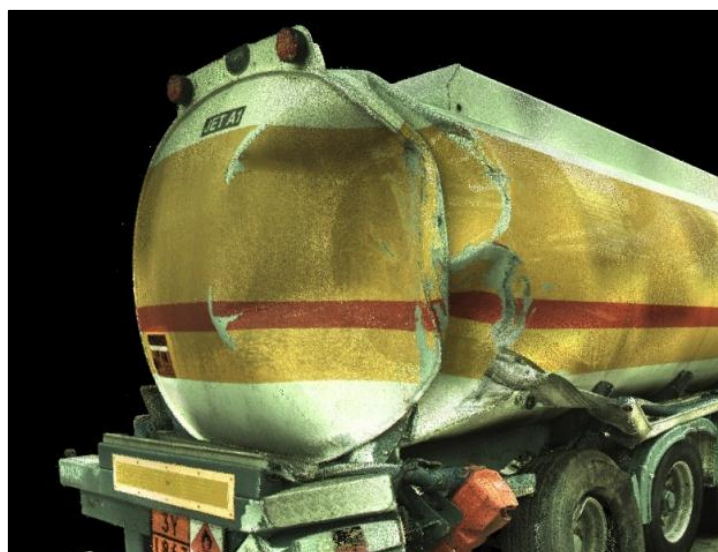
**Figure 39** Scan of damage to tanker J3217 subjected to offside rear impact
