Phase 1 Geotechnical and Geo-environmental Desk Study Report

HCA Compton

Project Number: 60544578

October 2019

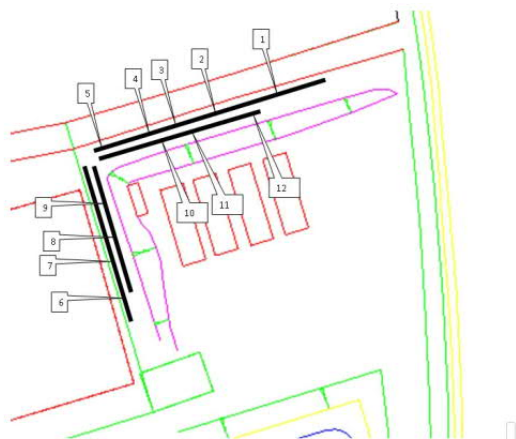
Figure 2 Location of survey pits and estimated extent of burial trenches.

A double trench was also found on the west bank, the first trench was 1.8m east of the fence, the second trench was 4.7m east of the fence. Radioactive materials were found in both trenches on the west bank, these consist of radioactive laboratory items, contaminated soil surrounding animal bones and bags of contaminated soil. Gamma radiation levels were found up to 100 cps measured with a Mini 900/44A scintillation probe, compared to a background instrument response of 5-10 cps.

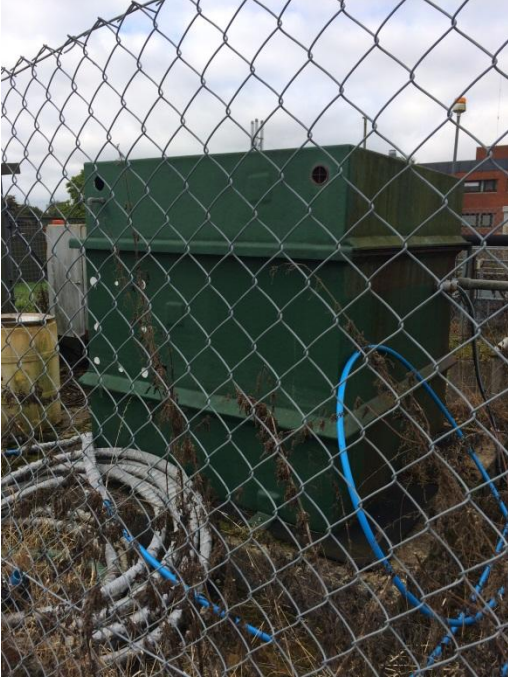
Client Name: HCA		Site Location: Former Pirbright Institute Compton	Project No. 60544578
Photo No. 3	Date: 18/09/17

Direction Photo Taken: N/A			
Description: Above Ground Storage Tank (AST 12)

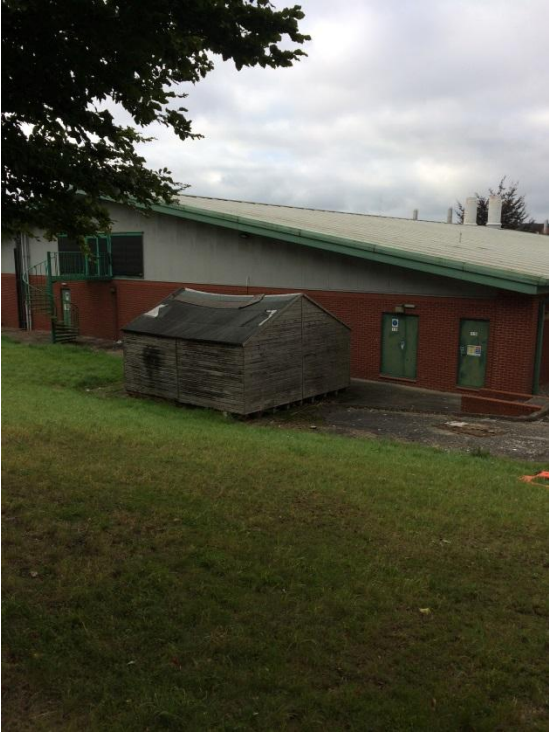
Photo No. 6	Date: 18/09/17

Direction Photo Taken: West		
Description: Taken from bank north of the effluent settlement looking to Buildings CO56 and CO57.

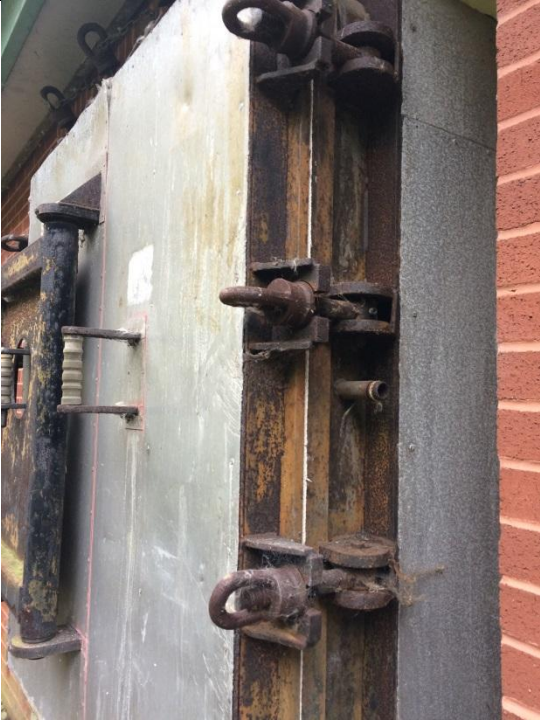
Client Name: HCA		Site Location: Former Pirbright Institute Compton		Project No. 60544578
Photo No. 7	Date: 18/09/17

Direction Photo Taken: N/A				
Description: The rear of building CO56

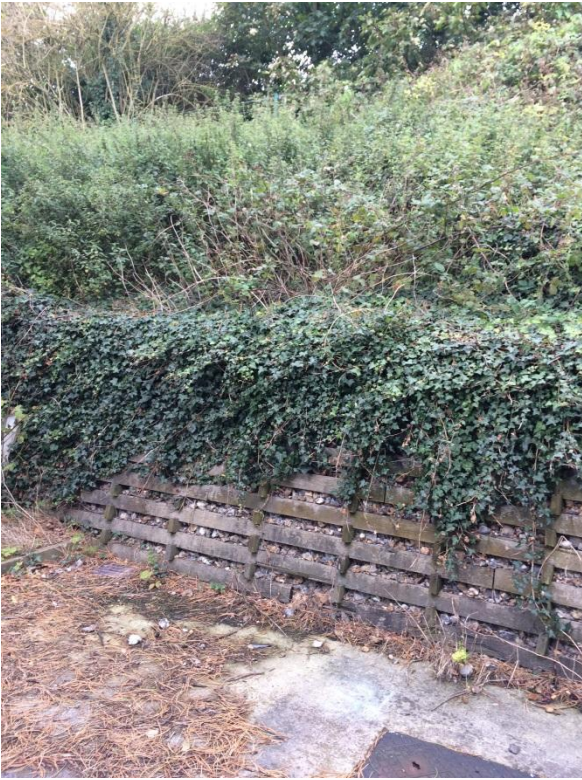
Photo No. 8	Date: 18/09/17

Direction Photo Taken: N/A		
Description: Retaining wall to the north of Zone 2

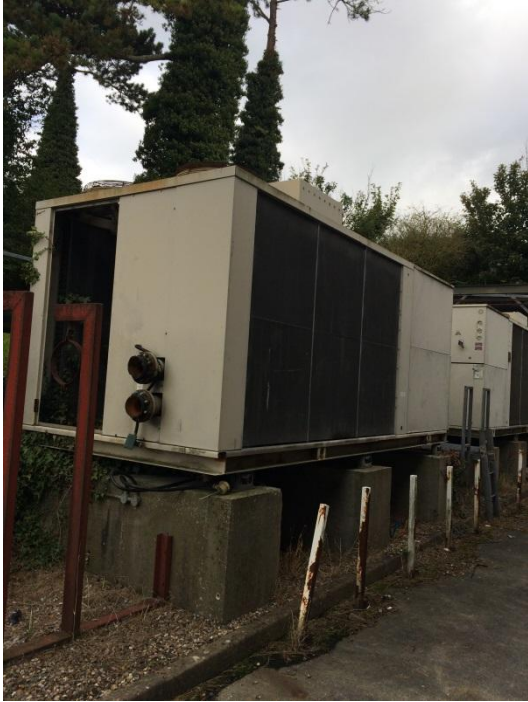
Client Name: HCA		Site Location: Former Pirbright Institute Compton		Project No. 60544578
Photo No. 9	Date: 18/09/17

Direction Photo Taken: N/A				
Description: Generators to the north of Zone 2.

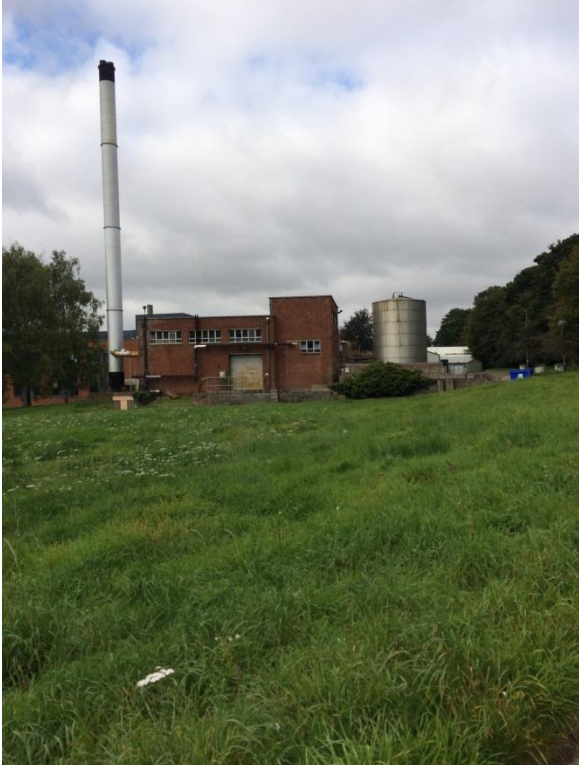
Client Name: HCA		Site Location: Former Pirbright Institute Compton		Project No. 60544578
Photo No. 11	Date: 18/09/17

Direction Photo Taken: West				
Description: Boiler house

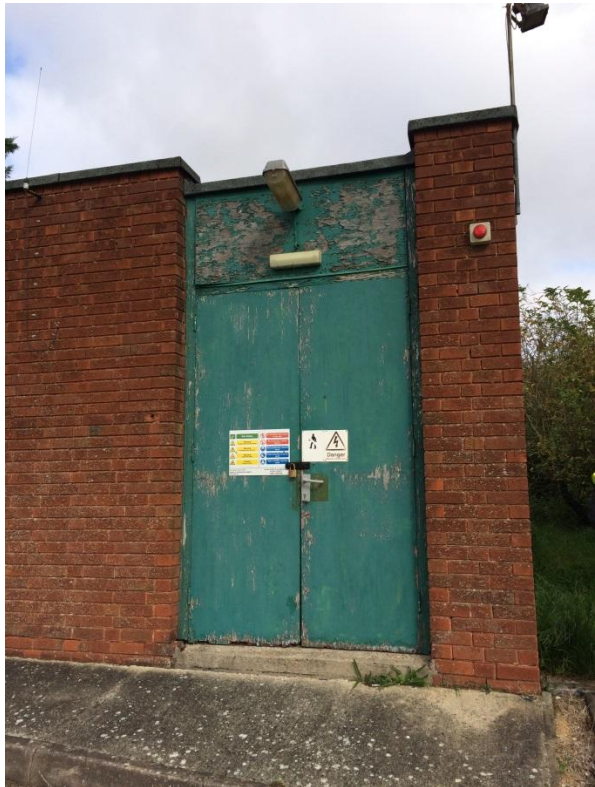
Photo No. 12	Date: 18/09/17

Direction Photo Taken: West				
Description: Substation 1 (Building CO54)

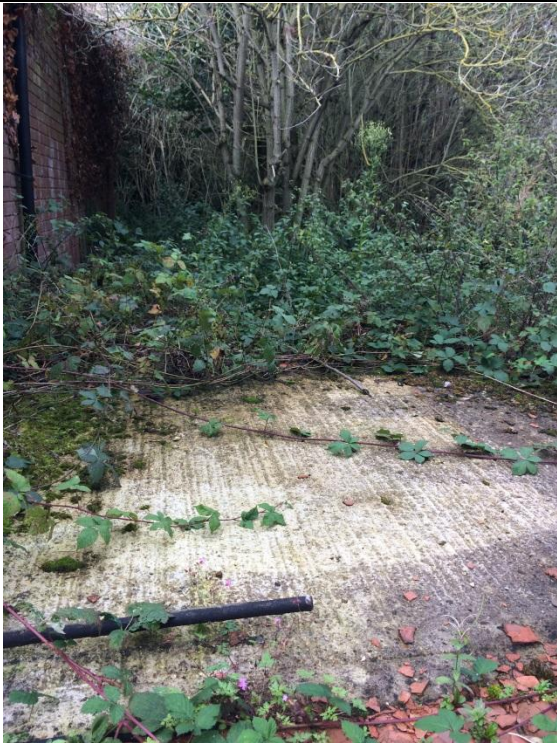
Client Name: HCA		Site Location: Former Pirbright Institute Compton	Project No. 60544578
Photo No. 13	Date: 18/09/17

Direction Photo Taken: N/A			
Description: Former platform for above ground storage tank (AST 13) next to Substation 1 (CO54)

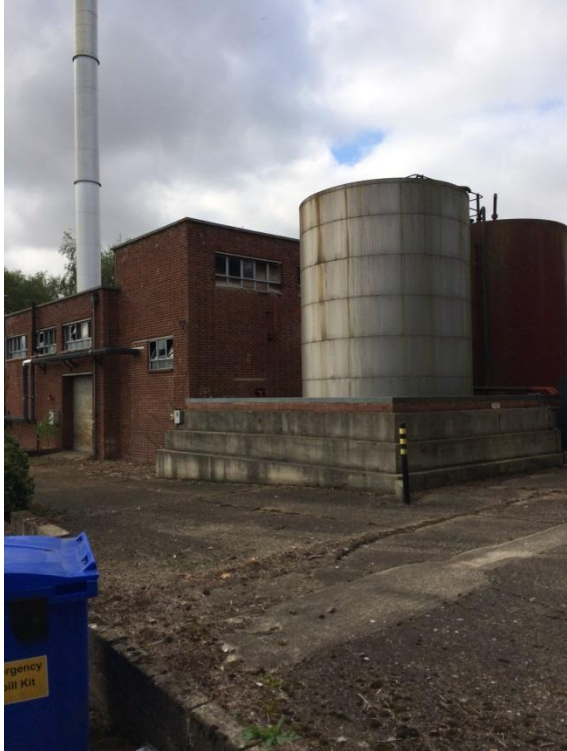
Photo No. 14	Date: 18/09/17

Direction Photo Taken: South West		
Description: Two above ground storage tanks associated with the boiler house to the rear of Building CO53

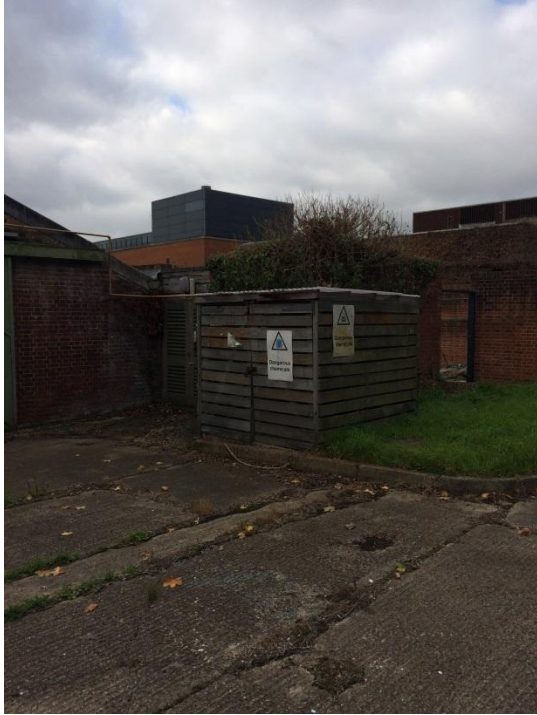
Client Name: HCA		Site Location: Former Pirbright Institute Compton	Project No. 60544578
Photo No. 15	Date: 18/09/17

Direction Photo Taken: South West			
Description: Chemical Store to the rear of Boiler House (CO53)

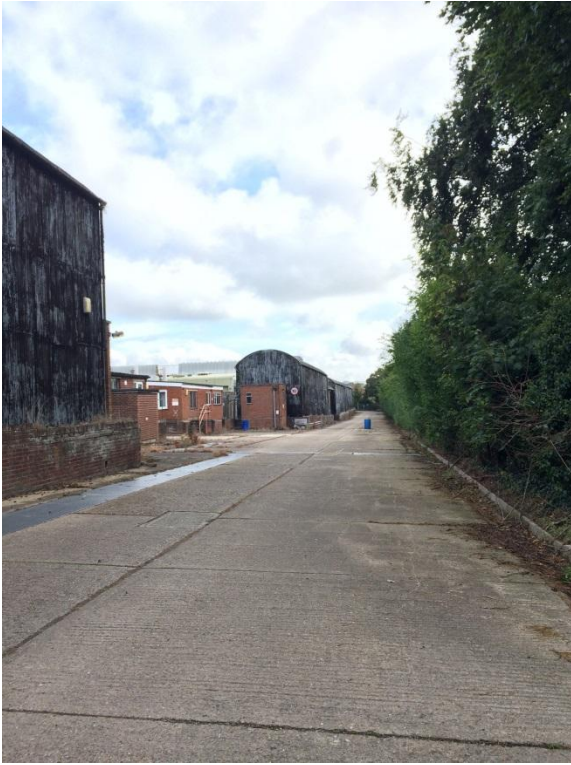
Photo No. 16	Date: 18/09/17

Direction Photo Taken: East			
Description: Looking towards to the barn CO35

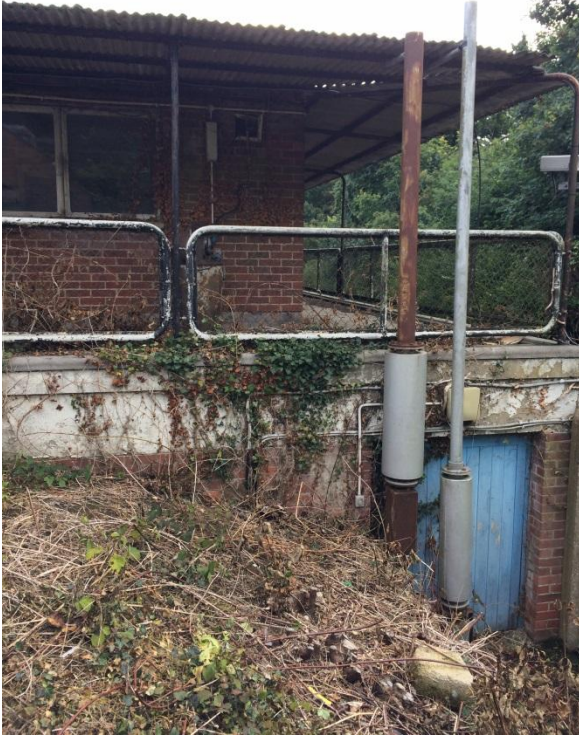
Client Name: HCA		Site Location: Former Pirbright Institute Compton	Project No. 60544578
Photo No. 17	Date: 18/09/17

Direction Photo Taken: East			
Description: Building CO23

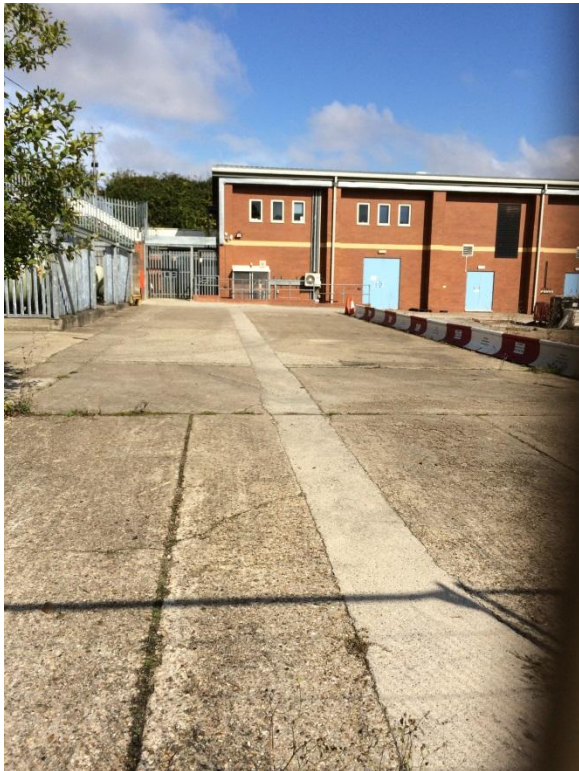
Photo No. 20	Date: 18/09/17

Direction Photo Taken: North			
Description: Operational Building CO06

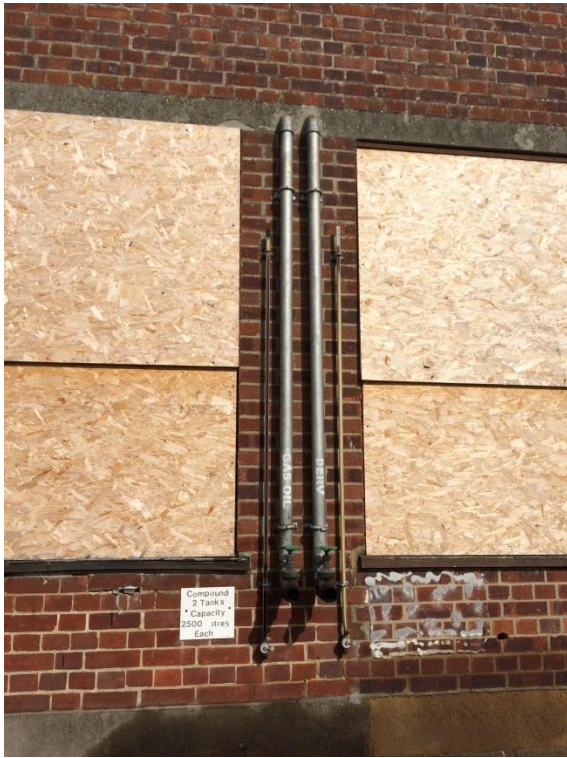
Client Name: HCA		Site Location: Former Pirbright Institute Compton	Project No. 60544578
Photo No. 21	Date: 18/09/17

Direction Photo Taken: N/A			
Description: Above Ground Storage Tanks associated with Incinerator in Building CO28

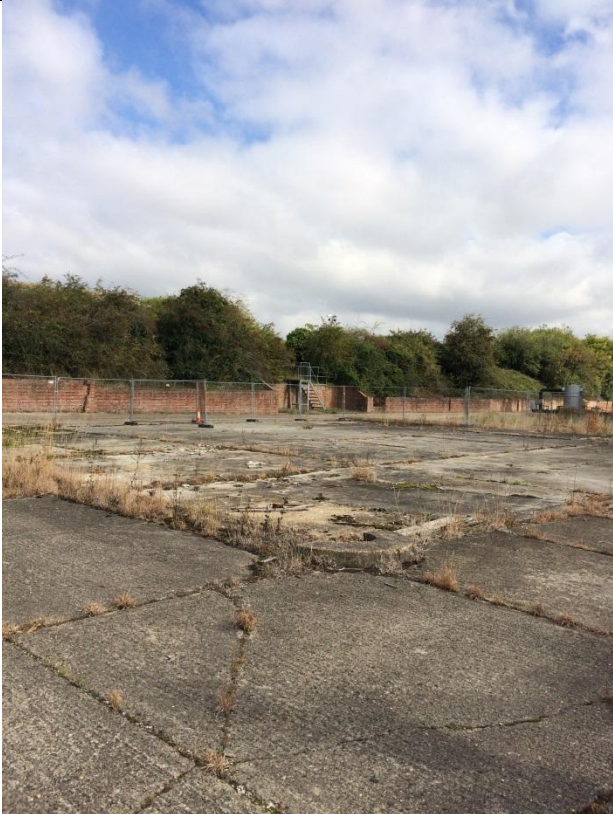
Client Name: HCA		Site Location: Former Pirbright Institute Compton		Project No. 60544578
Photo No. 23	Date: 18/09/17

Direction Photo Taken: North east				
Description: Skip Yard to the north of Zone 2

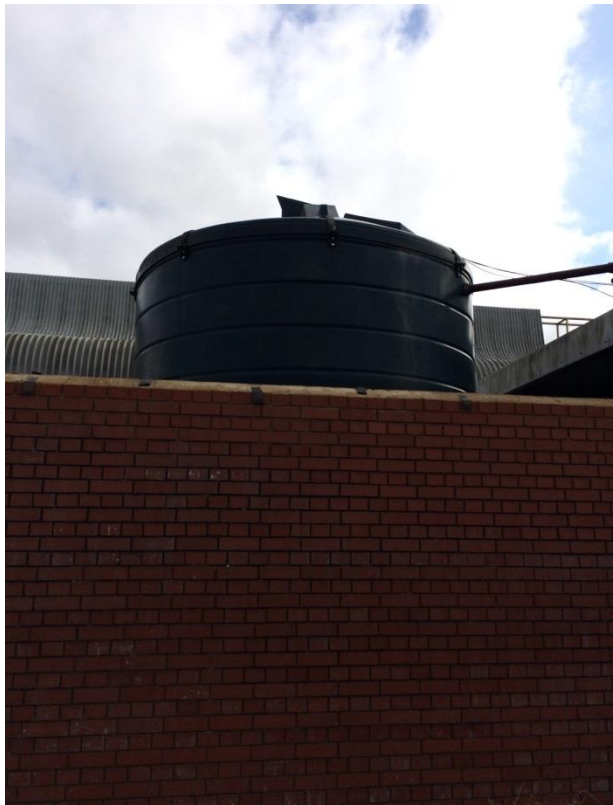
Photo No. 24	Date: 18/09/17

Direction Photo Taken: N/A				
Description: Above Ground Storage Tank (AST 7) associated with CO44

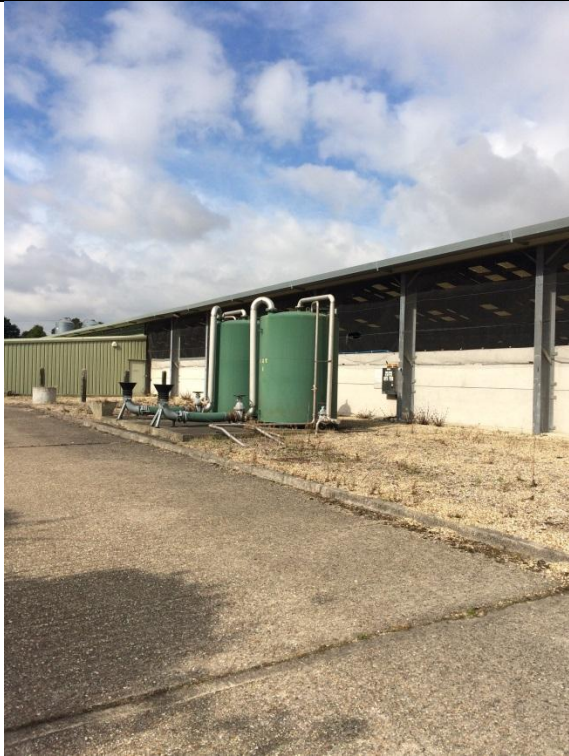
Client Name: HCA		Site Location: Former Pirbright Institute Compton		Project No. 60544578
Photo No. 29	Date: 18/09/17

Direction Photo Taken: N/A				
Description: Two storage tanks associated with the Greenfields Sheep Unit north of the building

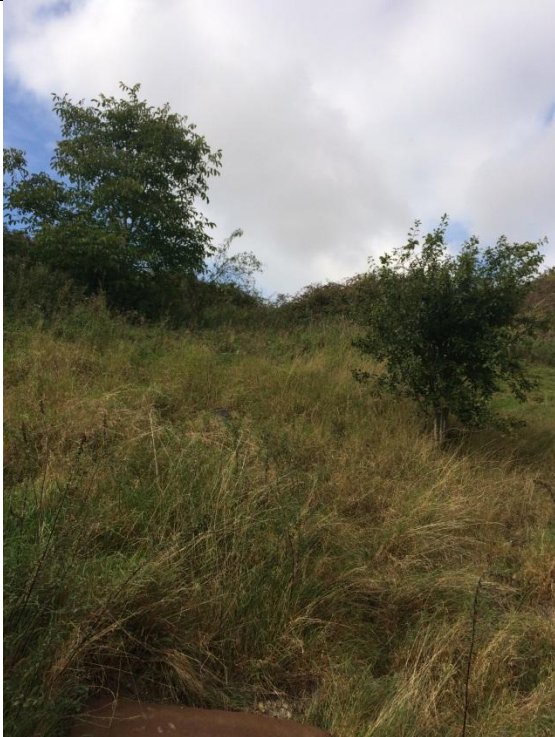
Client Name: HCA		Site Location: Former Pirbright Institute Compton		Project No. 60544578
Photo No. 31	Date: 18/09/17

Direction Photo Taken: North				
Description: Terrace/Mounds to the north boundary of the site

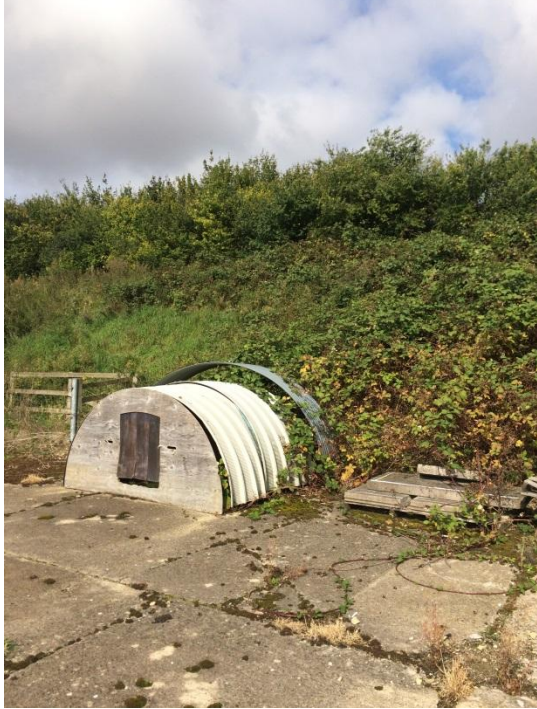
Client Name: HCA		Site Location: Former Pirbright Institute Compton	Project No. 60544578
Photo No. 33	Date: 18/09/17

Direction Photo Taken: North			
Description: Burial ground mounds along the northern boundary of the site.

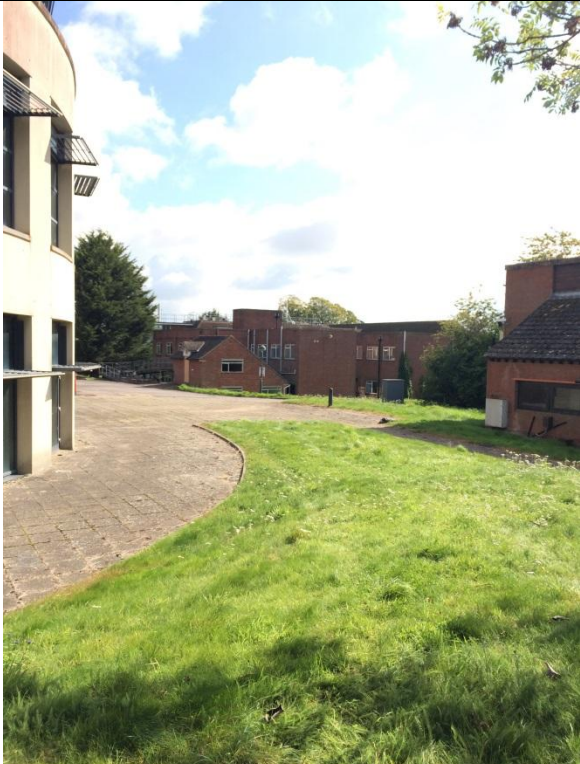
Photo No. 36	Date: 18/09/17

Direction Photo Taken: South East		
Description: South of the Jenner building (CO60) looking towards the Selborne Building (CO70).

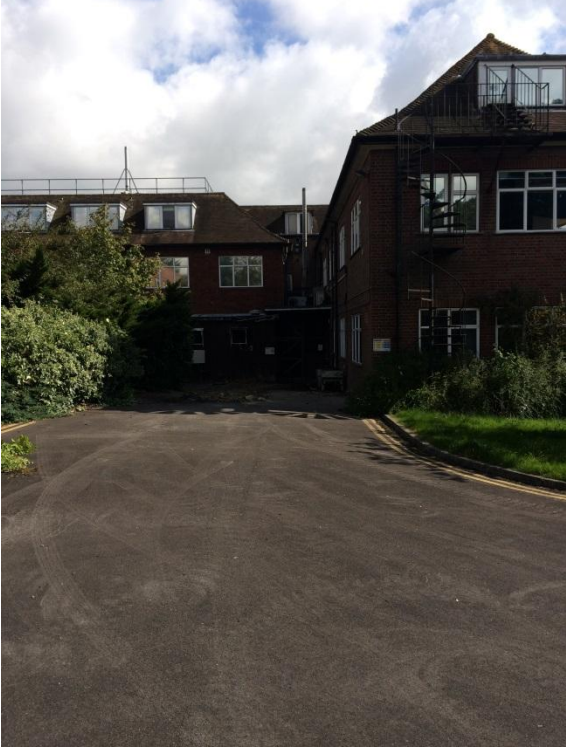
Client Name: HCA		Site Location: Former Pirbright Institute Compton	Project No. 60544578
Photo No. 37	Date: 18/09/17

Direction Photo Taken: East			
Description: Building CO69 the Gordon Building.

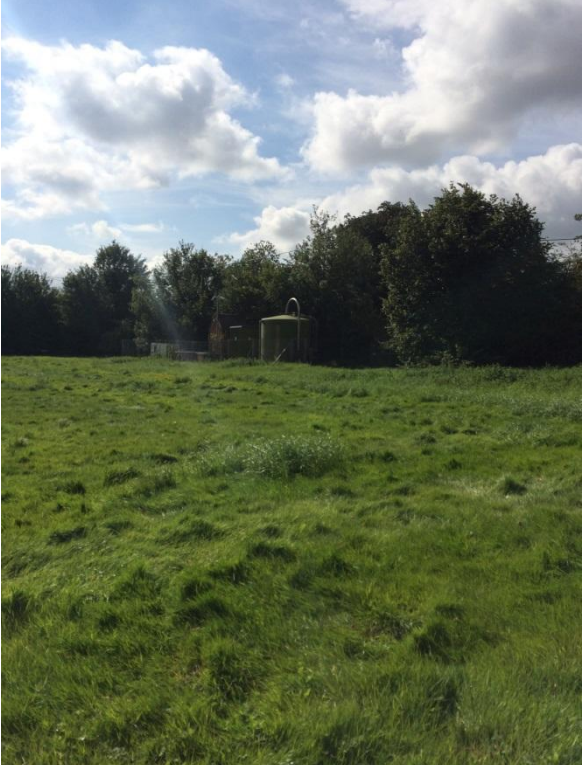
Photo No. 38	Date: 18/09/17

Direction Photo Taken: South			
Description: Cricket Ground with pumping house to the south western boundary of the site.
