## **Air Quality and Dust Monitoring Monthly Report – February 2020**

**London Borough of Hammersmith and  
Fulham**

A report prepared by Costain Skanska on behalf of HS2 Ltd.

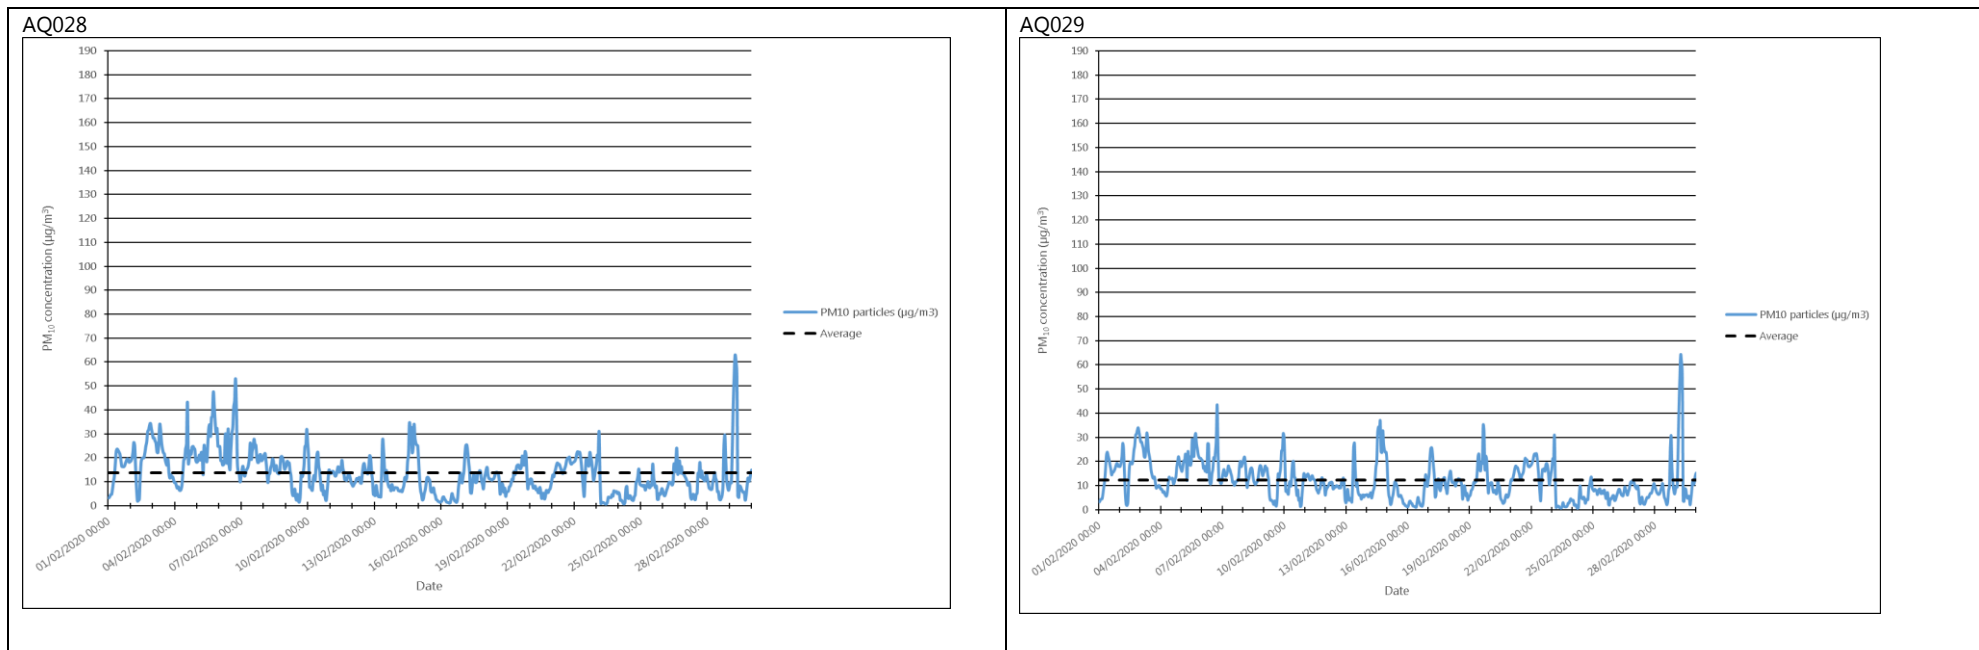
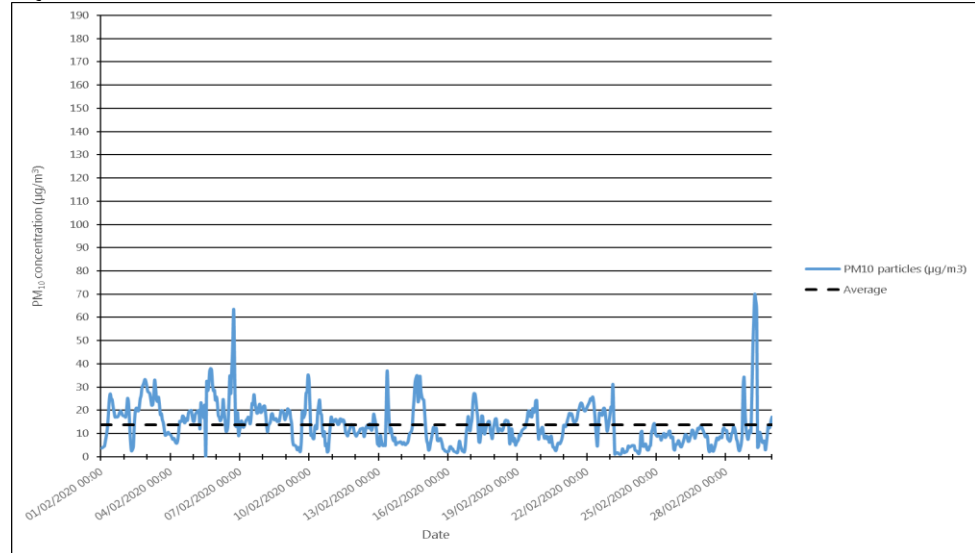
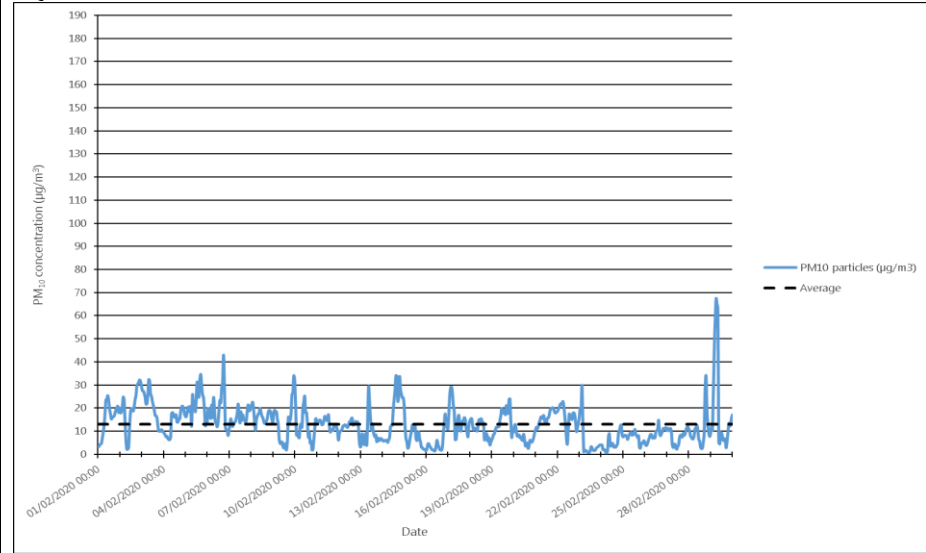
Figure 3: Construction dust 1-hour mean indicative PM<sub>10</sub> concentration for dust monitors

- 1.1.6 Dust monitoring locations and results are presented in Appendix B, Table 1, together with line charts of monthly data from each dust monitor in Figure 3. All continuous dust monitoring is undertaken using indicative monitors. Despite being Environment Agency (MCERTS) certified, indicative monitors carry a higher level of uncertainty than reference monitors, and therefore cannot be strictly compared with Air Quality Standards for human health and the environment. The purpose of the monitoring undertaken is to ensure the effectiveness of the on-site mitigation.

- 1.1.7 The trigger level of 190 µg/m<sup>3</sup>, over a 1-hour period, in accordance with the updated guidance document 'Guidance on Monitoring in the Vicinity of Demolition and Construction Sites – October 2018' has been applied.

- 1.1.8 There were no (0) dust trigger alerts recorded during this monitoring period (February 2020). All results were in line with expected ranges.
- 1.1.9 Diffusion tube monitoring of Nitrogen Dioxide (NO<sub>2</sub>) was undertaken at seven (7) locations in January 2020, around highways within the LBHF as part of the management of air quality where significant effects may occur as a result of the scheme.
