Construction noise and vibration Monthly Report – January 2020

London Borough of Camden

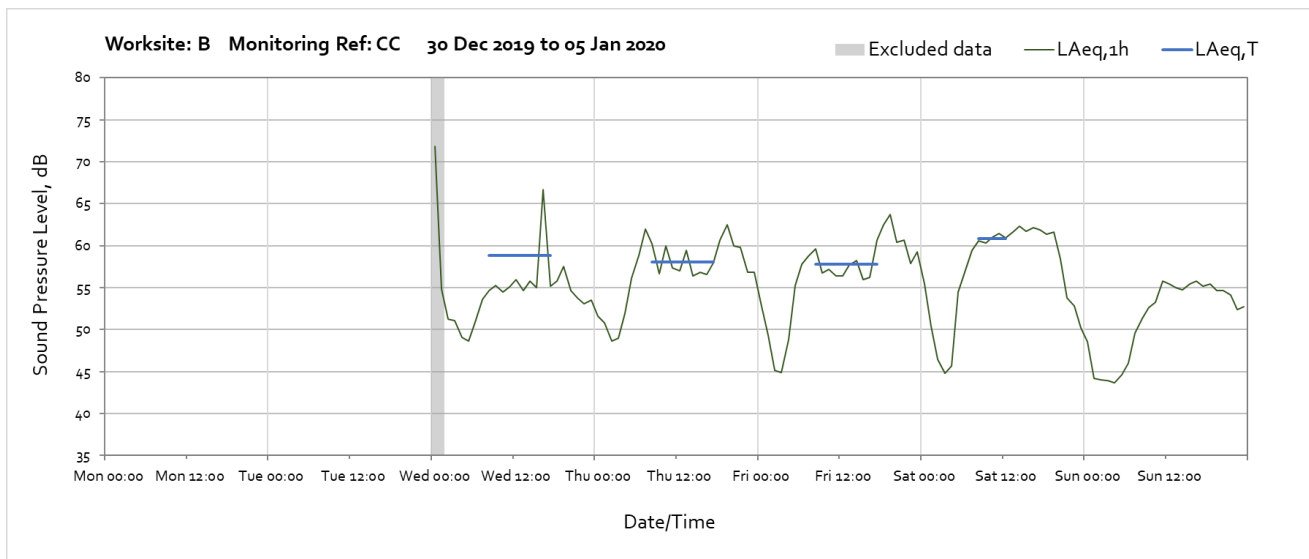
Worksite: B – Monitoring Ref: CC

Note: High noise levels on the early hours of the 1st January were due to New Year's Eve celebrations and have been excluded to calculate values in Table 4.

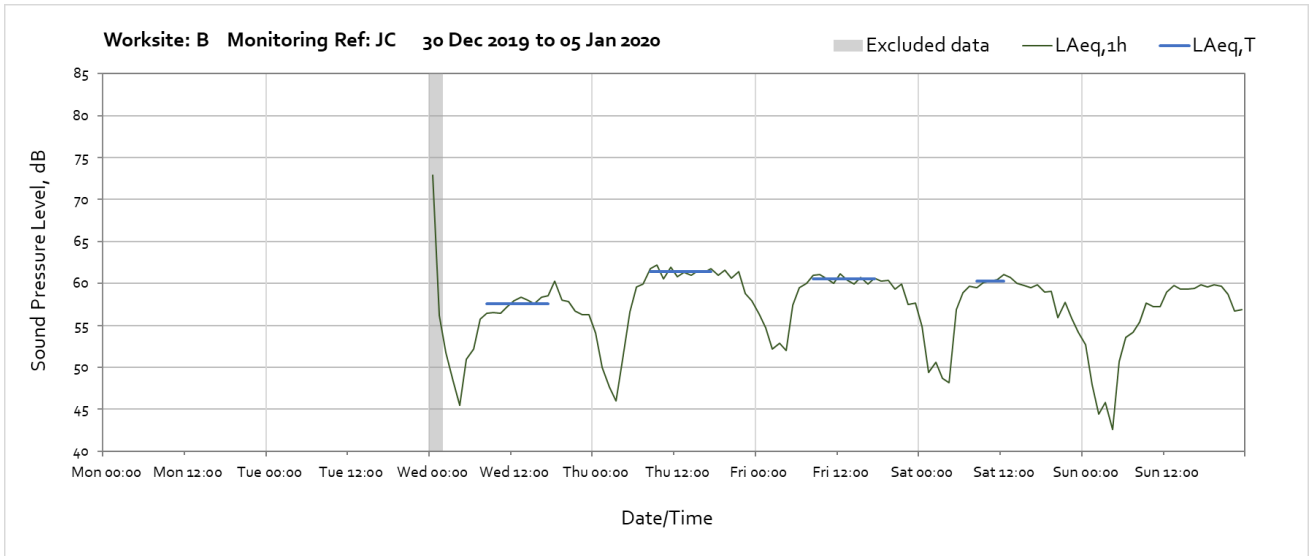
Worksite: B – Monitoring Ref: JC

Note: High noise levels on the early hours of the 1st January were due to New Year's Eve celebrations and have been excluded to calculate values in Table 4.

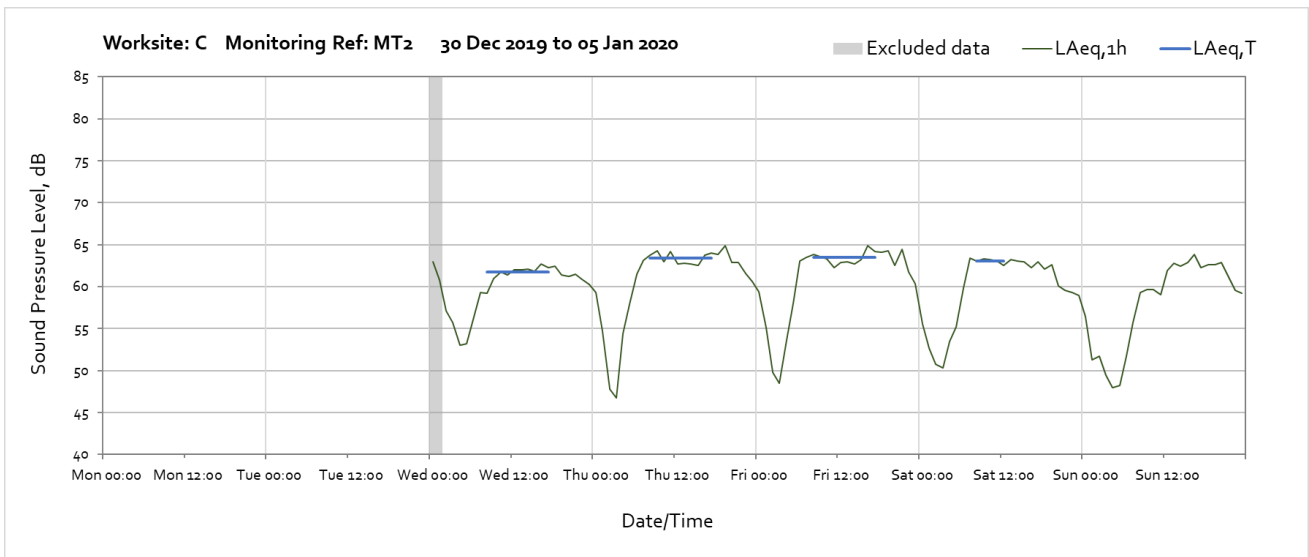
Worksite: C – Monitoring Ref: MT2

Note: High noise levels on the early hours of the 1st January were due to New Year's Eve celebrations and have been excluded to calculate values in Table 4.

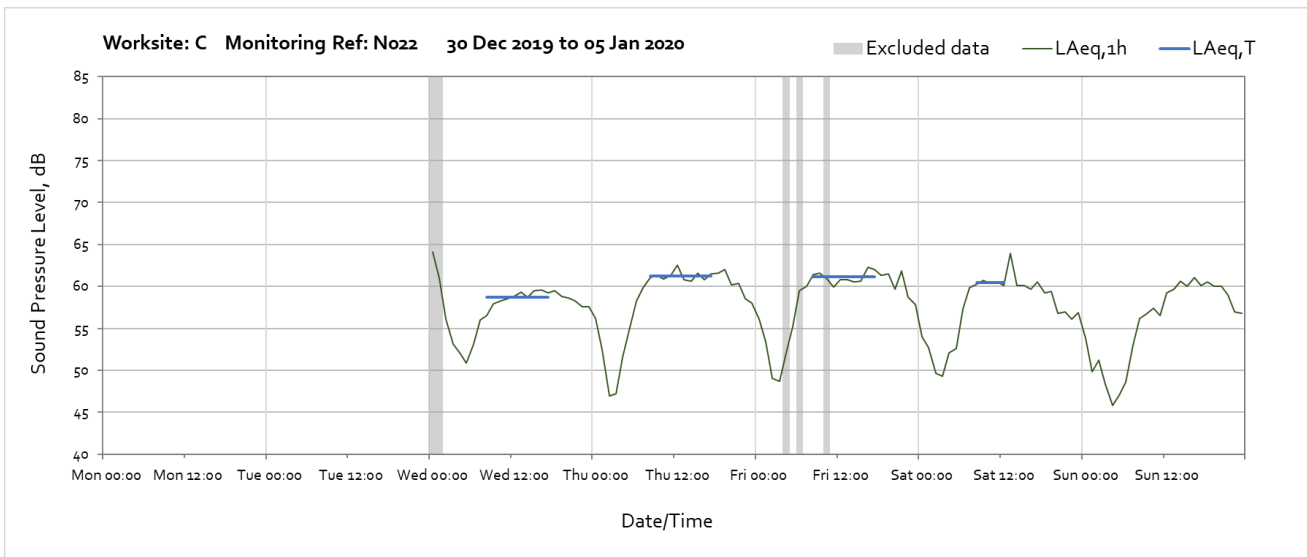
Worksite: C – Monitoring Ref: N022

Note: High noise levels on the early hours of the 1st January were due to New Year's Eve celebrations and have been excluded to calculate values in Table 4.

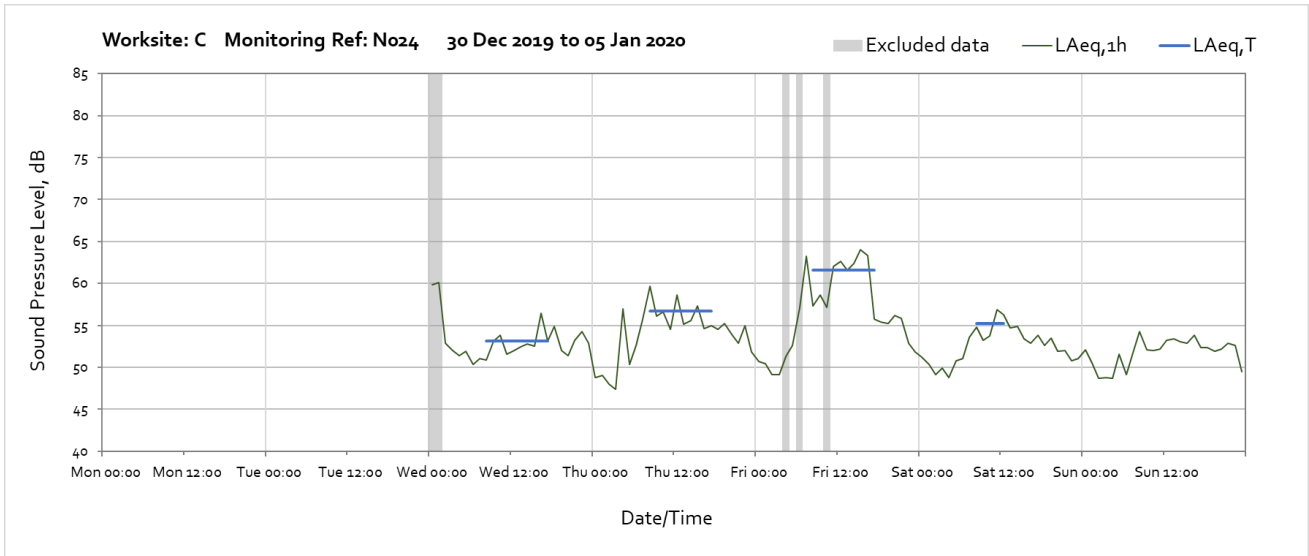
Worksite: C – Monitoring Ref: N024

Note: High noise levels on the early hours of the 1st January were due to New Year's Eve celebrations and have been excluded to calculate values in Table 4.

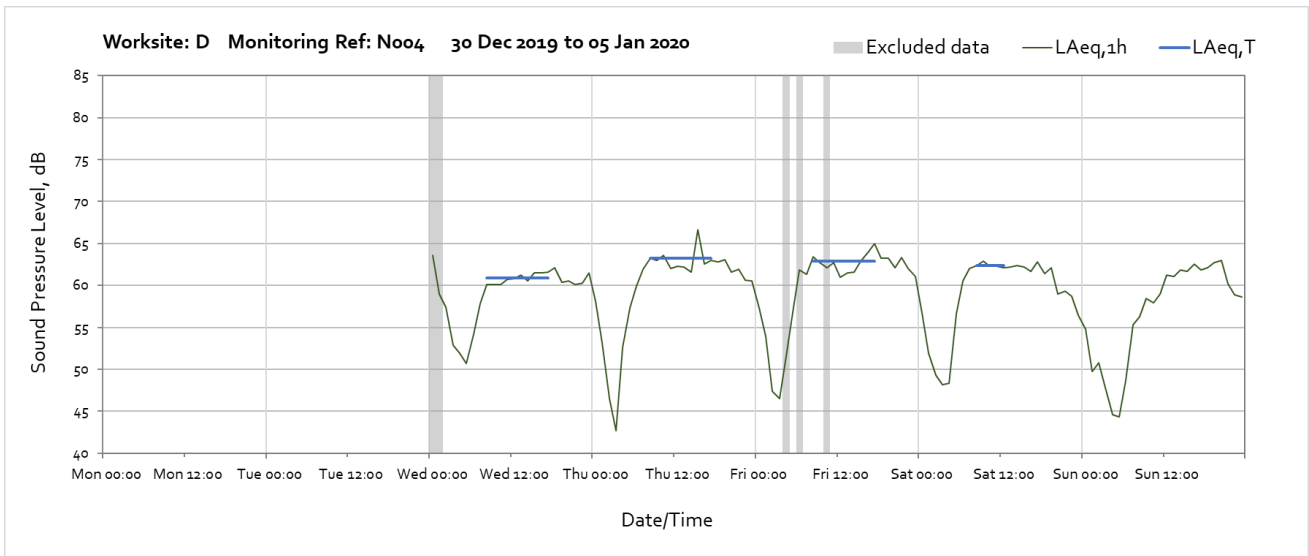
Worksite: D – Monitoring Ref: N004

Note: High noise levels on the early hours of the 1st January were due to New Year's Eve celebrations and have been excluded to calculate values in Table 4.

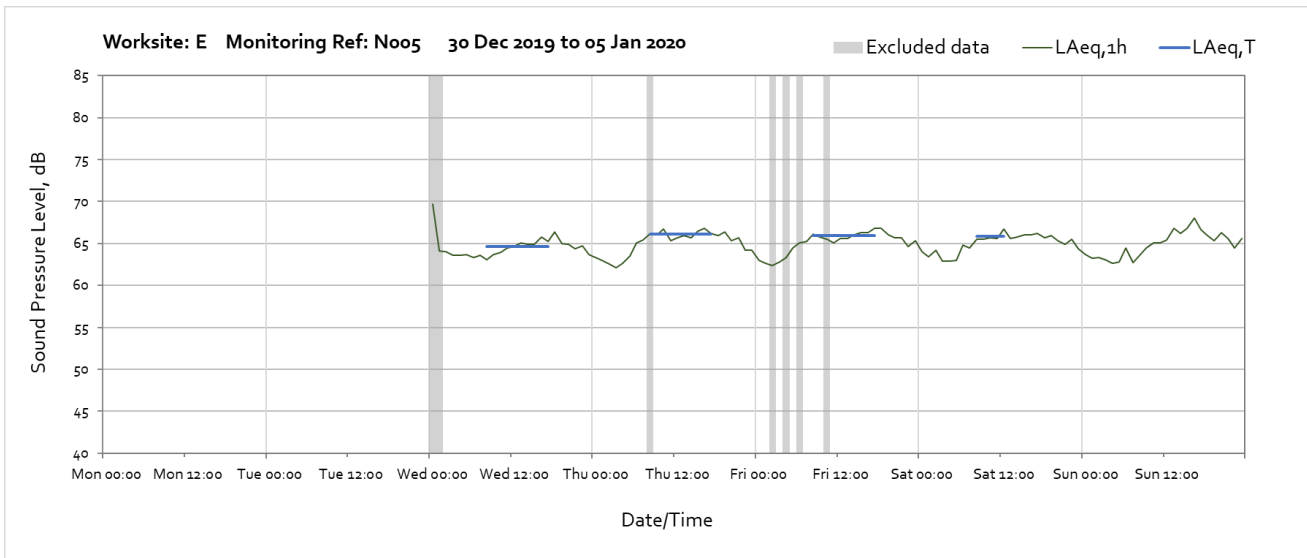
Worksite: E – Monitoring Ref: N005

Note: High noise levels on the early hours of the 1st January were due to New Year's Eve celebrations and have been excluded to calculate values in Table 4.

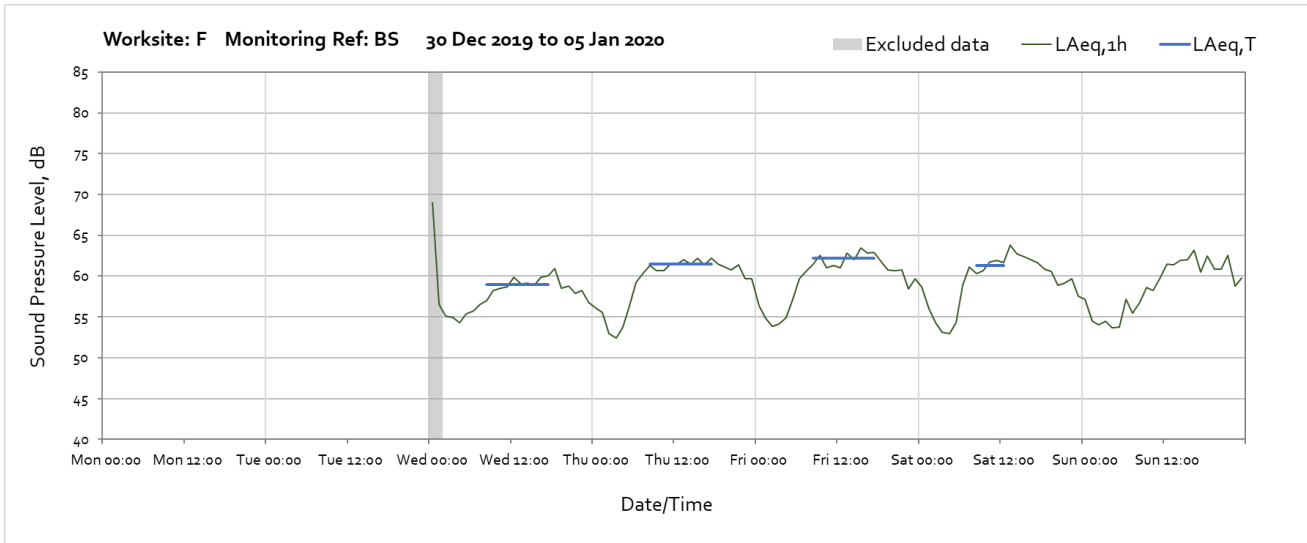
Worksite: F – Monitoring Ref: BS

Note: High noise levels on the early hours of the 1st January were due to New Year's Eve celebrations and have been excluded to calculate values in Table 4.

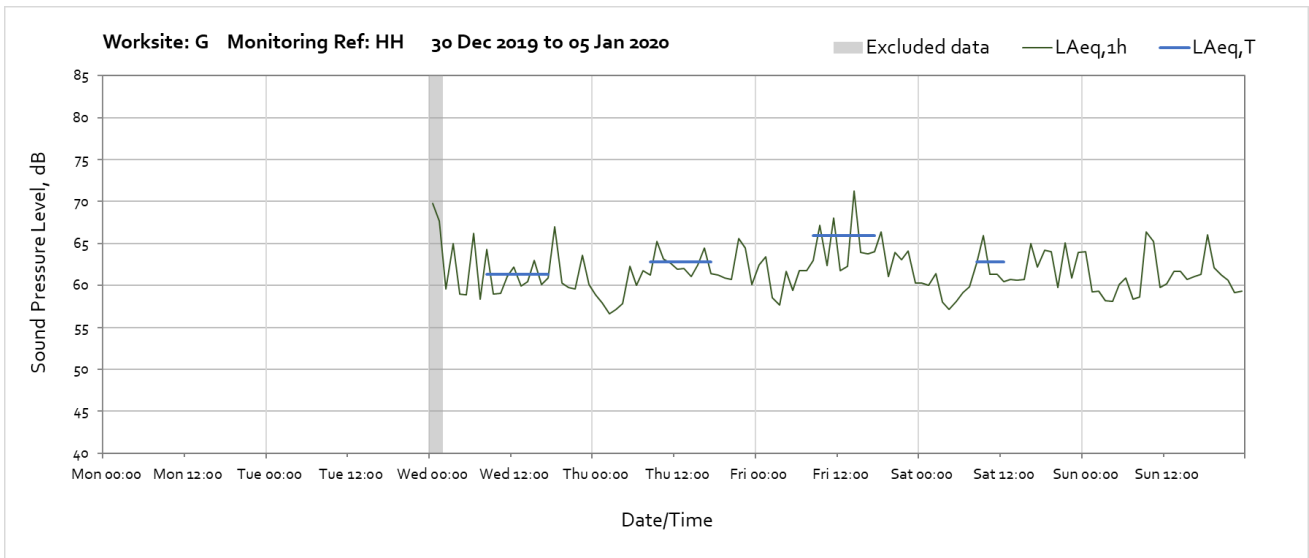
Worksite: G – Monitoring Ref: HH

Note: High noise levels on the early hours of the 1st January were due to New Year's Eve celebrations and have been excluded to calculate values in Table 4.

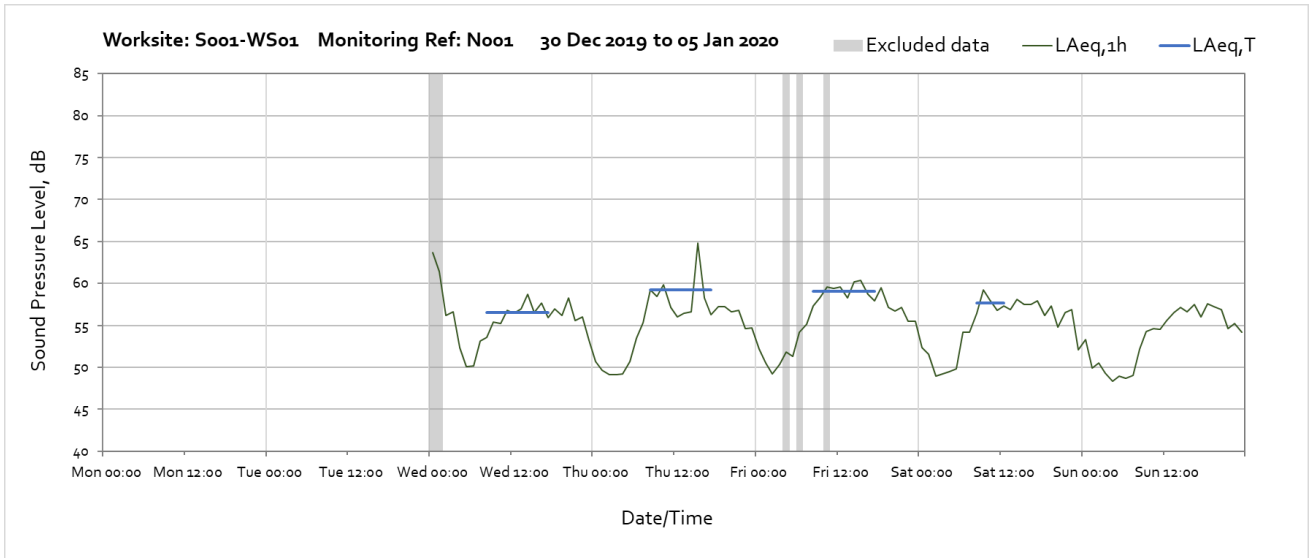
Worksite: S001-WS01 – Monitoring Ref: N001

Note: High noise levels on the early hours of the 1st January were due to New Year's Eve celebrations and have been excluded to calculate values in Table 4.

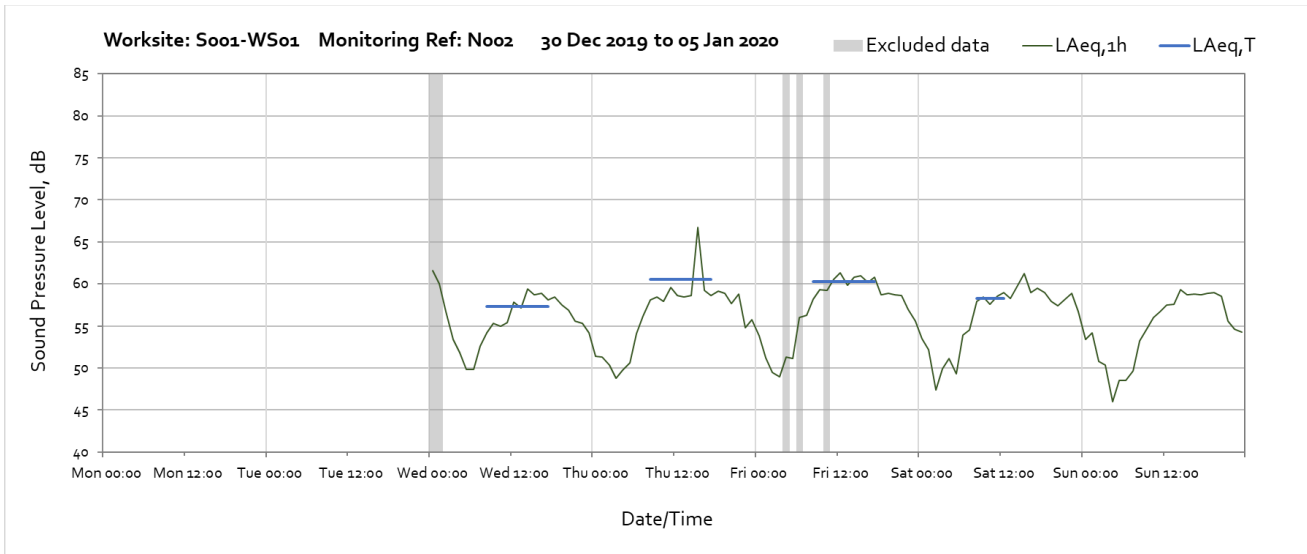
Worksite: S001-WS01 – Monitoring Ref: N002

Note: High noise levels on the early hours of the 1st January were due to New Year's Eve celebrations and have been excluded to calculate values in Table 4.

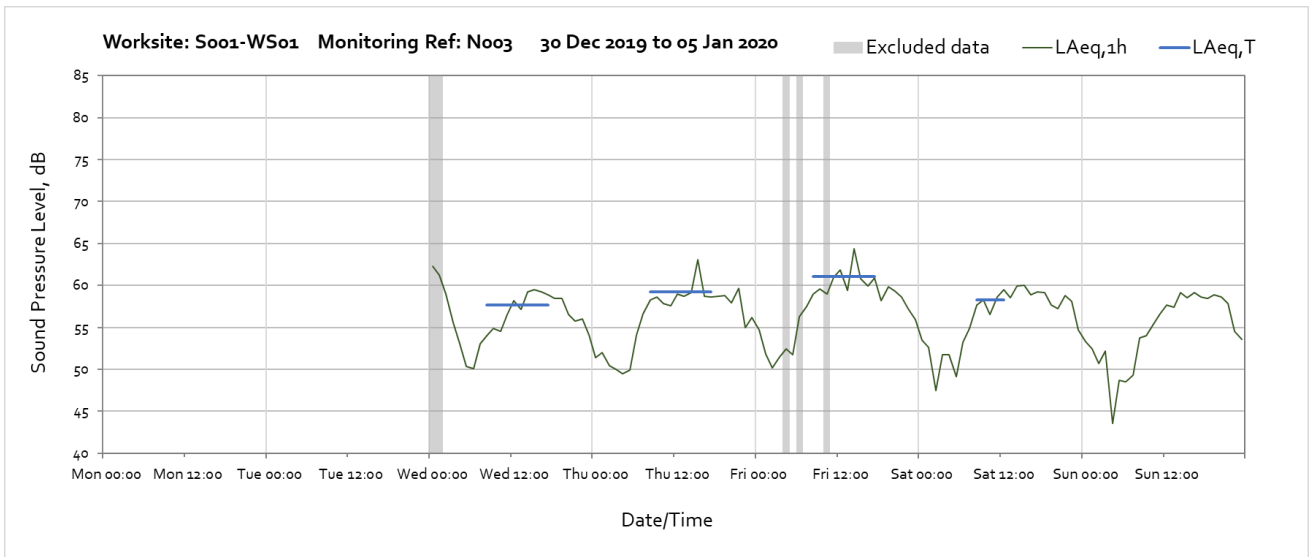
Worksite: S001-WS01 – Monitoring Ref: N003

Note: High noise levels on the early hours of the 1st January were due to New Year's Eve celebrations and have been excluded to calculate values in Table 4.

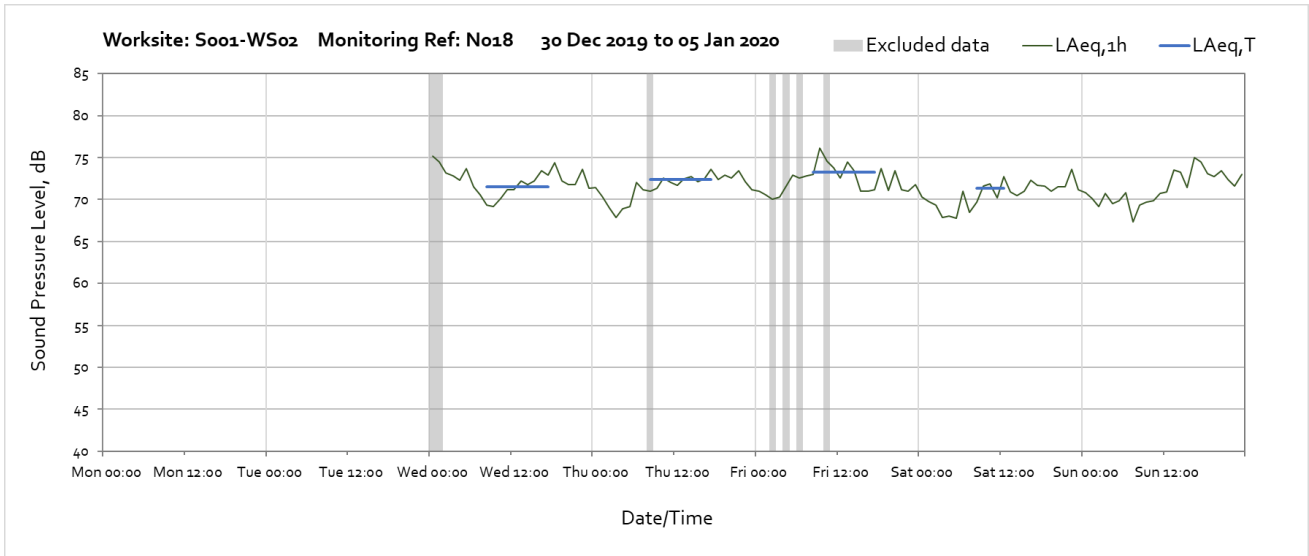
Worksite: S001-WS02 – Monitoring Ref: N018

Note: High noise levels on the early hours of the 1st January were due to New Year's Eve celebrations and have been excluded to calculate values in Table 4.

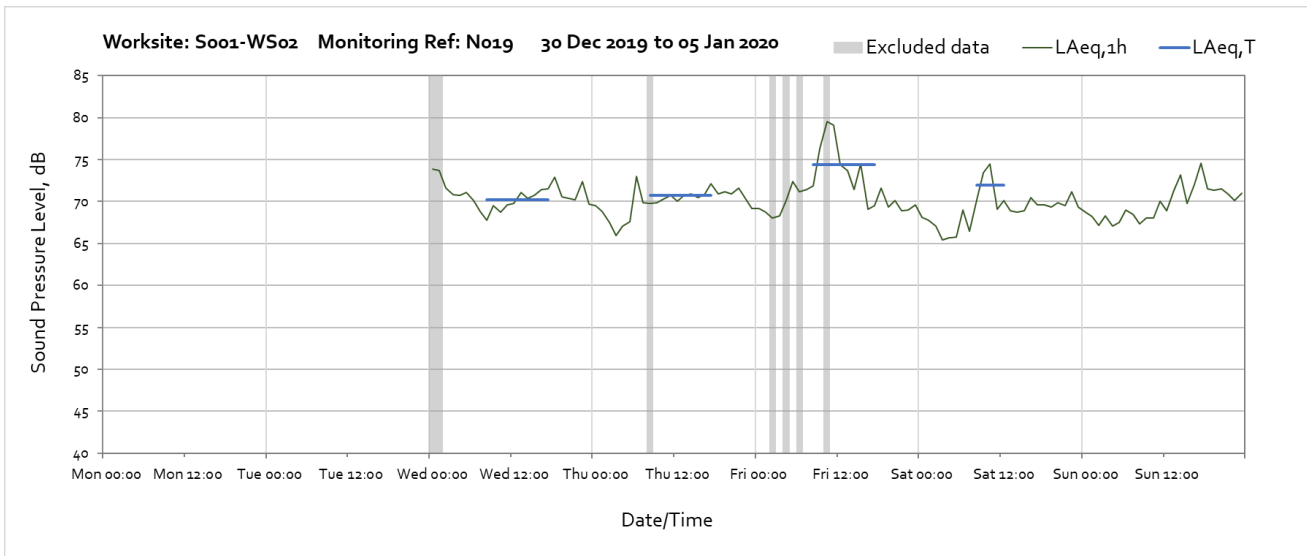
Worksite: S001-WS02 – Monitoring Ref: N019

Note: High noise levels on the early hours of the 1st January were due to New Year's Eve celebrations and have been excluded to calculate values in Table 4.

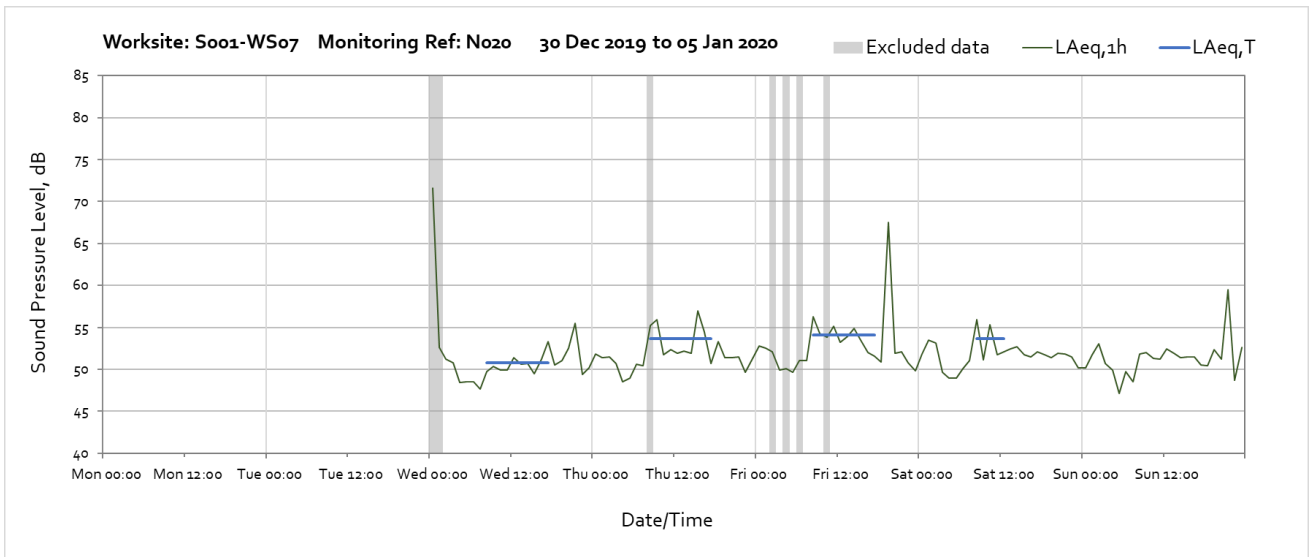
Worksite: S001-WS07 – Monitoring Ref: N020

Note: High noise levels on the early hours of the 1st January were due to New Year's Eve celebrations and have been excluded to calculate values in Table 4.

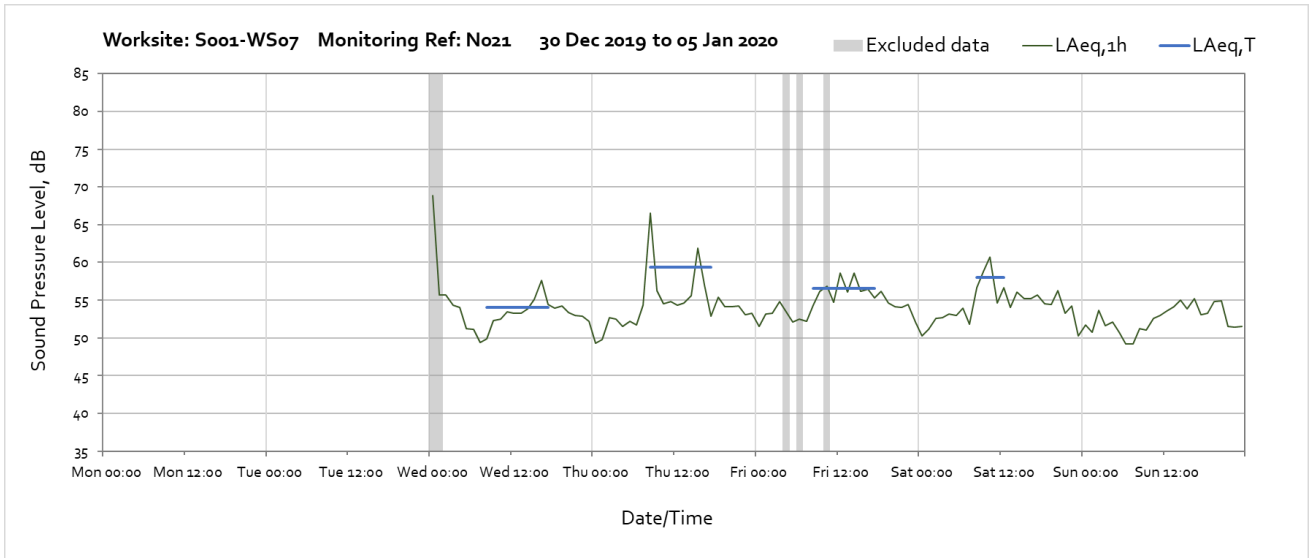
Worksite: S001-WS07 – Monitoring Ref: N021

Note: High noise levels on the early hours of the 1st January were due to New Year's Eve celebrations and have been excluded to calculate values in Table 4.

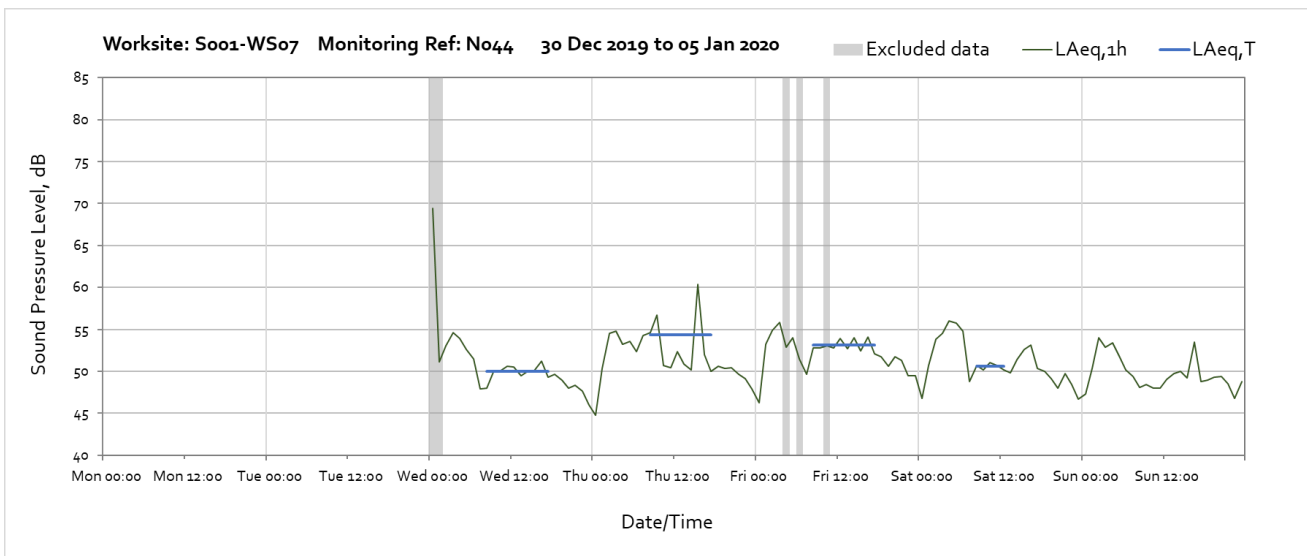
Worksite: S001-WS07 – Monitoring Ref: N044

Note: High noise levels on the early hours of the 1st January were due to New Year's Eve celebrations and have been excluded to calculate values in Table 4.

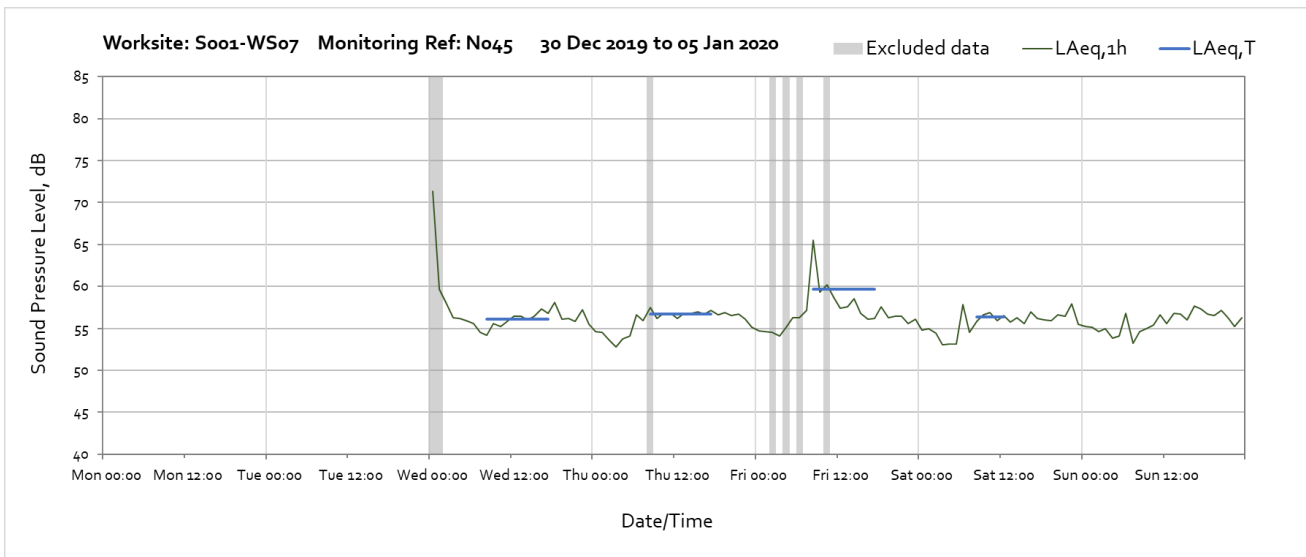
Worksite: S001-WS07 – Monitoring Ref: N045

Note: High noise levels on the early hours of the 1st January were due to New Year's Eve celebrations and have been excluded to calculate values in Table 4.

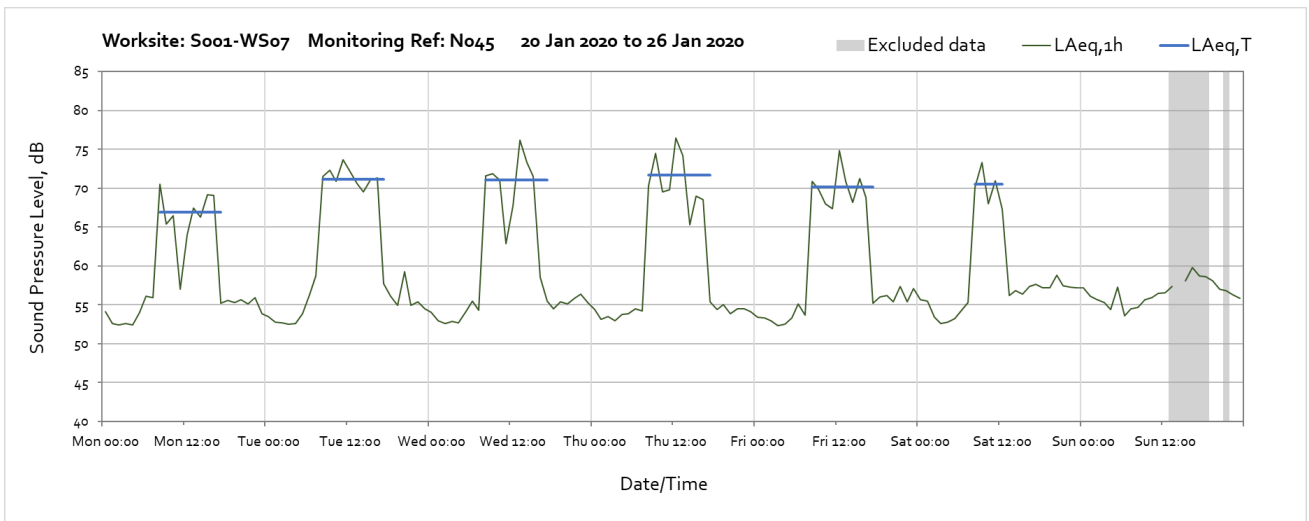
Note: Missing data between 14:00 and 15:00 on Sunday 26th of January was due to loss of power to the noise monitor.

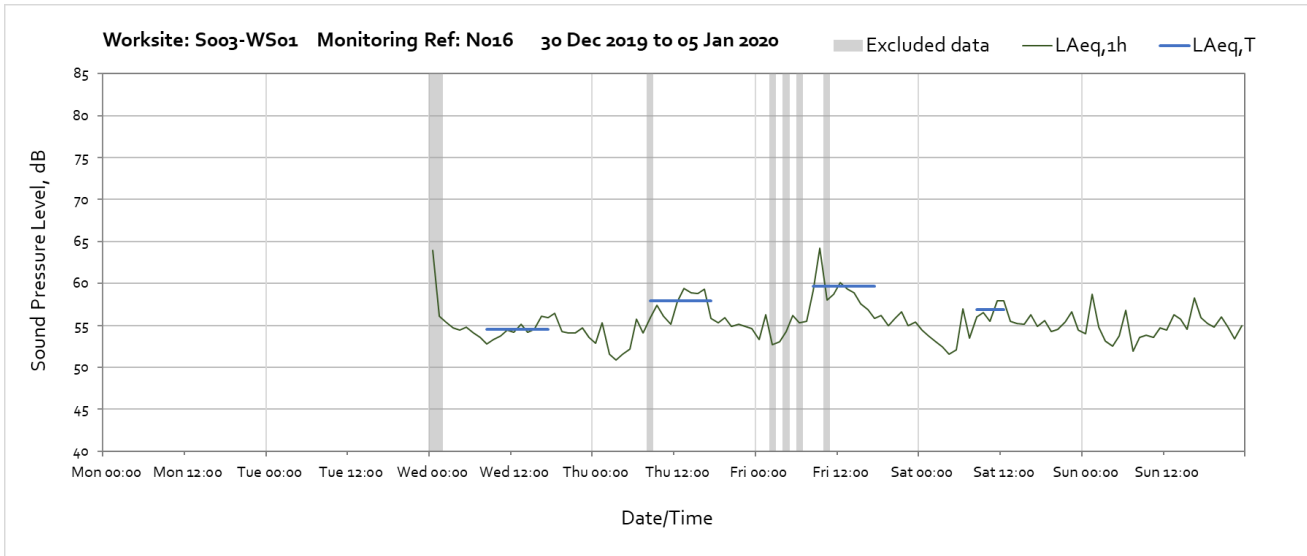
Worksite: S003-WS01 – Monitoring Ref: N016

Note: High noise levels on the early hours of the 1st January were due to New Year’s Eve celebrations and have been excluded to calculate values in Table 4.

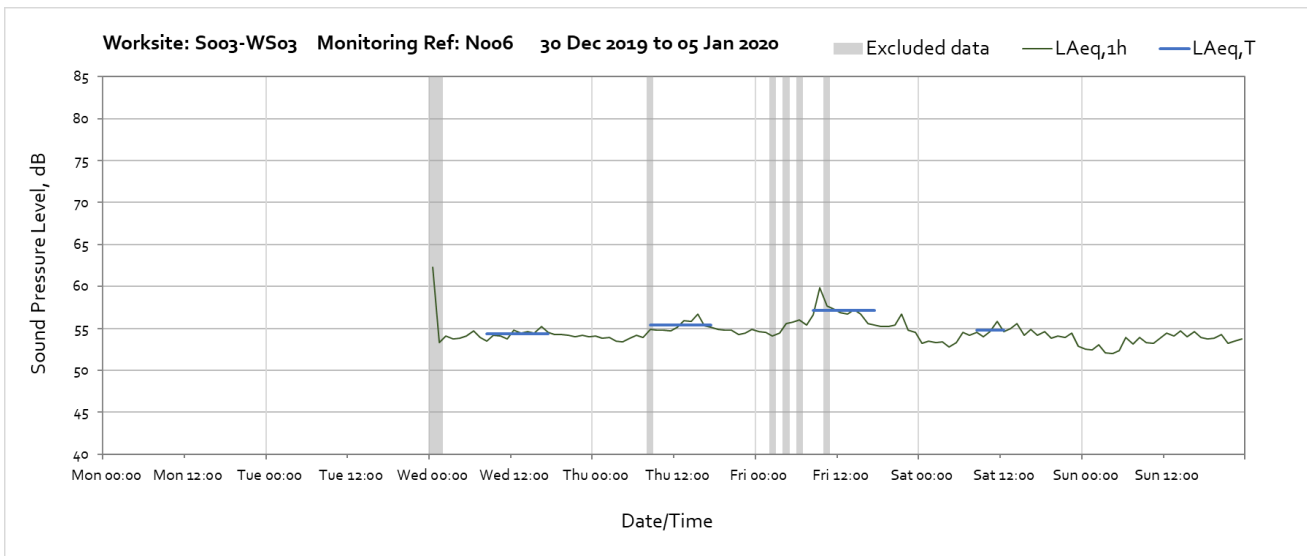
Worksite: S003-WS03 – Monitoring Ref: N006

Note: High noise levels on the early hours of the 1st January were due to New Year's Eve celebrations and have been excluded to calculate values in Table 4.

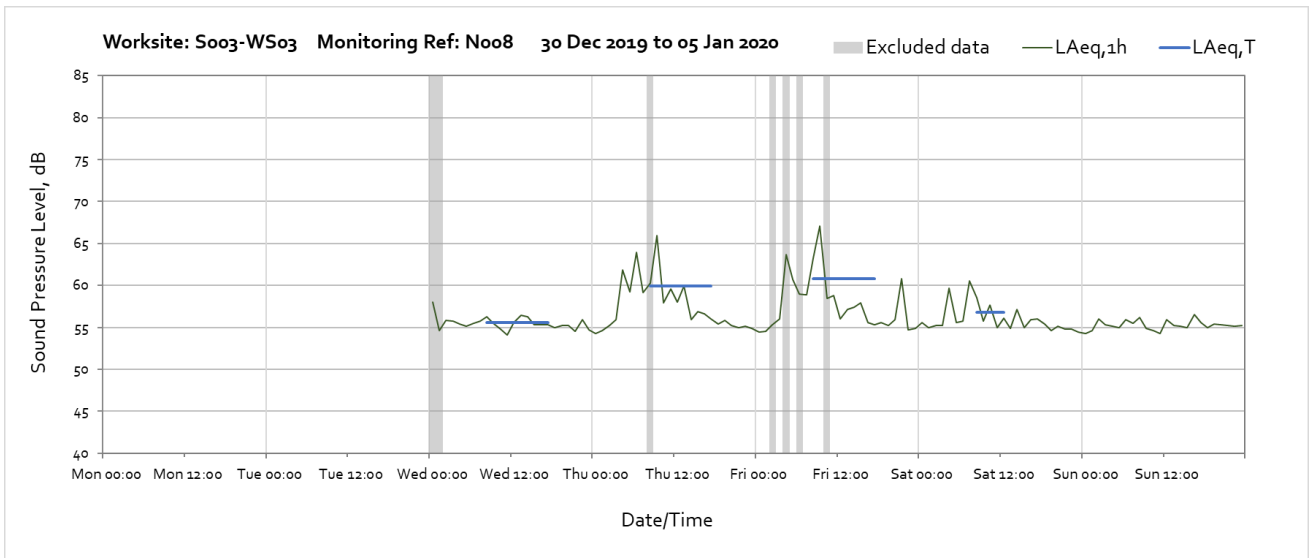
Worksite: S003-WS03 – Monitoring Ref: N008

Note: High noise levels on the early hours of the 1st January were due to New Year's Eve celebrations and have been excluded to calculate values in Table 4.

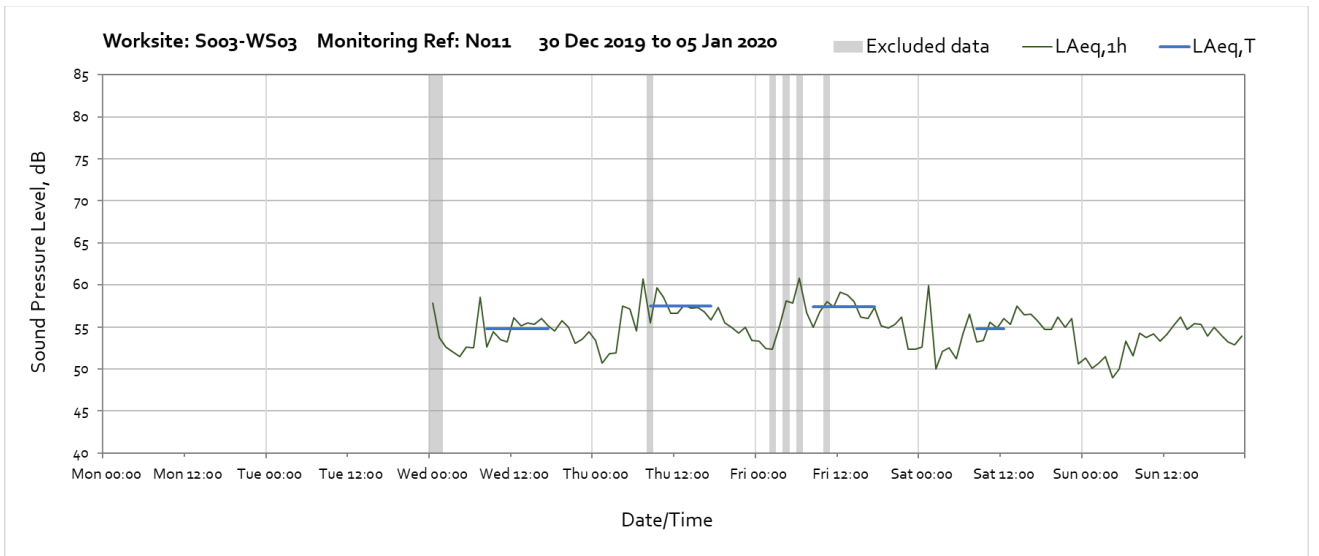
Worksite: S003-WS03 – Monitoring Ref: N011

Note: High noise levels on the early hours of the 1st January were due to New Year's Eve celebrations and have been excluded to calculate values in Table 4.

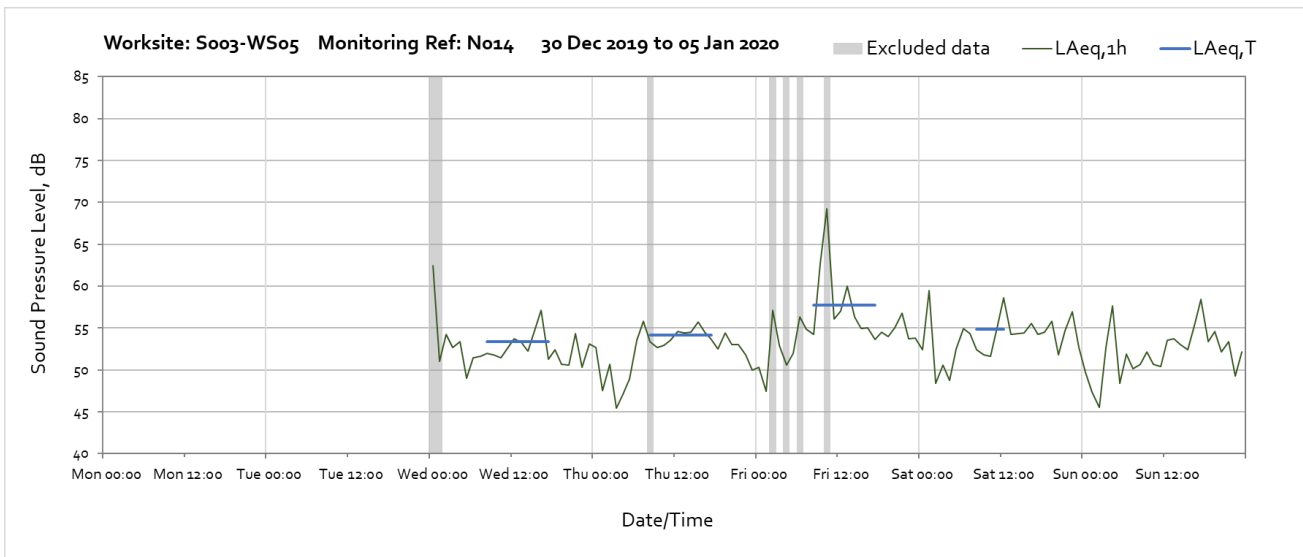
Worksite: S003-WS05 – Monitoring Ref: N014

Note: High noise levels on the early hours of the 1st January were due to New Year's Eve celebrations and have been excluded to calculate values in Table 4.

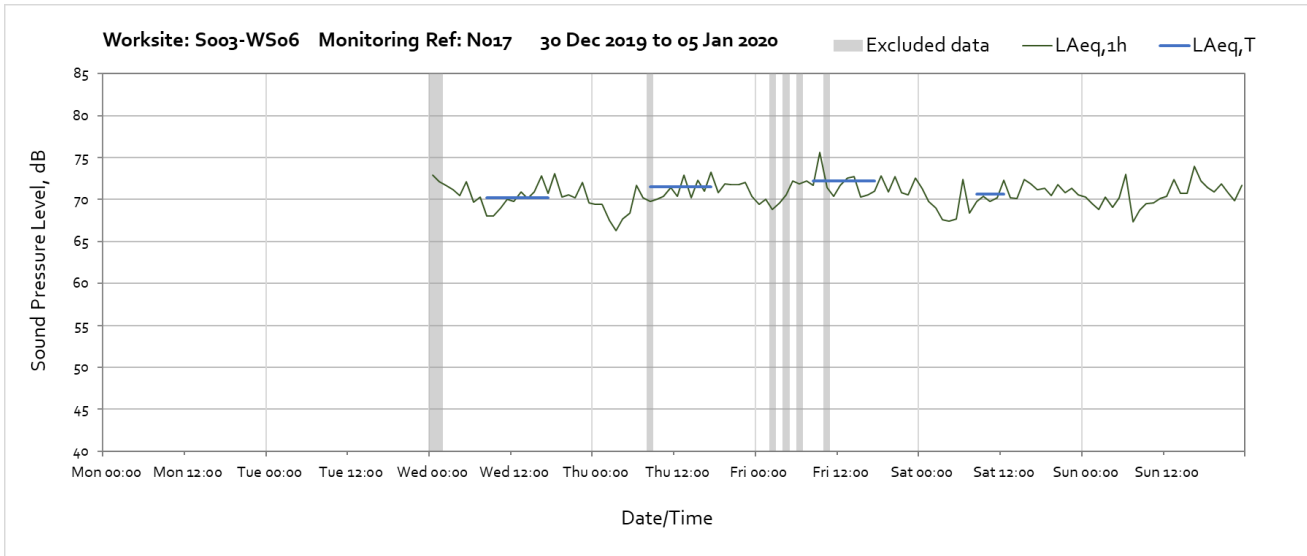
Worksite: S003-WS06 – Monitoring Ref: N017

Note: High noise levels on the early hours of the 1st January were due to New Year's Eve celebrations and have been excluded to calculate values in Table 4.

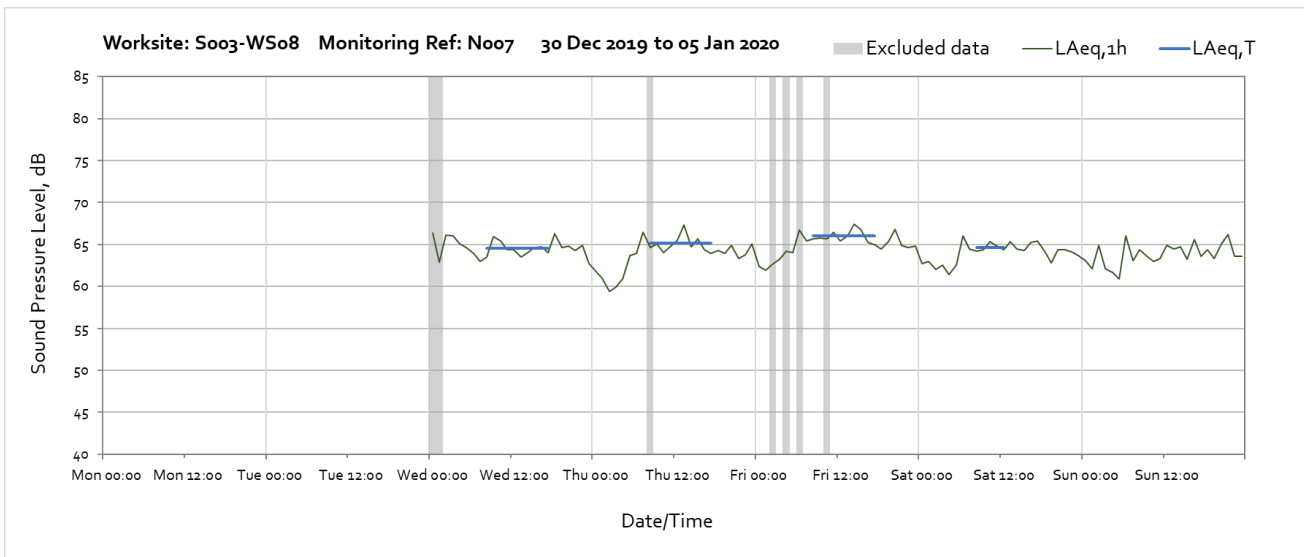
Worksite: S003-WS08 – Monitoring Ref: N007

Note: High noise levels on the early hours of the 1st January were due to New Year's Eve celebrations and have been excluded to calculate values in Table 4.

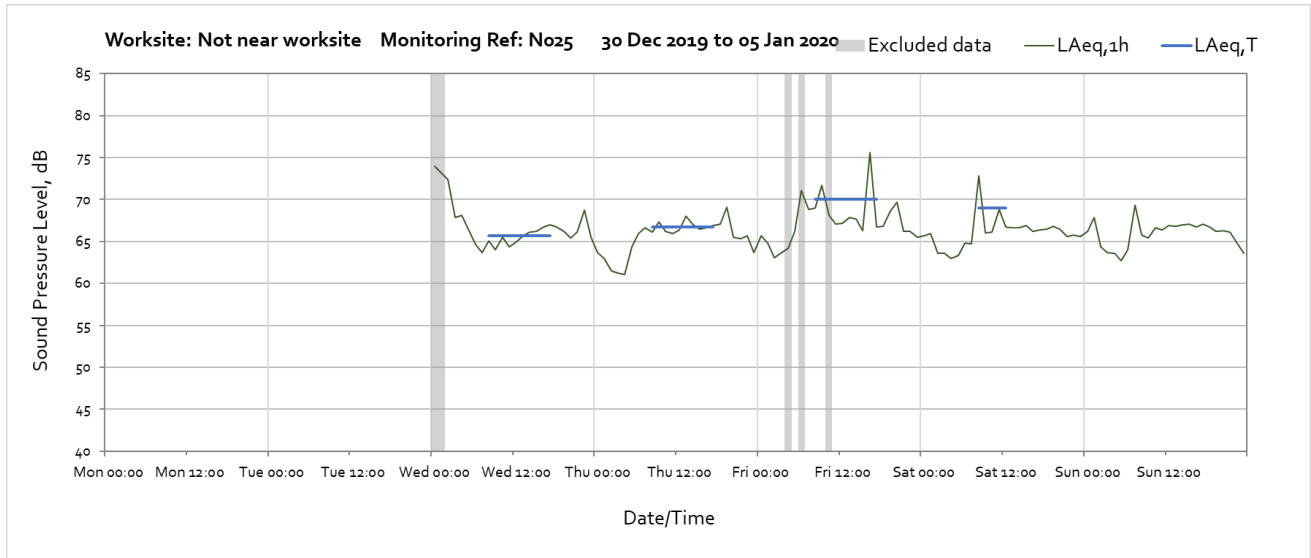
Monitoring Ref: N025

Note: High noise levels on the early hours of the 1st January were due to New Year's Eve celebrations and have been excluded to calculate values in Table 4.
