Construction noise and vibration Monthly Report – January 2020

London Borough of Camden

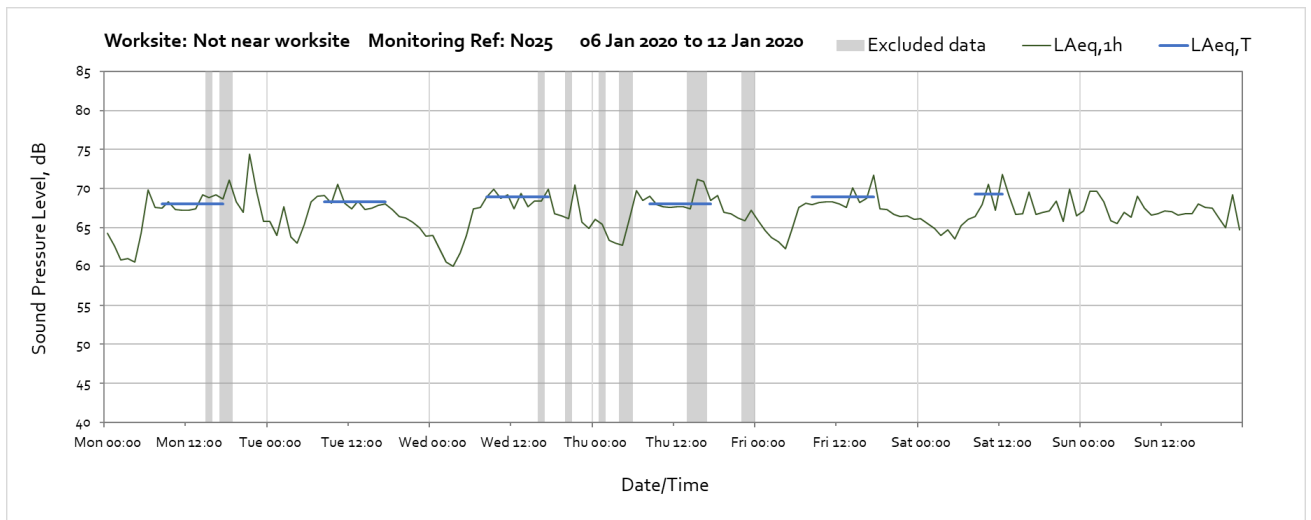
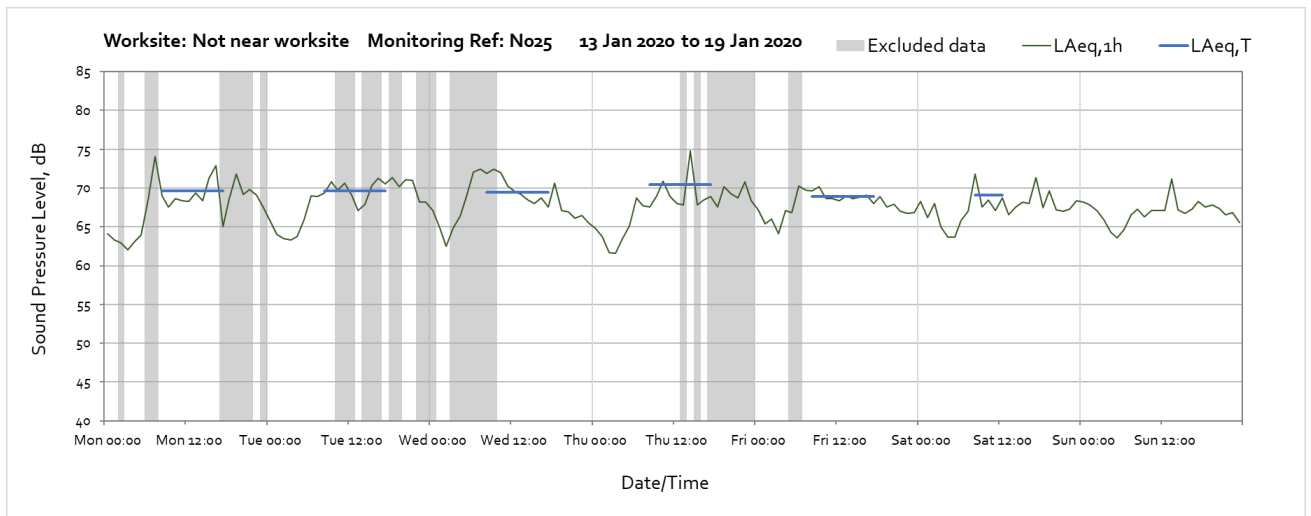
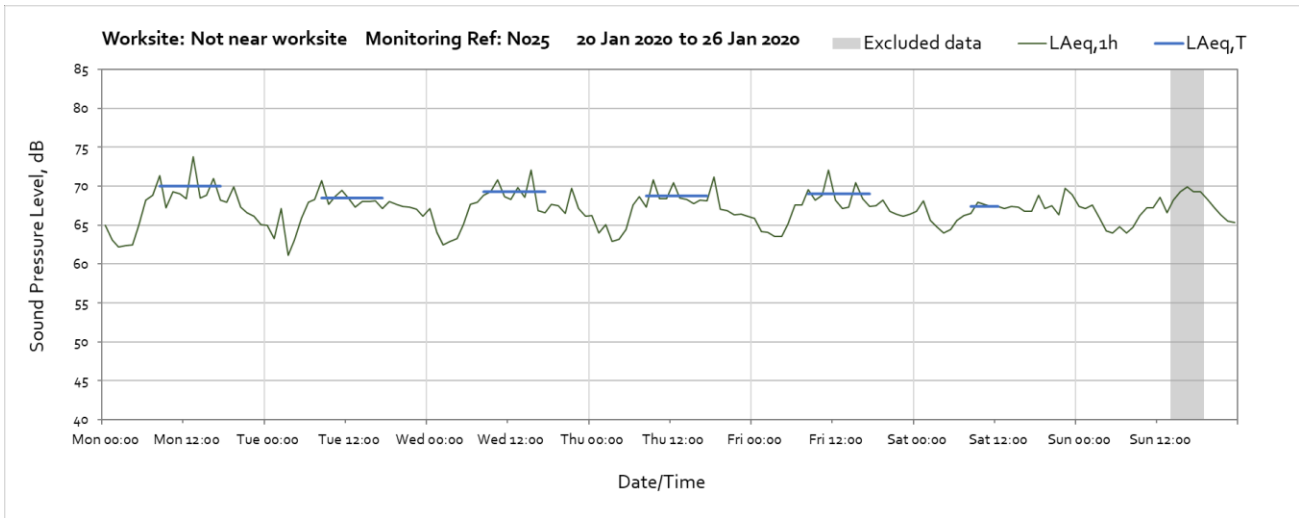
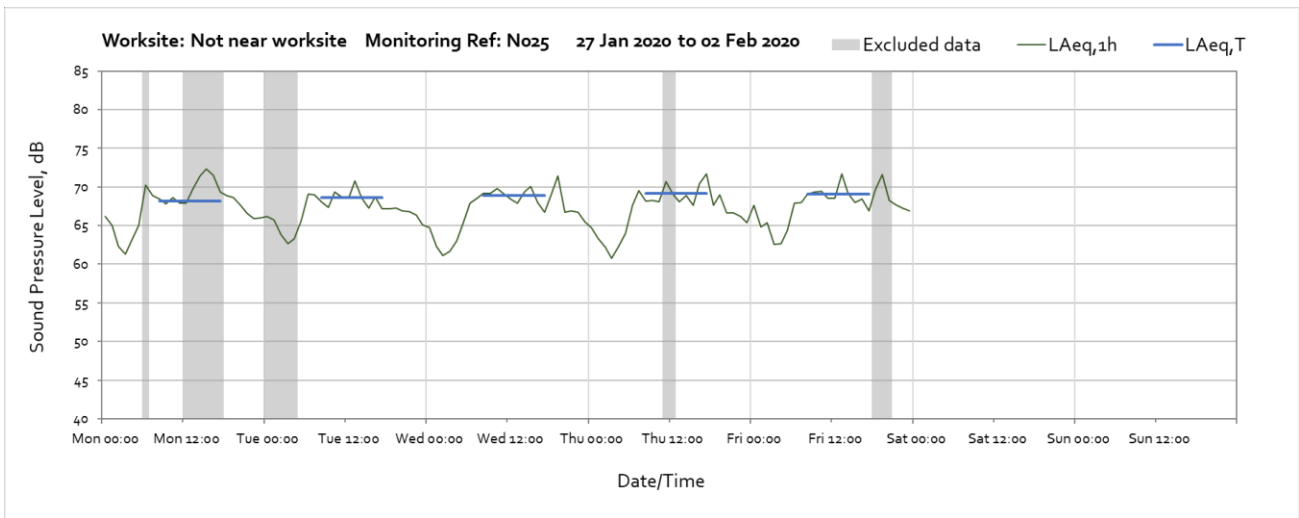
Monitoring Ref: N026

Note: High noise levels on the early hours of the 1st January were due to New Year's Eve celebrations and have been excluded to calculate values in Table 4.

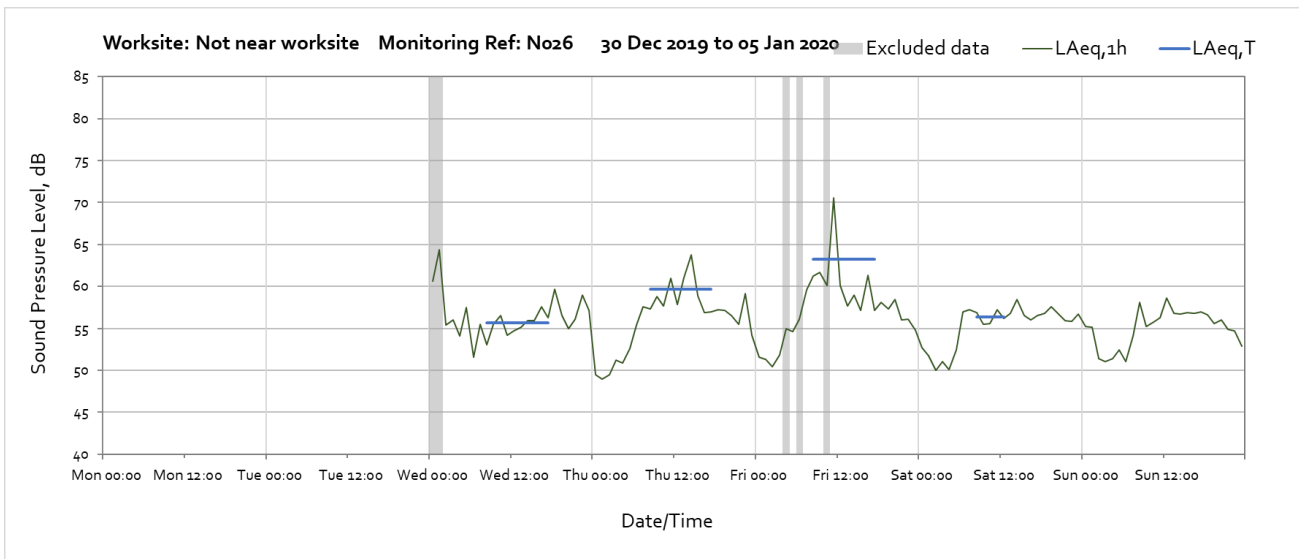
Note: High noise levels on the early hours of the 1st January were due to New Year's Eve celebrations and have been excluded to calculate values in Table 4.

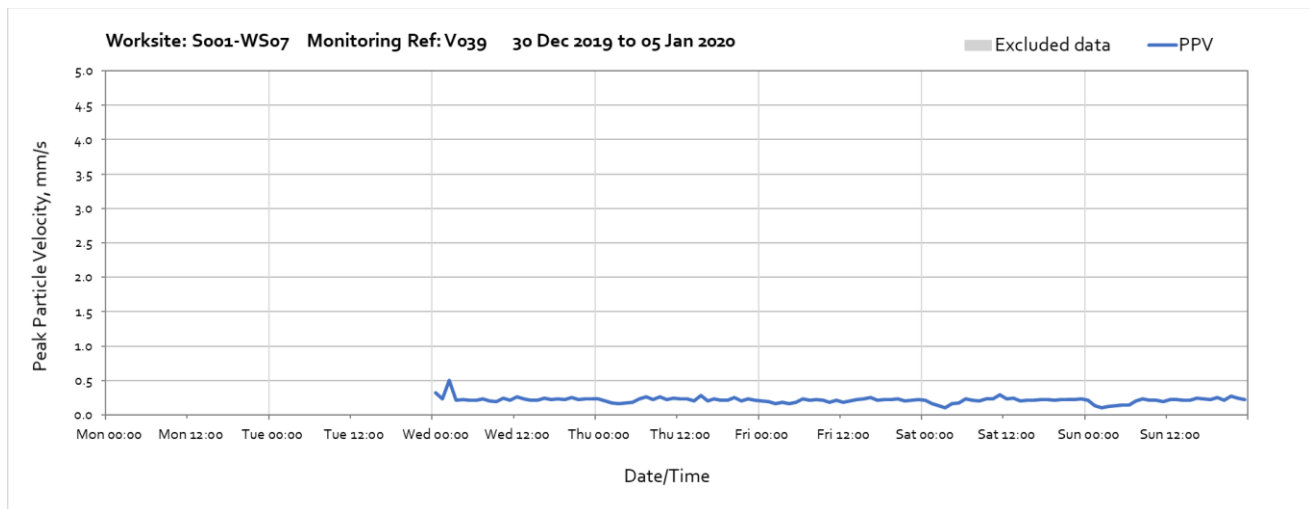
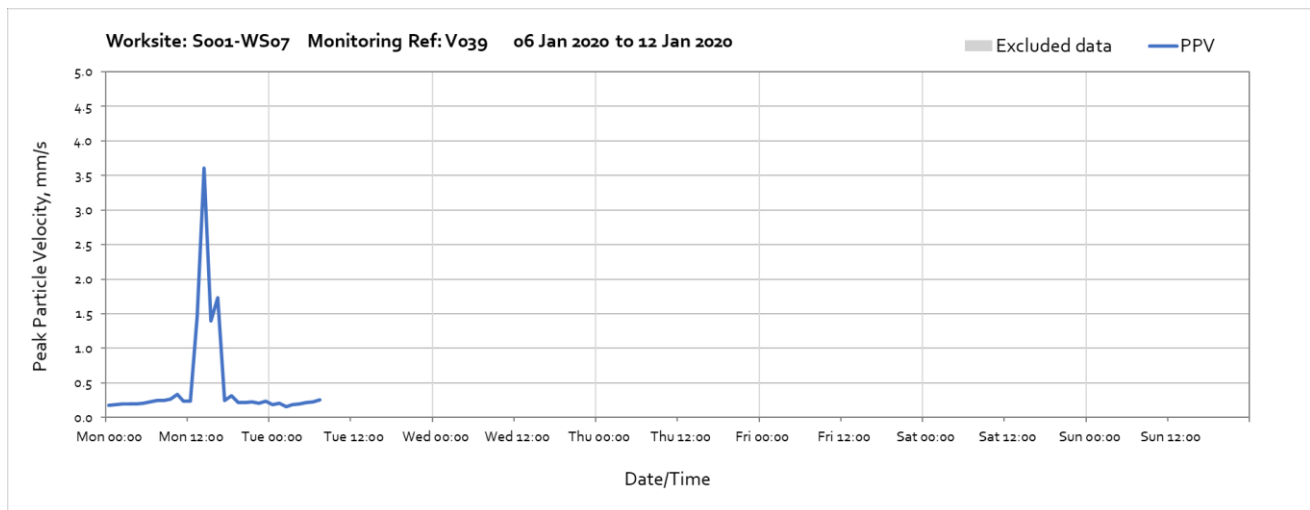
Worksite: S001-WS07 – Monitoring Ref: V039

Note: Missing data between 08:00 on Tuesday 7th January and 15:00 on Wednesday 29th January was due to the removal and reinstatement of the vibration monitor on site due to vehicles accessing the site within close proximity to the monitor.

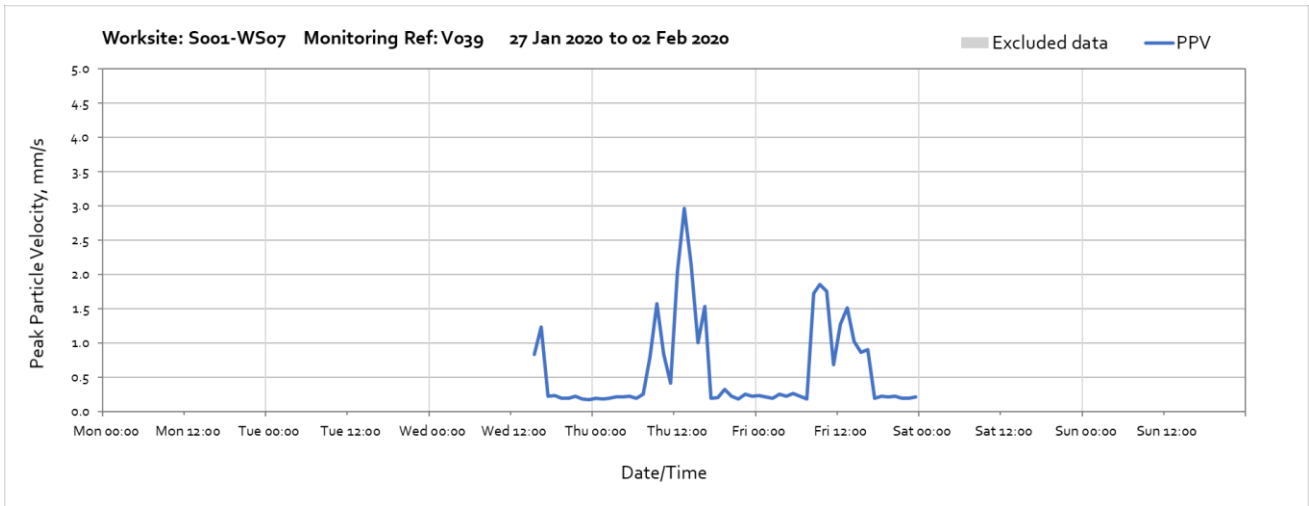
Note: Missing data between 08:00 on Tuesday 7th January and 15:00 on Wednesday 29th January was due to the removal and reinstatement of the vibration monitor on site due to vehicles accessing the site within close proximity to the monitor.

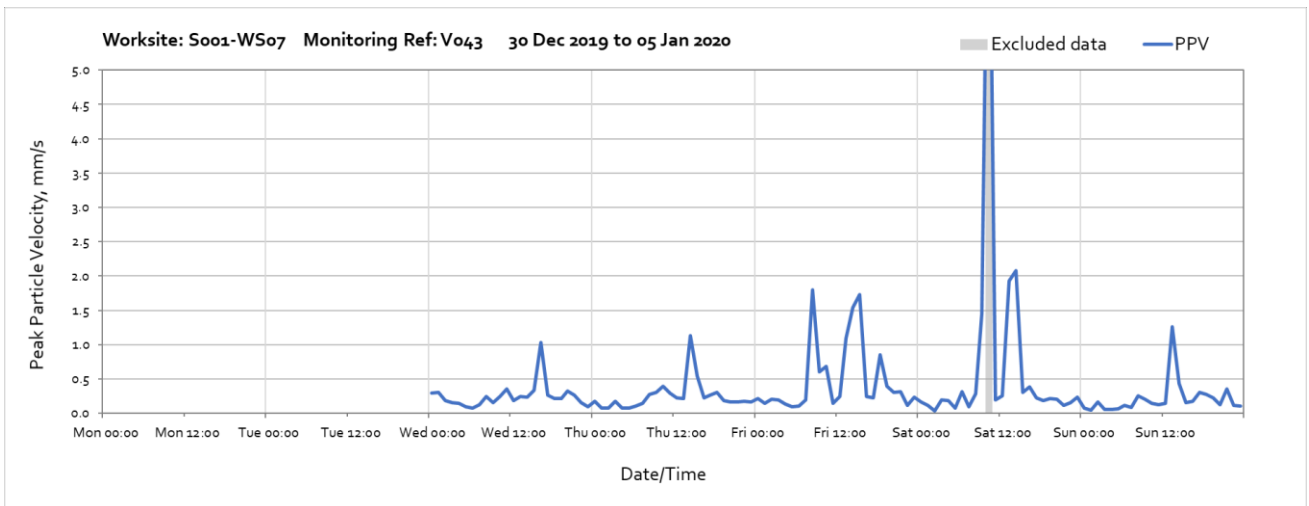
Worksite: S001-WS07 – Monitoring Ref: V043

Note: High vibration levels measured at 10:00 on Saturday 4th January were due to local disturbance of the vibration monitor and are not representative of HS2 vibration levels.

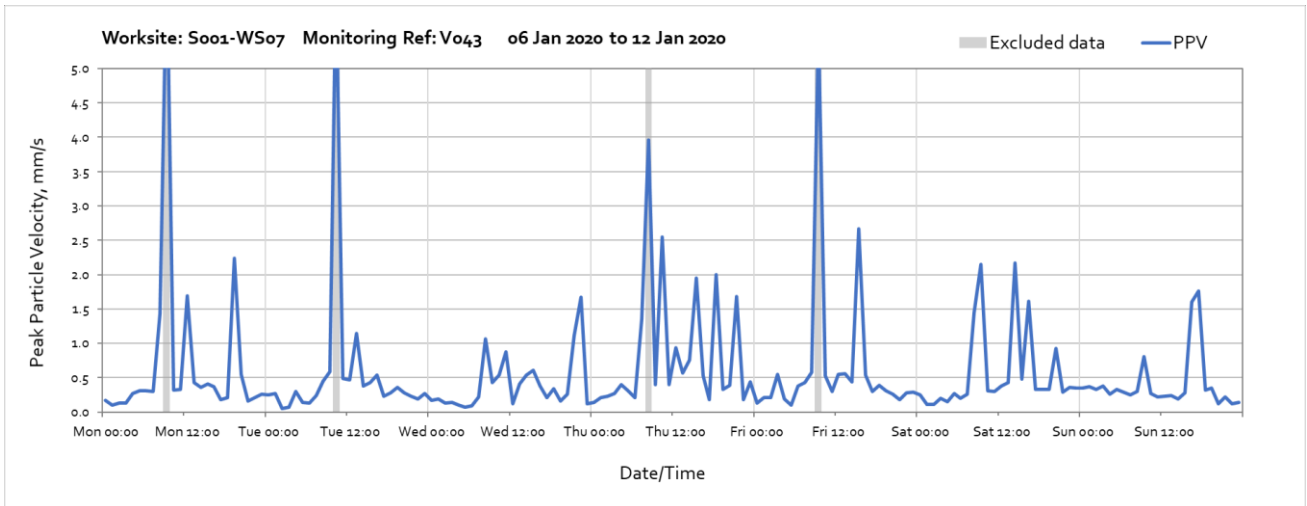
Note: High vibration levels throughout the week were due to local disturbance of the vibration monitor and are not representative of HS2 vibration levels.

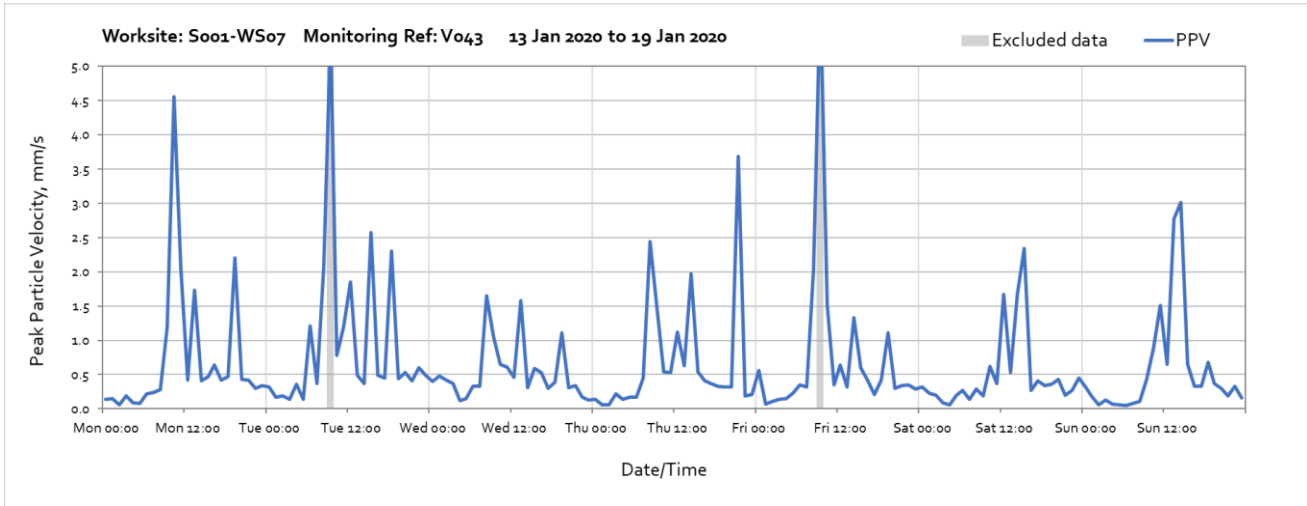
Note: High vibration levels throughout the week were due to local disturbance of the vibration monitor and are not representative of HS2 vibration levels.

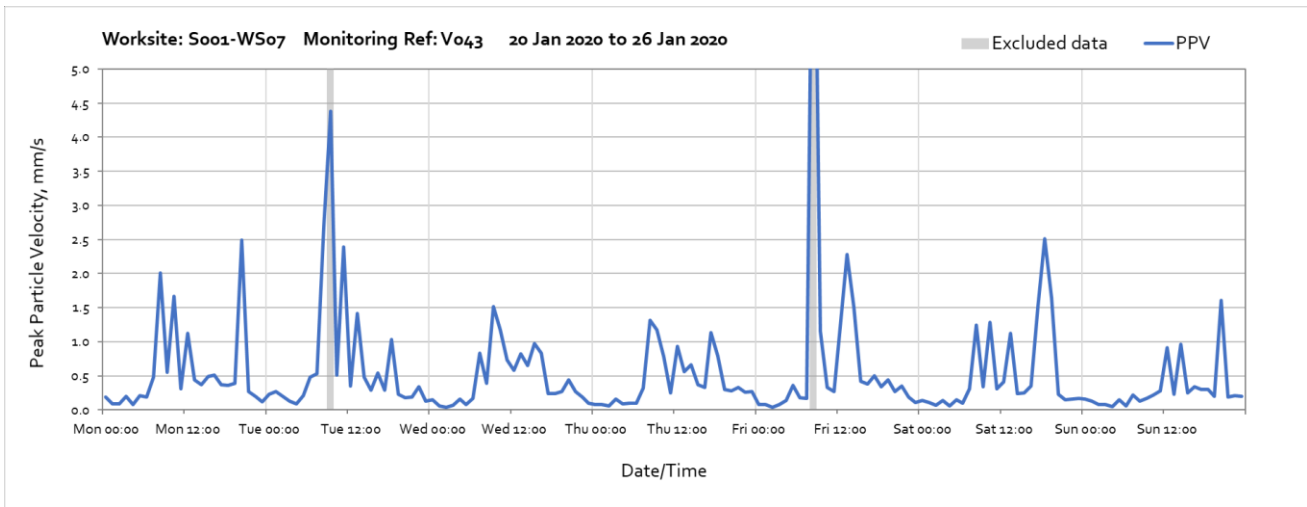
Note: High vibration levels throughout the week were due to local disturbance of the vibration monitor and are not representative of HS2 vibration levels.

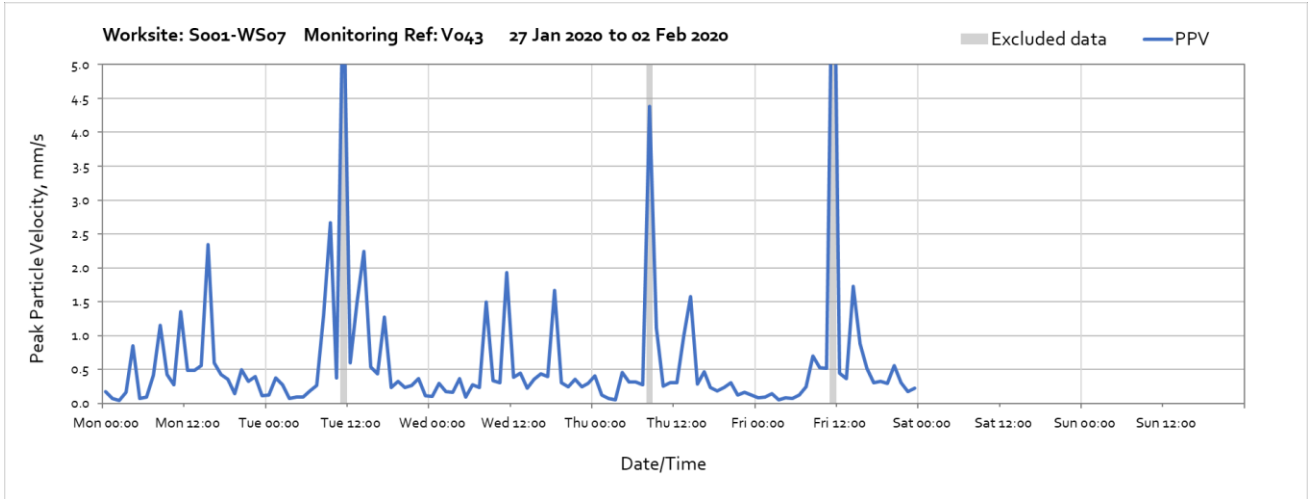
Note: High vibration levels throughout the week were due to local disturbance of the vibration monitor and are not representative of HS2 vibration levels.

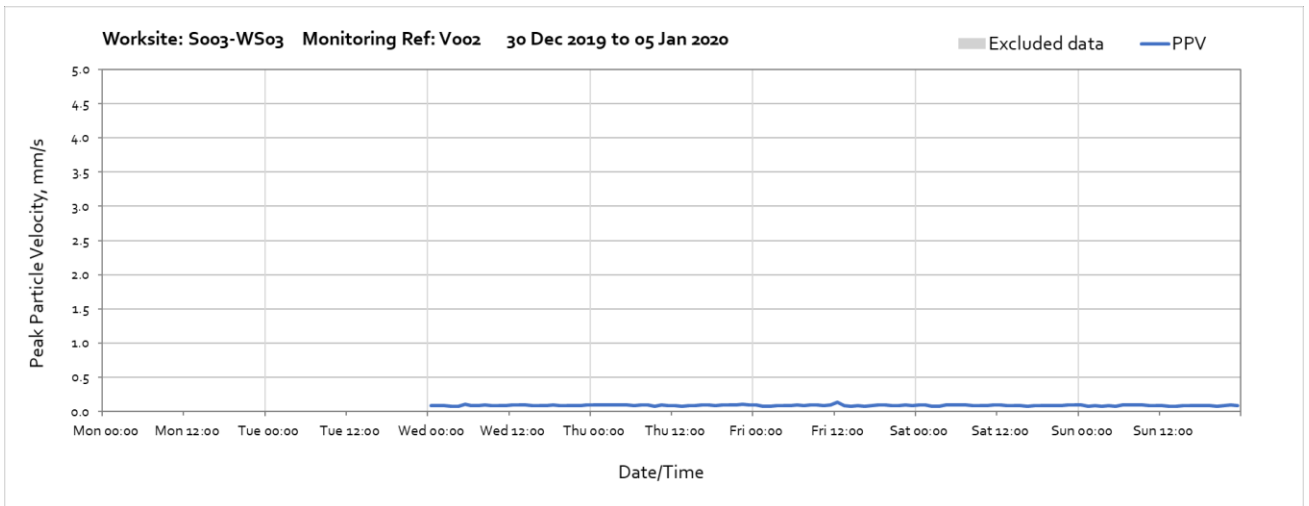
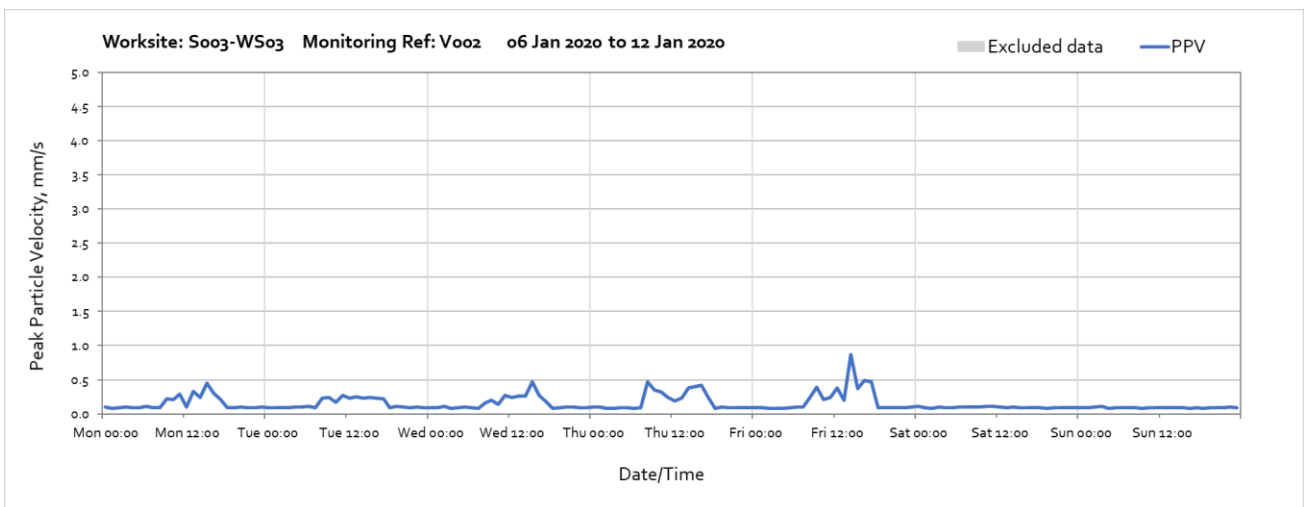
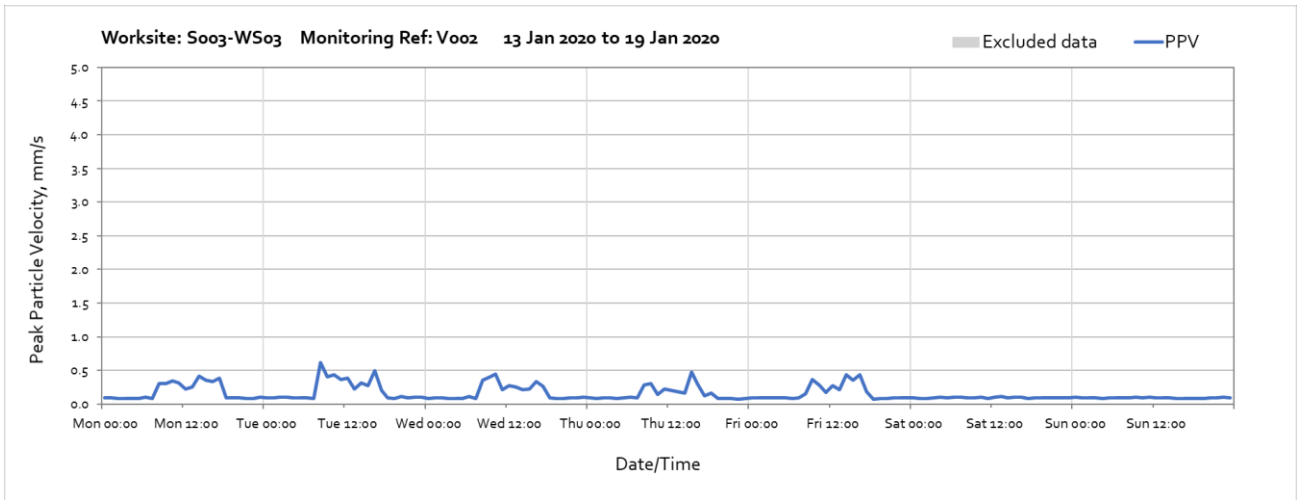
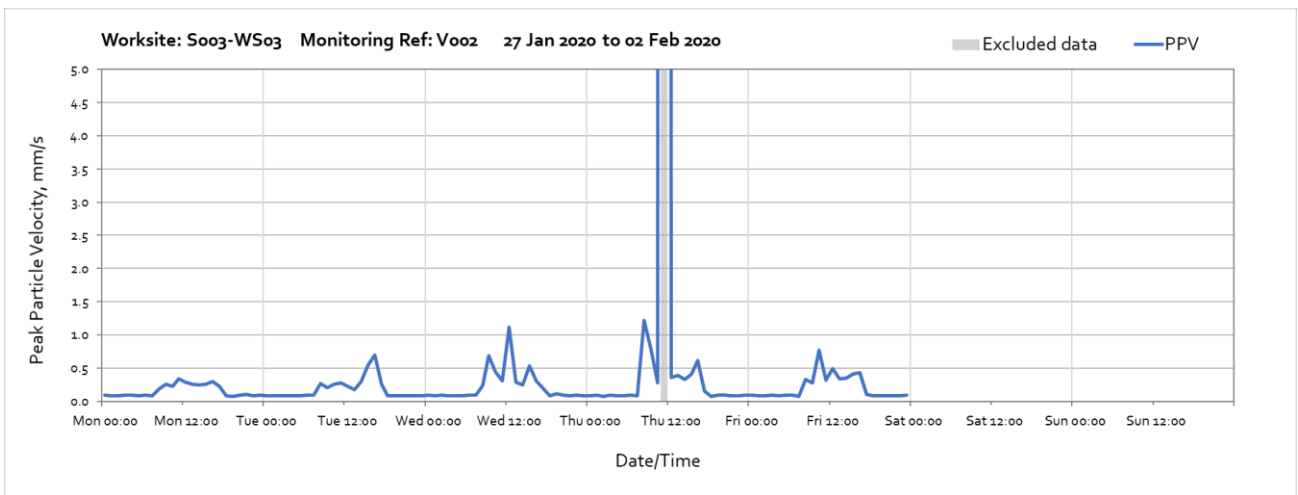
Worksite: S003-WS03 – Monitoring Ref: V002

Note: High vibration levels measured at 11:00 on Thursday 30th January were due to local disturbance of the vibration monitor whilst the monitor battery was changed and are not representative of HS2 vibration levels.

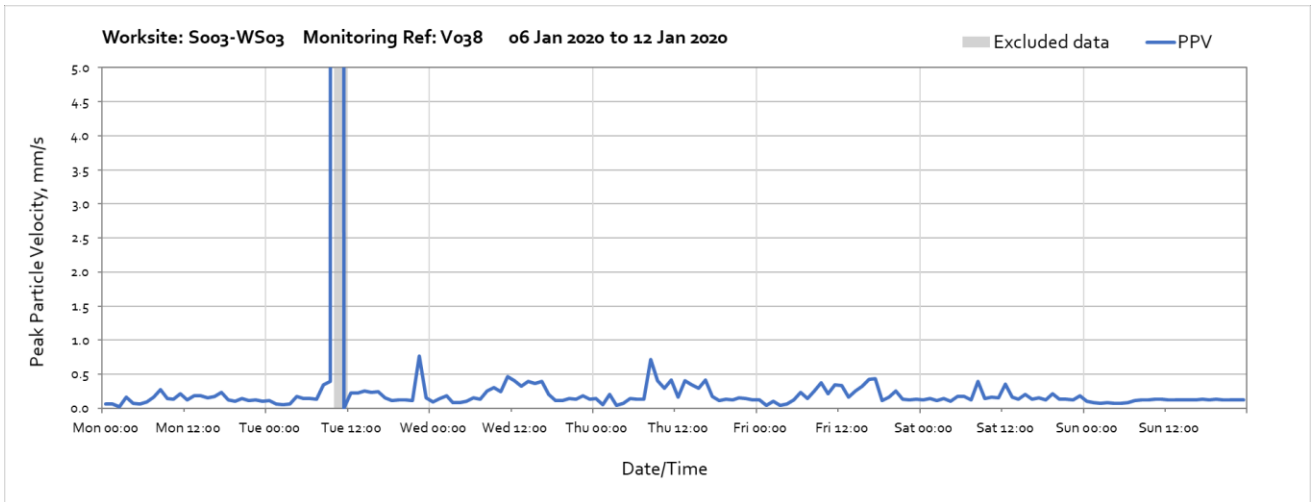
Worksite: S003-WS03 – Monitoring Ref: V038

Note: High vibration levels measured at 10:00 - 11:00 on Tuesday 7th January were due to local disturbance of the vibration monitor during routine maintenance of the monitor and are not representative of HS2 vibration levels.

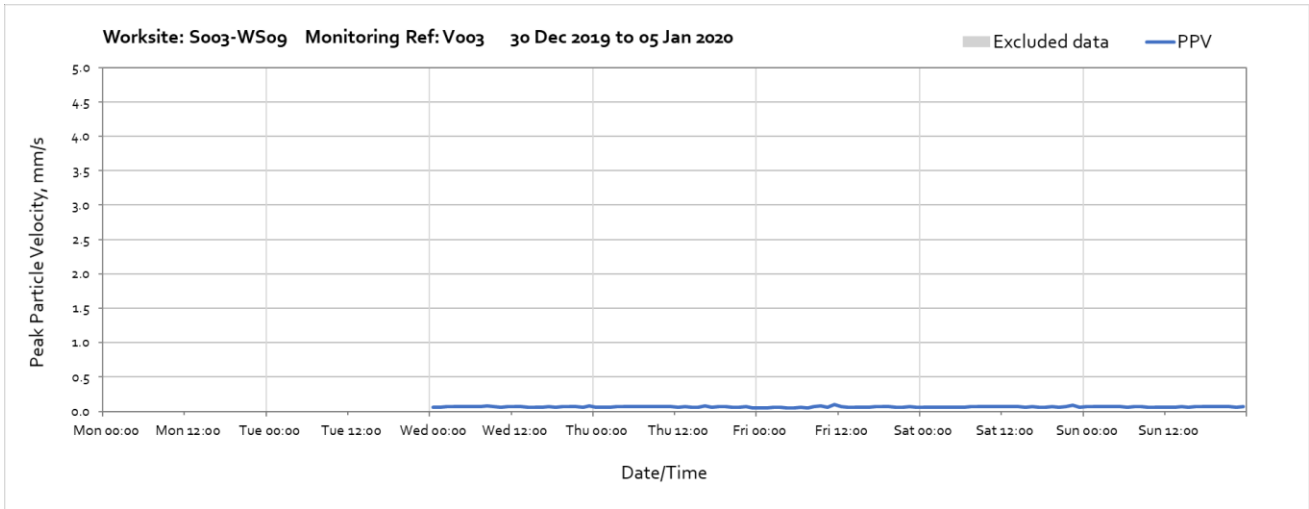
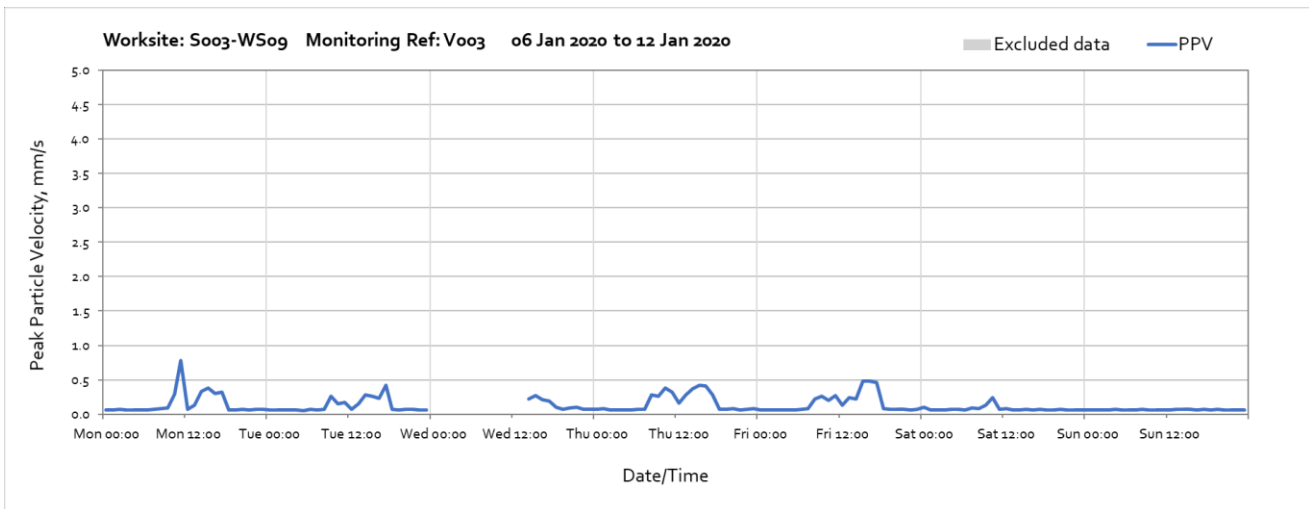
Worksite: S003-WS09 – Monitoring Ref: V003

Note: Missing data between 00:00 – 14:00 on Wednesday 8th January was due to an error with the data server.

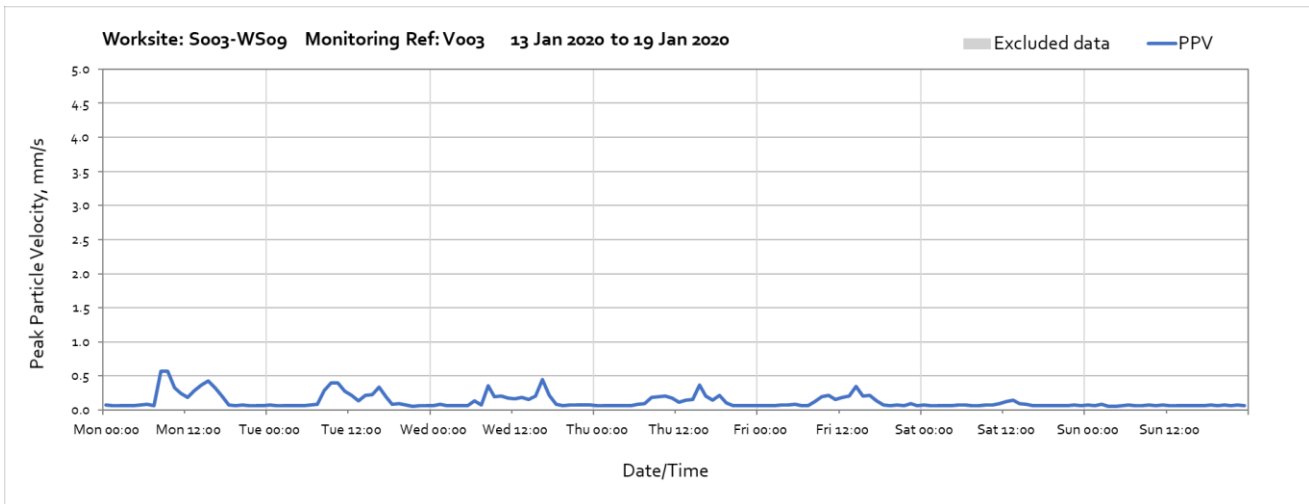
Note: High vibration levels measured throughout the week were due to local disturbance of the vibration monitor and are not representative of HS2 vibration levels.

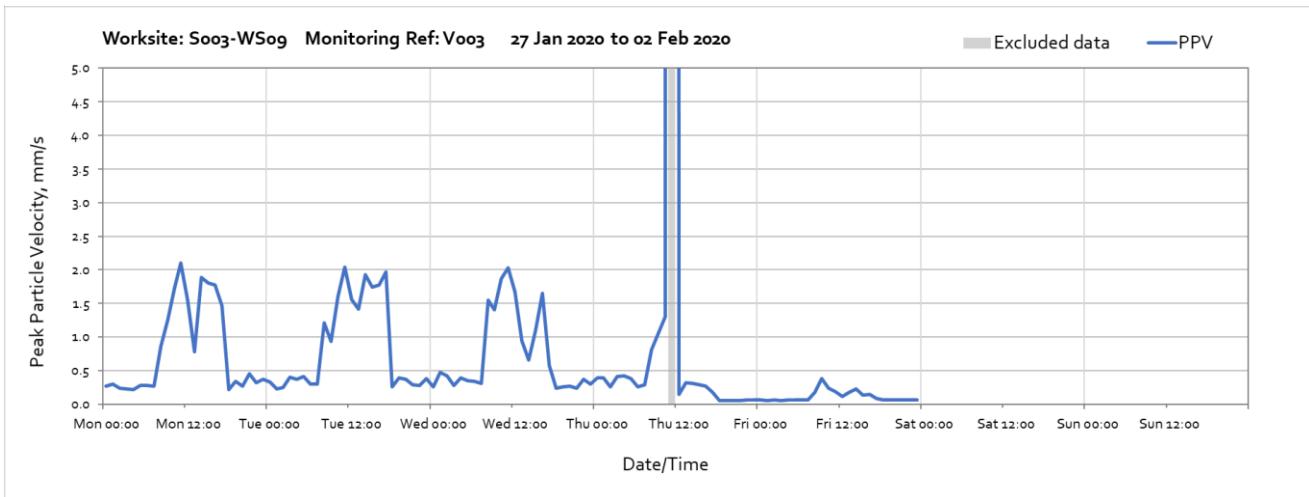
Note: High vibration levels measured throughout the week were due to local disturbance of the vibration monitor and are not representative of HS2 vibration levels.
