April 2020

HS2

Construction noise and vibration Monthly Report – February 2020

London Borough of Hillingdon

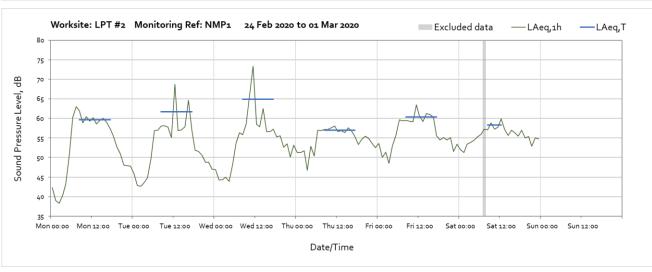
Worksite: LTP #2 – Monitoring Ref: NMP1

The following graphs show the hourly measured ambient noise level $L_{Aeq,1h}$ and, where relevant, the averaged noise level $L_{Aeq,T}$ values, where the time period T is as specified in Table 1 of HS2 Information Paper E23. Periods with adversely weather affected noise levels are greyed out and have been excluded from the calculation of the $L_{Aeq,T}$ values.

https://data.gov.uk/dataset/24542ae7-dd44-444f-b259-871c4cc43b5e/environmental-monitoring-data.
- 2.2.3 Ambient noise levels for the NMP1 in the locality of HOAC are dominated by noise emanating from the activity centre and the use of the car park. Ambient noise levels for the NMP2 in the locality of LTP #2 are dominated by noise emanating from local road traffic on Harvil Road to the east.
- 2.2.4 Ambient noise levels for monitoring locations NMP3 and NMP4 adjacent to West Ruislip Northolt Corridor are dominated by road traffic from Ickenham Road bridge, there are also contribution from trains pass-bys and London Underground trains departing the nearby West Ruislip Station into the early hours.
