Air Quality and Dust Monitoring Monthly Report – March 2020

Three Rivers District Council

A report prepared by Align JV on behalf of HS2 Ltd.

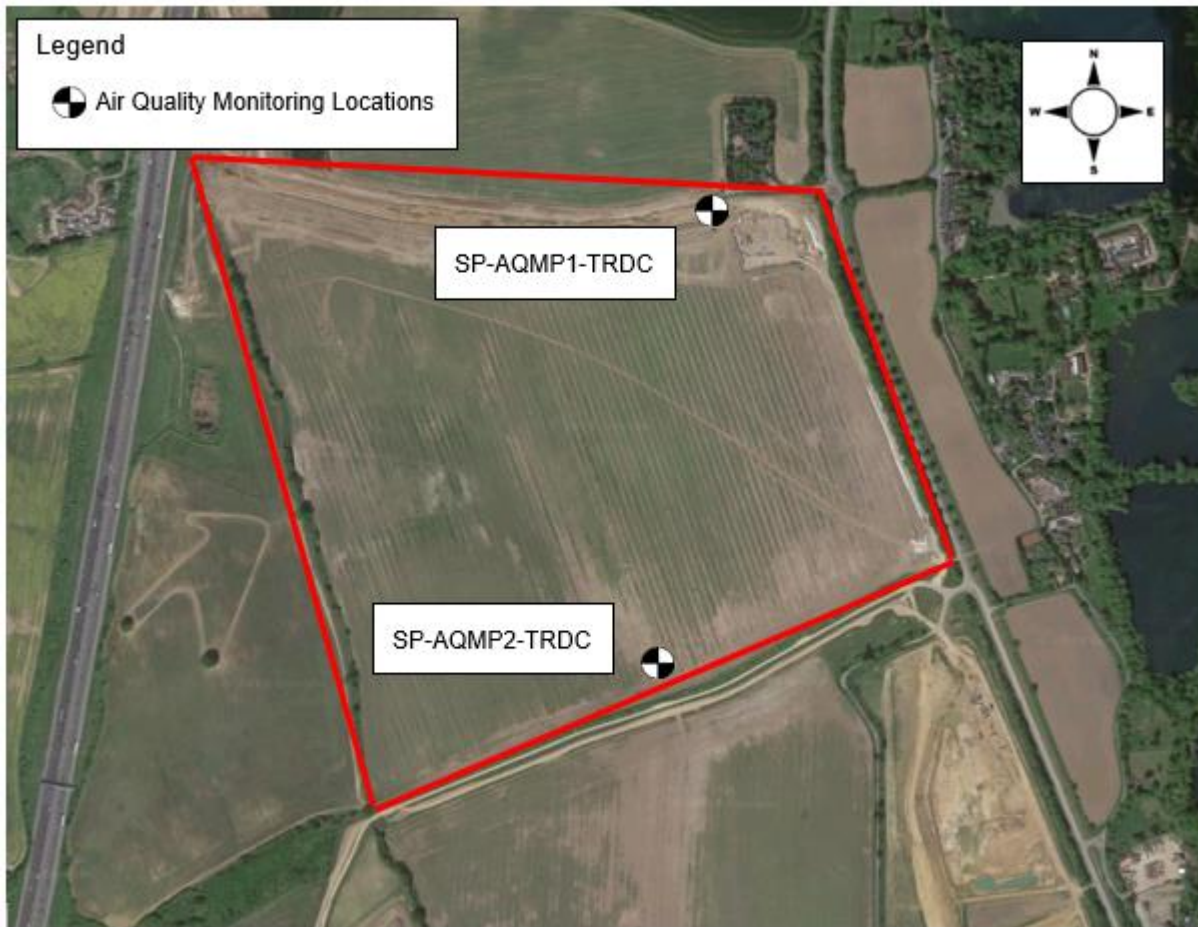
Figure 1: Worksites and Monitoring locations during March 2020

- 1.1.2 Figure 1 in Appendix A indicates the current worksite together with the dust monitoring locations for March 2020.
- 1.1.3 This summary should be read in conjunction with the overview monitoring report monthly available from www.gov.uk/government/collections/monitoring-the-environmental-effects-of-hs2, which highlights: the applicable standards and guidance, as well as the air quality and dust monitoring methodologies to be implemented by nominated undertakers throughout construction.

- 1.1.4 The current phase of works commenced within TRDC during July 2017 and is expected to be completed by May 2020. The current worksite at the Chiltern Tunnel South Portal Compound is presented in Appendix A, Figure 1. Activities within March included:

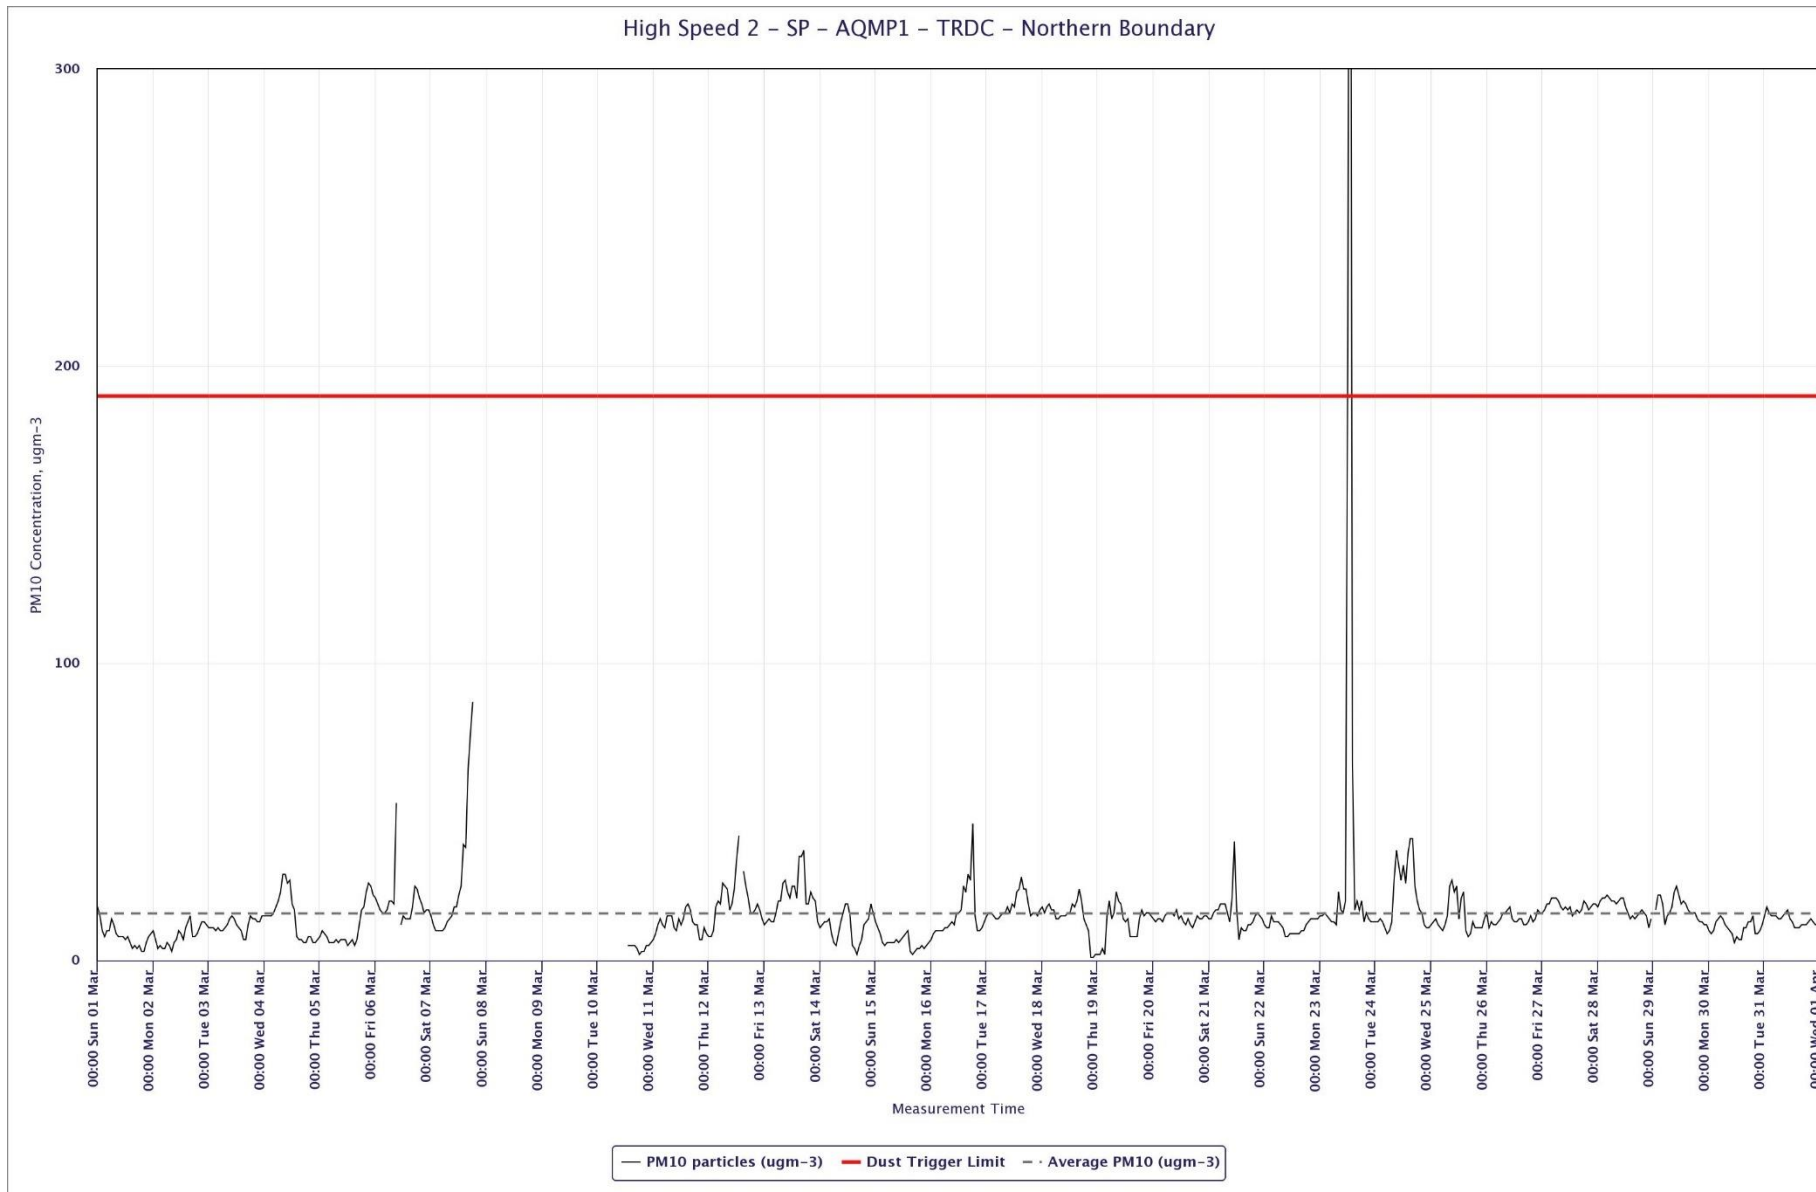
Figure 2: Continuous dust 1-hour mean indicative PM₁₀ concentration for SP-AQMP1_TRDC for March 2020

- 1.1.6 Dust monitoring locations and results are presented in Appendix B, Table 1, together with a line chart of monthly data from each dust monitor presented in Figures 2 and 3. All continuous dust monitoring is undertaken using indicative monitors. Despite being Environment Agency (MCERTS) certified, indicative monitors carry a higher level of uncertainty than reference monitors, and therefore cannot be strictly compared with Air Quality Standards for human health and the environment. The purpose of the monitoring undertaken is to ensure the effectiveness of the on-site mitigations.

- 1.1.7 The trigger level for PM₁₀ concentrations of 190 µg/m³, over a 1-hour period, in accordance with the updated guidance document '*Guidance on Monitoring in the Vicinity of Demolition and Construction Sites – (October 2018)*' has been applied.
- 1.1.8 There were two (2) dust trigger alerts recorded at SP-AQMP1_TRDC during the March 2020 monitoring period. No works were being undertaken in the vicinity of the monitor. Nearby works included auger boring using wet grout and movement of 4x4s along the haul road. Damping down increased in the area and good housekeeping measures continued on site, in line with the Code of Construction Practice. Exceedances are presented in Appendix B, Table 2. All other results were in line with expected ranges.
- 1.1.9 There were no (0) complaints, relating to dust or air quality, received during the monitoring period (March 2020).

Monitoring Site ID	Period of trigger alert & Concentration recorded	Investigation	Outcomes / Resolution / Remedial measures implemented
SP-AQMP1_TRDC	<u>23/03/2020</u> : 12:00 - 13:00: 211.4 µg/m ³	No works were being undertaken in the vicinity of the monitor.	Good housekeeping measures to be continued on site, in line with the Code of Construction Practice.
SP-AQMP1_TRDC	<u>23/03/2020</u> : 13:00 - 14:00: 502.7 µg/m ³	Nearby works included auger boring using wet grout and movement of 4x4s along the haul road.	Damping down was increased in the area.

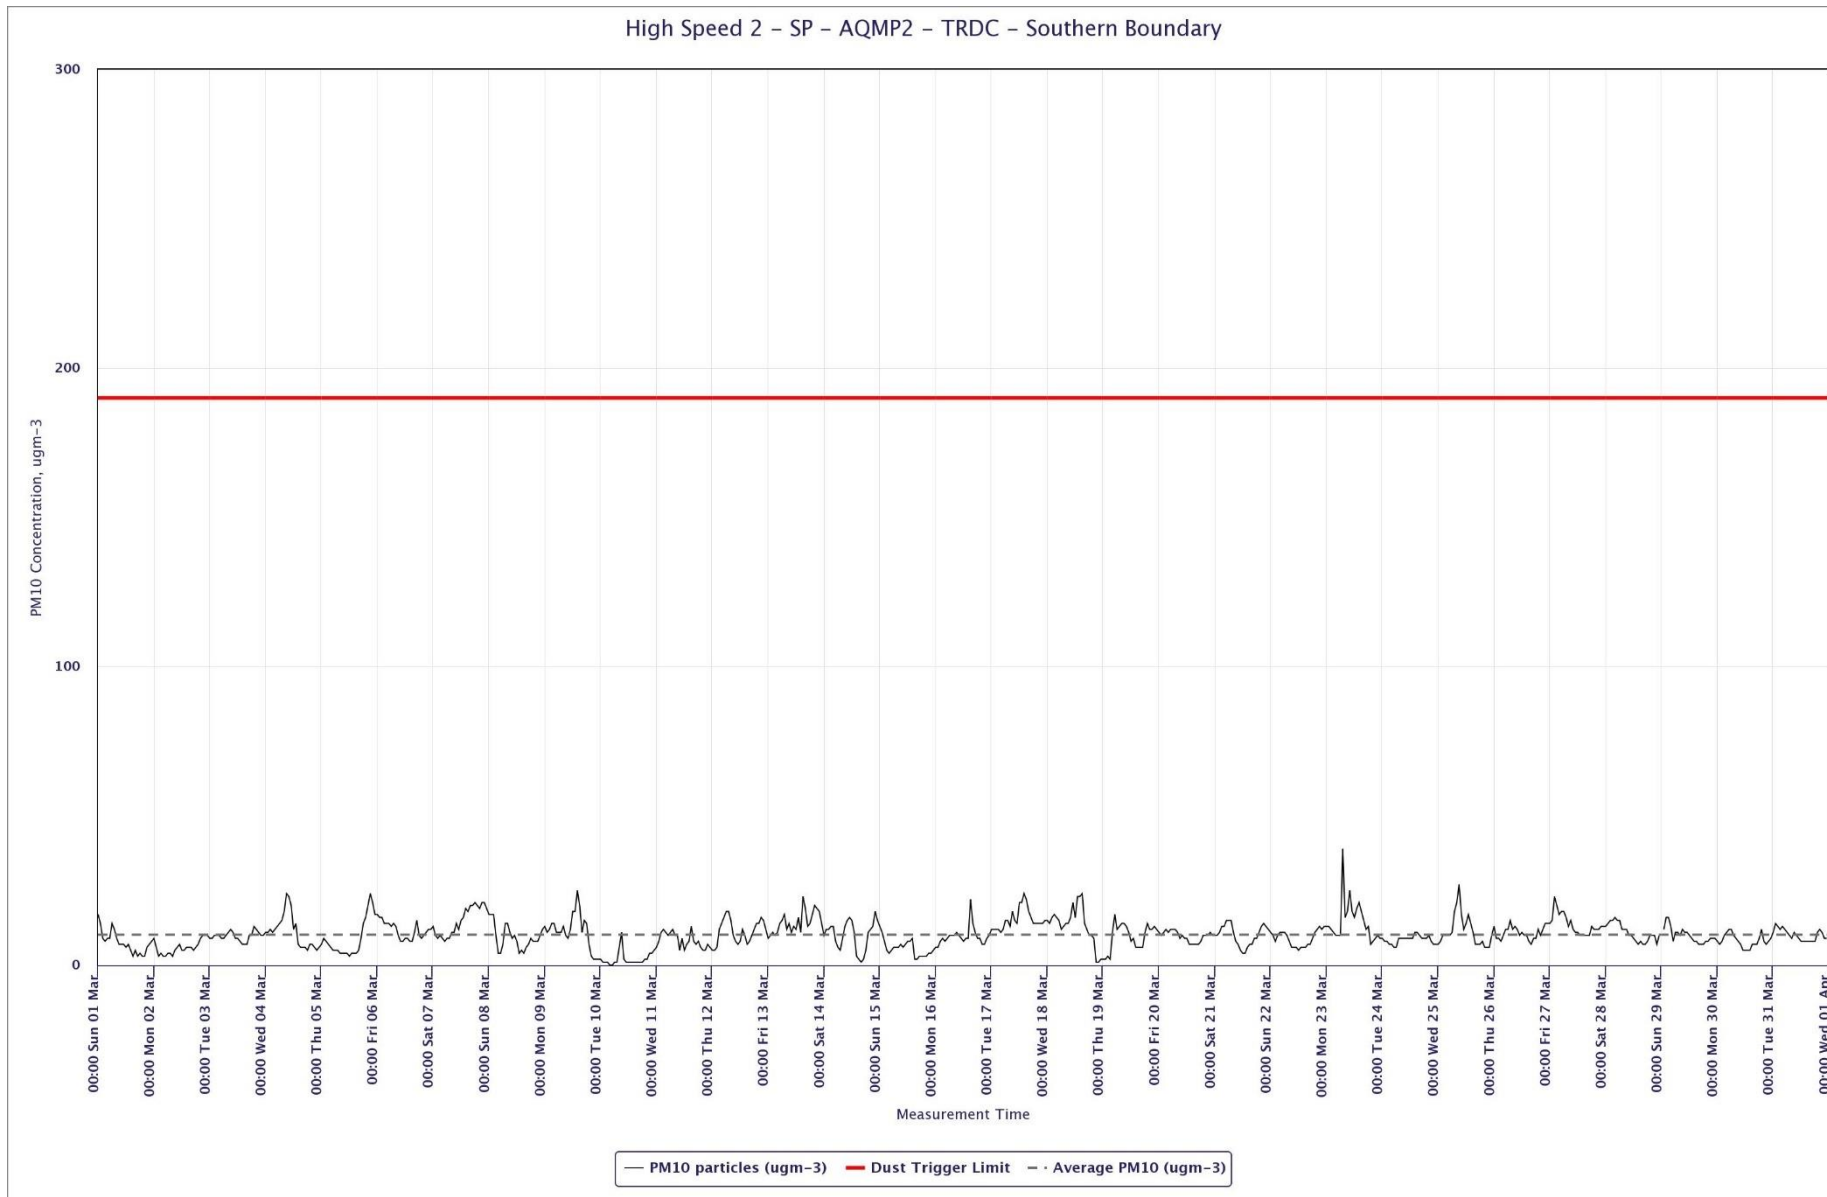
Figure 3: Continuous dust 1-hour mean indicative PM₁₀ concentration for SP-AQMP2_TRDC for March 2020
