Air Quality and Dust Monitoring Monthly Report – **April** 2020

London Borough of Hammersmith and
Fulham

A report prepared by Costain Skanska on behalf of HS2 Ltd.

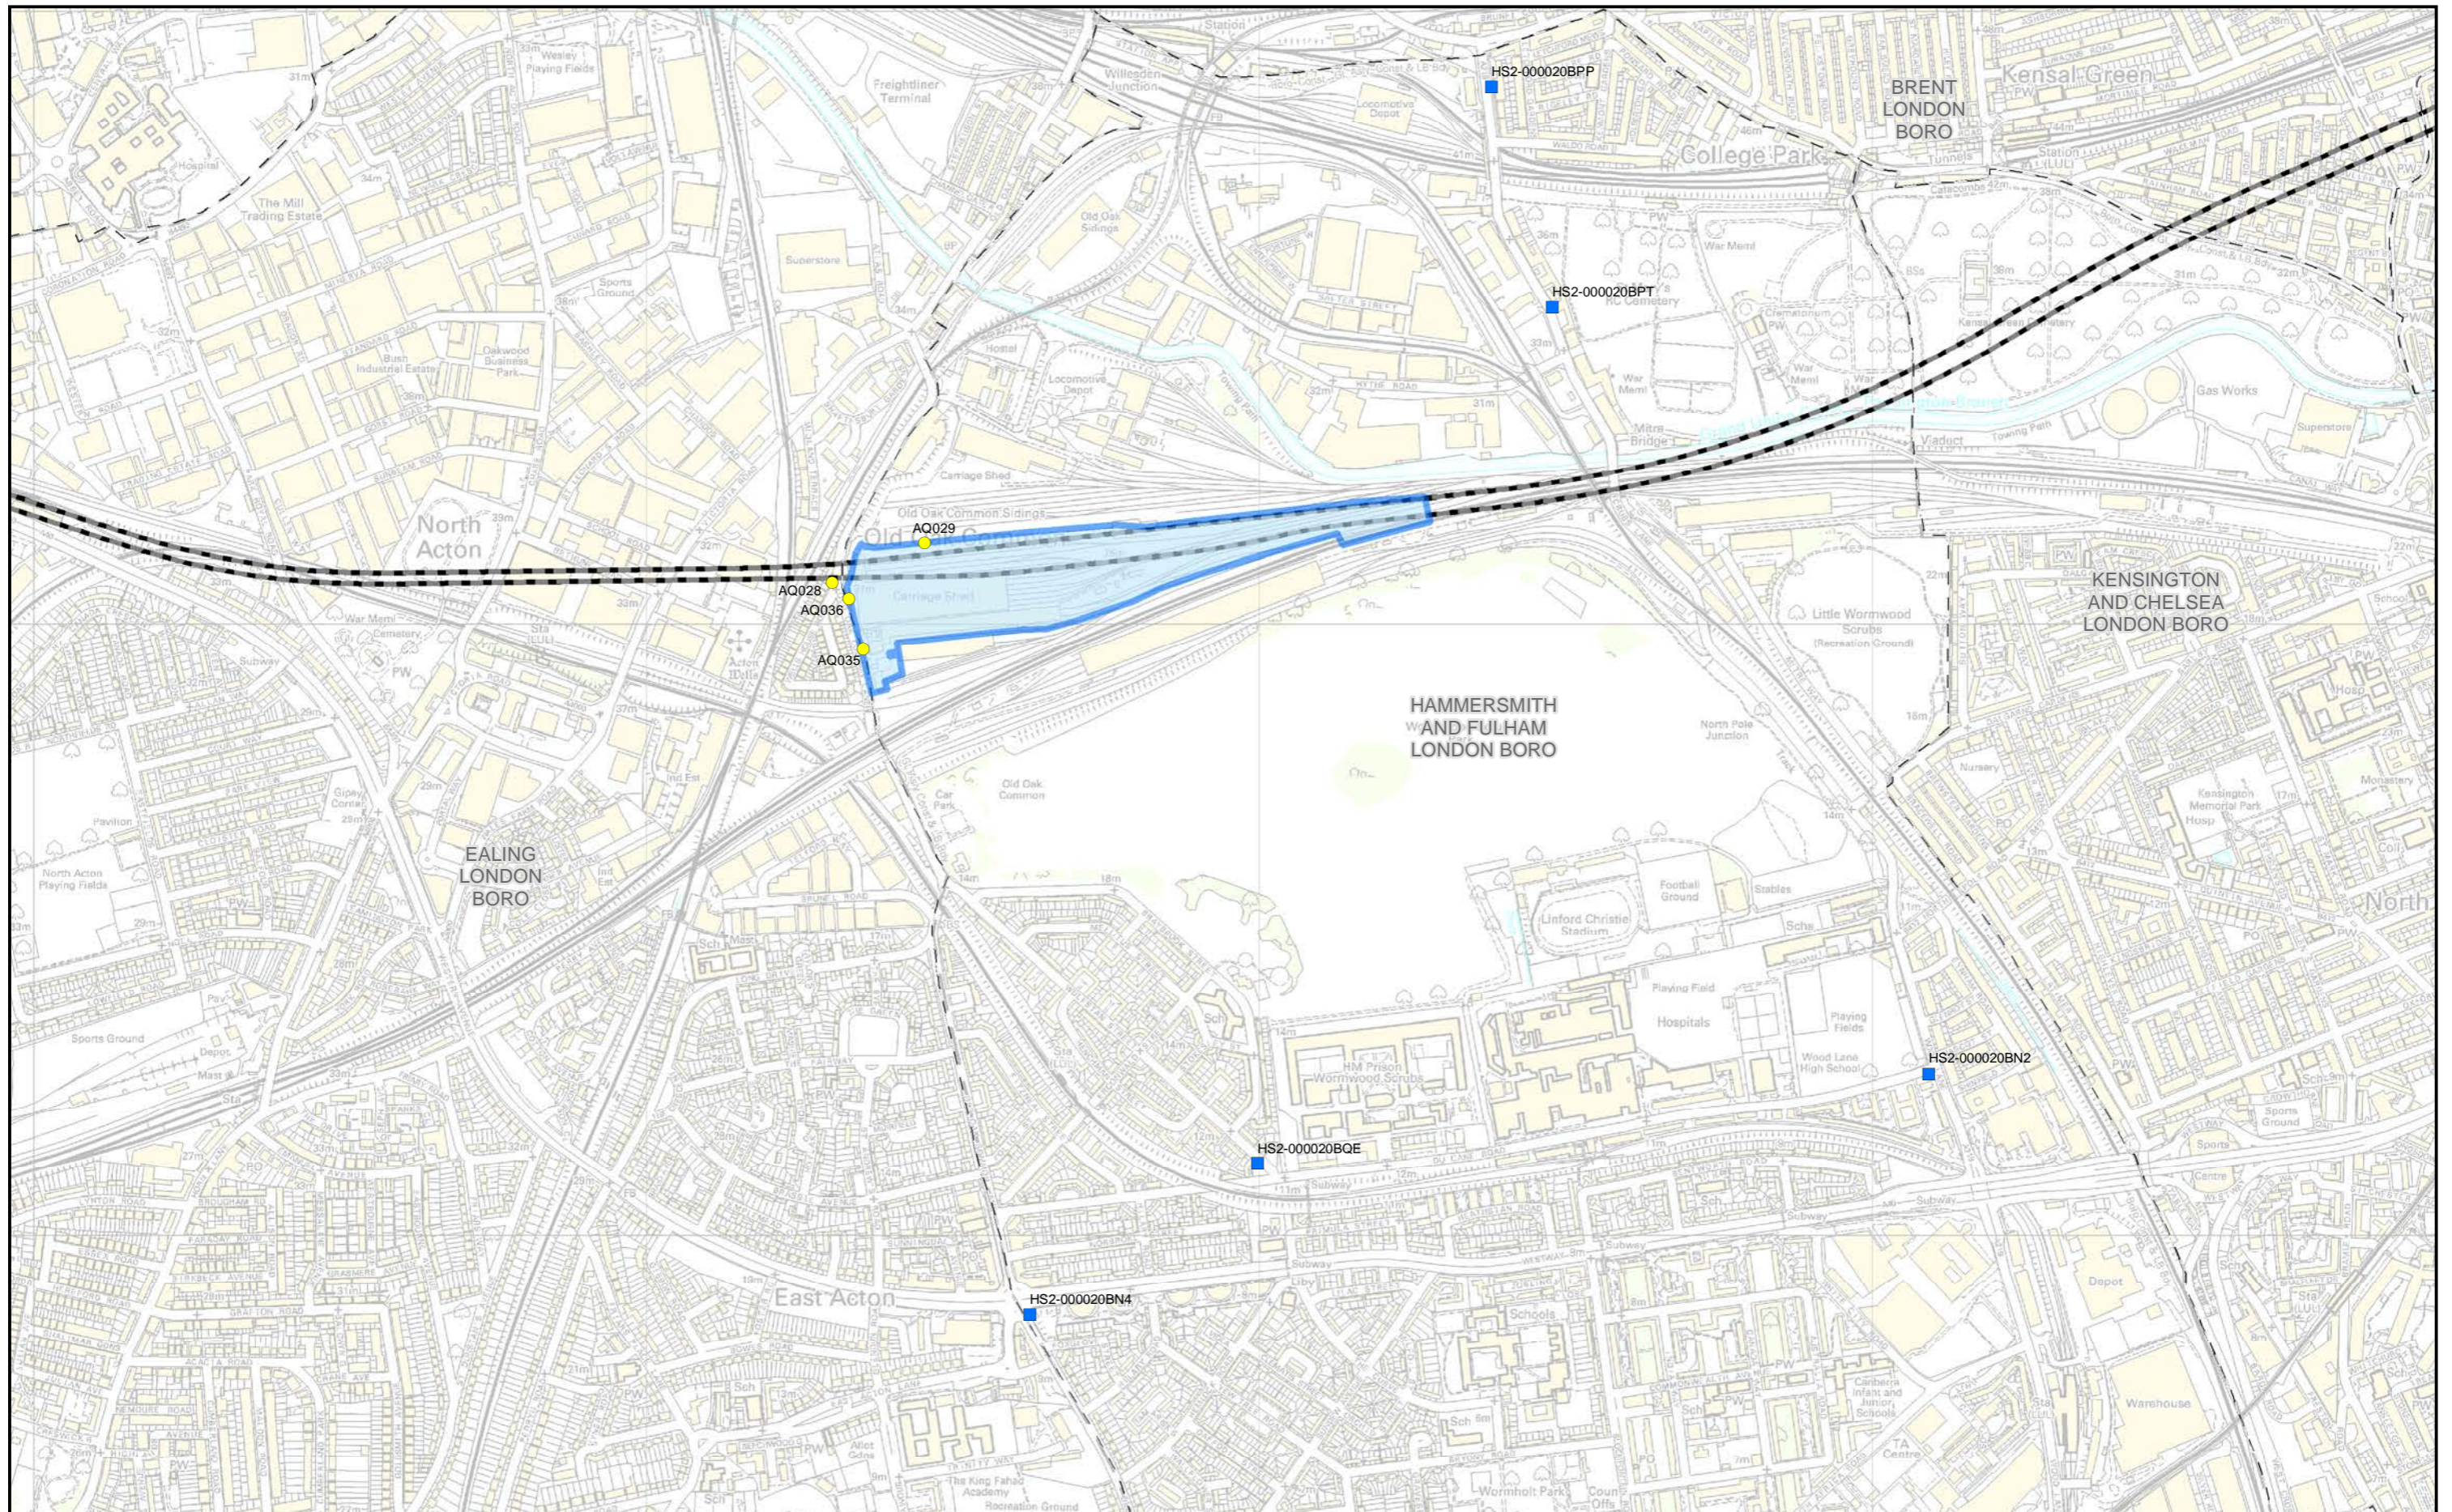
Figure Name
Worksites and Monitoring locations in LBHF (sheet 1)

- 1.1.2 Figure 1 and Figure 2 in Appendix A indicate the current worksite together with air quality and dust monitoring locations.
- 1.1.3 This summary should be read in conjunction with the overview monitoring report available from www.gov.uk/government/collections/monitoring-the-environmental-effects-of-hs2, which highlights: the applicable standards and guidance, as well as the air quality and dust monitoring methodologies to be implemented by nominated undertakers throughout construction.

- 1.1.4 The current phase of works commenced within the LBHF during May 2018 and are expected to be completed by October 2020. The current worksite, as presented in Appendix A, Figure 1, includes:

- Demolition and groundworks at Old Oak Common Depot.
- 1.1.5 Four (4) dust monitors are installed around the worksite, where demolition works are underway. This site returned a high dust risk rating.

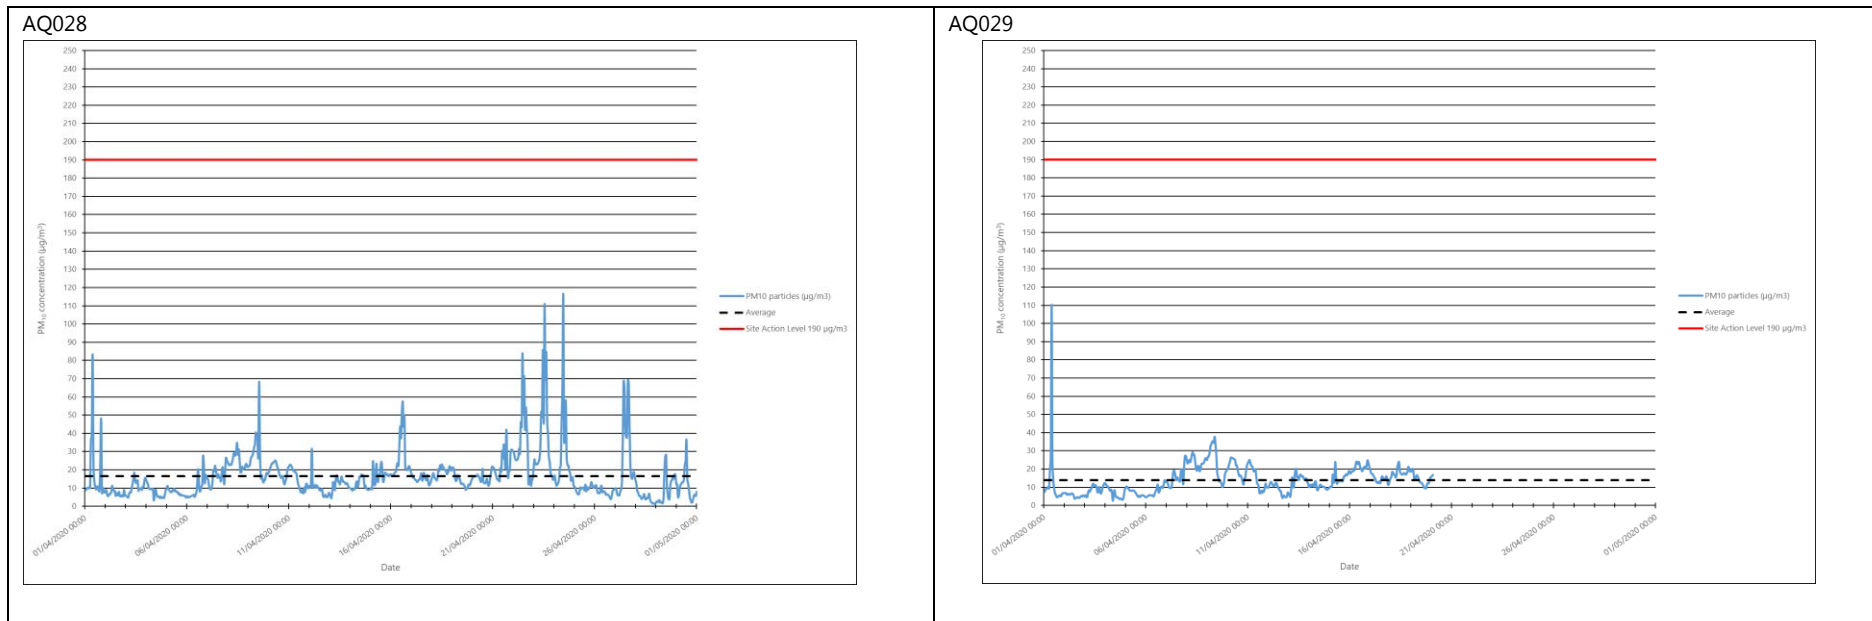
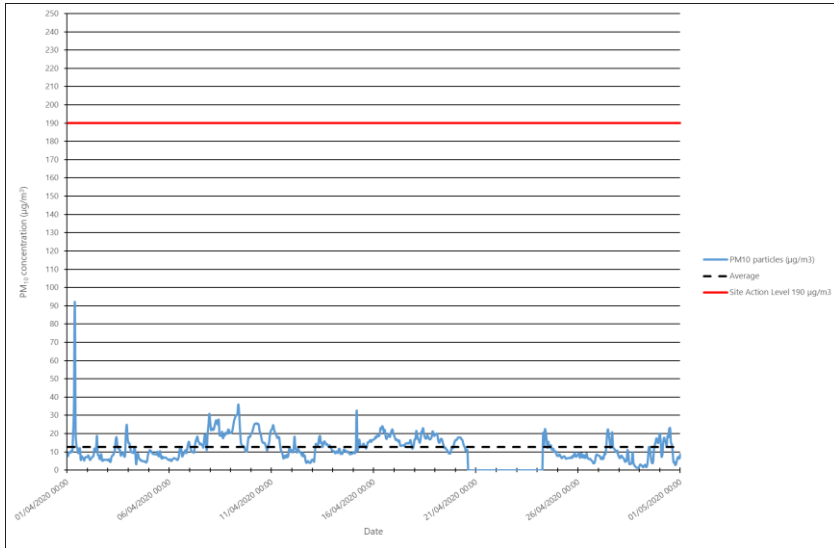
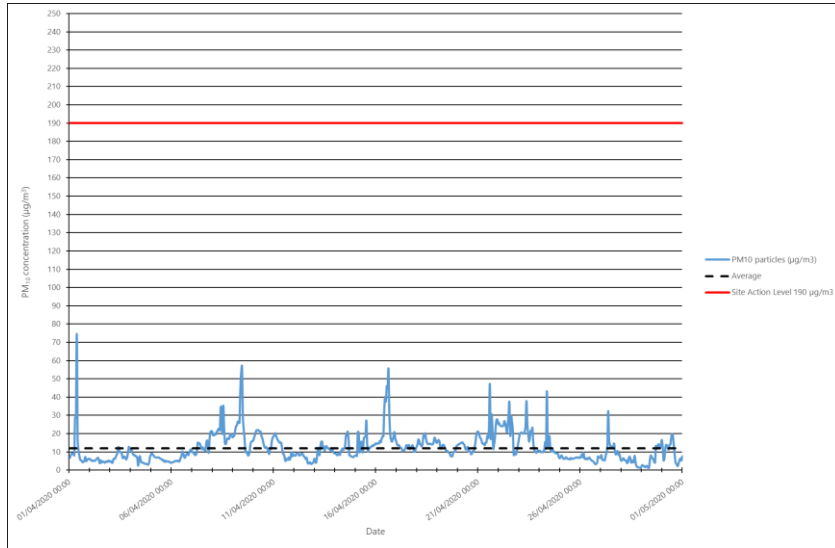
Figure 3: Construction dust 1-hour mean indicative PM₁₀ concentration for dust monitors

- 1.1.6 Dust monitoring locations and results are presented in Appendix B, Table 1, together with line charts of monthly data from each dust monitor in Figure 3. All continuous dust monitoring is undertaken using indicative monitors. Despite being Environment Agency (MCERTS) certified, indicative monitors carry a higher level of uncertainty than reference monitors, and therefore cannot be strictly compared with Air Quality Standards for human health and the environment. The purpose of the monitoring undertaken is to ensure the effectiveness of the on-site mitigation.

- 1.1.7 The trigger level for PM₁₀ concentrations of 190 µg/m³, over a 1-hour period, in accordance with the updated guidance document '*Guidance on Monitoring in the Vicinity of Demolition and Construction Sites – (October 2018)*' has been applied.

- 1.1.8 There were no (0) dust trigger alerts recorded during this monitoring period (April 2020). All results were in line with expected ranges.
- 1.1.9 Data capture for AQ029 and AQ035 was below 90% for the month of April 2020. This was due to technical faults with the monitors. Due to the COVID-19 pandemic and government lockdown it was not possible to visit and determine the cause of the fault or to conduct maintenance and repair work.
