## SAFETY FLYER TO THE FISHING INDUSTRY

### Capsize of fishing vessel *Anna-Marie II* (WK 875) with one fatality on 23 September 2019

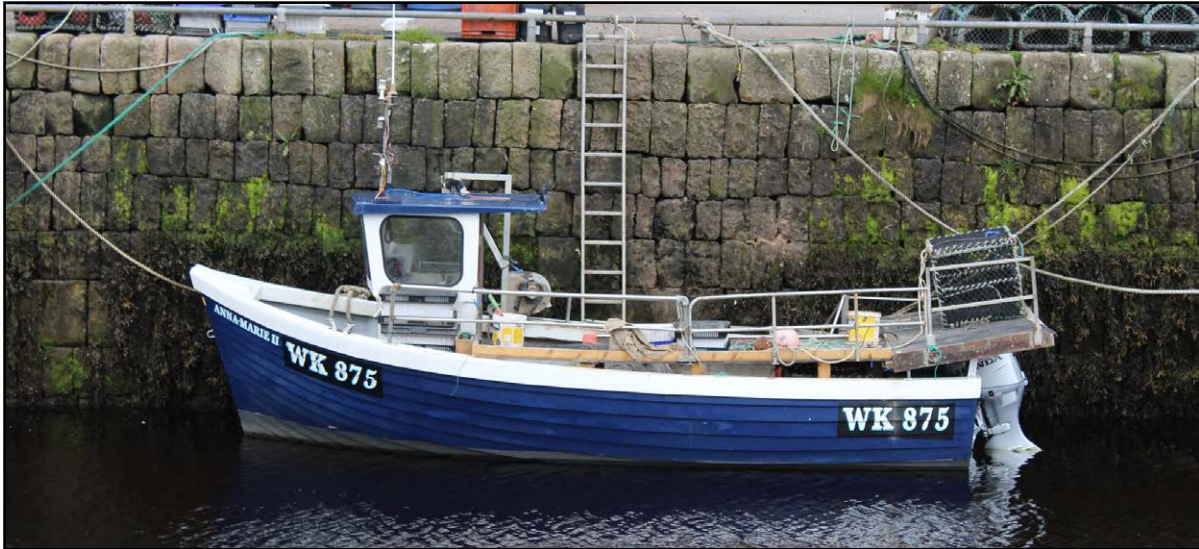
At about 1550 on 23 September 2019, the 6.2m fishing vessel, *Anna-Marie II* capsized as it entered the mouth of the Brora river while returning from its creel fishing grounds. The vessel broached and was slewed to starboard as the skipper lost steerage, and it was capsized and inverted due to the size and steepness of the next wave. The skipper and crewman were briefly trapped under the hull before surfacing. It is likely the skipper struck his head during the capsize, which might have affected his ability to swim. The crewman managed to swim ashore.

1. In open fishing vessels the risk of capsize and inverting, particularly in steep waves, is higher compared with decked vessels. Therefore, it is important that fishermen reduce the risk of broaching and capsize by conducting a thorough assessment to ensure they are prepared if a capsize occurs. Potential mitigation measures prior to crossing a river bar could include:
