Construction noise and vibration Monthly Report – April 2020

London Borough of Camden

Non-technical summary

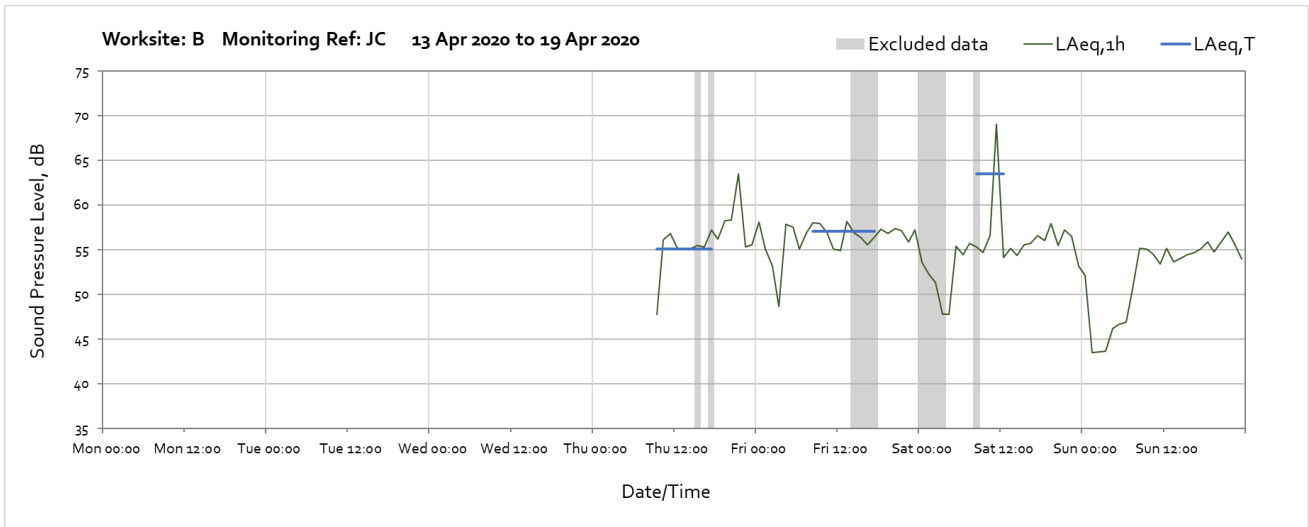
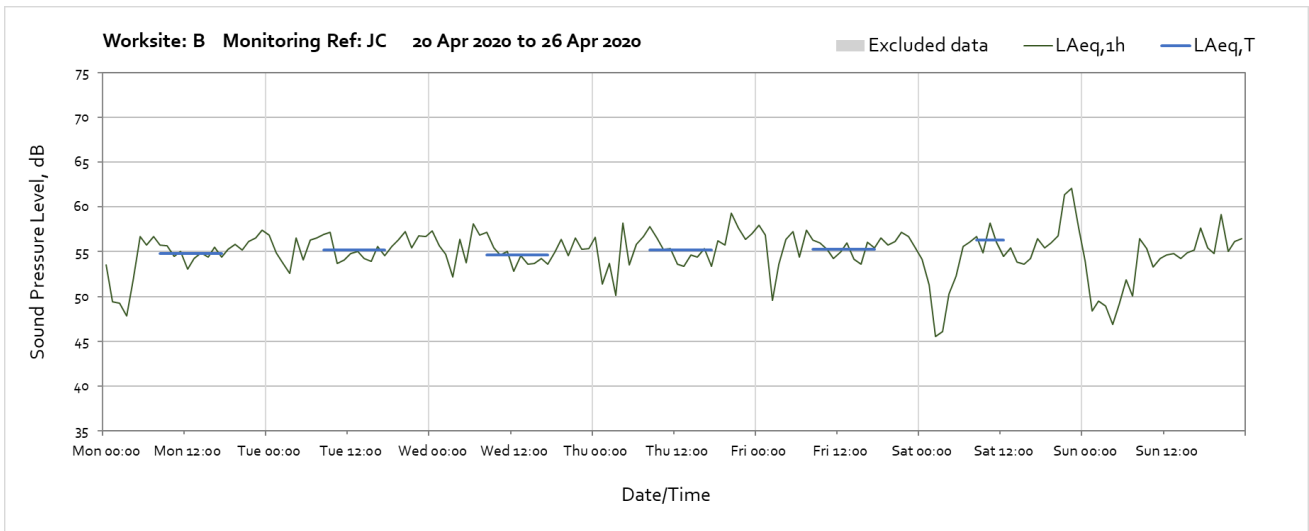
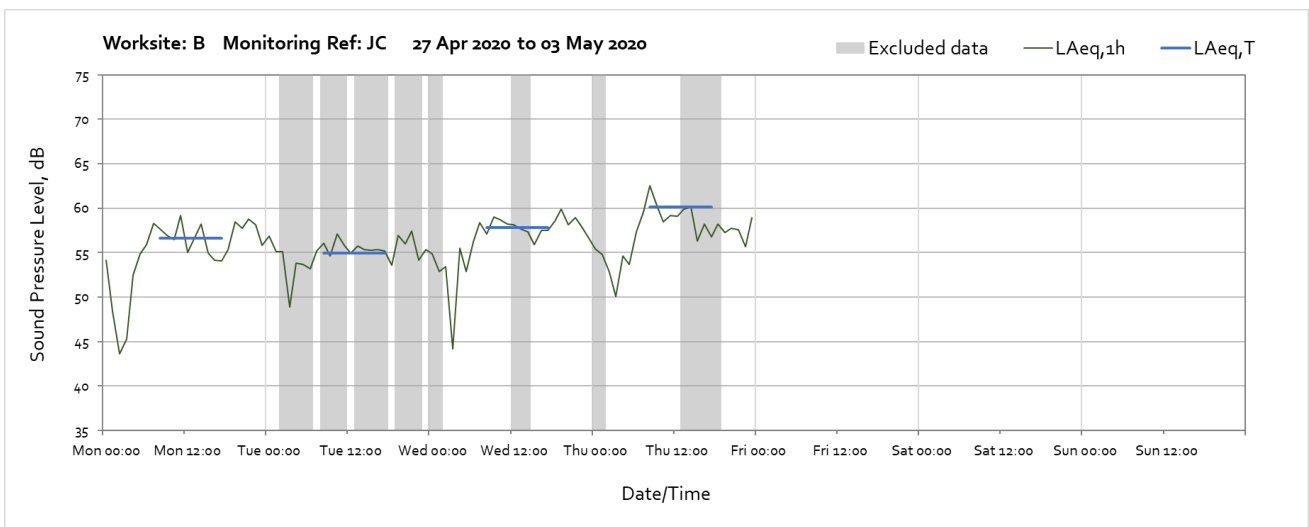
Worksite: B – Monitoring Ref: JC

Note: Missing data between 06:00 on Sunday 12th and Thursday 16th of April was due to loss of power at the monitoring station.

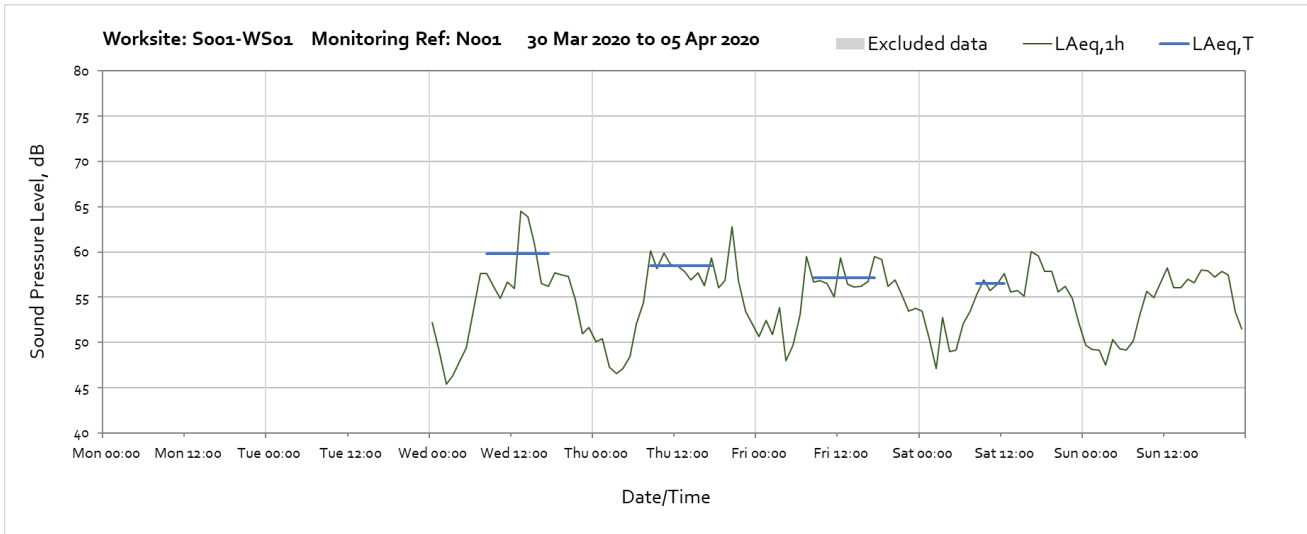
Worksite: S001-WS01 – Monitoring Ref: N001

Note: Missing data between 07:00 and 21:00 on Tuesday 29th April was due to a fault with the monitoring station power supply, which was later fixed.
