ACCIDENT

Aircraft Type and Registration:	Jodel D117A, G-AZII	
No & Type of Engines:	1 Continental Motors Corp C90-14F piston engine	
Year of Manufacture:	1958 (Serial no: 848)	
Date & Time (UTC):	8 April 2019 at 1310 hrs	
Location:	Full Sutton Airfield, York	
Type of Flight:	Private	
Persons on Board:	Crew - 1	Passengers - None
Injuries:	Crew - None	Passengers - N/A
Nature of Damage:	Landing gear, lower engine cowl, engine and propeller damaged	
Commander's Licence:	Light Aircraft Pilot's Licence	
Commander's Age:	69 years	
Commander's Flying Experience:	632 hours (of which 235 were on type) Last 90 days - 10 hours Last 28 days - 5 hours	
Information Source:	AAIB Field investigation

The aircraft landed heavily when the pilot's prosthetic adapter disconnected from the control column late in the approach. The pilot was unhurt.

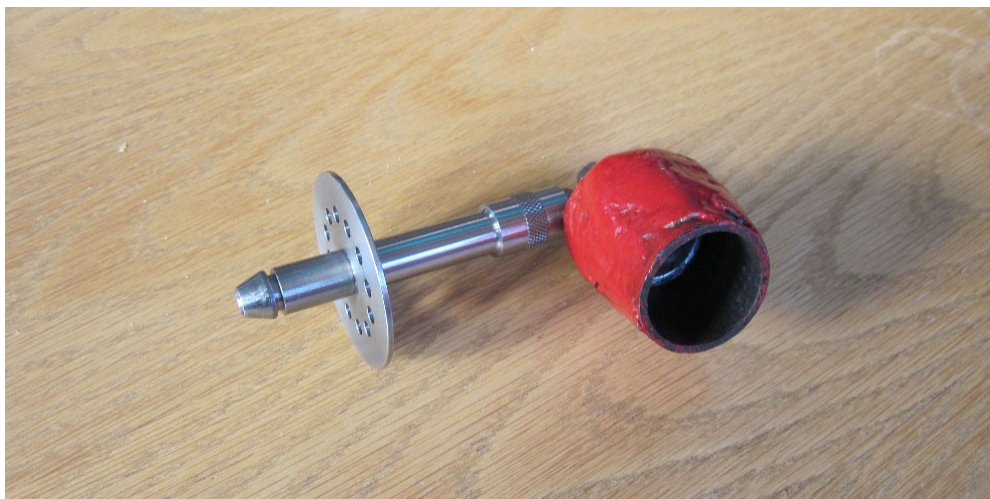
Figure 2
Prosthetic Attachment

The prosthetic adapter was made from a length of carbon fibre/epoxy high strength precision tube, the inner diameter of which provided an interference push-fit on the control column with the handgrip removed. The tube had a high tensile 1/4" bolt with a steel washer bonded into it, attached to an aviation rose joint which threaded into a standard artificial arm wrist rotary adapter.

The pilot had drawn upon his experience as a doctor in prosthetic rehabilitation and as a pilot to fabricate the bespoke prosthetic adapter. His approach was to modify the person rather than the aircraft, developing an adapter that would enable him to fly other aircraft of the same type. He aimed to make detachment from the control column simple and intuitive for others, such as rescue personnel, in an emergency. While there was no regulatory engineering assessment of the prosthetic adapter and its interface with the aircraft controls, the pilot had informal discussions with an LAA Inspector. The pilot also assessed the force to disconnect the adapter from the control column exceeded that required to detach the standard hand grip.

The pilot met the requirements for medical fitness to fly, but there was no engineering assessment by a suitably qualified individual of the interface between the prosthesis and the aircraft controls. The lack of a secondary device securing the prosthetic adapter to the control column meant that its security was solely reliant upon the interference fit.
