Construction noise and vibration Monthly Report – July 2020

London Borough of Camden

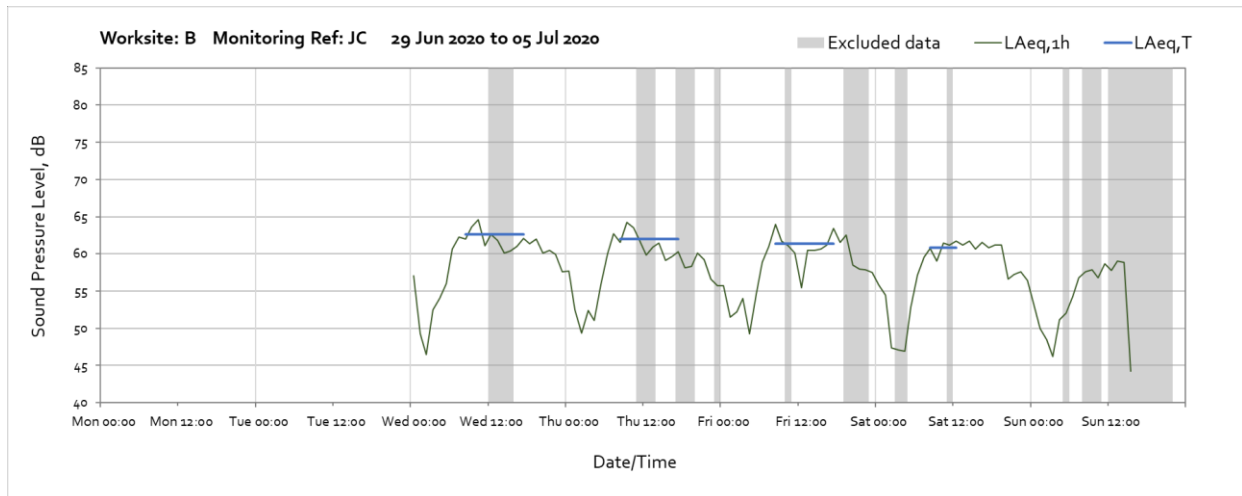
Worksite: B – Monitoring Ref: JC

Note: Missing data between 16:00 on Sunday 5th July and 00:00 Monday 13th July was due to loss of power at the monitoring station.

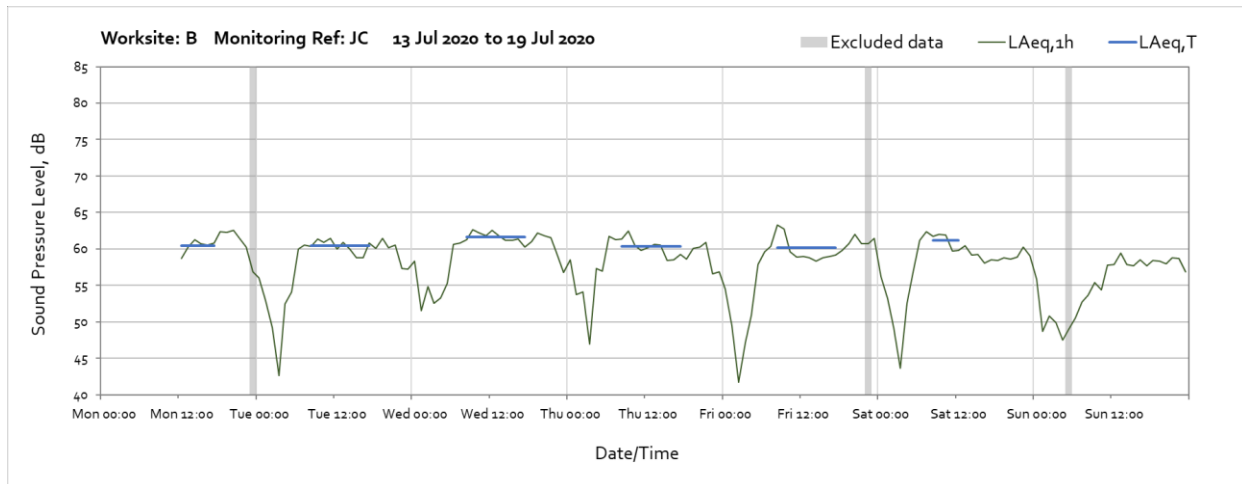
Note: Missing data between 00:00 on Sunday 5th July and 12:00 Monday 13th July was due to loss of power at the monitoring station.

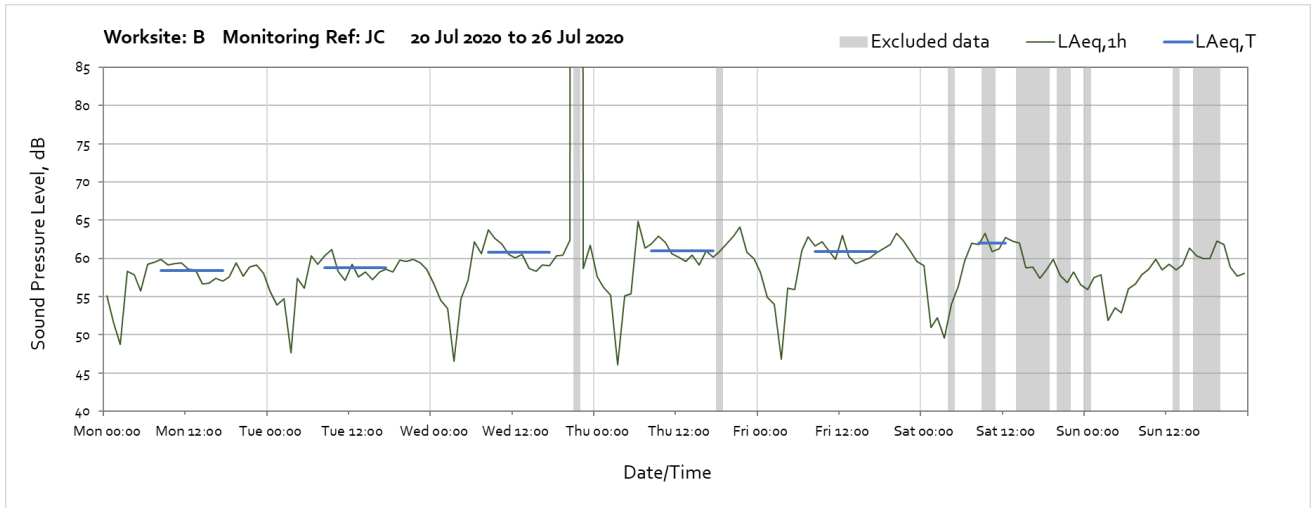
Note: Period between 21:00 and 22:00 on Wednesday 22nd was due excluded due to a meter malfunction causing a erroneous data log (98.2dB LAeq,1hr).

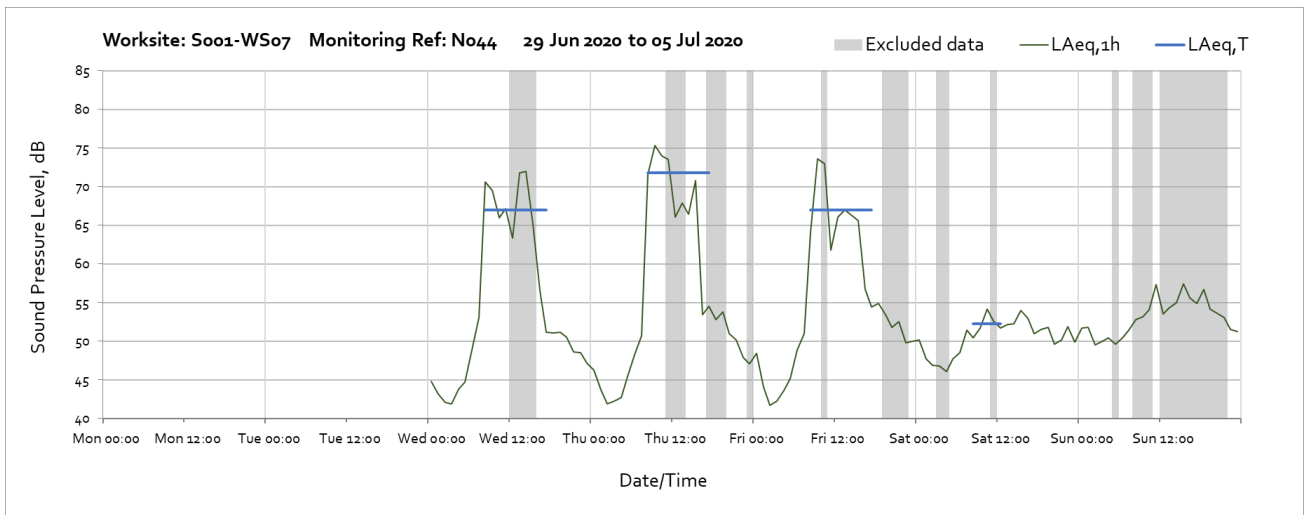
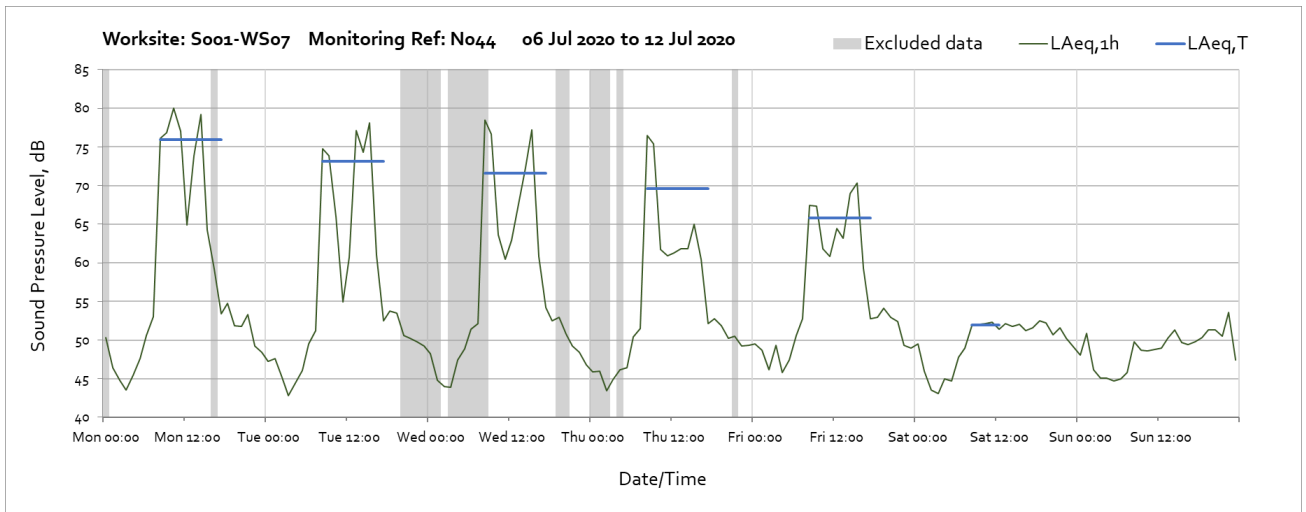
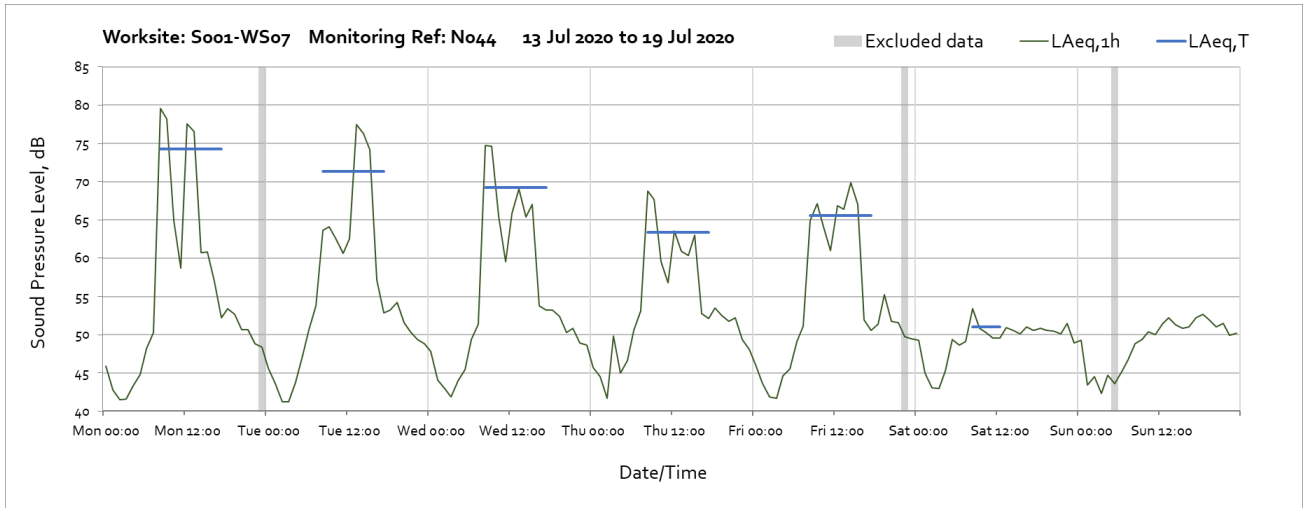
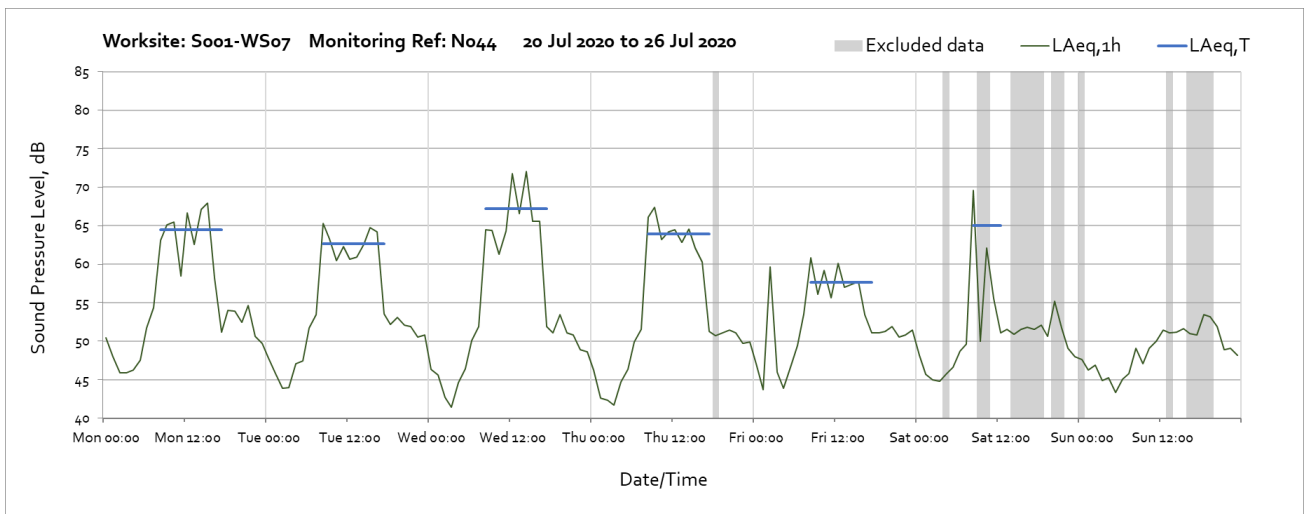
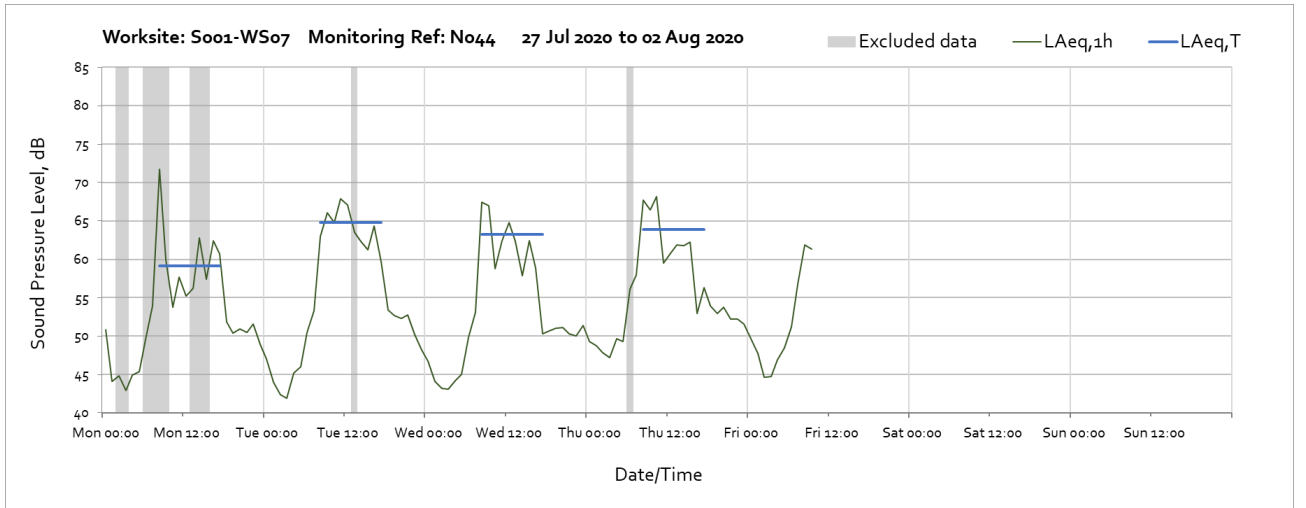
Worksite: S001-WS07 – Monitoring Ref: N044

Note: Missing data between 10:00 on Sunday 31st July and 00:00 on Monday 1st August was due to the removal of the noise monitor to allow hoarding works to take place. Installation of a temporary replacement monitor will follow at a later date due to ongoing works in the area.

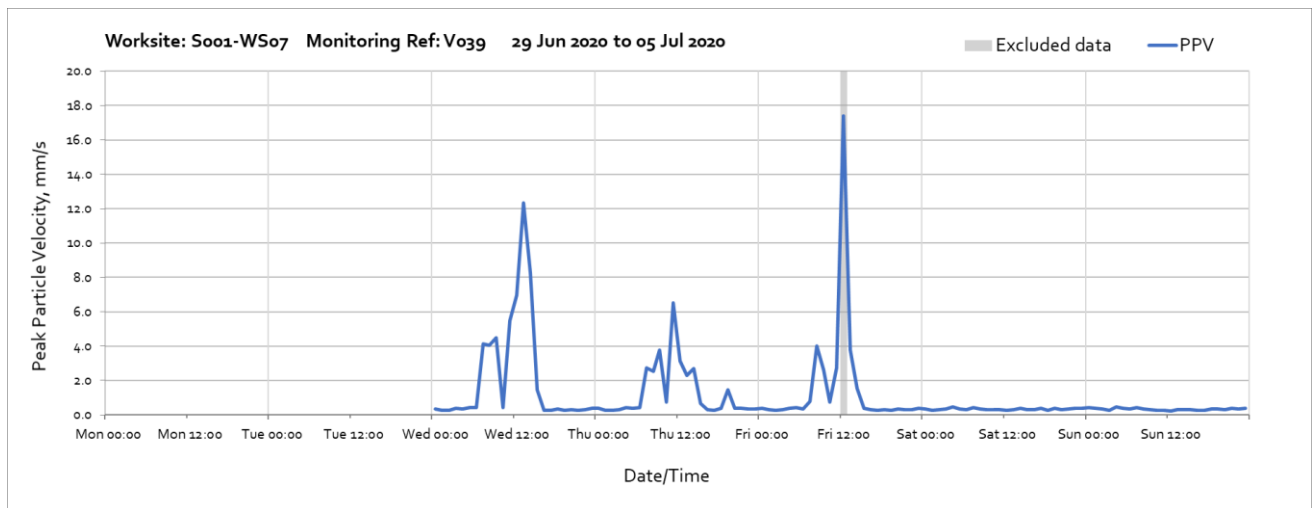
Worksite: S001-WS07 – Monitoring Ref: V039

Note: High vibration levels measured between 12:00 and 13:00 on Friday 3rd July were due to local disturbance of the monitor and are not representative of HS2 vibration levels.

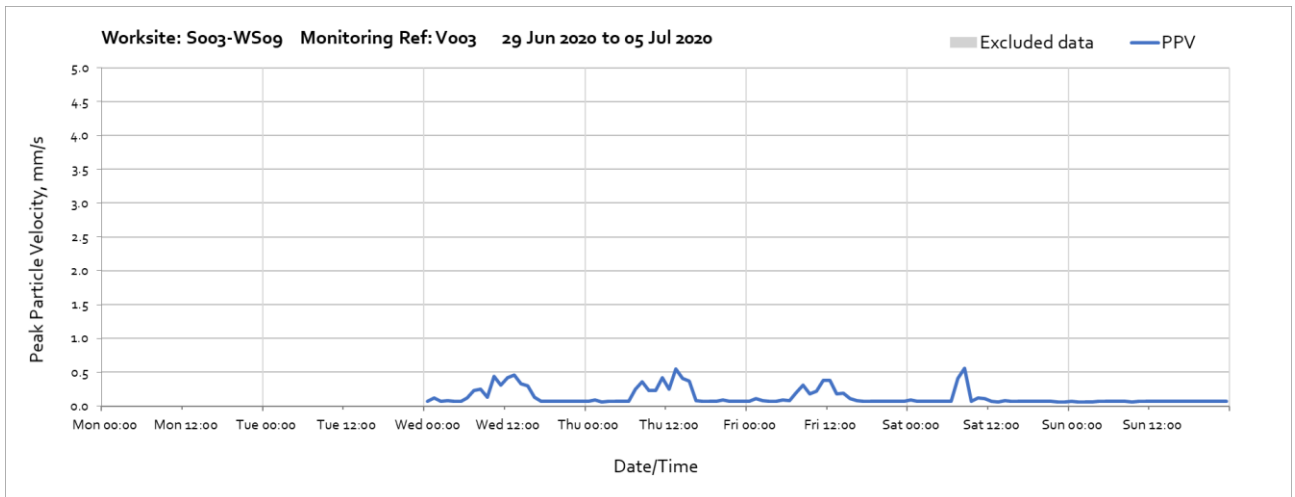
Worksite: S003-WS09 – Monitoring Ref: V003

The following graphs show the hourly measured peak particle velocity PPV recorded during the monitoring period. The graphs show the resultant PPV due to vibration components on three orthogonal axis x, y and z. Where high values of PPV were caused by local interference with the vibration monitor, which are not representative of HS2 construction works, these values have been greyed out in the following charts and have been excluded to calculate values in Table 4 of the main report.
