Construction noise and vibration Monthly Report – September 2020

London Borough of Camden

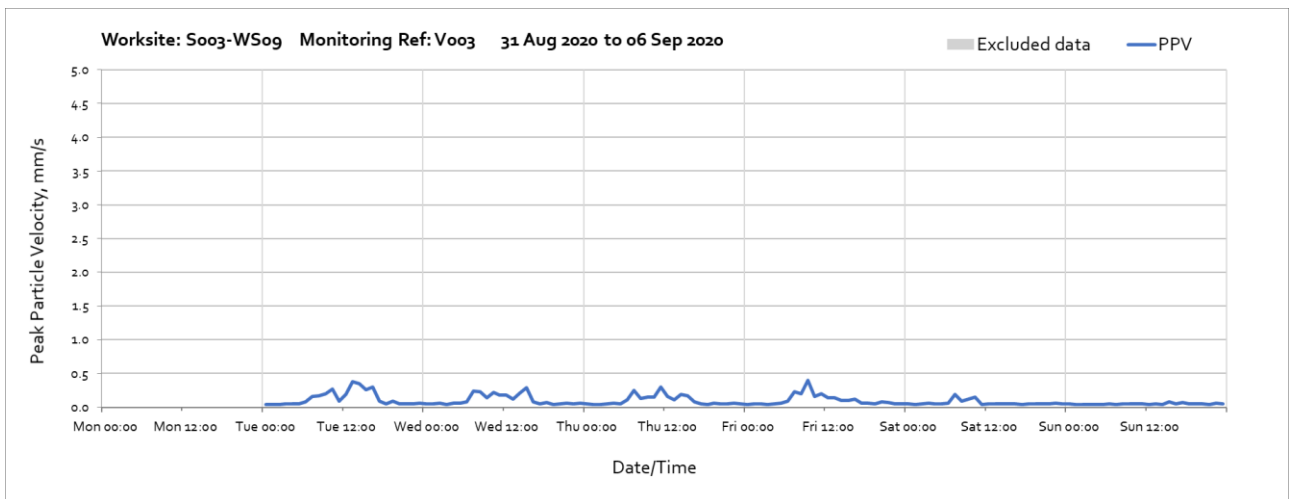
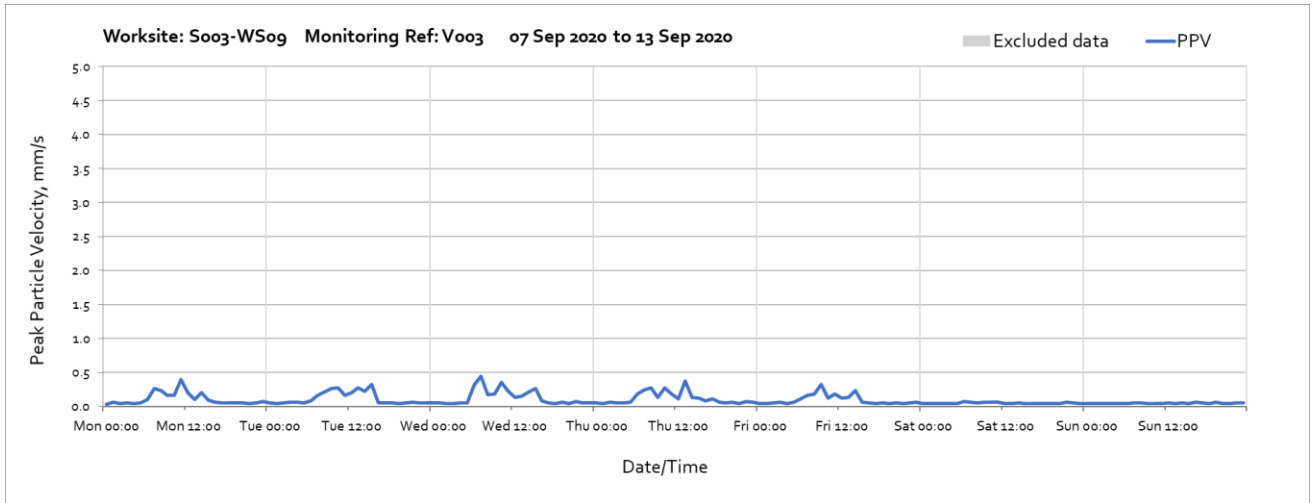
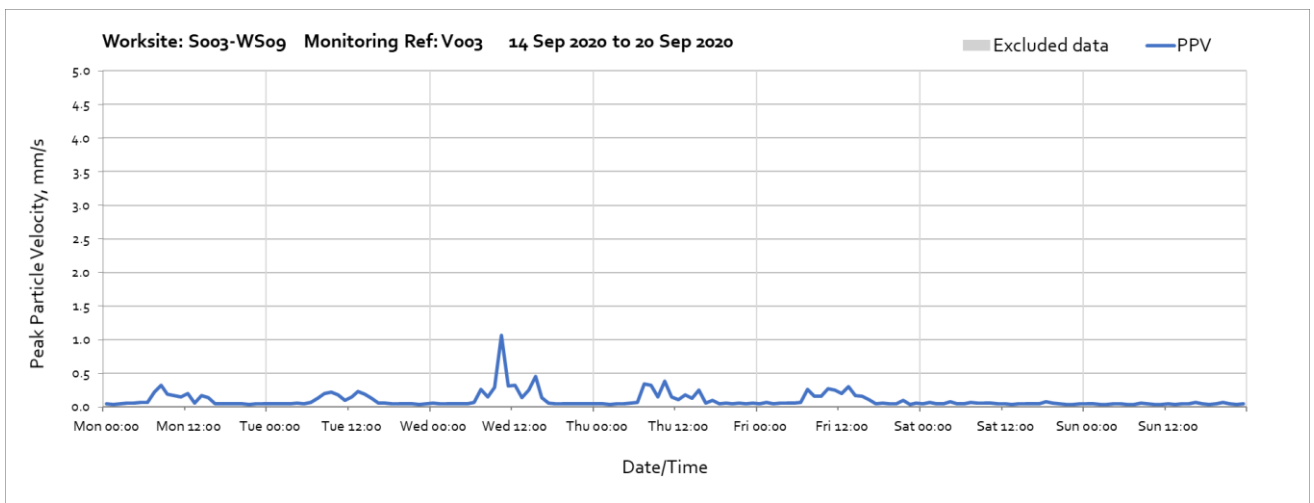
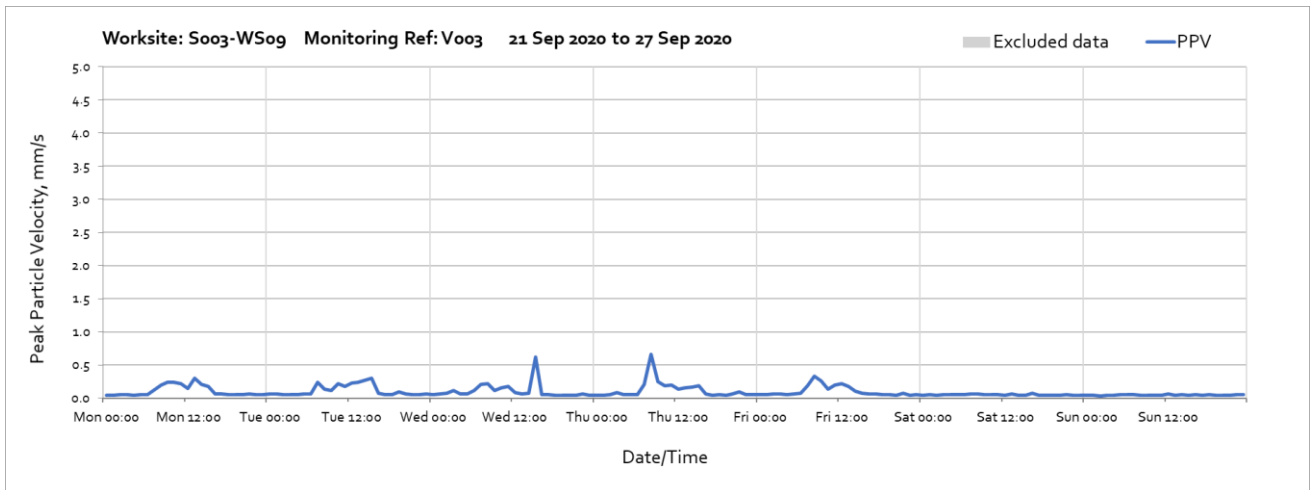
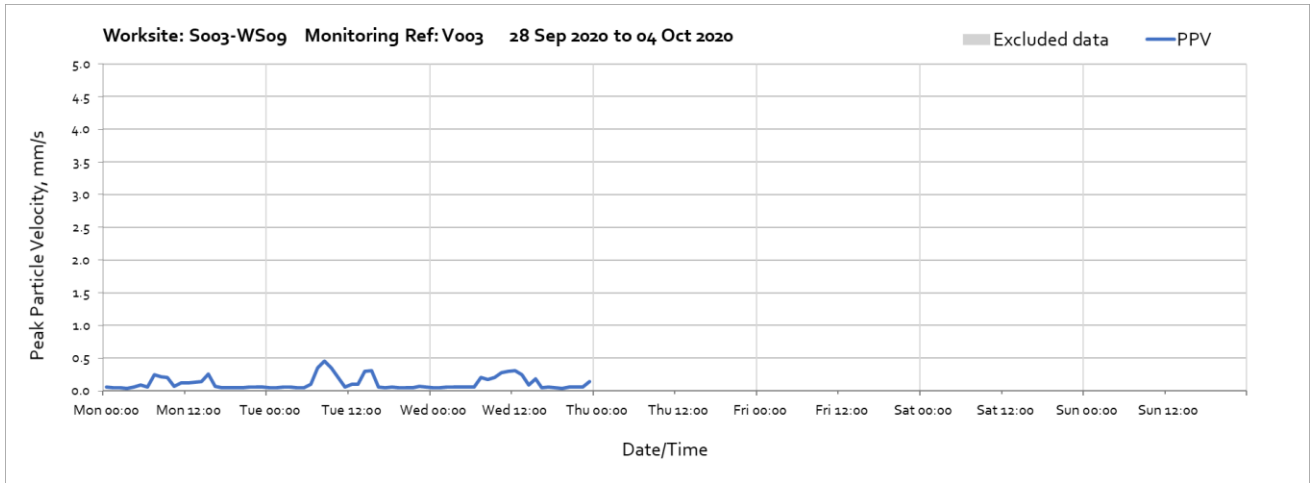
Worksite: S003-WS09 – Monitoring Ref: V003

The following graphs show the hourly measured peak particle velocity PPV recorded during the monitoring period. The graphs show the resultant PPV due to vibration components on three orthogonal axis x, y and z. Where high values of PPV were caused by local interference with the vibration monitor, which are not representative of HS2 construction works, these values have been greyed out in the following charts and have been excluded to calculate values in Table 4 of the main report.
