**Daedalus Waterfront Infrastructure  
Phase 1**

**Supplementary Land Quality Statement  
and Outline Remediation Strategy**

September 2016

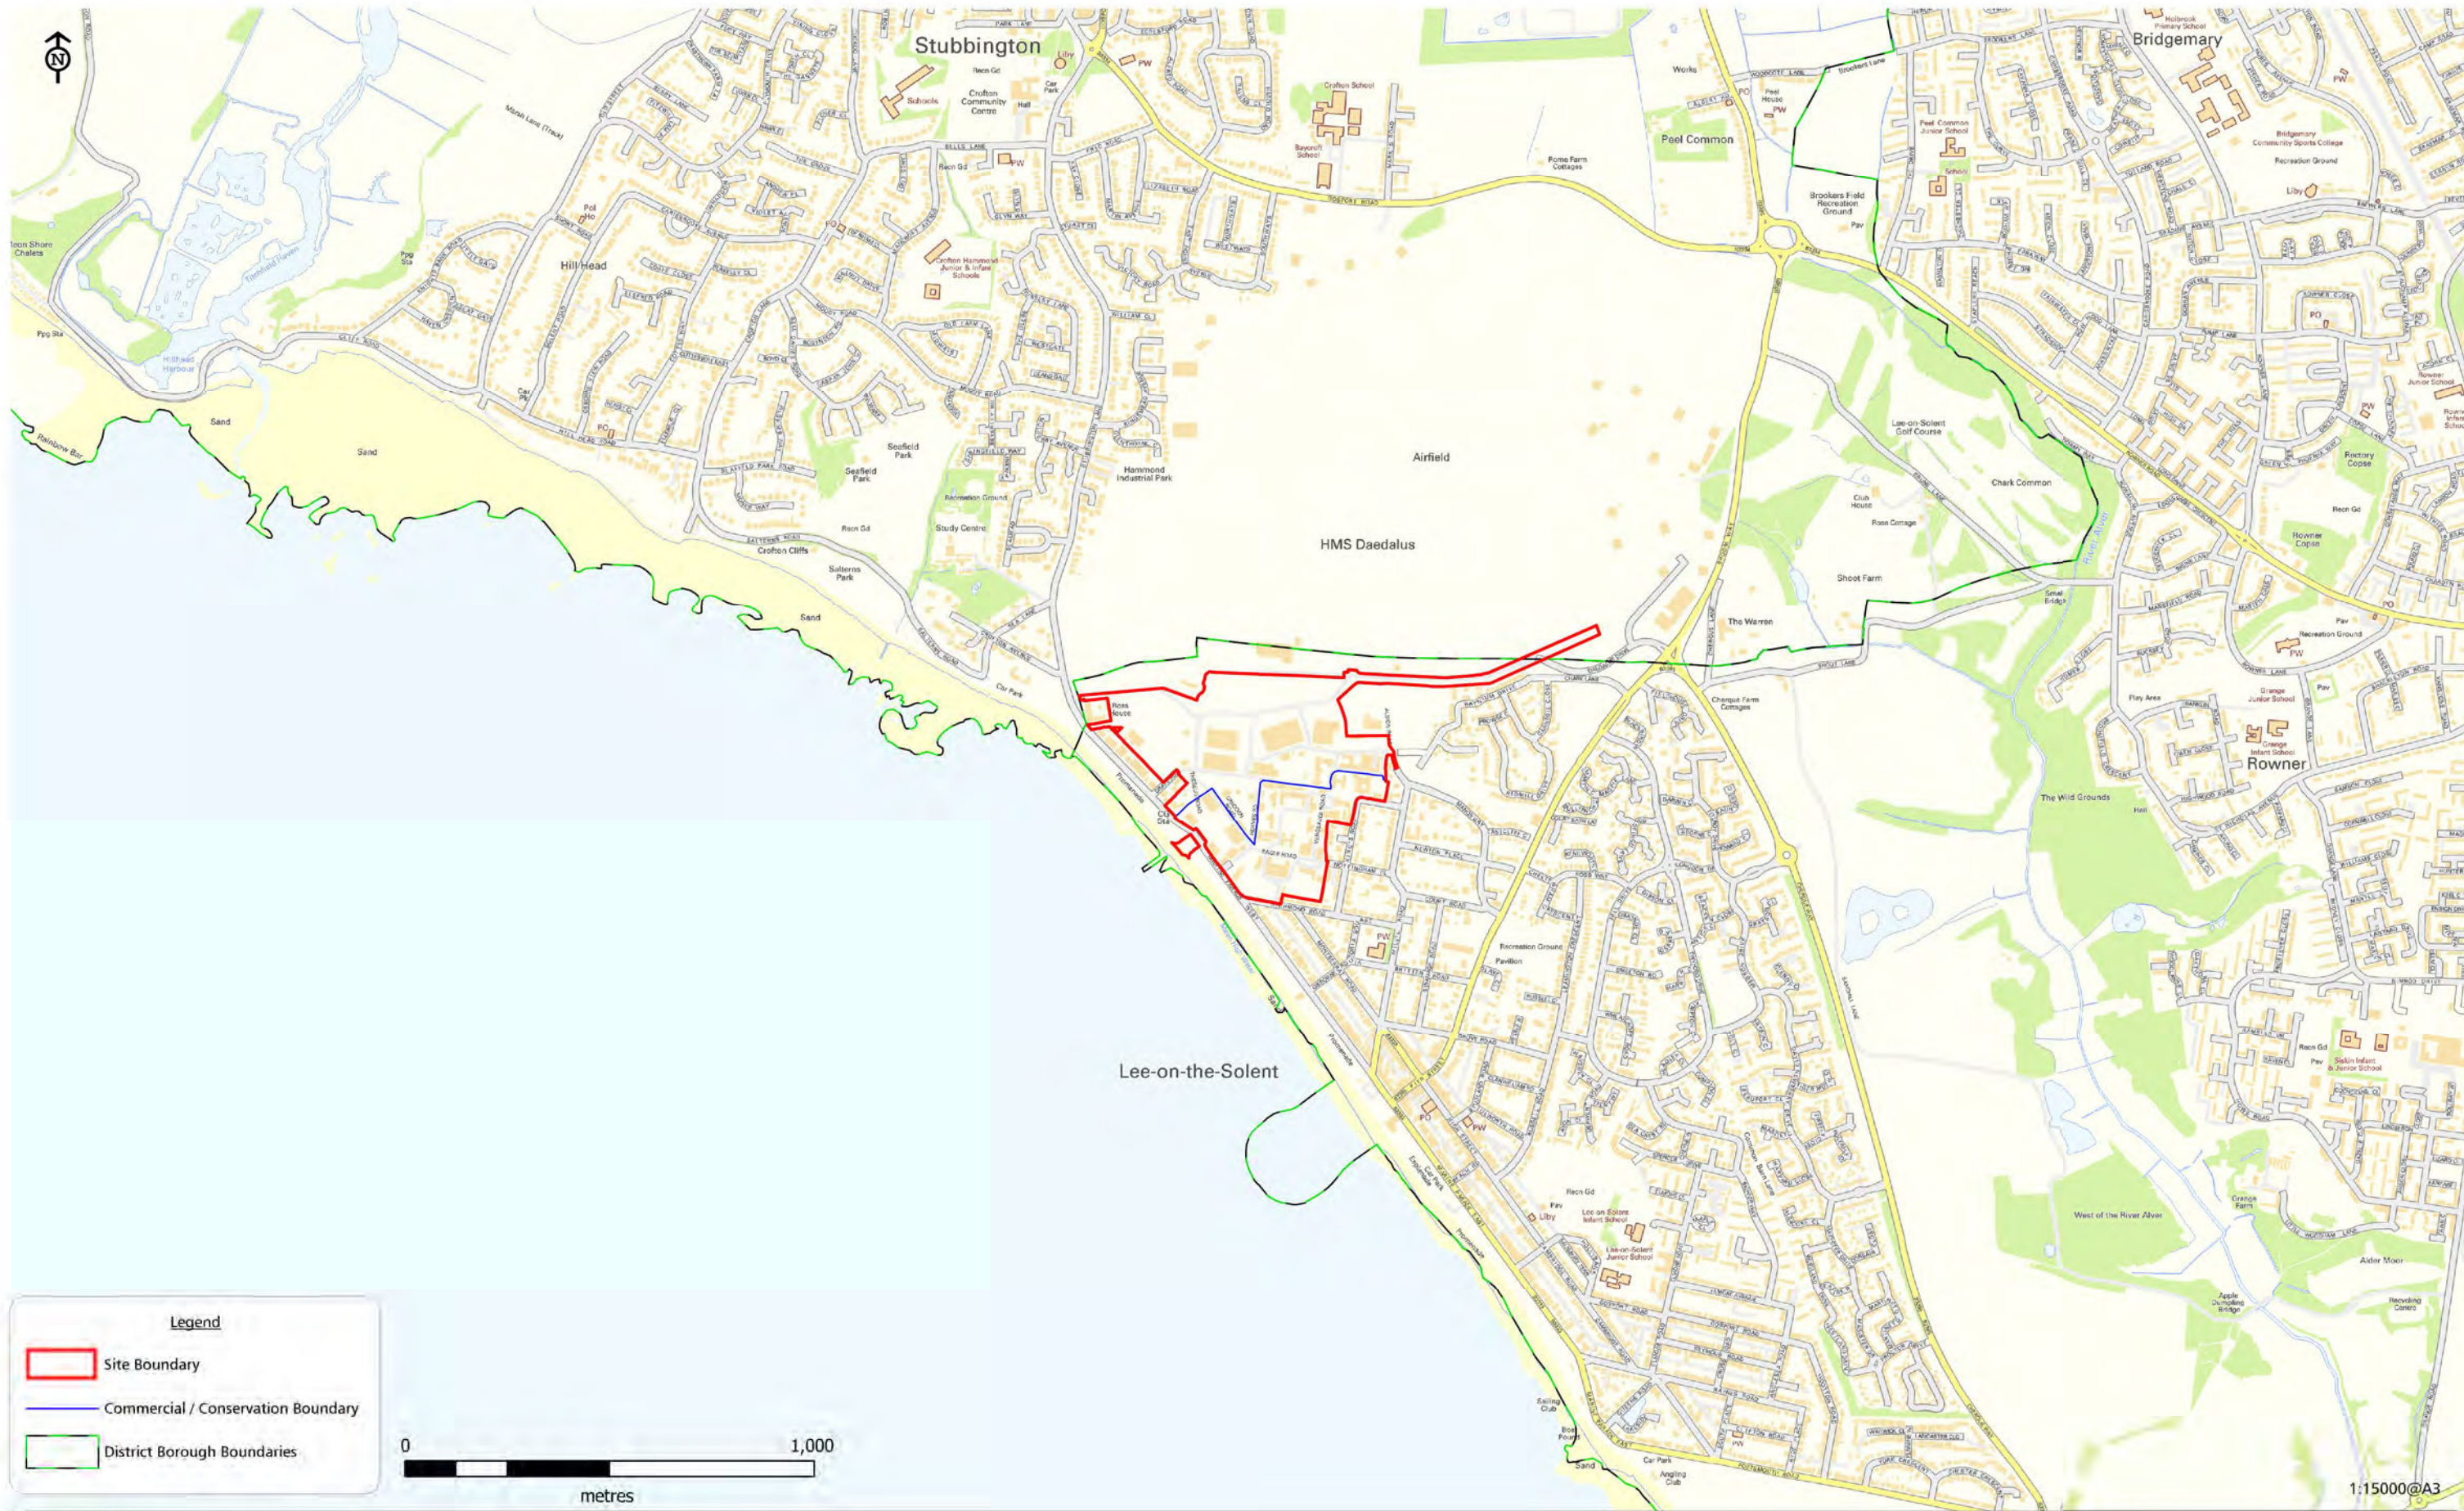
**Figure 2:**  
 Waterfront Infrastructure - Site Layout

2.3.1. Figures 1 and 2 show the site location and site layout. The works are focused on the northern part of the Waterfront Area, with the road alignment around the central commercial area, and two proposed residential areas to the east and west. Figure 2 refers to the residential areas to the west and east as Plots 1 and 2.

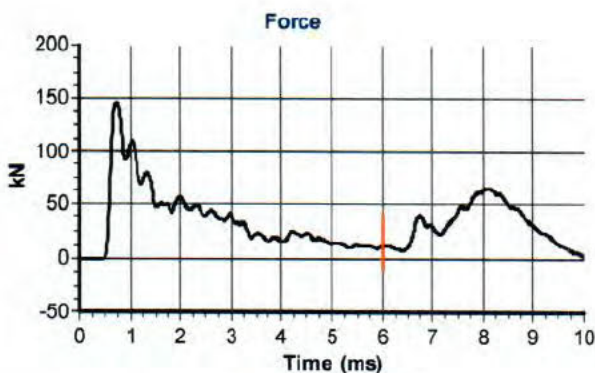
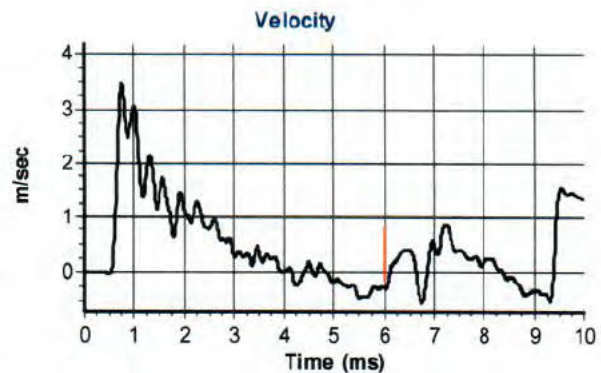
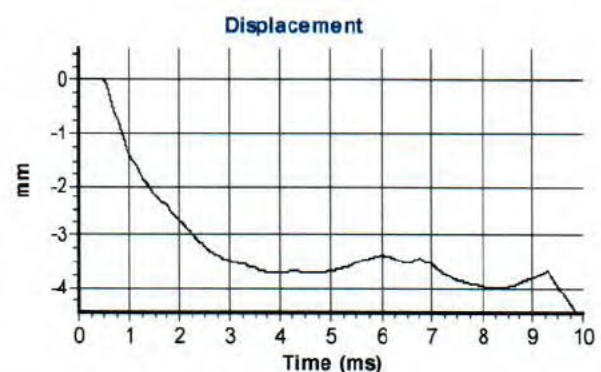
Area of Rod A (mm<sup>2</sup>): 905  
Theoretical Energy  $E_{theor}$  (J): 473  
Measured Energy  $E_{meas}$  (J): 360
