Working in refrigerated salt water tanks

Fatal enclosed space accident on board the fishing vessel Sunbeam (FR487)

at Fraserburgh, United Kingdom on 14 August 2018

MAIB SAFETY BULLETIN 4/2018

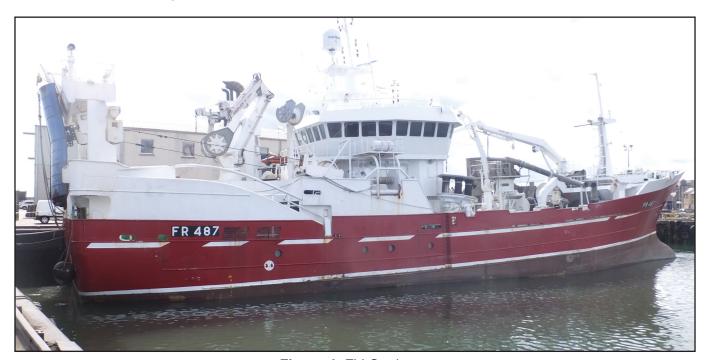
Figure 1: FV Sunbeam

Sunbeam (Figure 1) was a 56m UK registered pelagic trawler. Its home port was Fraserburgh, Scotland, and it was typically manned by a crew of eleven. In the weeks prior to the accident, it had been fishing for herring in the North Sea and landing its catch in Lerwick, Shetland. The vessel had nine refrigerated salt water (RSW) tanks for storing its catch.

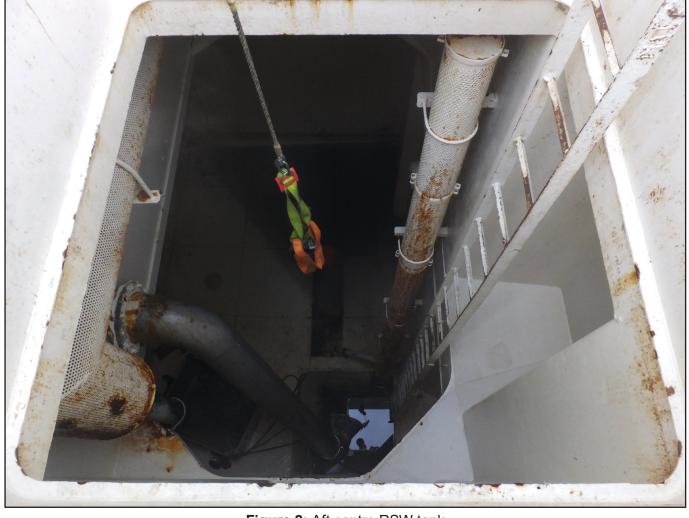
Figure 2: Aft centre RSW tank

At about 0900 on 14 August, *Sunbeam*'s crew arrived at the vessel's berth ready to begin work. The vessel's refrigeration plant had been shut down after landing the final catch at Lerwick, and its RSW tanks had been pumped out and tank lids opened in preparation for deep cleaning. At some time between 1200 and 1350, *Sunbeam*'s second engineer entered the aft centre RSW tank (**Figure 2**) and collapsed.

It is unclear when and why the second engineer entered the tank. However, evidence indicated that his intention was to sweep the residual seawater that had settled at the aft end of the tank forward in to the tank's bilge well. No safety procedures for entering or working in RSW tanks had been completed before he entered the tank.

Tests of the atmosphere in the tank following the accident showed that the level of oxygen at the bottom was less than 6% (normal level should be 20.9%). Further tests of both the tank atmosphere and residual water samples showed the presence of Freon R22, the refrigerant gas used in the RSW tank's refrigeration plant.

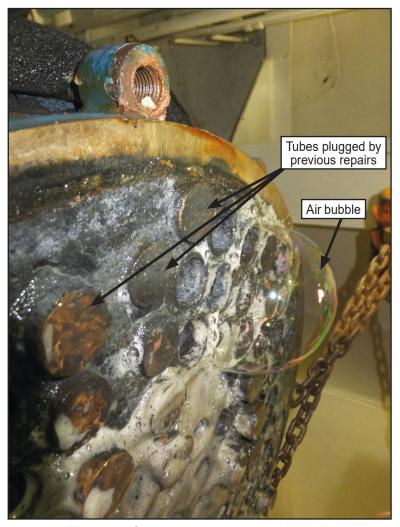
Figure 3: Starboard evaporator tube leak

The MAIB's initial investigation identified that the refrigeration plant sea water evaporators had suffered several tube failures resulting in a number of repairs (**Figure 3**). It is likely that the refrigerant leaked through one or more failed tubes into the seawater system, and was released into the RSW tank. Freon R22 is four times heavier than air so it will displace oxygen at the bottom of an enclosed space, such as an RSW tank. It is a toxic, tasteless and mostly odourless gas. If it is deeply inhaled, it can cut off vital oxygen to blood cells and lungs.

S2018/129 Conduct risk assessments specifically for entering and working in RSW tanks and provide safe operating procedures for its crew to follow and appropriate levels of safety equipment to use.
