HS2 Phase 1 Enabling Works- Central Section HERDS update to Heritage Sub Group

15 December 2020

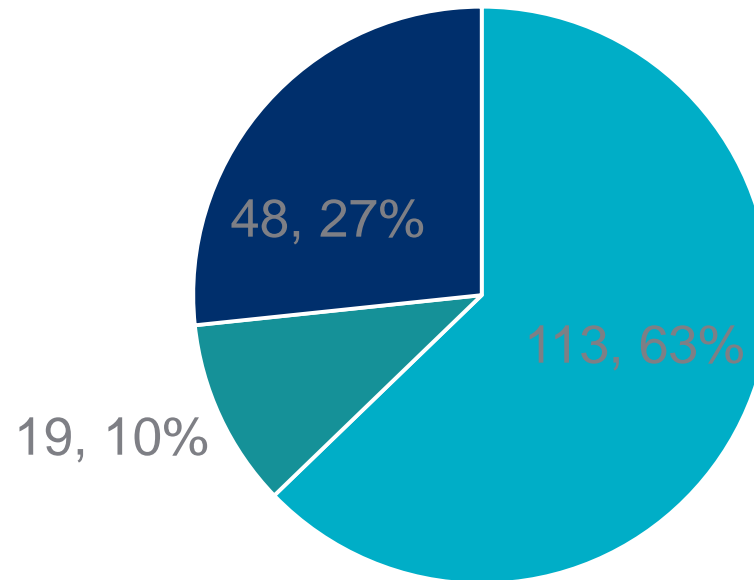
Intrusive surveys progress

- Design complete (180 evaluation site survey areas in total)
- 63% of scope complete
- 10% is in progress
- 27% mobilising for completion early 2021 (majority blank areas and handful of trench sites)

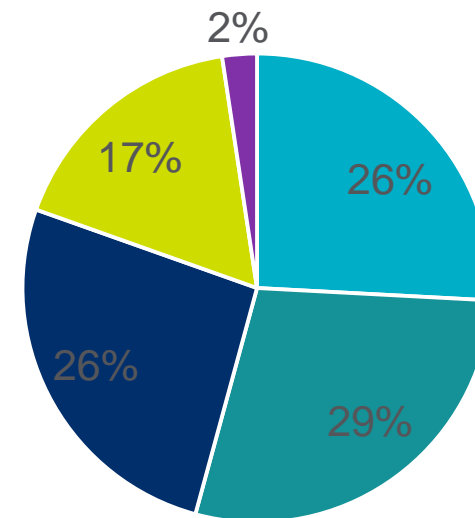
AWH Central AT03

- c16% of mitigation is now completed
- 30 locations are in progress
- 41 locations are designed and soon to mobilise
- 31 site areas are subject to completion of trenching and mitigation is not yet defined
- 1 site Illet's Farm descope by design
- Forecast total area (158ha) at 131 locations

Area ha	% split	Site Areas
Completed	25.25	15.93%	28
In Progress	27.74	17.50%	30
Premobilisation	25.59	16.15%	22
Procurement	16.79	10.59%	19
Descoped	2.33	1.47%	1
Design	60.78	38.35%	31
Total	158.48		131

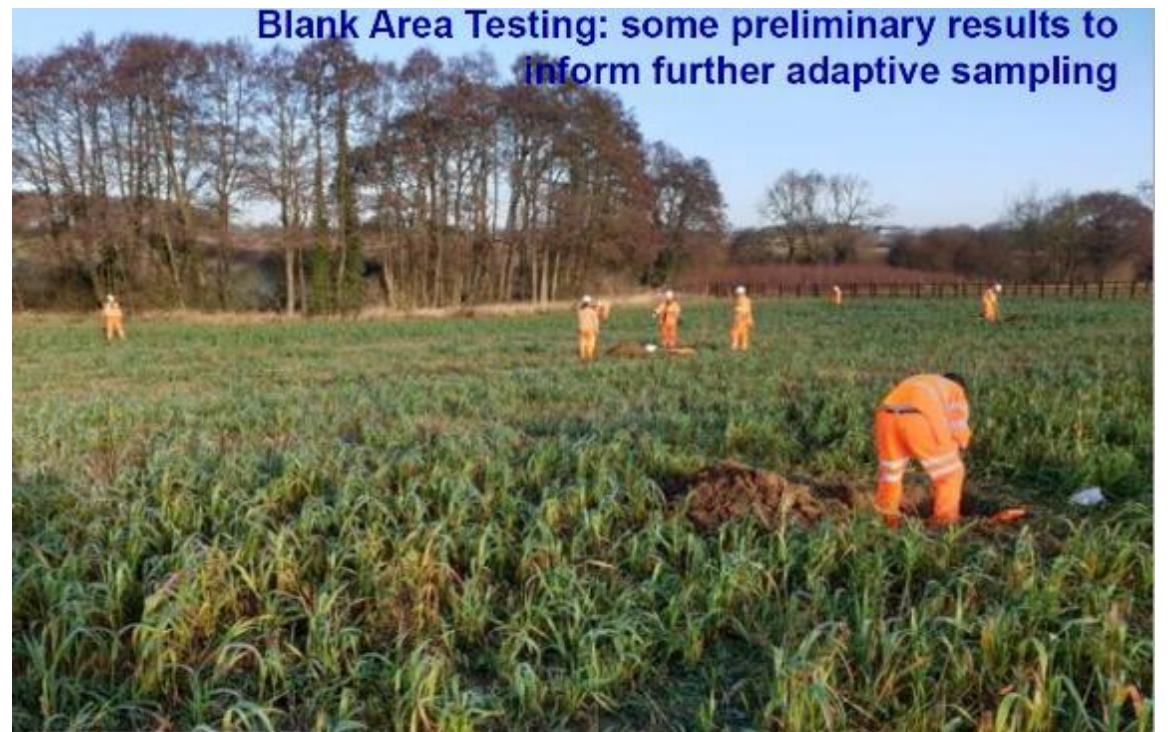
Density distribution of finds from test pits

Blank Area Testing: some preliminary results to inform further adaptive sampling

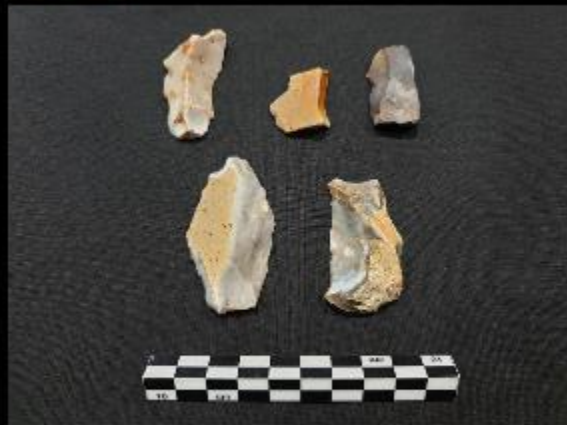
Field F21_0070

Retouched blades from Field F21_0070, the bottom row left piece might have been used as a spear point

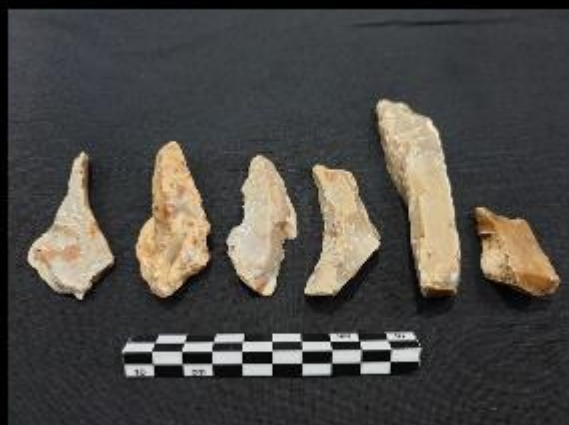
Selection of piercers from Field F21_0070 (points to the top)

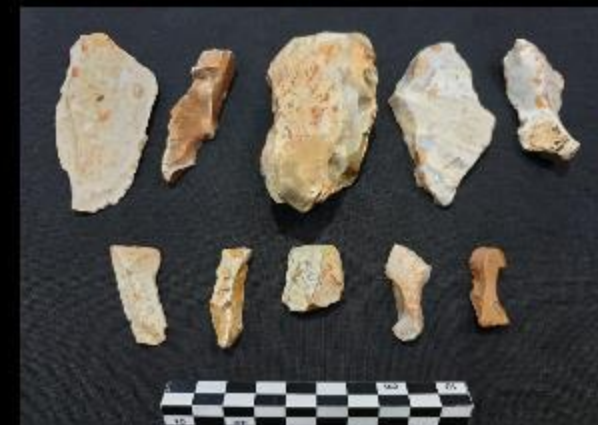
Field F21_0070

Flint scrapers from Field F21_0070: top row large scrapers, bottom row small scrapers. Left hand end of both rows Late Upper Palaeolithic material, right hand side likely Early Mesolithic.

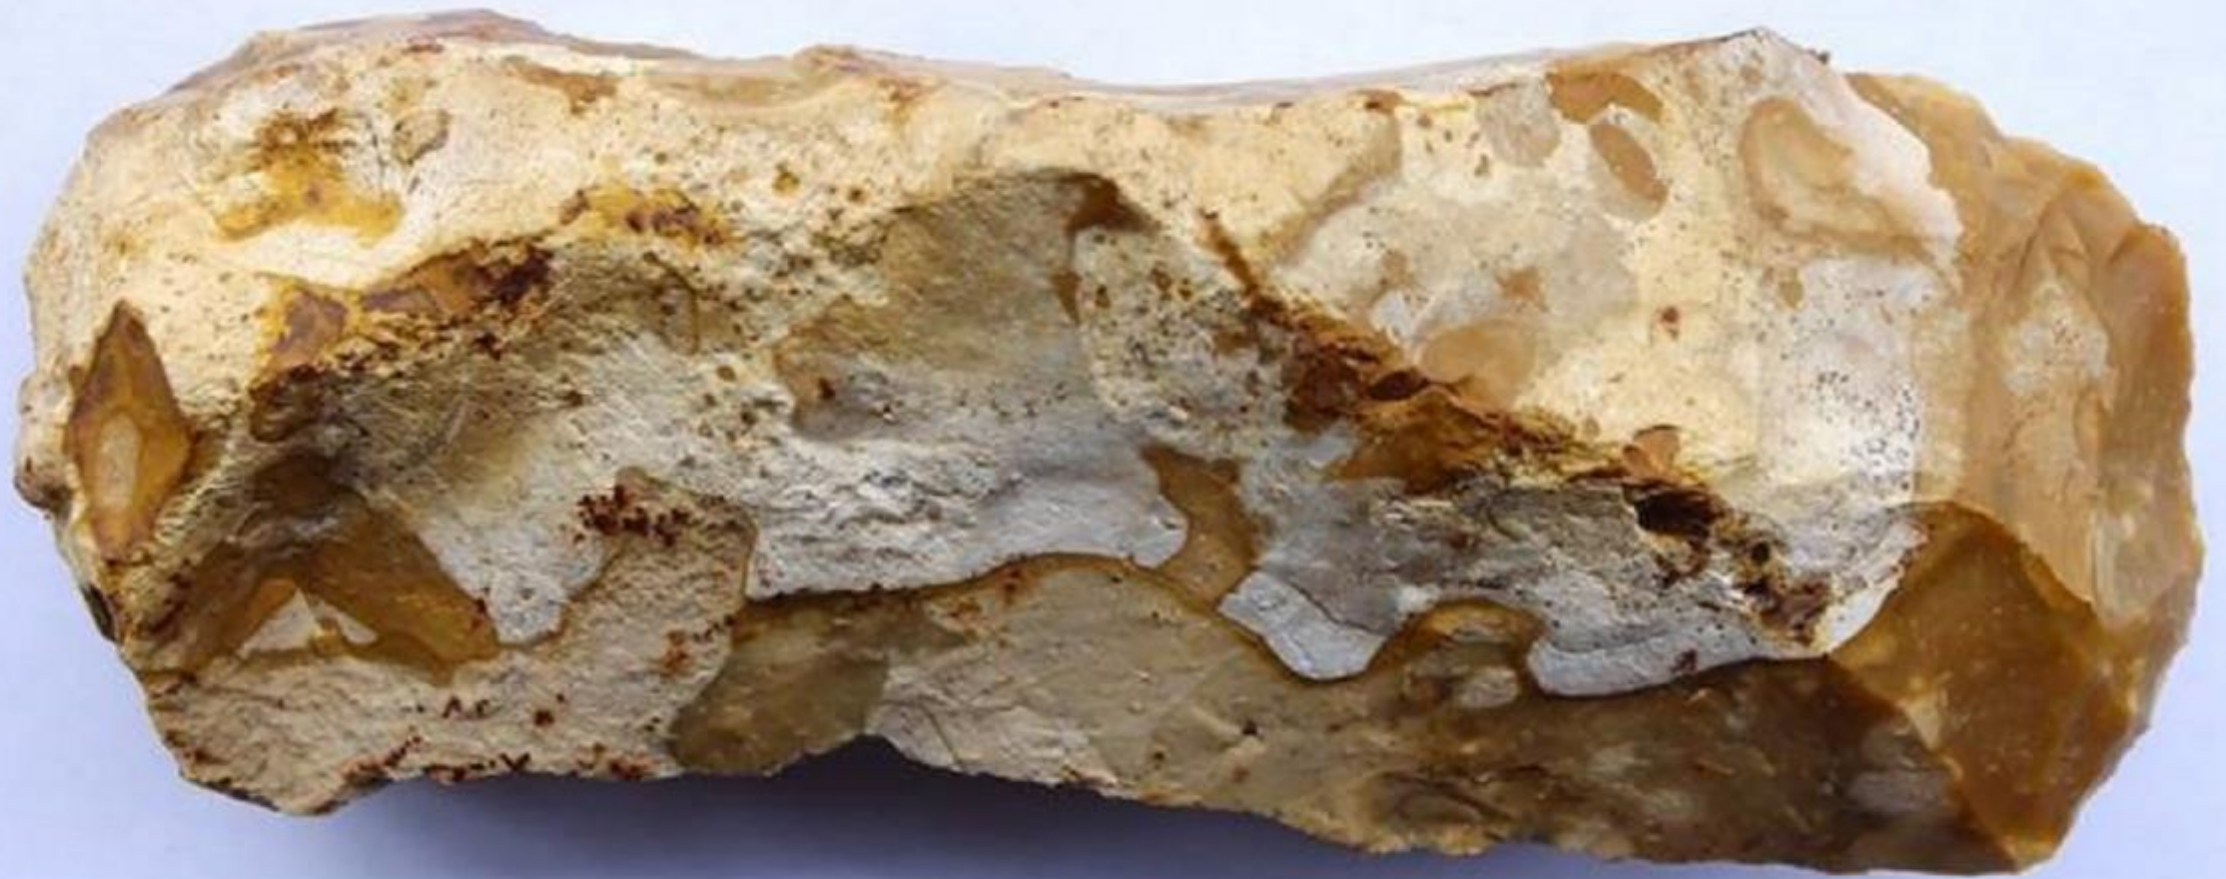
Lower Radbourne, Mesolithic axehead roughout from F28_009

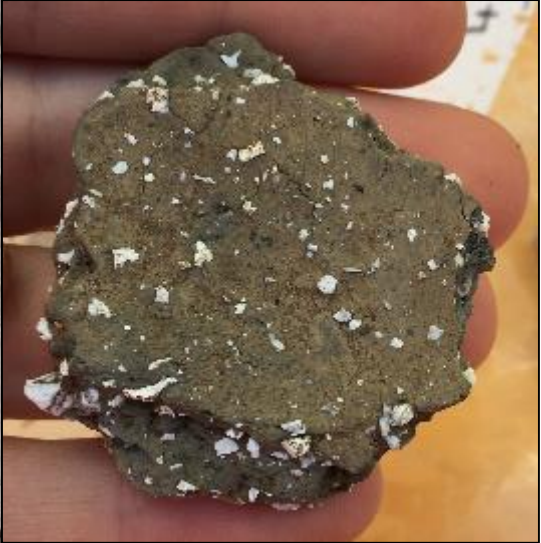
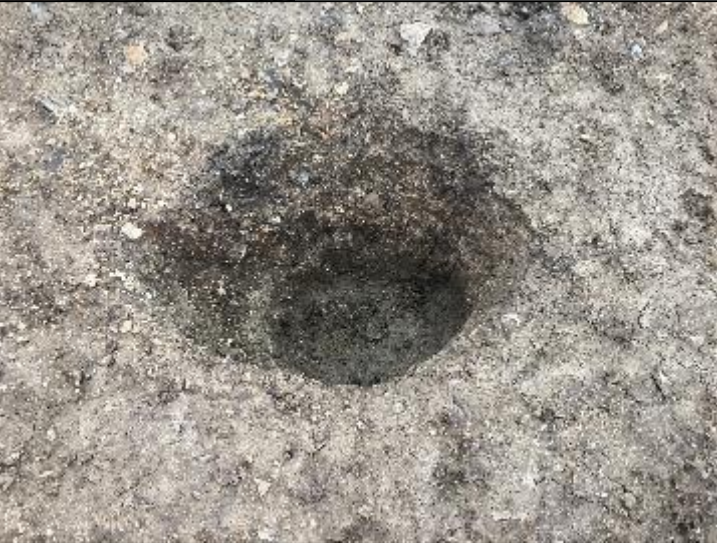
Above : Mid BA pottery
Below : entrance post-slot

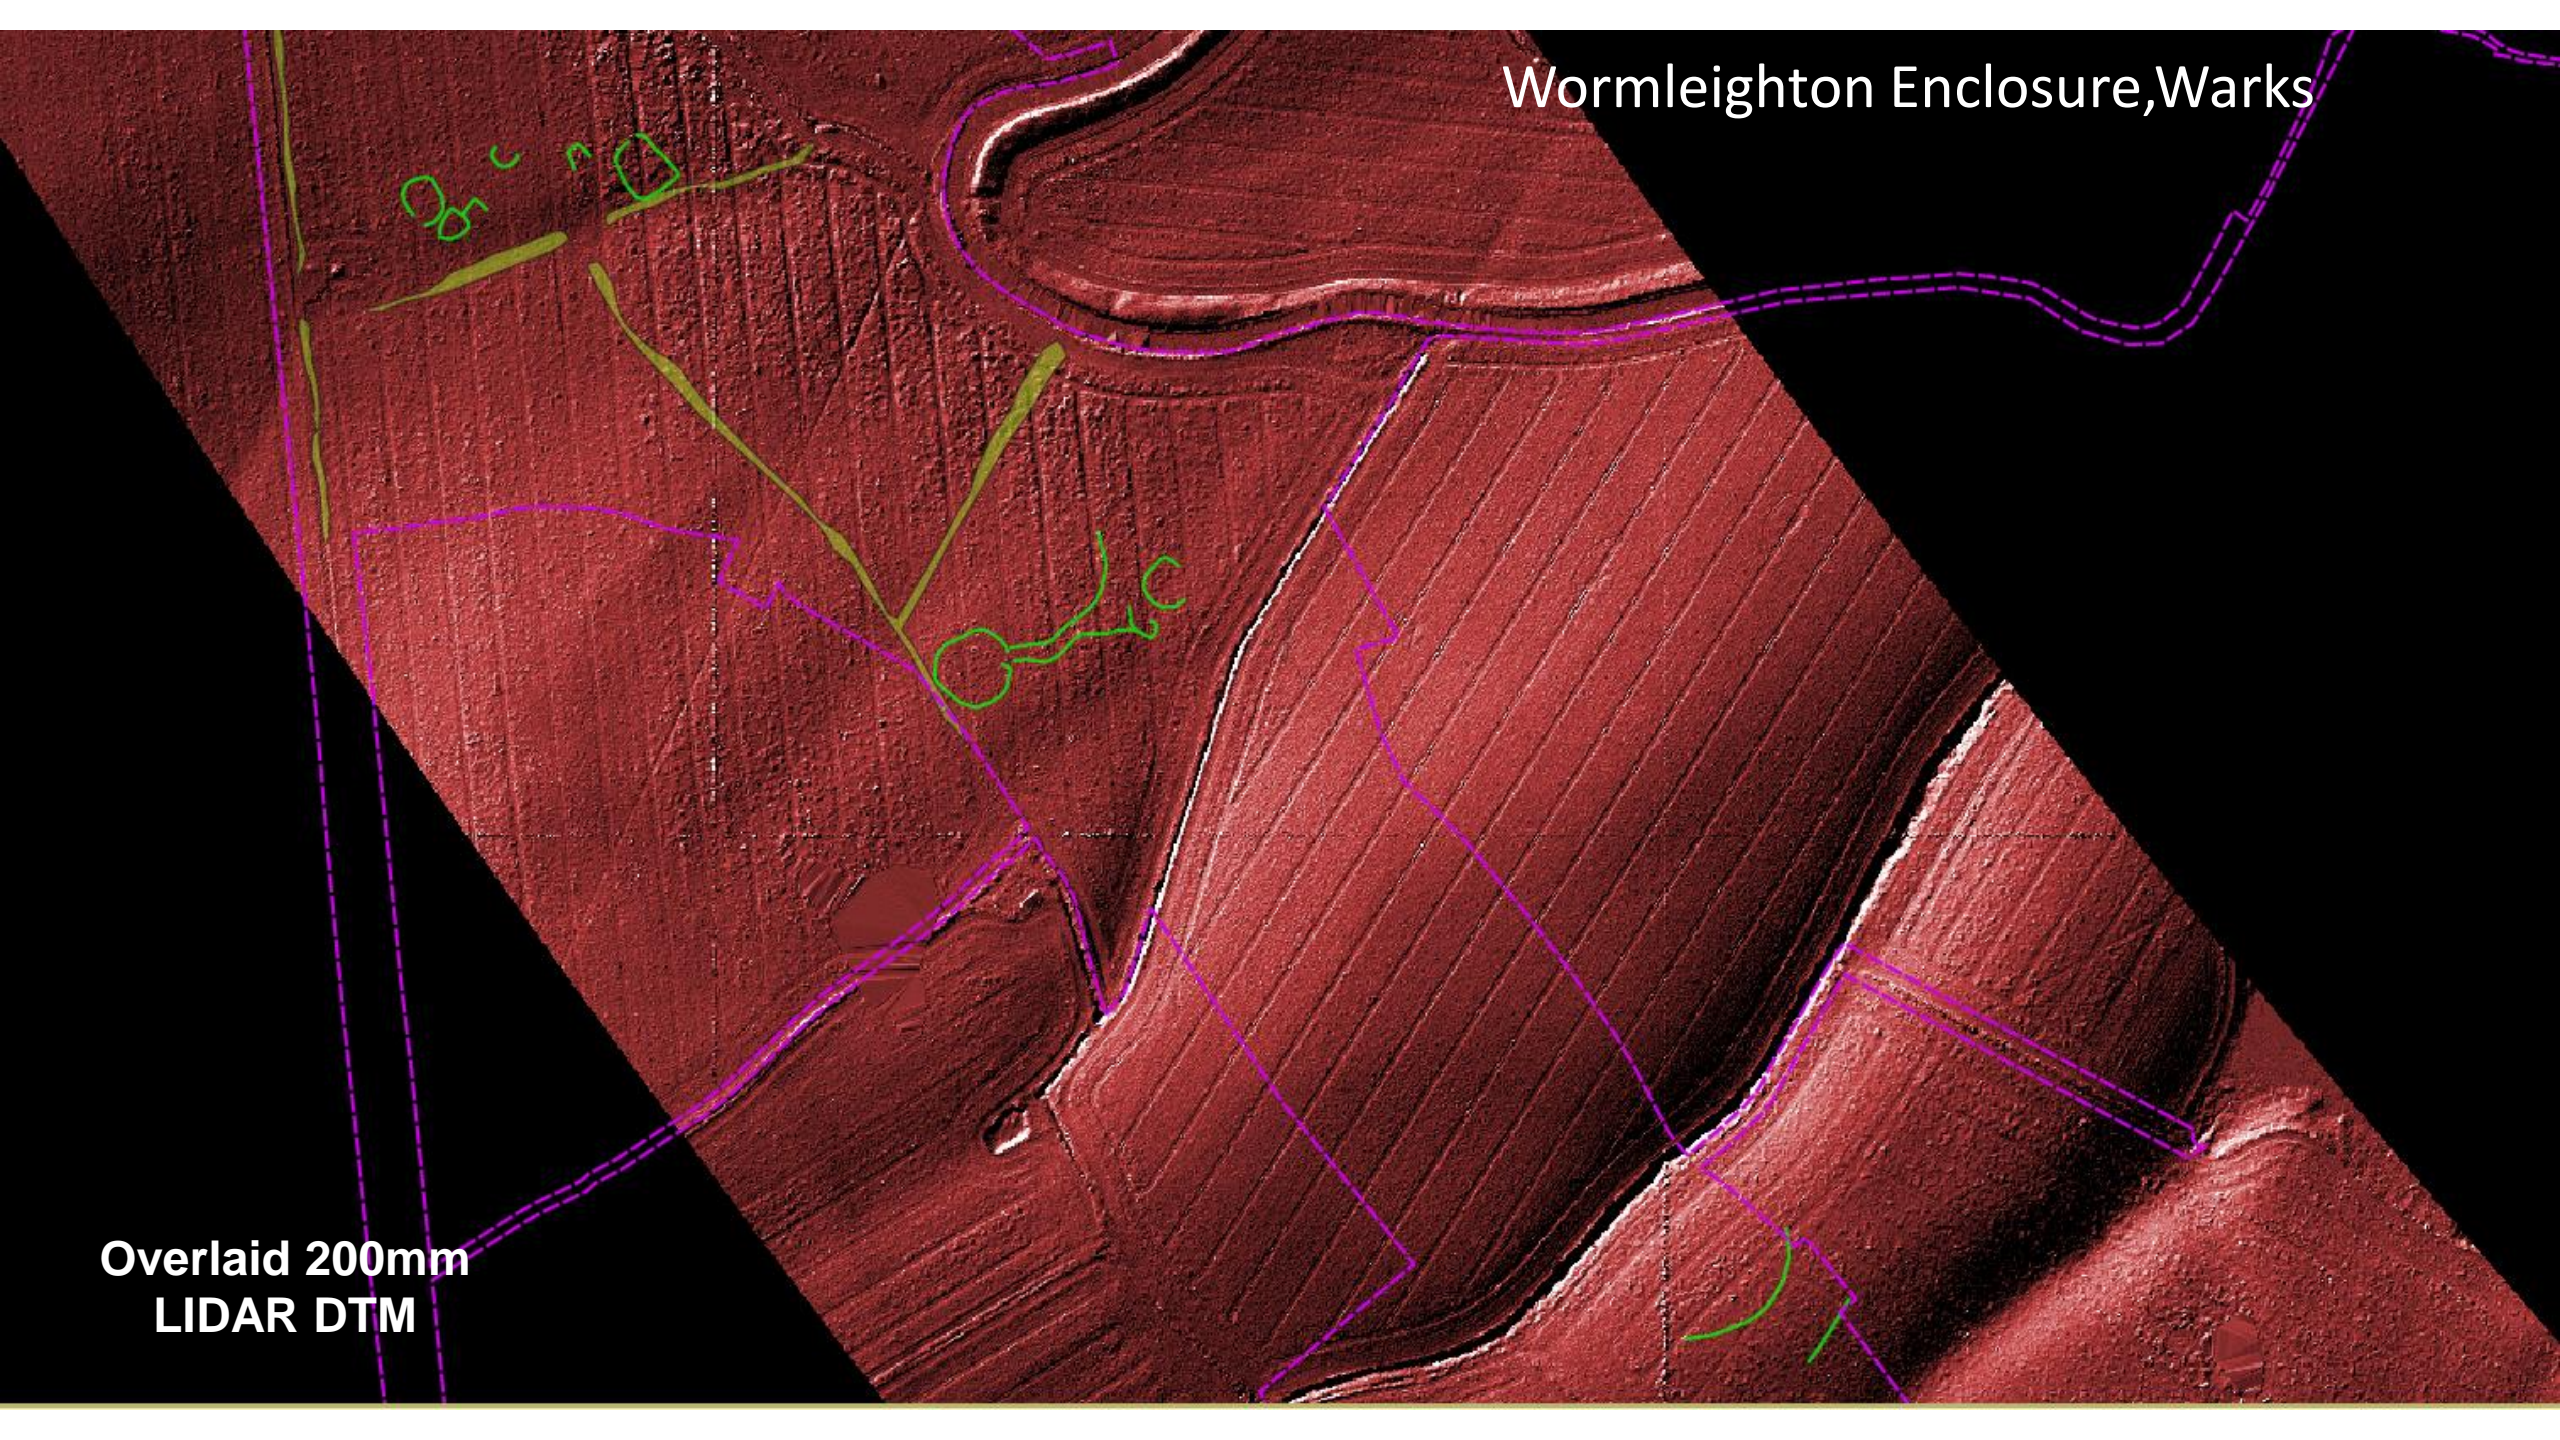
Wormleighton Enclosure, Warks

Overlaid 200mm
LIDAR DTM

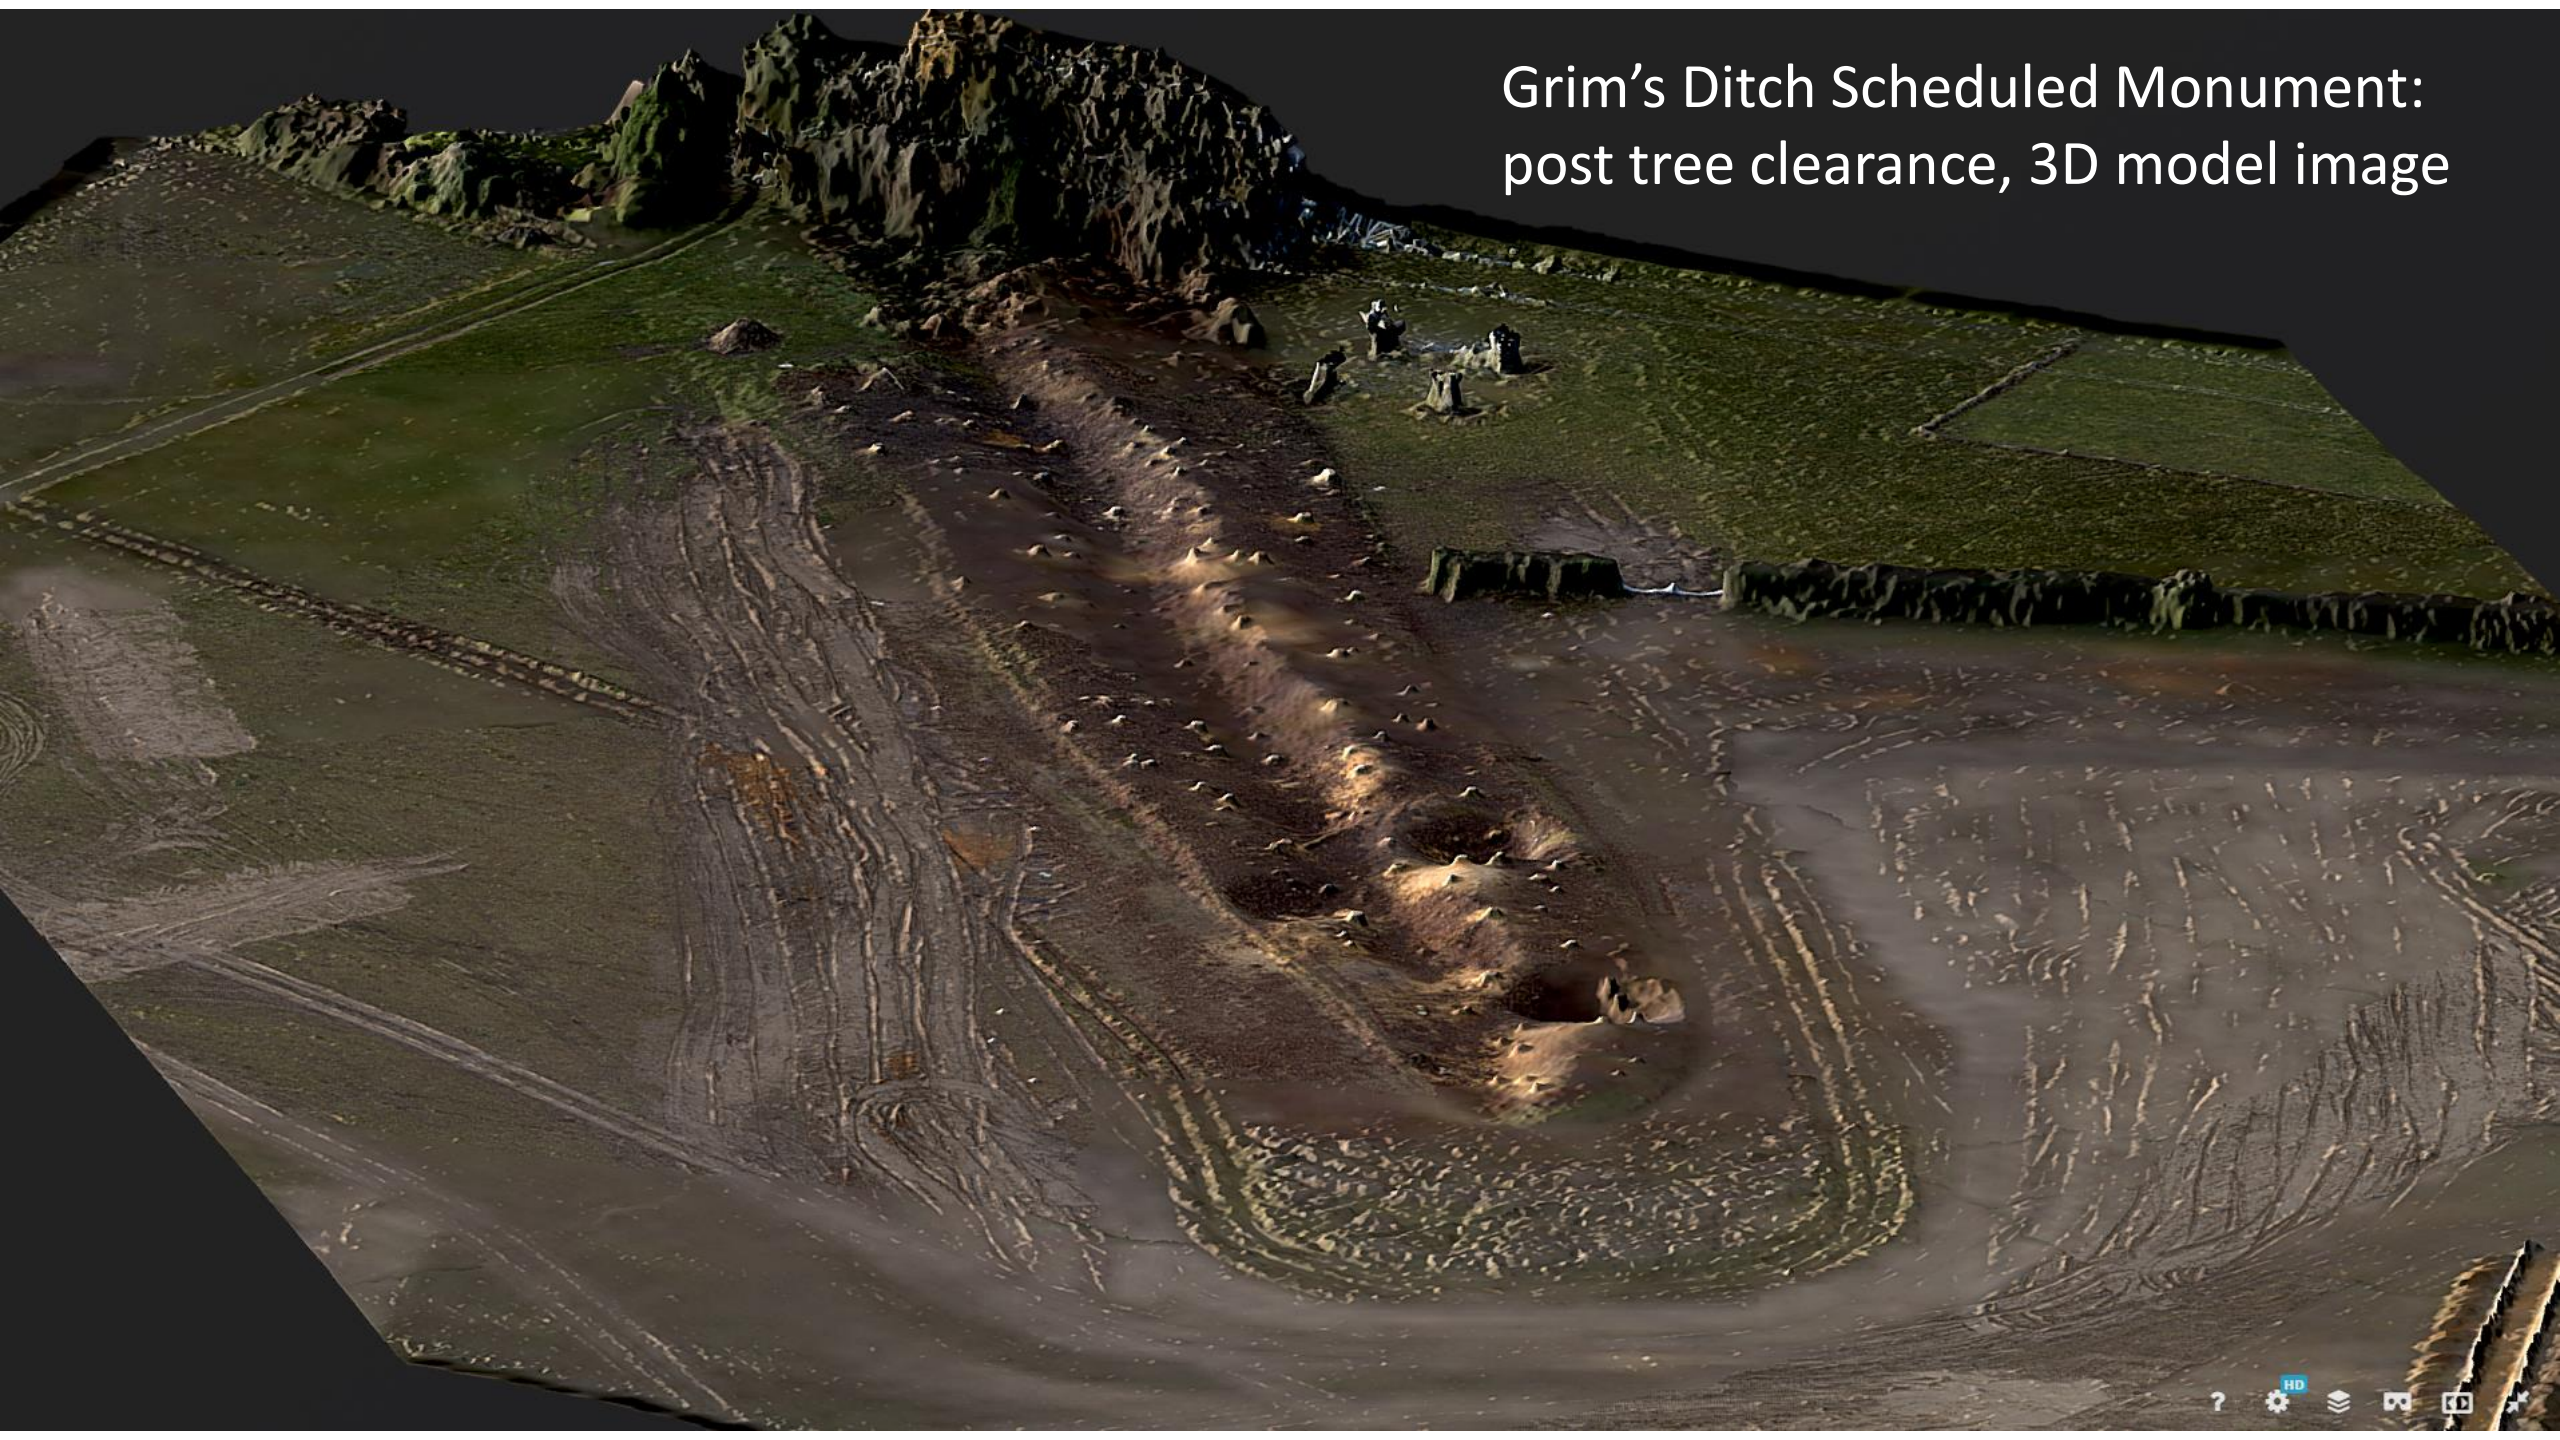
Grim's Ditch Scheduled Monument:
post tree clearance, 3D model image

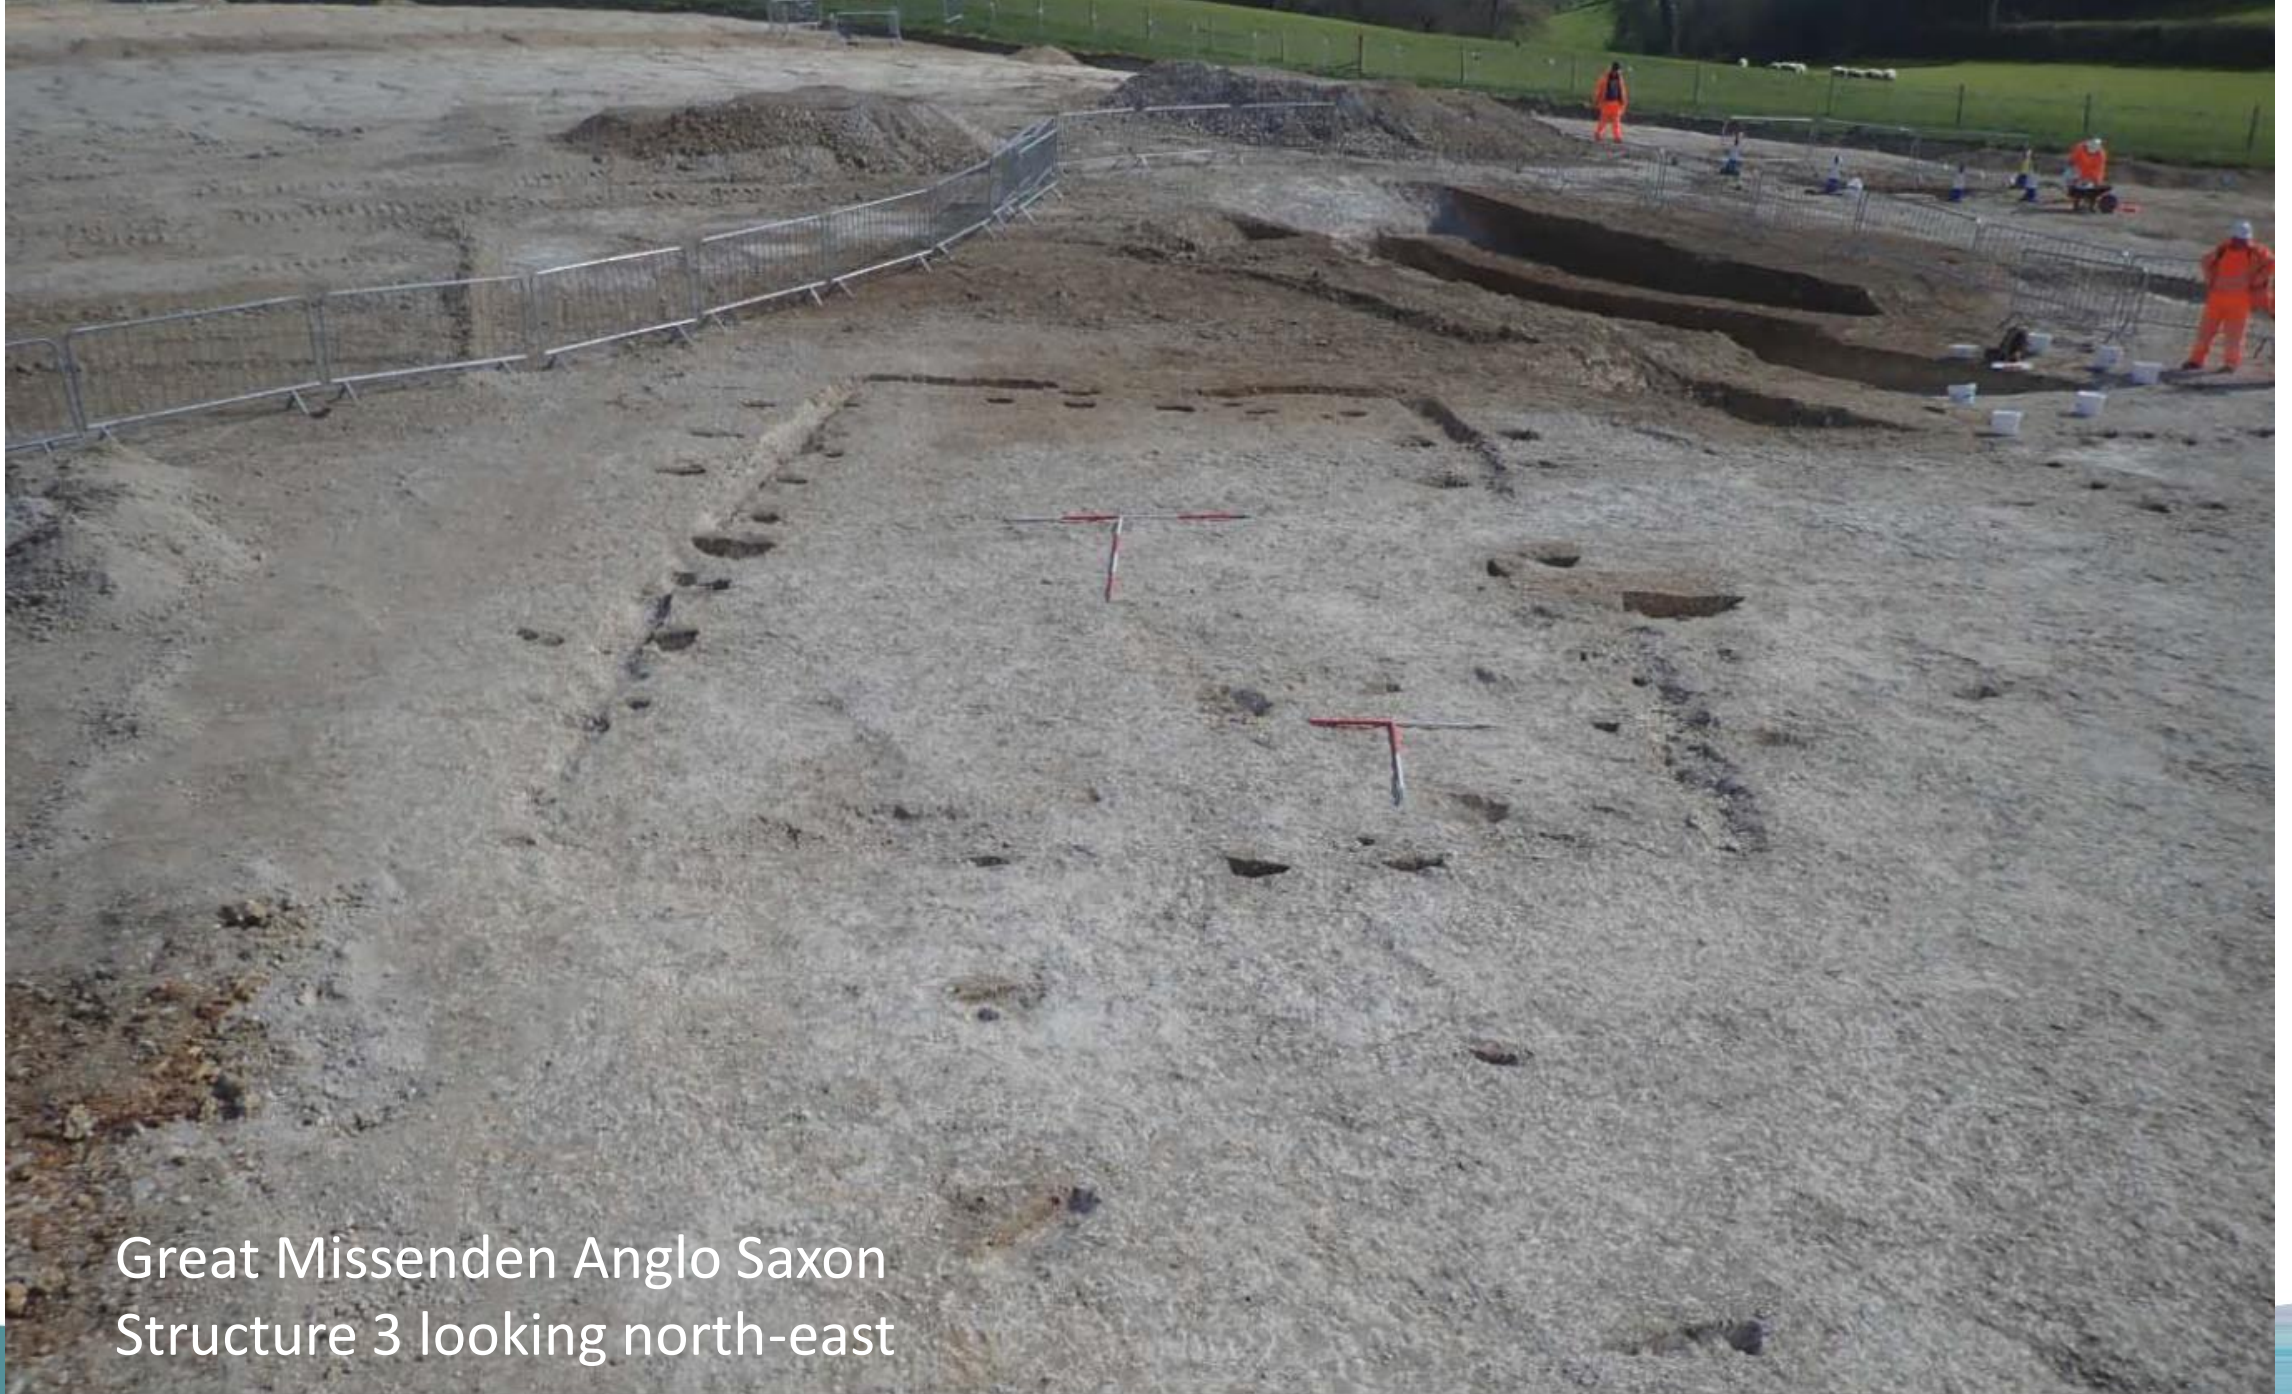
Great Missenden Anglo Saxon
Structure 3 looking north-east
