Fairfield Fagus Limited

Merlin Pipelines and Structures Decommissioning Programme Regulatory Close Out Report

Document number	FFL-DUN-MER-HSE-01-RPT-00004-01
Revision	A3
Date	18 th Jan 2021

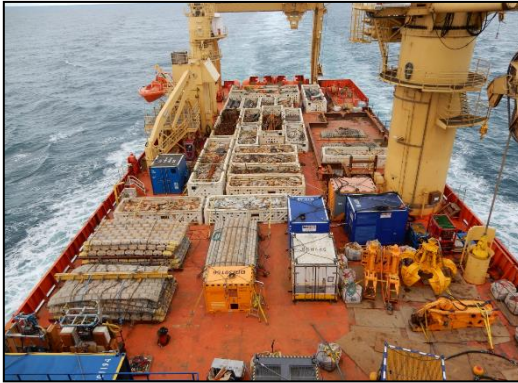
Debris Recovery

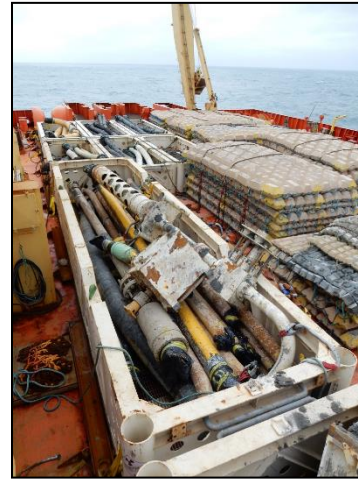
Infield Jumpers and Flowlines Recovered

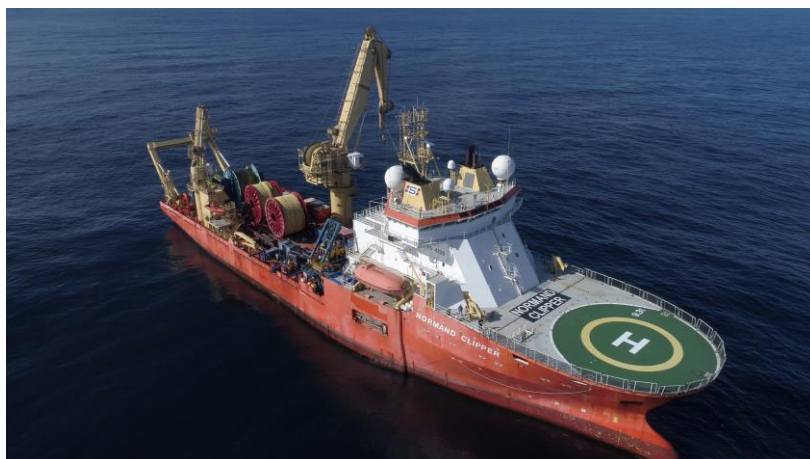
Normand Clipper Reverse Reeling

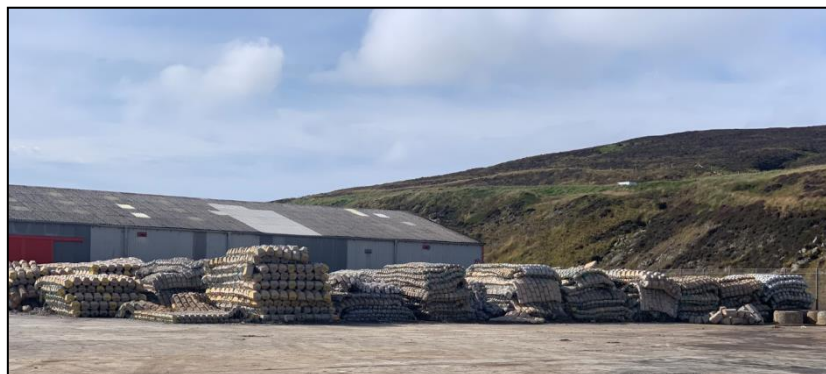
Mattresses Recovered from Osprey, Merlin and Dunlin

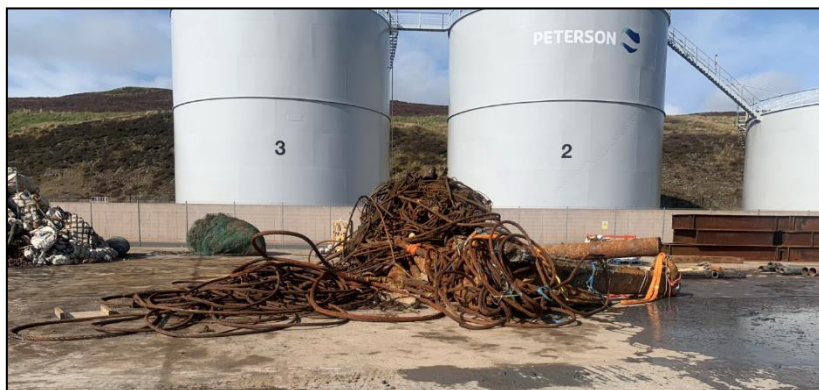
Wire Debris & Fishing Debris Recovered

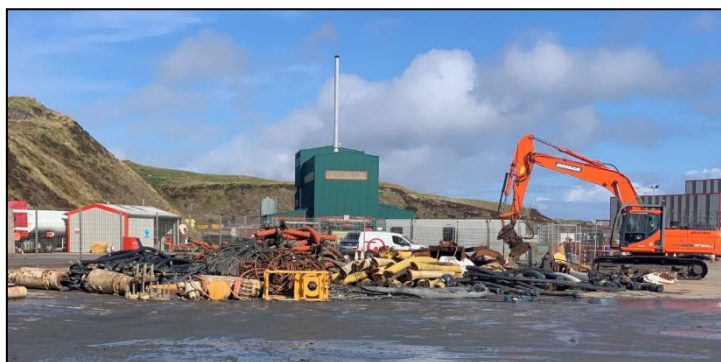
Waste Preparation & Separation

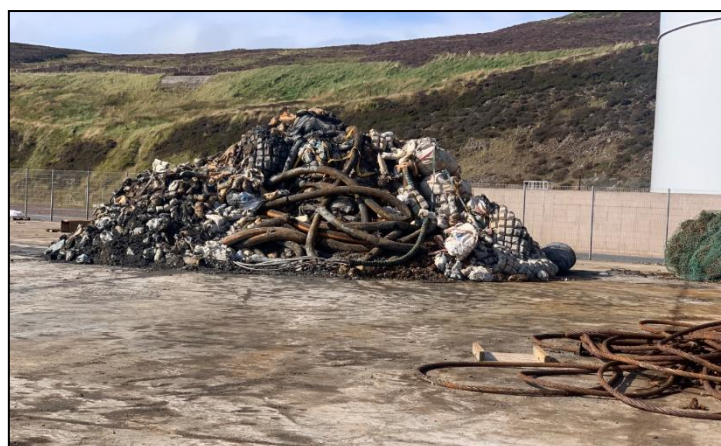
Mixed Sand / Grout / Mattress Deposits Recovered for Landfill
(Note flexible hose and umbilical were not recovered by Fairfield)
