DESIGN AND OPERATION OF TRASH SCREENS CASE STUDY

PLATT FIELDS

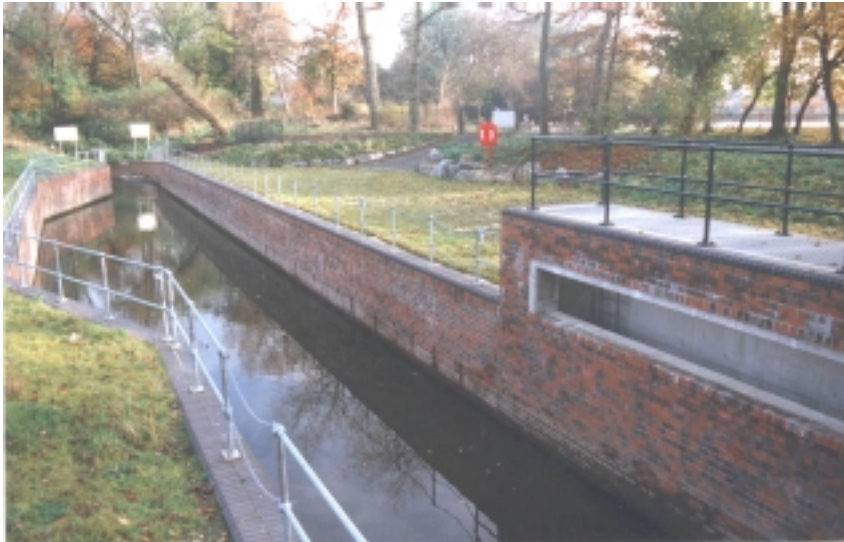
Figure 1.1 General view of Platt Fields trash screen site looking upstream showing silt trap, hard standing and emergency overflow weir. Note that the weir and hard standing are at coincident levels.

By raising the level of the hard standing by 300 to 400mm, it would be possible to carry out screen clearing without the need to stand or bring vehicles onto ground that has already been flooded.

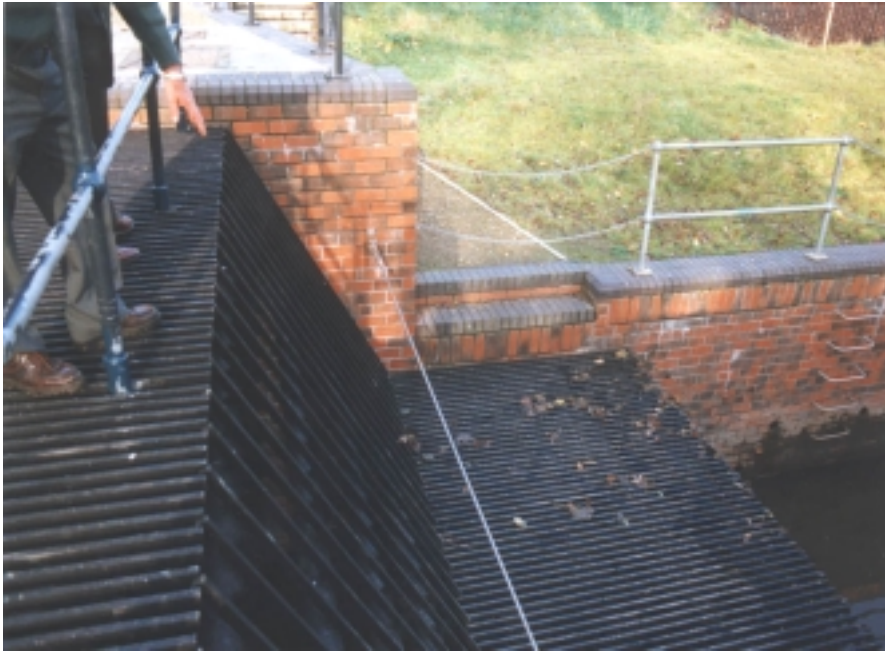
The total screen area is 28.8m², being of two stages of equal sizing. The raked screens are each 2m in height and are placed at an angle of 75 degrees to the horizontal. The working platforms are 1.6m in width.

Figure 2.3 General view of the screen. The top handrail position makes raking difficult, also the steps down to the lower working platform have different rises. The screen rake is steeper than recommended in the Manual.

The screen is formed of two stages with an intermediate landing. The two screens are 4m wide and approximately 4m high raked at an angle of 75° to the horizontal. Bar spacing is 200mm. Ladder access is provided to the watercourse at the foot of the lower screen. (*The manual recommends a bar spacing of 150mm if the exclusion of unauthorised persons is a requirement*).

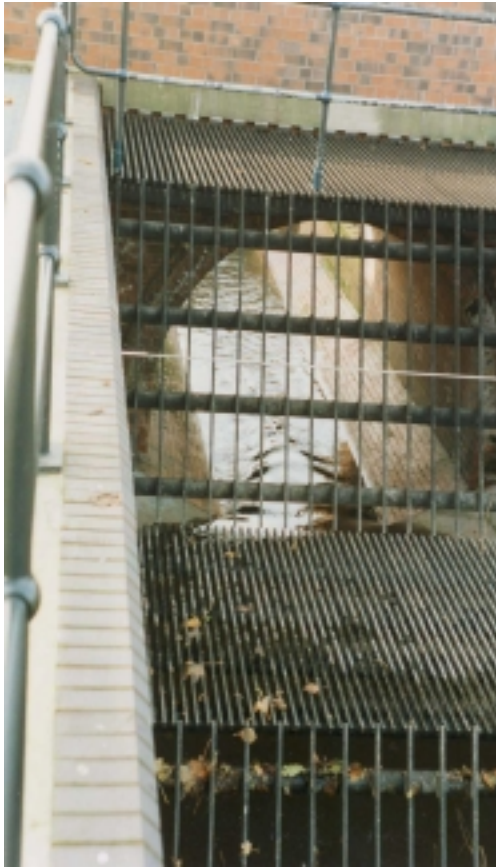
Figure 2.4 Trash clearance from the screen using rakes is made difficult by;

- **Position of the top handrailing**
- **Position of the screen bar supports**
- **The interface between the raking bars and the platform bars**

The backstays to the screen are formed of circular hollow sections, to which the bars are welded. When dragging a rake through the screen it either snags on the stay, with a risk of jarring injury or the rake needs to be moved out, with a risk that collected material is lost.

removed. Sections of handrail have been removed and replaced by safety chains to allow the Hiab to access the screen. (*Manual, Section 3.4.2 details alternative approaches to screen clearance. In this case the manual clearing arrangement has been made particularly difficult by the placing of obstacles to clean raking. Also, the rake angle is very steep increasing the operative effort required to clear debris*).

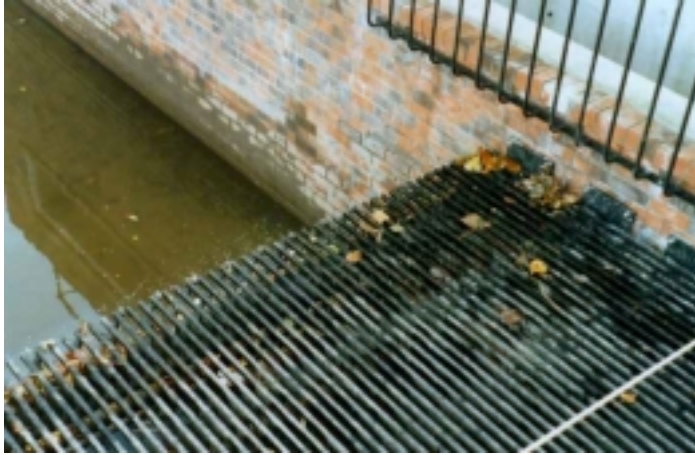
The emergency overflow is in itself a slot and is capable of becoming blocked by large floating objects. Access to remove these objects is very difficult. The overflow flies past the lower screen and is fitted with bars that prevent access by operatives. The screen is fitted with upstream/downstream telemetry. Gauges are housed within an off line chambers that silt up and are considered by the operators to respond slowly. No access is available to the downstream side of the screen through the screen itself.

Figure 3.1 The vertical bars at top right protect the entry to the emergency overflow channel. These were fitted after initial commissioning.

The overflow is constructed in part alongside the trash screen and to prevent access to a significant vertical drop it has been necessary to fit hand railing. There is no need to bring the overflow into the trash screen area. This would avoid this hazard.

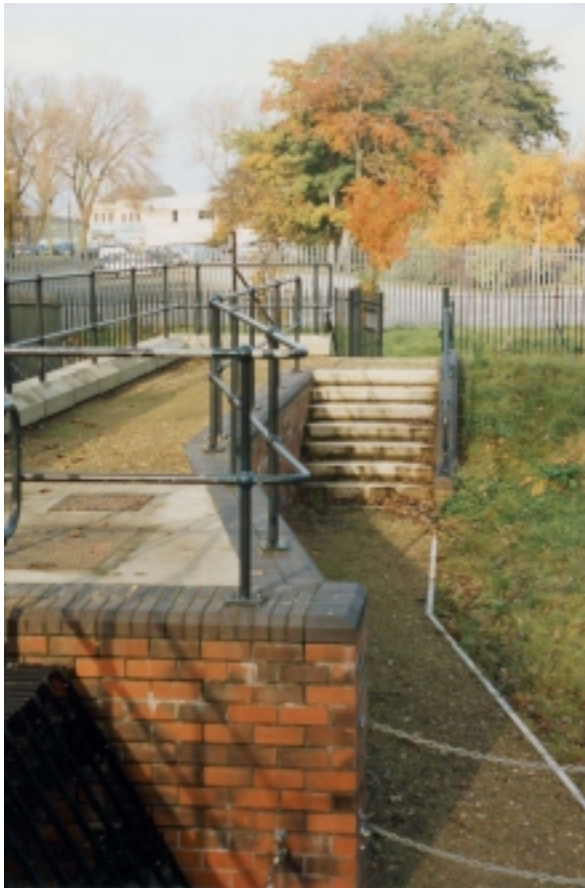
Figure 3.3 View from the screen looking towards the main access road. Note the complex detailing of the paths, steps, railing and brickwork.

The screen has excellent access off the public highway for both vehicles and operatives. Access for operatives however is compromised by poor ergonomic design, as detailed previously.

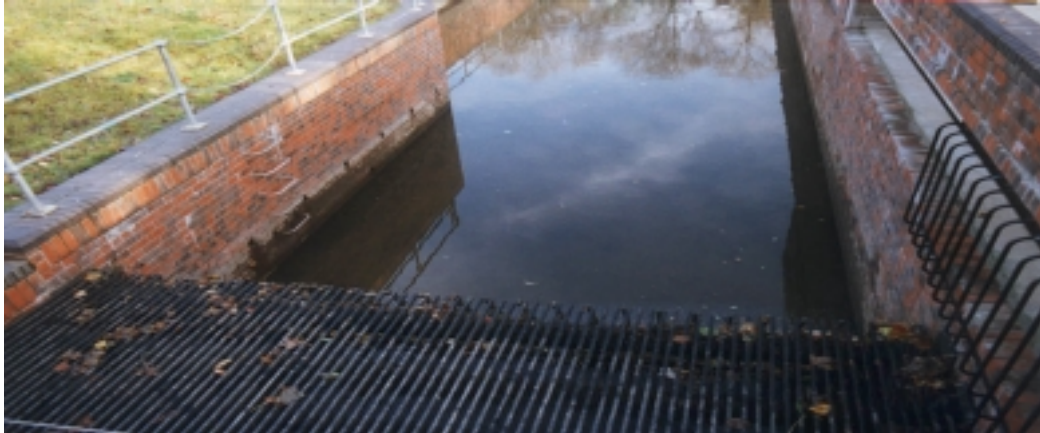
The level of the hard standing is coincident with the level of the overflow weir. This means that during flood events the entire area is beneath water.

Figure 3.4 View immediately upstream of the screen showing the levels of each bank top. On the right, the position of the overflow dictates the height of the hardstanding area where debris has to be collected.

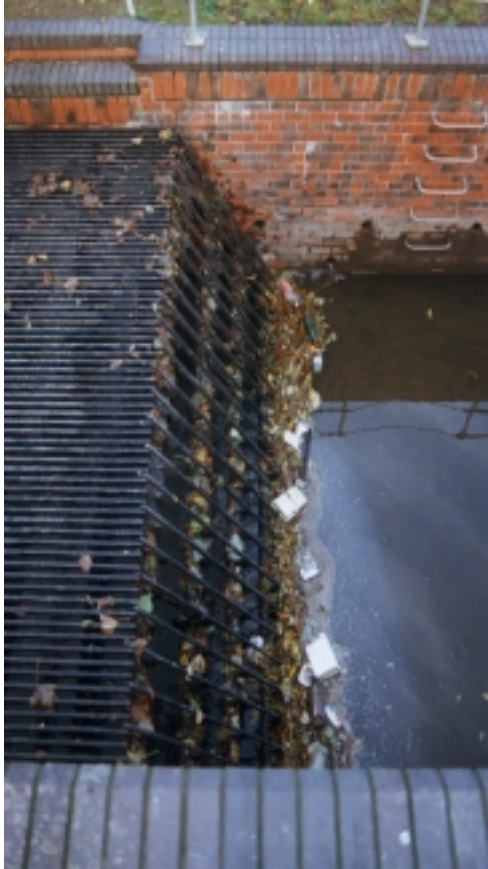
The bottom backstay is close to the surface of the water at normal flows. This leads to a ready accumulation of small vegetative debris that can ultimately lead to the screen becoming blocked. If the stay were positioned either above or below the normal flow, this material would pass through the screen without impediment.

Figure 5.1 Leaf debris is clearly visible at the bottom of the screen that should be passed through the screen. Operatives have stated that during an event the majority of their time is spent clearing leaves.

- The access arrangements for operatives provide numerous trip hazards that could have been easily avoided by consideration of ergonomics during the design process.
- The screen becomes blocked by leaves that should be able to pass through the screen. Raising the screen bars off the bottom of the channel would help this situation, as would the positioning of the lower structural support above the normal water level.
