River sediments and habitats and the impact of maintenance operations and capital works

Report on Stage 1

R&D Technical Report FD1920/TR

Authors: HR Wallingford

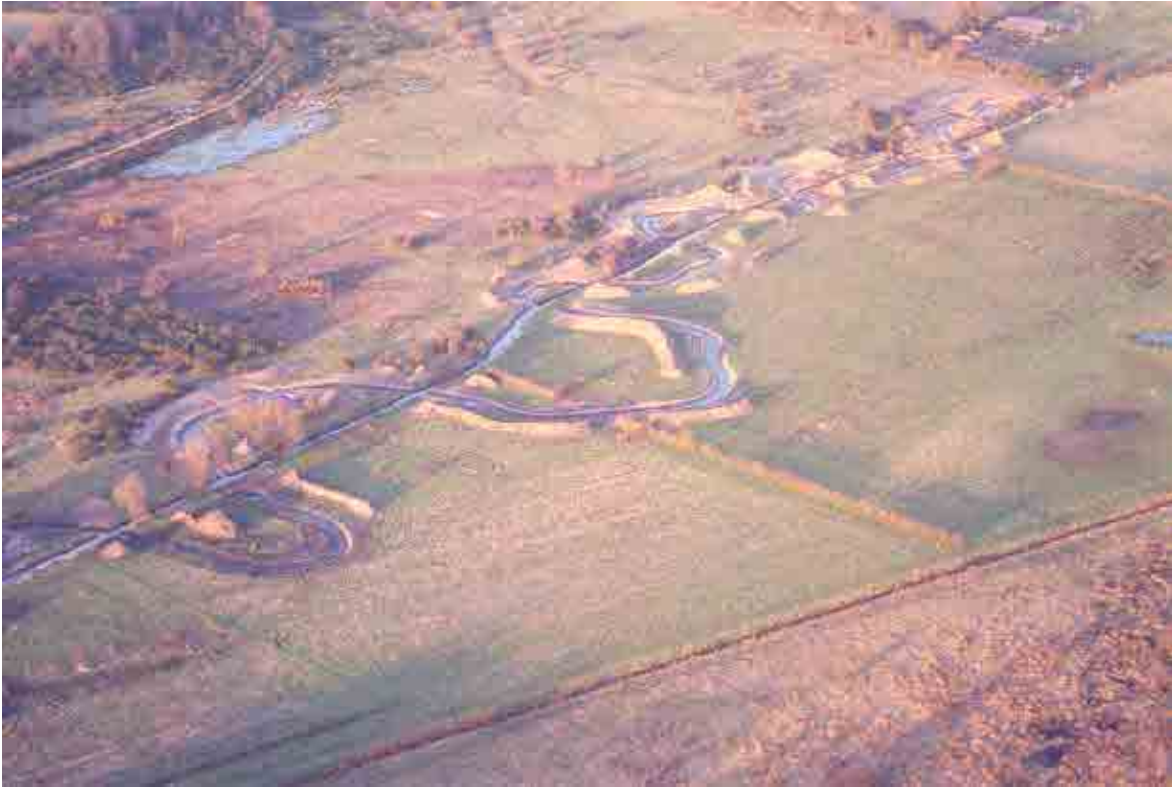
Plate 1 Previous straight course of river is visible against restored meanders.

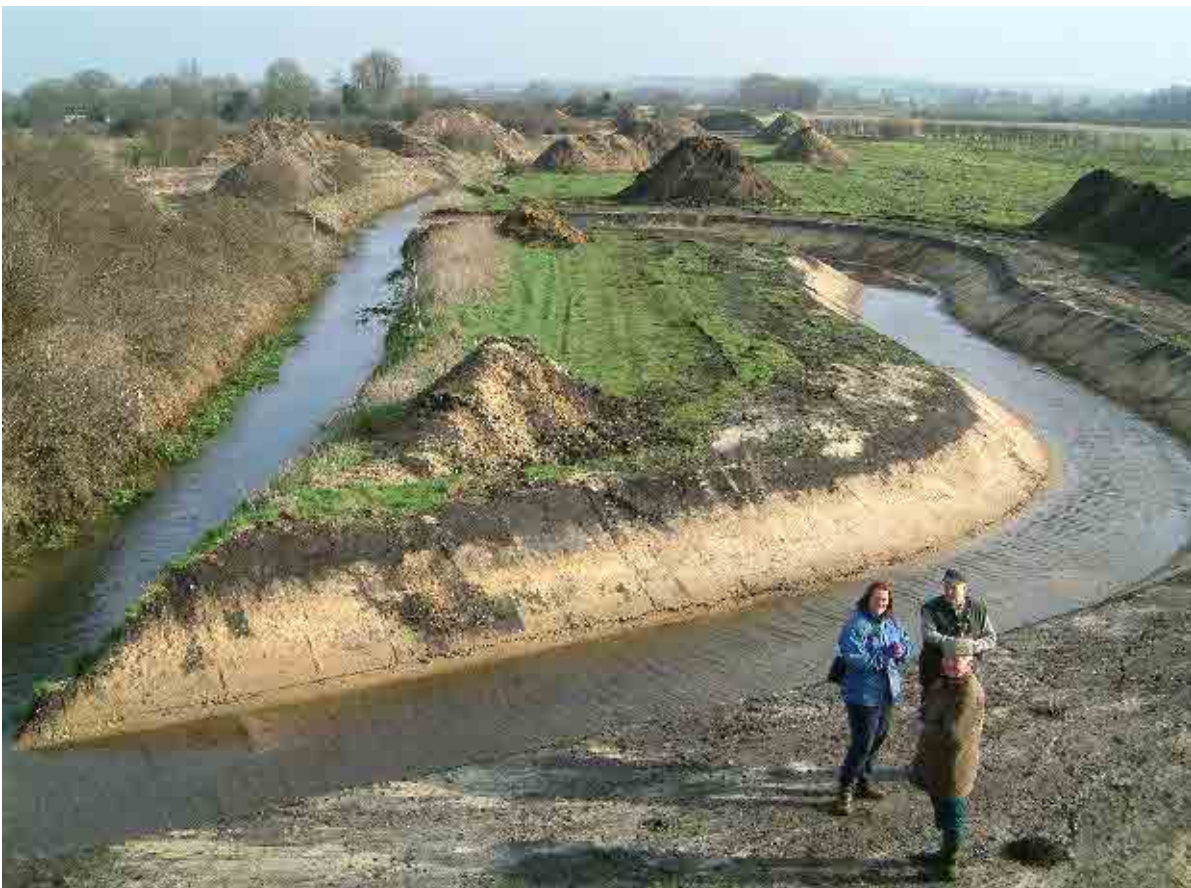
Plate 2 Restored meander at Gaywood Stream

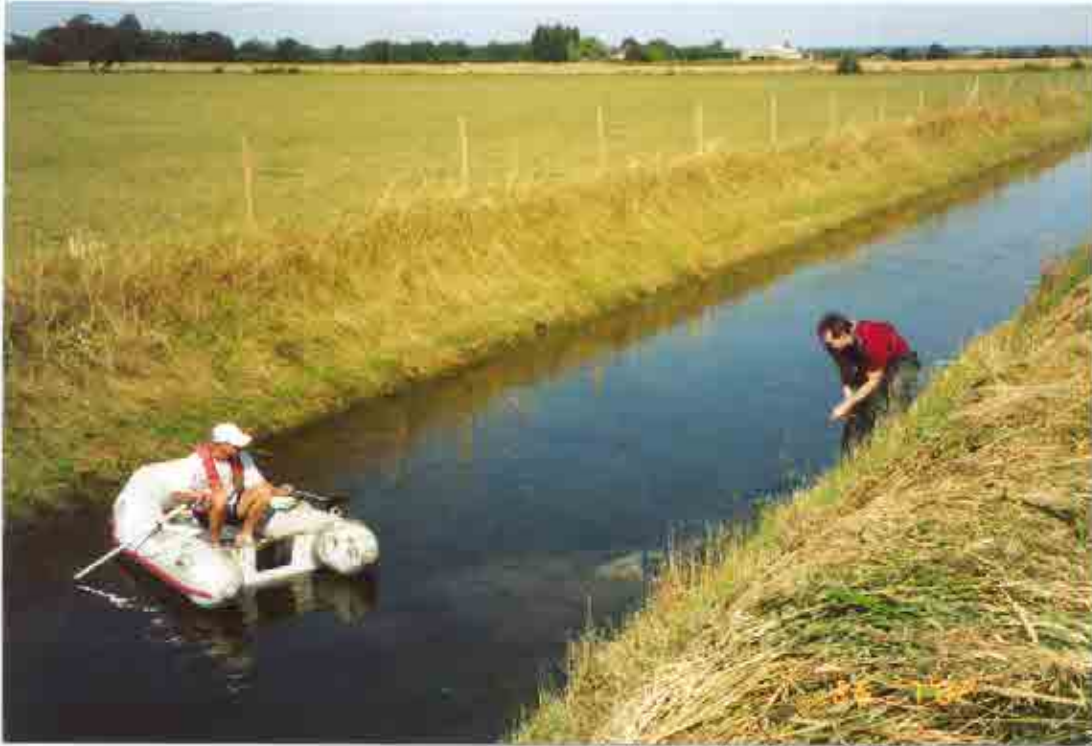
Plate 1 Site Work on Gravel Drain

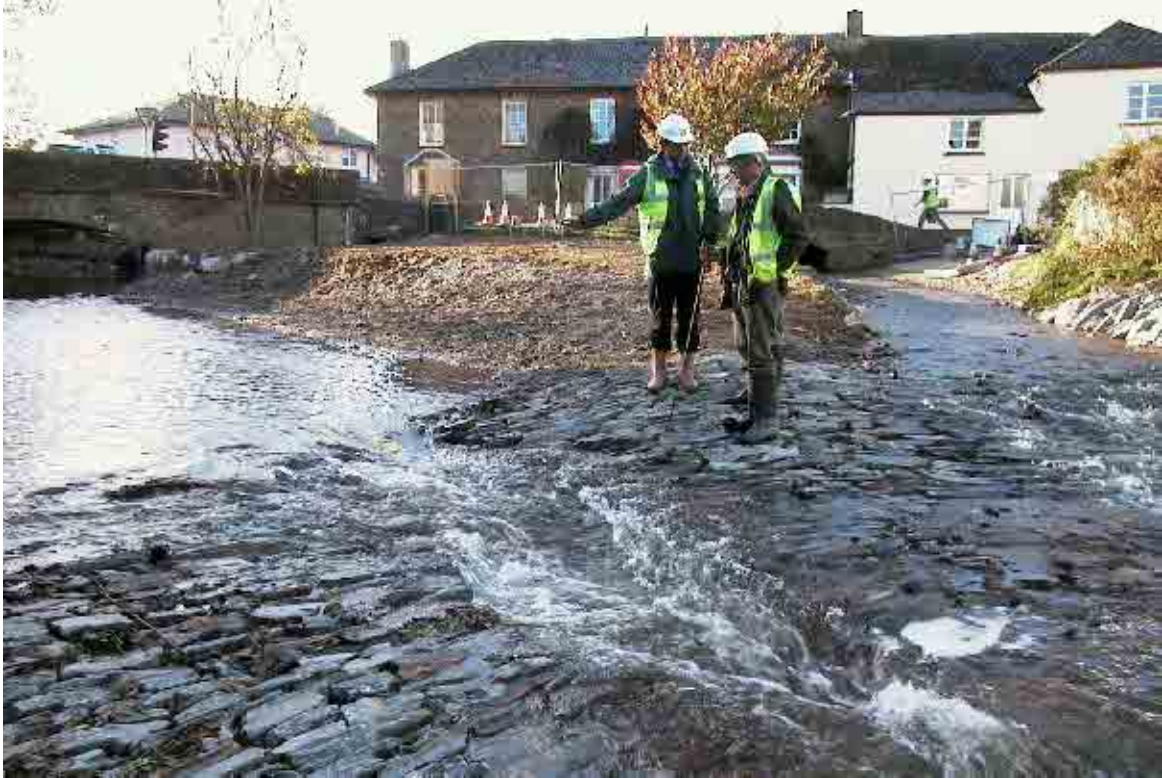
Photo 1: Village green riffle at low flow

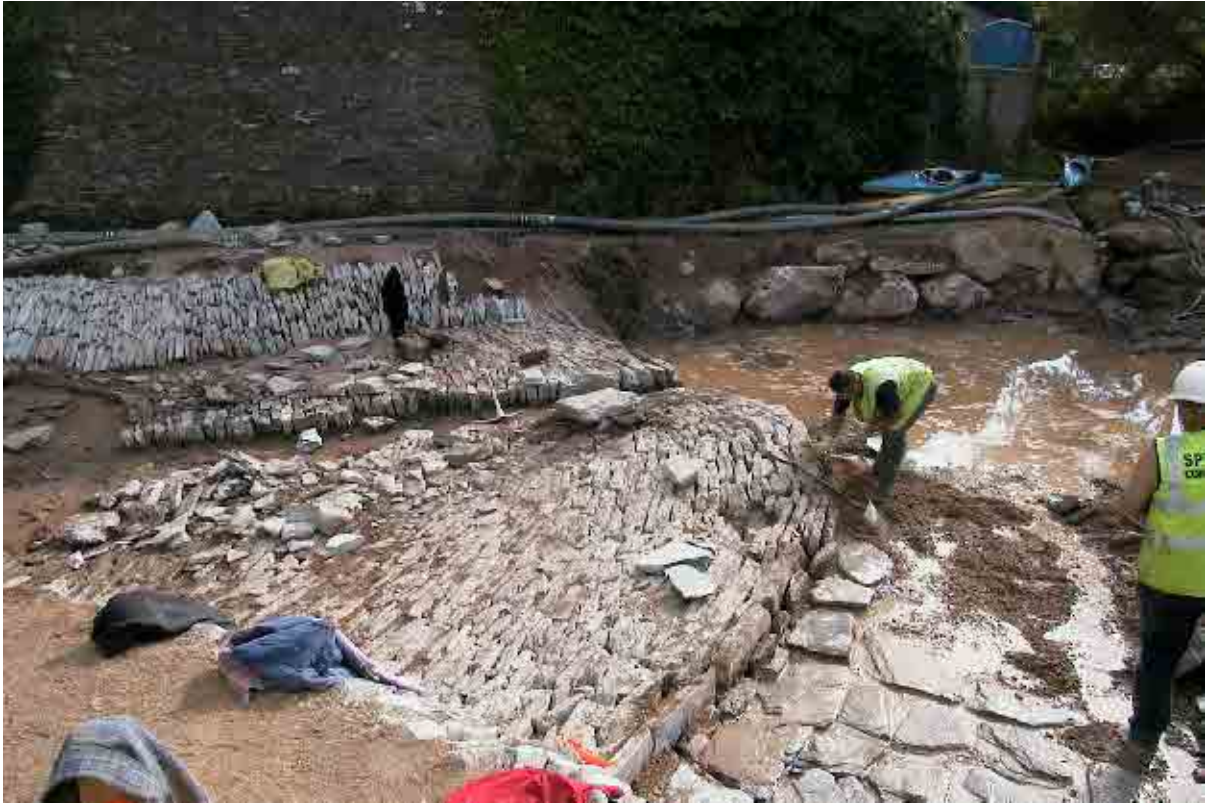
Photo 2: Village green riffle under construction

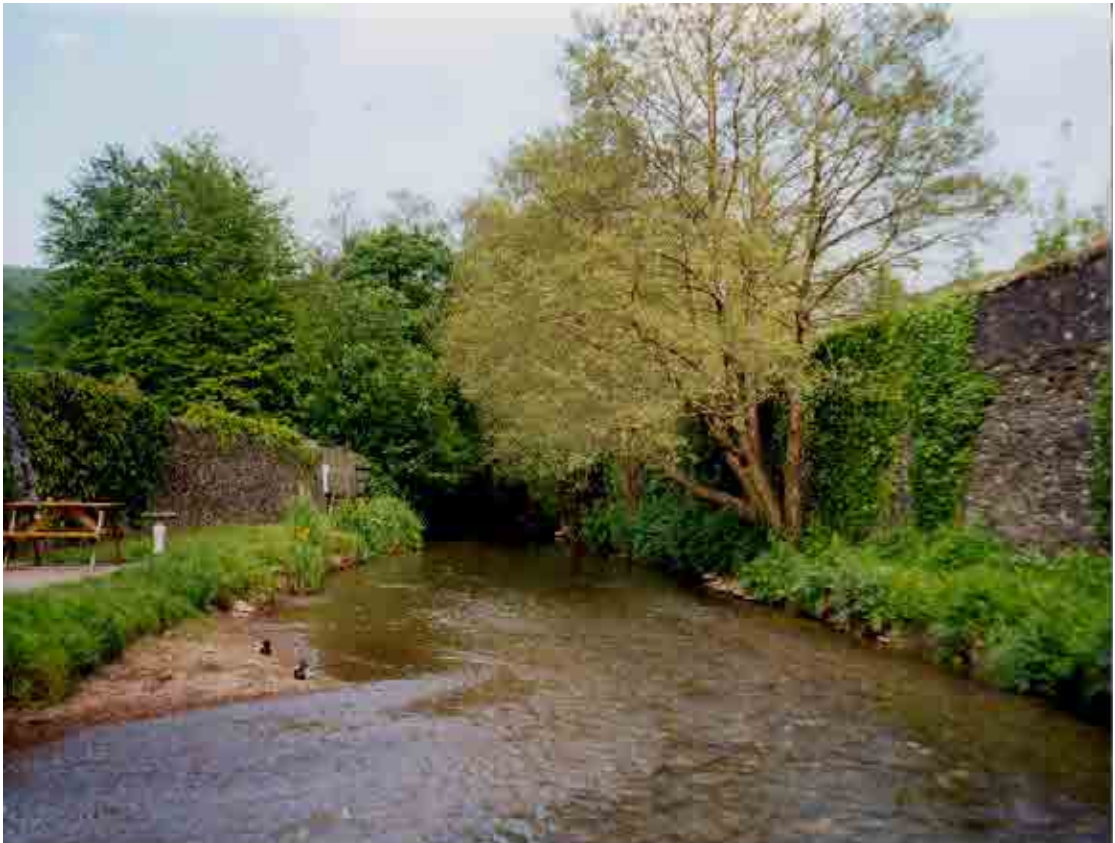
Photo 1: View of river before works

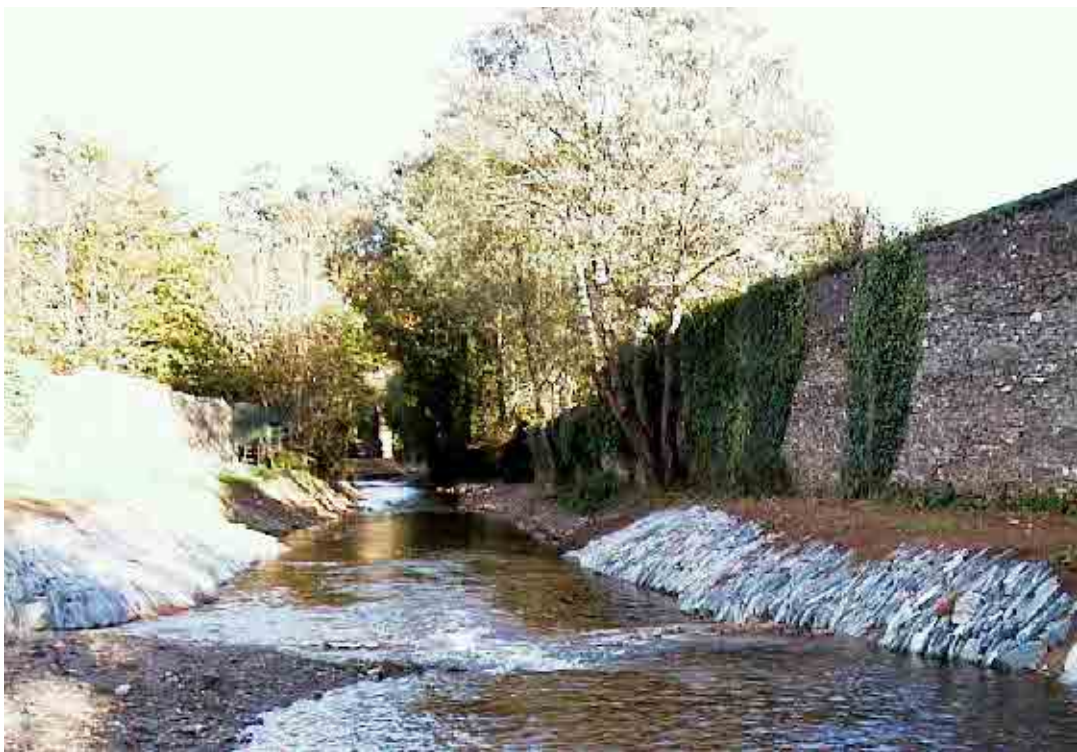
Photo 2: View of river after works

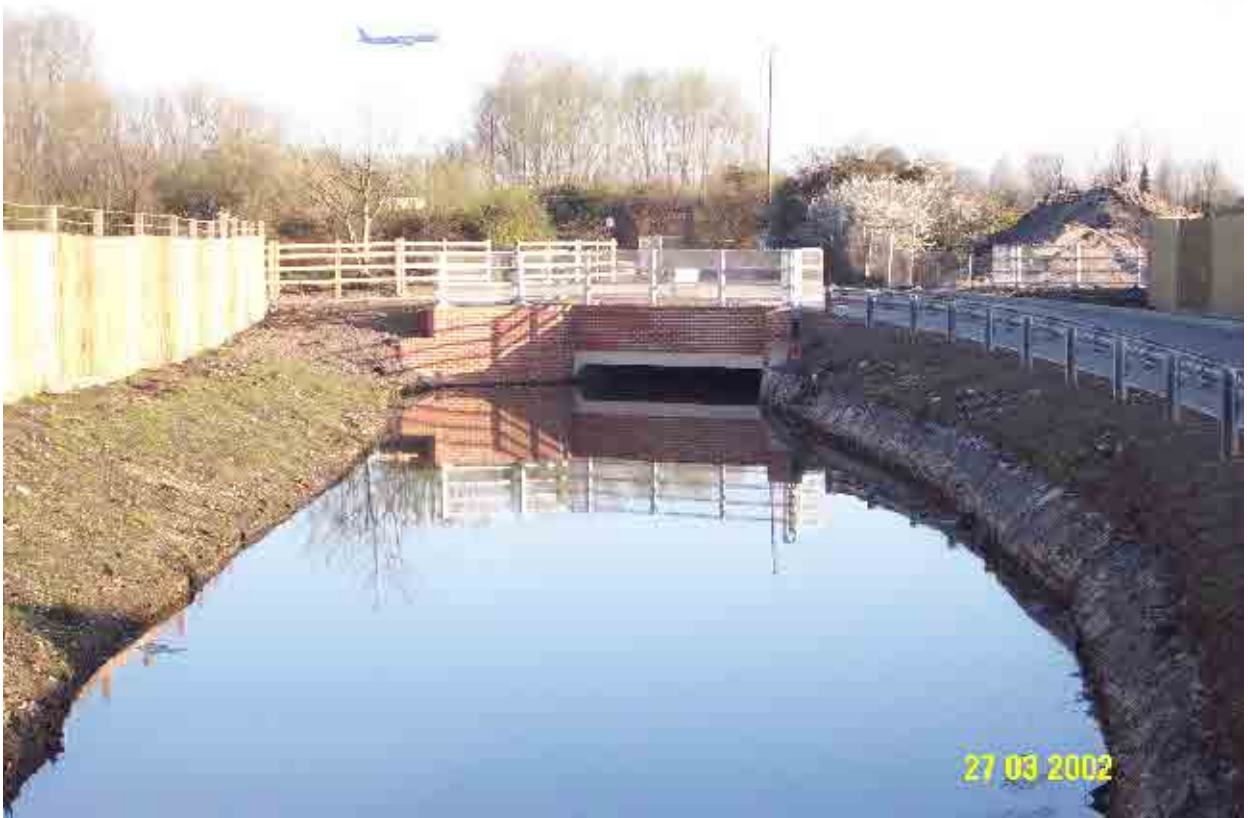
Leylands Lane culvert and new channel

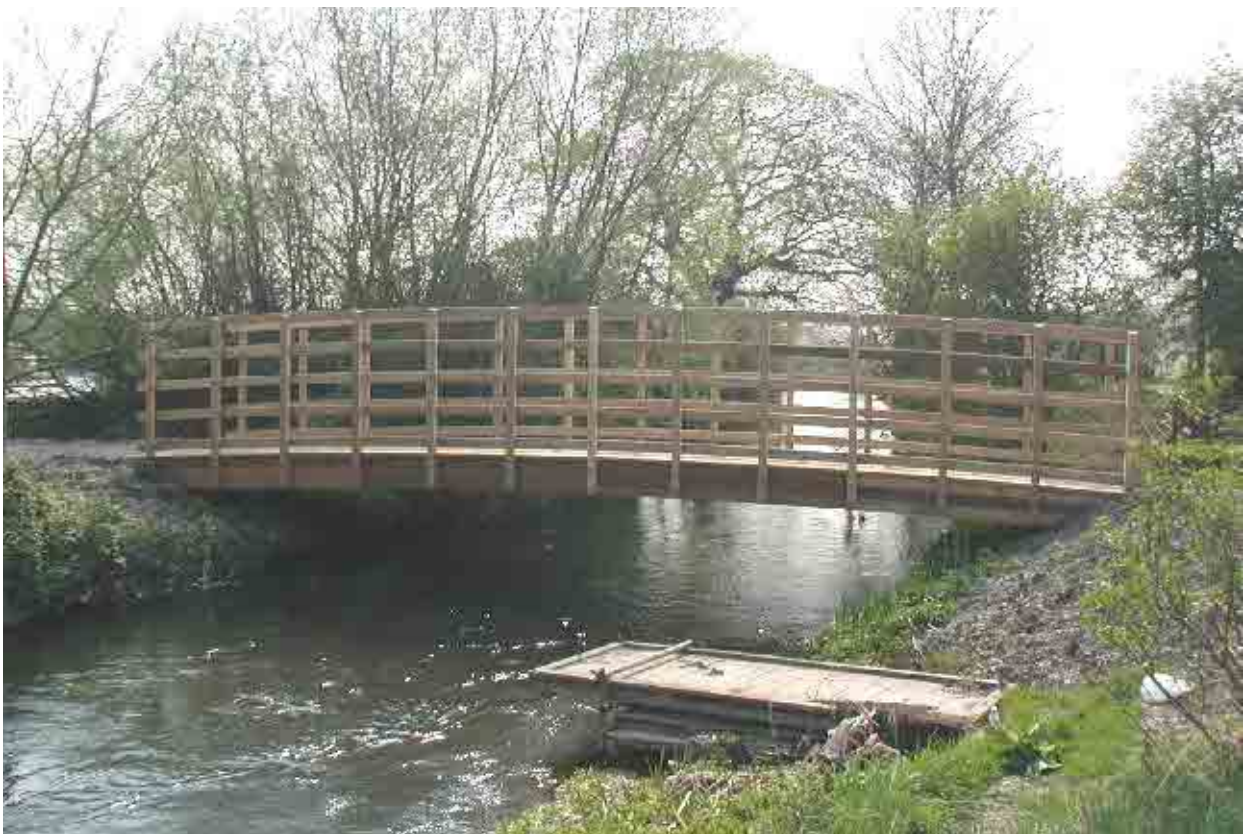
New bridleway bridge

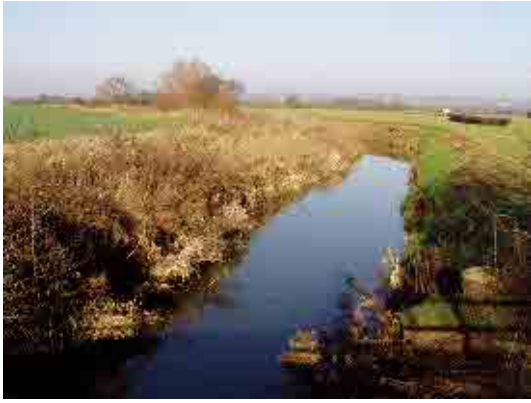
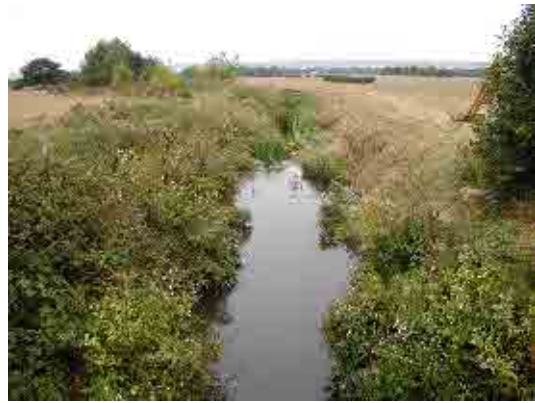
Upper Limit of site before and after: LEFT: after dredging in December; RIGHT: before dredging in autumn – note sluggish water flow and marginal emergent reeds

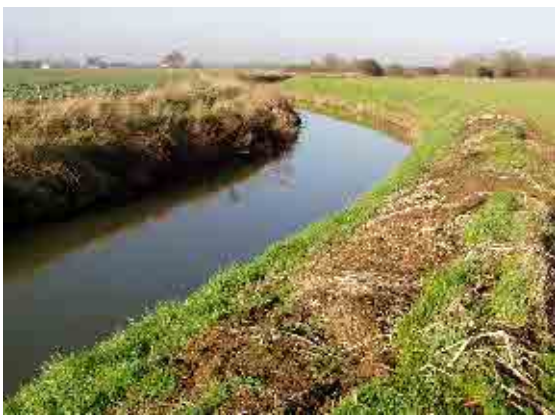
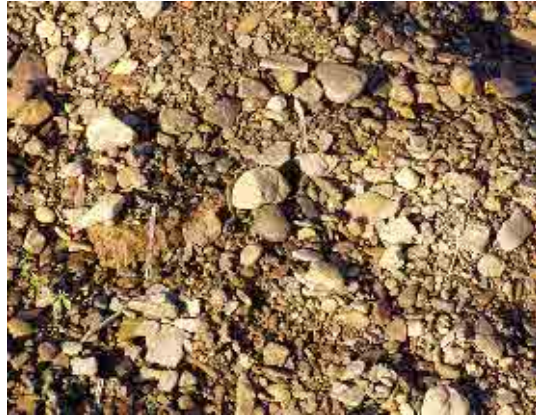
Typical dredged section – no toe left, and predominance of gravel and pebbles in dredgings

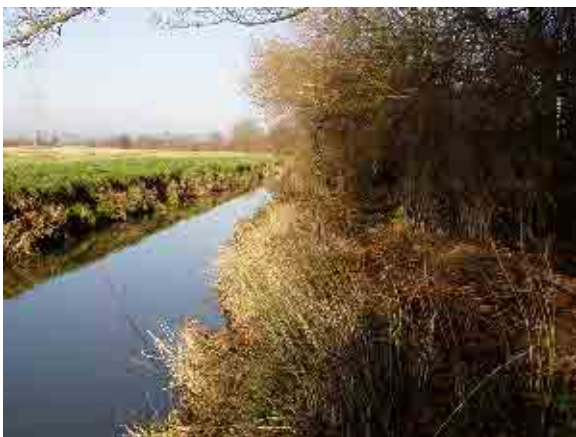
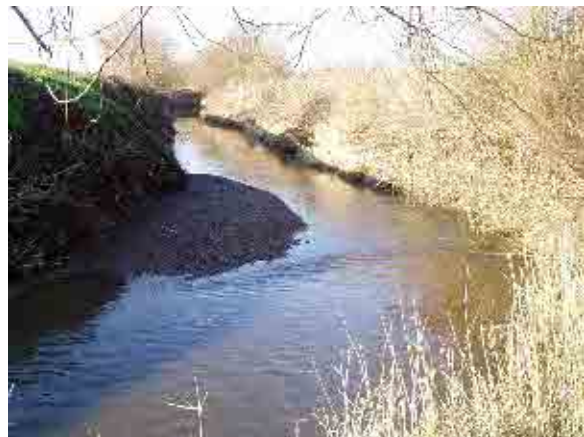
Left: top half of site – dense hedge-line along right bank, and typical featureless channel with smooth/no perceptible flow-type; Right; downstream limit where sediment is forming bars in the steeper gradient as the river drops down into the Beult. **NOTE IMPORTANT DIFFERENCE IN GRADIENT AND FLOW TYPE ON RIGHT – R&D COMPARISONS POSSIBLE**

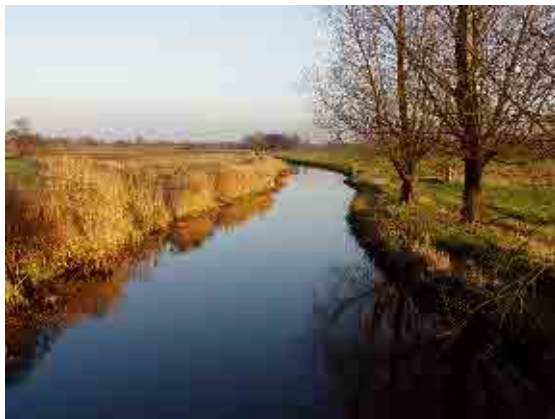
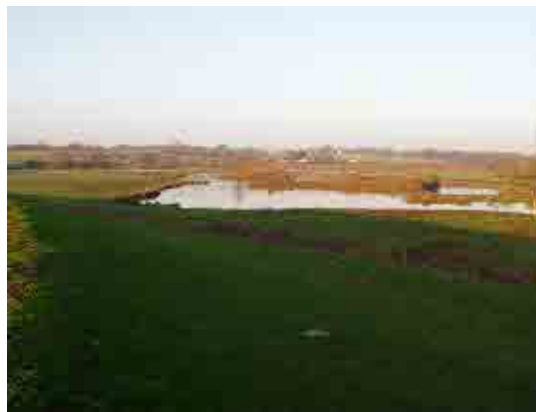
LEFT: perched main channel with arable and pasture; RIGHT: main flood storage area

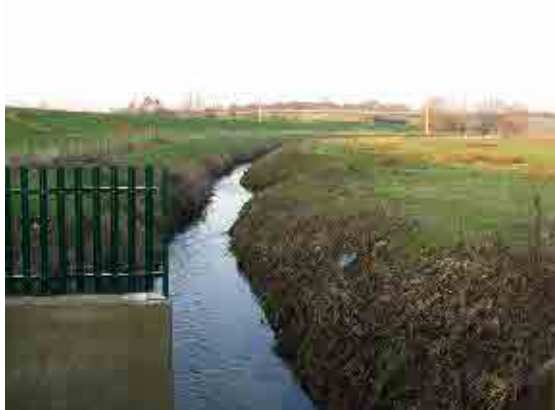
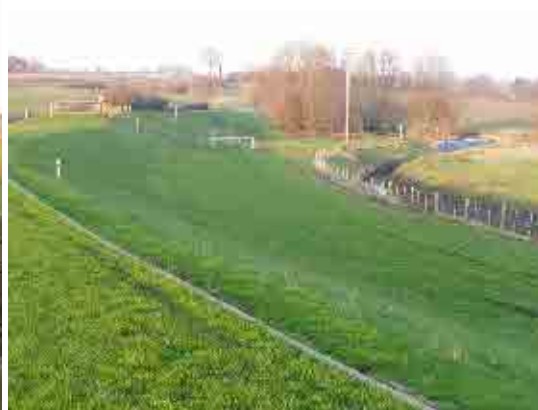
Main evacuation channel to 'throttle' – note large over-spill weir, top right, on photo on right (over-spill from main channel into flood storage area)

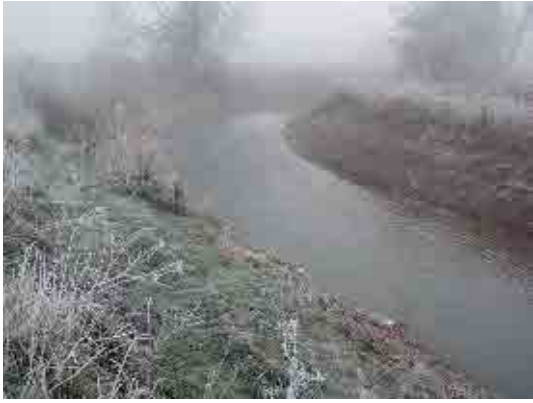
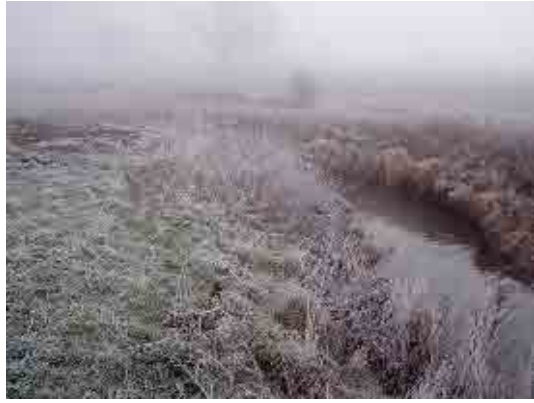
Left: probable removal of berm on inside of meander; Right: previously berms on both banks, one with edge 'nibbled'

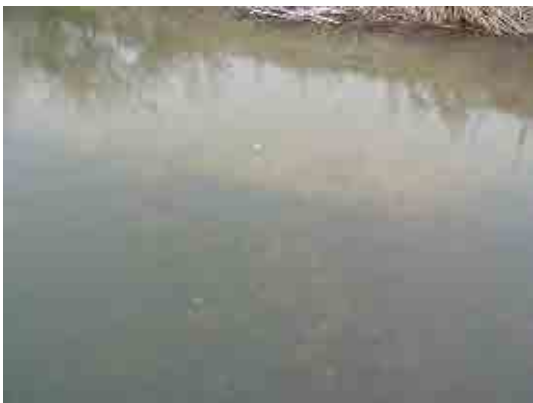
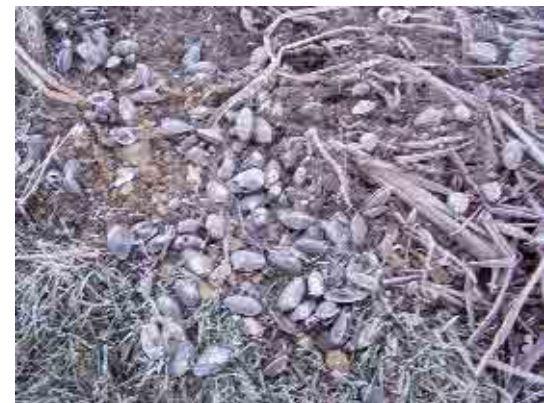
Left: area of clear gravel indicates reed fringe/berm removed to gravel bed only; Right: typical pile of mussels not returned to the river following completion of dredging

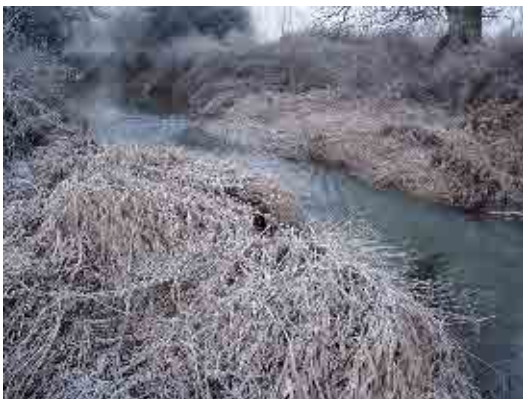
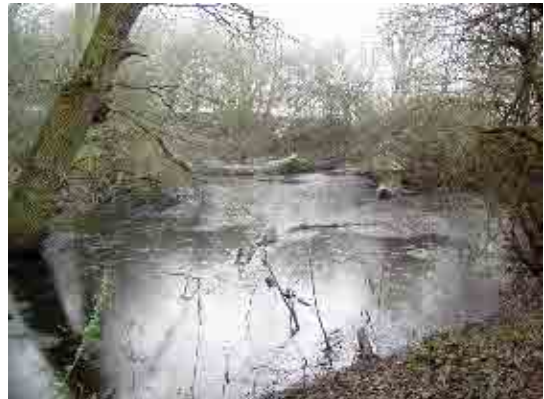
Left: paired berms and 'riffle' – site in Reach 2 - probable character in parts of Reach 1 upstream; Right: Cut-off meander 'ox-bow lake'.

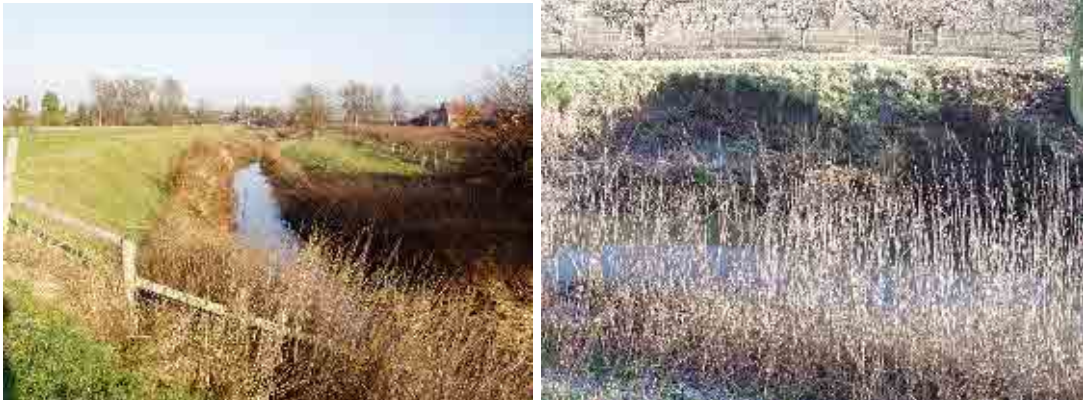
Teise upstream of weir.....Left: best practice mowing. Right: bank slump creating vertical bank (small cliff)

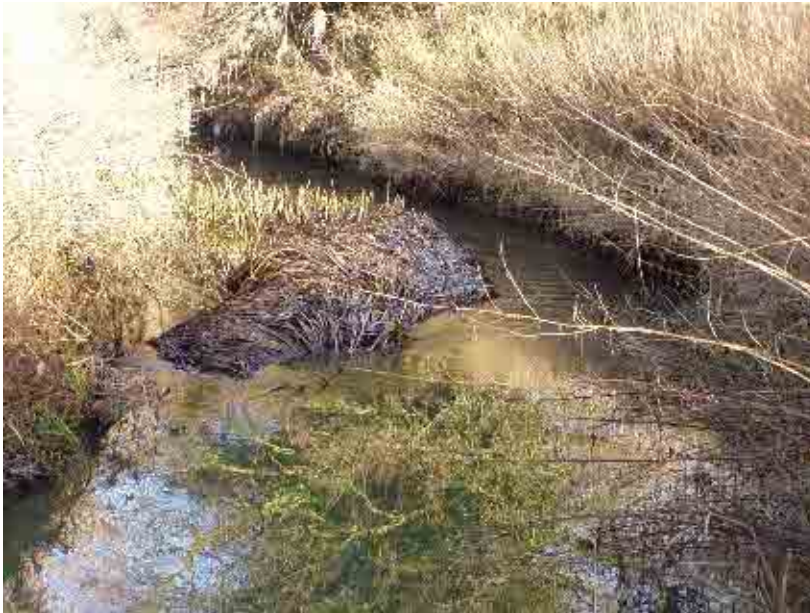
The one and only sediment feature in the reach – a tiny vegetated mid-channel bar

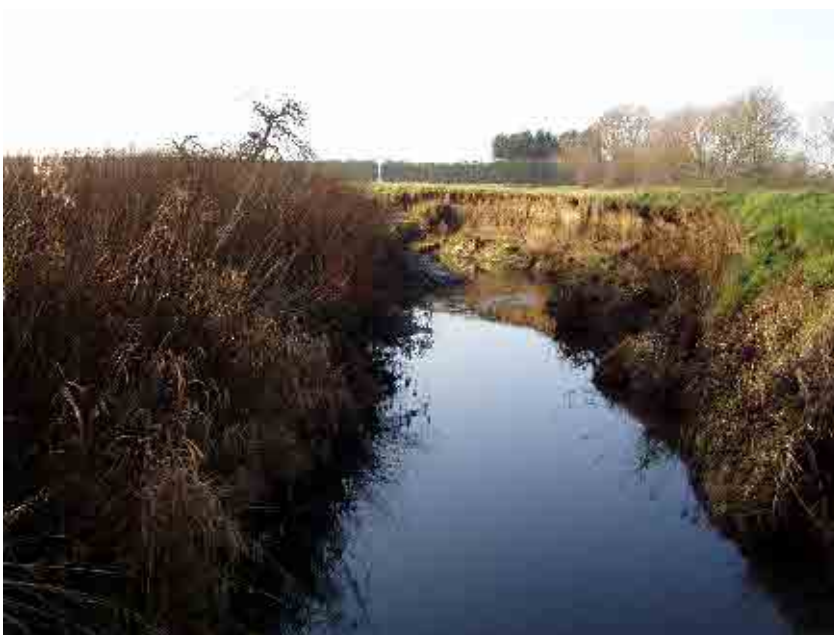
Cliff on outside of bend formed through erosion, rather than bank slumping (possible single example in whole reach)

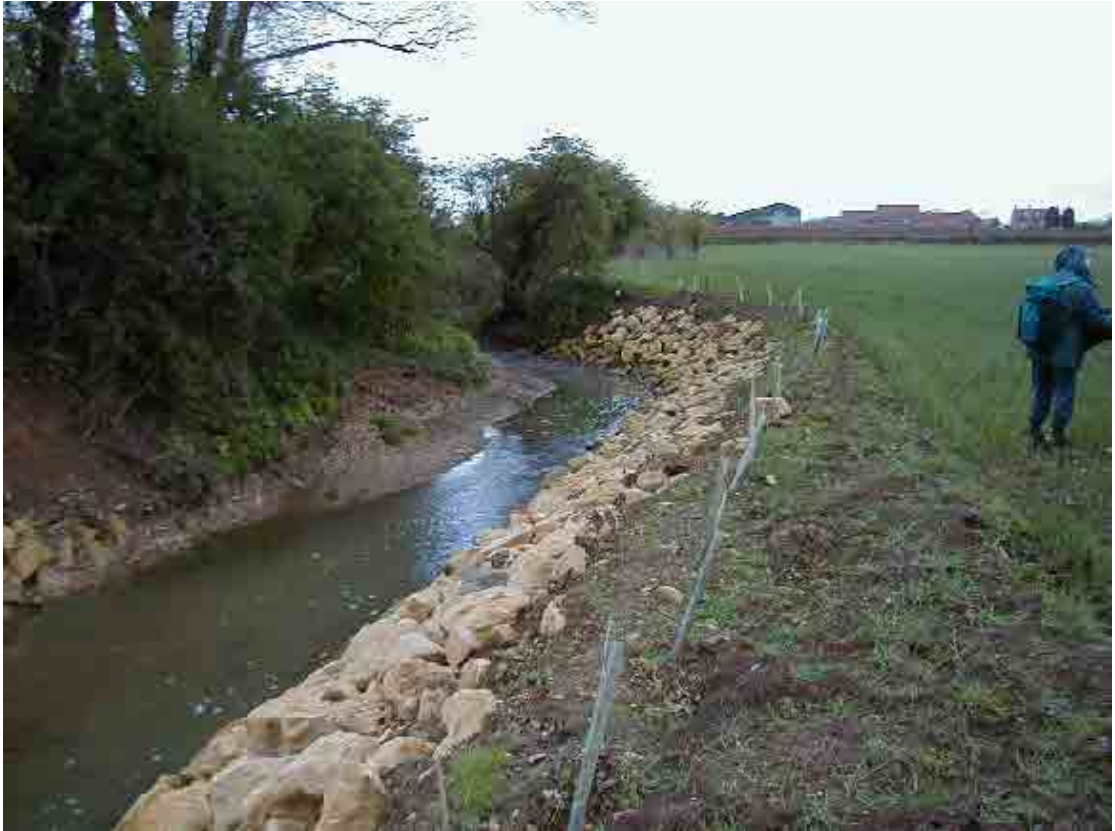
Plate 1 Southwick Brook looking upstream, left bank protection

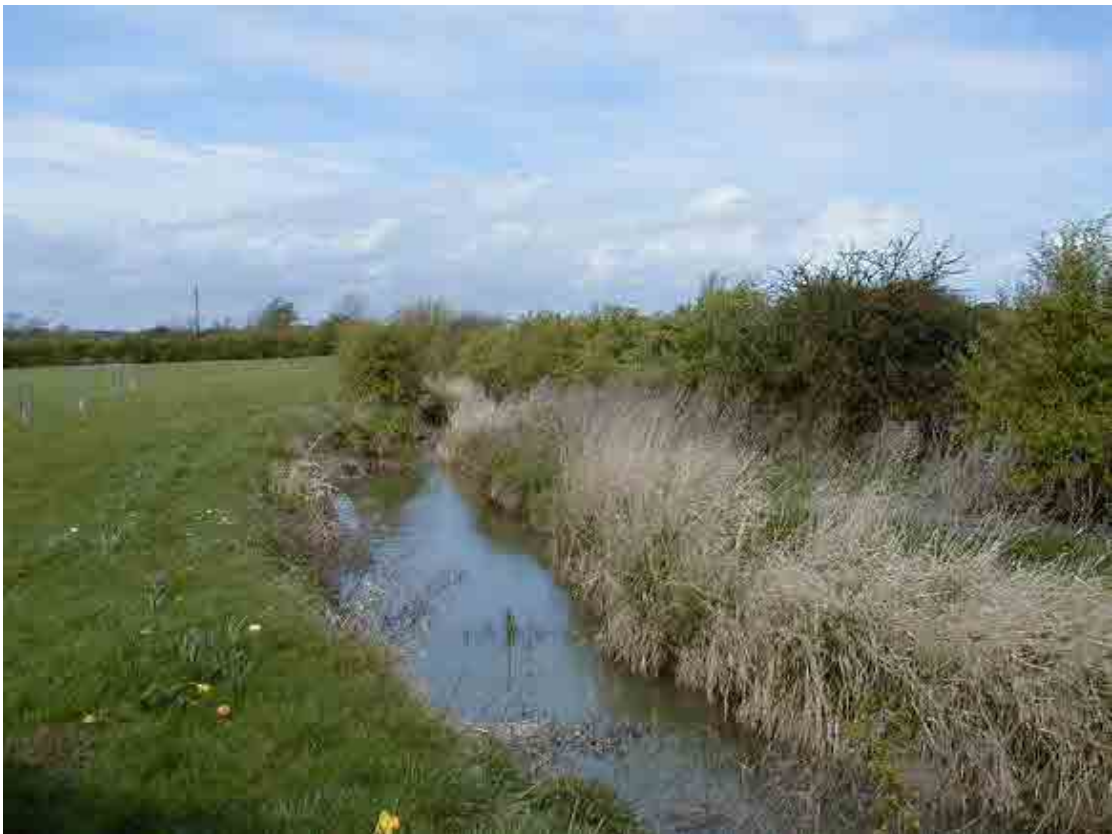
Plate 2 Southwick Brook before weed cutting has been carried out
