# D. Case Study Examples

## D.1 Introduction

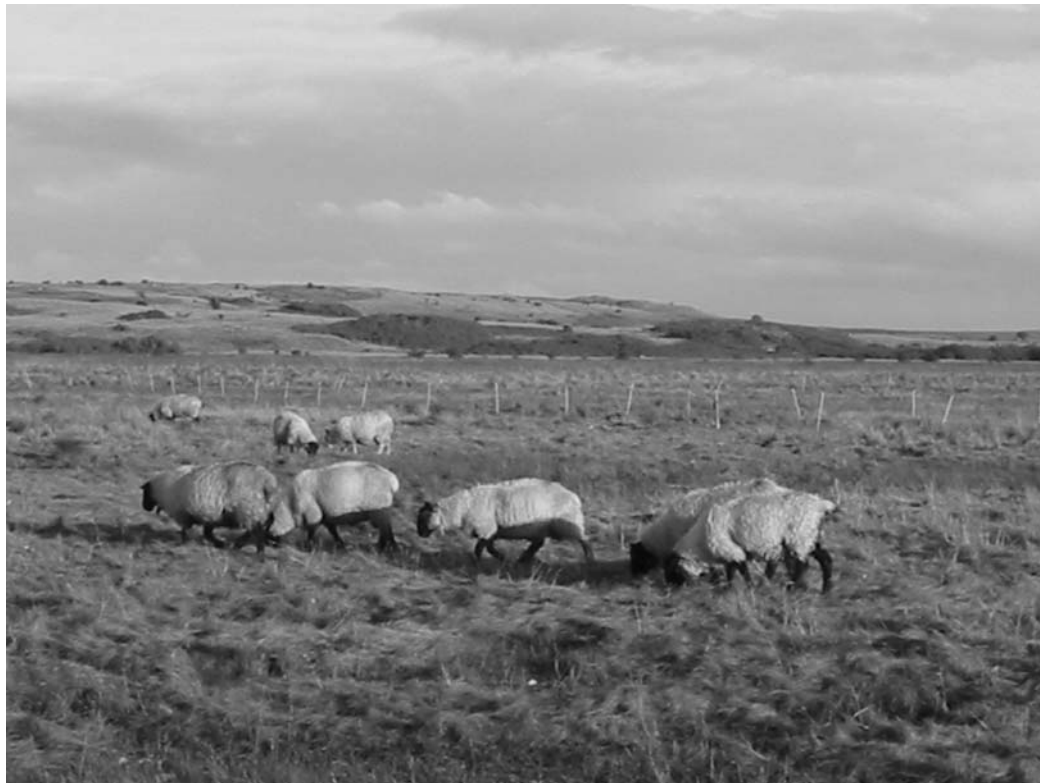
**Figure D.1** Sheep grazing on trial plot on Aberlady Nature Reserve, 2003

The results of the 2003 bird census on the reserve show that the grazing experiment appears to have been successful. Prior to the trials, annual bird counts recorded 1-2 breeding pairs of Lapwing and Redshank with numbers increasing to 6-7, post grazing. The increase in breeding adults on both sites also led to an increase in fledged young.

Unfortunately the experiment was not continued the following season due to problems sourcing suitable grazing stock so long term effects cannot be assessed. However East Lothian council are planning to repeat grazing later in 2005 providing suitable stock can be sourced.

Recommendations following the first trial experiment included:

- Introduction of cattle to a more-sheltered trial plot, with more robust fencing
- Areas important for nesting Lapwings/Redshanks should be protected by electric fencing

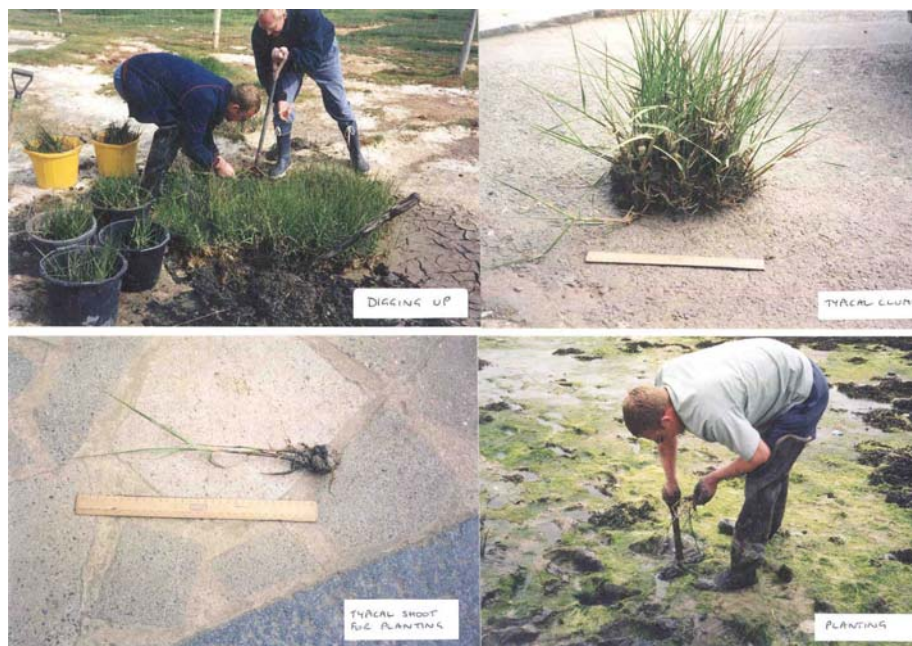
**Figure D.2 Spartina planting at Bosham, Chichester (copyright Chichester Harbour Conservancy)**

Following transplantation, the sprigs have grown and spread, and have developed seed heads. This is a very low wave energy site, but is inundated at high tides in excess of one metre depth. Two months after planting one hundred percent survival of the plants was evident.

This site provides a good example of how common cordgrass (*Spartina anglica*) can be planted and utilised for multiple purposes. That is, the planting has stabilised the substrate and prevented erosion, in conjunction with making the area more aesthetically pleasing to visitors to the area.

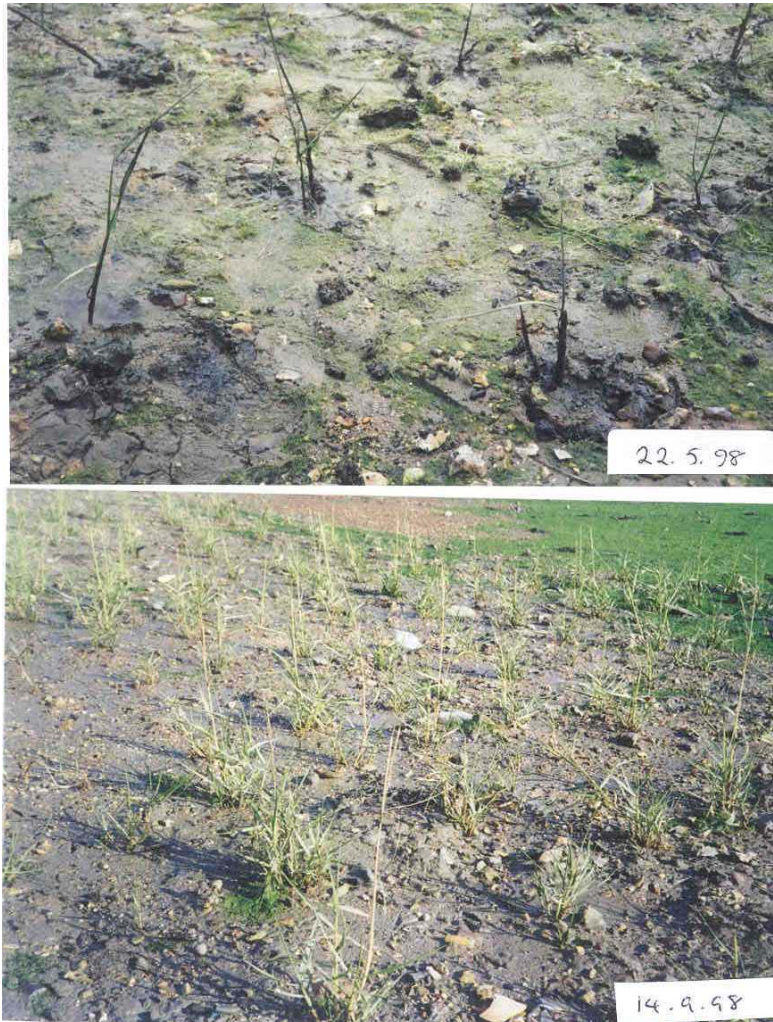
**Figure D.3** Spartina development following transplantation, Bosham, Chichester (copyright Chichester Harbour Conservancy)

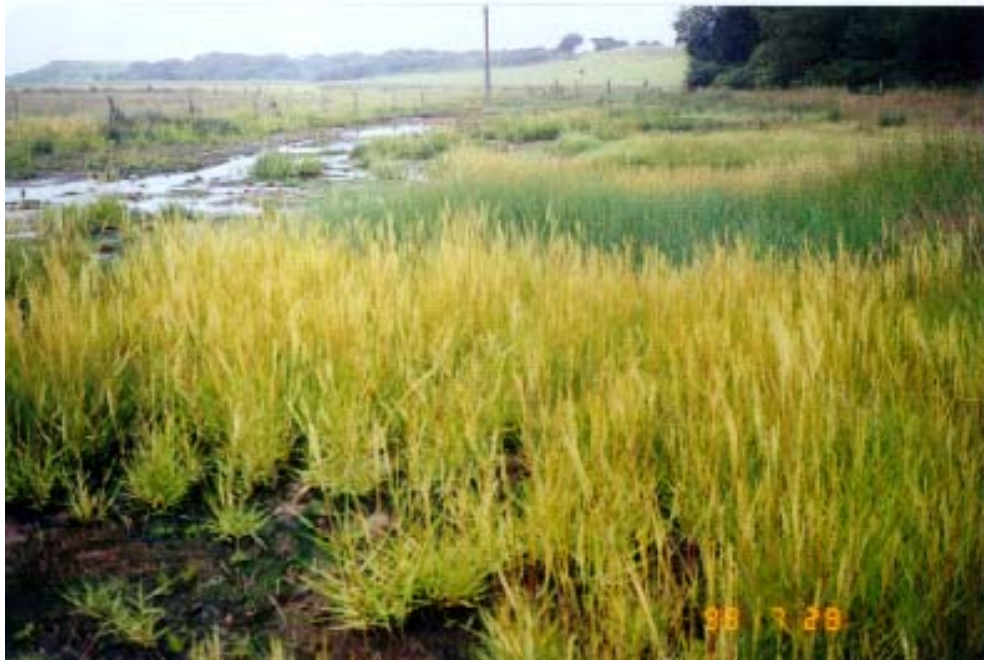
Figure D.4 *Spartina anglica* was planted using turfs at Cleaval Point, Dorset (from Brooke et al., 2000)

The saltmarsh at Cleavel Point underwent restoration following the excavation of a 0.15m diameter backwash pipeline in 1997/1998. *Spartina* was transplanted using turfs of approximately 0.15m square taken from the adjacent marsh. Care was taken to ensure that *Spartina* squares were removed from random locations so that the production of large bare patches was avoided. The turfs were replanted ‘firmly’ to prevent them from being washed away at the next tide and pegged in a 1m intersecting grid. It was important to plant the turfs at the same soil depth and tidal location as that at which they were originally growing.

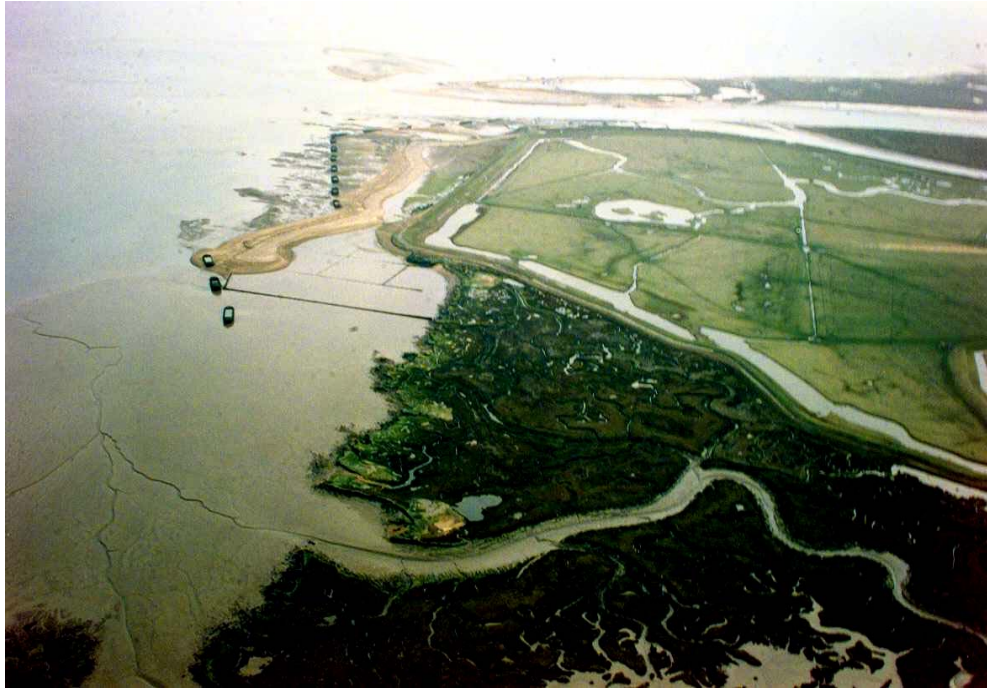
**Figure D.7** Recharge scheme at Horsey Island (source: Environment Agency)

The Horsey Island recharge scheme is considered to be one of the most successful projects of its type carried out in the UK in terms of providing the coastal defence function for which it was designed. The abundance of the ragworm *Nereis*, supports a thriving Sea Bass fishery and bird populations. A new marsh habitat also formed behind the recharged material.

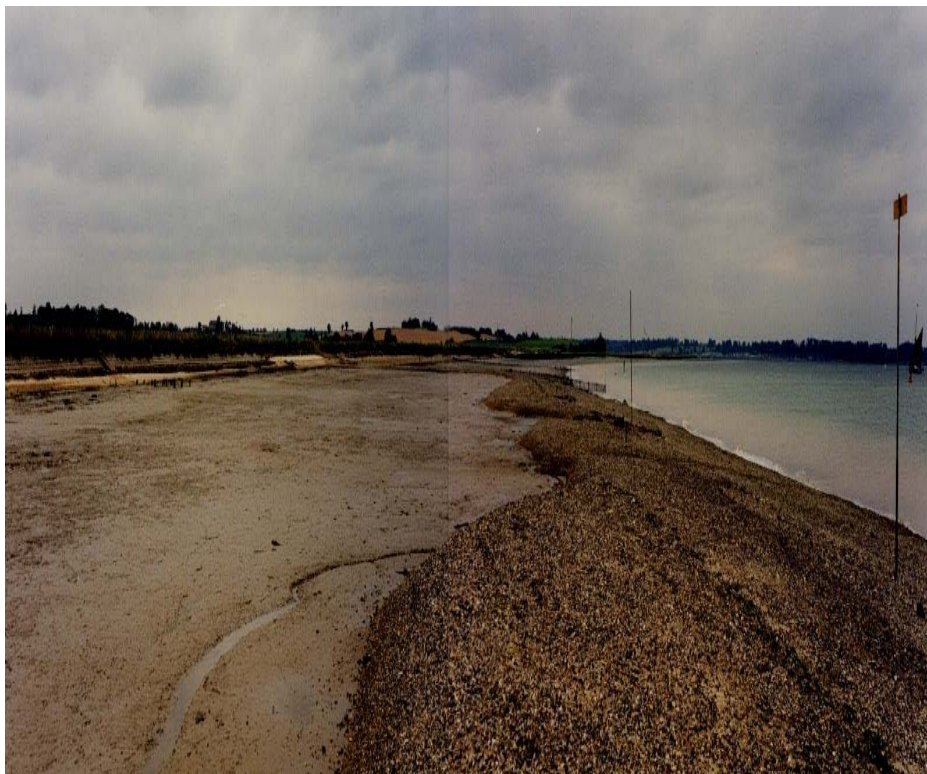
**Figure D.8** Recharge scheme at North Shotley (source: Environment Agency)

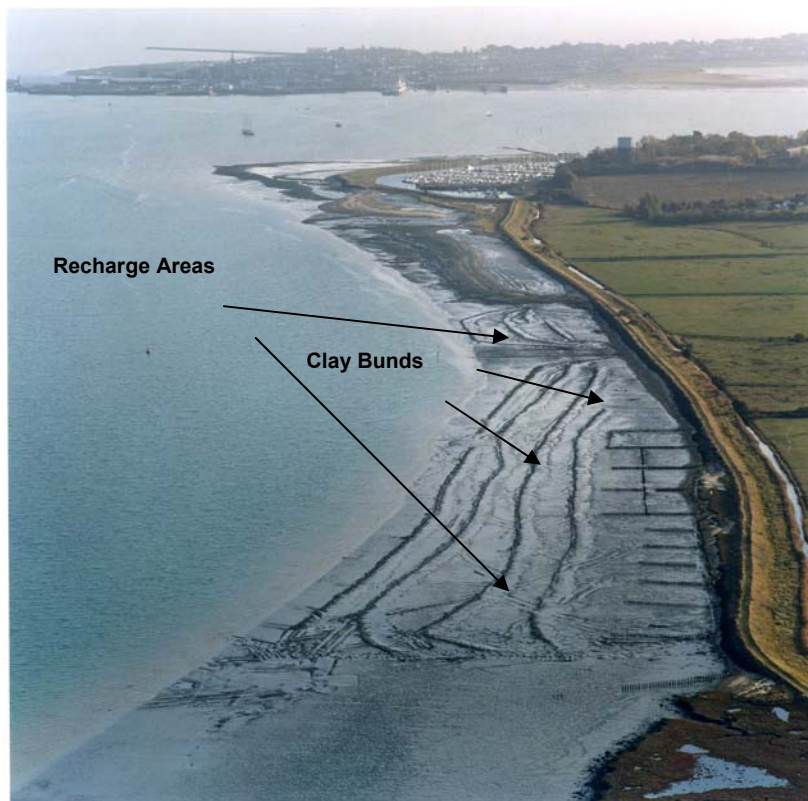
Figure D.9 Shotley habitat enhancement scheme

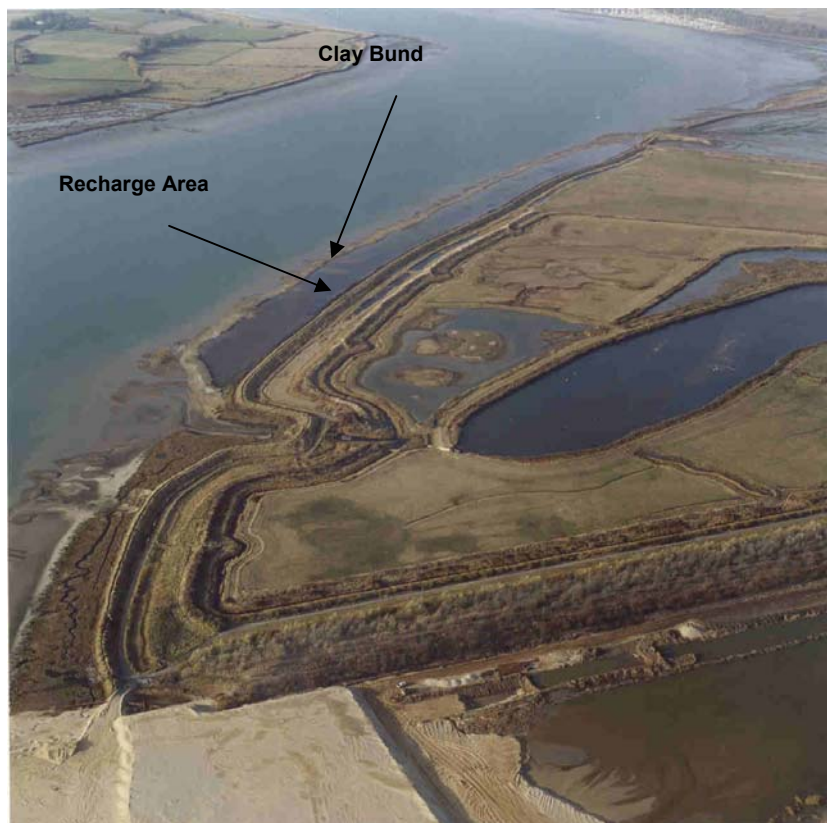
On the Trimley side of the Orwell, schemes were implemented that utilised both clay and gravel for the bunding. Following the removal of silt from the approach channel, gravel was dredged from the new approaches and placed in the quay construction zone and onto the Trimley foreshore in order to construct the habitat enhancement bunds, including a gravel island for nesting little terns. Approximately 22,000m<sup>3</sup> of gravel was placed on the Trimley foreshore for the bunds and 80,000m<sup>3</sup> stored for the gravel island, which covers approximately 1 hectare above high water.

**Figure D.10 Trimley habitat enhancement scheme**

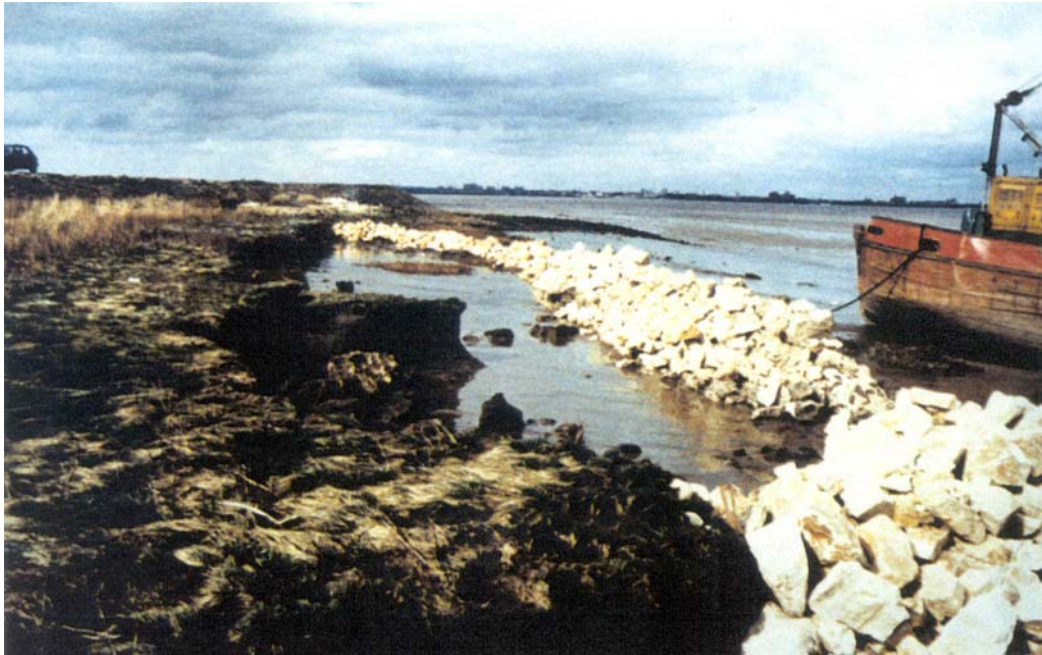
**Figure D.11** Construction of the rock beach sill, Goxhill on the Humber (from Toft et al., 1995)

Accretion at Goxhill was greater with over 80cm being deposited in the two year period. This resulted in reducing the height of the saltmarsh cliff from 1.5m to 0.8m, which would have a significant effect on supporting the toe of the seawall. Saltmarsh plants also colonised the accreted mud between the mound and the saltmarsh cliff. Monitoring carried out at Barrow Haven also revealed an increase in sediment levels.

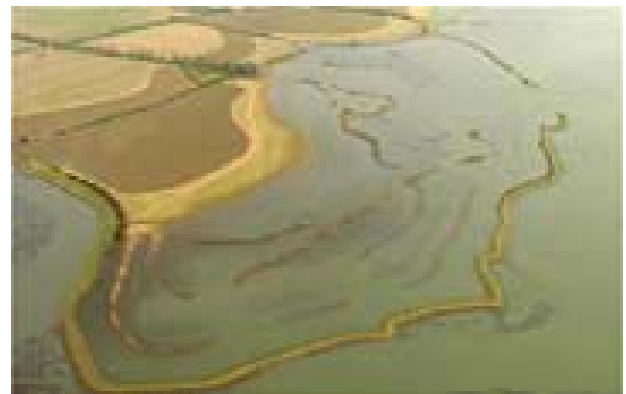
**Figure D.12 Abbots Hall Farm, before breach**  
(source: Environment Agency)

**Abbots Hall Farm, after breach**

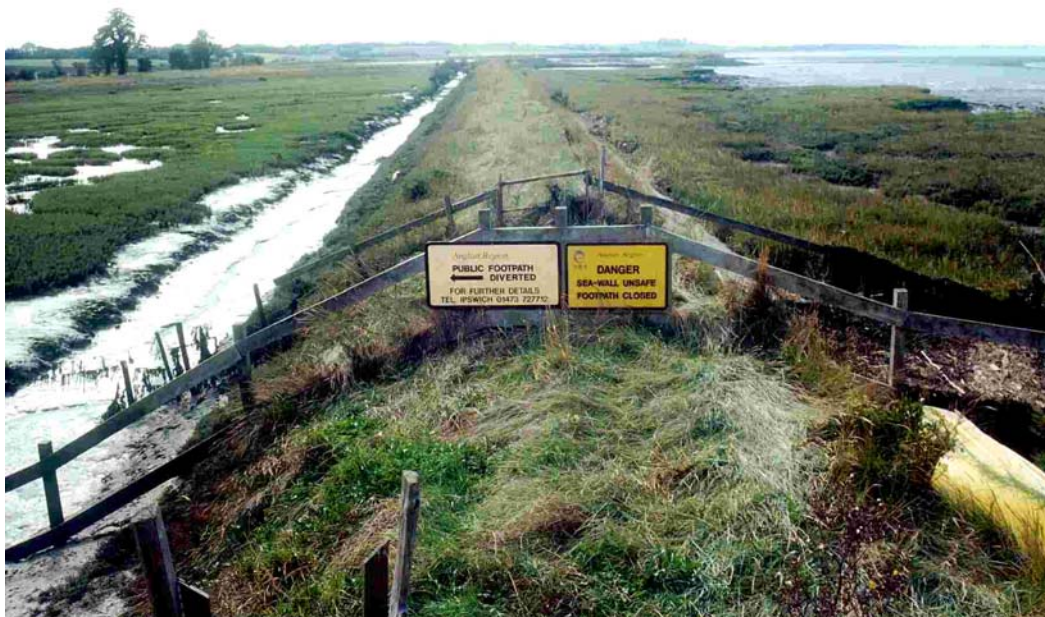
**Figure D.14 Orplands sea wall post breach; looking westwards along seawall from eastern end of site, showing badly eroding saltmarsh outside of the breached sea wall (to the right) and retreat site to the left of the picture (source: Environment Agency)**

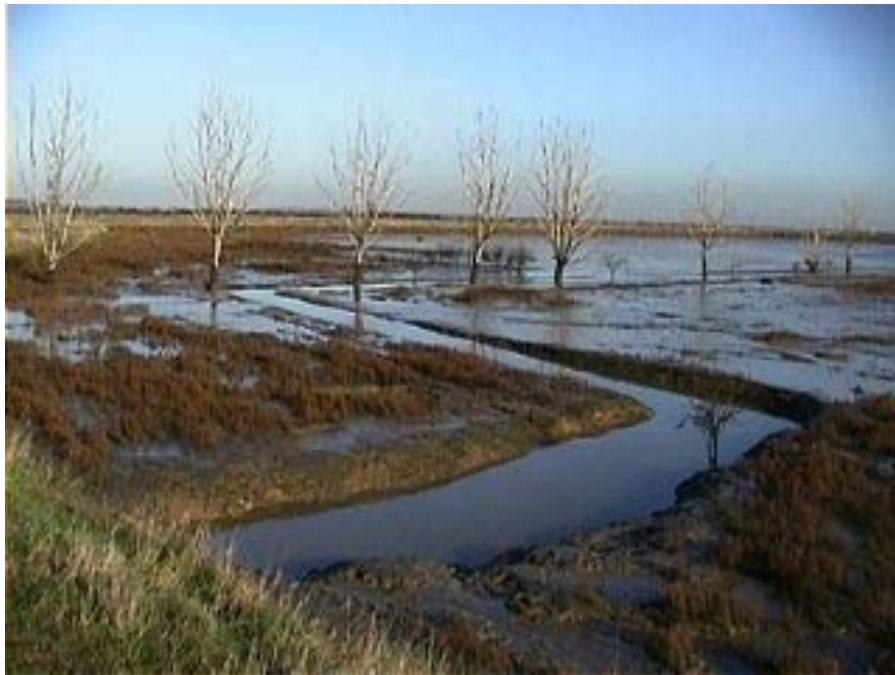
**Figure D.15** Tollesbury realignment site at High tide (from *Living with the Sea*, 2003)

By 2001, approximately 6ha of the 21ha site had been colonised by saltmarsh vegetation. The lower limit of the vegetation corresponded with the 1.5m contour. The dominant vegetation community established within the site was annual *Salicornia* saltmarsh, which composed of large strands of *Salicornia europaea* agg. (common glasswort) at high density, often with no other species. *Puccinellia maritima* (common saltmarsh-grass) and *Atriplex portulacoides* (sea purslane)

species that dominate the vegetation communities of the adjacent marshes were restricted to the highest land in the area near the foot of the new sea wall (>2.2m OD).

During the monitoring period, accretion rates showed no indication of declining, with an average of 23mm accretion per annum. However, there was considerable within-site variation, ranging from 8mm to 258mm of sediment build up over the original agricultural surface. Most of the variation was accounted for by differences in elevation.

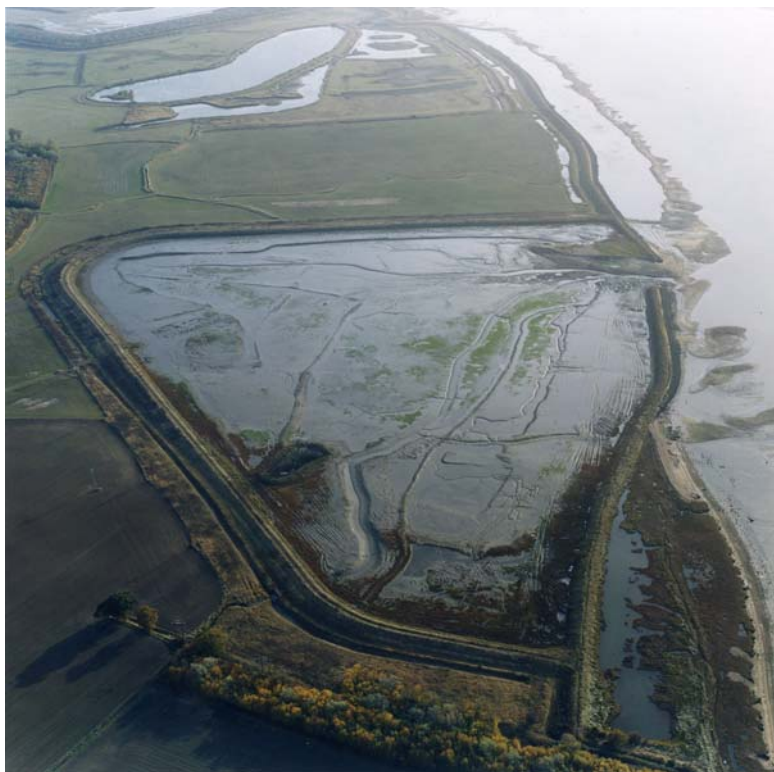
**Figure D.16 Trimley Marsh Managed Realignment Site (Posford Haskoning, 2004)**

One of the required criteria for the site was that no more than 30% of its area should develop into saltmarsh. At least 70% of the retreat area was, therefore, designed to be below the level of +3.5m CD, as saltmarsh was estimated to develop at levels higher than +3.5m CD. The entrance (i.e. the breach in the sea wall) was designed at +1.5m CD so that the site would completely drain at low tide.

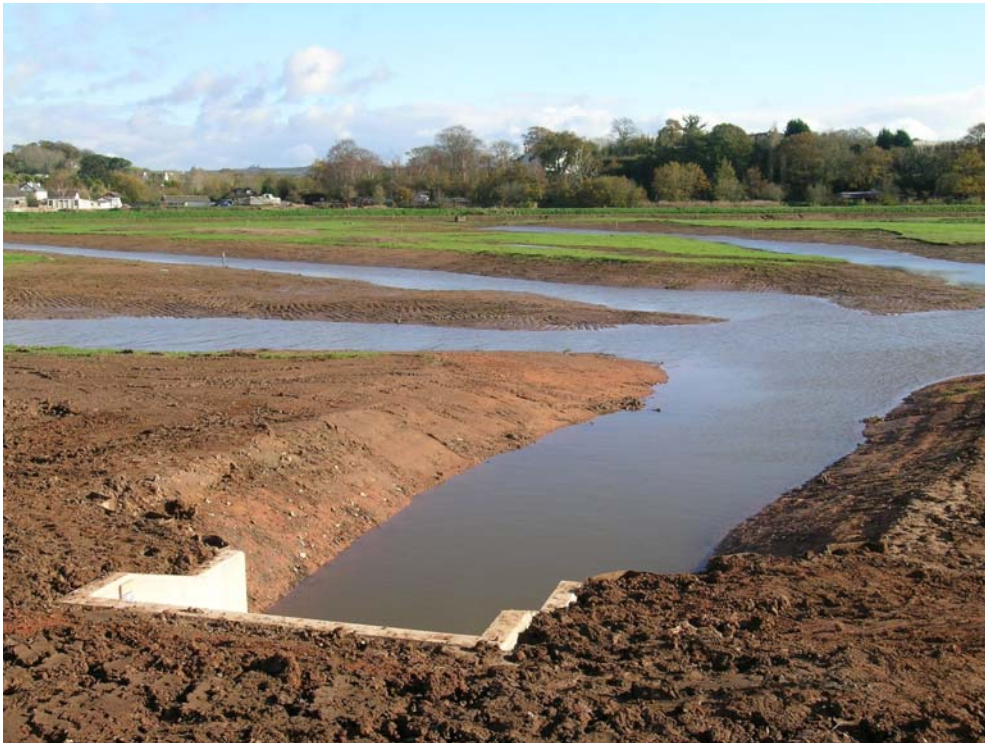
**Figure D.17 Internal creek network at Goosemoor (copyright AJ Bellamy)**

- Excavation of existing drains and ditches to create the new creek system
- Reprofilling of ground levels to create the intertidal habitat areas
- Creation of a secondary bank along the foot of the railway embankment
- Installation of a 1.0m internal diameter pipe through the sea wall with a Self Regulating Tidegate (SRT) on the seaward side, and a sluice in the inland side, to retain on-site water
- Excavation of a channel to link the River Clyst with the SRT and pipe

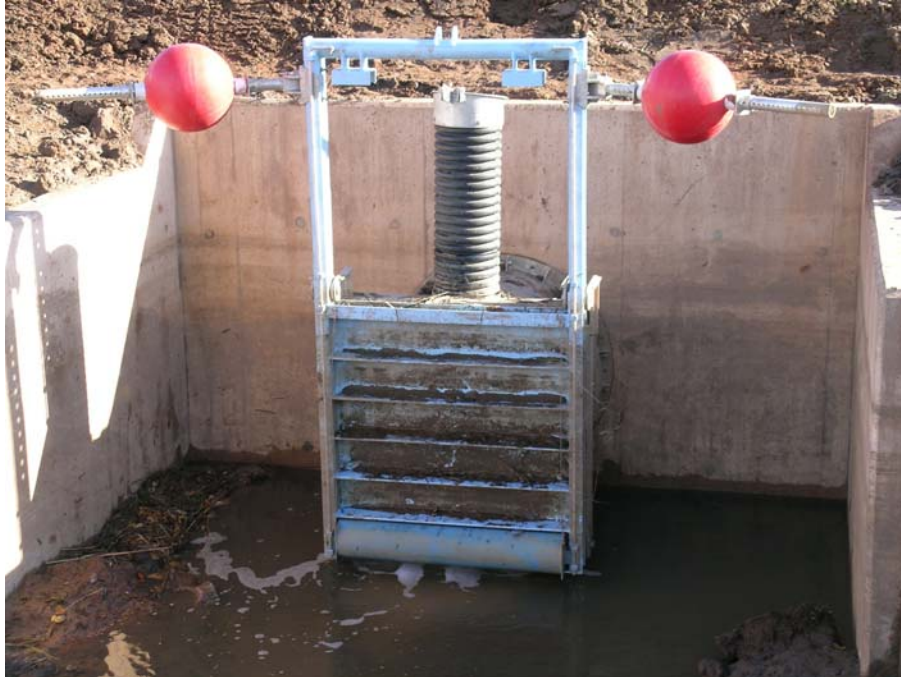
**Figure D.18 Self regulating tidegate imported from the USA (copyright AJ Bellamy)**
