Understanding the lowering of beaches in front of coastal defence structures, Stage 2 Technical Note 8

Understanding the lowering of beaches in front of coastal defence structures, Phase 2

Mitigation methods

Technical Note CBS0726/08 Release 4.0

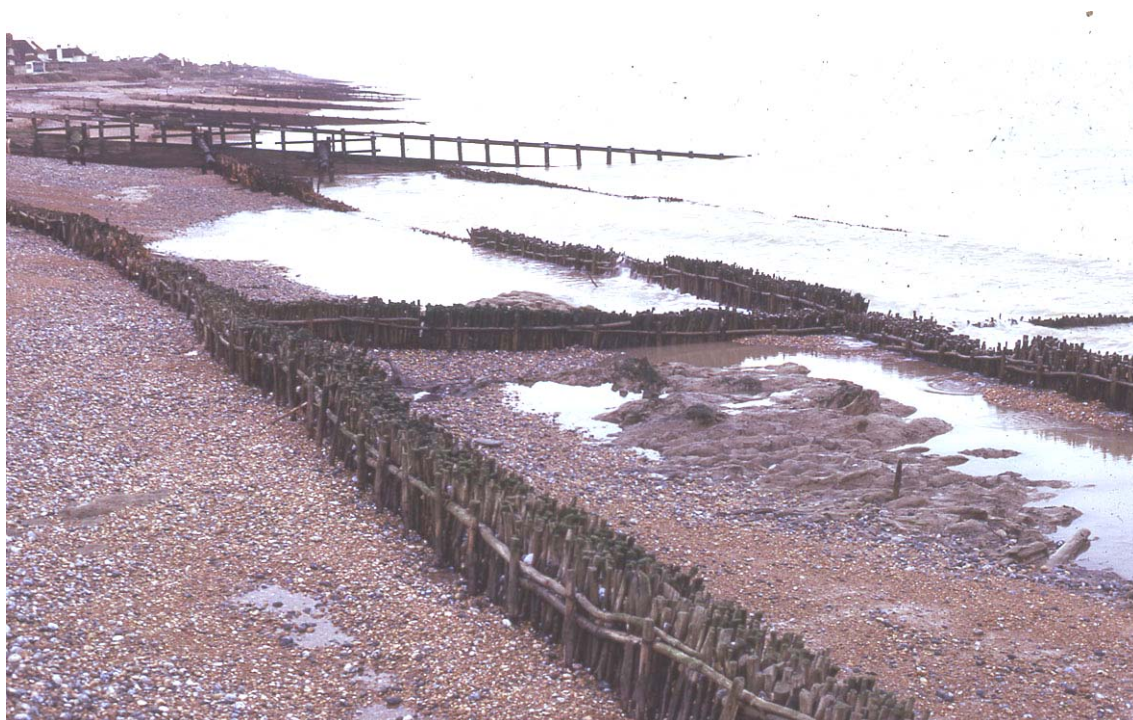
Plate 1 Fagotting at Cooden shingle beach, Pevensy Bay, 1983

Low-cost beach stabilisation, using fagotting, i.e. installing lines of brushwood stakes “dug” into the beach, was in wide usage on the south-east coast of the UK some forty to fifty years ago. Relatively low cost stabilisation has also been carried out, in the past, by means of driving timber posts mechanically into a beach to provide partial shelter to the upper beach from waves. Both methods have now largely fallen out of favour, due to the need for periodic repair or replacement, which can be labour-intensive.

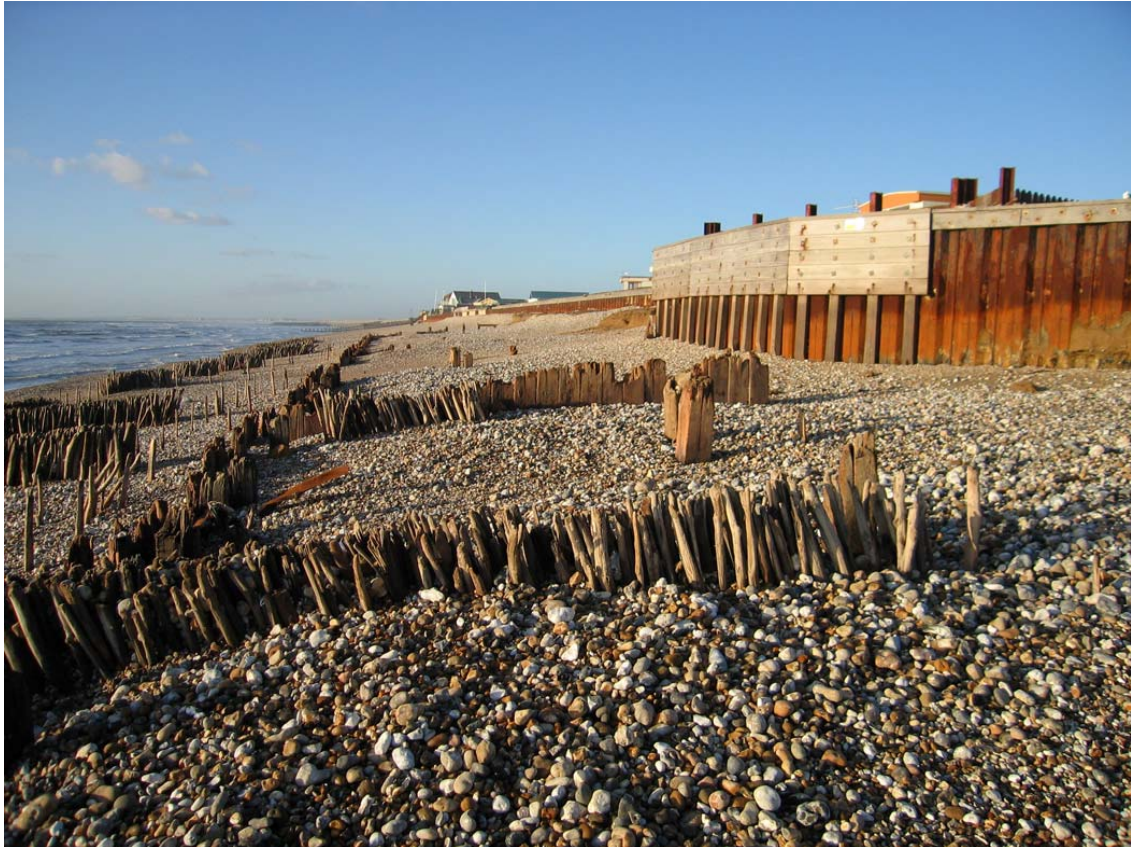
Plate 2 Fagotting at Medmerry, West Sussex, 2006

Fagotting was also used by the local Water Authority at Medmerry, West Sussex, on a low-lying coastline that was totally dependent on a narrow shingle ridge to prevent flooding (see Plate 2). Here, it was installed to retain a shingle cover over the underlying substratum of Bracklesham Clays. In the 1970s, the shingle ridge was nourished with shingle and has subsequently been managed by recycling, with periodic re-nourishment also being carried out. Falling beach levels have recently exposed the fagotting that has been buried for so long (see Plate 2). It can be seen that, despite all expectations, the fagotting is relatively intact, and with few signs of decay or marine borer infestation. However, the fagotting does appear to be ineffectual in stabilising beach levels at this location.

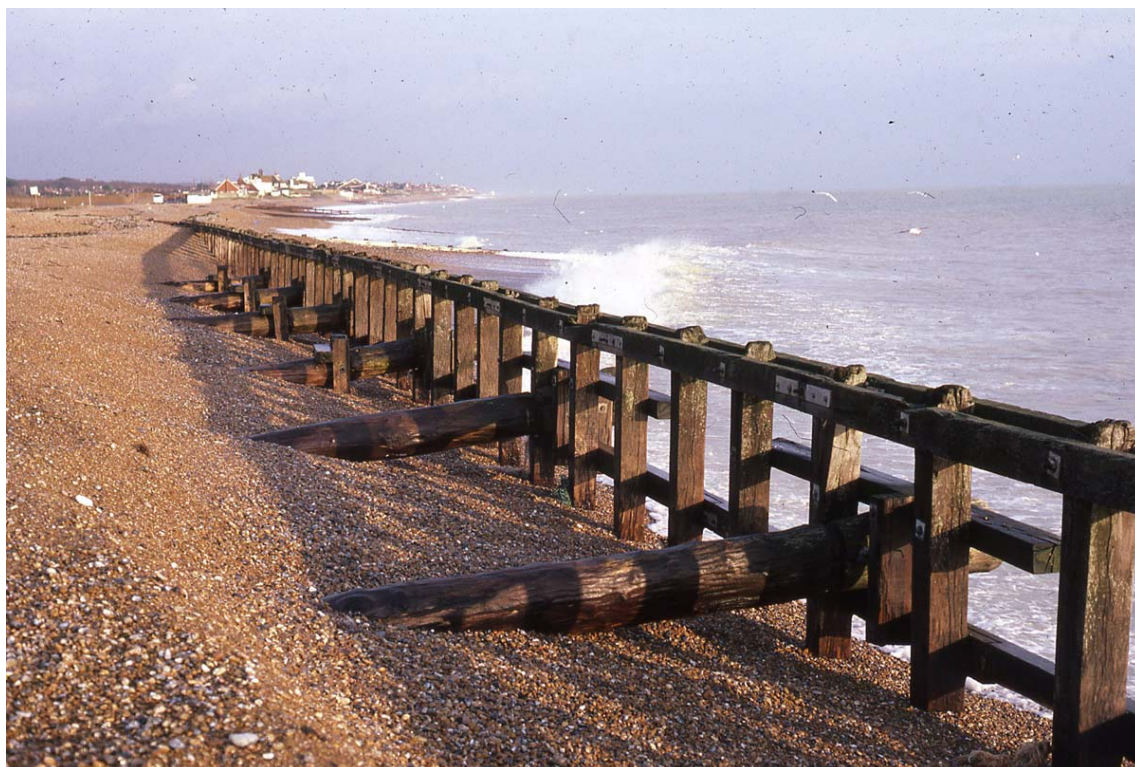
Plate 3 Wave breaker at Cooden Beach, Pevensey Bay, 1986

Examples of wave breakers are shown in the Plates 3 and 4. Plate 3 was taken in 1986 at Cooden Beach, Pevensey Bay. This is one of several such structures employed along this frontage to reduce shingle beach erosion and minimise the threat of wave overtopping (timber breastworks have also been used in this area). The structure shown is now too permeable to be effective in reducing wave action, or for retaining material to landward.

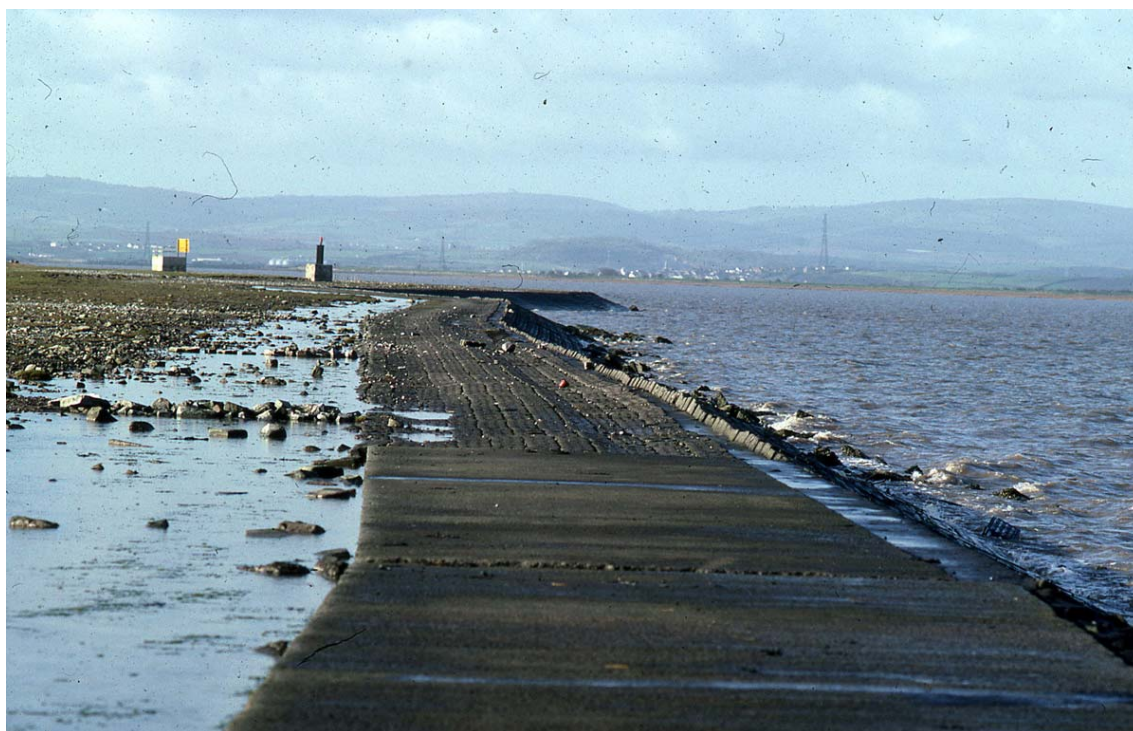
Plate 5 Concrete mattress revetment, West Huntspill, Somerset, 1993

Precast articulated concrete mattresses have been used successfully, in some sheltered locations, to protect earth embankments along the coastline and have the potential to be used as scour mattresses in front of seawalls. These would probably now be preferred in most situations to the older technique of using a fascine mattress overlain by stone. In 1983, a scheme consisting of interlinked concrete mattresses linked by cables, to form a continuous revetment, was installed at West Huntspill, Somerset, near the mouth of the river Parrett (see Plate 5). In this relatively sheltered environment the revetment has been relatively successful in reducing erosion of the salt marsh edge. However, even here, where the wave action is weak and infrequent, the system has been subject to some damage. Such damage would obviously be much more serious had the revetment been laid down within the inter-tidal zone, rather than on the backshore. Repairs by concrete patching, however, are fairly simple and cheap. We have found no other examples of these types of concrete mattresses around the UK coastline in the present research project. Further details on the use of such mattresses to form revetments, can be found in McConnell (1998).

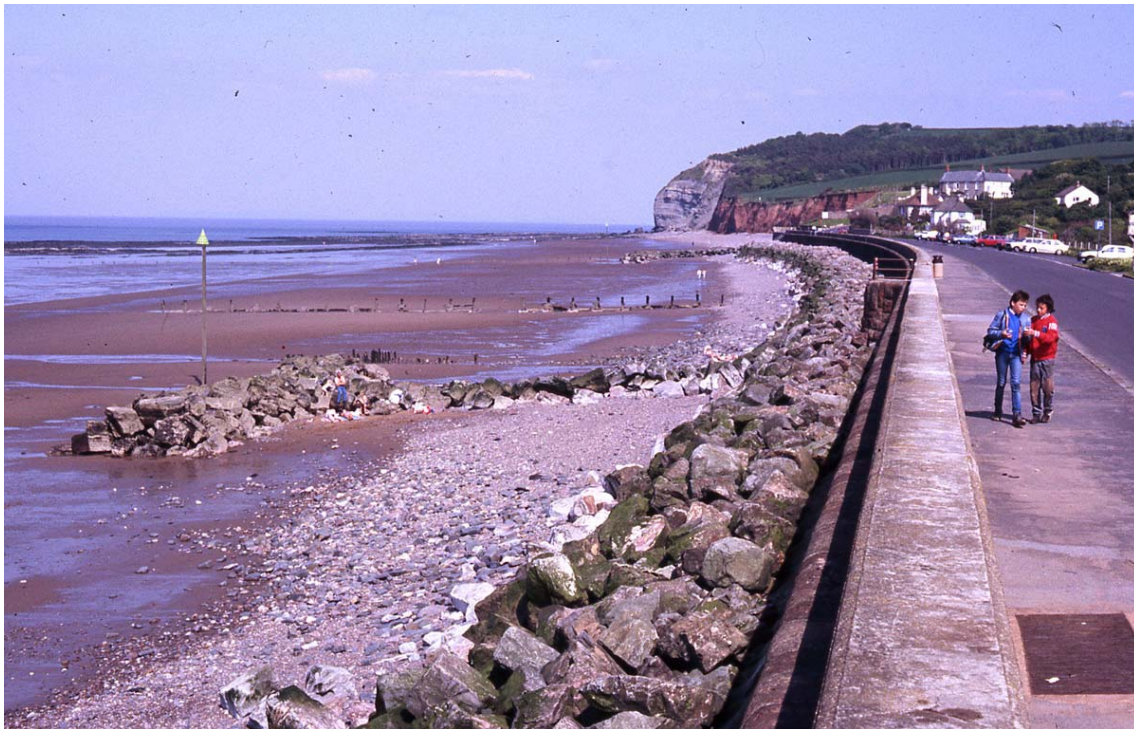
Plate 6 Rock fillet and groynes, Blue Anchor Bay, Somerset, 1988

Plates 6 to 9 provide illustrations of the use of rock to protect seawalls that were at risk of undermining, and were suffering from increased overtopping and/ or abrasion. Notice that Plate 8 shows a fillet built using a mixture of rock and concrete armour units. All of the mitigation measures described in this section could potentially be built using concrete armour units if this was a cheaper option, although this would probably make the filter requirements more onerous.

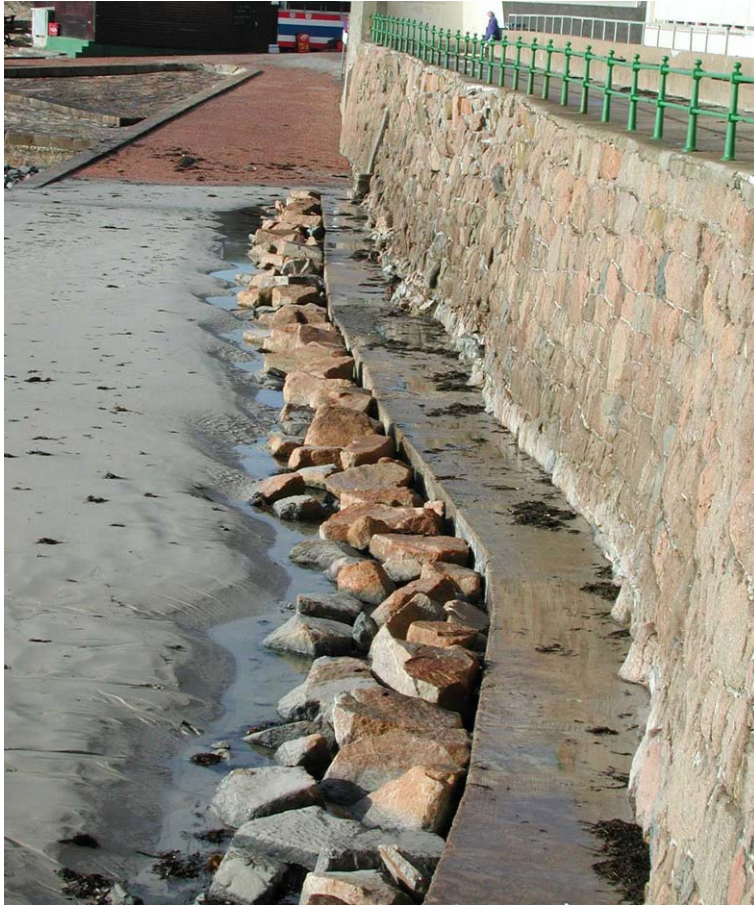
Plate 7 Rock infill of scour trough, Le Dicq, Jersey, 2005

More modest uses of rock as sketched in Figures 1(a) - (c) are intended to prevent undermining of the structure, allowing it to continue to perform as originally intended. The simple infilling of a scour trough, even using relatively small rock, e.g. rubble, is reported as being beneficial, although there is little published information on this topic. Wider and more substantial rock “blankets” as sketched in Figure 1(b) are less common in the UK, but have been used with some success to cover trenched cables and pipelines, and to reduce scour around breakwaters. These two options, together with the sloping rock toe shown in Figure 1(c) are normally designed to be at or just below lowest beach levels, and may well be covered by sediment for much of the time, only “emerging” in severe conditions. The permeable rough surface of these rock structures allows sand and gravel to remain within the interstices even in storms, and the rock is readily recovered by beach sediments once wave conditions reduce. The sand beach at Southbourne (HR Wallingford, 2006, Plate 1) has a rock fillet placed at a low beach level, at the toe of the sloping revetment shown in that photograph.

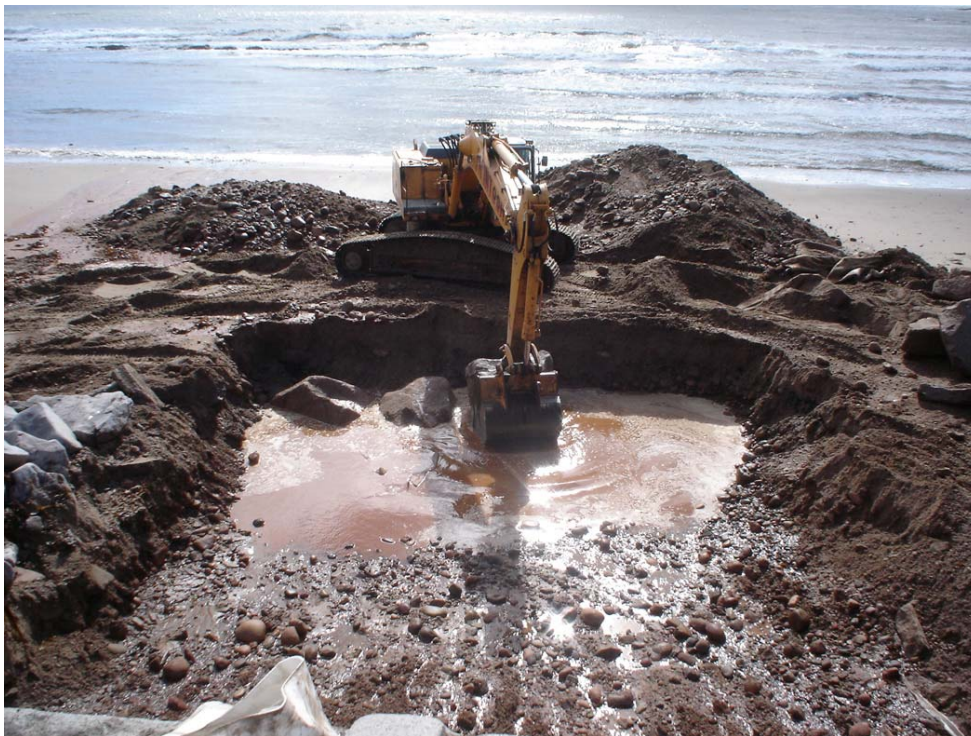
Plate 8 Installing sloping rock toe, Stonehaven, Aberdeenshire, 2004

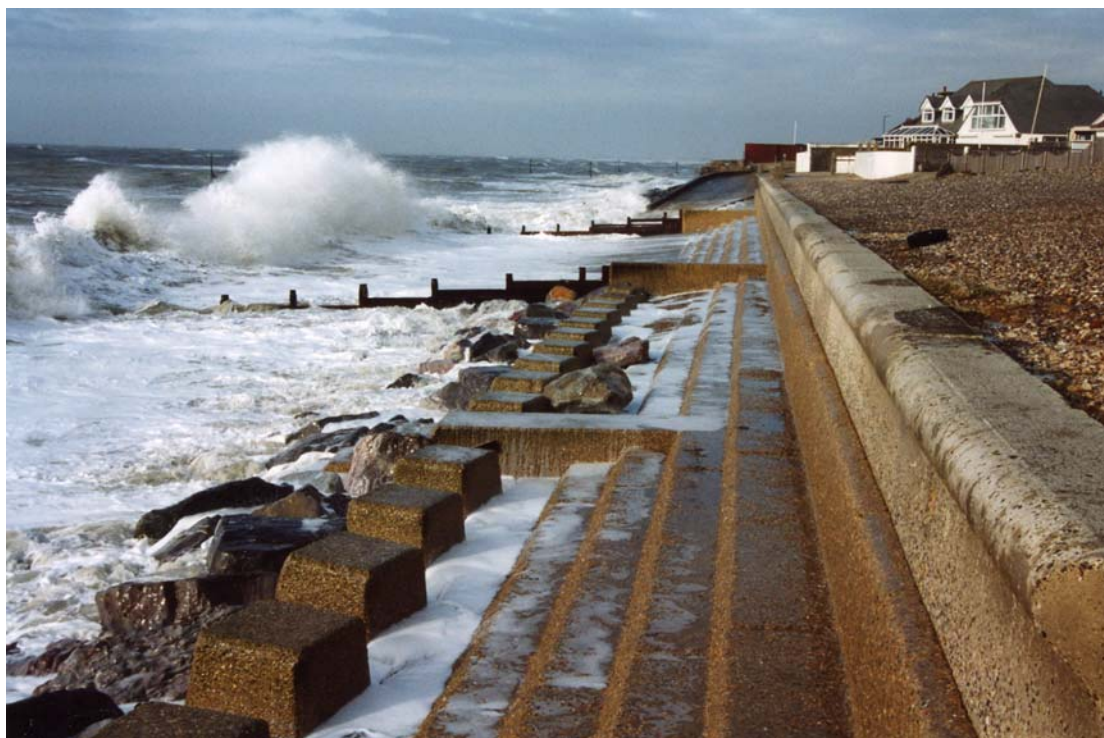
Plate 9 Concrete unit and rock fillet, Selsey Bill, West Sussex, 2006

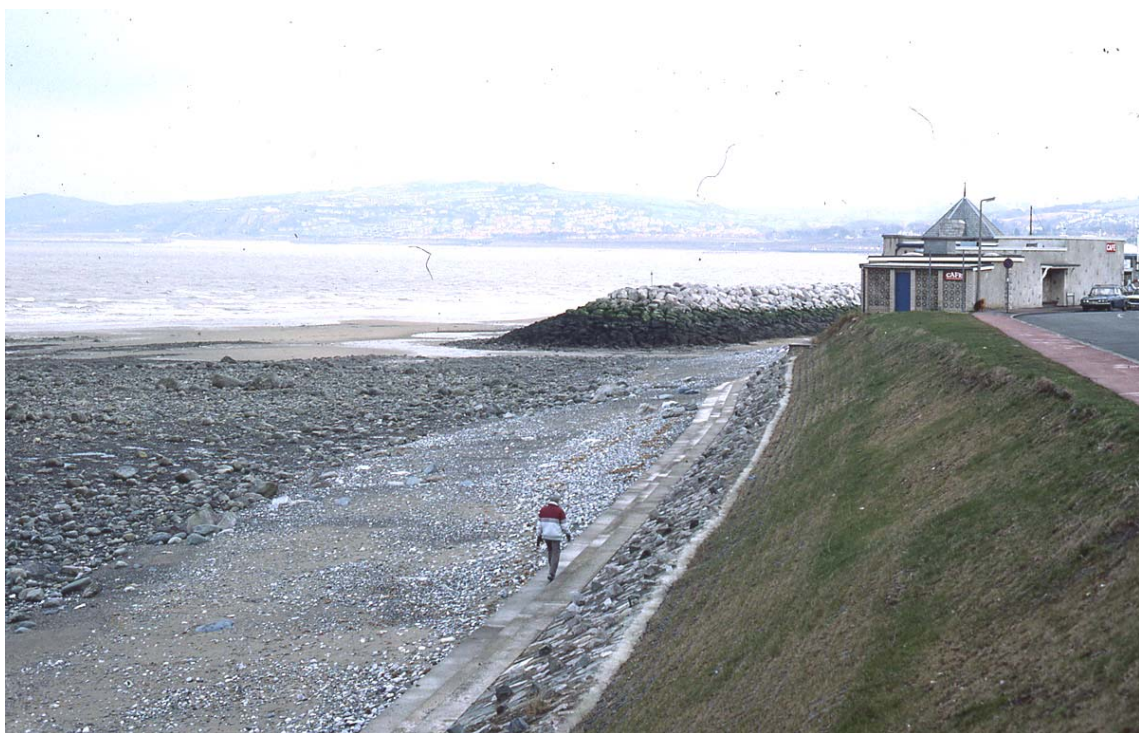
Plate 10 Detached breakwater, Rhos-on-Sea, Clwyd, 1986

The first detached breakwater in the UK was built at Rhos-on-Sea, Clwyd, in 1983 to reduce overtopping of the promenade and the coast road behind. This problem was particularly serious over a short frontage where the seawall formed a slight promontory jutting out from the general alignment of the frontage. The breakwater immediately reduced the overtopping problems and built up a sand and shingle beach in its lee (see Plate 10). The beach has now widened so that it now extends along the seaward face of the breakwater, so that the longshore sediment transport past this point is not interrupted, restoring the supply of sediment to the downdrift beaches, further east.

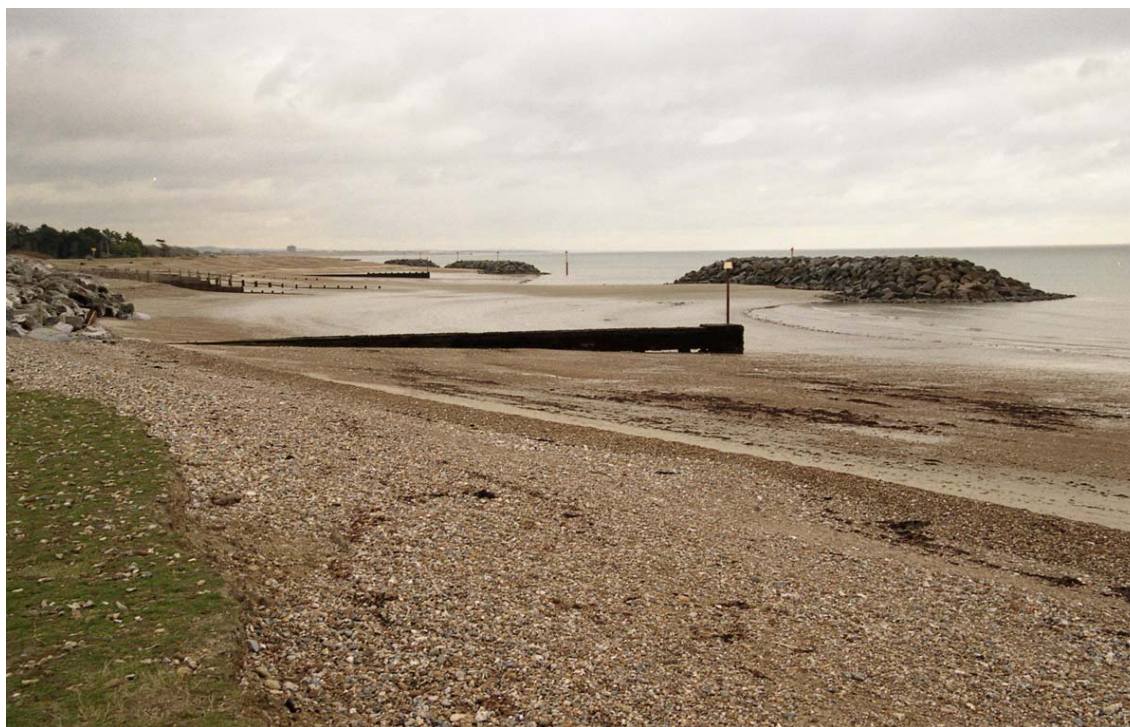
Plate 11 Detached breakwaters, Elmer, West Sussex, 2005

More recently, a series of detached breakwaters were constructed over the sandy lower foreshore at Elmer, West Sussex (Plate 11) immediately updrift of a “terminal groyne” with associated nourishment to prevent downdrift erosion. They have eliminated the overtopping that was taking place at the shorefront properties, although some erosion has occurred in one of the gaps between the breakwaters, and along the downdrift coastline.

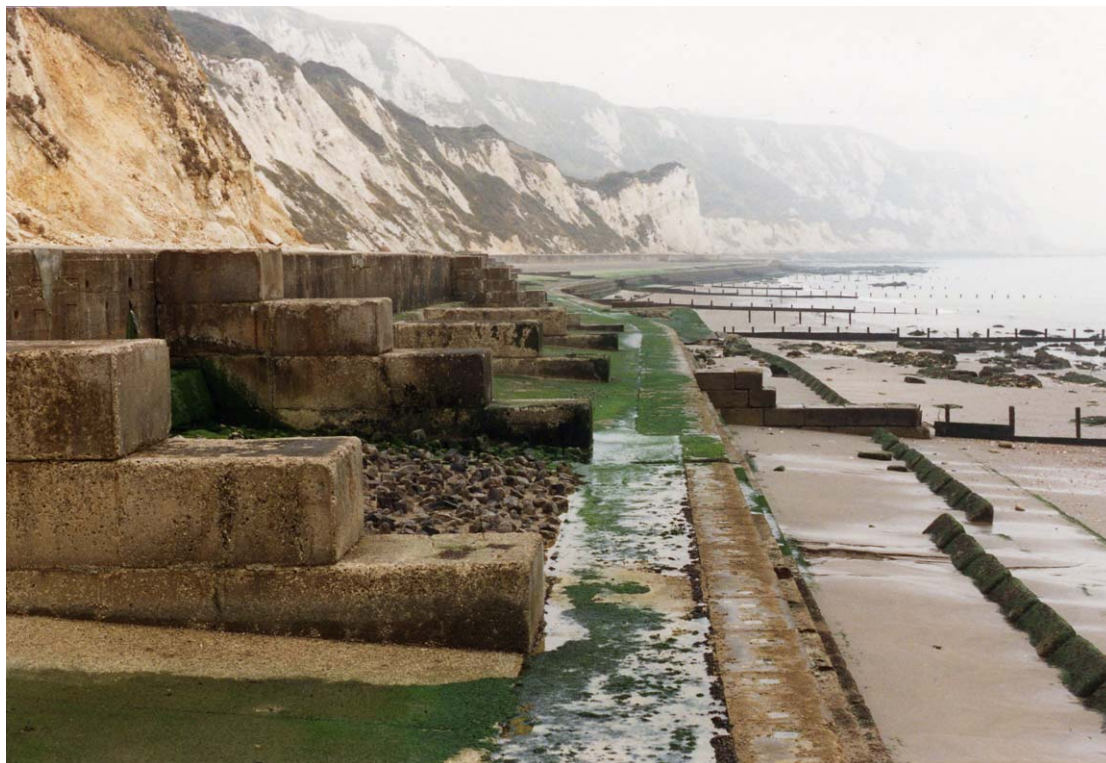
Plate 12 Concrete sill, East Wear Bay, Folkestone, 1986

One example of a concrete sill is found in East Wear Bay, Kent (see Plate 12). In this application the sill was constructed at the same time as the wall itself and thus forms an integral part of the seawall toe. The concrete sill is exposed at mid tide and serves to reduce the wave impact on the seawall, as well as preventing scour at the wall toe itself. Sills of this type are clearly not ideally suited for use on amenity beaches, but are very good at prolonging the life of the wall itself.

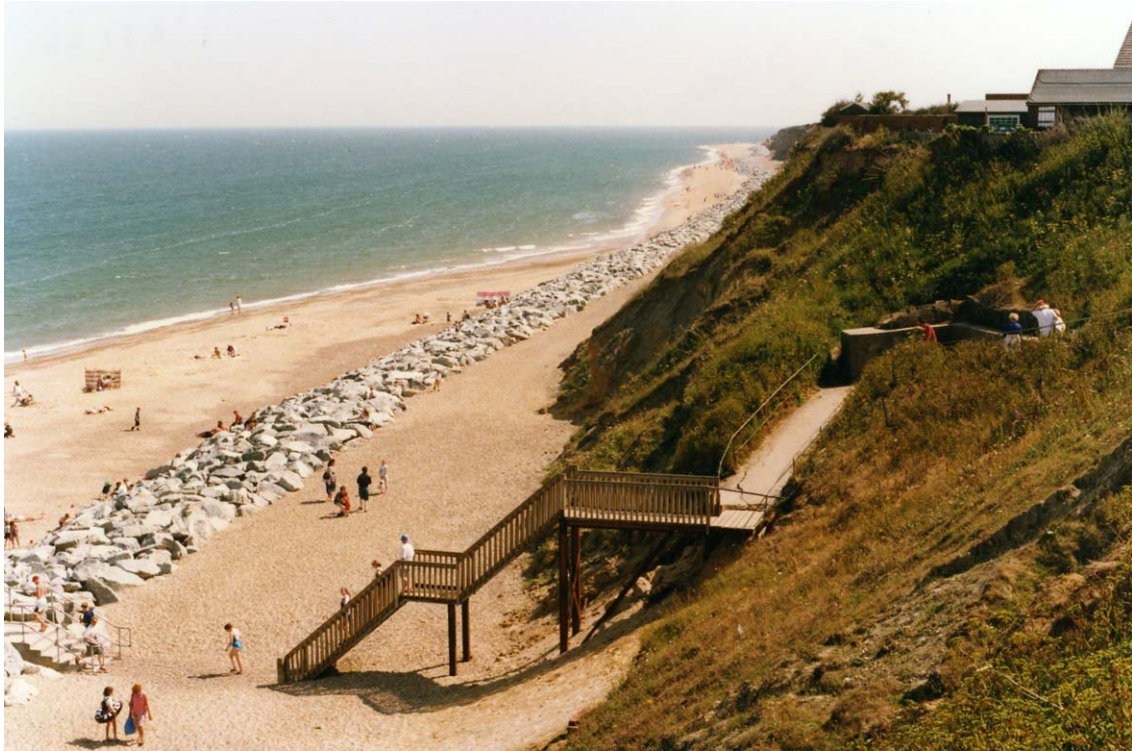
Plate 13 Rock sill, California, Norfolk

It is more usual for sills to be constructed of rock. An example of this can be found at California, Norfolk, where the sill has been constructed to maintain high beach levels at the foot of the sandy cliffs. With appropriate access over the sill, this appears to have been beneficial for tourism. Despite a large footprint, the rock sill provides a dry beach at all states of the tide (see Plate 13).

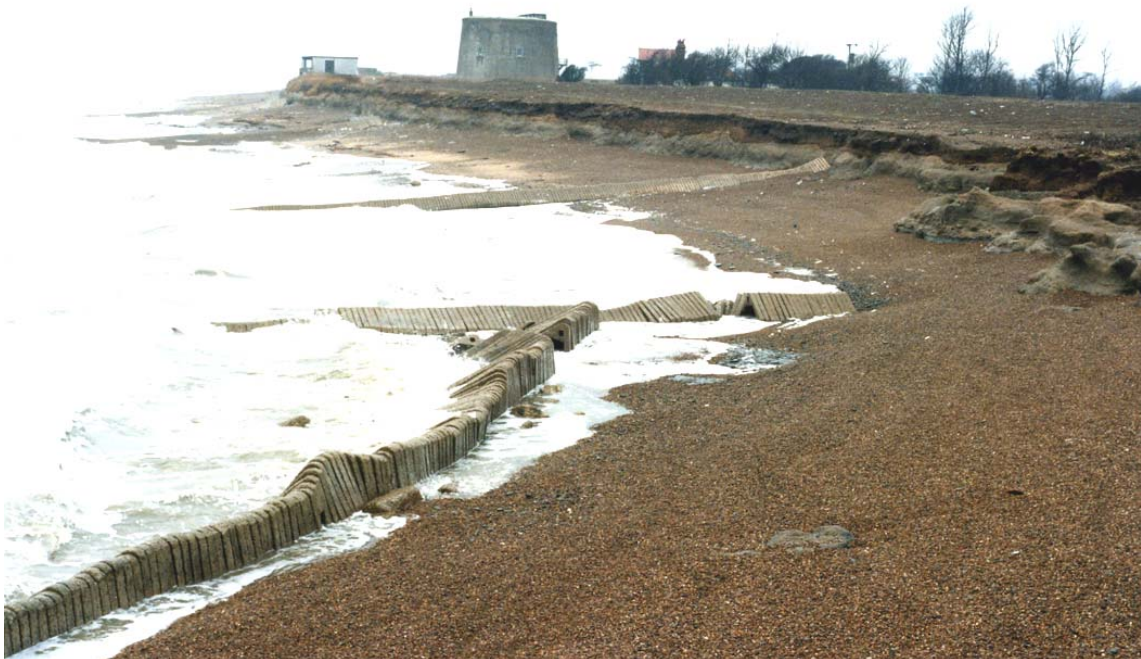
Plate 14 Concrete sill and groynes, Bawdsey, Suffolk, 1996

At Bawsdey in Suffolk, the erosion of a low cliff downdrift of a deteriorating seawall led to the experimentation with interconnected concrete units, rows of which were used to form low-crested groynes and sills (see Plate 14). In this instance the structures appear to be too modest in size to affect beach processes substantially. A similar structure constructed at Bawsdey Manor appears to have been more successful, being situated in more sheltered environment, having some protection by banks at the mouth of the river Deben (see Plate 15).

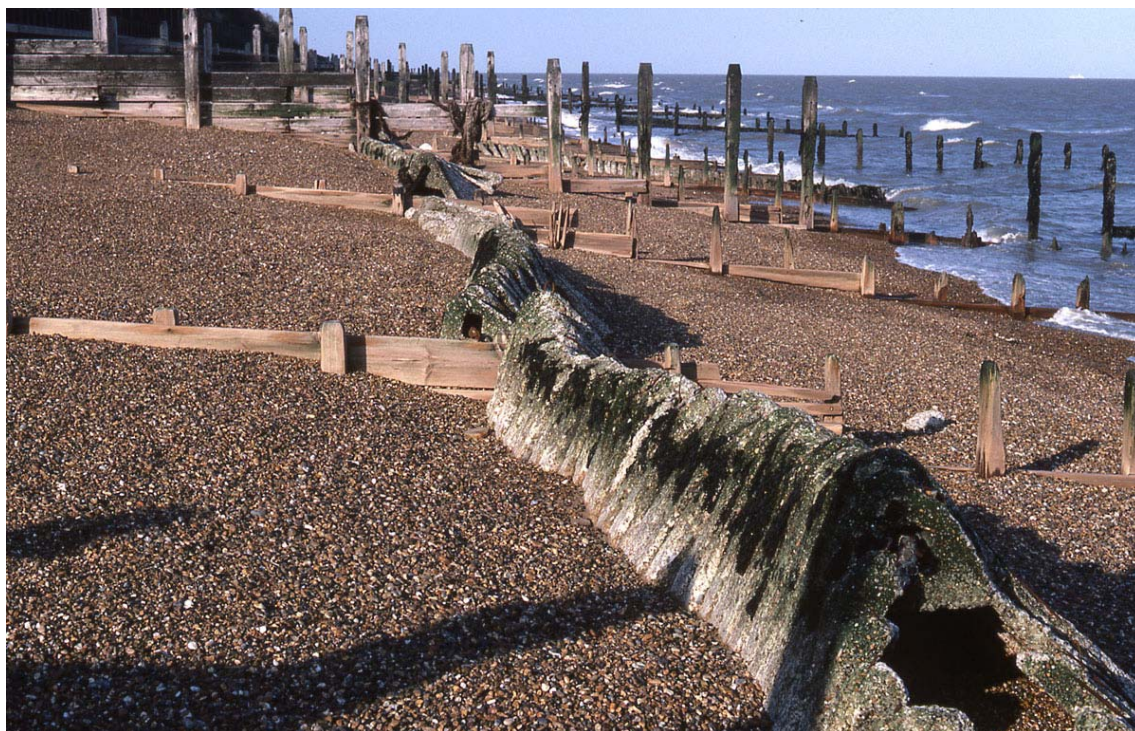
Plate 15 Concrete sill, Bawdsey Manor, Suffolk, 1986

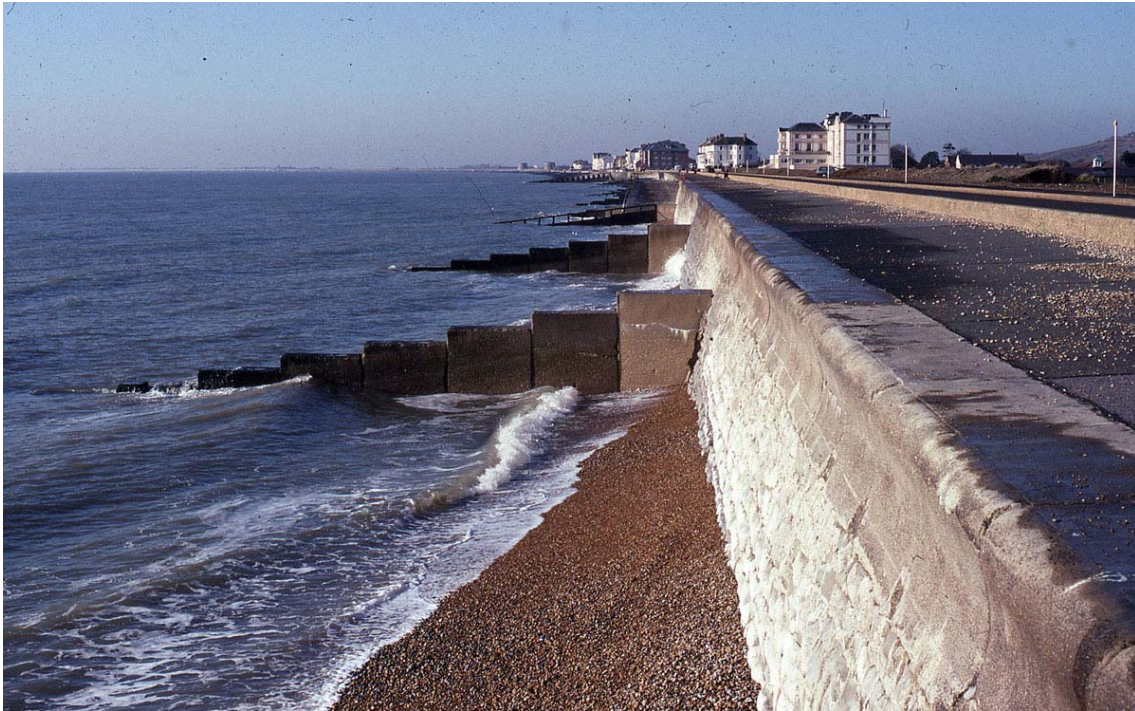
Plate 16 Old groyne field, Sandgate, Kent, 1986

High impermeable groynes may cause the beach plan shape to become saw-toothed, concentrating scour on one side of the groynes and increasing beach levels on the other, rather than a general improvement in beach levels along the whole shoreline (see Plate 16). This is a particular danger if groynes are built without an accompanying recharge as is now recommended (in this instance the frontage was subsequently nourished, long widely spaced rock groynes constructed, and beach material recycled as and when required). In front of coastal

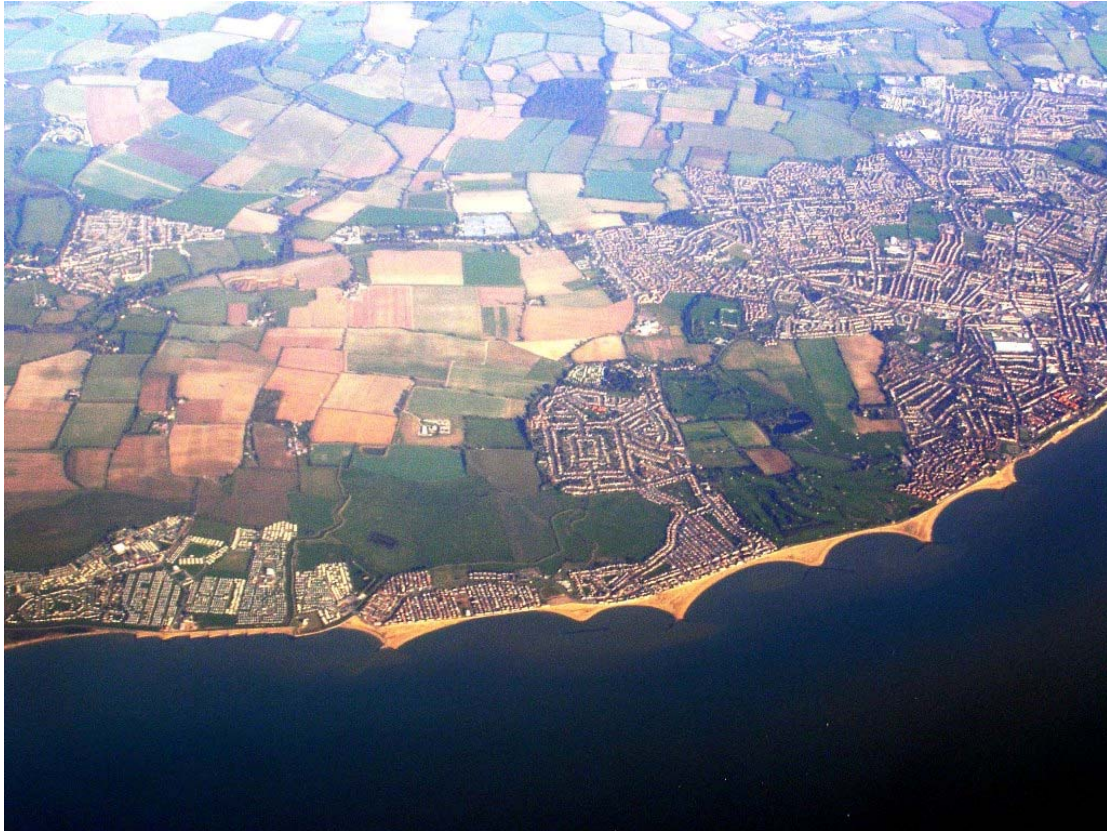
Plate 17 Variations in beach width caused by rock groynes at Jaywick

Plate 17 shows the wide variations in sand beach width caused by the rock groynes at Jaywick. However, in most instances the differential build up of beach levels is more acute on shingle than on sand beaches. Plate 18 shows an aerial view of the beach in the vicinity of Brighton’s easternmost pier. The acute change in beach alignment in this instance is affected by the changes in alignment of the backshore. This makes the efficiency of adjacent groynes of equal length vary markedly. In this photograph large quantities of sand being carried in suspension are apparent, by strong littoral currents skirting the groyne ends. Designing groyne systems under these rapidly varying conditions is greatly enhanced through the use of laboratory models.

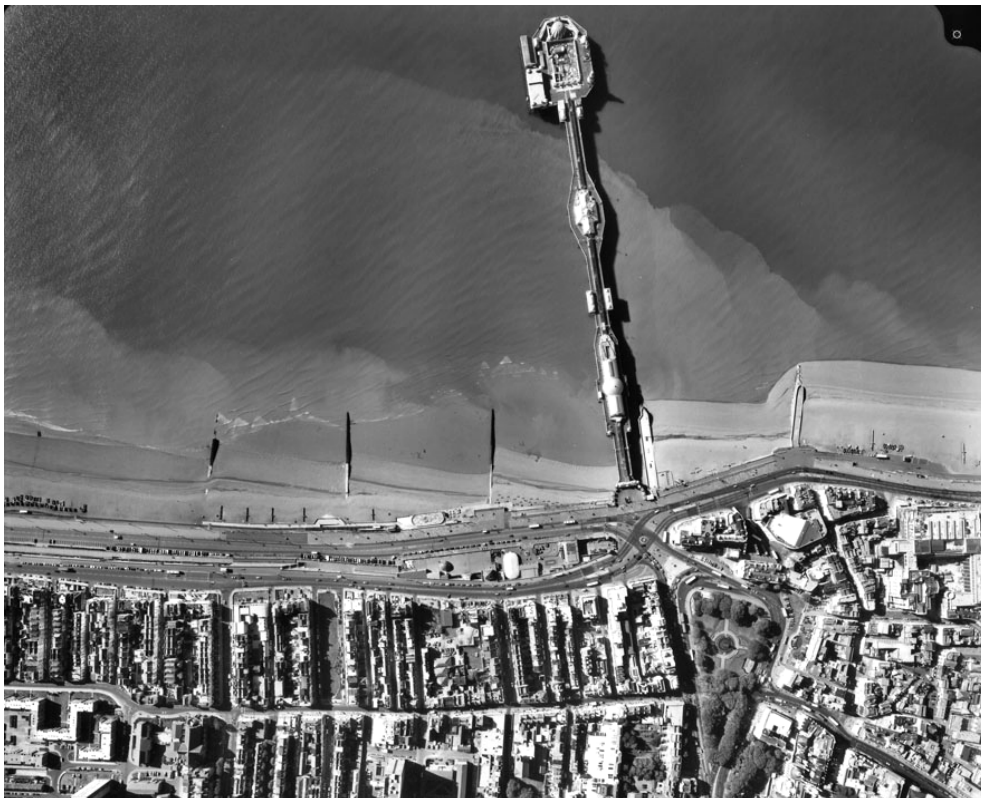
Plate 18 Saw toothed beach plan shape, Brighton

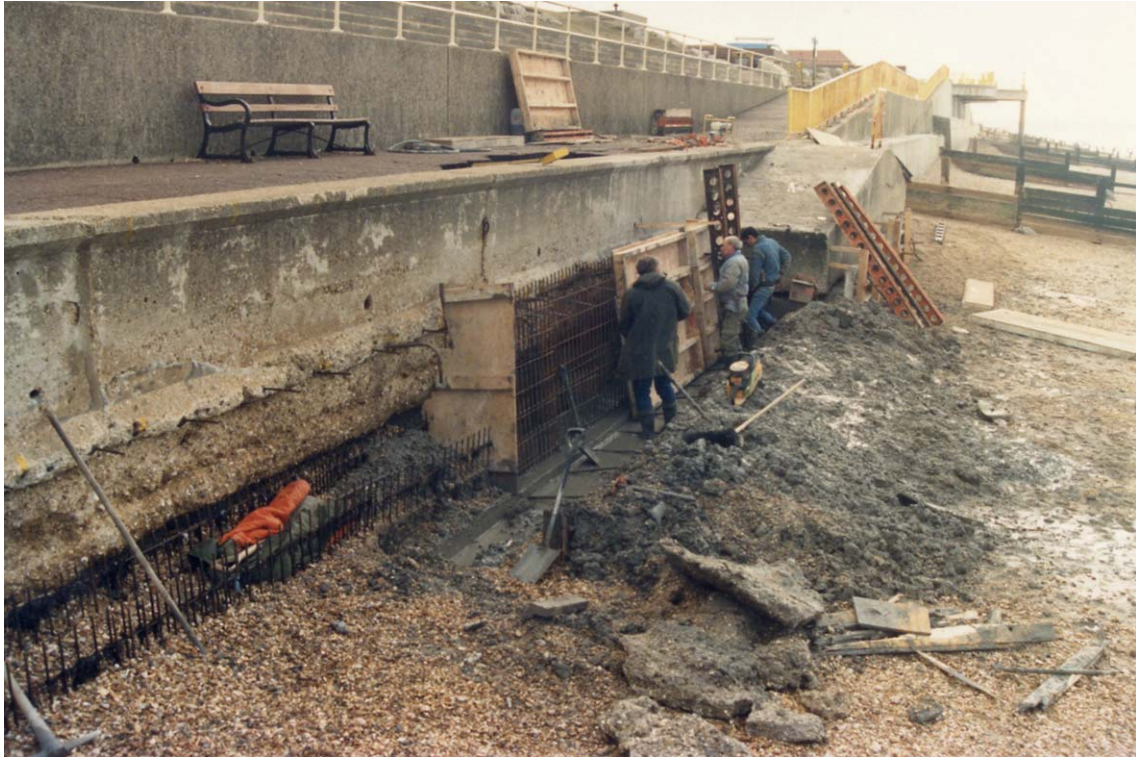
Plate 19 Extension of seawall footings, Lee on Solent, Hampshire

This type of mitigation of the effects of beach lowering is widely used in the United Kingdom, although there are few guidelines for such schemes. Plate 19 shows a typical operation to extend the toe of a seawall downwards. The base of the original wall, on the left-hand side of the photograph, can be seen to be well above the level of the gravel beach. This resulted in the loss of the “fill material” behind the seawall, followed by a partial collapse of the promenade surface into the void beneath. After the forming of a new deeper concrete toe, the void behind the seawall face was filled and the promenade re-instated. Apart from the small seaward extension at the toe of the existing wall, there is no change in the seawall profile.

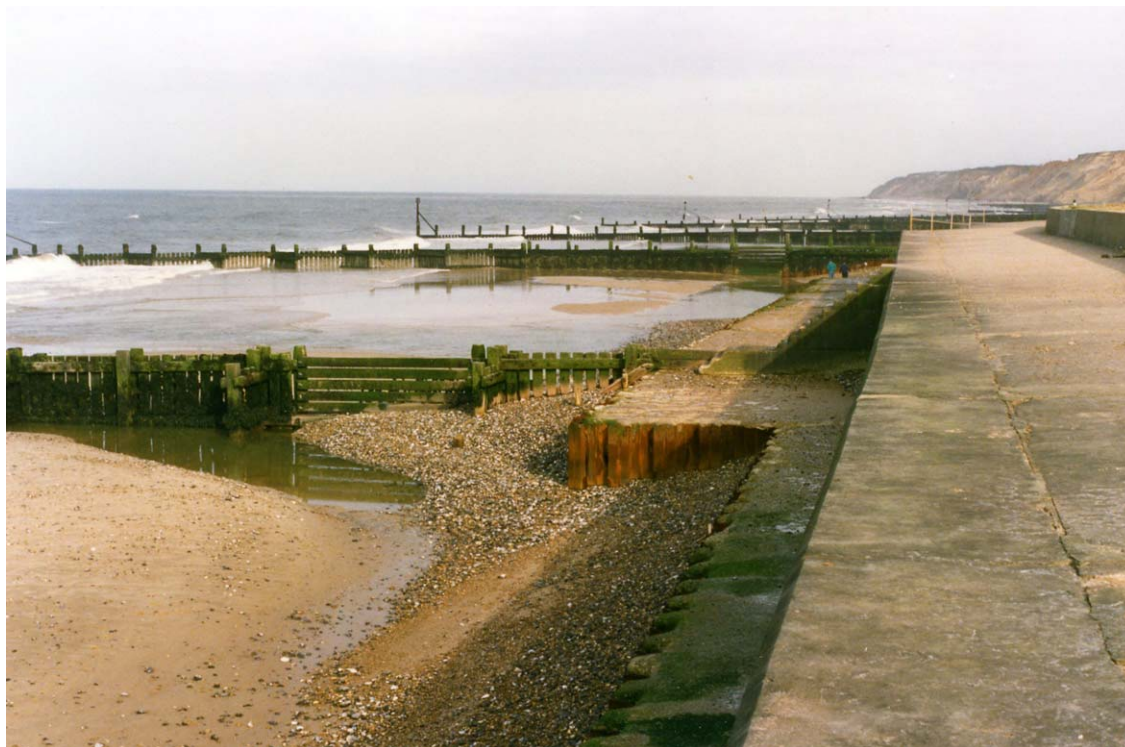
Plate 20 Vertical faced apron, Overstrand, Norfolk, 1991

Plate 20 shows the seawall at Overstrand, Norfolk. Here the extended footings form a substantial vertical-faced apron, modifying the profile of the wall. It can be seen that beach levels in front of the wall are lower close to the wall than just to the seaward, where a “bar” has formed. This may be an effect of the profile of the wall. Tidal flows and wave-driven longshore currents are strong along this frontage, and may also affect the beach profile.

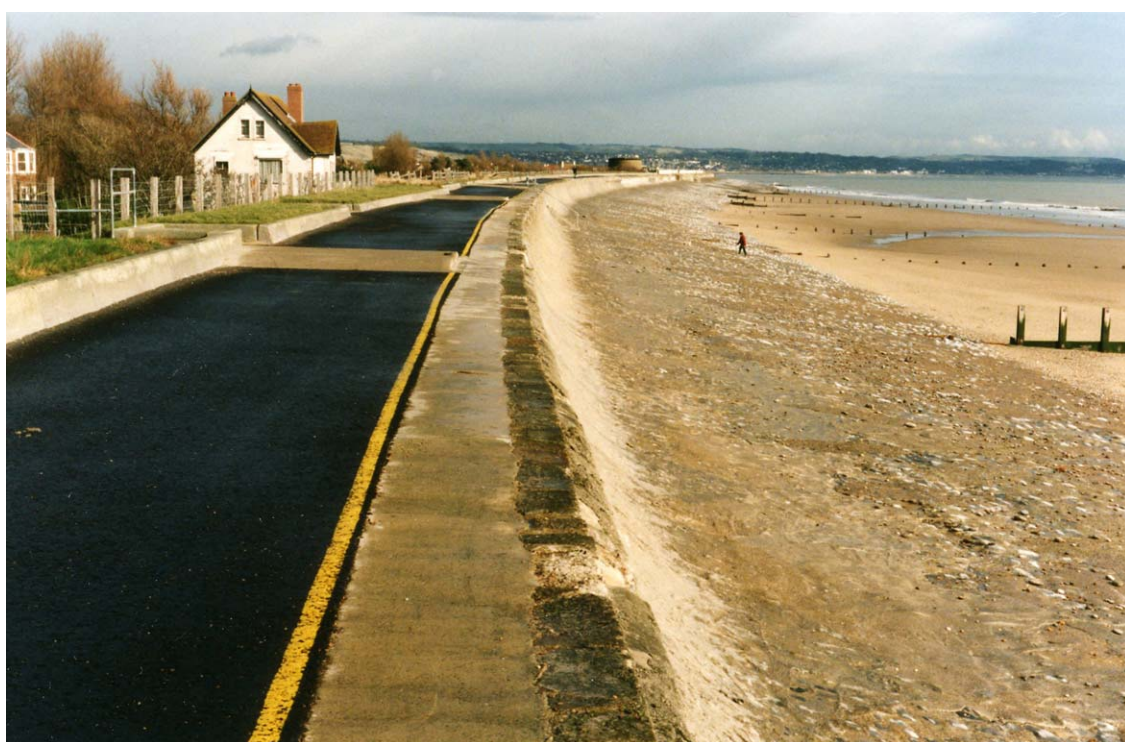
Plate 21 Sloping apron to seawall, Dymchurch, Kent,

A very large apron extension can be found at Dymchurch seawall (see Plate 21). The latter has a sufficiently shallow slope that deters scour. However, it was actually constructed in this manner to dissipate wave action on the toe of the structure, by making waves break in the shallow water there.

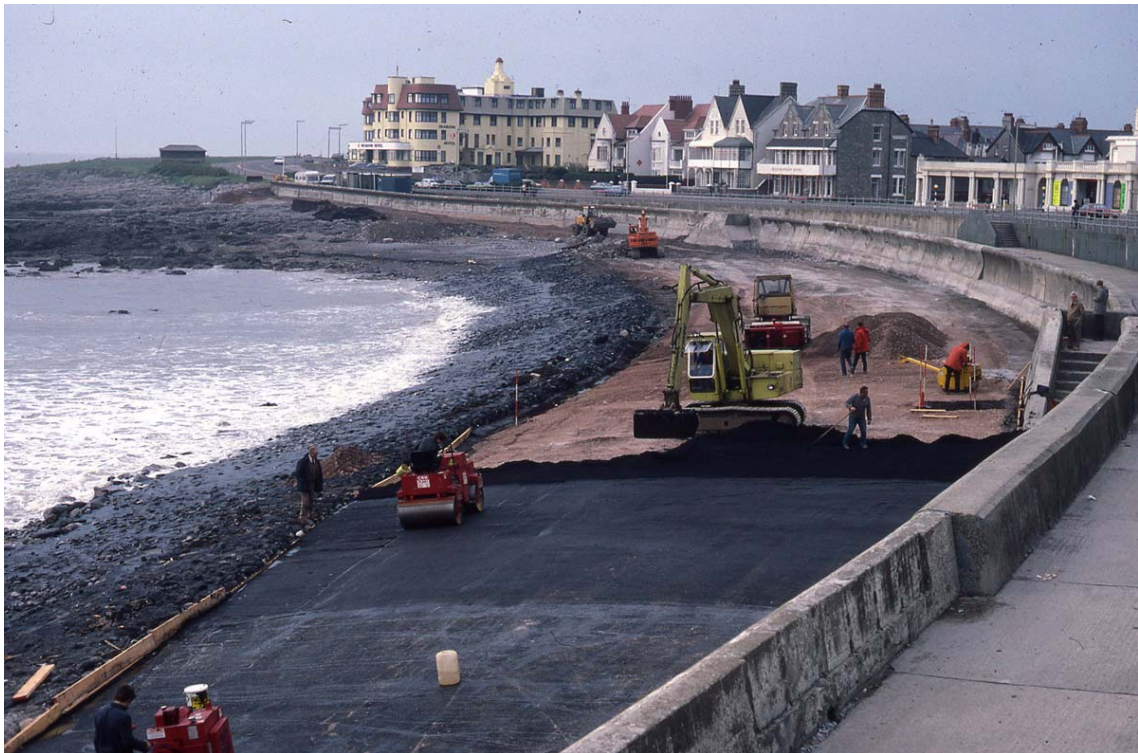
Plate 22 Asphaltic revetment under construction, Porthcawl, Glamorgan, 1984

An alternative to extending the toe of a seawall in concrete is to provide an asphaltic revetment, or similar structure. Asphaltic aprons have now been used at several UK sites, to prevent beach lowering and to reduce wave overtopping and/or to safeguard the integrity of the walls themselves. One of their advantages is the relatively simple construction. An example of this is the asphaltic apron built in front of the seawall at Porthcawl, South Wales in the 1980s. This apron was designed to prevent further abrasion of the seawall and to reduce the wave overtopping that was affecting the roadway immediately behind the wall. The asphaltic apron was designed to cover the lower part of the seawall, thus not only increasing its structural life, but also making it more effective in dissipating wave energy. Plates 22 and 23 show the wall during construction and a decade afterward. The second photograph shows some minor damage to the asphaltic apron that is very easily repairable.

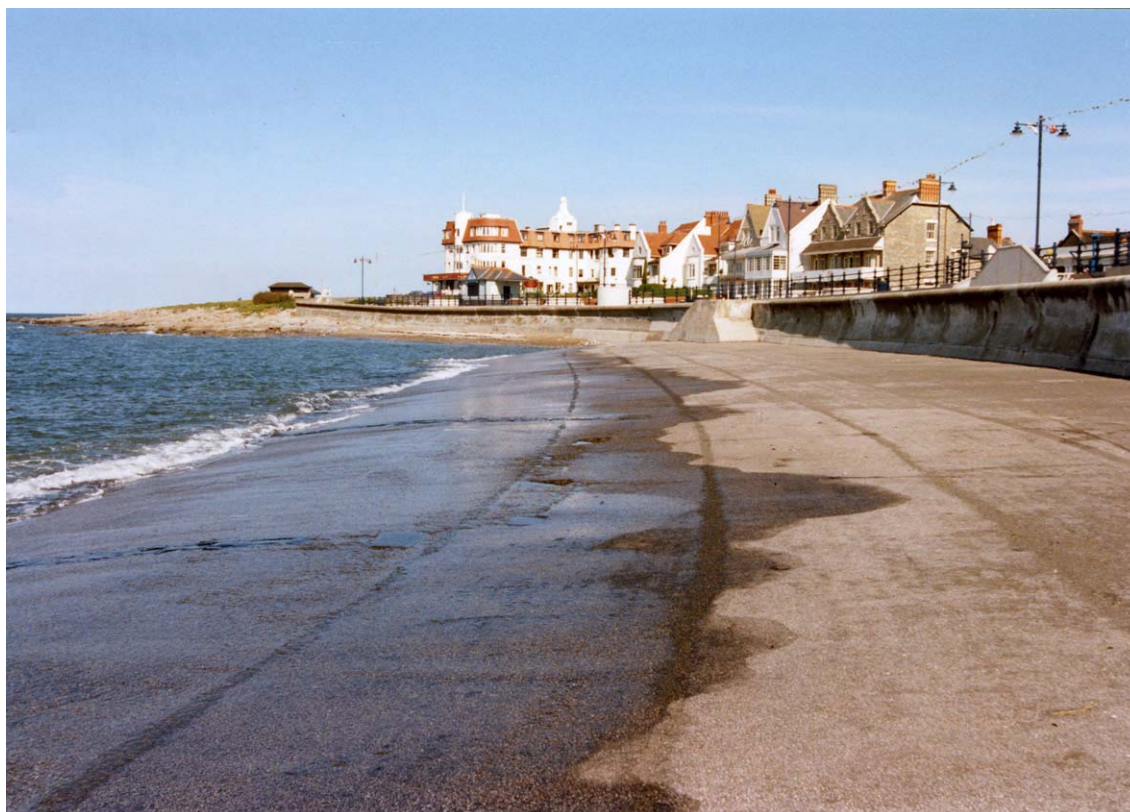
Plate 23 Asphaltic apron at high tide, Porthcawl, Glamorgan, 1995

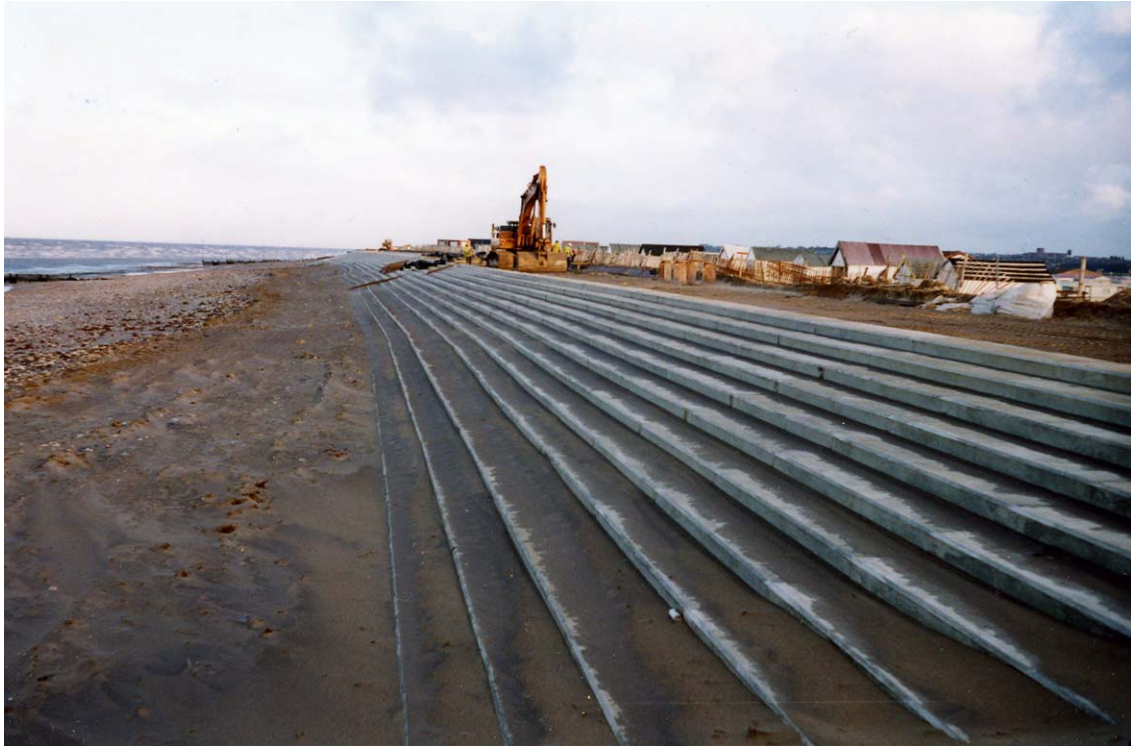
Plate 24 Stepped sloping seawall, Heacham, Norfolk, 2003

An example is provided by the defences at Heacham North Beach, Norfolk. Here a new stepped concrete seawall had to be built, see Plate 24, because of falling beach levels at the toe of the previous articulated concrete-block revetment. Its seaward face is sufficiently shallow to reduce wave reflections, and hence reduce the associated problems of localised scour at its toe. However, building a wall with this shallow slope to its front face is not always practicable. On a steeply sloping beach, such a wall would result in the occupation of a substantial part of the inter-tidal area, reducing its amenity value and interfering with alongshore sediment transport processes.
