Understanding the lowering of beaches in front of coastal defence structures, Stage 2 Technical Note 8

Understanding the lowering of beaches in front of coastal defence structures, Phase 2

Mitigation methods

Technical Note CBS0726/08 Release 4.0

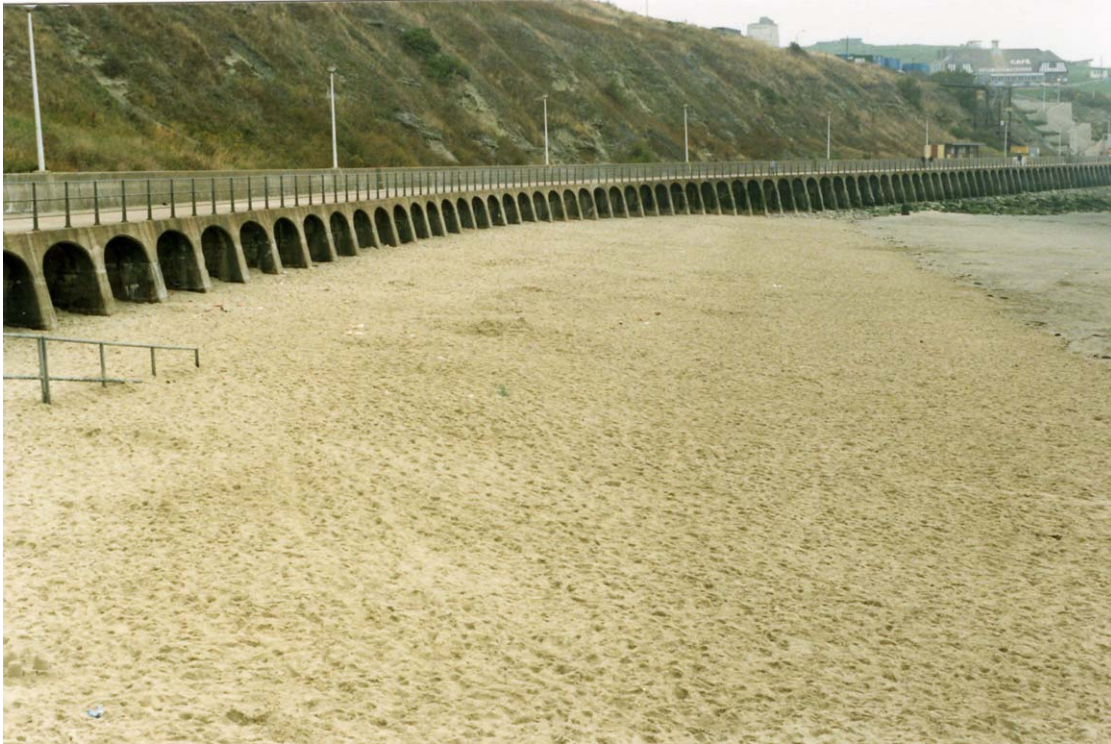
Plate 25 Cellular seawall, Folkestone, Kent, 1986

It is theoretically possible to construct a wall that minimises wave reflection while still maintaining a near vertical profile. One such way is to provide a wave screen in front of the wall. The reflection performance of a wall and screen combination would primarily be dependent on the screen porosity and the distance of the screen from the wall (McBride, Smallman and Allsop, 1995) but may result in reflection coefficients as low as 0.11 to 0.15 compared to 0.9 to 1.0 for a vertical seawall. A rare example of this “cellular” type of seawall construction is found east of Folkestone Harbour (see Plate 25). This type of construction has the advantage of reducing wave energy by dissipation under the arches. However, this has been at the expense of structural integrity. Due to the high impact forces the wall has suffered significant damage over the years.

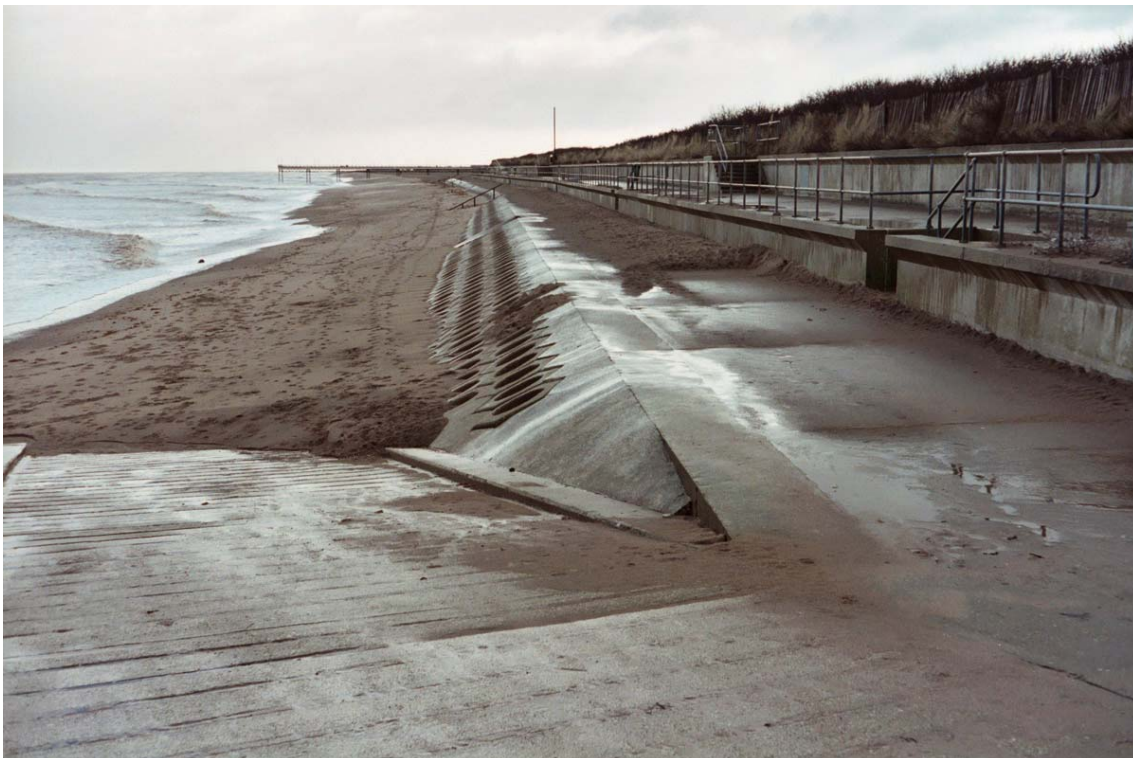
Plate 26 Seathorne, near Skegness, Lincolnshire, 2001

Examples of energy absorbing structures are the interlocking concrete block revetments that have been constructed at Shoreham, West Sussex and Seathorne, near Skegness, Lincolnshire (see Plates 26 and 27). In both cases the armour blocks are designed to absorb wave energy. The structures require site specific modelling, since if one unit were to be dislodged then the whole revetment would tend to “unravel”. Also, it is evident that the dissipative characteristics will be strongly dependent on the size of the incident waves. As a general observation it would appear that such blocks are most effective when the wave height is about the size of the individual blocks or smaller (when the waves are much larger the blocks would be swamped during wave uprush).

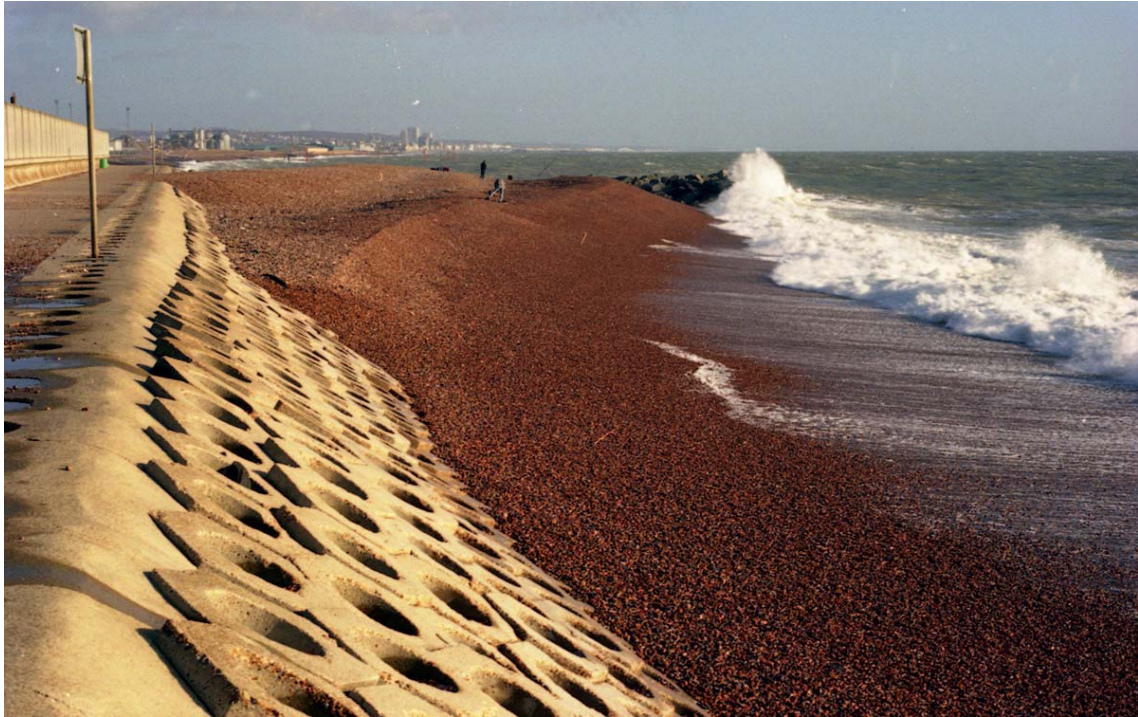
Plate 27 *Energy dissipating concrete block wall, Shoreham, West Sussex, 2005*
