Practical aspects of executing renourishment schemes on mixed beaches

Science Report - SC030010

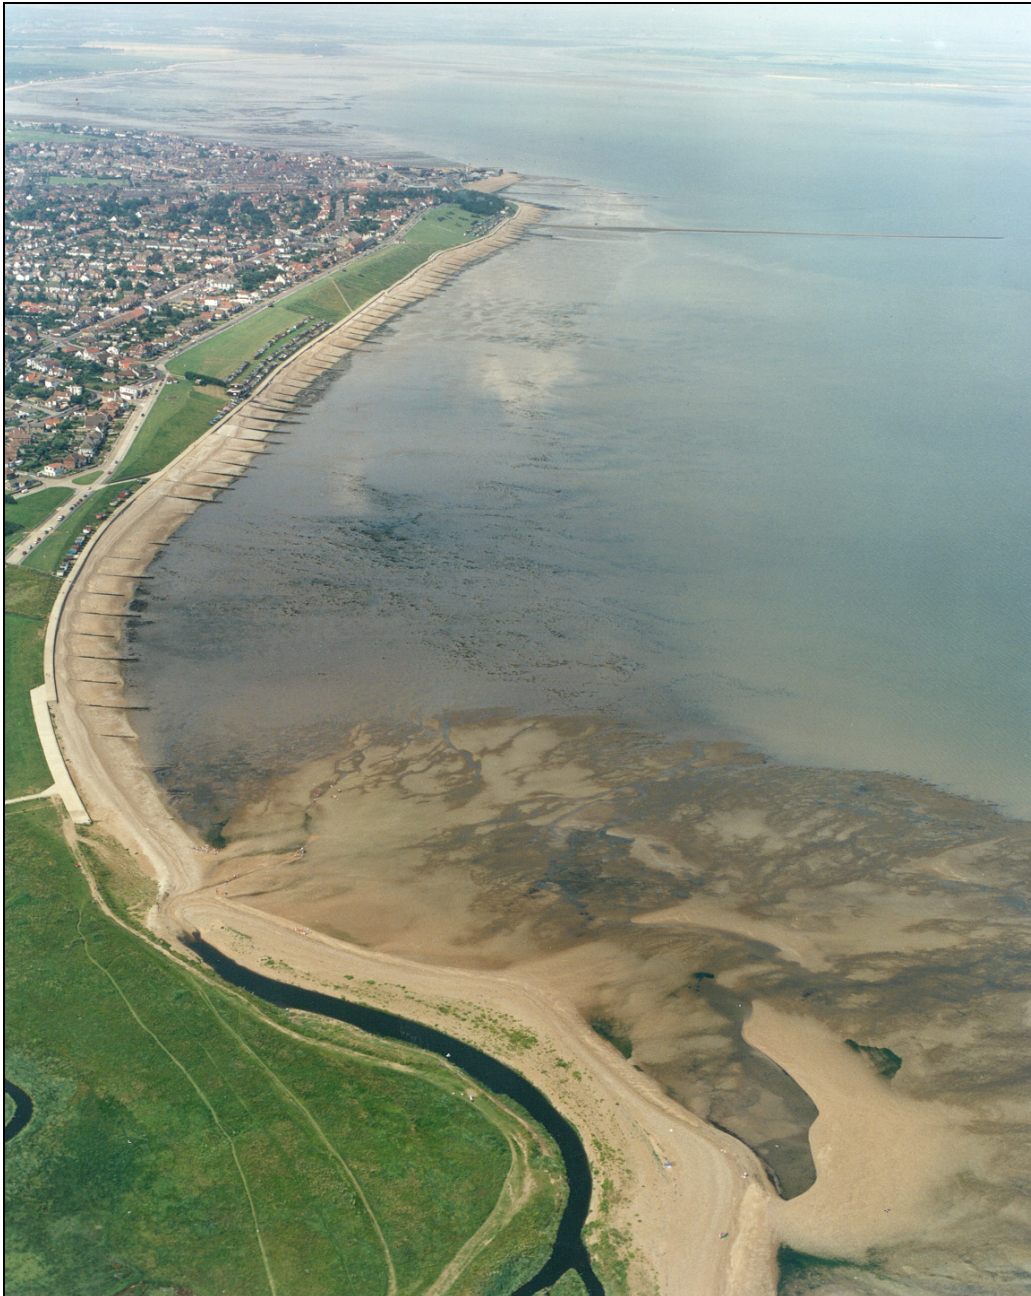
Figure 1 Aerial view of Tankerton coastline, north Kent

Tankerton in north Kent (Figure 1) is a typical erosive mixed shingle and sand beach, stretching from Whitstable harbour to the mouth of the Swalecliffe Brook. Two-thirds of the length of this beach was renourished in 1998–99 (Phase I & II), with the remaining length of beach receiving renourishment in spring/summer 2004 (Phase III).

The coast is subjected to a tidal range of 4m and has an established storm threshold of 1.6m Hs (significant wave height) for waves measured 1km offshore. In an average year, this will be exceeded a few times during the most severe storms.

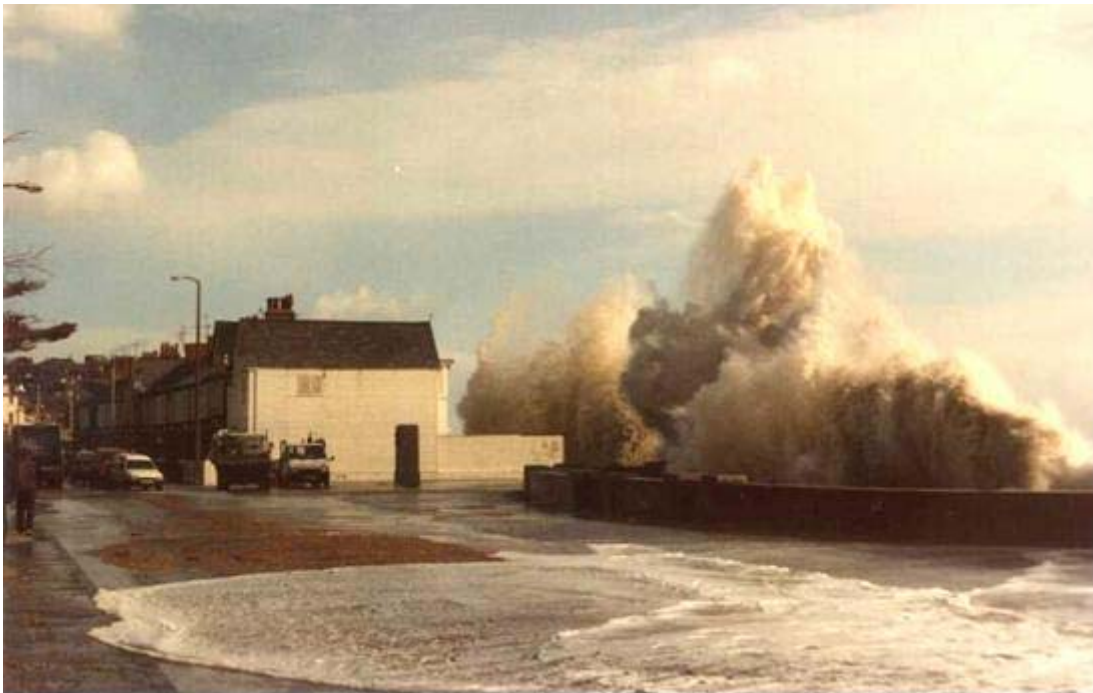
Figure 2 Photograph showing extensive coastal flooding at Sandgate – pre-coast protection scheme

years frequent breaches were likely, potentially resulting in extensive inland flooding and erosion of the coastline (see Figure 2).

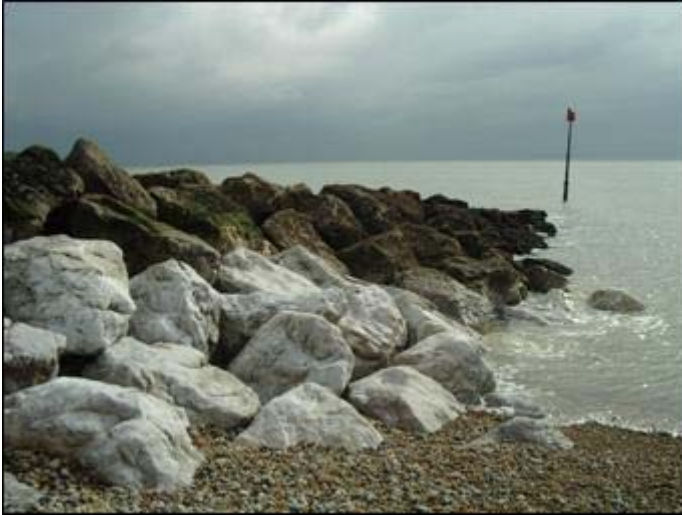
Figure 3 Photograph of a typical rock groyne along the Folkestone to Hythe frontage

The first phase of the works was carried out by Costain Civil Engineering Limited. Work commenced on site in August 1994 and consisted of the construction of two rock groynes at Twiss Road and Battery Point. These structures, orientated at right angles to the sea wall, each comprised a 6000m³ core of filter rock, with the individual rocks ranging from 60kg to 1 tonne in weight. This was overlaid by two layers of armour rock totalling 10,000m³ and weighing 3–9 tonnes per piece. The groynes are 135m long and tapered both horizontally and vertically (see Figure 3).

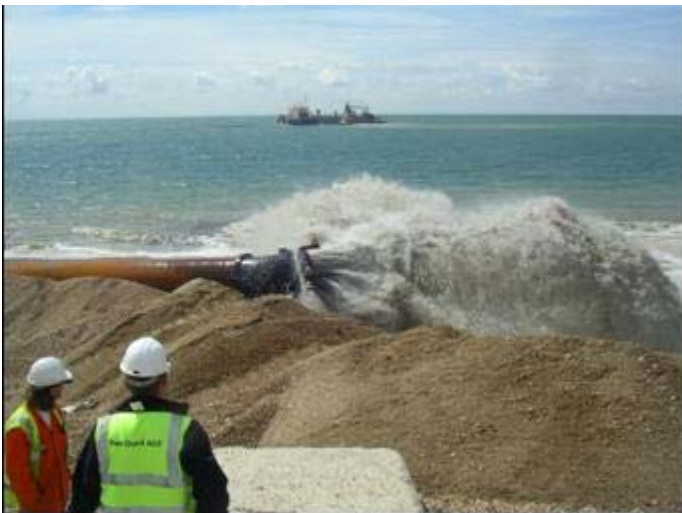
Figure 4 Photograph of a typical rock groyne along the Folkestone to Hythe frontage

For the second phase of the works, Ham Dredging Ltd was appointed to carry out the beach replenishment. This contract required placing 1.25 million m³ of shingle delivered by the sea. These works were completed by the end of September 1996 (see Figure 4).

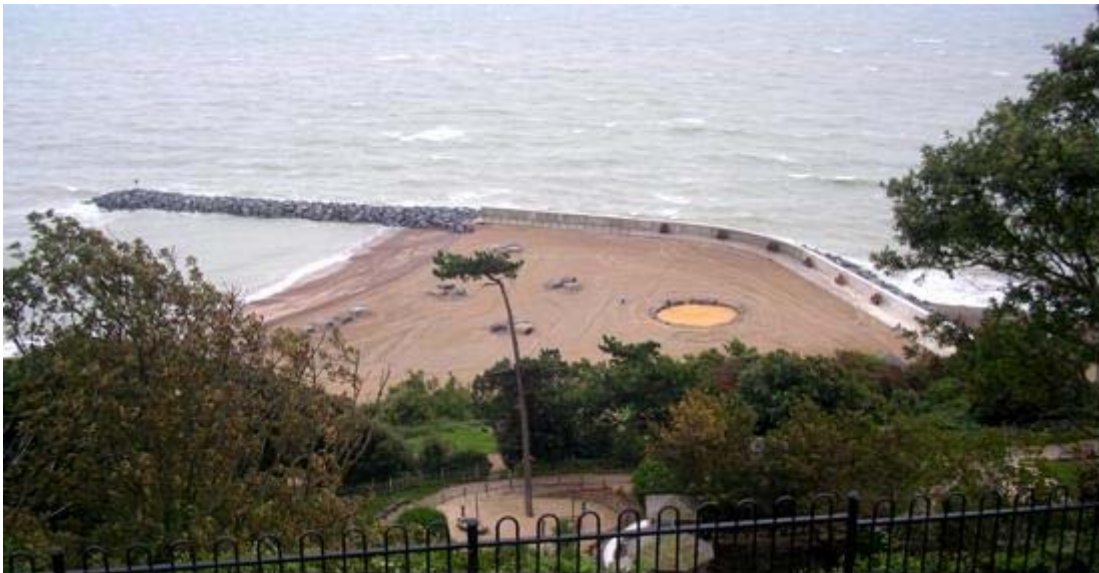
Figure 6 Photograph of the finished scheme at Folkestone

The results of the project have been outstanding. The finished scheme, as shown in Figure 6, won several engineering awards and SDC received the Society of Procurement Officers Award for Outstanding Achievement in Local Government Procurement for 2004. What was once an area under-utilised by the public has now been transformed into an area frequented by visitors and local residents alike.

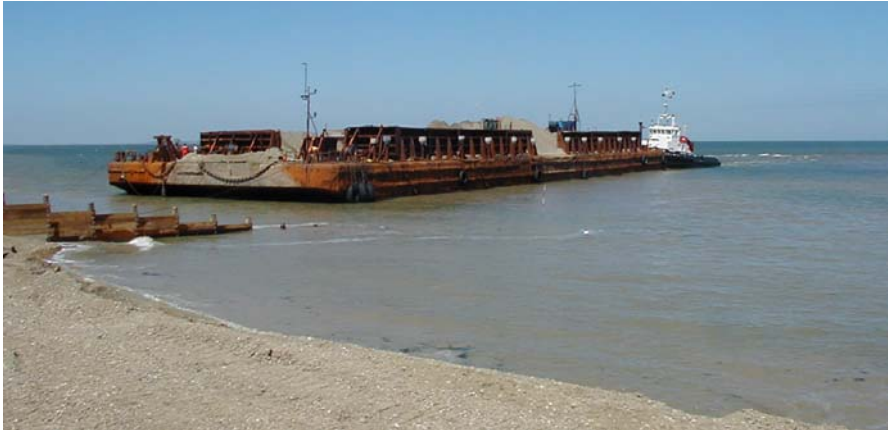
Figure 7 Dredged shingle delivered by barge

With the exception of the control bay on the mature beach, all bays were replenished within a week of each other as part of the Canterbury City Council Tankerton sea defence scheme. As the composition of dredged shingle can vary dramatically depending on the dredging location, a grading envelope was included in the contract specification to define the limits of acceptable material.

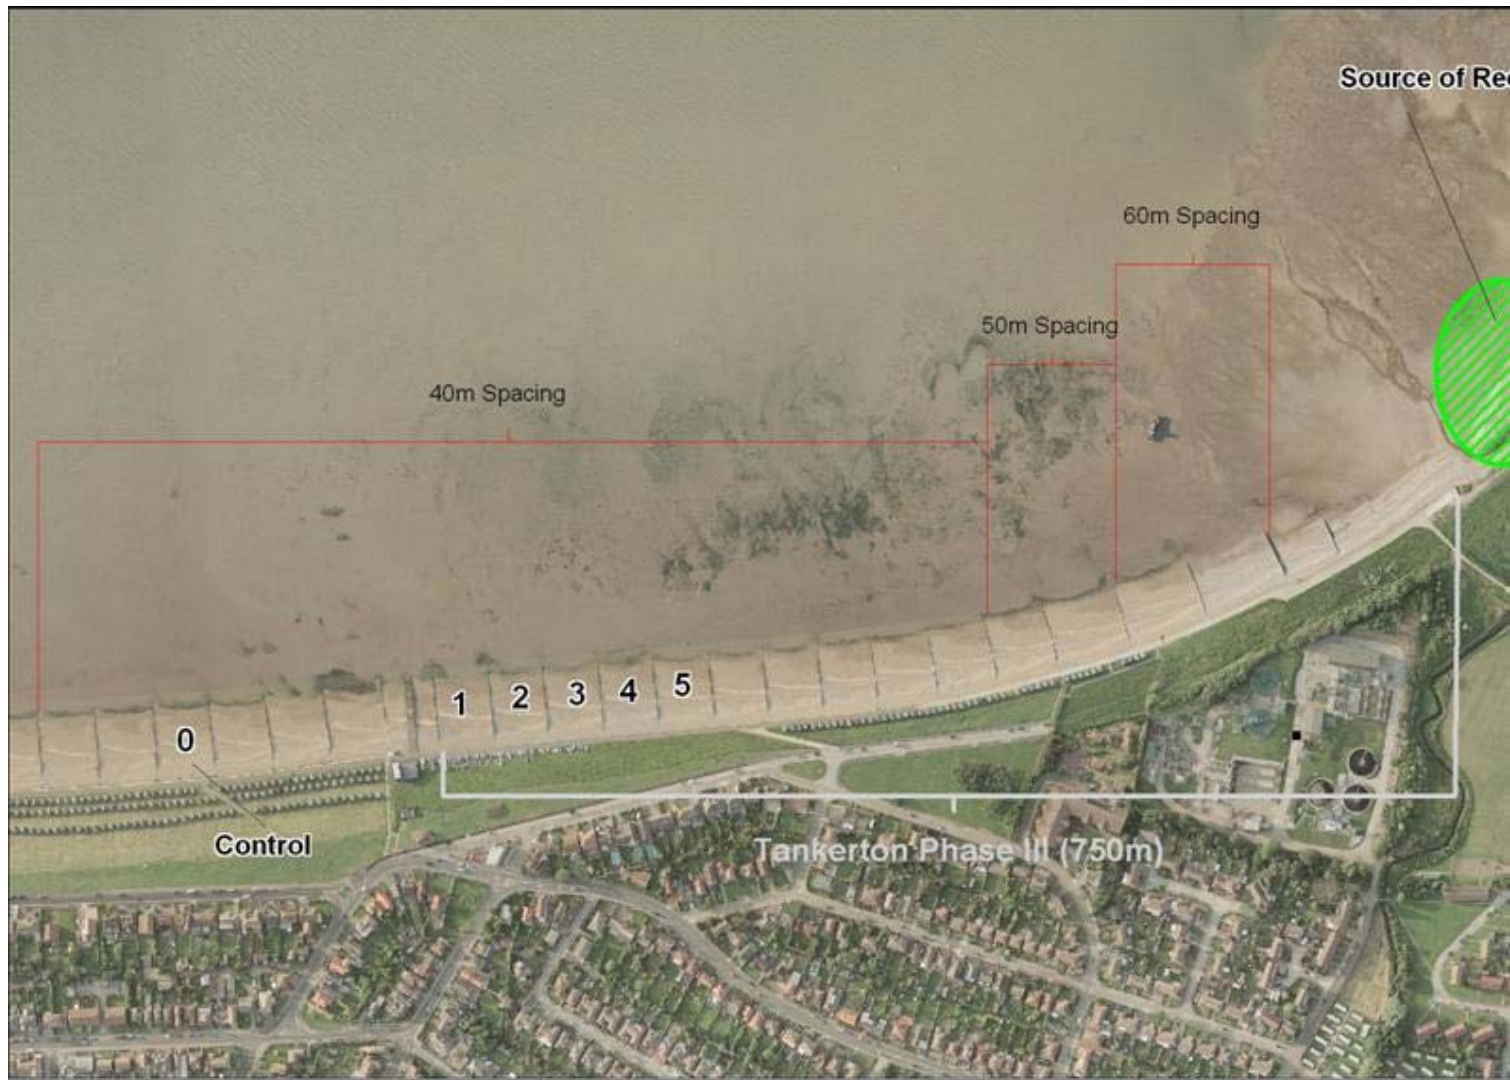
Figure 8 Location of experimental groyne bays

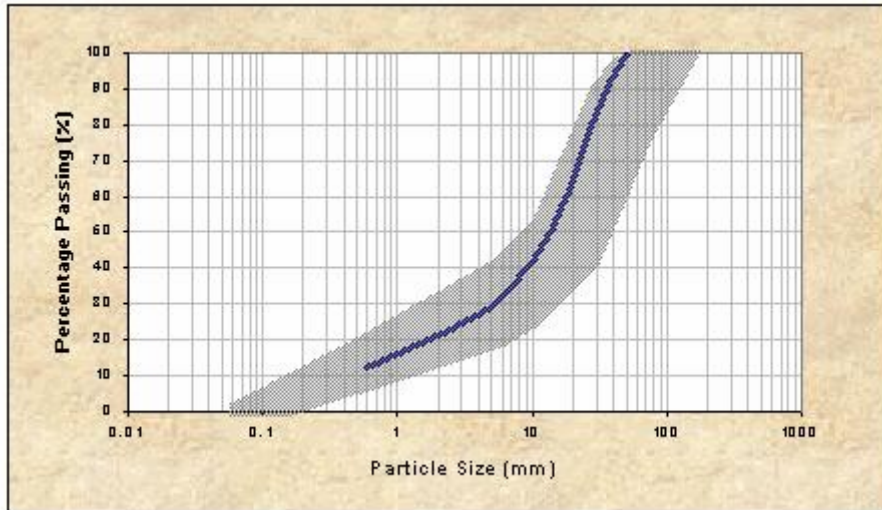
Figure 9 Grading envelope – recycled material (grey polygon = contract grading envelope; blue line = shingle sample).

Historically, shingle has been recycled from the spit at Long Rock and used to replenish erosive parts of the coast to the immediate east and west. This material was used to fill bay 1; samples of the material indicated that it had a D_{50} of 14mm with a reasonably low fine content.

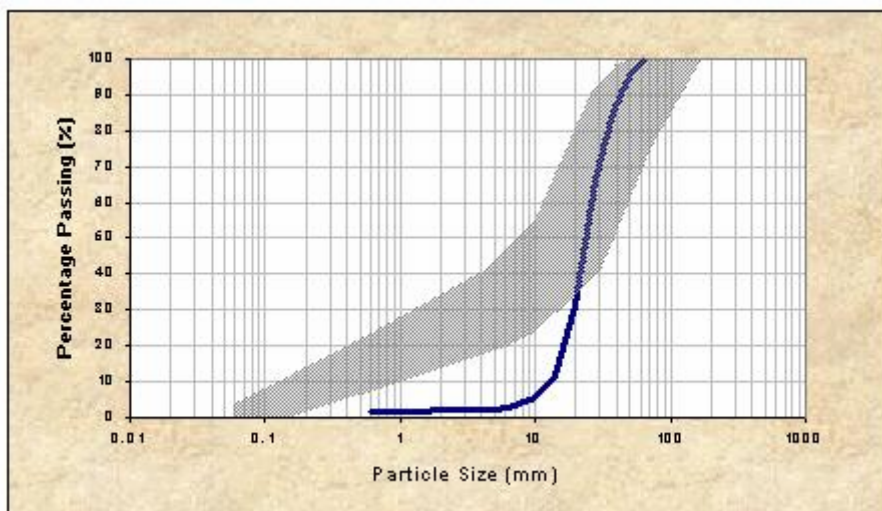
Figure 12 Grading envelope – 'capped' material (grey polygon = contract grading envelope; blue line = shingle sample)

Coarse, well-sorted material was scraped off the top of the native beach and stockpiled. The bay was then part-filled with the standard replenishment material (see section 2.1.5) and capped with the native material. It was hoped that this layer of naturally-sorted material would prevent some of the problems traditionally encountered as beaches evolve.

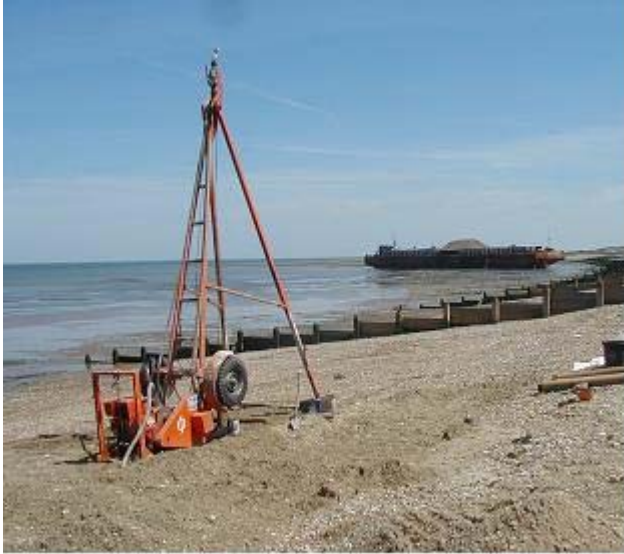
Figure 14 Borehole rig on newly-replenished beach

Accurate sampling of a mature or replenished beach is a more complicated process. The composition of the beach varies not only as you move seawards down the beach, but also (more critically) within the beach itself. As a consequence, meaningful sediment sampling has to be conducted using boreholes extending from the beach surface right down to the underlying clay, at several locations along the beach.

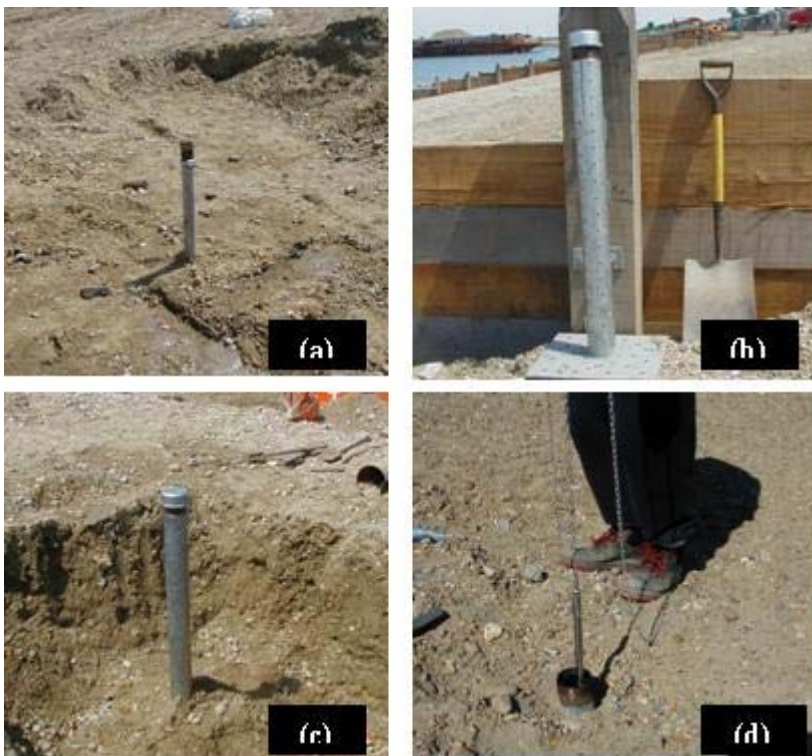
Figure 16 Components of beach water level monitoring system

length that would suspend the instruments 0.5m above the bottom of the tubes. Cap levels were surveyed with GPS to provide an accurate level for each instrument.

Due to the potential for the miniTROLLS to degrade in seawater, they were originally only deployed for short periods of time, covering a couple of tidal cycles. After the first few months, the length of deployment was increased to several weeks at a time. Sampling frequency depended on the length of each session and ranged from five seconds to five minutes.

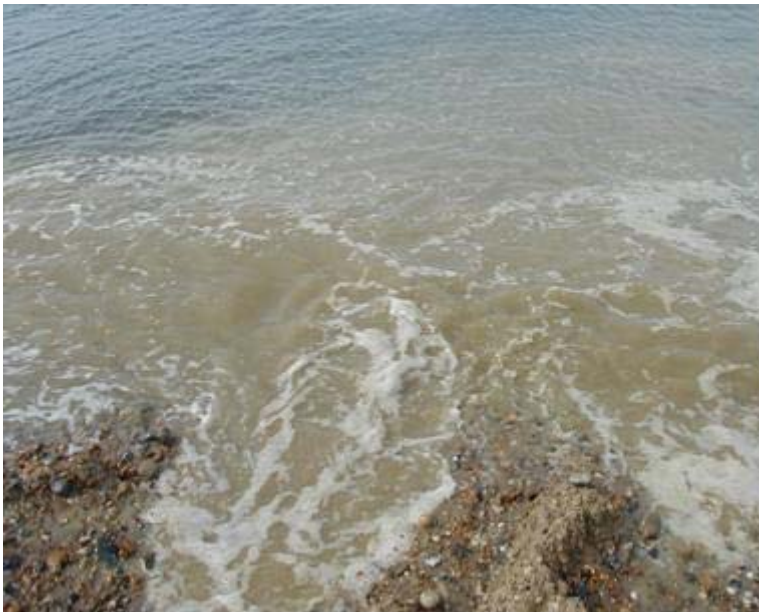
Figure 17 Fine material leaching from the beach after replenishment

After placement, the newly-replenished bays all looked similar, with the exception of the bay containing recycled material, which had a different colour to the dredged sediment. Immediately after placement, a slick of fine material could be seen leaching from the beach (see Figure 17). This was a consistent feature for the first week following the replenishment.

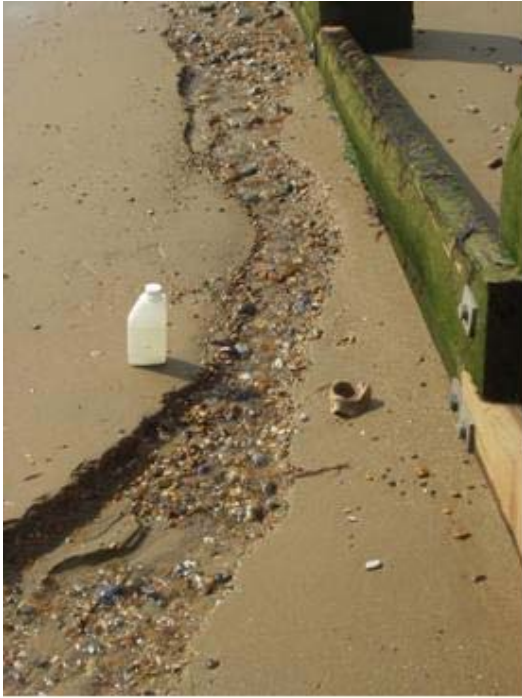
Figure 18 Exfiltrating water following high tide

the finer material past the toe of the beach (see Figure 18). This continued until the rising tide reached the toe of the beach, suggesting that the beach never fully drained.

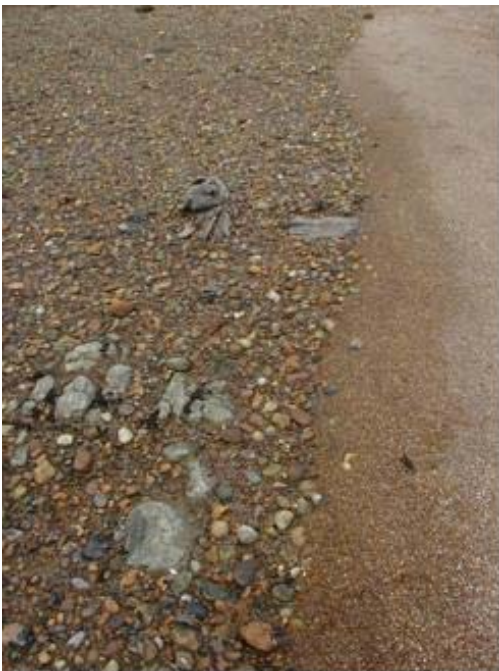
Figure 19 Angular 'grit-like' sediment deposited along the beach toe

After the first few months, the fine material at the base of the beach disappeared and was replaced by some coarser angular material (see Figure 19). It is not known why this fine material was expelled from the beach, but it had completely disappeared by the start of the 2004 winter season.

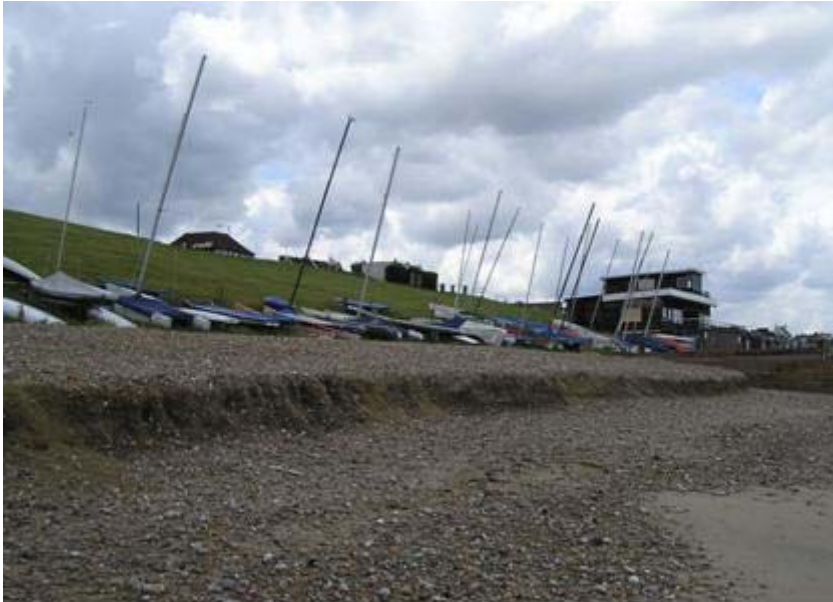
Figure 20 Cliffing in the 'fine' bay a few months after placement

Cliffing of the beach face occurred in some bays and was particularly evident in the fine bay (see Figure 20). These cliff-like scarps initially formed as the beach was worked over by spring tides and, in later months, as the beach was subjected to storm events that affected the unsorted sections of the rear beach. No such structures formed in the capped bay and the effects were minimal in the other bays.

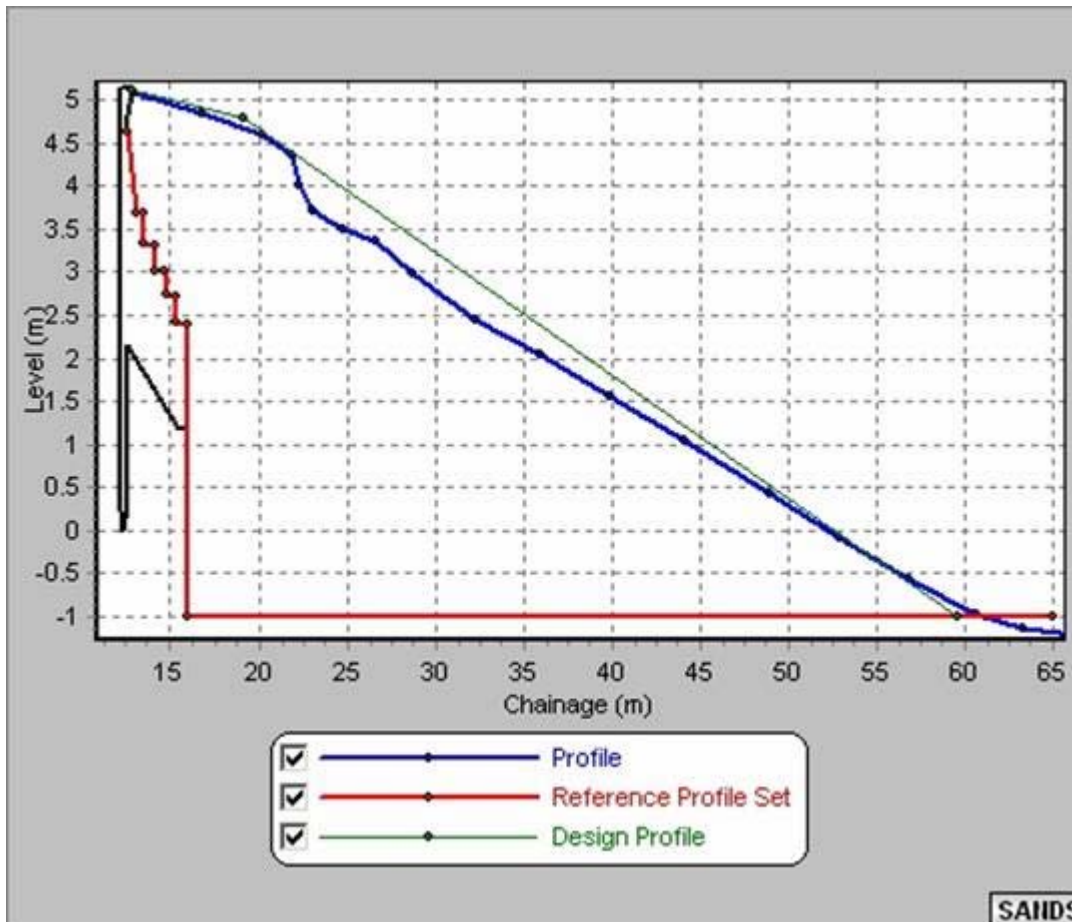
Figure 21 Recycled bay profile survey, February 2005

From the profile surveys, it would appear that the majority of the erosion occurred over the 2004–05 winter period (Figure 21). This resulted in a reduction in berm width, losses along the upper beach and a shallower beach face gradient.

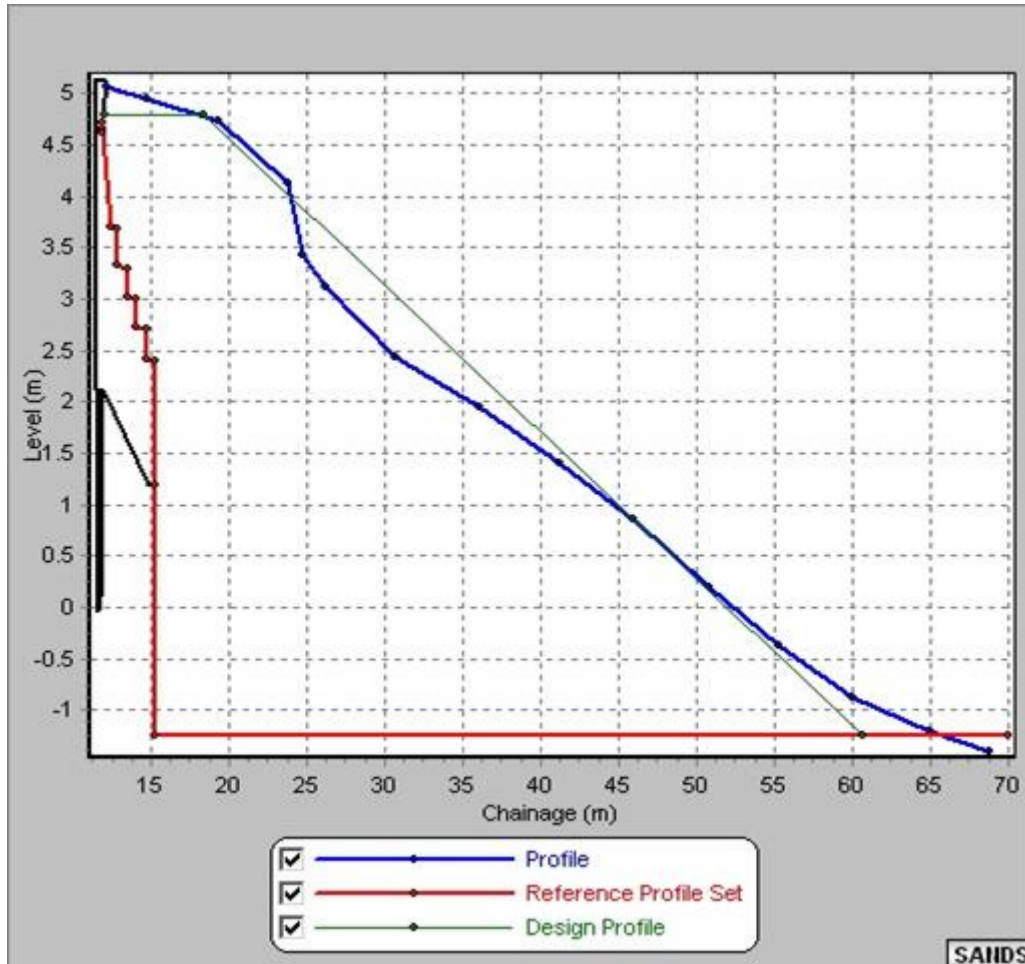
Figure 22 Change in fine bay profile over the first month

Large losses were experienced in the fine bay from the moment the scheme was finished. By the start of July 2004, only a month after replenishment, the active beach face had flattened to a 1:9 gradient, erosion was evident on the upper beach and the position of the beach toe had migrated seaward (Figure 22).

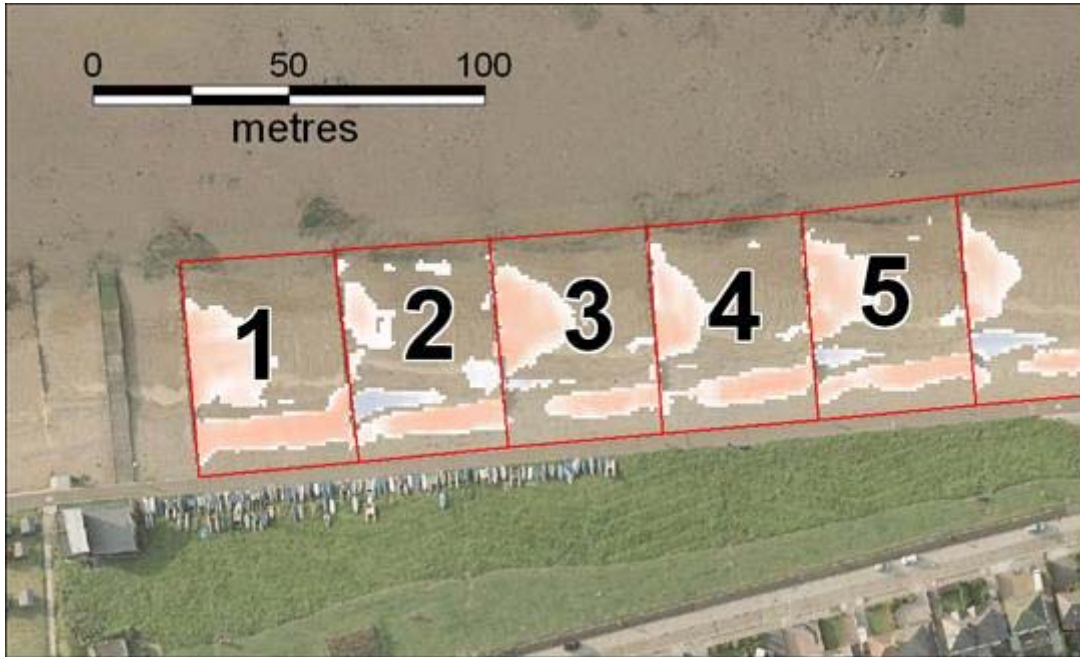
Figure 24 Map of erosion (pink-red) and accretion (pale blue-dark blue) between July 2004 and June 2007

In order to validate the profile results, periodic beach plan surveys were performed to provide more accurate data on volumetric changes and to map the entire groyne bay. Figure 24 shows the difference between the scheme out survey in 2004 and the 2007 beach plan survey. Erosion is evident along each berm, although it is less pronounced in the coarse bay. It is also less pronounced on the west side of each bay, as a result of beach reorientation.

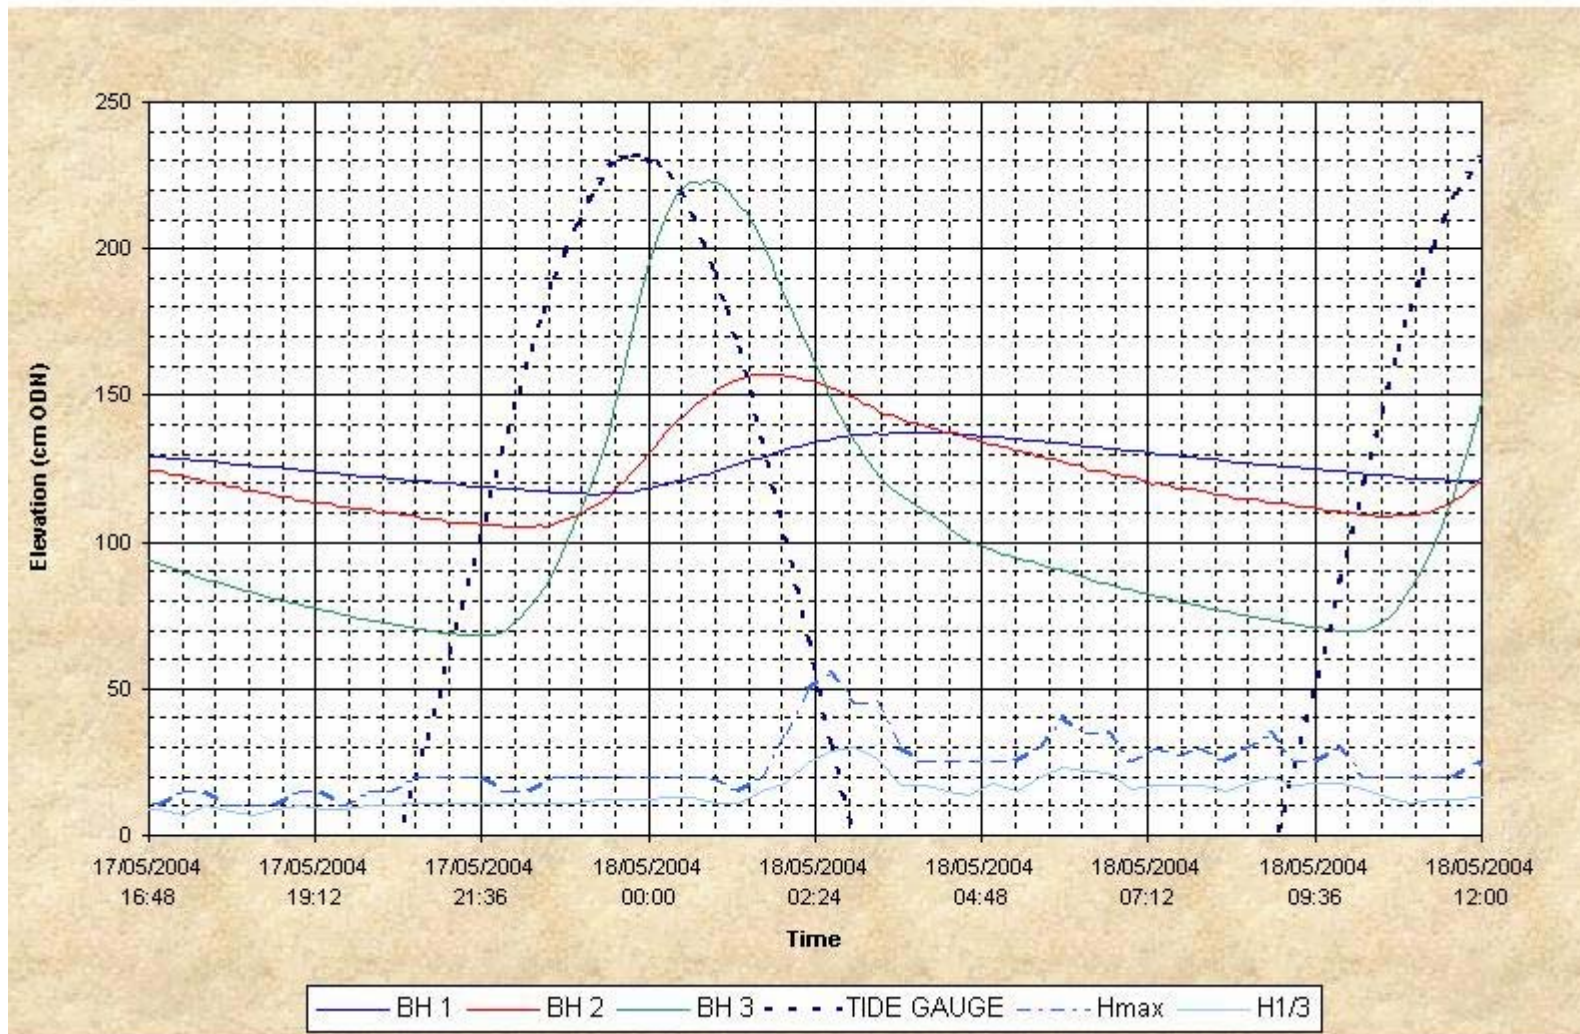
Figure 25 Variation in beach water table during a tidal cycle on a mature beach

As the tide rises up the beach, there is a time lag as water starts to infiltrate the beach. At this point, the beach ground water level is higher in the boreholes towards the back of the beach. The closer to the seawall, the longer the lag, with the first borehole not reacting to the rising tide until two hours after the sea level has reached the water height in the borehole.

It should be noted that there is an increase in the magnitude of water table fluctuations and the amount of standing water left in the beach as the tidal range increases towards spring tides and a reduction in both as the tidal range decreases towards neaps.

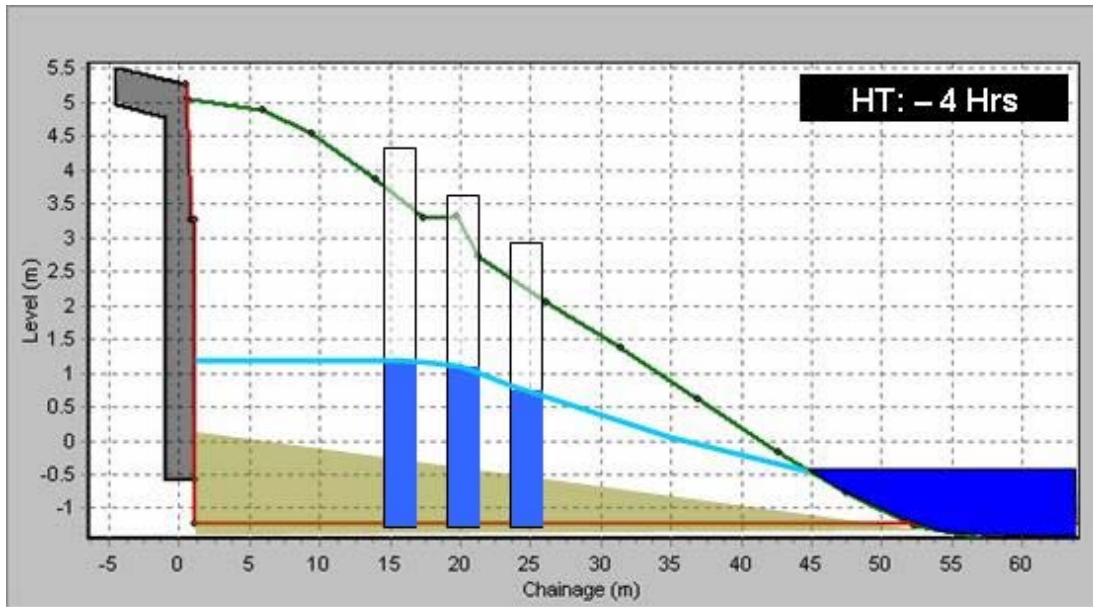
Figure 26 Beach water table fluctuations (part I)

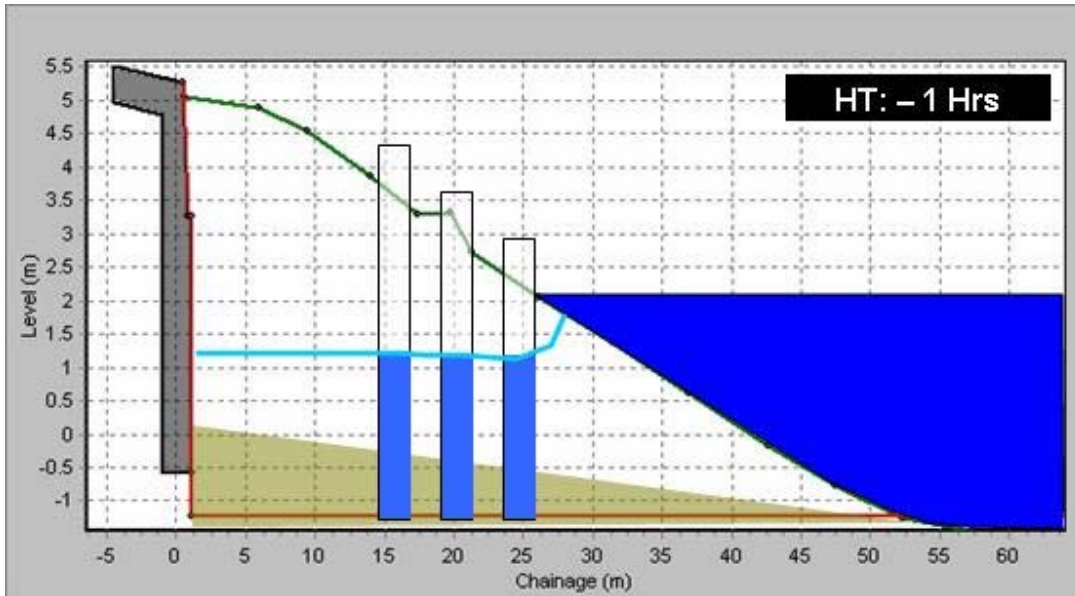
Figure 27 Beach water table fluctuations (part II)

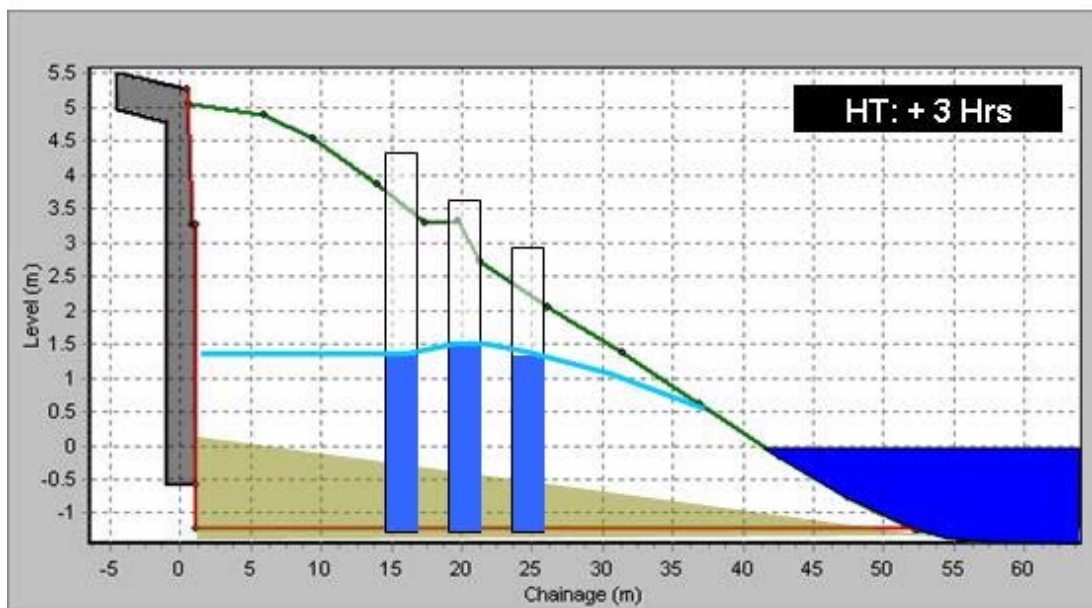
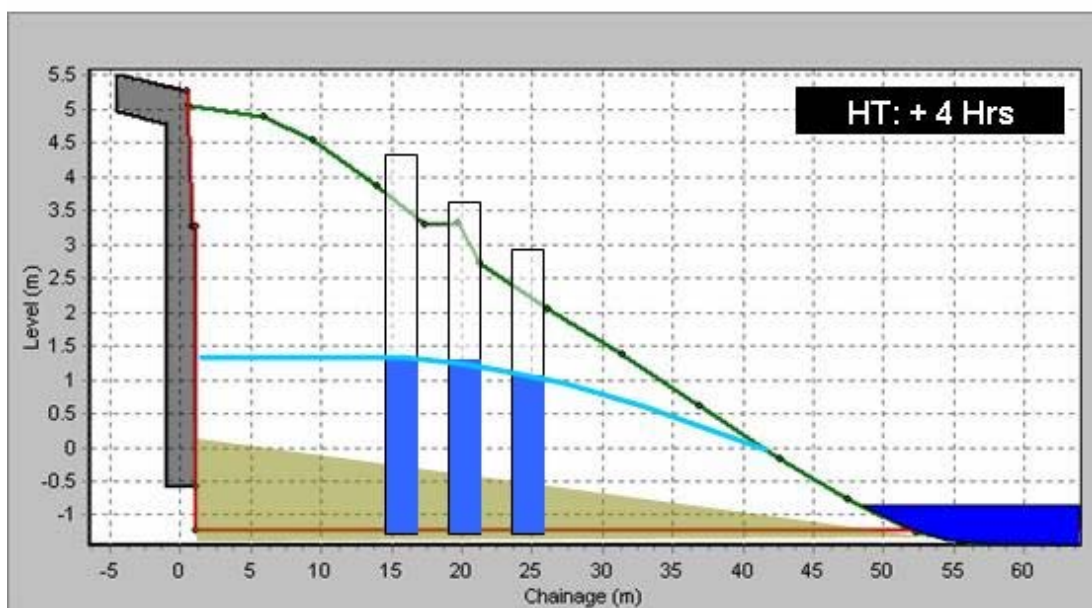
Figure 28 Beach water table fluctuations (part III)

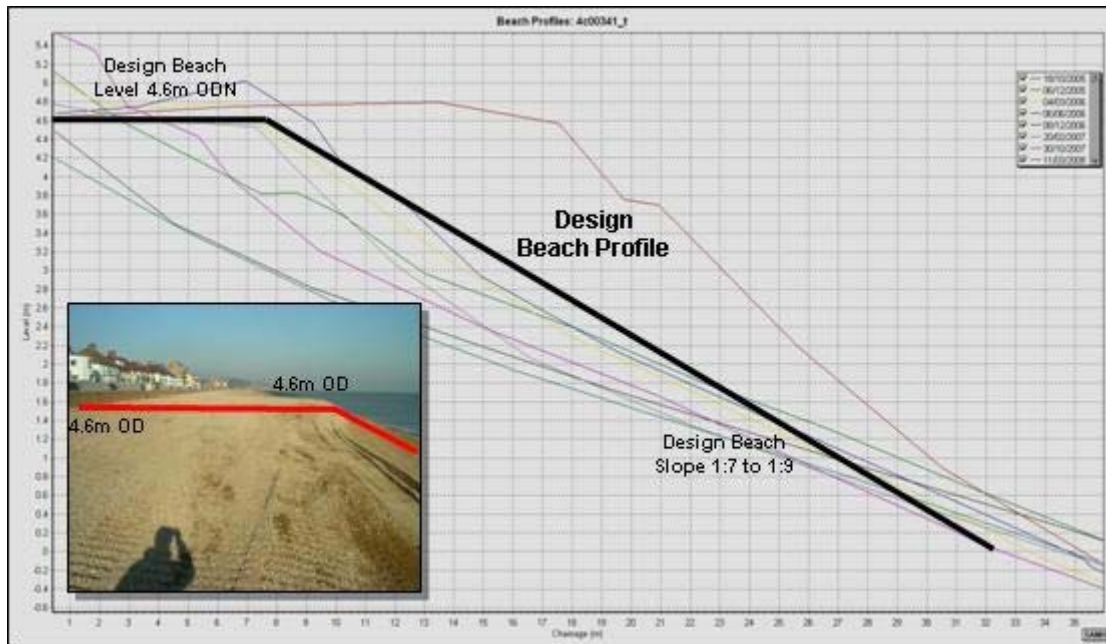
Figure 30 SANDS plot identifying the design beach profile, ideal crest width and gradient

To establish a baseline, a pre-recycling survey (or in-survey) was conducted. This gave an indication of the current gradient of the beach and allowed all subsequent placed material to be referenced to it. The conventional stakeout method was used to inform the driver of where to move the material in order to produce the desired crest height (see Figure 30).

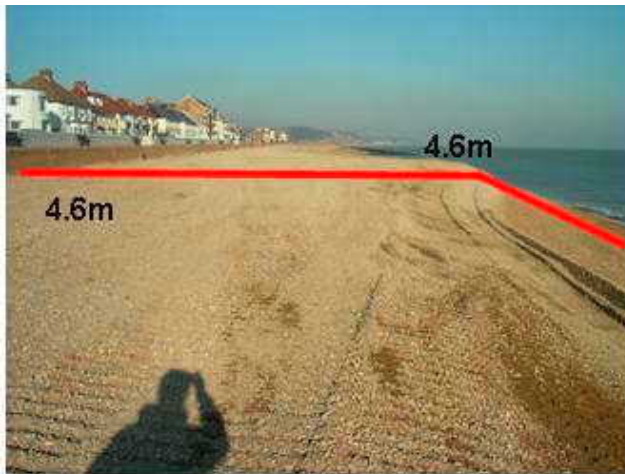
a: Crest Width after recycling approx. 20m crest width, Beach Level 4.6m OD

Following a storm event, the more frequent low energy waves transport material deposited at the beach toe further up the profile, thus eventually forming a berm. If this profile is not artificially managed, the excess shingle in the upper section of the profile is not drawn back down the profile and instead remains up against the primary defence. In turn, the beach crest width is reduced and the standard of protection is lowered. See Figure 33 below.

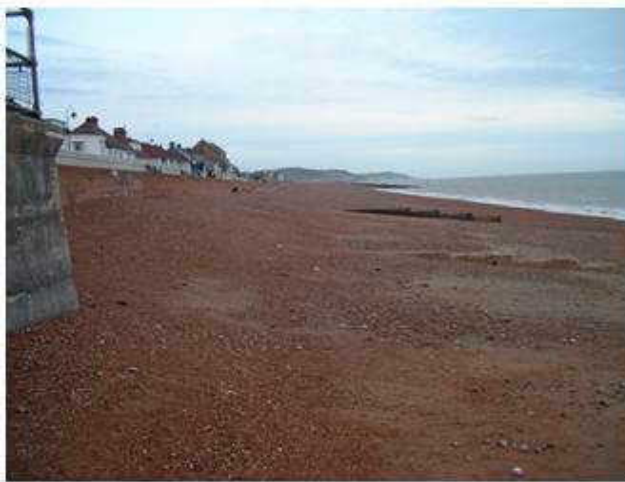
b: Crest Width after storm event (2007) approx. 0m, shingle pushed against the seawall and beach level significantly lowered.

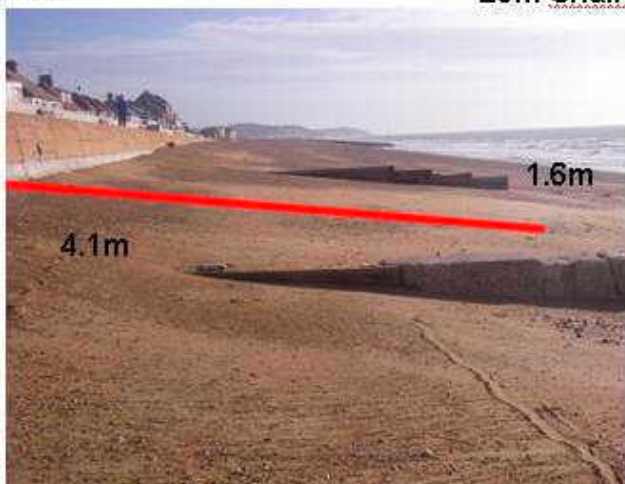
c: Current Crest Width after storm event approx. 0m, shingle depleted from base of seawall exposing foundations to wave action.

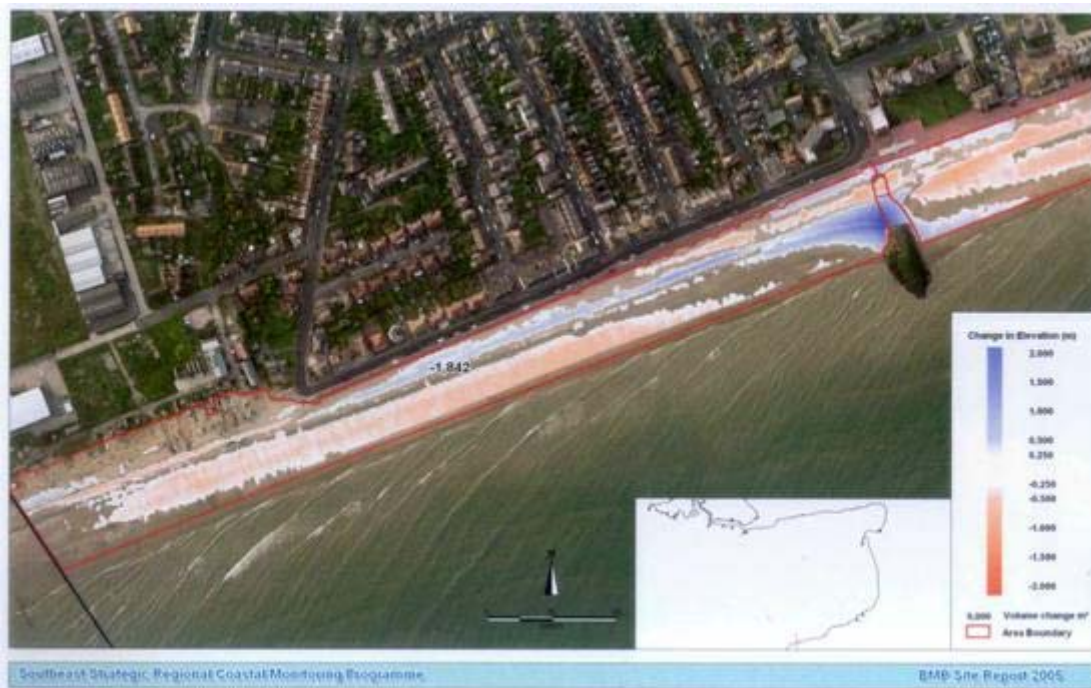
Figure 35 Volumetric analysis – a cut/fill model showing stockpile redistributed along the frontage

As can be seen from the volumetric analysis (Figure 35), the material had been redistributed along the frontage, finally being trapped on the western side of the rock groyne – 500m east of the original deposition site.

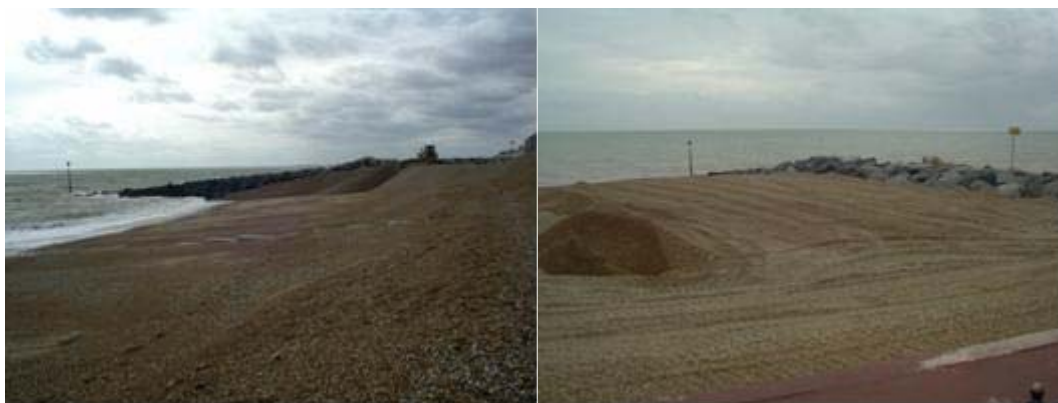
Figure 36 Stockpile being placed at Stade Street, in the shelter of groyne A

As in phase 1, the recycled material was stockpiled in a concentrated location, but this time in the shelter of rock groyne A (see Figure 36). In contrast to the results observed in phase 1, the stockpile did manage to remain in place for a longer period of time when deposited in the shelter of the rock groyne.

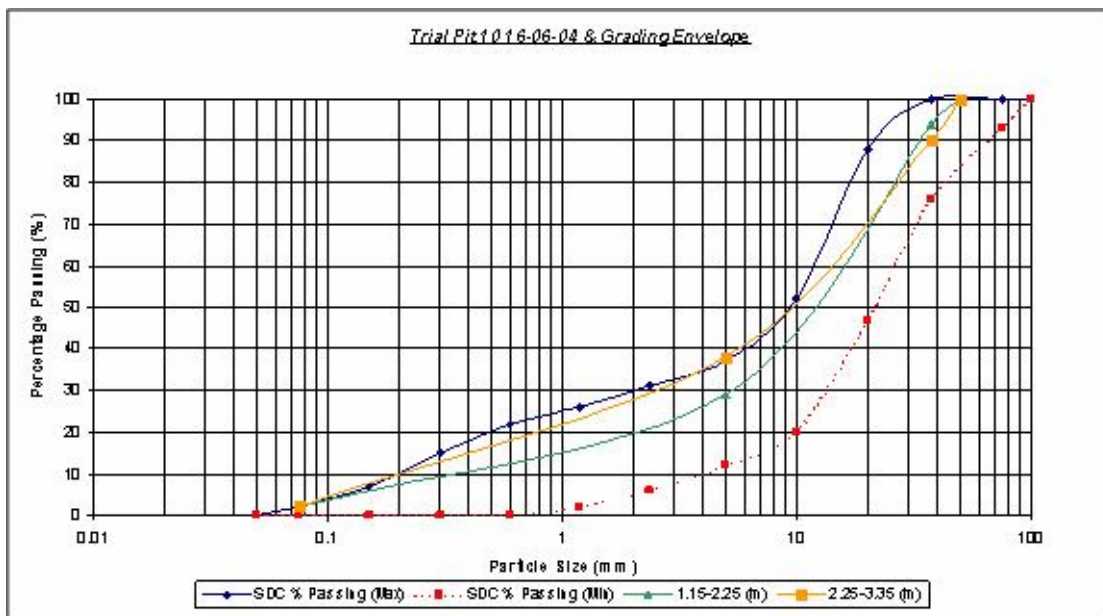
Figure 37 A typical example of the grading curve produced following sediment sampling (the red and blue lines indicate the grading envelope)

As expected, in areas where the wave energy is at its highest, the greatest degree of sorting and the highest loss of fines were observed (see Figure 37).
