Practical aspects of executing renourishment schemes on mixed beaches

Science Report - SC030010

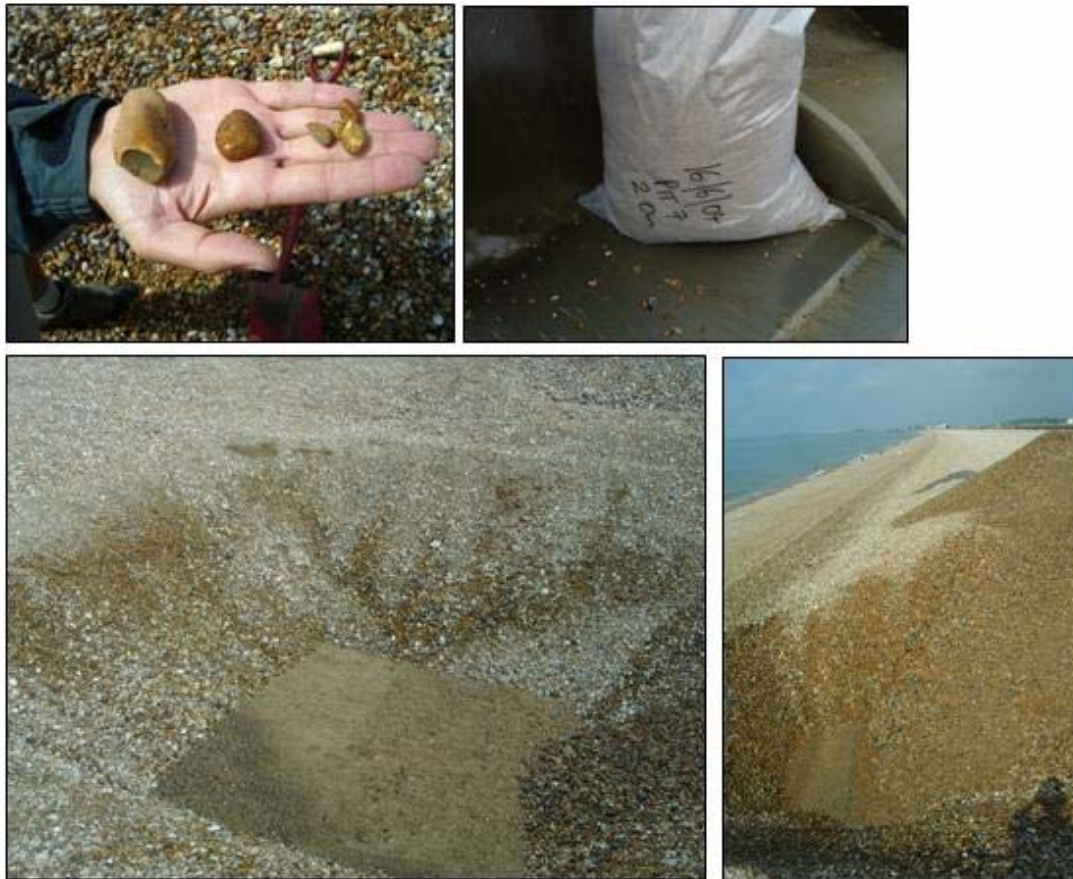
Figure 38 Photographs showing trial pits and sediment samples being taken

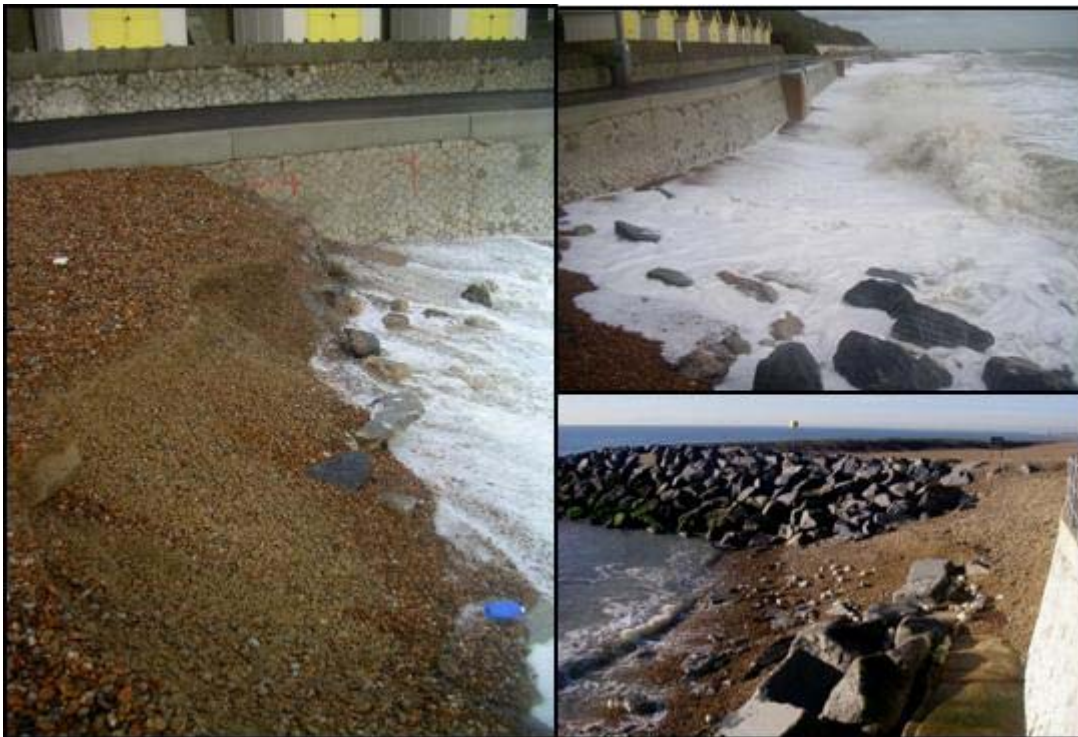
Figure 39 Photographs showing the dramatic storms and subsequent erosion east of groyne B (cell 5).
