## APPENDIX 1: SITE SURVEY

### 1 METHODOLOGY

For the purpose of conducting topographic cross section surveys and velocity readings for the five trial sites, Royal Haskoning commissioned Longdin and Browning Surveyors Ltd to undertake the surveys during the three-year trial study. For this purpose, a Topographic Survey Specification Report was produced and provided to Longdin and Browning detailing the aims of the study, areas to be surveyed and number of cross-sections to be conducted within each reach (Royal Haskoning, 2005). The Topographic Survey Specification Report can be found in Appendix D, however the rest of this report summarises the main methods and techniques employed during the project.

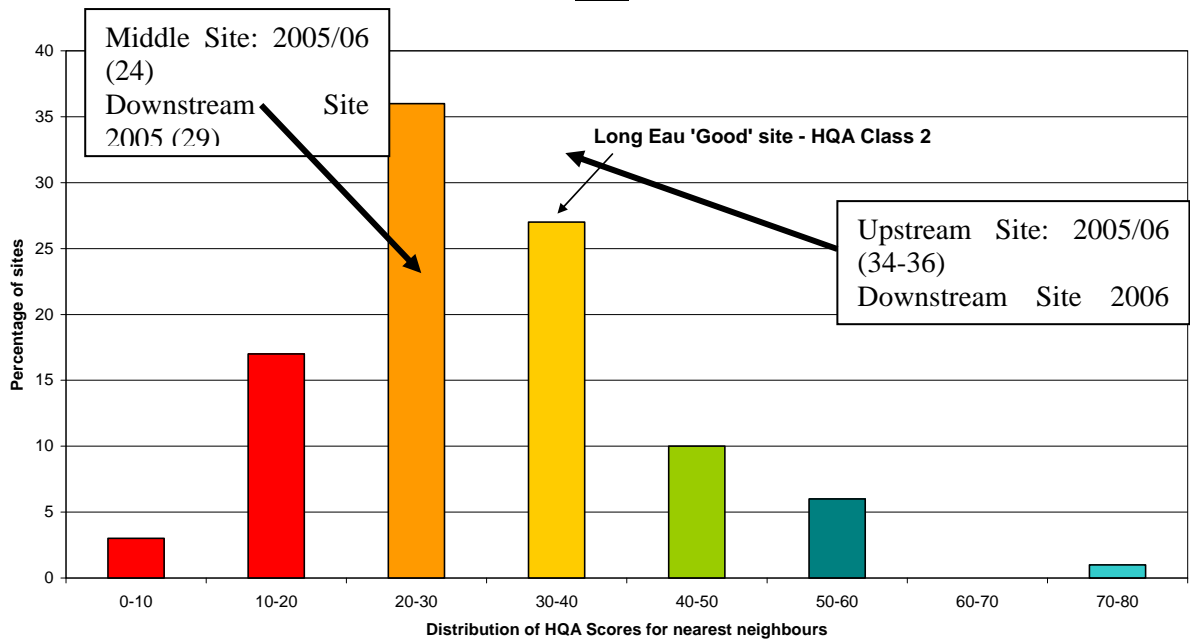
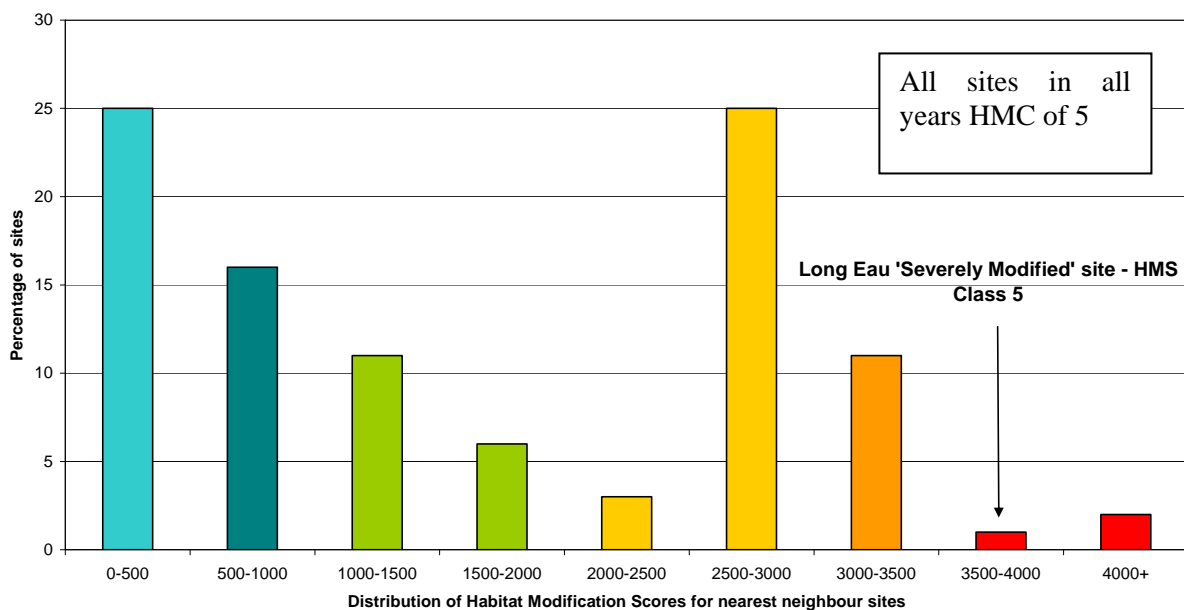
**Habitat Quality Assessment of the Long Eau (HQA 34) in relation to nearest neighbour sites**

**Habitat Modification Score for the Long Eau (HMS 3525) in relation to nearest neighbour sites**

**Figure 3.1** Range of HMS and HQA scores for the 150 nearest neighbour sites on the RHS database for the baseline data-set; the scores for the middle Long Eau site in 2005 are shown for comparison

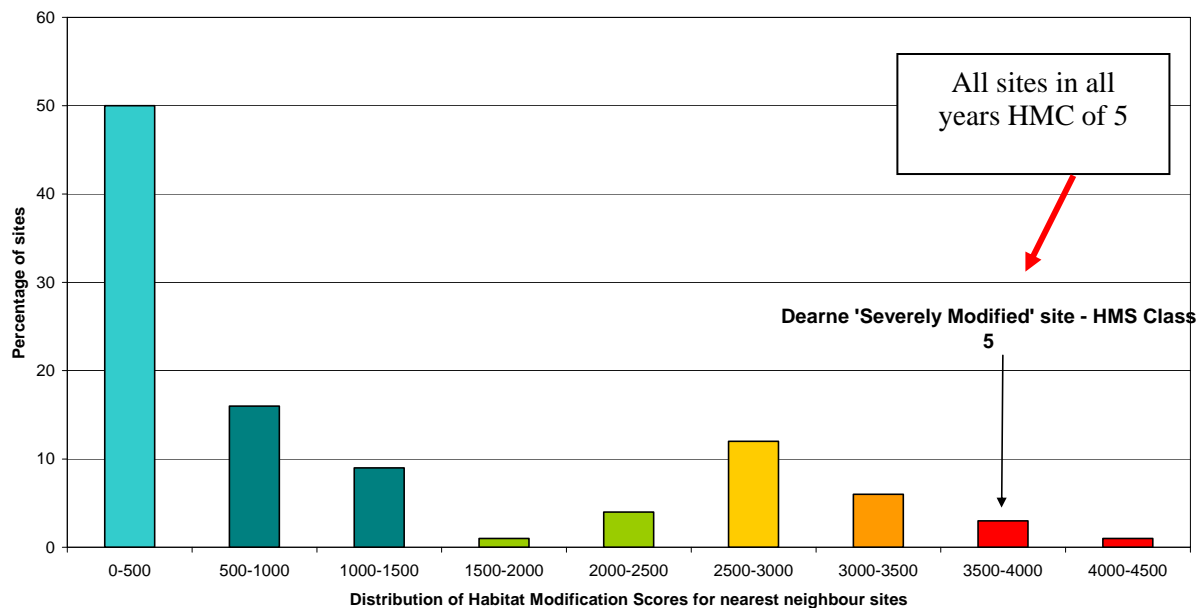
**Habitat Quality Assessment of the Dearne (HQA 32) in relation to nearest neighbour sites**

**Habitat Modification Score for the Dearne (HMS 3832) in relation to nearest neighbour sites**

**Figure 3.2 Range of HMS and HQA scores for the 150 nearest neighbour sites on the RHS database for the baseline data-set; the scores for the middle DEARNE site in 2005 are shown for comparison**

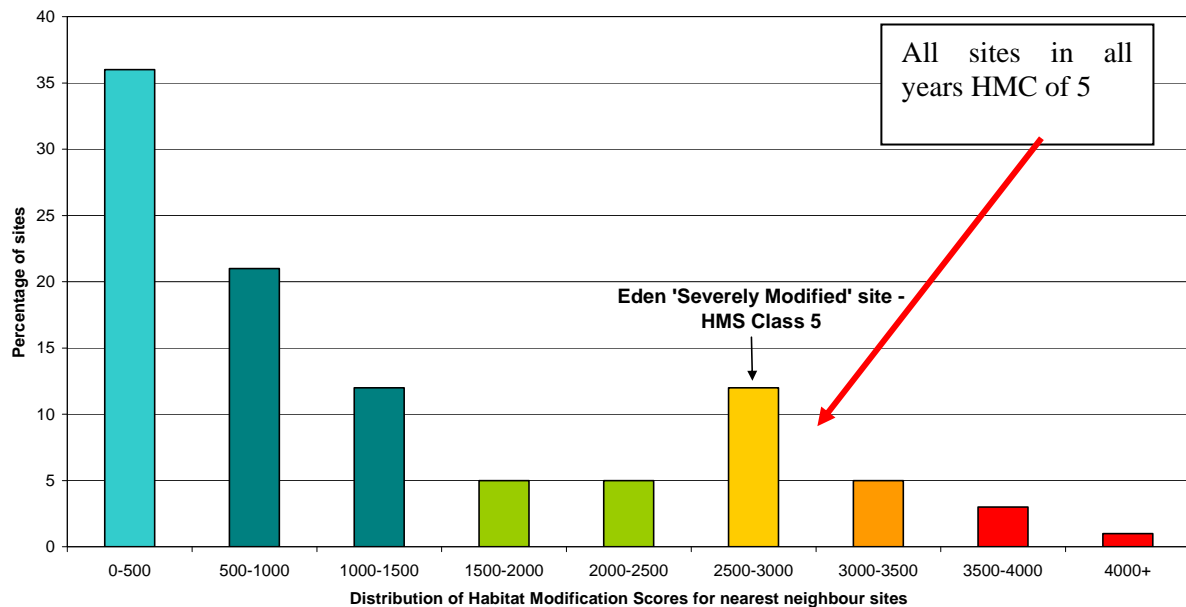
**Habitat Quality Assessment of the Eden (HQA 36) in relation to nearest neighbour sites**

**Habitat Modification Score for the Eden (HMS 2610) in relation to nearest neighbour site**

**Figure 3.3 Range of HMS and HQA scores for the 150 nearest neighbour sites on the RHS database for the baseline data-set; the scores for the middle EDEN site in 2005 are shown for comparison**

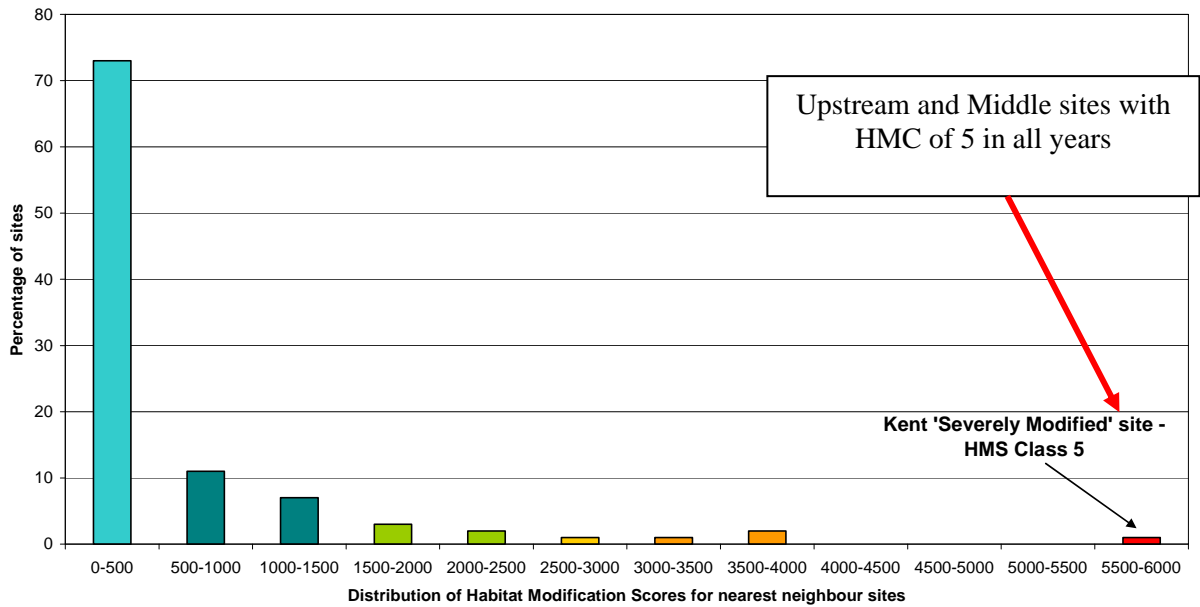
**Habitat Quality Assessment of the Kent (HQA 45) in relation to nearest neighbour sites**

**Habitat Modification Score for the Kent (HMS 5905) in relation to nearest neighbour sites**

**Figure 3.5** Range of HMS and HQA scores for the 150 nearest neighbour sites on the RHS database for the baseline data-set; the scores for the middle KENT site in 2005 are shown for comparison

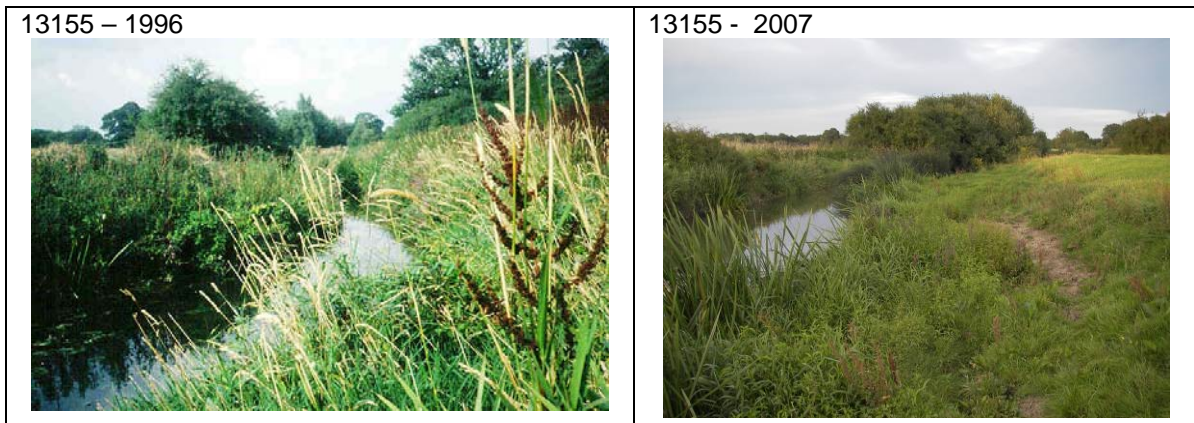
**Reach 13155 (see Plate 4.5)**

**Plate 4.5 River Arun: Repeat photography of reach 13155**

Little overall change was observed in terms of overall dimensions or bank characteristics. However, there did appear to be a large amount of silt in this reach. Despite being August and, given the floods earlier in the year, there was still a significant amount of in-channel vegetation indicative of silty, slow flowing conditions. Apart from this little changed could be observed as a result of the cessation of maintenance.

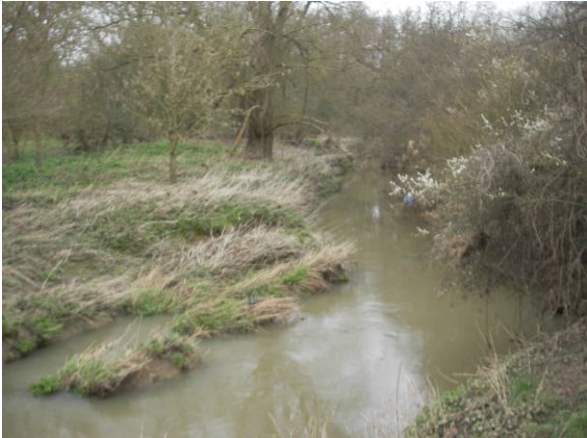
The bank vegetation in this section had clearly been recently affected by the local high flows. In addition the trees had been cleared on the left hand bank, probably related to the new track that has been made associated with a house on that bank. As with most of the other sections visited along the Arun, the channel features are limited. There are some in-channel features and these are being enhanced though local bank failure (see Plate 4.16) which should over time help to narrow over-wide sections.

**Plate 4.16 River Arun showing local bank failure which may help to narrow overwide reaches over time.**

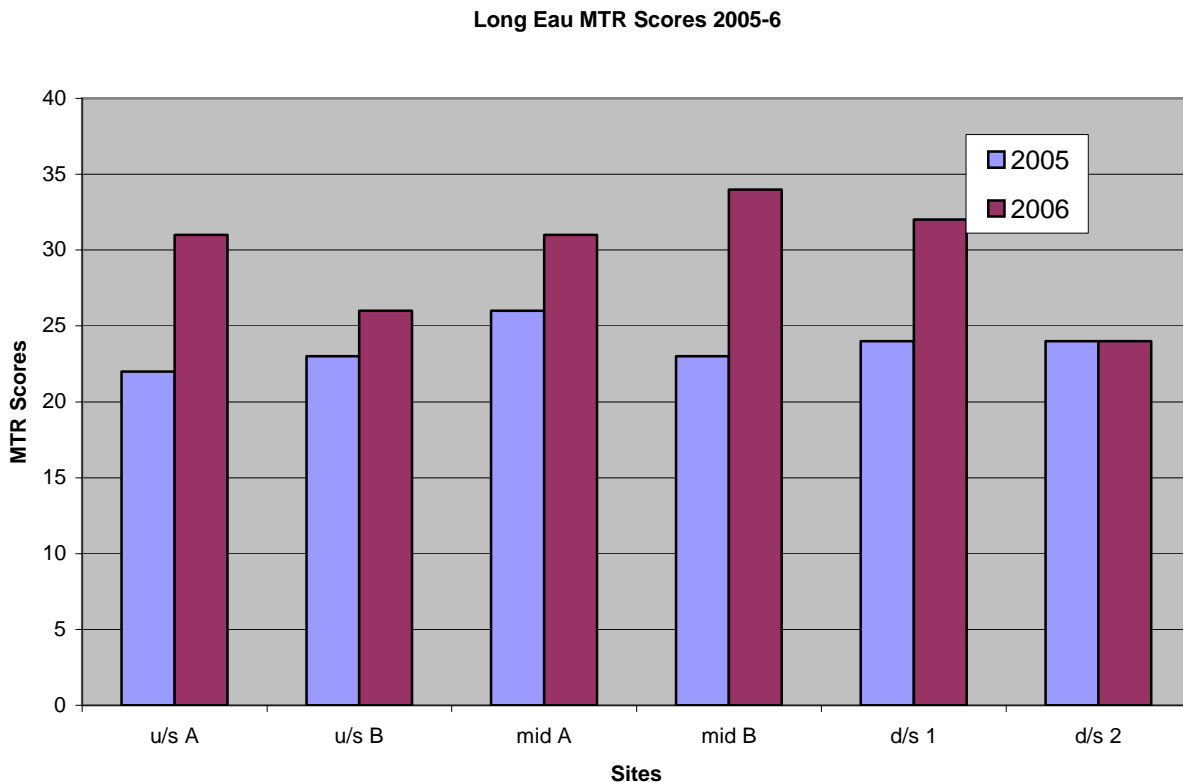
**Figure 2.1 MTR scores for Long Eau sites.**

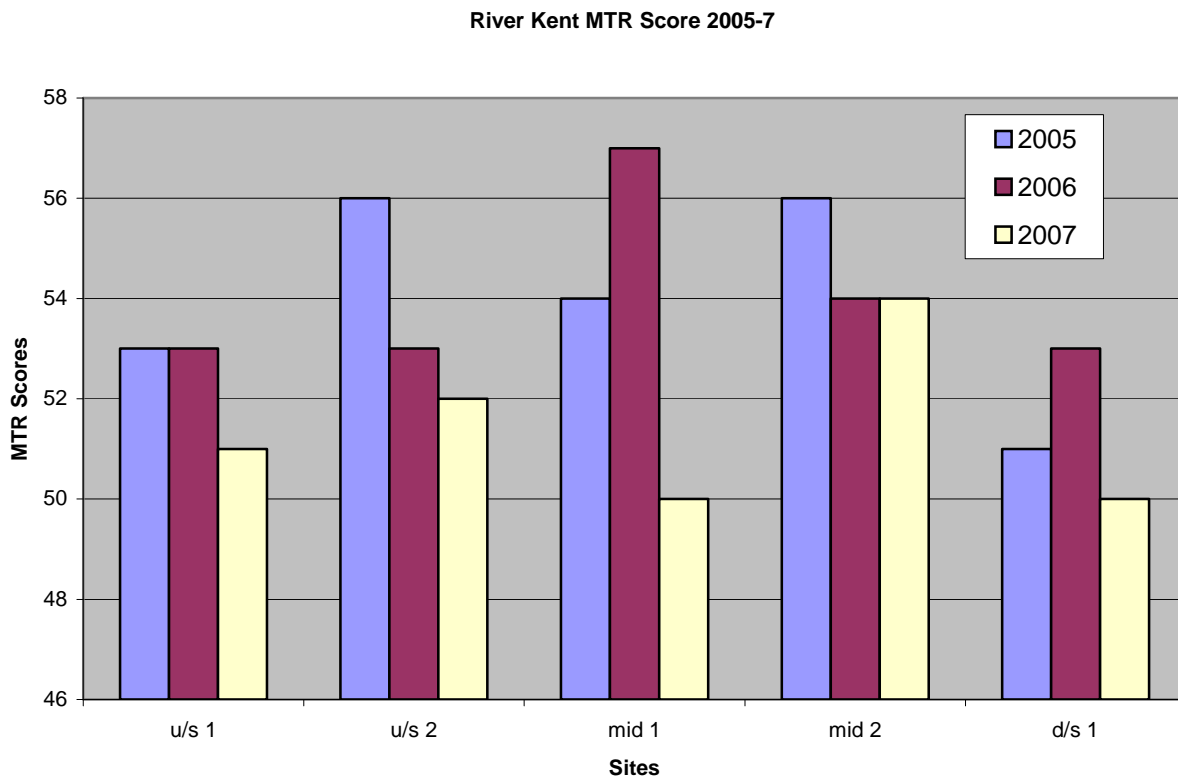
**Figure 6.1 MTR scores for the River Kent sites**

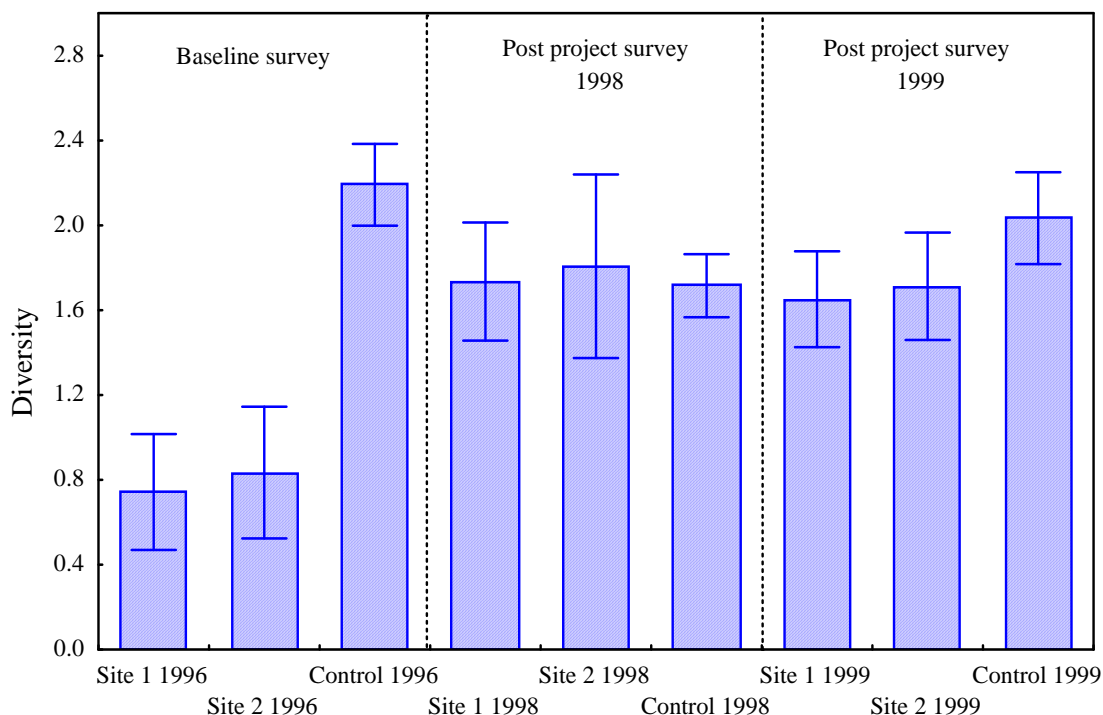
Species diversity index gives a measure of the richness and relative abundance of taxa, and is normally reduced in rivers that have been physically degraded. In England's studies (2006), where river rehabilitation works attempted to restore some natural habitats lost by previous river channel works, the recovery of invertebrates was staggering, as shown by Figure 4.1 below taken from her thesis. Each bar represents the average diversity, with the standard error also shown. At the control sites there was no change or a drop in diversity, but where habitats were restored, diversity more than doubled over the same time period.

**Figure 4.1 Diversity of invertebrates related to rehabilitation works**

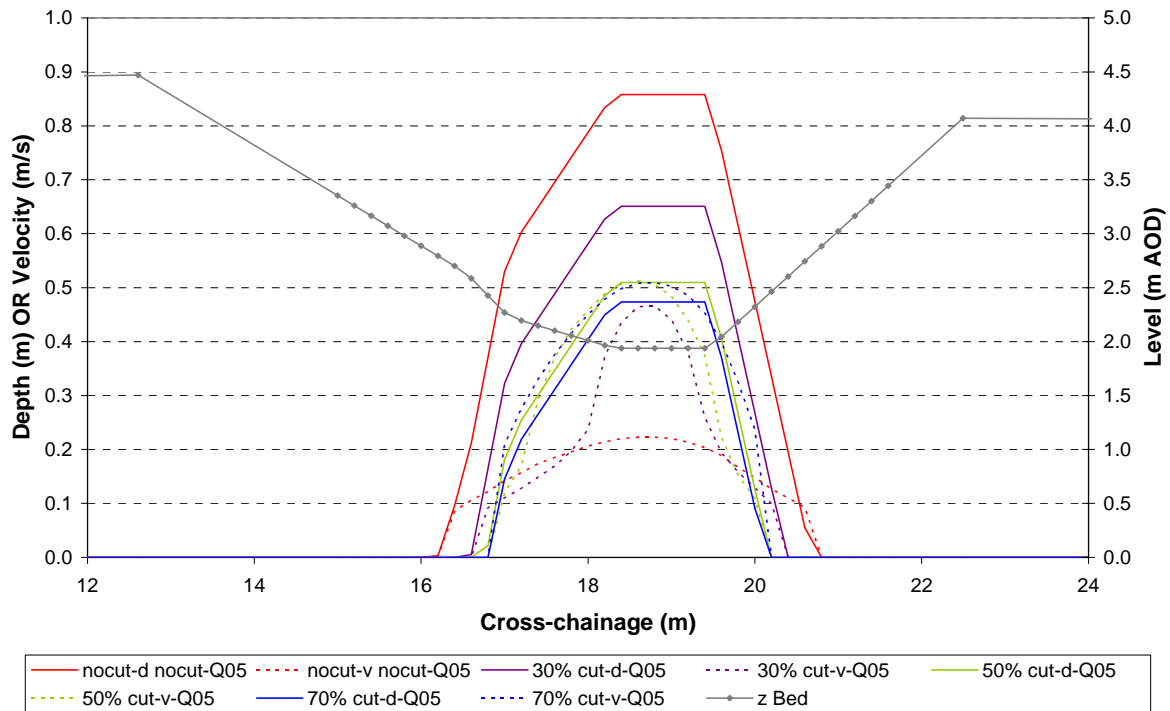
The impact of vegetation management on velocities and depths was investigated further by applying CES to individual cross-sections and simulating the impact of different vegetation cutting strategies. Three different vegetation cuts were imposed, 30% of width, 60% of width, which corresponds approximately to the Environmental Options W9 cut, and a cut over the full width of the channel, which corresponds to the Environmental Options W1 cut. Calculations were carried out for three discharges corresponding to the Q50 flow, the Q05 flow and the flow with an annual probability of exceedence of 0.5 (T02). Figure 2.6 shows the variation in water levels and flow velocities for Q05 flow. It can be seen that the no vegetation cut gives smallest overall flow velocities. These are relatively uniform across the channel width. Cutting just 30% of the width of the channel significantly increases the flow velocity in the central portion of the channel and leads to a significant reduction in water level. Progressively increasing the width of channel that is cut increases the maximum flow velocity in the channel. As more of the channel width is cut the velocity profile broadens. The difference between a 50% cut and a 70% cut in terms of both flow velocity and depth is small.

**Figure 2.6: Impact of different vegetation cuts on flow velocities and depths for Q05 discharge**

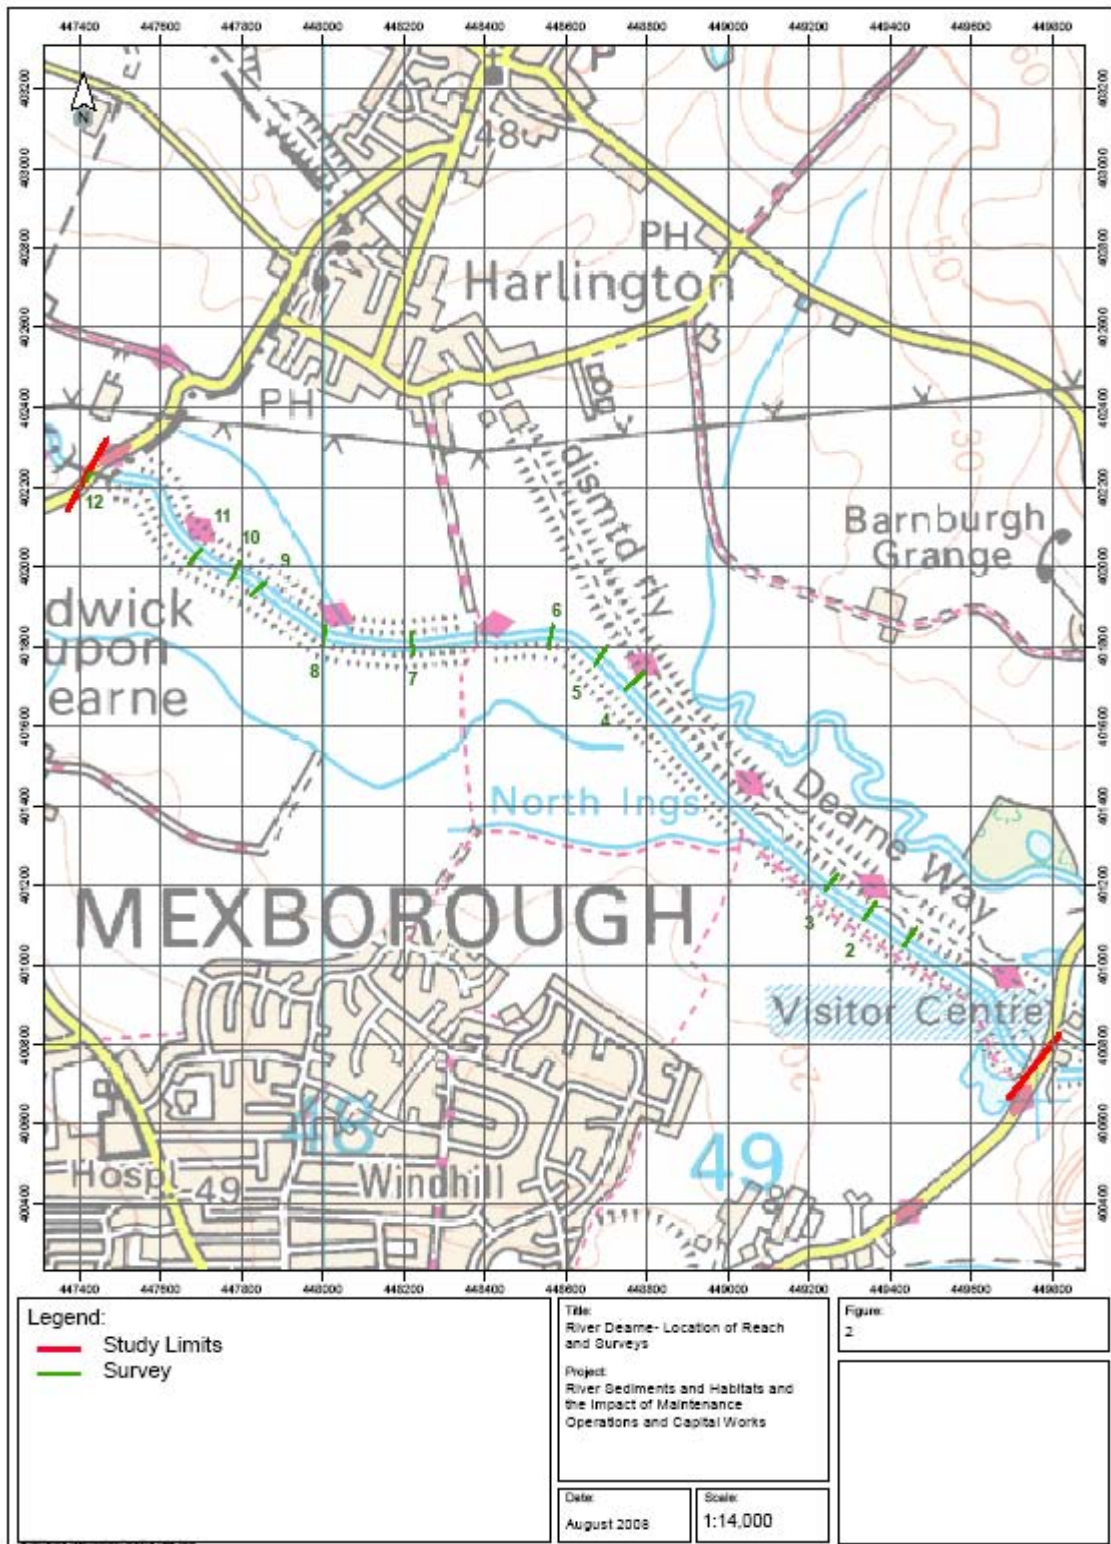
**Figure 3.2 Locations of cross-sections**

A cross-section survey of eleven cross-sections and one weir crest was taken in 2005 for an understanding of the levels through the reach and to construct the hydraulic model. This extended from Mexborough Road Bridge at the downstream end to the bridge at the upstream end, and, therefore, covered all the restored reach and upstream weir. The survey was repeated in 2007 for Sections 5 to 11. The locations of the surveyed cross-sections are shown in Figure 3.2

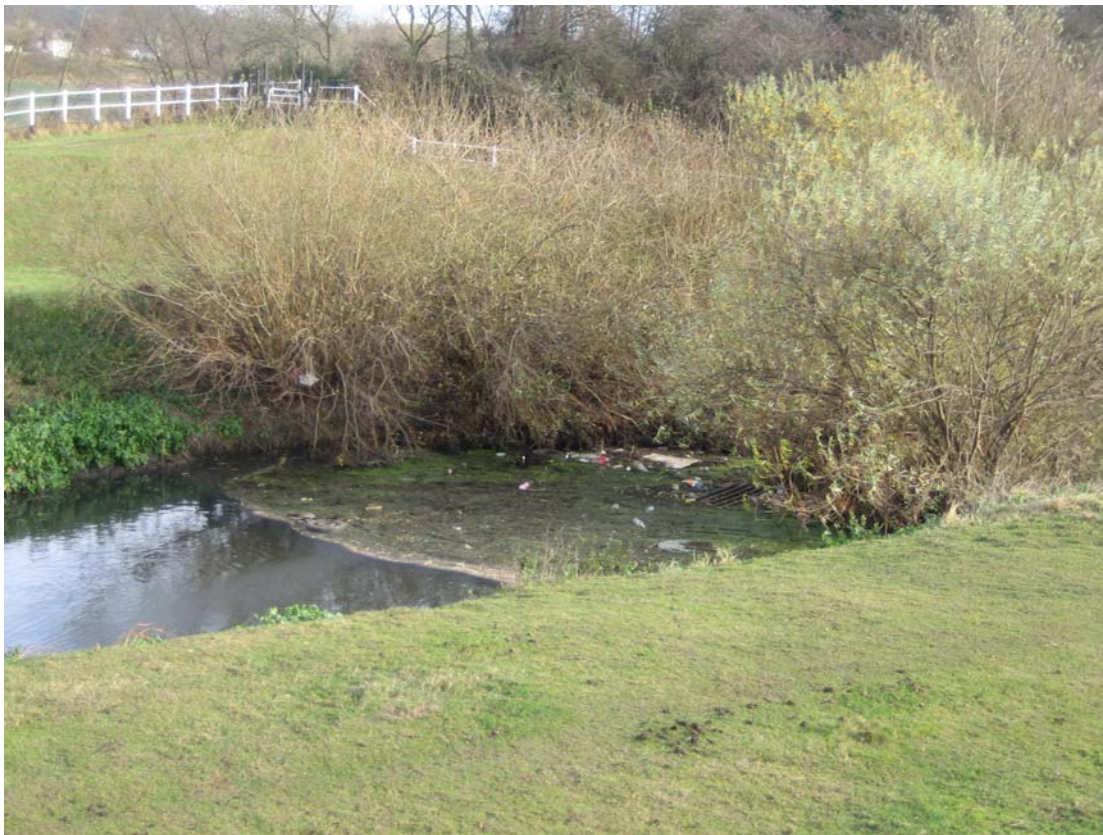
**Plate 3.3 Cross Section 4 of River Dearne showing encroaching vegetation growth on berms and banks**

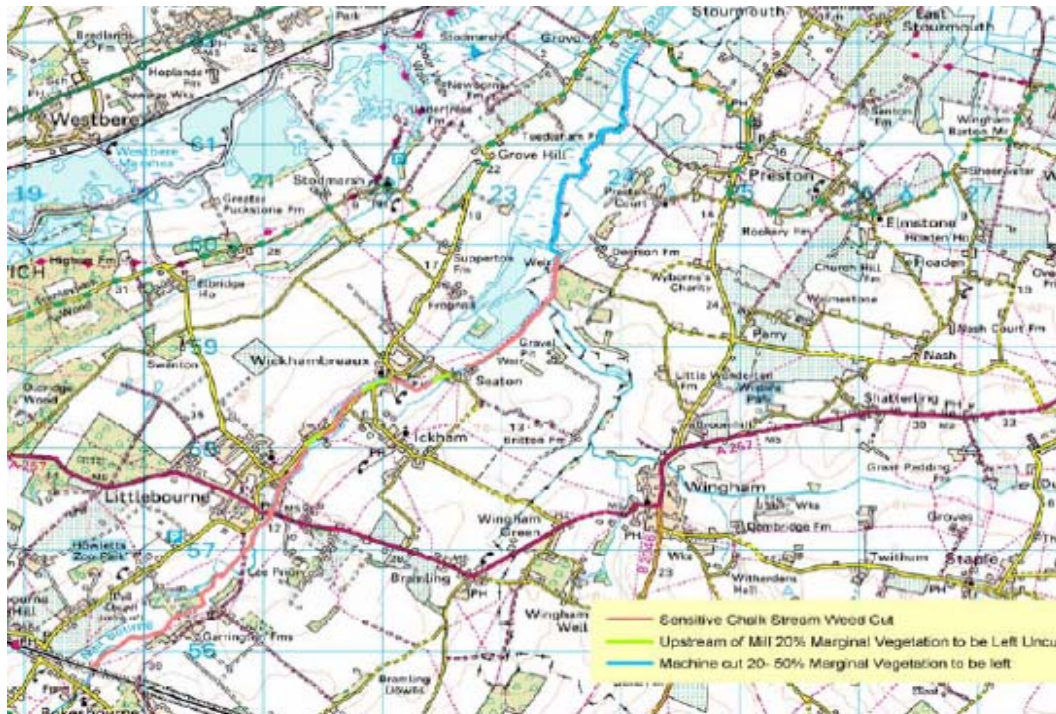
**Figure 3.4 Maps providing information about how management at different reaches could be approached**
