## Guidance for the Design and Maintenance of Stepped Masonry Spillways

Project: SC080015

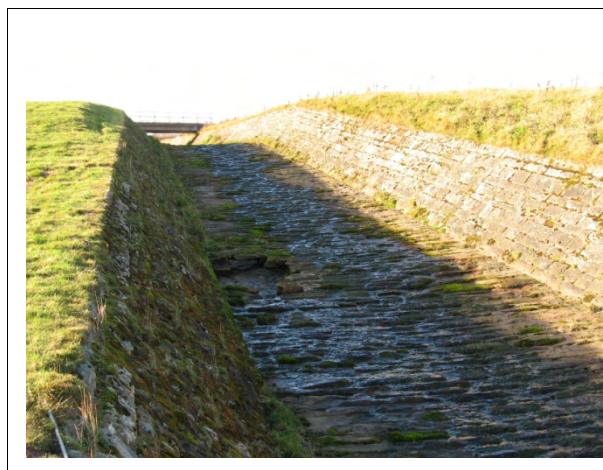
**Figure 2.2 An example of a sloping bed in a masonry spillway, with the wall masonry laid parallel to the bed.**

Sidewalls on both types of spillway can feature top surfaces which also slope with the line of the spillway (see Figure 2.2) or be formed in a series of steps (see Figure 2.3). Both types of upper wall profile can be found with both types of invert.

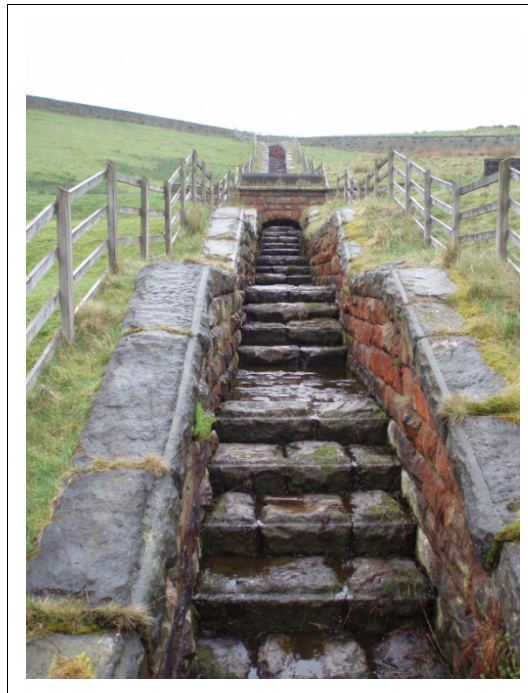
**Figure 2.3 An example of a stepped bed in a masonry spillway. The wall masonry is laid horizontally.**

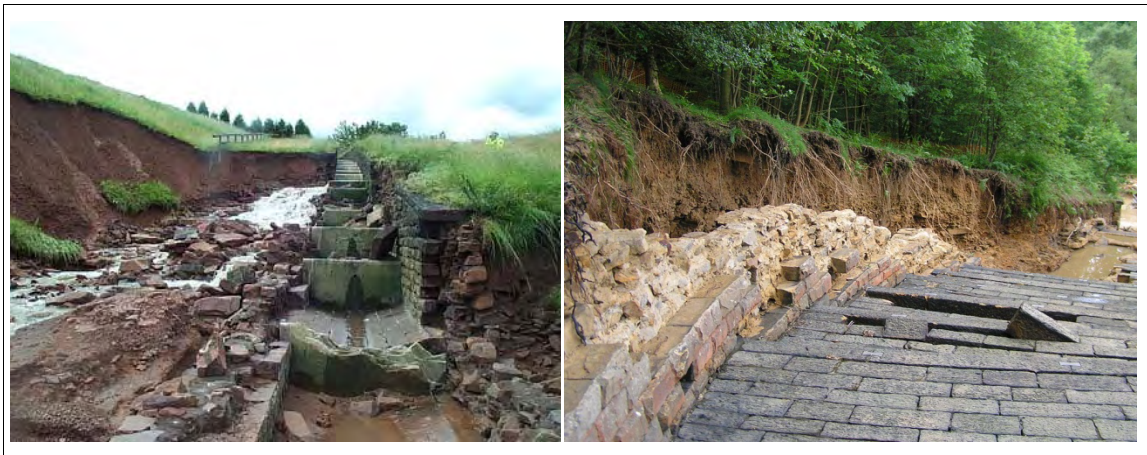
**Figure 2.4 Examples of failures of masonry spillways. The spillway wall on the left has random rubble masonry backing, whilst the spillway wall on the right has mass concrete hearting between the random rubble backing and the dressed face.**

Figure 2.5 illustrates the types of plans and details often associated with stepped masonry spillways. Further details of typical spillway construction can be seen in the remaining figures. One common feature in all cases is that the internal (water) faces of the spillways tend to be in dressed masonry. These may often be bedded into backing walls of random rubble masonry. Such an arrangement can be seen in Figure 2.4.

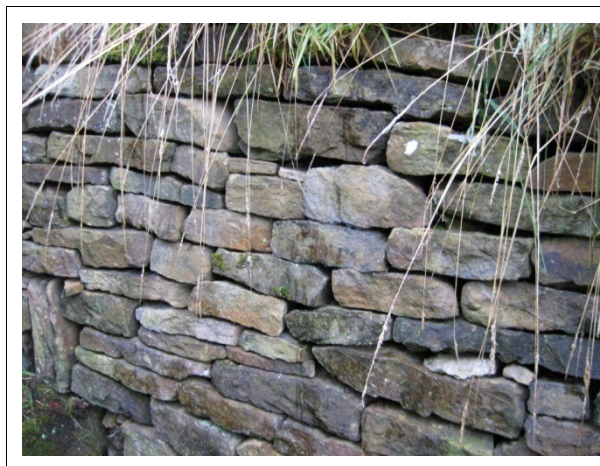
**Figure 2.6 Example of dry stone wall masonry**

Figure 2.6 to Figure 2.11 show examples of the various types of stone masonry described above.

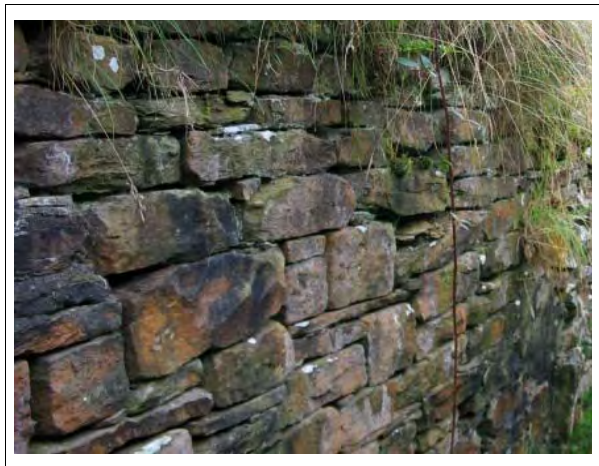
**Figure 2.8 Example of stone that has been brought to courses**

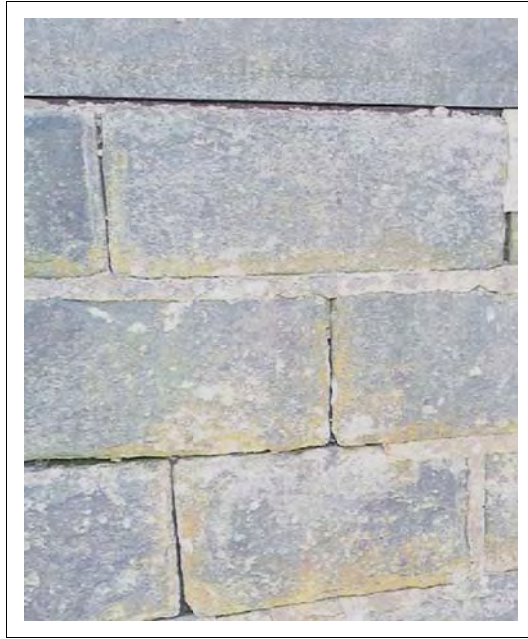
**Figure 2.9 Example of coursed stone masonry**

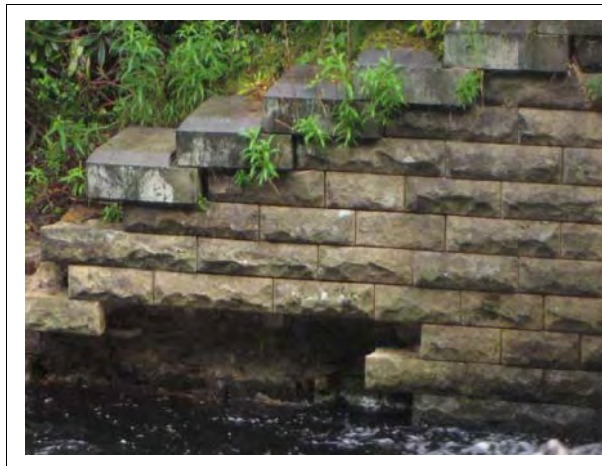
**Figure 2.10 Example of coursed dressed stone masonry laid horizontally**

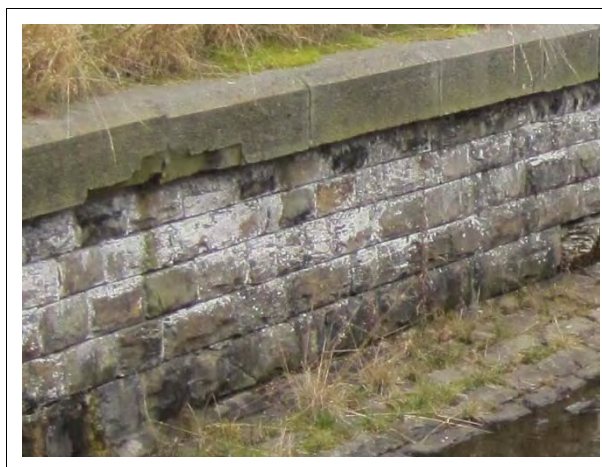
**Figure 2.11 Example of coursed dressed stone masonry laid horizontally with ashlar masonry copings**

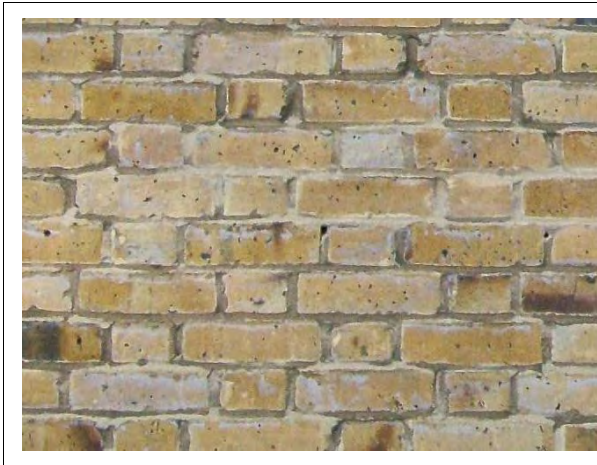
**Figure 2.13 Example of Flemish bond masonry**

Brick masonry spillways generally comprise engineering bricks. The colours may vary to give a more sympathetic finish with the surrounding area. Figures 2.12 to 2.14 are examples of the more common bonding patterns to be found in brick masonry.

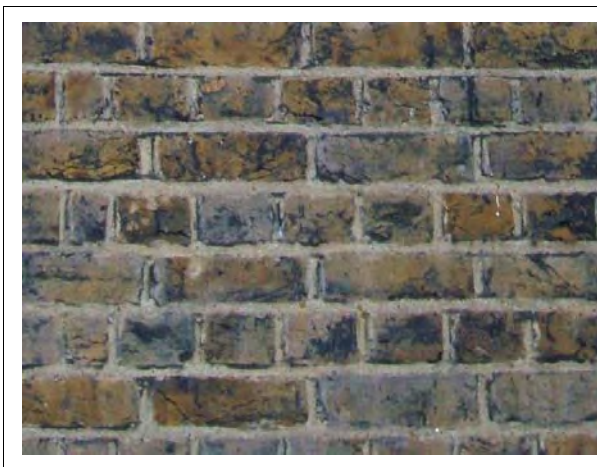
**Figure 2.14 Example of English bond masonry**

The type of bonding pattern used can give an indication of what lies in the bulk of the masonry behind the wall, for example, a stretcher bonded wall is a flat plate, half a brick thick, made up of bricks that run along the length of the wall. It does not include any bricks running through its thickness, so it is difficult to build it into walling behind it without using ties. As a result, it is likely that the masonry behind it is of a different type - such as random rubble.

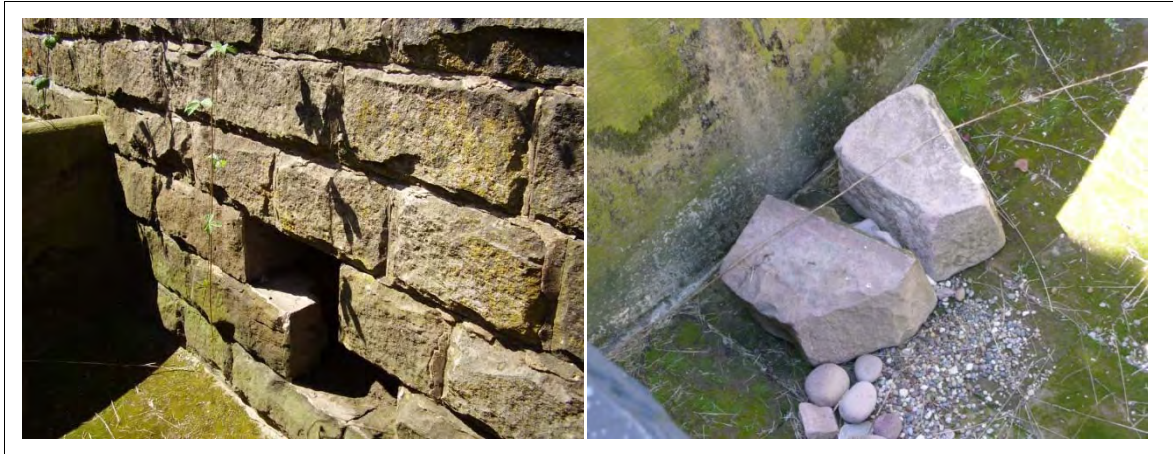
**Figure 2.15 Examples of localised loss of masonry blocks**

Examples of localised loss are shown in Figure 2.15. Widespread external failure is illustrated on Figure 2.16. The same vulnerabilities apply to the invert as to the sidewalls, as can be seen in Figure 2.17. Details of examples of problems at stepped masonry spillways in the UK are given in Appendix A.

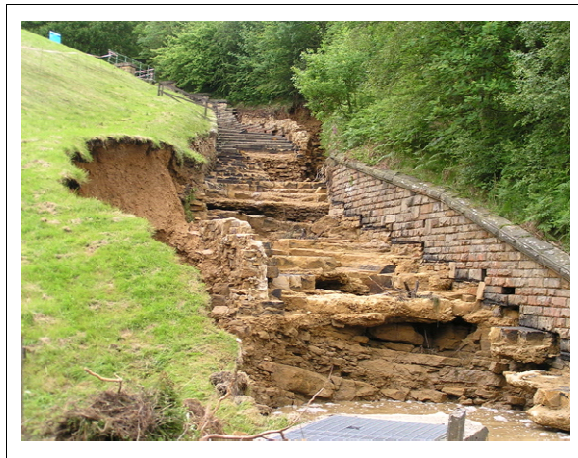
**Figure 2.16 An example of a widespread failure of a stepped masonry spillway**

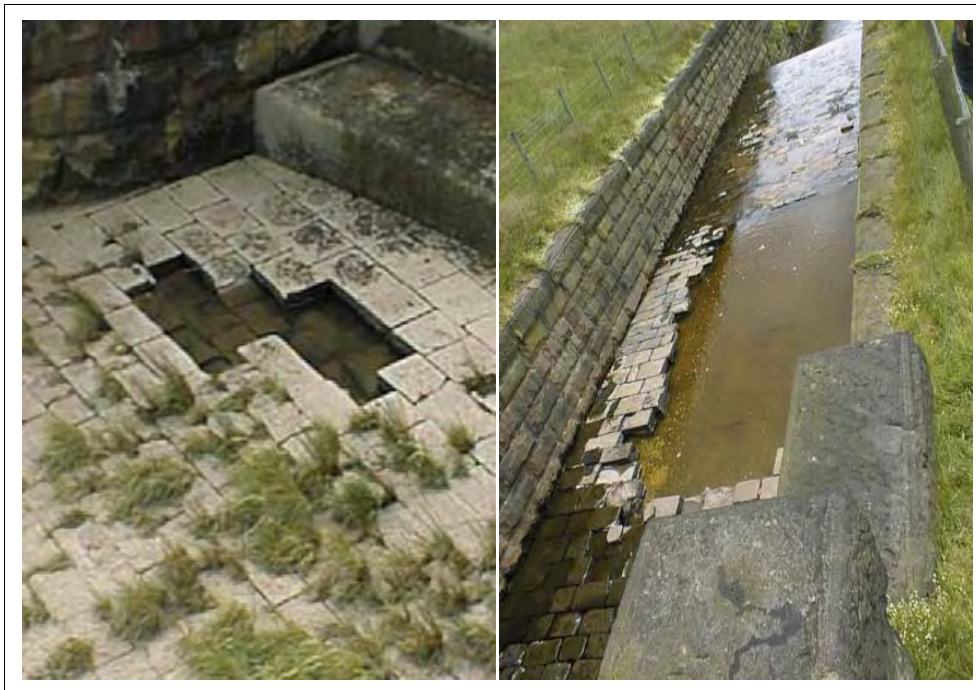
**Figure 2.17 Examples of invert failures of stepped masonry spillways**

Such failures only serve to illustrate the need to maintain both the masonry blocks and the mortar pointing in good condition.

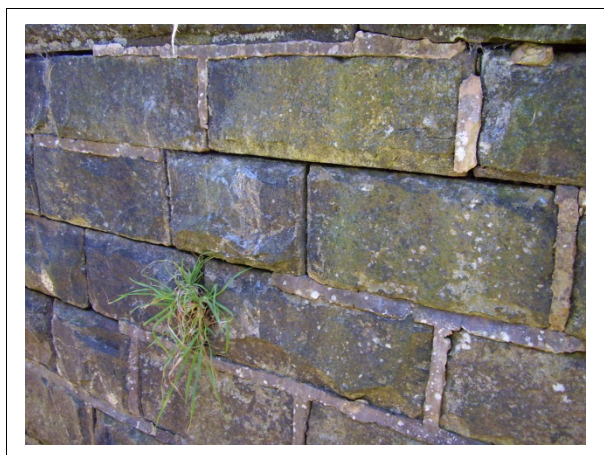
**Figure 2.18** An example of poor pointing and missing mortar beds in a spillway wall

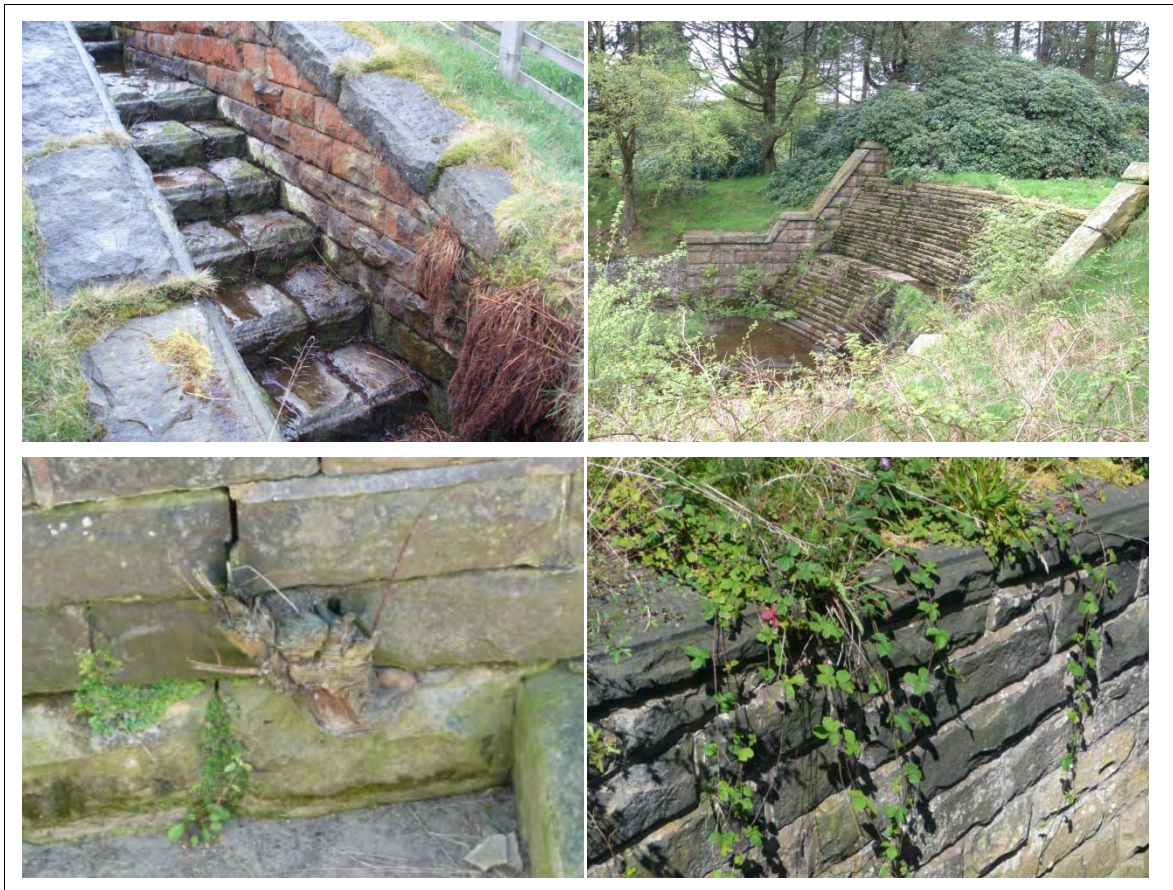
**Figure 2.19 Examples of vegetation growing in or on stepped masonry spillways**

Examples of vegetation growing on or in masonry spillway channels can be seen in Figure 2.19.

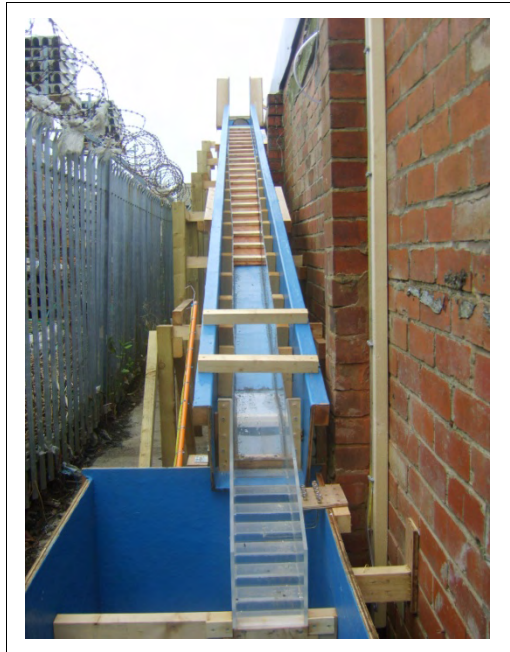
**Figure 4.1 Acceleration chute**

The test rig was used to collect flow rate, velocity, depth and pressure data.

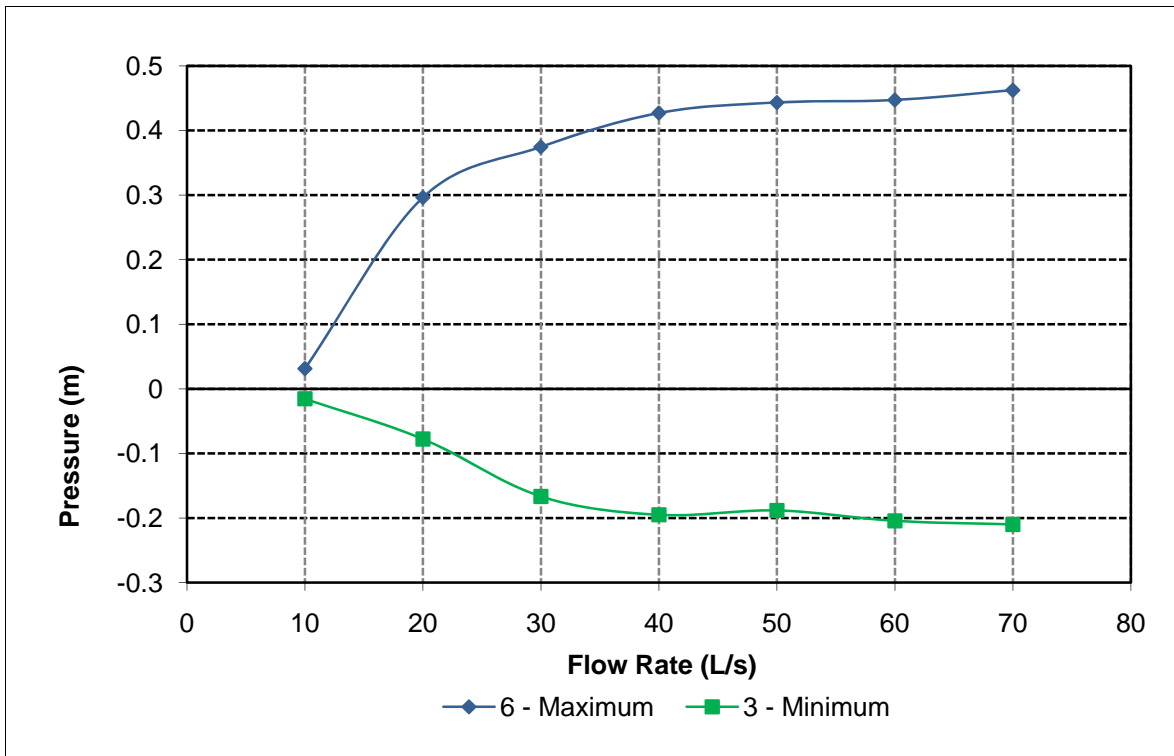
Figure 4.8 shows the maximum pressure fluctuation on tapping 6 (located at the base of the wall at the downstream end of the step) relative to the minimum pressure fluctuation on tapping 3 (located in the centre of the wall) - the coincidence of these extremes represents the worst case scenario. The pressure differential on the model, where the steps are 31 mm high, is around 0.65 m at 70 l/s. If this represents a 1:10 scale model of a real 0.31 m high step, then the pressure differential on the real step would be 6.5 m of water pressure. This demonstrates the need to consider the peak negative and positive pressures and forces exerted by the flow when assessing the stability of a masonry block rather than simply considering the mean pressures and forces.

**Figure 4.8 Possible pressure range across a block with poor pointing**

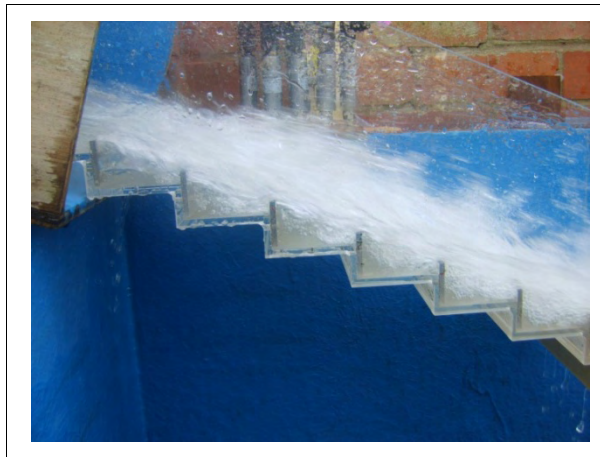
On some existing spillways, an end upstand has been provided on the downstream edge of every step to encourage a pool of water to form and assist with energy dissipation under nappe flow. Therefore, a 10mm high end upstand was added to the model steps to simulate this situation (see Figure 4.13).

**Figure 4.13 Steps with end upstands**

Modelling showed that the presence of the end upstand had the effect of increasing the pressure fluctuations, especially on tappings 3, 4, 6 and 12 and increasing the pressure on tapping 4 which is very close to the end of the upstand.

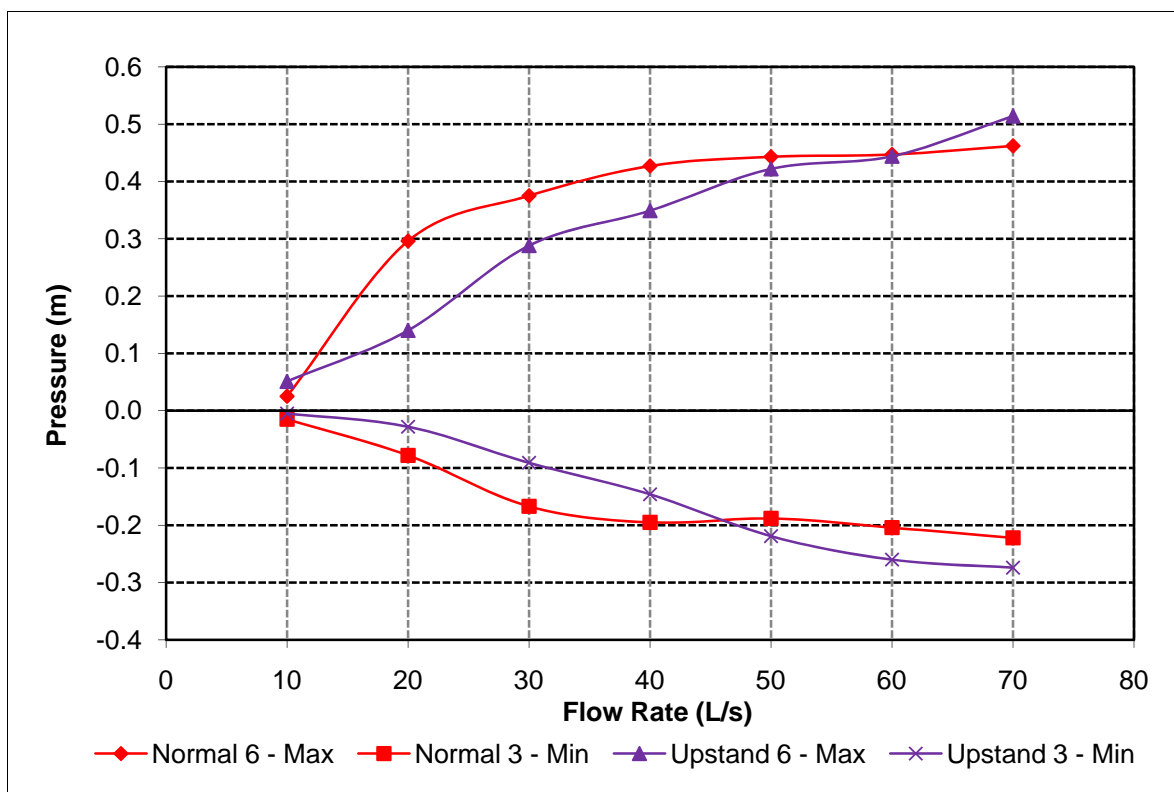
**Figure 4.14 Pressure differential – smooth approach and end upstand**

Figure 4.14 and Figure 4.15 show the pressure differentials along the steps for both a smooth and rough approach with the end upstand in place. It can be seen that for the rough approach, the pressure differential is always larger with the end upstand in place regardless of flow rate. However, for the smooth approach, the differential is smaller at low flow rates with the end upstand in place, but becomes much larger as the flow rate increases. At 70 l/s on the smooth approach, the potential pressure differential on the model is 0.79 m compared to 0.65 m for the normal step with no end upstand in place. The equivalent figures for the rough approach are 0.63 m with the end upstand in place and 0.52 m for the normal step. The implication of this is that, whilst the presence of an end upstand may aid energy dissipation under nappe flow conditions, it will most likely increase the risk of masonry failure at high flows.

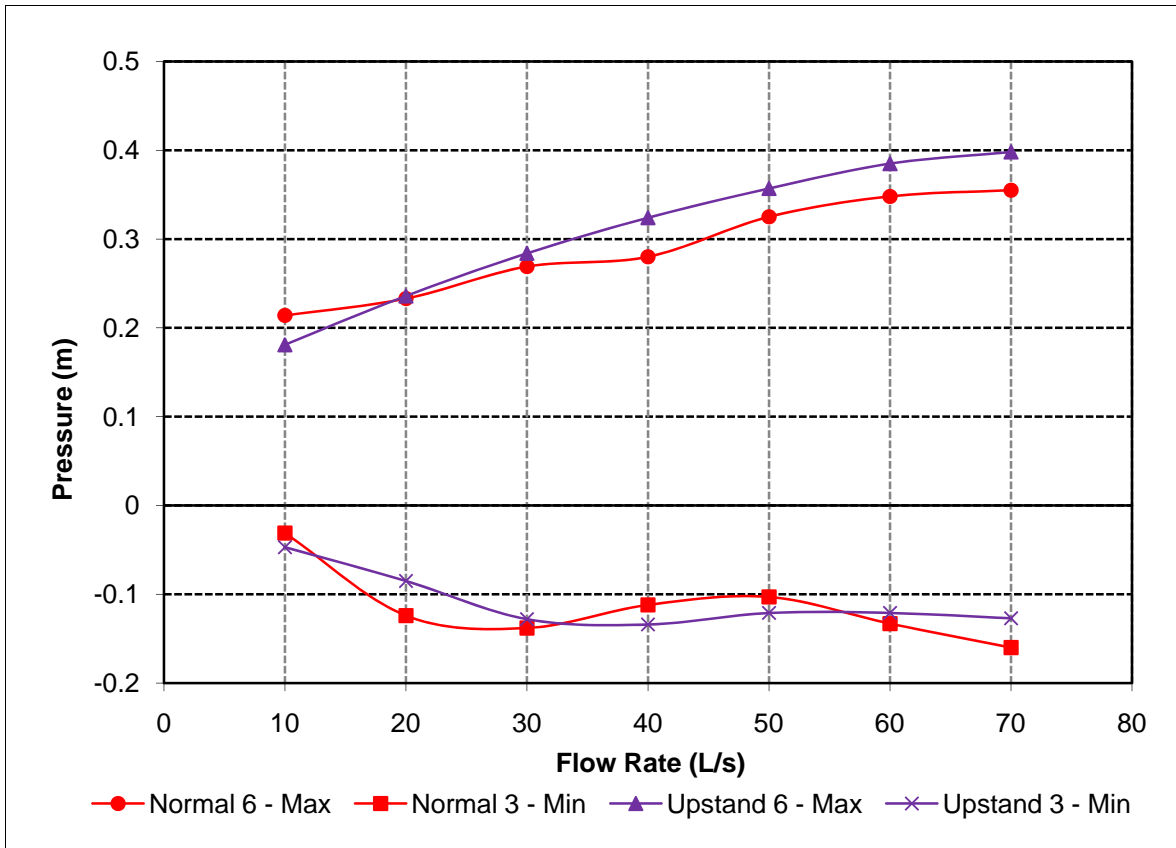
**Figure 4.15 Pressure differential – rough approach and end upstand**

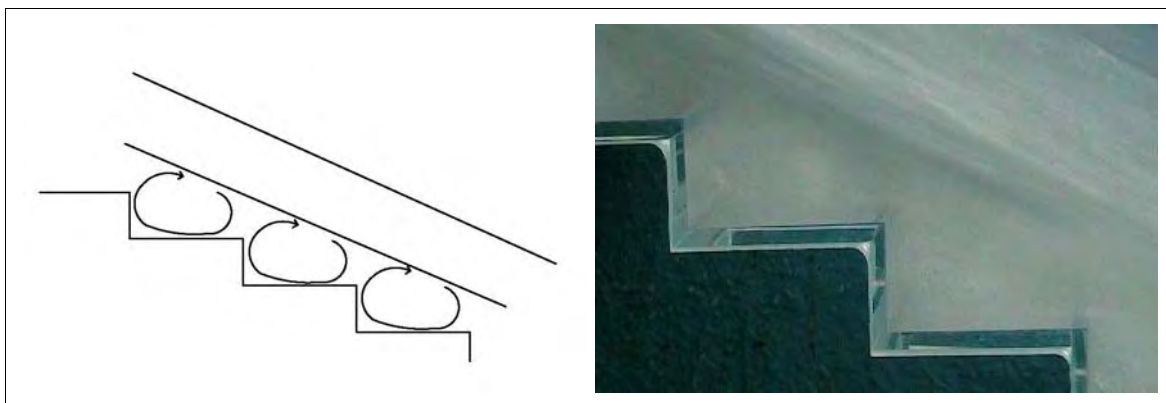
**Figure 4.19 Roller above steps**

any of the steps. All of the steps were in zones of reduced pressure and the roller was observed to be above the level of the step edges (see Figure 4.19).

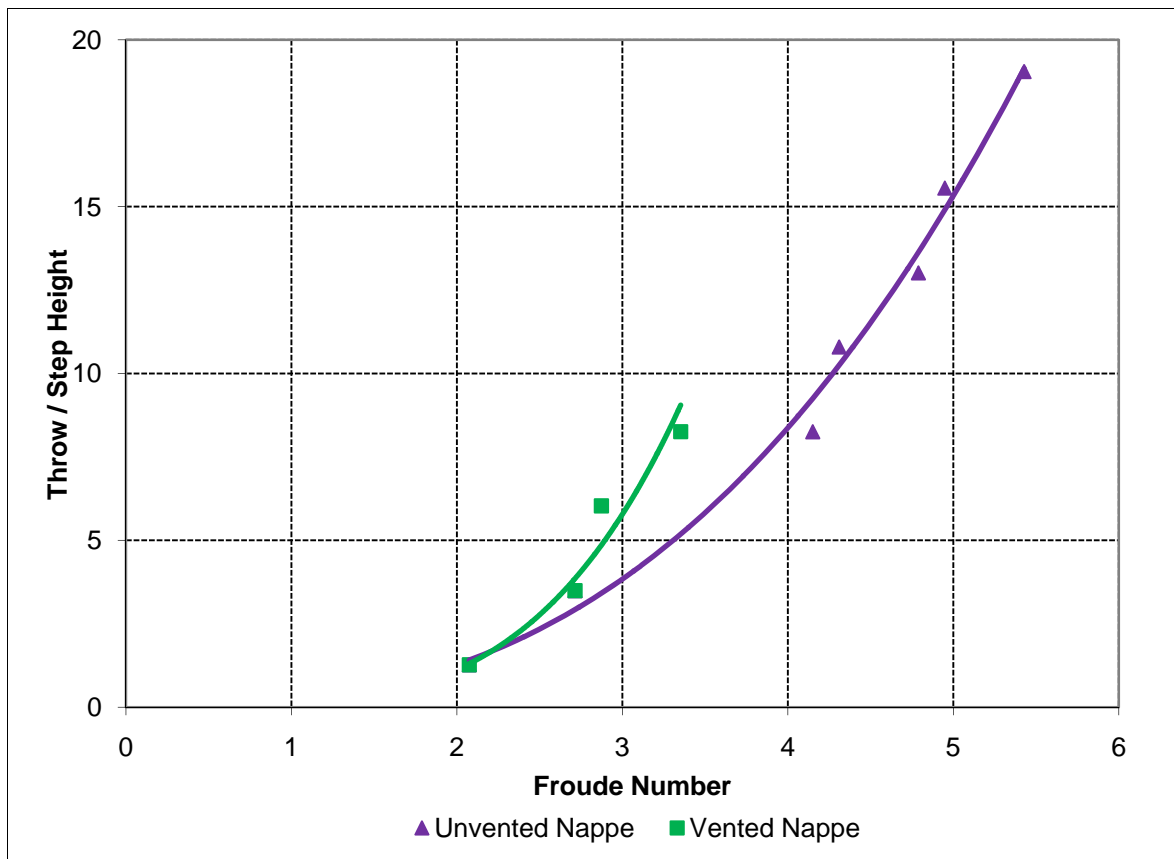
**Figure 4.21 Horizontal location of the reattachment point for a change in angle of 20.9°**

Figure 4.21 shows a plot of Froude Number against dimensionless reattachment distance (horizontal throw / step height) which would allow the impact point of separated flow to be determined. This chart is valid for a change in angle at the top of the flight of steps of 20.9°. Further research would be needed with varying changes of angle to obtain a family of design curves suitable for universal usage.

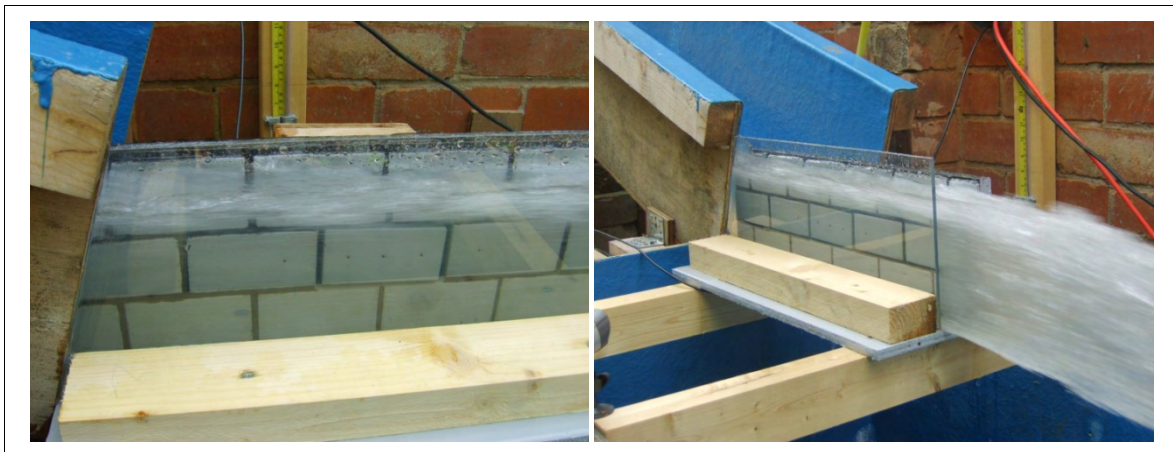
**Figure 4.24 Upstream and downstream joints open - block flush**

Under these test conditions, flow was uniform and parallel to the bed (see Figure 4.24) and there was very little pressure fluctuation against the wall, with only tappings 4 and 6 recording an offset from zero (the slight negative pressure is a result of the velocity of flow rushing across the joint setting up a suction effect).

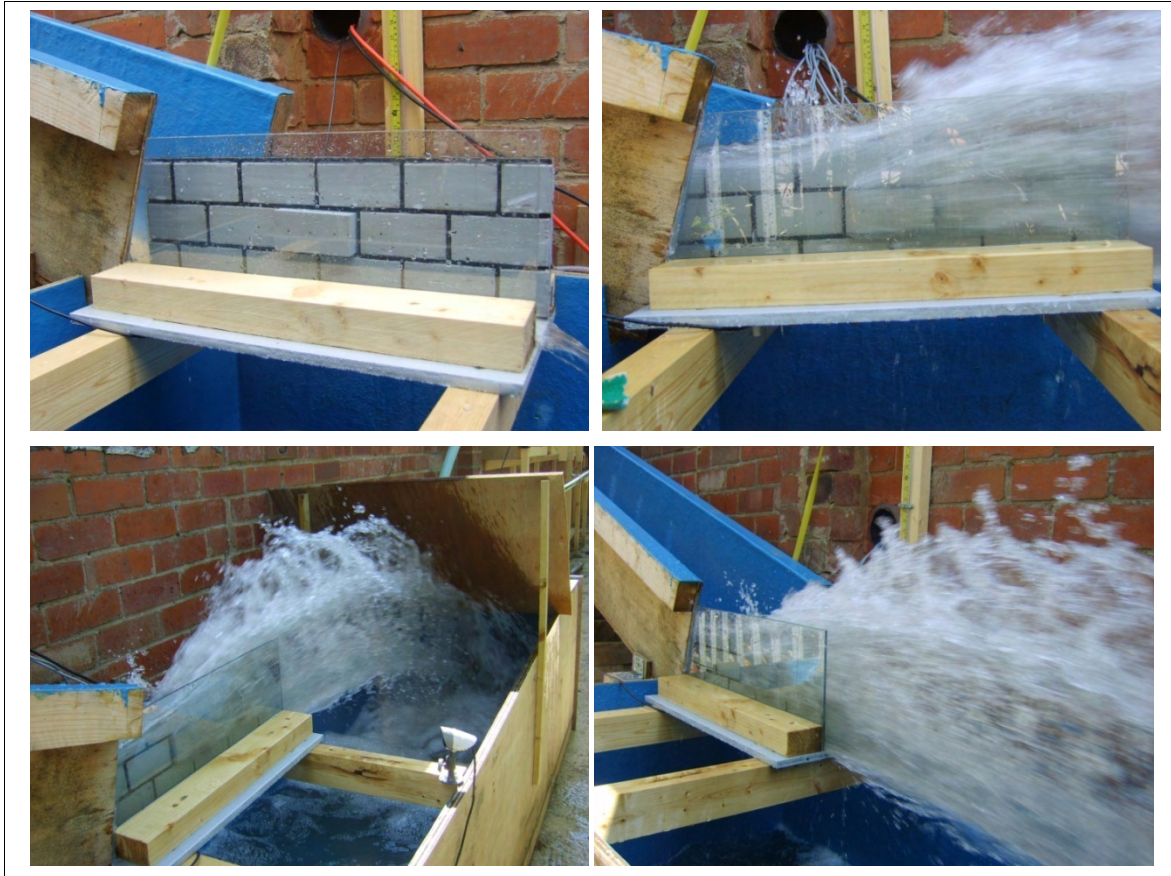
**Figure 4.25 Upstream and downstream joints open - block proud by 15 mm**

It should be noted that the difference in pressure rise between +10 mm and +15 mm is not that dramatic, most of the 'damage' is done by the block standing just a few millimeters proud of the surface.

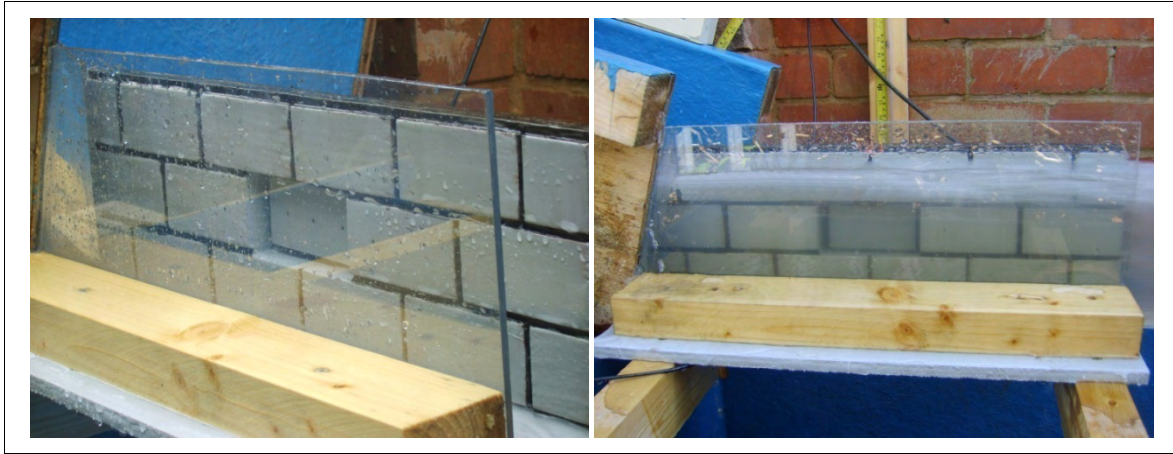
**Figure 4.26 Upstream and downstream joints open - block inset by 15 mm**

The indent in the wall acts like a step edge so that a low pressure zone forms in the lee of the step, drawing down the pressure at tapping 1 and tapping 4 in the upstream joint. Flow re-attaches to the surface of the indented block around tapping 2 generating an impact pressure slightly greater than that given at tapping 5 which is in the regular flow. The flow impacts onto the end of the downstream block generating a stagnation point with high pressure at tapping 3 and extreme pressure fluctuations at tapping 6 in the downstream joint. Tapping 7 sits in a small separation zone as the water rises over the edge of the downstream block.

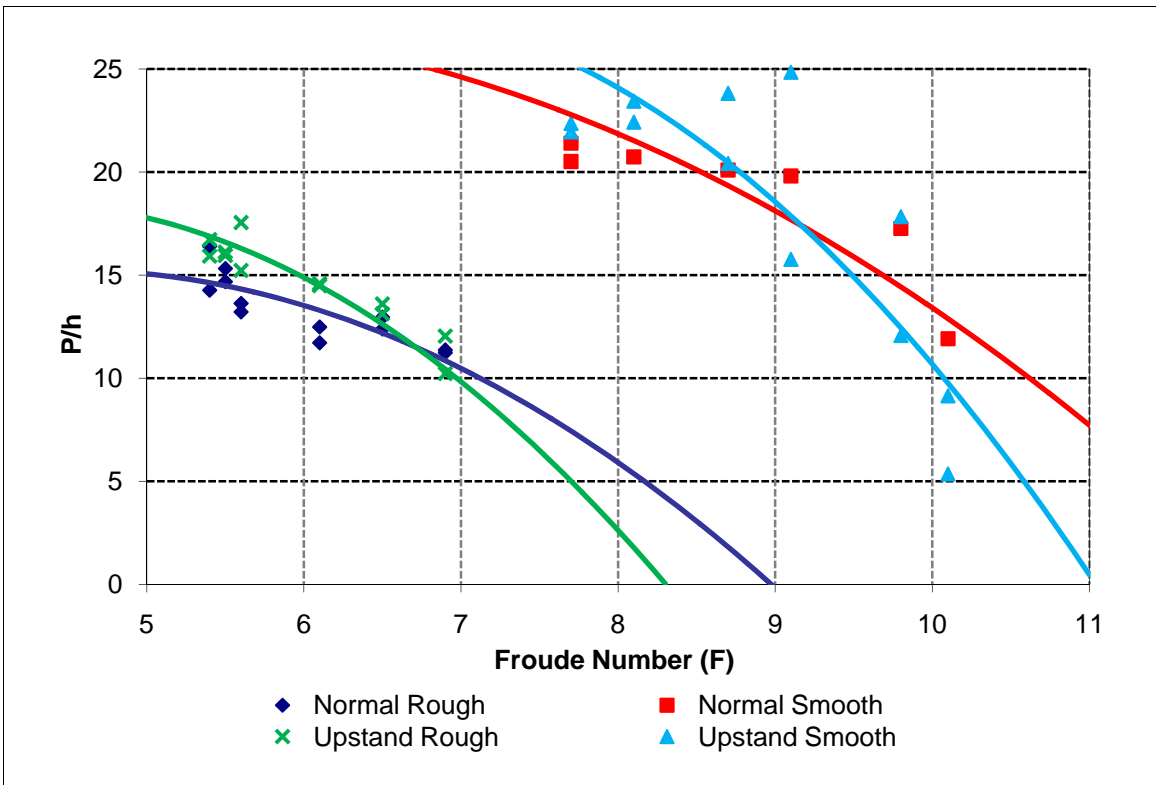
**Figure 5.1 Pressure differential on wall design chart**

Figure 5.1 and Figure 5.2 can be used to calculate the pressure differential that could exist on a channel wall adjacent to a step in skimming flow.

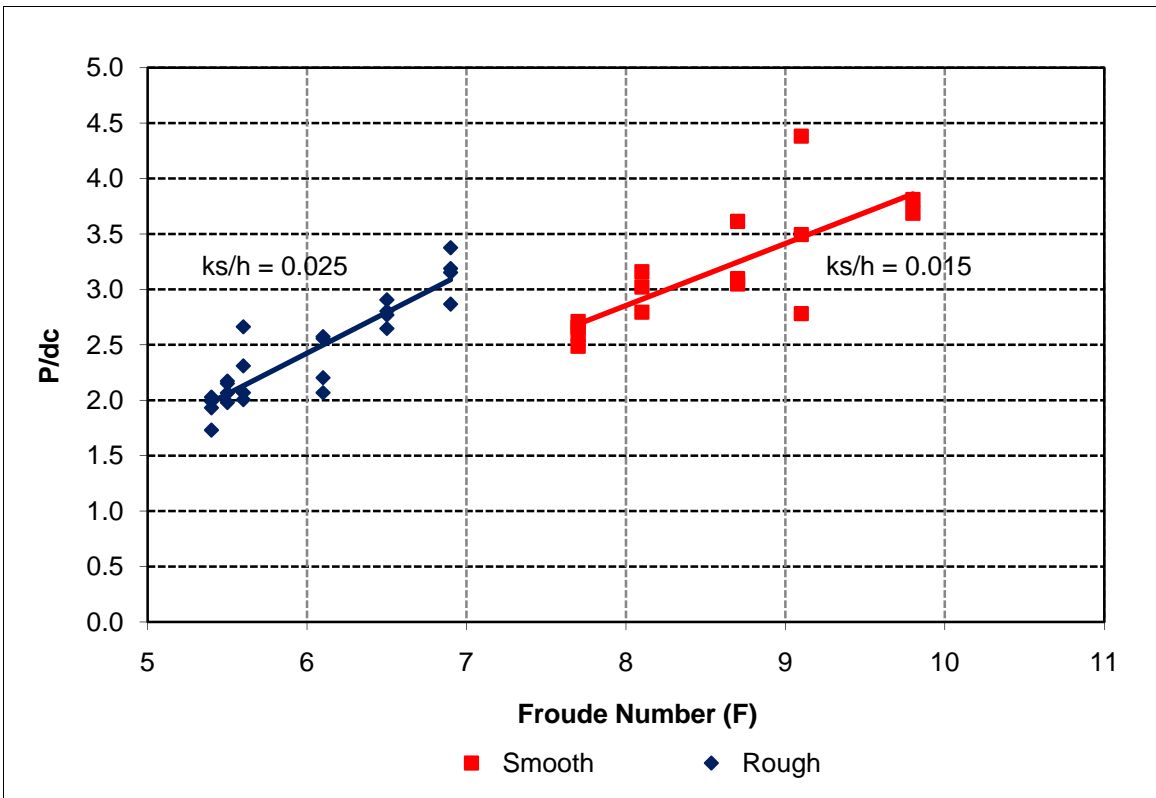
**Figure 5.2 Maximum pressure differential on wall design chart**

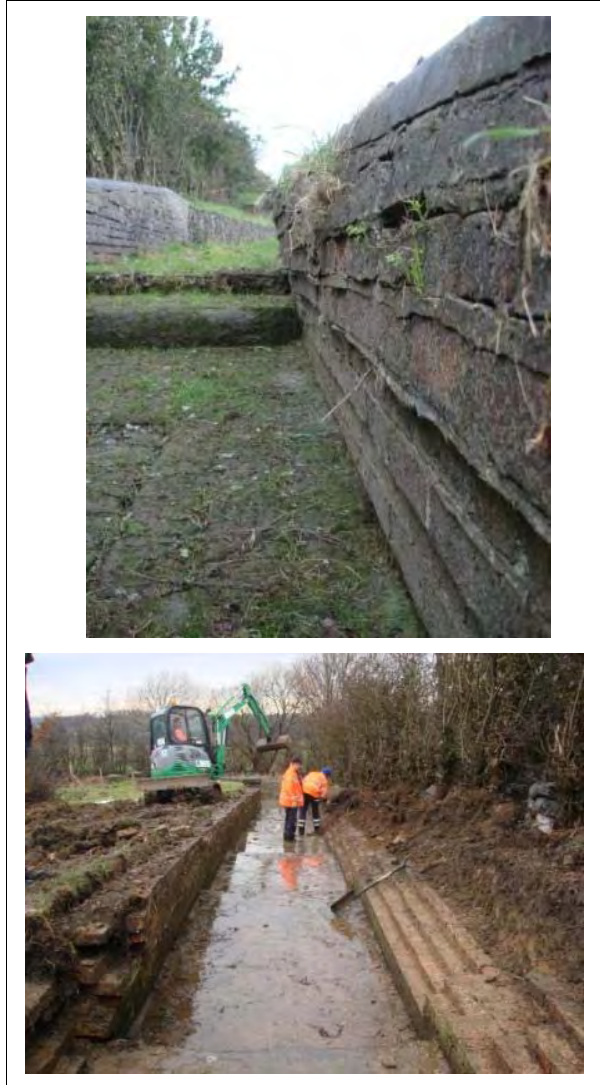
**Figure 5.8 Side wall with a definite lean – before and after local demolition. Wall will be rebuilt.**

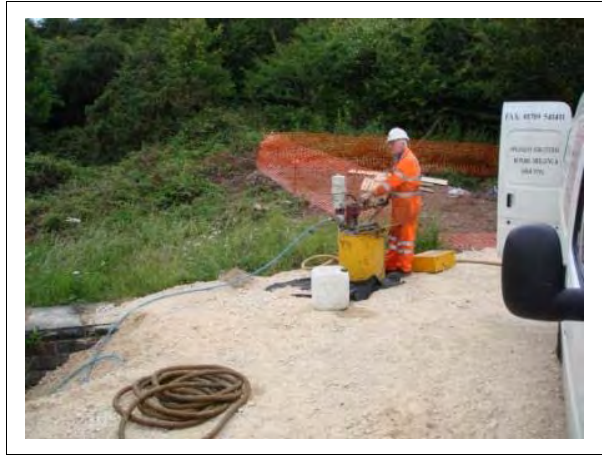
**Figure 5.9 Plant for pressure pointing**

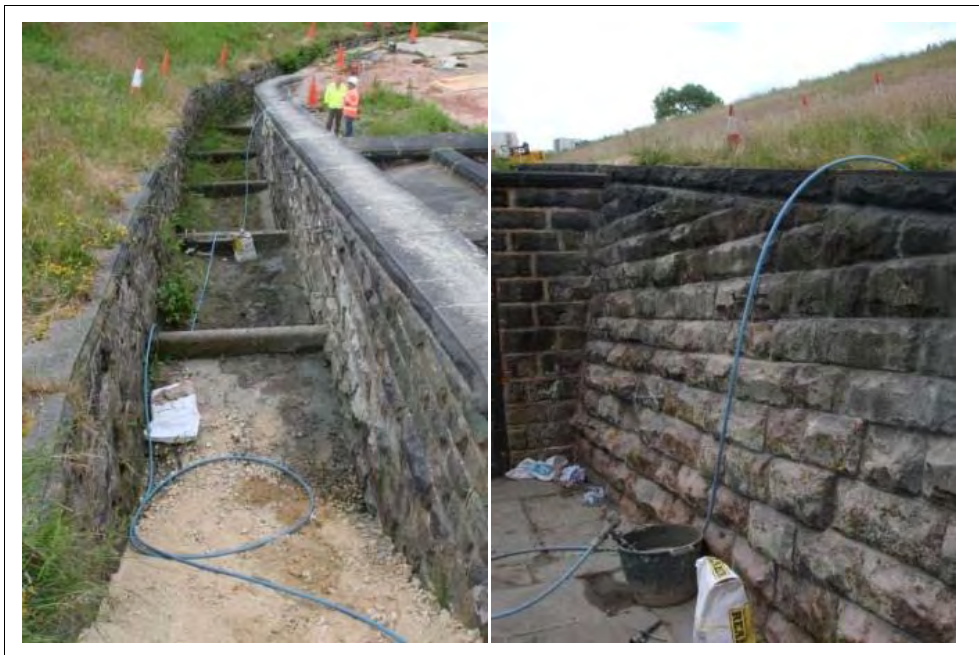
**Figure 5.10 Lines along a spillway channel to pressure point both sides of the wall on the right hand side of the spillway**

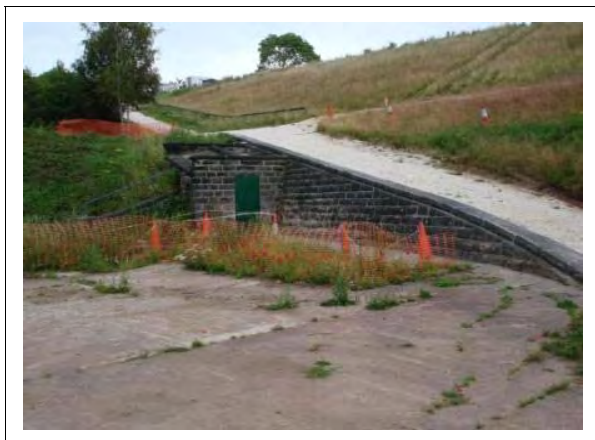
**Figure 5.11 Completed wall – spillway behind has been infilled**

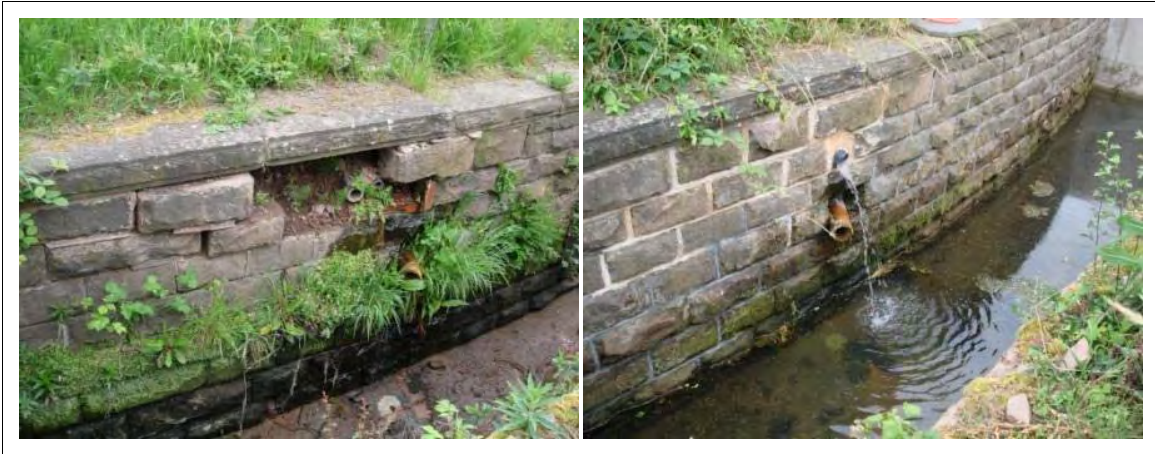
**Figure 5.12** Damage to masonry wall repaired by replacement of missing blocks, repointing and fixing of leaky pipe

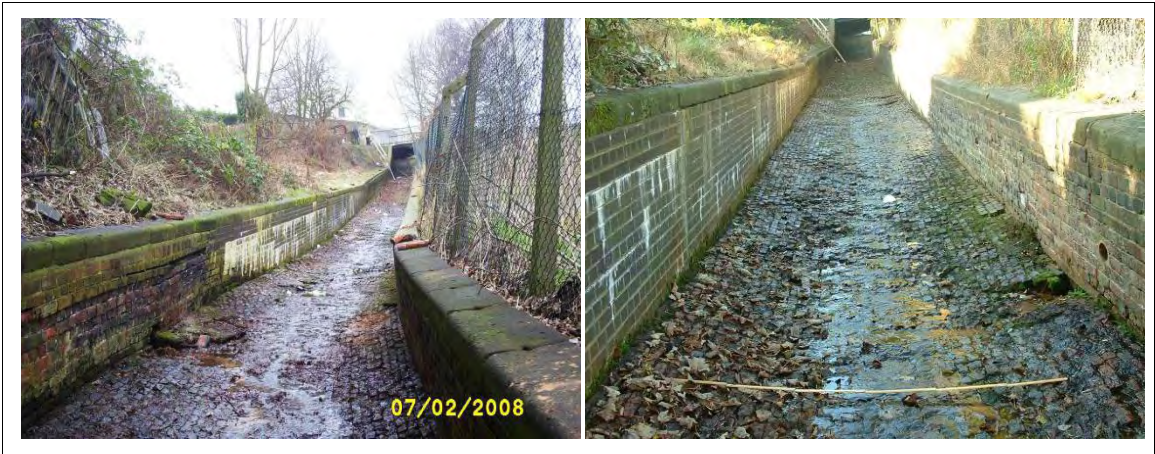
**Figure 5.13** Channel invert before repairs

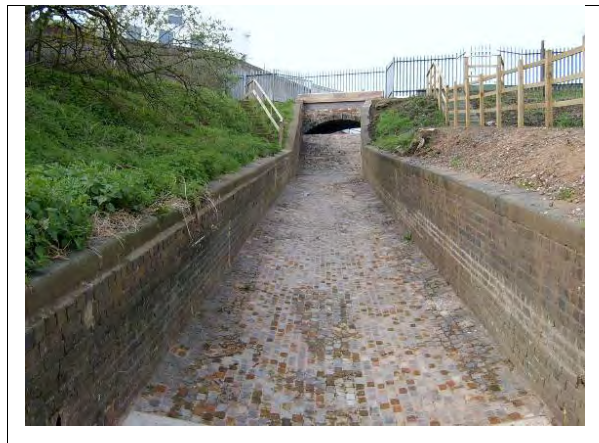
**Figure 5.14** Repaired spillway channel

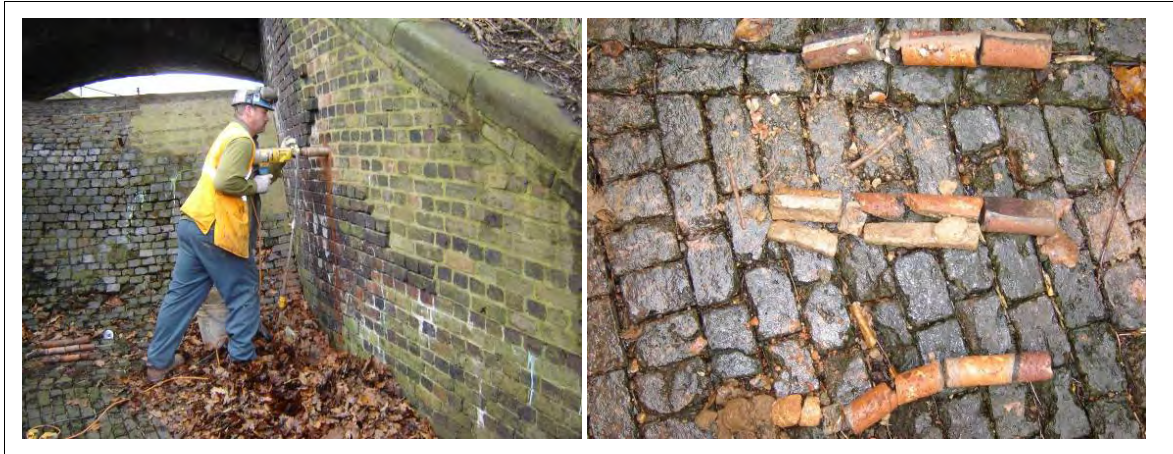
**Figure 5.15 Cores being extracted from the side wall to determine thickness**

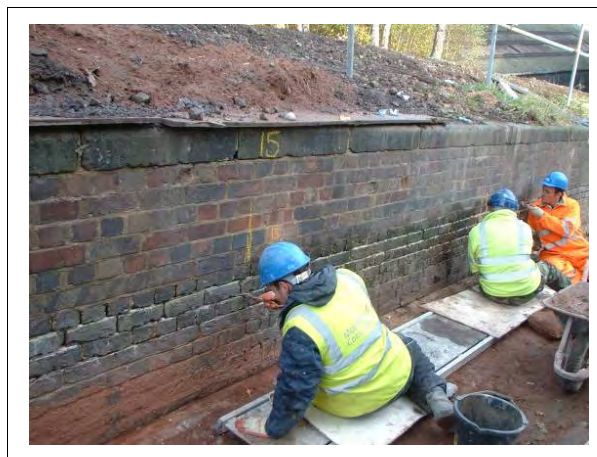
**Figure 5.16 Repointing of original brickwork with lime mortar**

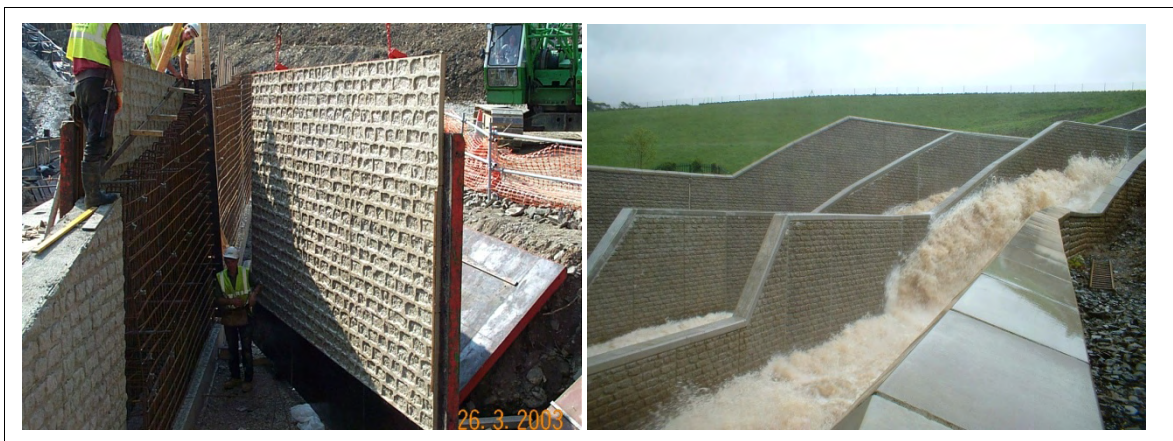
**Figure 5.17 Examples of masonry replacement using textured concrete**

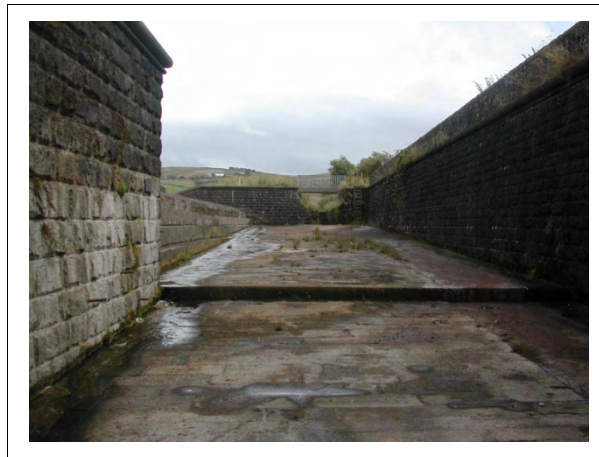
**Figure 5.19 Replacement of masonry invert with concrete slab**

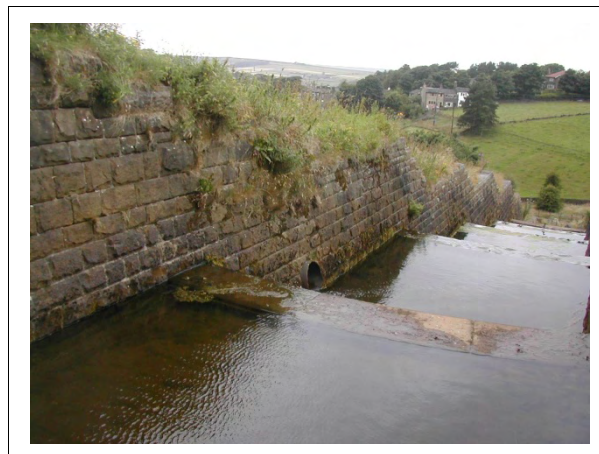
**Figure 5.20 Replacement of horizontal invert (impact) masonry slabs of steps with concrete slabs**

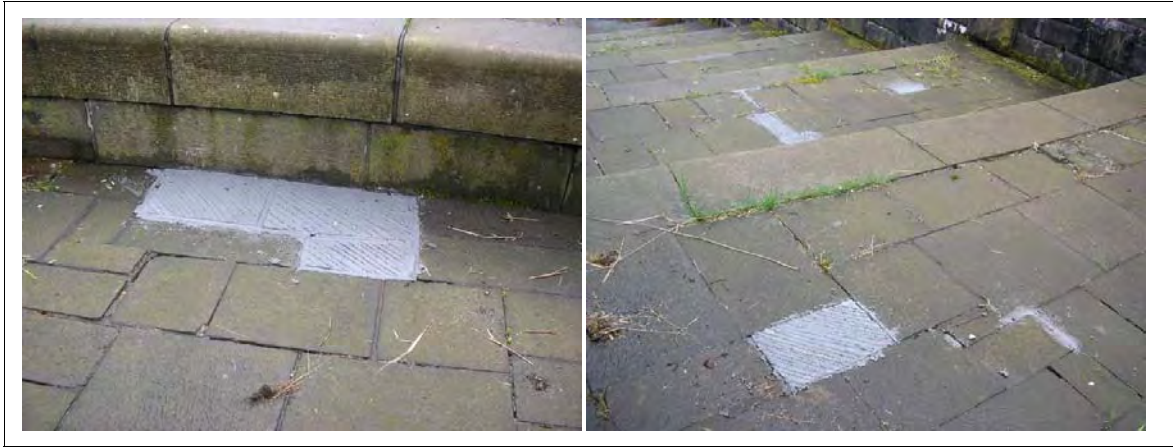
**Figure 5.21 Replacement of missing masonry invert blocks with concrete**
