## Guidance for the Design and Maintenance of Stepped Masonry Spillways

Project: SC080015

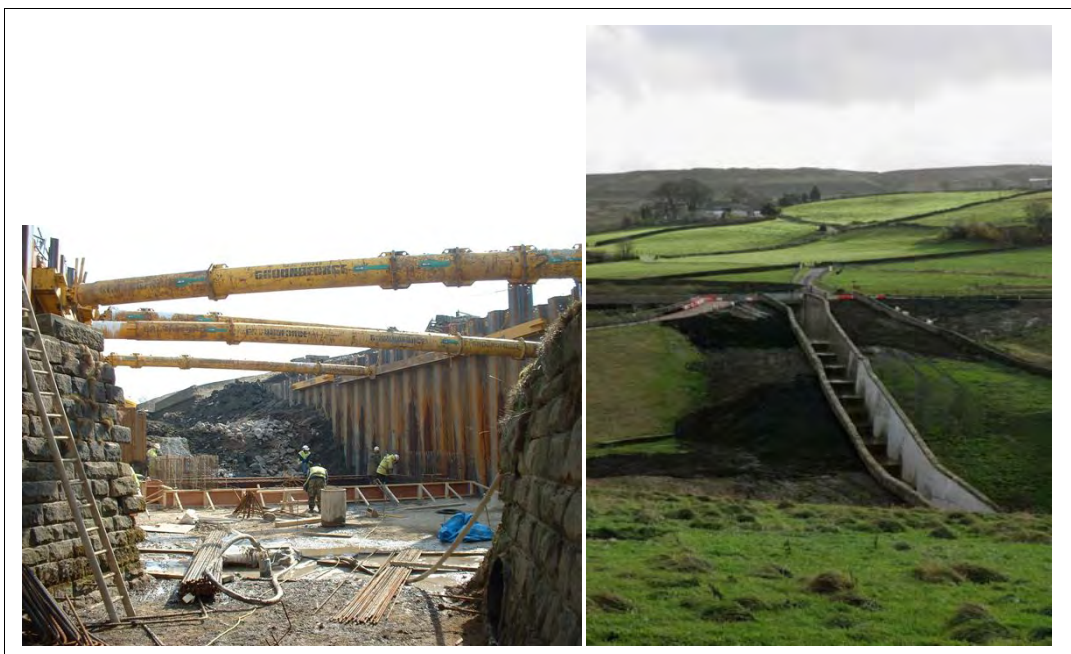
**Figure 5.22 Replacement of masonry stepped spillway with new stepped spillway constructed along same line in reinforced concrete**

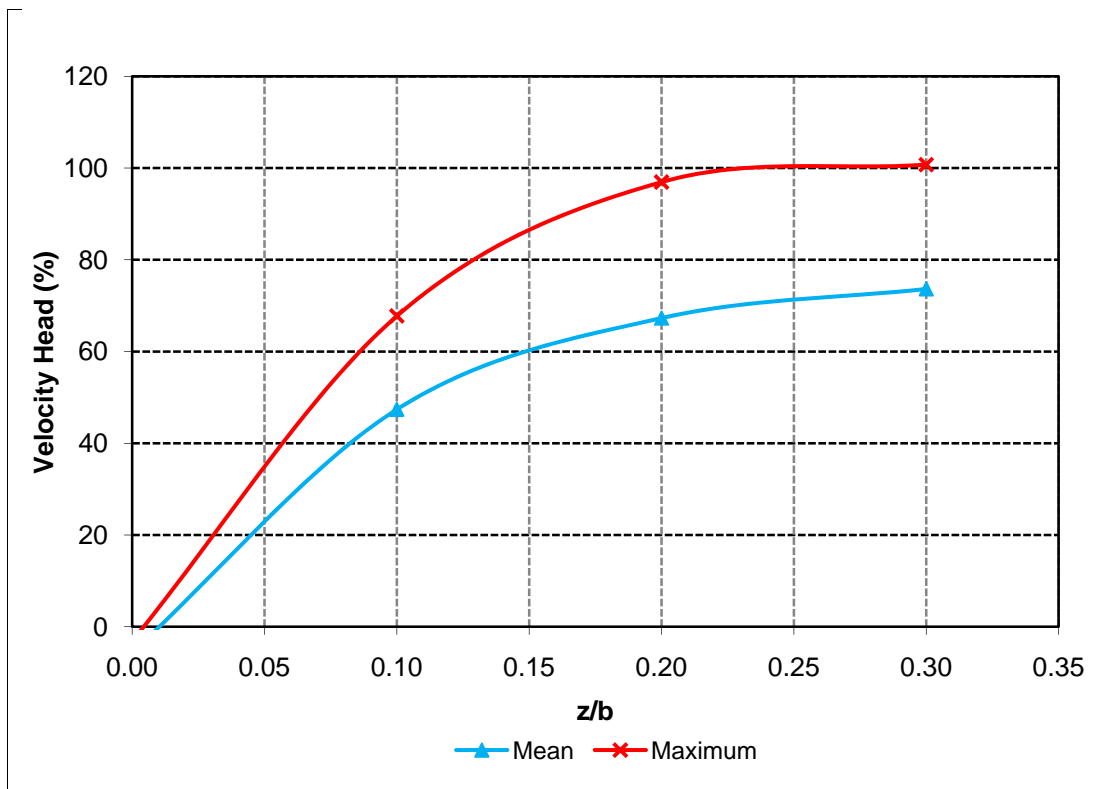
Figure 5.3 Percentage of velocity head mobilised in the upstream joint by a block protruding into the flow

**Figure 5.3 Percentage of velocity head mobilised in the upstream joint by a block protruding into the flow**

These charts can be used to calculate the maximum and mean velocity heads on a channel wall adjacent to a step in skimming flow. Although the data were collected at joints in the channel wall, there is no logical reason why they could not be used to assess the risk of failure of blocks in the invert of a smooth masonry chute.

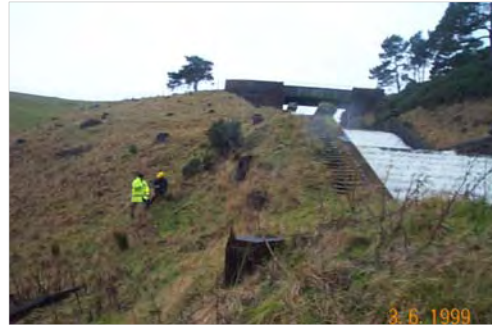
**June 1999**

Seepage emerging on valley side and pathway below masonry spillway, related to flow in spillway. Personnel are photographed standing at locations of issue.

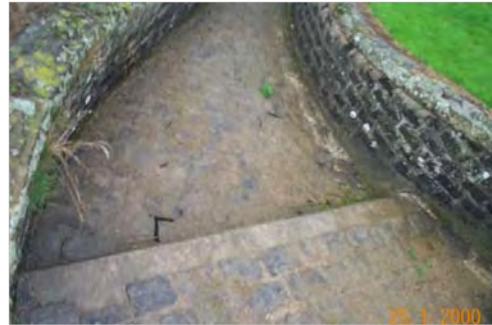
**January 2000**

Gap in masonry floor.  
Routine repair.

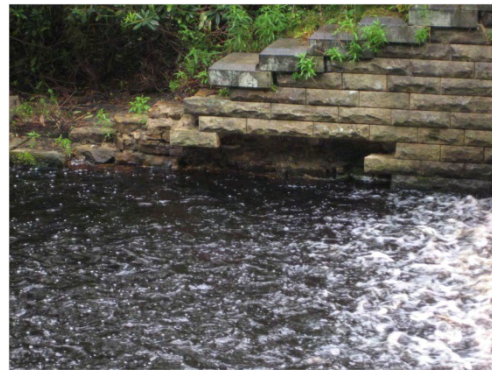
**June 2007**

Damage to right sidewall of spillway at downstream end. Wall consists of dressed sandstone (550 mm long x 180 mm high). 3-4 blocks in length were removed over 3 courses vertically. Just downstream, 2 capping stones were lost. Backing of wall is made of random rubble which was eroded to a depth of 500-600mm.

Flood estimated to have 1 in 200 year return period.

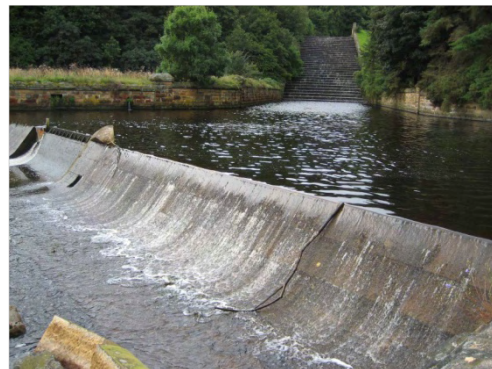
**June 2007**

Loss of capping blocks on downstream stilling basin crosswall. All sandstone crest blocks were washed off into downstream channel and are resting against flow breaking blocks in channel below. There are 4 complete blocks with remainder being broken into 18 half blocks. Estimated that blocks were originally 1.2 m long.

Flood estimated to have 1 in 200 year return period.

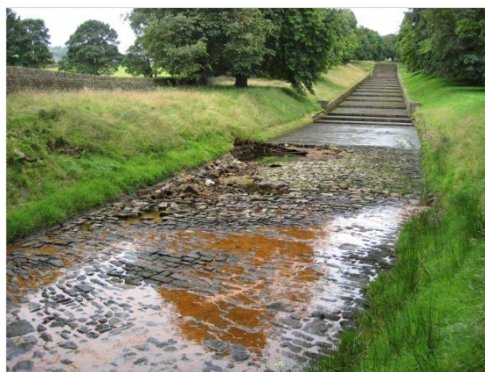
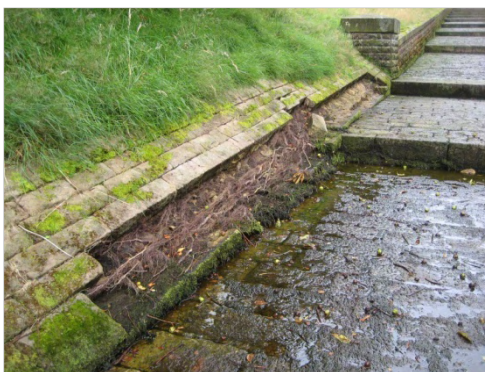
**June 2007**

In worst area, a section 3 m wide by 6 m long was eroded to a maximum depth of 1 m. In masonry section on right-hand side, 2-3 courses of sandstone block were removed from sidewall over 10 m length. On left-hand side, damage was less with only 1 stone being removed. Root growth noted behind masonry. Flood estimated to have 1 in 200 year return period.

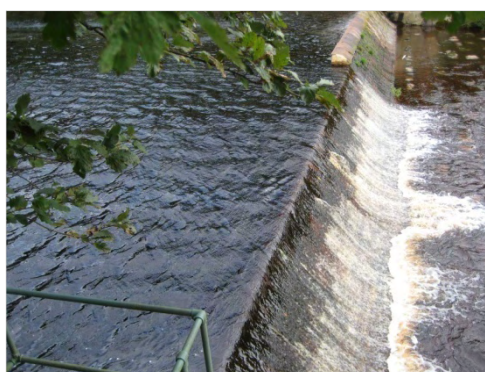
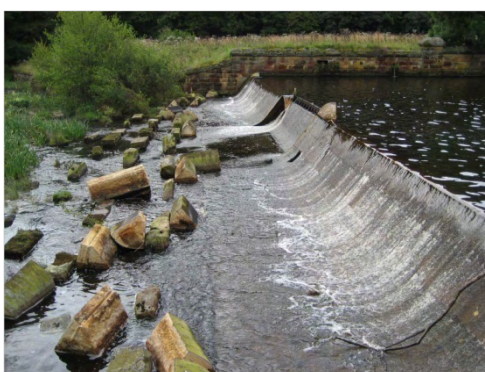
**June 2007**

Damage to crosswall at downstream end of stilling basin. 10 sandstone blocks were removed and were laying in channel downstream; a further 3 blocks were displaced. Total length 26 m.

Flood estimated to have 1 in 200 year return period.

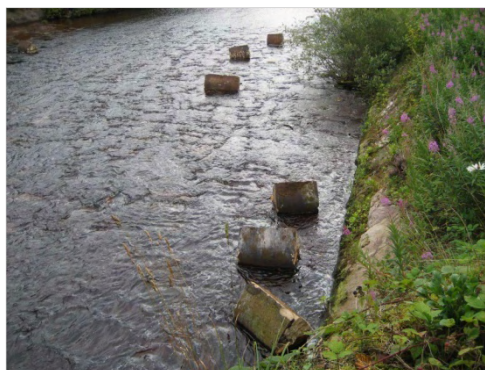
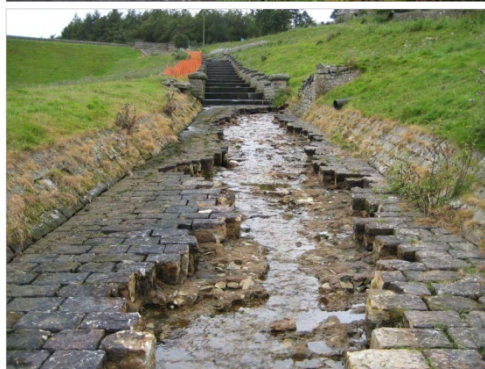
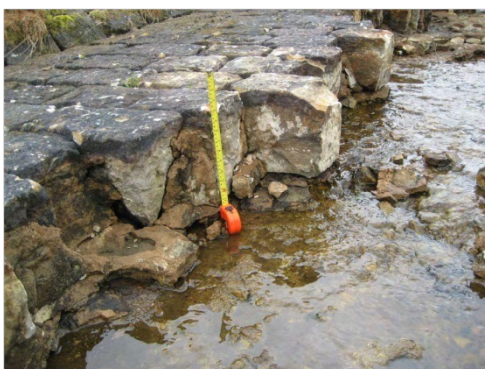
**June 2007**

Damage to lower section of main spillway. Channel is 69 m long, 3.65 m wide and 800 mm deep. Flood resulted in large proportion of blocks being removed (50% - 60% in upper section, 40% in lower section). Blocks were 400 mm x 200 mm and 200-250 mm thick and founded onto mortar and stone bedding, which remained in place. Bedding experienced significant erosion in only very few places. Flood estimated to have 1 in 200 year return period.

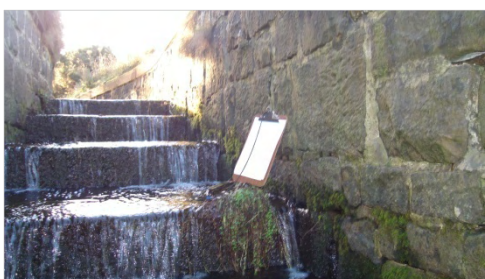
**Date unknown**

Gaps in pointing of masonry at base of sidewalls allowing flow to disappear behind and re-emerge from base of sidewall.
