Department  
for Environment  
Food & Rural Affairs

Environment  
Agency

## Beach modelling: Lessons learnt from past scheme performance

Project: SC110004/R2

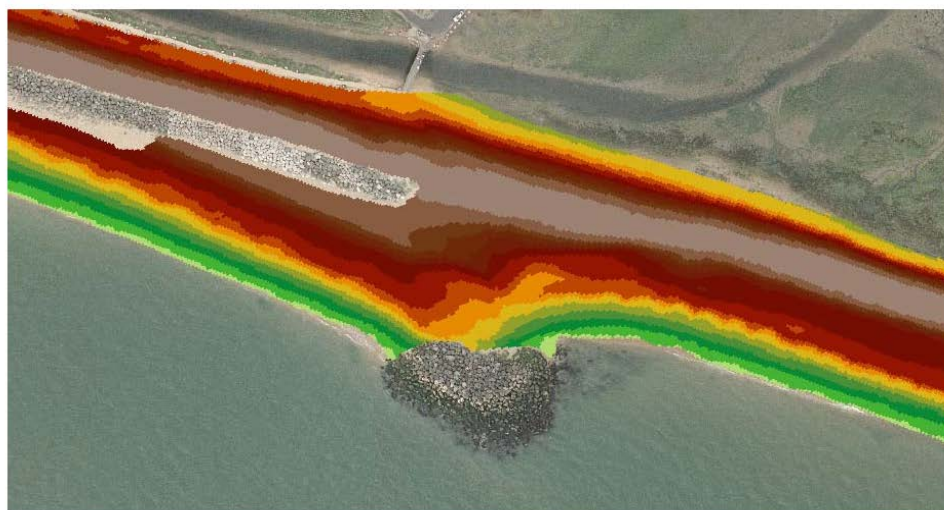
The recent planform of the beach (Figure C.3.9) has remained relatively stable over a period of several years, with occasional fluctuations arising from severe events. The extension of the dissipation zone and reorientation of waves has had the desired effect of spreading wave energy and reducing losses from the vulnerable junction. The typical plan form shown in Figure C.3.9 was developed at the site within a period of less than one year.

**Figure C.3.9 Planform development of beach adjacent to beach 12 years after construction**

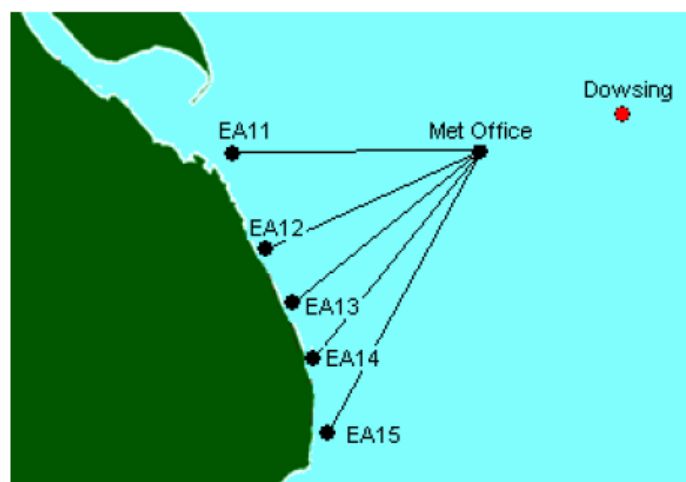
as indicated in Figure C.4.3. These nearshore points were then used as boundary conditions to the local models built into the numerical cross-shore and beach plan shape models.

**Figure C.4.3 Transformation of waves to Lincolnshire coast for 2003 strategy review**

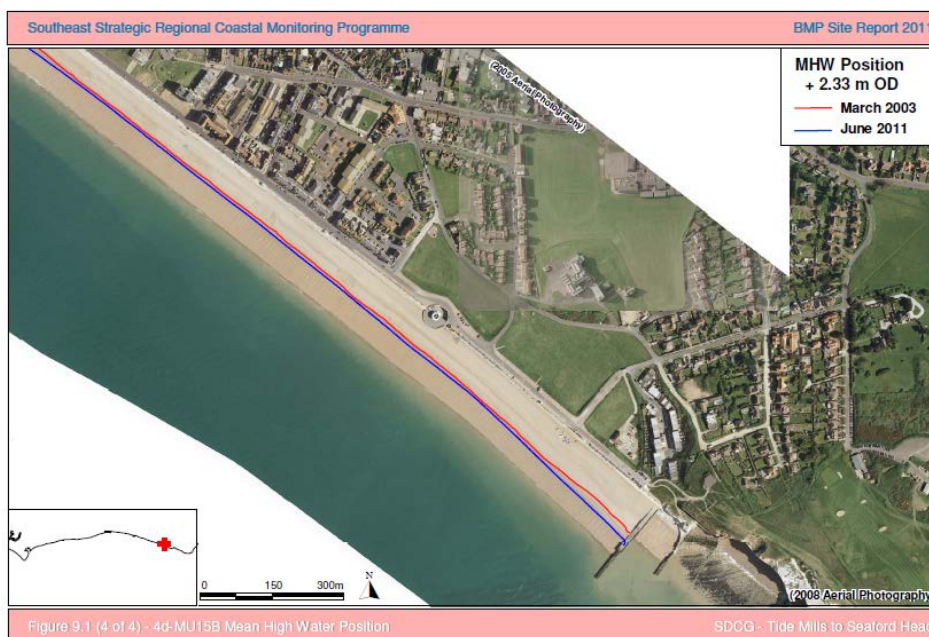
**Figure C.10.14 Plan form development of beach adjacent Splash Point terminal groyne 25 years after scheme construction**
