SITE CONDITION REPORT TEMPLATE

1.0 SITE DETAILS	
Name of the applicant	Morgan Thermal Ceramics Company Registration Number: 0890443
Activity address	Fibre Centre of Excellence, Tebay Road, Brombough, Wirral, Uk CH62 3PH
National grid reference	SJ3542081640 (Easting 335420, Northing 381640)
Document reference and dates for Site Condition Report at permit application and surrender	Site Permit Ref: EPR/AP3137HG
Document references for site plans (including location and boundaries)	BRG-P01

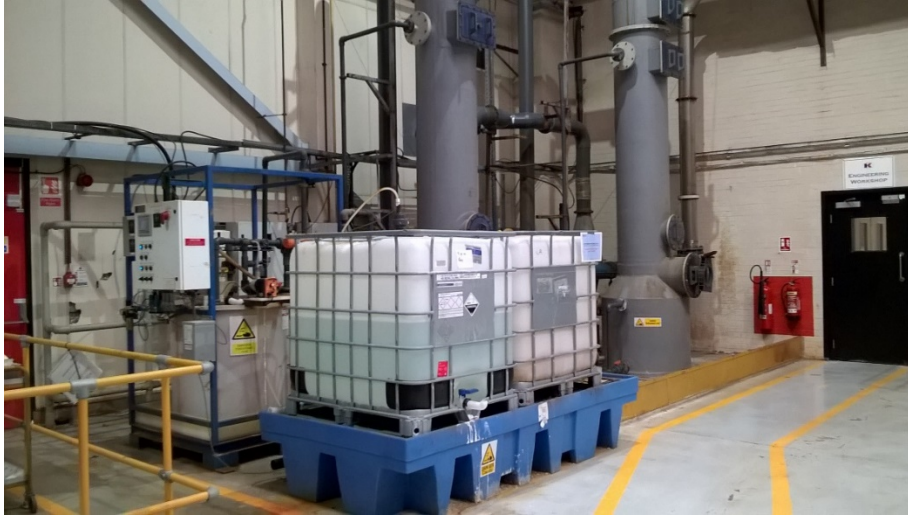
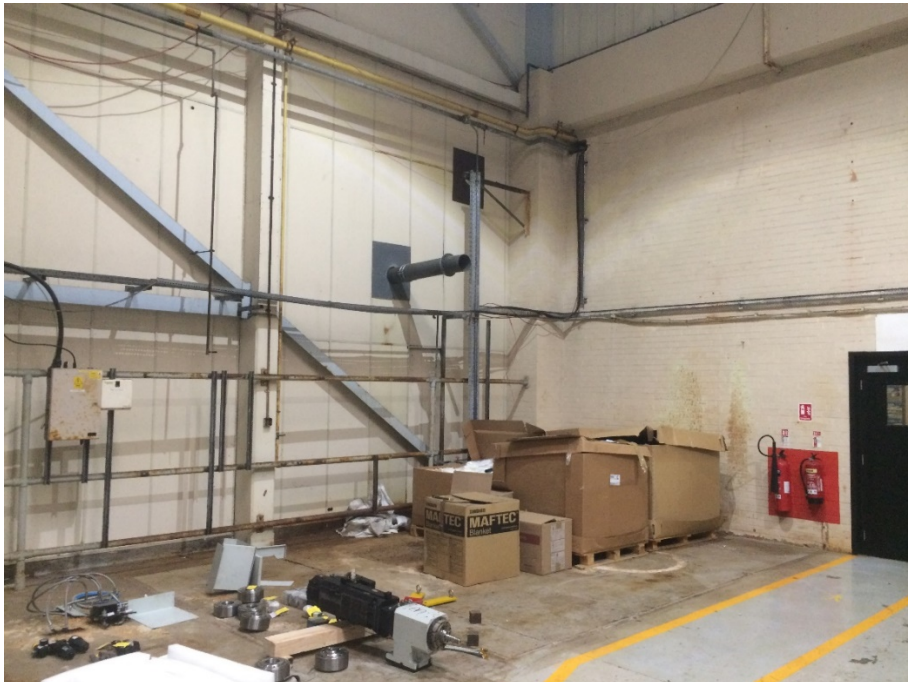
1. Acid gas abatement scrubbers & associated chemicals

Scrubbers removed.
Chemicals used to abate acid gases removed and disposed of.

1. Emissions to air from the Kiln scrubber stack – which was monitored annually as per the permit instructions. All scrubber pipework and associated equipment has been removed, and the kiln has been removed from the process line. The kiln is currently being refurbished and re-purposed onto an alternate R&D fibre line.
2. Emissions to water from the Kiln scrubber liquor buffer (saline solution) – which was monitored constantly, with ALL liquor held in IBCs and analysed before discharge.
