# A14 Cambridge to Huntingdon Improvement Scheme

## POST CONSTRUCTION AUDIT - AUGUST 2020

PROJECT NUMBER: HA528983			DOCUMENT REF: HA528983-ACJV-HGN-SG_XX-RP-C-0003			
P01.1	First Issue	AKAK				
Revision	Purpose Description	Originated	Checked	Reviewed	Authorised	Date

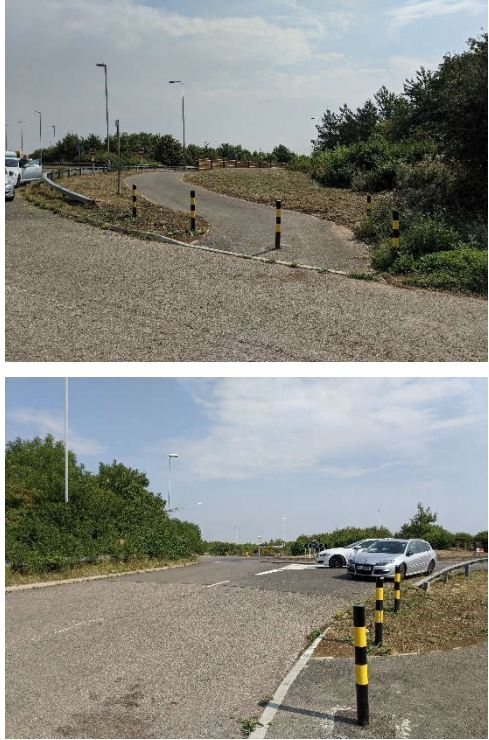
Ref.	Photo	Problem/Observation	Recommendation
S1.1

<p><u>Observation:</u> As stated in the 2016 Audit, NMU 1.1 provides a route towards Alconbury, although the design terminates at Brooklands Lane and does not connect with NCN Route 12 and other public rights of way in the vicinity.</p> <p>It is acknowledged that the designer's response to the 2016 Audit confirmed that this is outside the DCO. The termination at Brooklands Lane does present a barrier for users of the proposed new NMU route adjacent to the A1 and other noteworthy routes through Alconbury, and the trip generators and attractors thereafter e.g. Huntingdon.</p>	<p>It is recommended that HE give the provision of a route north to Alconbury consideration, perhaps through Legacy as stated in the designer's response in the 2016 Audit.</p> <p><b>Designer's Response:</b></p>

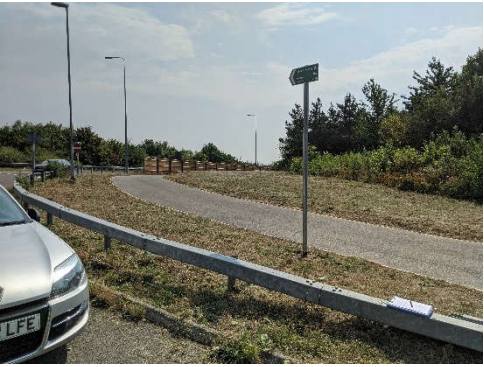
Ref.	Photo	Problem/Observation	Recommendation
S1.2

<p><u>Observation:</u> It is observed that a public bridleway sign to guide users of the route to Huntingdon and Brampton is provided for the benefit of southbound users and orientated to serve southbound users of the carriageway.</p> <p><u>Problem:</u> It is noted that no tactile paving has been provided at the termination of the route at Brooklands Lane, nor is there any signage advising users of their need to rejoin the carriageway. There does not appear to be onward provision suitable for pedestrians.</p>	<p>It is recommended that appropriate tactile paving and markings (TSRGD Diagram 1023B, 1003B and 1009B) are provided at the appropriate transitions.</p> <p>It is recommended that direction signage and signage advising cycle users to rejoin the carriageway (Diagram 966) is provided where the route connects with Brookland Lane.</p> <p>It is also recommended that warning signs in advance to allow users to exit at the most appropriate point to use the adjacent network, and what users should do at this location.</p> <p><b>Designers Response:</b></p>

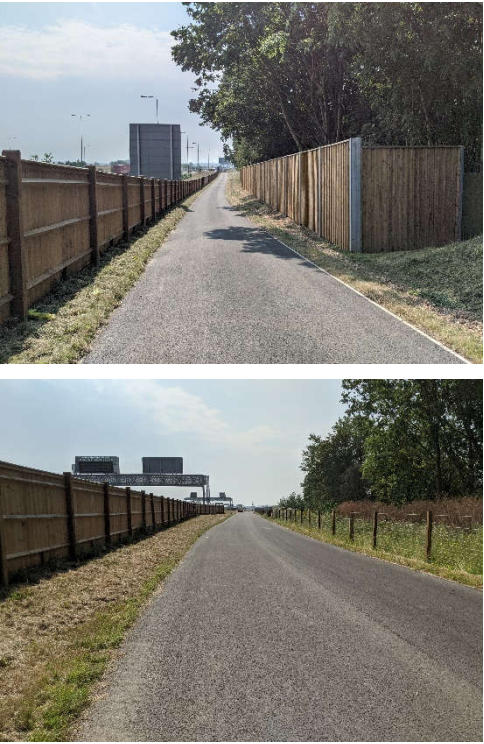
Ref.	Photo	Problem/Observation	Recommendation
S1.3

<p><u>Observation:</u> NMU 1.1 is specified as a bridleway. As referenced in Table 1, a bridleway is to have a width of 4.5 m. It was recorded on-site that NMU 1.1 has a width of approximately 3.5 m (first photo) and widening where the route is shared with Highways England maintenance vehicles (second photo). This does not relate to the generic dimensions from the Design Impact Statement.</p> <p>Nevertheless, guidance on the cross-section of a shared NMU facility specifies a preferred minimum width for an unsegregated shared facility as 3.0m.</p>	<p>It is recommended that justification is provided why the proposed width differs from that specified in Table 1, although it is accepted that the proposed width could be deemed appropriate based on guidance.</p> <p><b>Designer's Response:</b></p>
S1.4

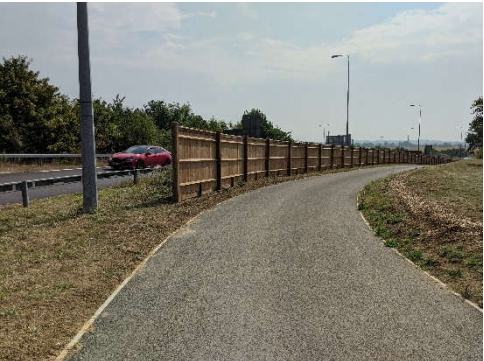
<p><u>Observation:</u> It is noted that there is a variable spacing width between NMU 1.1 and the carriageway and is separated by a 1.8 m high close boarded fence.</p>	<p>No recommendation.</p> <p><b>Designers Response:</b></p>

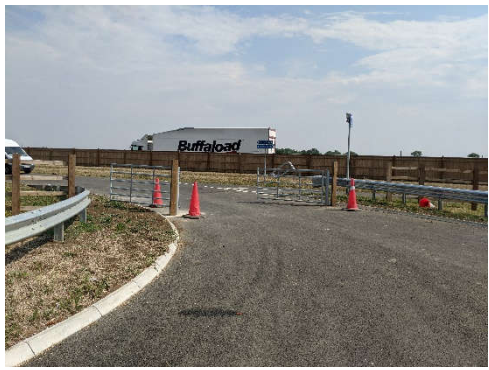
Ref.	Photo	Problem/Observation	Recommendation
S1.6

<p><u>Observation:</u> It is noted that there is no link provided to the adjacent Huntingdon Life Sciences, via Woolley Road/LAR, which is a trip attractor in this area.</p> <p>If users do cycle on-road and want to connect with the new NMU route (at the connection between NMU 1.1 and 1.2 – see photo), there is no obvious opening to allow users to do this, unless the gate is open.</p>	<p>It is recommended that consideration to providing a comfortable 'transition' between Woolley Road and the NMU route, or consultation undertaken with Huntingdon Life Sciences to establish the feasibility of a direct connection between to the proposed NMU route.</p> <p><b>Designer's Response:</b></p>
S1.7

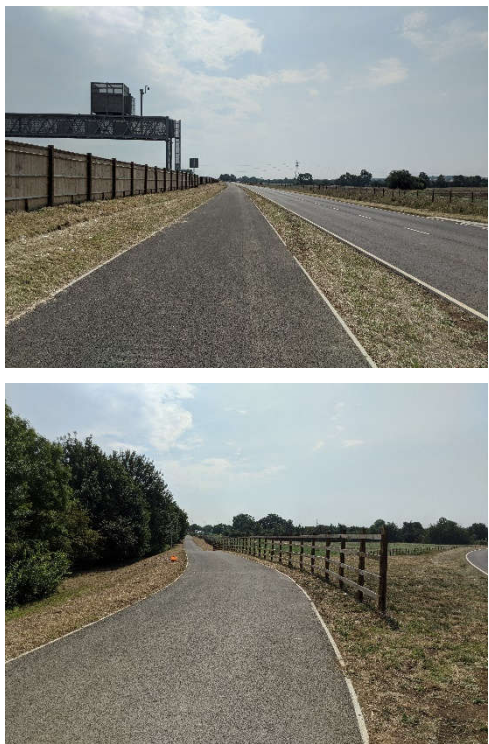
<p><u>Observation:</u> NMU 1.2 is referenced as a shared footway/cycleway/equestrian track in the drawings and documents provided by the Highways Teams. As specified in Table 1, a shared footway/cycleway/equestrian track is proposed to have a width of 3.0 m. It was recorded on site that the route has a width of approximately 3.5 m, with a verge of approximately 1.6 m between the route and Woolley Road (the spacing between NMU 1.2 and the A14 is significantly wider and separated by a 1.8 m high close boarded fence). The Auditor acknowledges that the route width exceeds the preferred minimum by 0.5 m, with equestrians perhaps served by using the adjacent verge, and is consistent with the widths of adjacent facilities (NMU 1.1 and NMU 1.3).</p> <p>Motor vehicles access to NMU 1.2 is prohibited using a bollard and associated 'no vehicular access' sign.</p>	<p>No recommendation.</p> <p><b>Designers Response:</b></p>

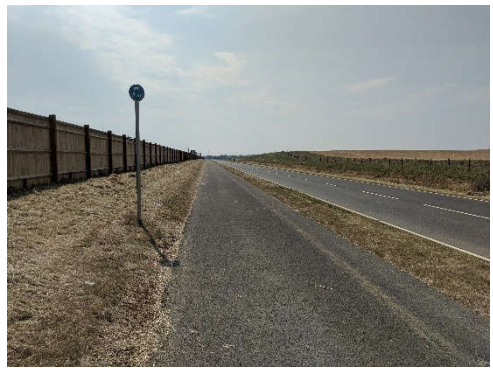
Ref.	Photo	Problem/Observation	Recommendation
S1.8

<p><u>Observation:</u> It is noted that signs to <i>TSRGD</i> Diagram 956.1 are located adjacent to NMU 1.2 indicating a route for use by pedal cycles, horses and pedestrians only.</p>	<p>No recommendation.  <b>Designers Response:</b></p>
S1.9	 	<p><u>Observation:</u> NMU 1.3 is specified as a bridleway. As referenced in Table 1, a bridleway is to have a width of 4.5 m. It was recorded on-site that NMU 1.3 has a width of approximately 3.5 m (see photos) although the route does narrow over the bridge. The width does not relate to the generic dimensions from the Design Impact Statement.</p> <p>Nevertheless, guidance on the cross-section of a shared NMU facility specifies a preferred minimum width for an unsegregated shared facility as 3.0m., and the width is consistent with the preceding widths of NMU 1.1 and 1.2.</p>	<p>No recommendation.  <b>Designer's Response:</b></p>

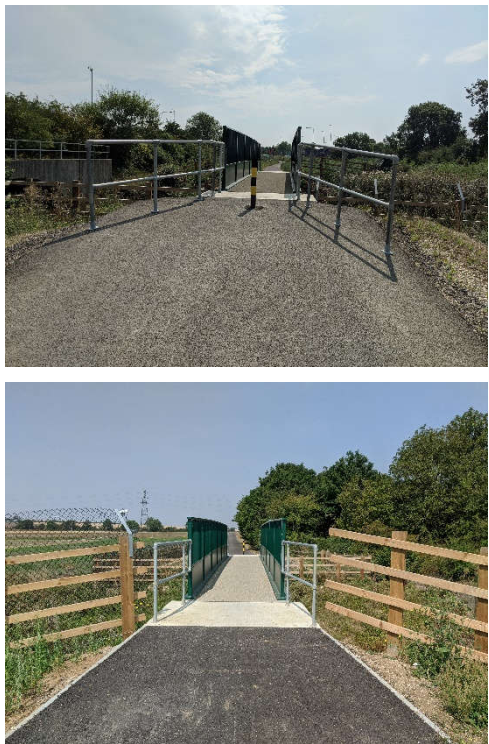
Ref.	Photo	Problem/Observation	Recommendation
S1.10

<p><u>Problem:</u> As noted above NMU 1.3 narrows at the bridge over Ellington Brook to approximately 1.5 m. Given the adjacent parapets (height 1.5 m) this reduces the effective width of the route over the bridge to approximately 0.5 m.</p> <p>Further to the narrowing, there is a bollard on the north side of the bridge which could limit access to users of non-standard cycles e.g. tricycles, inclusive cycles, tandems, trailers and trailer bikes, and may also restrict use by equestrians.</p>	<p>It is recommended that the bollard is removed and that signs are added that require users to 'share with care'.</p> <p>Ideally, the bridge should be sufficiently wide, with additional clearance to the parapets, to maintain the effective width of 3.5 m over Ellington Brook.</p> <p><b>Designer's Response:</b></p>
S1.11

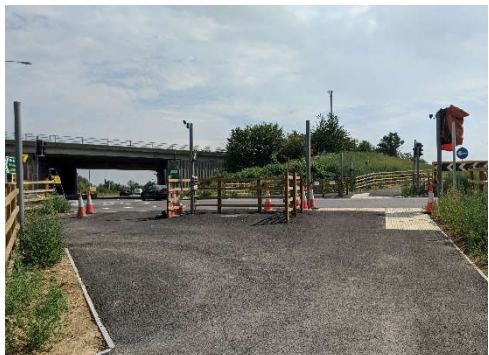
<p><u>Observation:</u> NMU 1.3 connects with Section 2 at Brampton Hut Junction.</p>	<p>No recommendation.</p> <p><b>Designer's Response:</b></p>

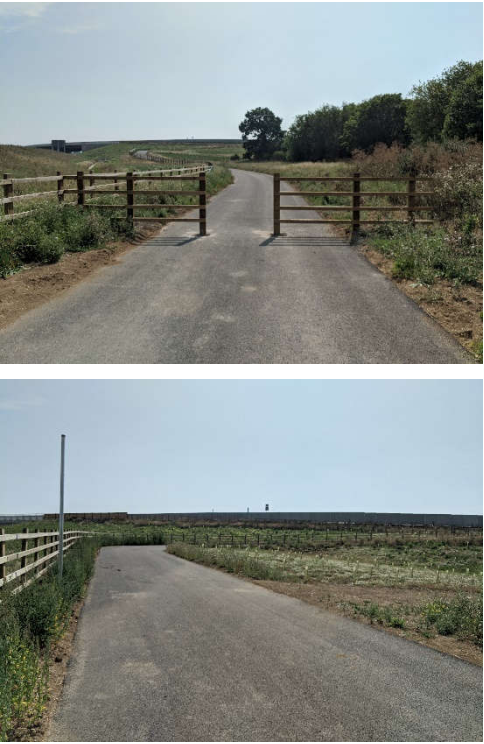
Ref.	Photo	Problem/Observation	Recommendation
S2.3

<p><u>Observation:</u> NMU 2.2 is specified as a bridleway and on-site observations note a route width of approximately 4.5-5.0 m. As referenced in Table 1, a bridleway is proposed to have a width of 4.5 m.</p> <p>It is noted that a wooden post and rail fence is provided across the route with a gap of approximately 1.5-1.6 m (see first photo), assuming to act as a barrier to motor vehicles. This should be sufficiently wide for most cycle vehicle types and should be enough for horse-riders.</p>	<p>No recommendation.</p> <p><b>Designers Response:</b></p>

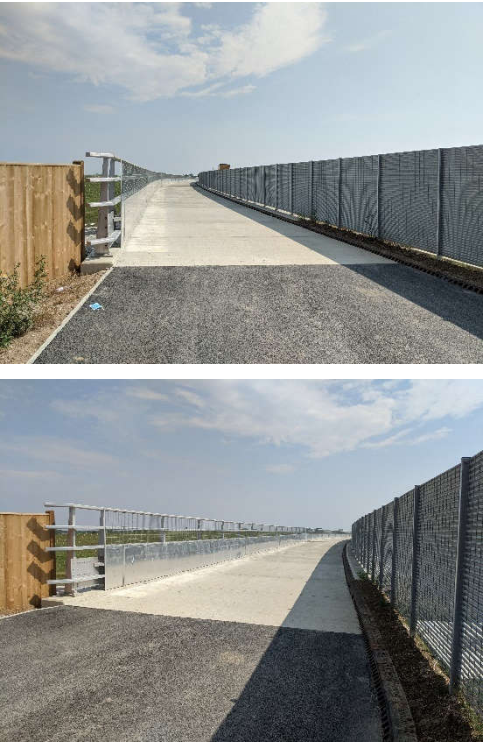
Ref.	Photo	Problem/Observation	Recommendation
S2.5

<p><u>Observation:</u> It was recorded that the route over the bridge was sufficiently wide and is consistent with the route either side of the bridge i.e. approximately 5.0 m. Nevertheless, the parapet and screening fence will reduce the effective width by approximately 0.5 m either side.</p> <p>The fence blocks measurement of spacing between NMU route and carriageway. The Design Input Statement specified a spacing of 3.5 m, exceeding the minimum of 1.8 m specified in guidance. Nevertheless, the 2.0 m high screening fence provides additional protection for equestrian users.</p> <p>A 1.8m parapet is provided on the northern side of the bridge and incorporates an appropriate 1.0 m high infill on the parapet to obscure the horses view of traffic on the carriageway below.</p>	<p>No recommendation.</p> <p><b>Designers Response:</b></p>
S2.6

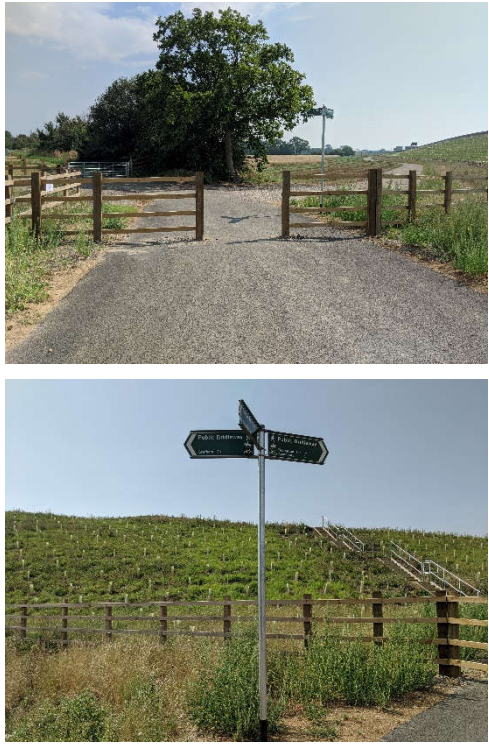
Ref.	Photo	Problem/Observation	Recommendation
S2.7

<p><u>Observation:</u> It is observed that public bridleway signs to guide users to Brampton, Brampton Hut, Alconbury and Grafham are provided.</p>	<p>No recommendation.</p> <p><b>Designers Response:</b></p>

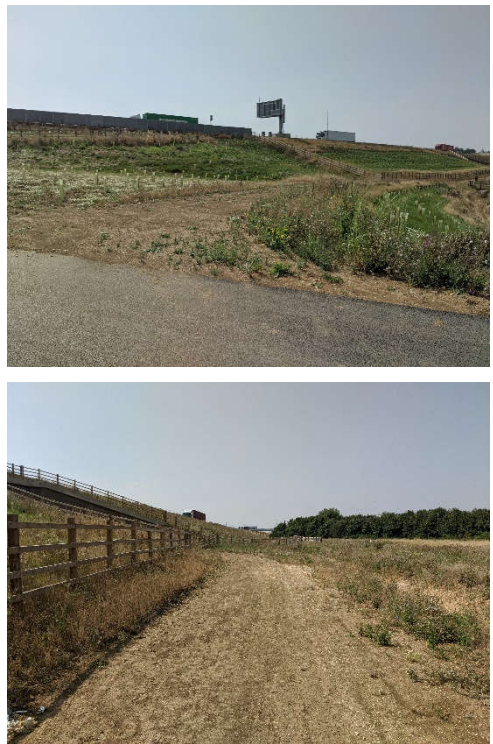
Ref.	Photo	Problem/Observation	Recommendation
S2.8

<p>The top photograph shows a gravel path leading up a grassy embankment towards a road sign. The bottom photograph shows a dirt path running alongside a wooden fence and a road.</p>	<p><u>Observation:</u> The proposed A14 alignment south of Brampton Hut Service Area is proposed to incorporate an underpass to enable the continuation of the proposed NMU route to the west of the A1 (connecting with public rights of way further south).</p> <p>However, the underpass and access beyond was closed during the time of the site visit.</p>	<p>It was confirmed previously that the underpass will be 4.0m wide with a headroom height of 3.7m, which would meet current standards and guidance.</p> <p>NMU 2.3 is proposed to be a bridleway, and as referenced in Table 1, a bridleway is proposed to have a width of 4.5 m.</p> <p>It is recommended that confirmation is provided on the underpass and height.</p> <p>It is recommended that confirmation is provided on the width of the route between the underpass and Grafham Road.</p> <p><b>Designers Response:</b></p>

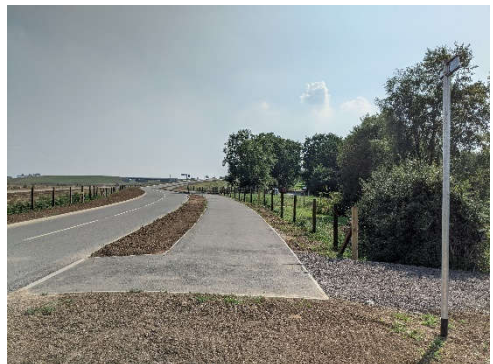
S2.9

<p>The photograph shows a newly constructed concrete bridleway path running parallel to a road, with a gravel shoulder and a fence on the right side.</p>	<p><u>Observation:</u> It is noted that the the new bridleway provided on the eastern side of the new A14 just south of Brampton Hut Junction extends to Grafham Road Bridge, with signs to guide users.</p>	<p>No recommendation.</p> <p><b>Designers Response:</b></p>

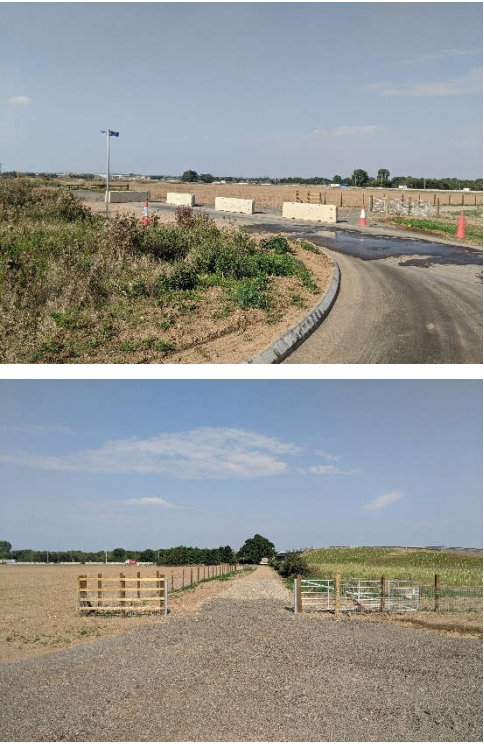
Ref.	Photo	Problem/Observation	Recommendation
S2.10

<p><u>Observation:</u> It is noted that the the new bridleway provided on the western side of the new A14 just south of Brampton Hut Junction extends to Grafham Road Bridge, with signs to guide users.</p>	<p>No recommendation.  <b>Designers Response:</b></p>
S2.11

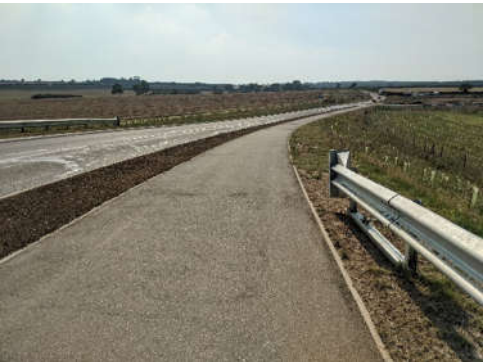
<p><u>Observation:</u> It was observed that NMU 2.4/2.5 is 3.0 m wide with a 1.8 m separation.</p>	<p>No recommendation.  <b>Designers Response:</b></p>

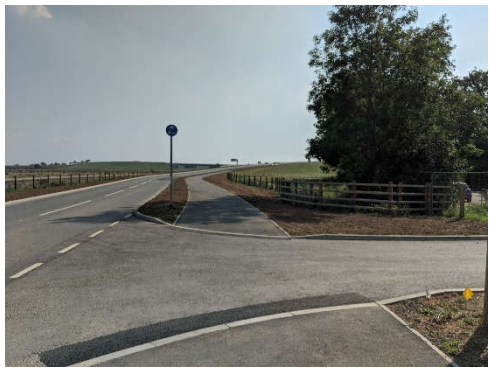
Ref.	Photo	Problem/Observation	Recommendation
S2.14

<p><u>Problem:</u> It is noted that signs to <i>TSRGD</i> Diagram 956.1 are located adjacent to NMU 2.4/2.5 indicating a route for use by pedal cycles, horses and pedestrians only.</p> <p>It is noted that tactile paving has not been provided at the junction shown in the photo.</p>	<p>It is recommended that appropriate tactile paving and markings (<i>TSRGD</i> Diagram 1023B, 1003B and 1009B) are provided.</p> <p><b>Designers Response:</b></p>
S2.15	-	<p><u>Observation:</u> It was noted in the 2016 Audit that steps were proposed to the west of Grafham Road Bridge connecting NMU 2.4/2.5 with NM 2.3. It is noted that these were not constructed as part of the final scheme.</p>	<p>It is recommended that confirmation is if steps were no longer deemed necessary.</p> <p><b>Designers Response:</b></p>
S2.16	 	<p><u>Observation:</u> On-site observations confirm that NMU 2.6 is 3.0 m wide, which concurs with the preferred minimum width for an unsegregated facility of 3.0 m as expressed in guidance, and a 1.8 m separation, in line with the preferred width in guidance.</p>	<p>No recommendation.</p> <p><b>Designers Response:</b></p>

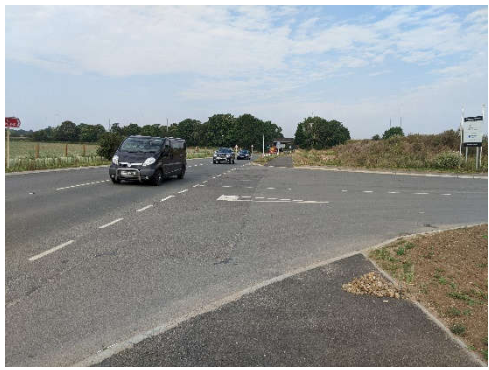
Ref.	Photo	Problem/Observation	Recommendation
S2.17

<p><u>Problem:</u> It is noted that tactile paving has not been provided at the junction shown in the photo.</p>	<p>It is recommended that appropriate tactile paving markings (TSRGD Diagram 1023B, 1003B and 1009B) are provided.</p> <p><b>Designers Response:</b></p>
S2.18

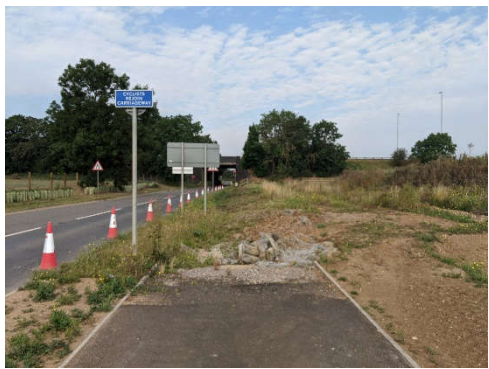
<p><u>Problem:</u> It is noted that a sign advising cycle users to rejoin the carriageway (Diagram 966) and a sign to <i>TSRGD</i> Diagram 956.1 on the reverse are provided as appropriate.</p> <p>However, the on-site audit identified that the transition between the route and the carriageway is still to be completed.</p>	<p>It is recommended that appropriate tactile paving and markings (TSRGD Diagram 1023B, 1003B and 1009B) are provided at the transition.</p> <p>This will likely include the need to warn pedestrians with visual impairments using tactile paving i.e. so they do not continue into oncoming traffic.</p> <p><b>Designers Response:</b></p>

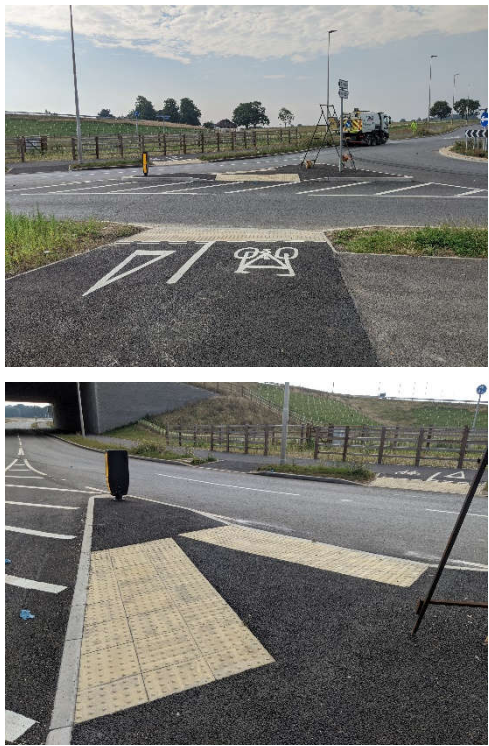
Ref.	Photo	Problem/Observation	Recommendation
S2.19

<p><u>Observation:</u> It is observed that tactile paving and markings have been provided for pedestrian and cycle users crossing the eastern arm of the roundabout.</p> <p>It is noted that the splitter island varies in width, at the crossing, from 2.4 m to 4.2 m. Although at its narrowest it is below the 2.5 m minimum for constrained location, the crossing should be able to accommodate the potential users of the crossing e.g. tandems; parent/prams; cycles towing trailers etc.</p> <p><u>Problem:</u> It was observed that one of the dropped kerb upstands at the crossing for pedestrians and cyclists exceeds the permissible tolerance of 6 mm (at approximately 12 mm).</p>	<p>It is recommended that the dropped kerb upstands are checked and altered to be no more than the permissible 6 mm.</p> <p><b>Designers Response:</b></p>

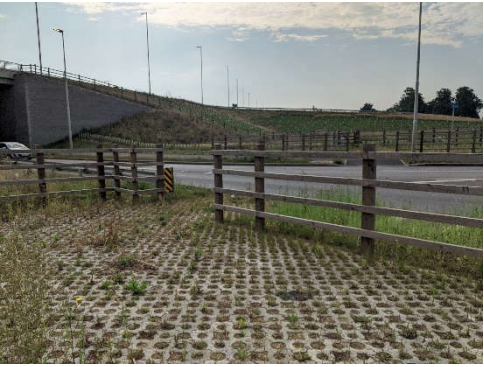
Ref.	Photo	Problem/Observation	Recommendation
S2.20

<p><u>Observation:</u> It is noted that there is separate crossing provision for equestrians. DMRB states that this should be a fenced, grassed holding area of 10.0 m wide by 5.0 m long.</p>	<p>It is recommended, as per DMRB, that the holding areas for equestrians should be a fenced, grassed area of 10.0 m wide by 5.0 m long.</p> <p>It is recommended, as per DMRB, that a 10.0m band of high friction surfacing should be provided on the carriageway to prevent horses from slipping, and, where possible, this should be of the same colour as the carriageway.</p> <p>The BHS acknowledge that there may be circumstances where a variation from the standard design is appropriate.</p> <p><b>Designers Response:</b></p>

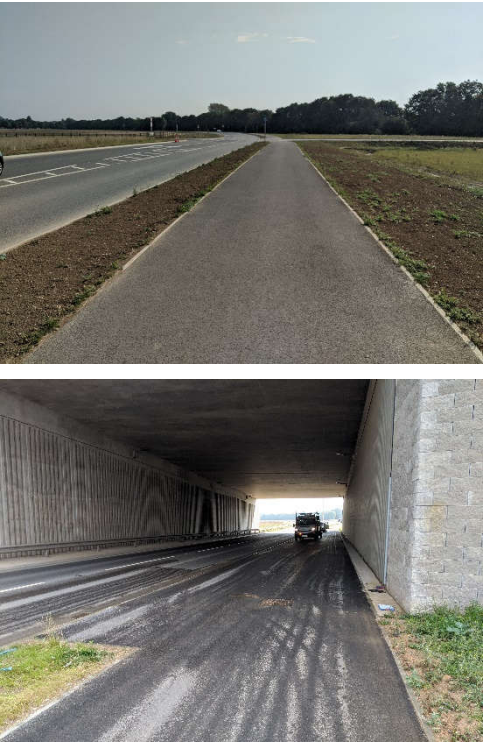
Ref.	Photo	Problem/Observation	Recommendation
S2.21

<p><u>Observation:</u> On-site observations confirm that NMU 2.7 is 3.0 m wide, which concurs with the preferred minimum width for an unsegregated facility of 3.0 m as expressed in guidance, and a 1.8 m separation, in line with the preferred width provided in guidance.</p>	<p>No recommendation.</p> <p><b>Designers Response:</b></p>
S2.22

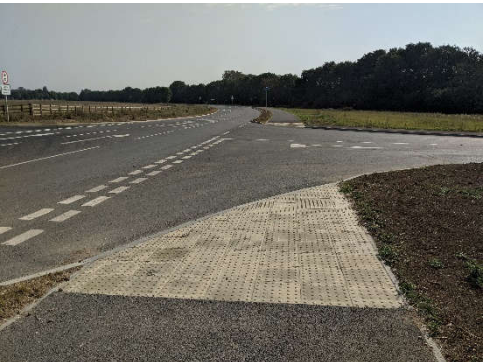
<p><u>Observation:</u> It is noted that tactile paving has been provided at the junction shown in the photo (access to Station Farm).</p>	<p>It is recommended that appropriate markings (TSRGD Diagram 1023B, 1003B and 1009B) are provided.</p> <p><b>Designers Response:</b></p>

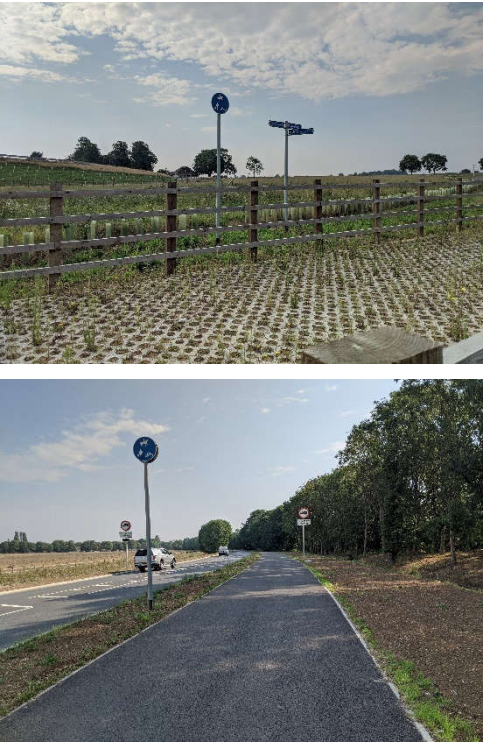
Ref.	Photo	Problem/Observation	Recommendation
S2.23

<p><u>Observation:</u> It is noted that direction signs are provided that direct users to Brampton, Huntingdon, Buckden, The Offords and Brampton Wood.</p> <p>It is noted that signs to <i>TSRGD</i> Diagram 956.1 are located adjacent to NMU 2.7 indicating a route for use by pedal cycles, horses and pedestrians only.</p>	<p>No recommendation.</p> <p><b>Designers Response:</b></p>
S2.24

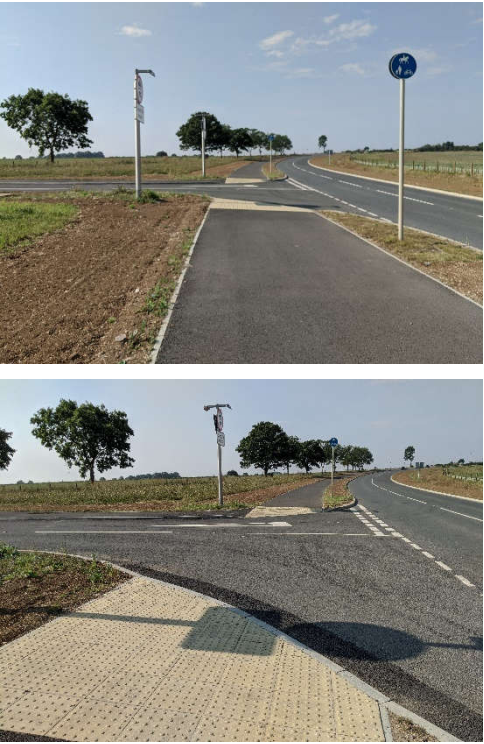
Ref.	Photo	Problem/Observation	Recommendation
S2.25

<p><u>Observation:</u> It is noted that signs to <i>TSRGD</i> Diagram 956.1 are located adjacent to NMU 2.7 indicating a route for use by pedal cycles, horses and pedestrians only.</p> <p>It is noted that tactile paving has been provided at the junction shown in the photo (access to/from emergency/maintenance access from A14).</p> <p>The route extends to connect with existing facilities to Buckden and The Offords.</p>	<p>It is recommended that appropriate markings (<i>TSRGD</i> Diagram 1023B, 1003B and 1009B) are provided.</p> <p><b>Designers Response:</b></p>
S2.26	-	<p><u>Observation:</u> As observed during the 2016 Audit, users are required to negotiate tight angles i.e. circa 90 degrees, at various locations.</p>	<p>It is recommended that all 90-degree angles should be refined to include a 45-degree splay (or suitable radius) to ease movement and avoid conflicts between users.</p> <p><b>Designers Response:</b></p>

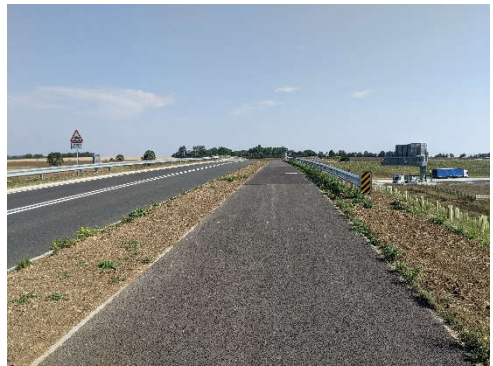
Ref.	Photo	Problem/Observation	Recommendation
S3.1

<p><u>Observation:</u> On-site observations confirm that NMU 3.1 is 3.0 m wide, which concurs with the preferred minimum width for an unsegregated facility of 3.0 m as expressed in guidance, and a 1.8 m separation, in line with the preferred width specified in guidance.</p>	<p>No recommendation.</p> <p><b>Designers Response:</b></p>
S3.2

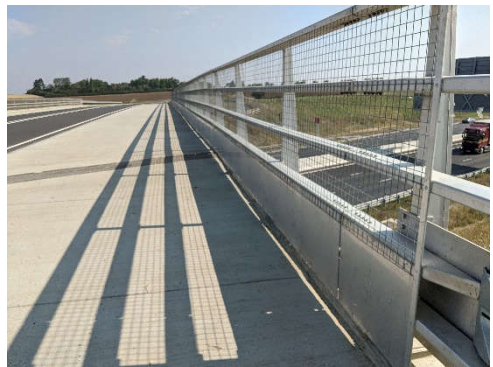
<p><u>Problem:</u> It was observed that the parapet on NMU 3.1 is at an appropriate height of 1.8 m.</p> <p>However, it was observed that the parapet did not include the appropriate infill on the parapet to obscure a horse's view of traffic passing beneath the bridge.</p>	<p>It is recommended that an infill is installed on the parapet i.e. a solid panelling fixed to the parapet railings. The British Horse Society guidance advises that the height of the infill should be 1.0 m with an uplift of 25 mm.</p> <p><b>Designers Response:</b></p>

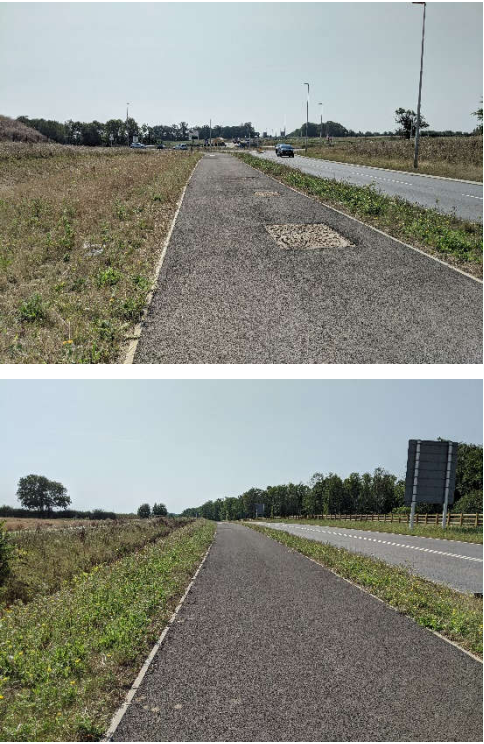
Ref.	Photo	Problem/Observation	Recommendation
S3.5

<p><u>Observation:</u> On-site observations confirm that NMU 3.2 is 3.0 m wide, which concurs with the preferred minimum width for an unsegregated facility of 3.0 m as expressed in guidance, and a 1.8 m separation, in line with the preferred width specified in guidance.</p>	<p>No recommendation.</p> <p><b>Designers Response:</b></p>

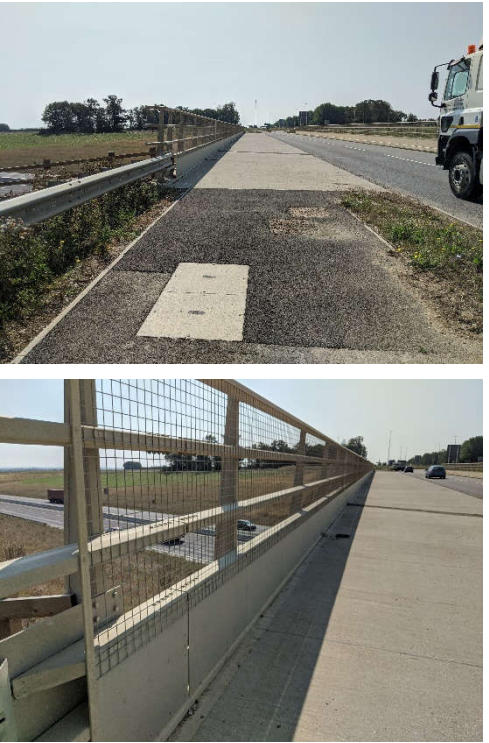
Ref.	Photo	Problem/Observation	Recommendation
S3.6

<p><u>Problem:</u> It was observed that the parapet on NMU 3.2 is at an appropriate height of 1.8 m.</p> <p>However, it was observed that the parapet did not include the appropriate infill on the parapet to obscure a horse's view of traffic passing beneath the bridge.</p>	<p>It is recommended that an infill is installed on the parapet i.e. a solid panelling fixed to the parapet railings. The British Horse Society guidance advises that the height of the infill should be 1.0 m with an uplift of 25 mm.</p> <p><b>Designers Response:</b></p>

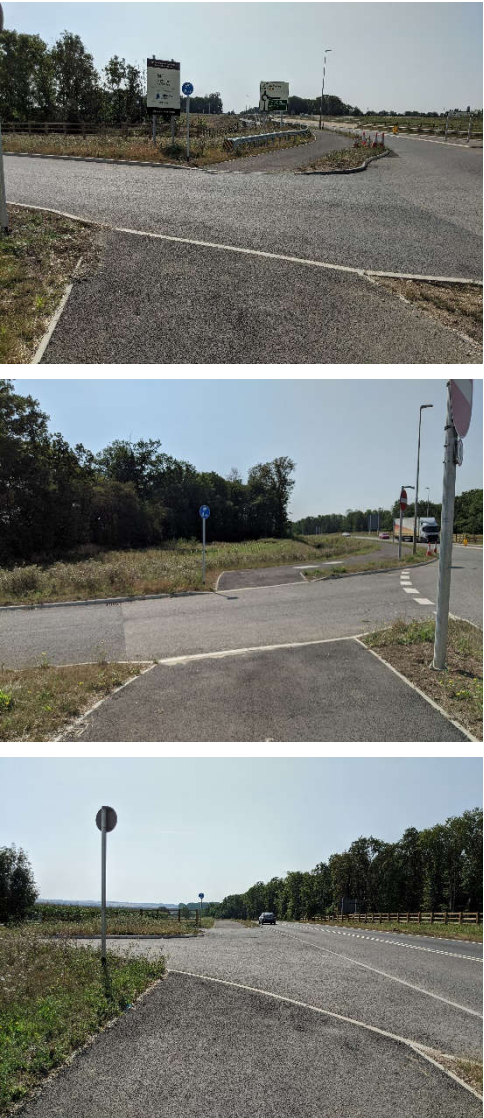
Ref.	Photo	Problem/Observation	Recommendation
S3.7

<p><u>Problem:</u> It is noted that tactile paving has not been provided at the junction of the emergency/maintenance accesses from A14 with the A1198, Ermine Street, or at the private access south of the Ermine Street Bridge.</p> <p><u>Problem:</u> It was observed that dropped kerb upstands exceed the permissible tolerance of 6 mm (at approximately 12 mm).</p>	<p>It is recommended that appropriate tactile paving and markings (TSRGD Diagram 1023B, 1003B and 1009B) are provided.</p> <p>It is recommended that the dropped kerb upstands are checked and altered to be no more than the permissible 6 mm.</p> <p><b>Designers Response:</b></p>

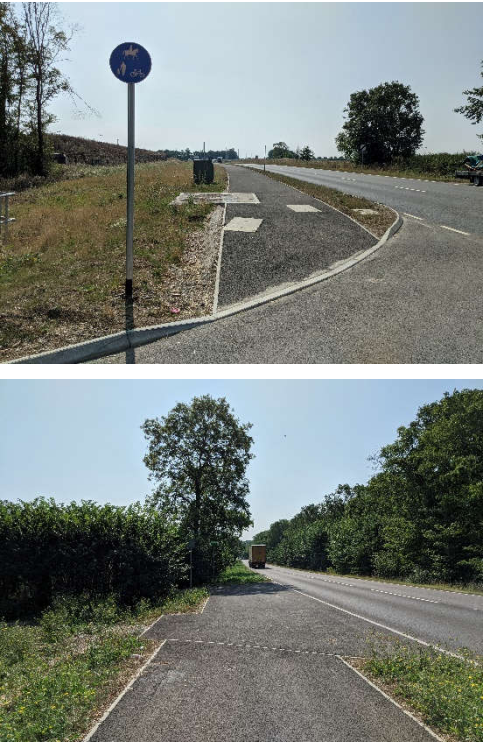
Ref.	Photo	Problem/Observation	Recommendation
S3.8

<p><u>Problem:</u> It is noted that signs to <i>TSRGD</i> Diagram 956.1 are located adjacent to NMU 3.1 indicating a route for use by pedal cycles, horses and pedestrians only.</p> <p><u>Observation:</u> It is noted that dropped kerbs are provided where the off-road route ends either side of Ermine Street Bridge. It is noted that the termination of the off-road route either end presents a barrier for some users.</p> <p>It is important to ensure that the transitions provided are safe, comfortable to use and minimise delay to cyclists.</p>	<p>It is recommended that appropriate tactile paving and markings (<i>TSRGD</i> Diagram 1023B, 1003B and 1009B) are provided.</p> <p>This will likely include the need to warn pedestrians with visual impairments using tactile paving i.e. so they do not continue into oncoming traffic.</p> <p>It is recommended that signs advising cycle users to rejoin the carriageway (<i>Diagram 966</i>) are provided as appropriate, on the reverse of the signs to <i>TSRGD</i> Diagram 956.1 that have been provided to advise cyclists transitioning from the carriageway.</p> <p><b>Designers Response:</b></p>

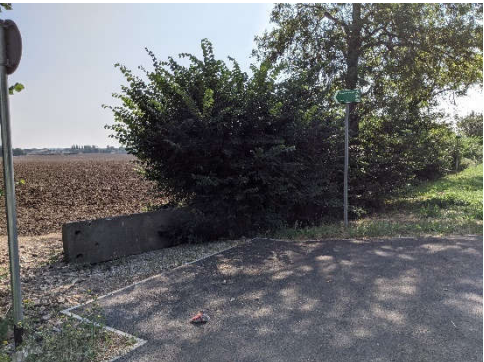
S3.9

<p><u>Observation:</u> It is noted that NMU 3.2 terminates south of Ermine Street Bridge with users having to rejoin the carriageway (A1198) south, or users are signed eastbound to bridleway 121/10 – signed for Hilton.</p> <p>It is not clear if improvements are intended on bridleway 121/10.</p>	<p>It is recommended that confirmation is provided on the intentions for bridleway 121/10, if anything.</p> <p><b>Designers Response:</b></p>

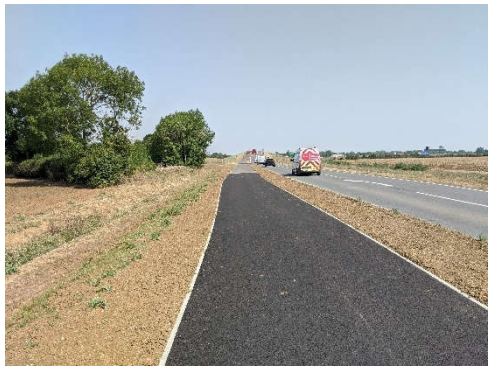
Ref.	Photos	Problem/Observation	Recommendation
S3.11

<p><u>Observation:</u> On-site observations confirm that NMU 4.1 is 3.0 m wide, which concurs with the preferred minimum width for an unsegregated facility of 3.0 m as expressed in guidance, and a 1.8 m separation, in line with the preferred width specified in guidance.</p>	<p>No recommendation.</p> <p><b>Designers Response:</b></p>
S3.12

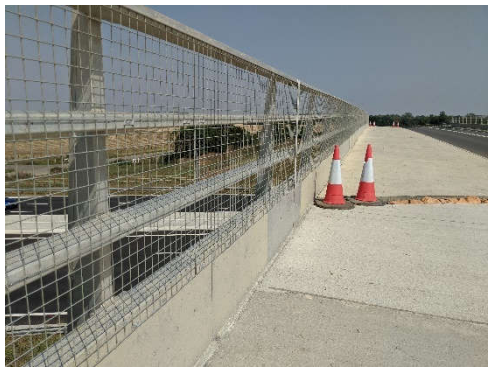
<p><u>Problem:</u> It was observed that the parapet on NMU 4.1 is at an appropriate height of 1.8 m.</p> <p>However, it was observed that the parapet did not include the appropriate infill on the parapet to obscure a horse's view of traffic passing beneath the bridge.</p>	<p>It is recommended that an infill is installed on the parapet i.e. a solid panelling fixed to the parapet railings. The British Horse Society guidance advises that the height of the infill should be 1.0 m with an uplift of 25 mm.</p> <p><b>Designers Response:</b></p>

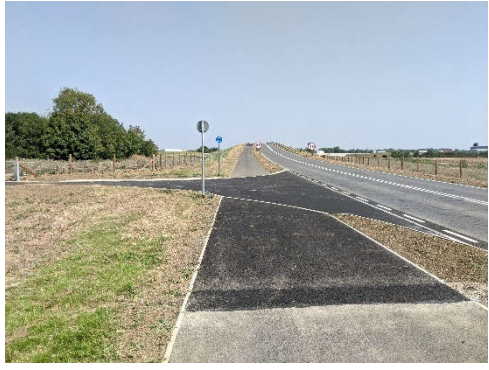
Ref.	Photos	Problem/Observation	Recommendation
S3.13

<p><u>Observation:</u> It is noted that signs to TSRGD Diagram 956.1 are located adjacent to NMU 4.1 indicating a route for use by pedal cycles, horses and pedestrians only.</p> <p><u>Problem:</u> It is noted that tactile paving has not been provided at the side road accesses/junctions, north and south of the B1040, Potton Road Bridge.</p>	<p>It is recommended that appropriate tactile paving and markings (TSRGD Diagram 1023B, 1003B and 1009B) are provided.</p> <p>It is recommended that the dropped kerb upstands are checked and altered, if necessary, to be no more than the permissible 6 mm.</p> <p><b>Designers Response:</b></p>

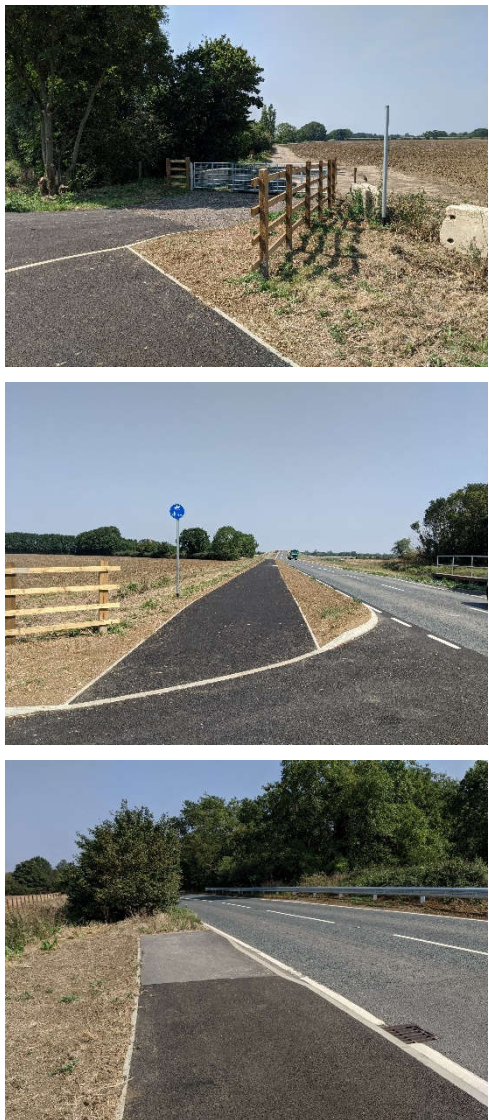
Ref.	Photos	Problem/Observation	Recommendation
S3.14

<p><u>Problem:</u> It is noted that dropped kerbs are provided where the off-road route ends either side of Potton Road Bridge. It is noted that the termination of the off-road route either end presents a barrier for some users i.e. those uncomfortable with cycling on-road.</p> <p>It is important to ensure that the transitions provided are safe, comfortable to use and minimise delay to cyclists.</p> <p><u>Observation:</u> It is noted that no bridleway signs are provided to direct users to Bridleway 122/14.</p>	<p>It is recommended that appropriate tactile paving and markings (TSRGD Diagram 1023B, 1003B and 1009B) are provided at the appropriate transitions.</p> <p>This will likely include the need to warn pedestrians with visual impairments using tactile paving i.e. so they do not continue into oncoming traffic.</p> <p>It is recommended that signs advising cycle users to rejoin the carriageway (Diagram 966) are provided as appropriate, with signs to <i>TSRGD</i> Diagram 956.1 provided to advise cyclists transitioning from the carriageway.</p> <p>It is recommended that signs directing users to Bridleway 122/14.</p> <p><b>Designers Response:</b></p>

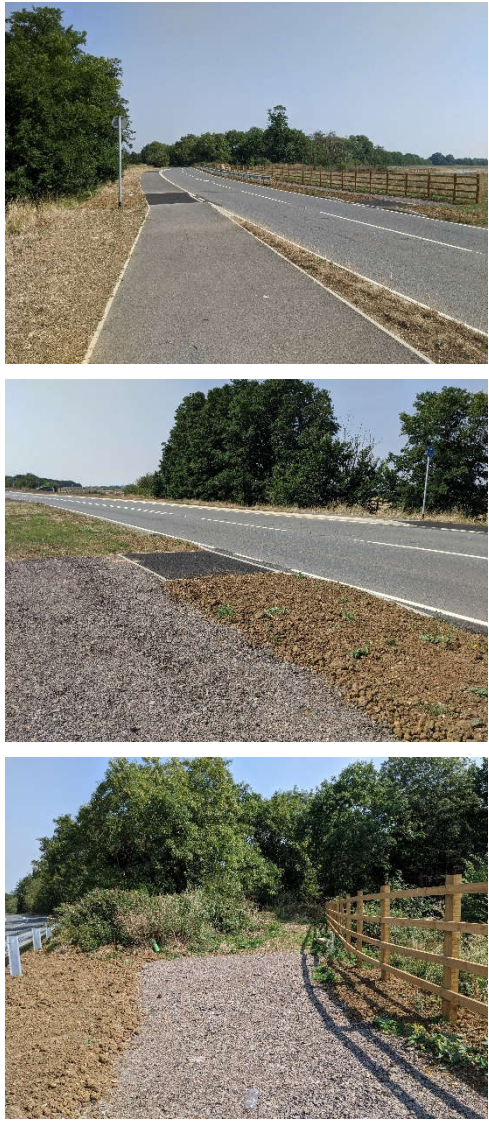
Ref.	Photos	Problem/Observation	Recommendation
S3.15

<p><u>Observation:</u> It is acknowledged that provision has been made to connect the B1040 Potton Access Road to connect with FP 122/10 and FP 87/7, either side of St Ives Road north of Potton Road Bridge.</p> <p><u>Problem:</u> It is noted that tactile paving has not been provided at the uncontrolled crossing of the B1040, St Ives Road that connects FP 122/10 and FP 87/7.</p> <p><u>Observation:</u> It is noted that the surface of the route connecting FP 122/10 and FP 87/7 on the eastern side of the B1040, St Ives Road is unbound.</p>	<p>It is recommended that appropriate tactile paving is provided at the uncontrolled crossing.</p> <p>It is recommended that confirmation be provided as to the chosen surface for the footway connection on the eastern side of the B1040, St Ives Road. It is anticipated that this is to correspond with the surface of the route that continues north.</p> <p><b>Designers Response:</b></p>

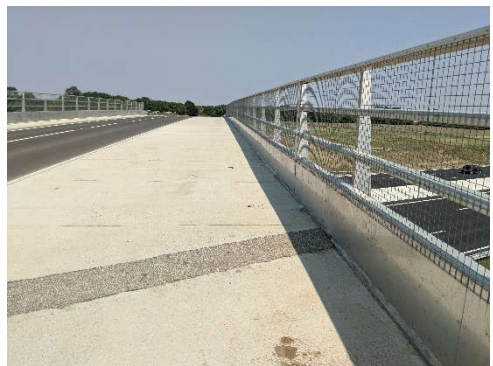
<p><u>Problem:</u> It was observed that the parapet on NMU 4.2 is at an appropriate height of 1.8 m.</p> <p>However, it was observed that the parapet did not include the appropriate infill on the parapet to obscure a horse's view of traffic passing beneath the bridge.</p>	<p>It is recommended that an infill is installed on the parapet i.e. a solid panelling fixed to the parapet railings. The British Horse Society guidance advises that the height of the infill should be 1.0 m with an uplift of 25 mm.</p> <p><b>Designers Response:</b></p>

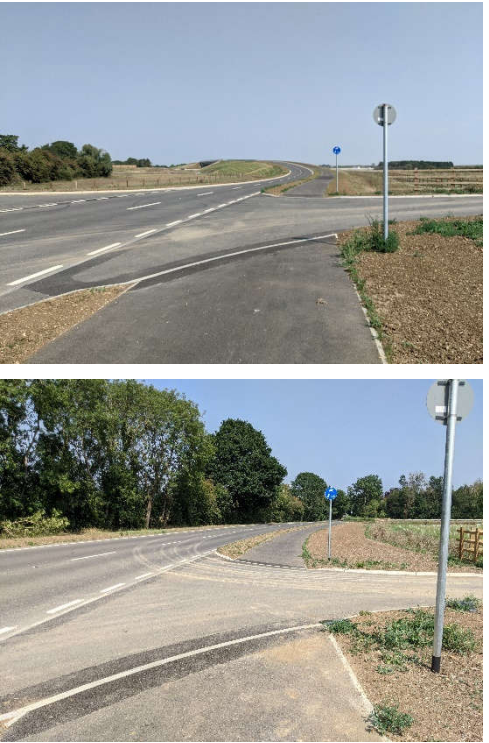
Ref.	Photos	Problem/Observation	Recommendation
S3.19

<p><u>Problem:</u> It is noted that tactile paving has not been provided at the side road accesses/junctions, north and south of the Hilton Road Bridge.</p>	<p>It is recommended that appropriate tactile paving and markings (TSRGD Diagram 1023B, 1003B and 1009B) are provided at the appropriate transitions.</p> <p><b>Designers Response:</b></p>

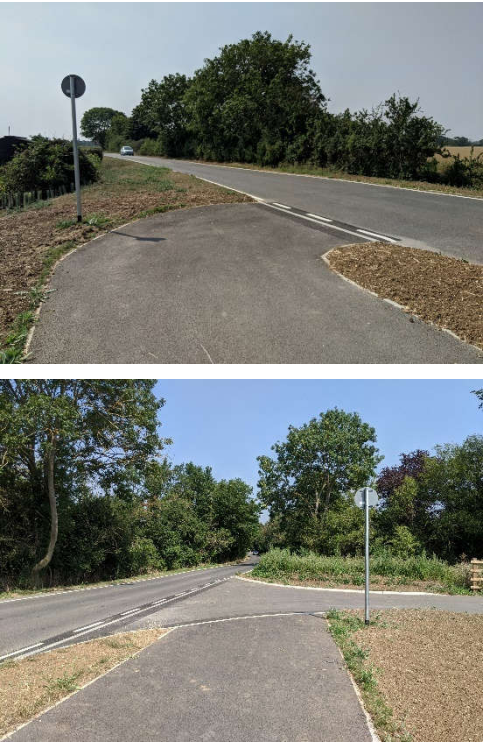
Ref.	Photos	Problem/Observation	Recommendation
S3.20

<p><u>Problem:</u> It is noted that dropped kerbs are provided where the off-road route ends either side of Hilton Road Bridge. It is noted that the termination of the off-road route either end presents a barrier for some users i.e. those uncomfortable with cycling on-road.</p> <p>It is important to ensure that the transitions provided are safe, comfortable to use and minimise delay to cyclists.</p>	<p>It is recommended that appropriate tactile paving and markings (TSRGD Diagram 1023B, 1003B and 1009B) are provided at the appropriate transitions.</p> <p>This will likely include the need to warn pedestrians with visual impairments using tactile paving i.e. so they do not continue into oncoming traffic.</p> <p>It is recommended that signs advising cycle users to rejoin the carriageway (Diagram 966) are provided as appropriate, with signs to <i>TSRGD</i> Diagram 956.1 provided to advise cyclists transitioning from the carriageway.</p> <p><b>Designers Response:</b></p>

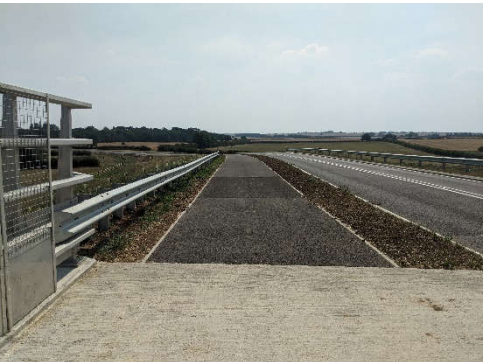
S3.21

<p><u>Observation:</u> On-site observations confirm that NMU 4.3 is 3.0 m wide, which concurs with the preferred minimum width for an unsegregated facility of 3.0 m as expressed in guidance, and a 1.8 m separation, in line with the preferred width specified in guidance.</p>	<p>No recommendation.</p> <p><b>Designers Response:</b></p>

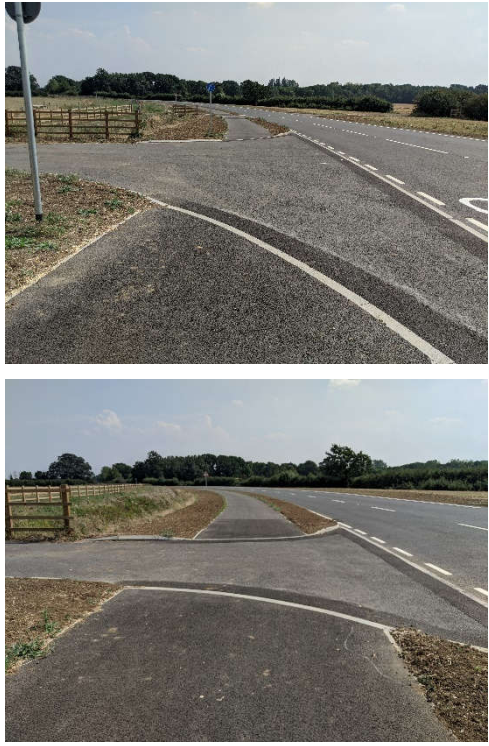
Ref.	Photos	Problem/Observation	Recommendation
S3.25

<p><u>Observation:</u> It is noted that signs to TSRGD Diagram 956.1 are located adjacent to NMU 4.4 indicating a route for use by pedal cycles, horses and pedestrians only.</p> <p><u>Problem:</u> It is noted that tactile paving has not been provided at the side road accesses/junctions south of Conington Road Bridge.</p>	<p>It is recommended that appropriate tactile paving and markings (TSRGD Diagram 1023B, 1003B and 1009B) are provided.</p> <p><b>Designers Response:</b></p>

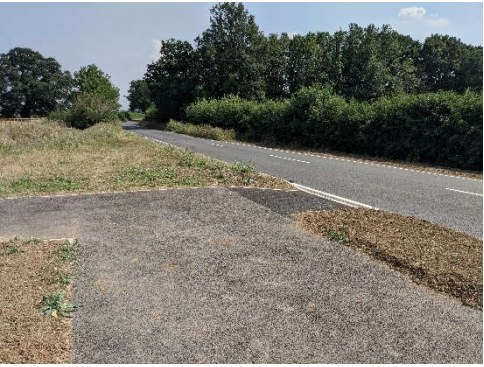
Ref.	Photos	Problem/Observation	Recommendation
S3.26

<p><u>Problem:</u> It is noted that a dropped kerb is provided where the off-road route ends south of Conington Road Bridge. It is noted that the termination of the off-road route presents a barrier for some users i.e. those uncomfortable with cycling on-road.</p> <p>It is important to ensure that the transition provided is safe, comfortable to use and minimises delay to cyclists.</p>	<p>It is recommended that appropriate tactile paving and markings (TSRGD Diagram 1023B, 1003B and 1009B) are provided at the appropriate transitions.</p> <p>This will likely include the need to warn pedestrians with visual impairments using tactile paving i.e. so they do not continue into oncoming traffic.</p> <p>It is recommended that signs advising cycle users to rejoin the carriageway (Diagram 966) are provided as appropriate, with signs to <i>TSRGD</i> Diagram 956.1 provided to advise cyclists transitioning from the carriageway.</p> <p><b>Designers Response:</b></p>

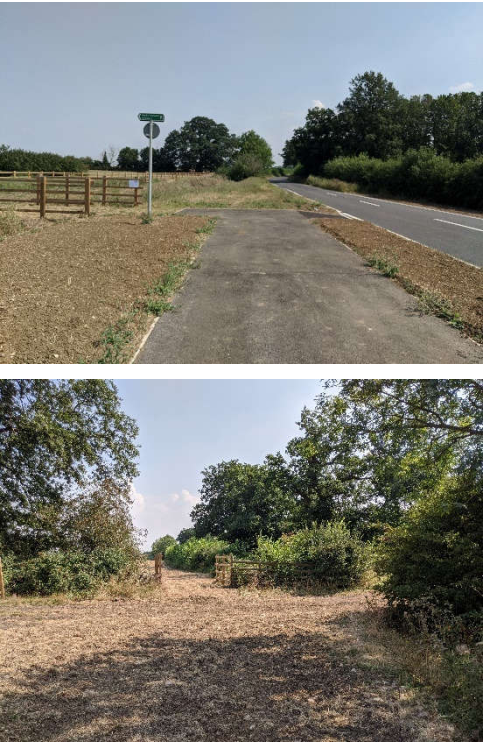
Ref.	Photos	Problem/Observation	Recommendation
S3.27

<p><u>Observation:</u> It is noted that the route connects with a bridleway (to Conington) that continues east of Conington Road at the same location that NMU 4.4 rejoins the carriageway.</p> <p>Appropriate signage is provided.</p>	<p>No recommendation.</p> <p><b>Designers Response:</b></p>

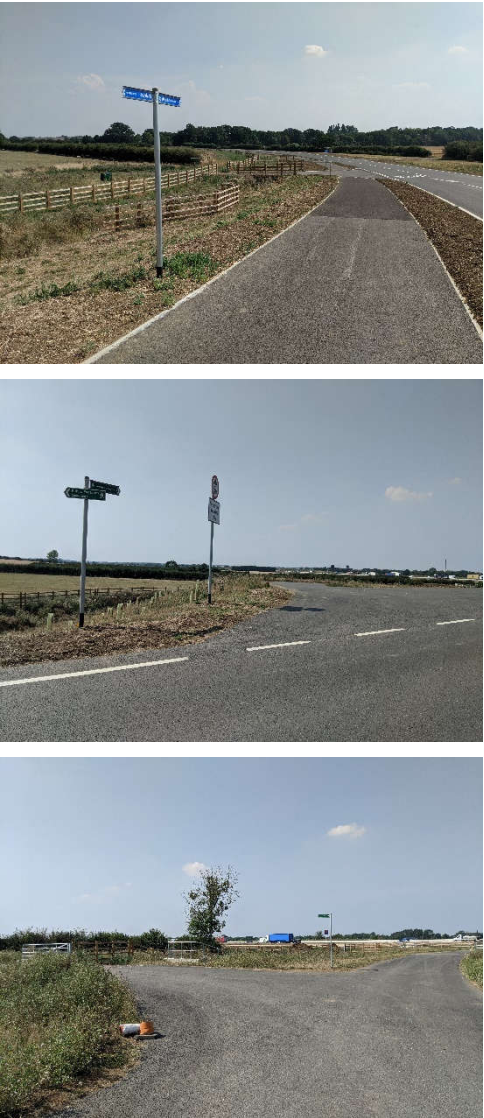
<p><u>Problem:</u> Similarly, it is noted that the route is signed opposite the emergency/maintenance exit and access from the A14 (authorised vehicles only) on the western side of Conington Road, in combination with signs that connect a permissive footpath to the west of Conington Road and the bridleway to Conington.</p> <p>However, it is noted that no crossing has been provided for users to cross Conington Road at this location.</p>	<p>It is recommended that an appropriate crossing is provided conforming to the appropriate standards that can accommodate all users.</p> <p>Appropriate signage should be provided that warns motor vehicles using the emergency/maintenance exit and access that they are sharing this route with pedestrians, cyclists and equestrians.</p> <p><b>Designers Response:</b></p>

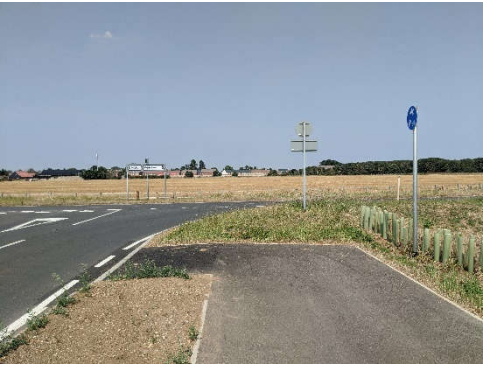
Ref.	Photos	Problem/Observation	Recommendation
S3.31

<p><u>Problem:</u> It is noted that a dropped kerb is provided where the off-road route ends north of Conington Road Bridge. It is noted that the termination of the off-road route presents a barrier for some users i.e. those uncomfortable with cycling on-road.</p> <p>It is important to ensure that the transition provided is safe, comfortable to use and minimises delay to cyclists.</p> <p>Note current standards and best practice recommend that “a cycleway should not feed cyclists onto the carriageway at, or close to, road junctions, as this introduces additional conflicts at the junction. Consideration should be given to providing a cycleway transition onto the carriageway clear of the main junction”.</p>	<p>It is recommended that appropriate tactile paving and markings (TSRGD Diagram 1023B, 1003B and 1009B) are provided at the appropriate transition.</p> <p>This will likely include the need to warn pedestrians with visual impairments using tactile paving i.e. so they do not continue into oncoming traffic.</p> <p>It is recommended that signs advising cycle users to rejoin the carriageway (Diagram 966) are provided as appropriate, with signs to <i>TSRGD</i> Diagram 956.1 provided to advise cyclists transitioning from the carriageway.</p> <p><b>Designers Response:</b></p>

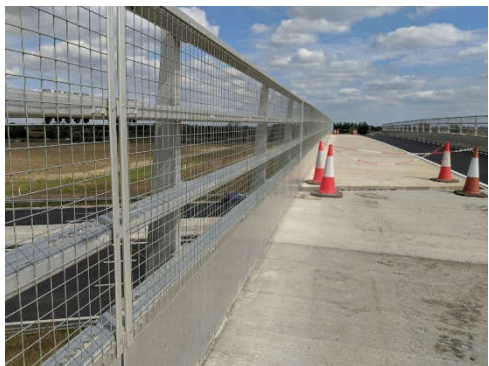
<p><u>Problem:</u> It was observed that the parapet on NMU 4.7 is at an appropriate height of 1.8 m.</p> <p>However, it was observed that the parapet did not include the appropriate infill to obscure a horse's view of traffic passing beneath the bridge.</p>	<p>It is recommended that an infill is installed on the parapet i.e. a solid panelling fixed to the parapet railings. The British Horse Society guidance advises that the height of the infill should be 1.0 m with an uplift of 25 mm.</p> <p><b>Designers Response:</b></p>
