# A14 Cambridge to Huntingdon Improvement Scheme

## POST CONSTRUCTION AUDIT - AUGUST 2020

PROJECT NUMBER: HA528983			DOCUMENT REF: HA528983-ACJV-HGN-SG_XX-RP-C-0003			
P01.1	First Issue	AKAK				
Revision	Purpose Description	Originated	Checked	Reviewed	Authorised	Date

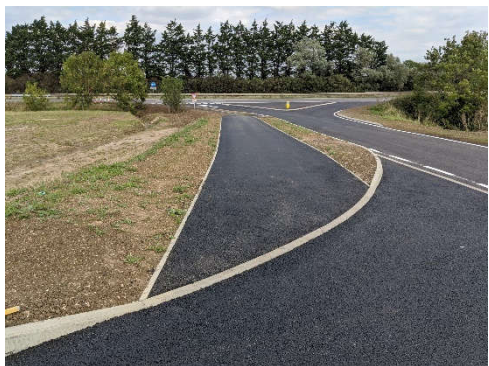
S3.35

<p><u>Problem:</u> It is noted that tactile paving has not been provided at the side road accesses/junctions north of Conington Road Bridge.</p>	<p>It is recommended that appropriate tactile paving and markings (TSRGD Diagram 1023B, 1003B and 1009B) are provided.</p> <p><b>Designers Response:</b></p>

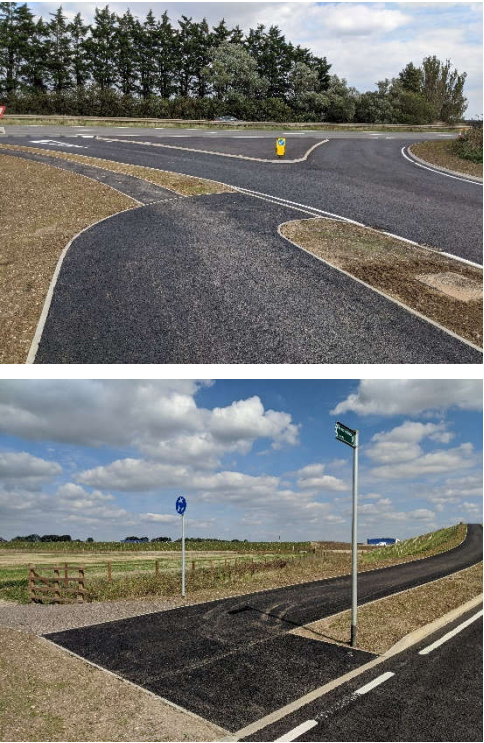
<p><u>Problem:</u> It is noted that a dropped kerb is provided where the off-road route ends north and south of New Barns Lane Bridge. It is noted that the termination of the off-road route may present a barrier for some users i.e. those uncomfortable with cycling on-road.</p> <p>It is important to ensure that the transition provided is safe, comfortable to use and minimises delay to cyclists.</p> <p><u>Observation:</u> It is noted that signs to TSRGD Diagram 956.1 are located adjacent to NMU 4.7 indicating a route for use by pedal cycles, horses and pedestrians only.</p> <p><u>Problem:</u> It is observed that NMU 4.7 connects with a narrow 1.2 m wide footway that continues along the A1307 (A14 de-trunked). As stated in the earlier audit, this does not provide the opportunity for all users to connect with communities either side of the A1307 e.g. Conington with Fen Drayton, and their attractions therein. Also, just to the west of the proposed New Barns Lane Bridge, existing Footpaths (FP 53/2 and FP 86/3) are severed by the existing A14.</p>	<p>It is recommended that appropriate tactile paving and markings (TSRGD Diagram 1023B, 1003B and 1009B) are provided at the appropriate transitions.</p> <p>This will likely include the need to warn pedestrians with visual impairments using tactile paving i.e. so they do not continue into oncoming traffic.</p> <p>It is recommended that signs advising cycle users to rejoin the carriageway (Diagram 966) are provided as appropriate.</p> <p>It is recommended that an appropriate connection is considered that connects New Barns Lane Bridge NMU facilities over the A1307. This could be via the provision of an appropriate NMU crossing to connect with PRoW 86/3. The designer's response to the earlier audit did note that this was outside the DCO, and that HE were to confirm further consideration.</p> <p><b>Designers Response:</b></p>

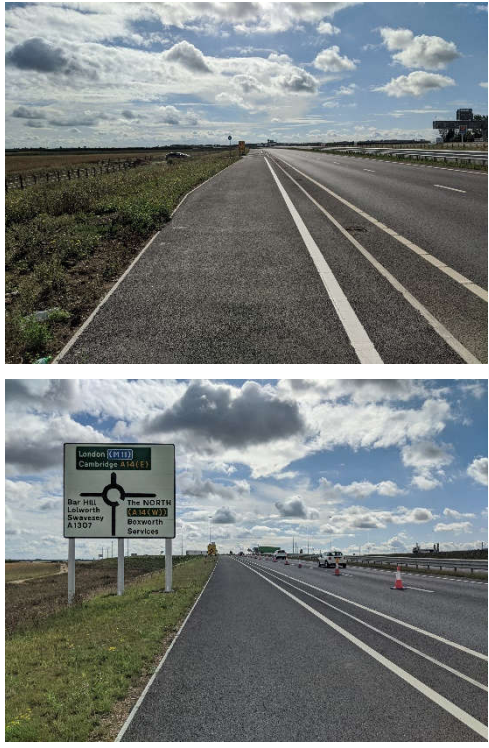
<p><u>Observation:</u> On-site observations confirm that NMU 5.1 is 3.0 m wide, which concurs with the preferred minimum width for an unsegregated facility of 3.0 m as expressed in guidance, and a 1.8 m separation (including hardstrip), in line with the preferred width specified in guidance.</p>	<p>No recommendation.</p> <p><b>Designers Response:</b></p>
S4.3

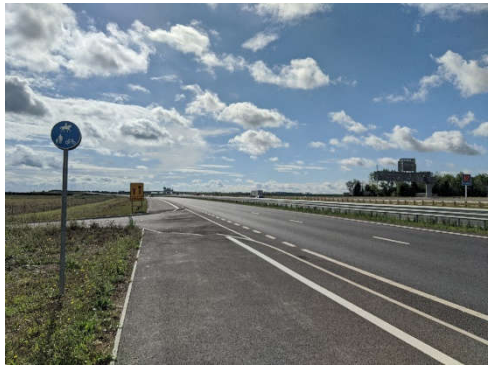
<p><u>Observation:</u> It is noted that signs to TSRGD Diagram 956.1 are located adjacent to NMU 5.1 indicating a route for use by pedal cycles, horses and pedestrians only.</p> <p><u>Problem:</u> It is noted that tactile paving has not been provided at the side road access.</p>	<p>It is recommended that appropriate tactile paving and markings (TSRGD Diagram 1023B, 1003B and 1009B) are provided.</p> <p>It is recommended that the dropped kerb upstands are checked and altered, if necessary, to be no more than the permissible 6 mm.</p> <p><b>Designers Response:</b></p>

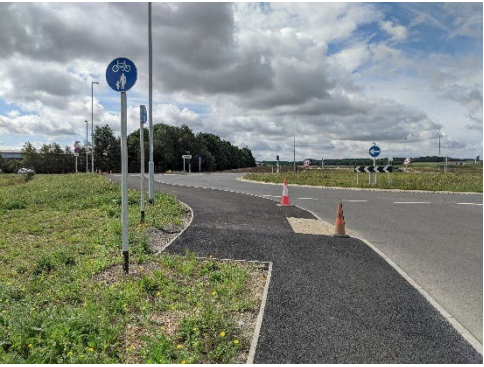
Ref.	Photos	Problem/Observation	Recommendation
S4.4

<p><u>Observation:</u> It is observed that tactile paving has been provided for pedestrian and cycle users crossing arms of the roundabout between NMU route 5.1 and 5.2 at the Swavesey Junction.</p>	<p>It is recommended that the dropped kerb upstands are checked and altered to be no more than the permissible 6 mm.</p> <p><b>Designers Response:</b></p>
S4.5

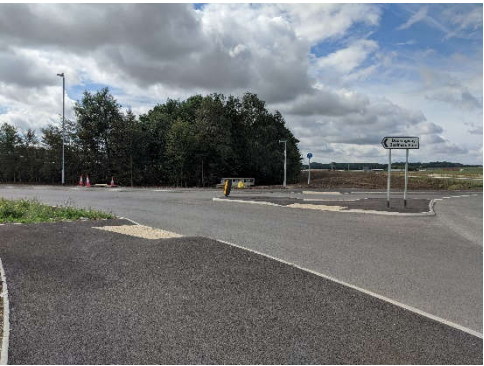
<p><u>Observation:</u> It is noted that the appropriate markings for pedestrian and cycle users has not been provided across the Bucking Way Road, Anderson Road or Local Access Road arms of the roundabout.</p>	<p>It is recommended that the appropriate markings are provided at the dropped kerb crossings intended for use by pedestrian and cycle users.</p> <p><b>Designers Response:</b></p>

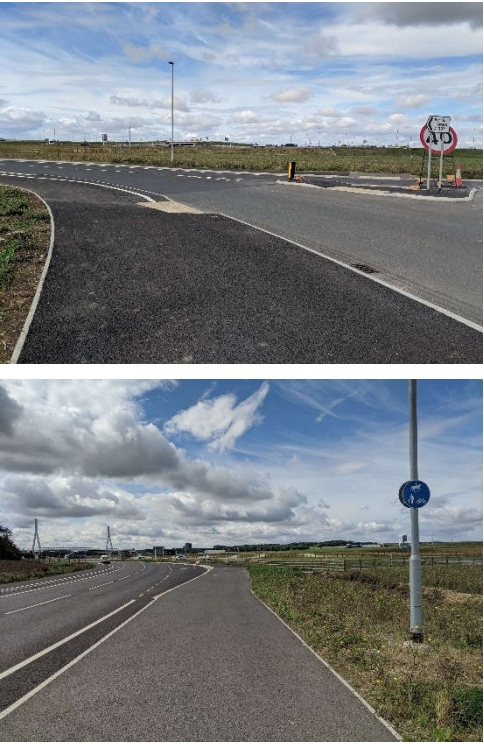
<p><u>Observation:</u> It is observed that the NMU route illustrated on the western side of Bucking Way Road, extending south from Bucking Way Road Roundabout leads to a bus stop. However, this potentially can mislead cyclists to cross at the roundabout approach arm.</p>	<p>It is recommended that additional information is provided to cyclists, potentially via signage.</p> <p><b>Designers Response:</b></p>

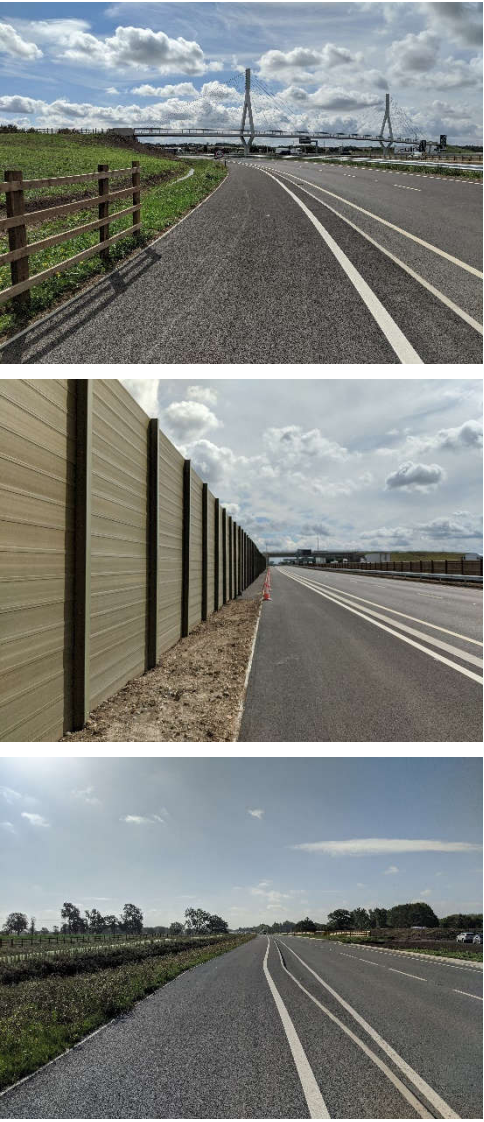
<p><u>Observation:</u> On-site observations confirm that NMU 5.2 is 3.0 m wide, which concurs with the preferred minimum width for an unsegregated facility of 3.0 m as expressed in guidance, and a 1.8 m separation (including hardstrip), in line with the preferred width specified in guidance.</p>	<p>No recommendation.</p> <p><b>Designers Response:</b></p>

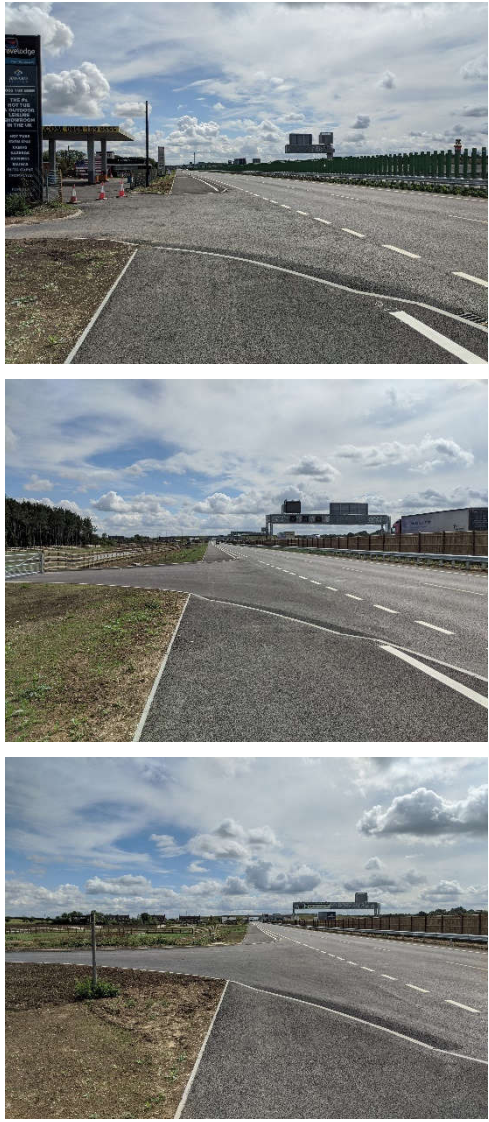
<p>The first photograph shows a road junction with a signpost on the left. The second and third photographs show similar junctions from different angles, highlighting the lack of tactile paving on the side road surfaces.</p>	<p><u>Problem:</u> It is noted that tactile paving has not been provided at the various side road accesses/junctions on NMU 5.2 between Swavesey Junction and Dry Drayton.</p>	<p>It is recommended that appropriate tactile paving and markings (TSRGD Diagram 1023B, 1003B and 1009B) are provided.</p> <p>It is recommended that the dropped kerb upstands are checked and altered, if necessary, to be no more than the permissible 6 mm.</p> <p><b>Designers Response:</b></p>

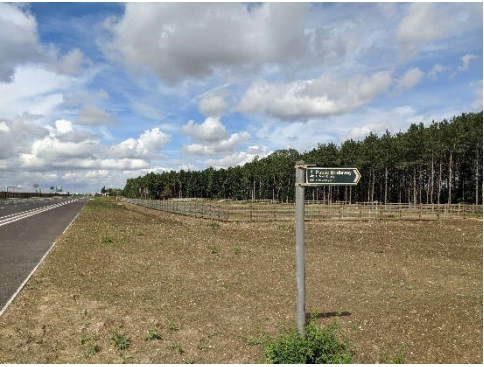
Ref.	Photos	Problem/Observation	Recommendation
S4.9

<p><u>Observation:</u> It is acknowledged that Swavesey NMU Bridge (NMU 5.3) is not to accommodate equestrians. As noted in the 2016 Audit, Bridleways 225/14 (just west of Swavesey Junction and 225/15 (see photo) are located north of the existing A14 and are linked by the NMU 5.1 and 5.2.</p>	<p>No recommendation.  <b>Designers Response:</b></p>
S4.10

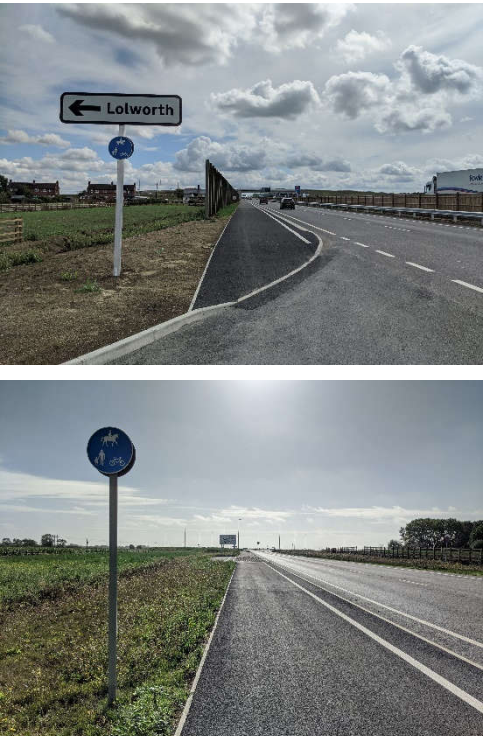
<p><u>Observation:</u> It is noted that signs to TSRGD Diagram 956.1 are located adjacent to NMU 5.2 indicating a route for use by pedal cycles, horses and pedestrians only.</p>	<p>No recommendation.  <b>Designers Response:</b></p>

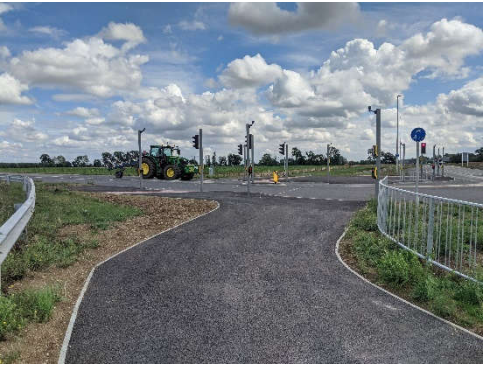
Ref.	Photos	Problem/Observation	Recommendation
S4.11

<p><u>Problem:</u> It is observed that there is a signal-controlled crossing where NMU 5.2 intersects the link road between the A1307 and the B1050, Hattons Road at Bar Hill Junction, with equestrians separated from pedestrians and cyclists at a parallel equestrian crossing.</p> <p>While it is noted that there is separate crossing provision for equestrians, DMRB states this should be a fenced, grassed holding area of 10.0 m wide by 5.0 m long.</p> <p>It is noted that no high friction surfacing is currently provided on the carriageway to prevent horses from slipping, although it is also noted that the crossings are not currently available for use.</p>	<p>It is recommended, as per DMRB, that the holding area for equestrians should be a fenced, grassed area of 10.0 m wide by 5.0 m long.</p> <p>It is recommended, as per DMRB, that a 10.0m band of high friction surfacing should be provided on the carriageway to prevent horses from slipping, and, where possible, this should be of the same colour as the carriageway.</p> <p>The BHS acknowledge that there may be circumstances where a variation from the standard design is appropriate.</p> <p><b>Designers Response:</b></p>

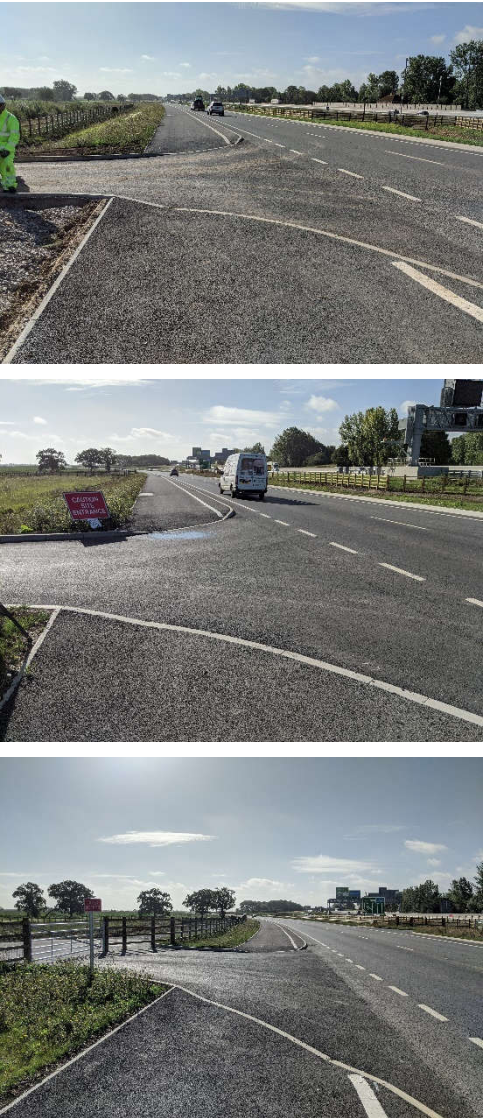
<p>The photos show three different views of road junctions. The top photo shows a side road junction with a dropped kerb and no tactile paving. The middle photo shows a similar junction with a white van and a 'Caution Wet Pavement' sign. The bottom photo shows another side road junction with a dropped kerb and no tactile paving.</p>	<p><u>Problem:</u> As noted previously, tactile paving has not been provided at the various side road accesses/junctions on NMU 5.2 between Swavesey Junction and Dry Drayton.</p>	<p>It is recommended that appropriate tactile paving and markings (TSRGD Diagram 1023B, 1003B and 1009B) are provided.</p> <p>It is recommended that the dropped kerb upstands are checked and altered, if necessary, to be no more than the permissible 6 mm.</p> <p><b>Designers Response:</b></p>

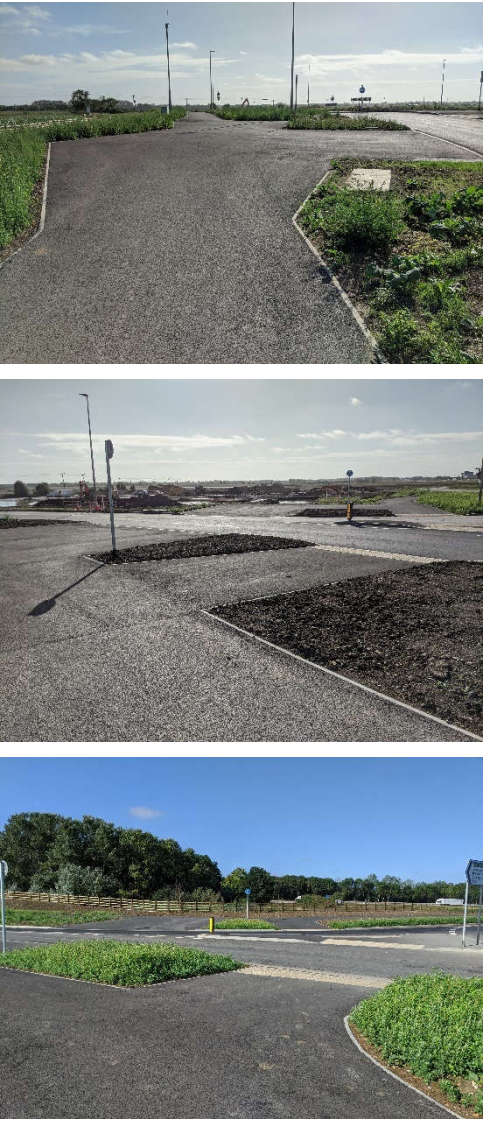
<p><u>Observation:</u> It is observed that tactile paving has been provided for pedestrian and cycle users crossing the arms of Dry Drayton Road Roundabout.</p> <p><u>Observation:</u> It is noted that the appropriate markings for pedestrian and cycle users has not been provided across the Bucking Way Road, Anderson Road or Local Access Road arms of the roundabout.</p> <p><u>Problem:</u> It is noted that there is separate crossing provision for equestrians. DMRB states that this should be a fenced, grassed holding area of 10.0 m wide by 5.0 m long.</p>	<p>It is recommended that the dropped kerb upstands are checked and altered to be no more than the permissible 6 mm.</p> <p>It is recommended that the appropriate markings are provided (TSRGD Diagram 1023B, 1003B and 1009B) at the dropped kerb crossings intended for use by pedestrian and cycle users.</p> <p>It is recommended, as per DMRB, that the holding areas for equestrians should be a fenced, grassed area of 10.0 m wide by 5.0 m long.</p> <p>It is recommended, as per DMRB, that a 10.0m band of high friction surfacing should be provided on the carriageway to prevent horses from slipping, and, where possible, this should be of the same colour as the carriageway.</p> <p>The BHS acknowledge that there may be circumstances where a variation from the standard design is appropriate.</p> <p><b>Designers Response:</b></p>

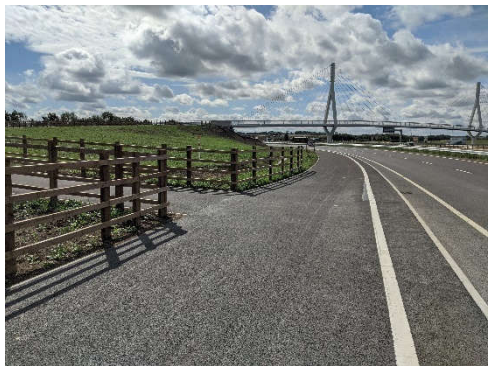
Ref.	Photos	Problem/Observation	Recommendation
S4.14

<p><u>Problem:</u> It is not clear that users will be appropriately directed to the Swavesey NMU Bridge (NMU 5.3).</p>	<p>It is recommended that appropriate signage is included to direct users at the connection between NMU 5.2 and NMU 5.3.</p> <p><b>Designers Response:</b></p>
S4.15

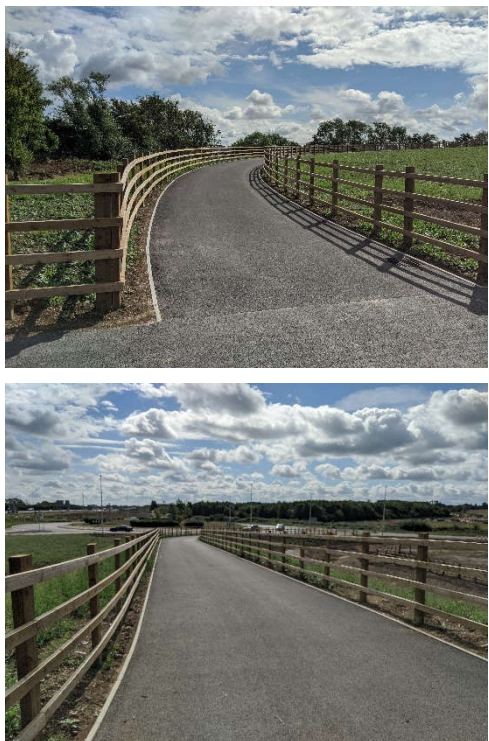
<p><u>Observation:</u> On-site observations confirm that NMU 5.3 is 4.0 m wide, which exceeds the preferred minimum width for an unsegregated facility (3.0 m) as expressed in guidance. It is noted that the adjacent wooden post and rail fence will mean the effective width is reduced by up to 0.5 m either side.</p>	<p>No recommendation.</p> <p><b>Designers Response:</b></p>

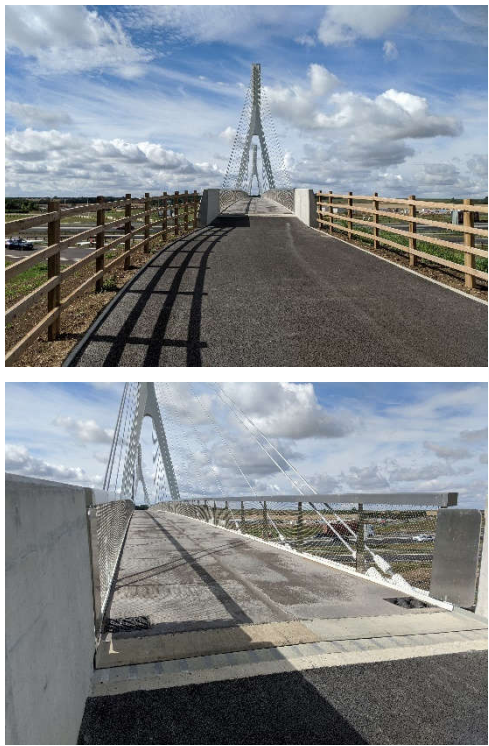
<p><u>Observation:</u> On-site observations confirm that NMU 5.3 is 4.0 m wide, which exceeds the preferred minimum width for an unsegregated facility (3.0 m) as expressed in guidance. It is noted that the adjacent bridge parapets mean the effective width is reduced by up to 0.5 m either side.</p> <p>It is noted that Swavesey NMU Bridge is to accommodate pedestrians and cyclists only.</p> <p><u>Observation:</u> It is observed that the parapet heights are 1.4 m high, the desirable minimum parapet height where no equestrians are to be accommodated.</p> <p><u>Observation:</u> It is observed that no handrails are incorporated into the Swavesey NMU Bridge.</p>	<p>It is recommended that handrails are provided on the proposed bridge, although the impact this may have on the effective width should be considered. Note, the colour of any handrail should contrast with its surroundings, noting that <i>Inclusive Mobility</i> states that “colour/tonal contrasted handrails are essential to assist partially sighted users”.</p> <p><b>Designers Response:</b></p>

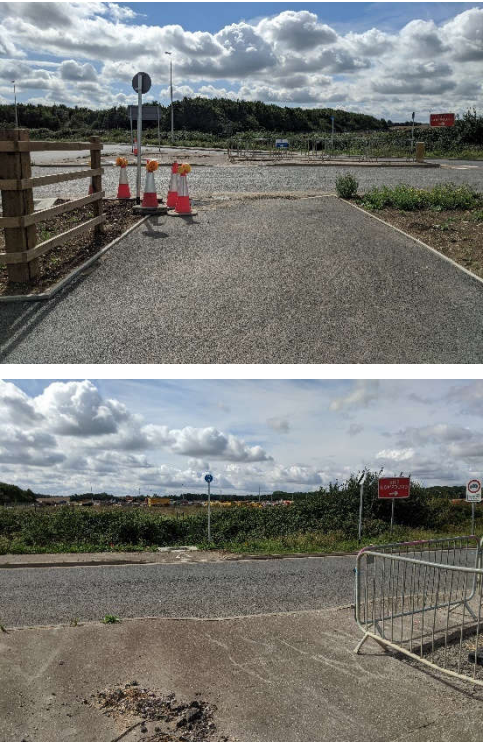
<p><u>Observation:</u> It is noted that NMU 5.3 links with an existing shared cycleway at the roundabout access to adjacent Services and a route south to Boxworth.</p> <p><u>Problem:</u> It is noted that the crossing facilities across Boxworth Road need upgrading.</p>	<p>It is recommended that appropriate tactile paving and markings (TSRGD Diagram 1023B, 1003B and 1009B) are provided at the dropped kerb crossings intended for use by pedestrian and cycle users.</p> <p>It is recommended that the dropped kerb upstands are checked and altered to be no more than the permissible 6 mm.</p> <p><b>Designers Response:</b></p>

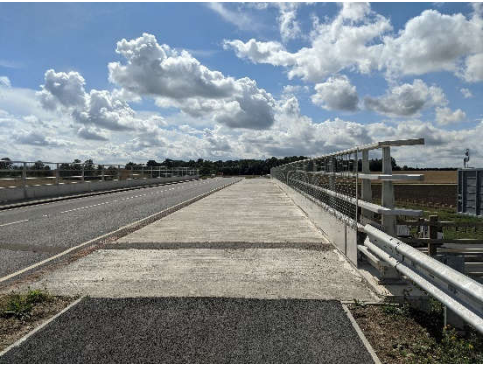
Ref.	Photos	Problem/Observation	Recommendation
S4.18

<p><u>Observation:</u> NMU 5.4, Robins Lane Bridge, carries a shared route over the A14, connecting NMU 5.2 south towards Lolworth. On-site observations confirm a width of 4.8 m (concrete) with 0.7 m hardstrip (effectively a 3.0 m wide route and a 1.5 m separation).</p> <p><u>Problem:</u> It was observed that the parapet on NMU 5.4 is at an appropriate height of 1.8 m.</p> <p>However, it was observed that the parapet did not include the appropriate infill on the parapet to obscure a horse's view of traffic passing beneath the bridge.</p> <p>NMU 5.4 is connected either side by NMU 5.5.</p>	<p>It is recommended that an infill is installed on the parapet i.e. a solid panelling fixed to the parapet railings. The British Horse Society guidance advises that the height of the infill should be 1.0 m with an uplift of 25 mm.</p> <p><b>Designers Response:</b></p>

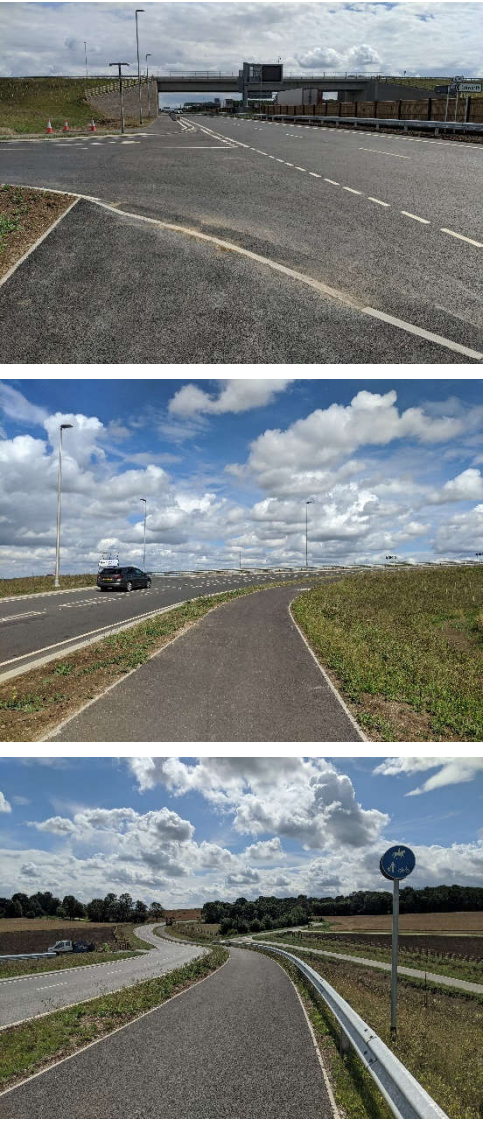
Ref.	Photos	Problem/Observation	Recommendation
S4.19

<p><u>Observation:</u> NMU 5.5 connects NMU 5.2 with NMU 5.4 (Robins Lane Bridge) and connects south towards Lolworth.</p> <p>It was observed on-site that the route is 3.0 m wide with appropriate signs to TSRGD Diagram 956.1 indicating a route for use by pedal cycles, horses and pedestrians only.</p> <p>Spacing between the route and the road was confirmed as approximately 1.8 m, including the hardstrip.</p>	<p>No recommendation.</p> <p><b>Designers Response:</b></p>

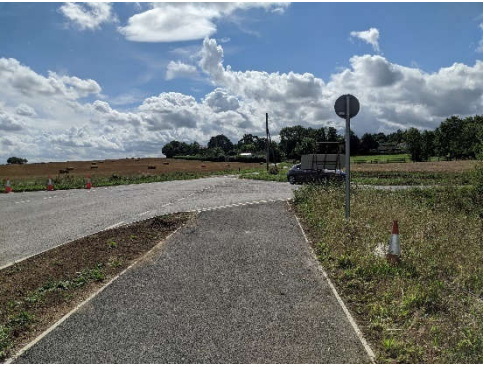
Ref.	Photos	Problem/Observation	Recommendation
S4.20

<p><u>Problem:</u> It is noted that a dropped kerb is provided where the off-road route (NMU 5.5) ends south of Robins Lane Bridge (onto Robin's Lane). It is noted that the termination of the off-road route will present a barrier to some users.</p> <p>It is important to ensure that transitions are safe, comfortable to use and minimise delay to cyclists.</p> <p>It is also noted that the transition is located directly on a junction to Clare College farm. Note current standards and best practice recommend that a cycleway should not feed cyclists onto the carriageway at, or close to, road junctions, as this introduces additional conflicts at the junction.</p>	<p>It is recommended that appropriate tactile paving and markings (TSRGD Diagram 1023B, 1003B and 1009B) are provided at the appropriate transitions.</p> <p>This will likely include the need to warn pedestrians with visual impairments using tactile paving i.e. so they do not continue into oncoming traffic.</p> <p>It is recommended that signs advising cycle users to rejoin the carriageway (Diagram 966) are provided as appropriate, on the reverse of the sign to TSRGD Diagram 956.1.</p> <p><b>Designers Response:</b></p>

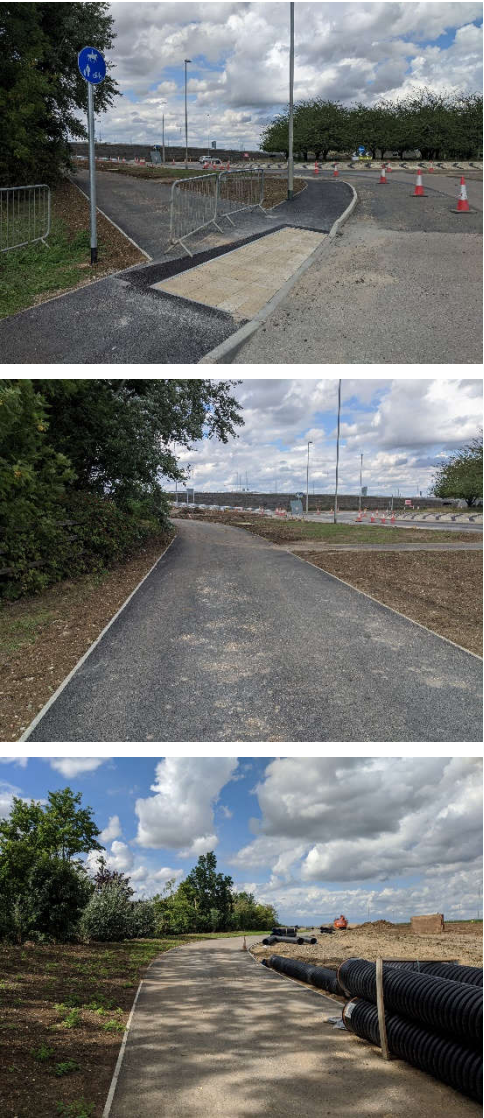
Ref.	Photos	Problem/Observation	Recommendation
S4.22

<p><u>Observation:</u> NMU 5.7 is proposed to provide a 4.5 m wide route, diverting the existing Bridleway 16/1 (NMU 5.7) to connect with the route at Bar Hill i.e. NMU 5.10.</p> <p>Connects with Swavesey NMU Bridge and ultimately NMU 5.2 north of the A14.</p> <p>The on-site audit identified that much of the works on NMU 5.7 are still to be completed.</p>	<p>No recommendation.</p> <p><b>Designers Response:</b></p>

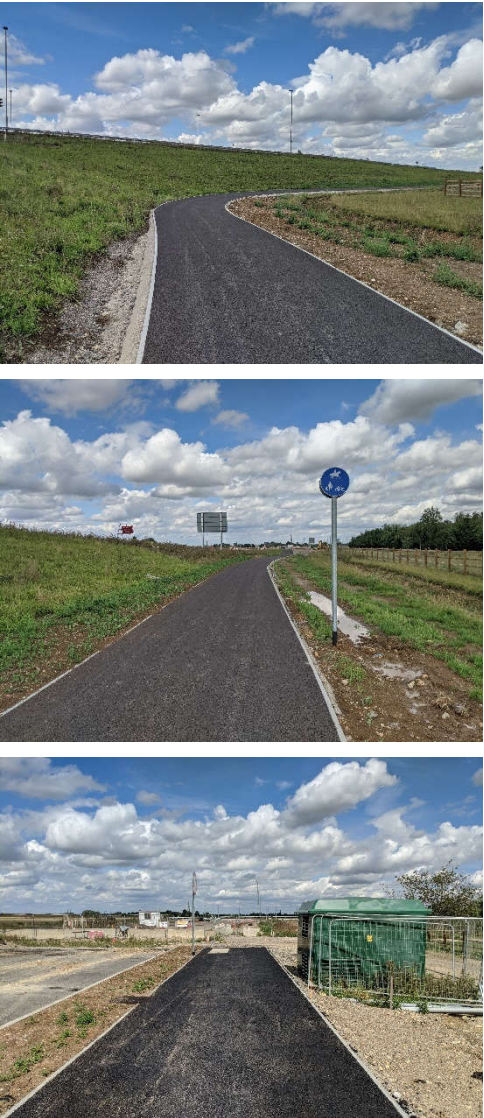
Ref.	Photos	Problem/Observation	Recommendation
S4.24

<p><u>Observation:</u> NMU 5.9 was recorded on-site as being 2.4 m wide and signed as a shared use route with signs to TSRGD Diagram 956.1 indicating a route for use by pedal cycles, horses and pedestrians only. It is noted that these were proposed to be 3.0 m wide.</p> <p>Work is currently ongoing, and it is not clear how the route links with CCC/ Northstowe Developer cycle route proposals.</p>	<p>It is recommended that clarification is provided on the width of the route.</p> <p>It is recommended that the designer confirms the proposed routes and the intended tie-in with the CCC/Northstowe Developer proposals.</p> <p><b>Designers Response:</b></p>

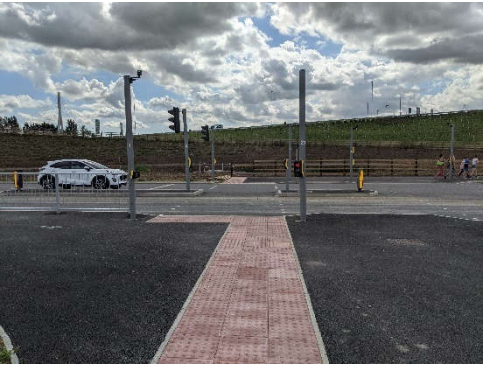
Ref.	Photos	Problem/Observation	Recommendation
S4.24

<p><u>Problem:</u> It is observed that there is a signal-controlled crossing where NMU 5.2 links across the A1307 to Bar Hill NMU Bridge (NMU 5.10), with equestrians separated from pedestrians and cyclists at a parallel equestrian crossing.</p> <p>While it is noted that there is separate crossing provision for equestrians, DMRB states this should be a fenced, grassed holding area of 10.0 m wide by 5.0 m long.</p> <p>It is noted that no high friction surfacing is currently provided on the carriageway to prevent horses from slipping, although it is also noted that the crossings are not currently available for use.</p>	<p>It is recommended, as per DMRB, that the holding area for equestrians should be a fenced, grassed area of 10.0 m wide by 5.0 m long.</p> <p>It is recommended, as per DMRB, that a 10.0m band of high friction surfacing should be provided on the carriageway to prevent horses from slipping, and, where possible, this should be of the same colour as the carriageway.</p> <p>The BHS acknowledge that there may be circumstances where a variation from the standard design is appropriate.</p> <p><b>Designers Response:</b></p>

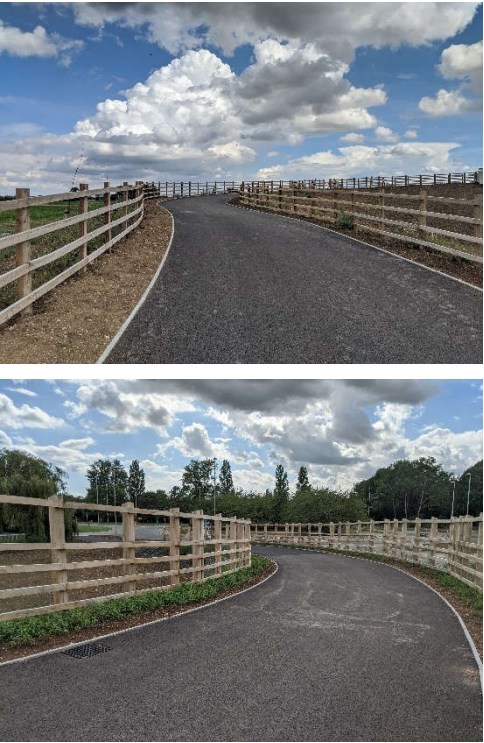
Ref.	Photos	Problem/Observation	Recommendation
S4.25

<p><u>Observation:</u> On-site observations confirm that NMU 5.10, approached to Bar Hill NMU Bridge, is 4.5 m wide, which exceeds the preferred minimum width for an unsegregated facility, and is in line with the proposed 4.5 m. It is noted that the adjacent wooden post and rail fence may mean a slight reduction in the effective width.</p>	<p>No recommendation.</p> <p><b>Designers Response:</b></p>

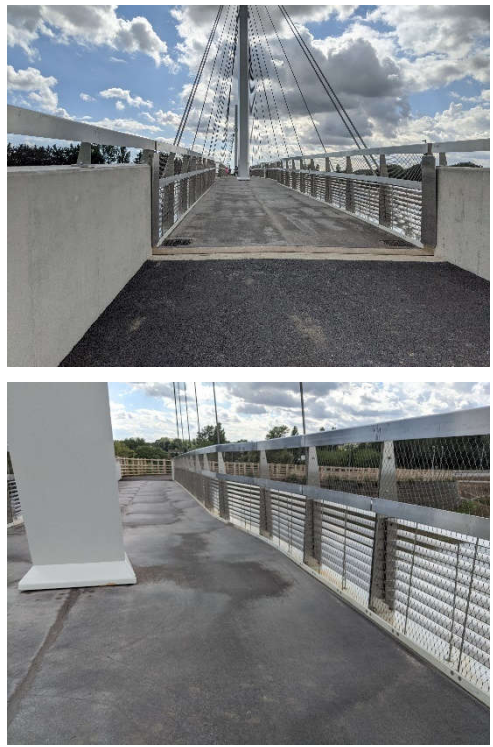
Ref.	Photos	Problem/Observation	Recommendation
S4.26

<p><u>Observation:</u> On-site observations confirm that NMU 5.10 is 4.5 m wide to accommodate pedestrian, cyclists and equestrians. It is noted that the adjacent bridge parapets mean the effective width is reduced by up to 0.5 m either side.</p> <p><u>Observation:</u> It is observed that the parapet heights are 1.8 m high, the desirable minimum parapet height where equestrians are to be accommodated.</p> <p>It was observed that the parapet did not include infill on the parapet to obscure a horse's view of traffic passing beneath the bridge. However, it is understood that the architectural design of the bridge means that a horse's view is obscured.</p> <p><u>Observation:</u> It is observed that no handrails are incorporated into the Bar Hill NMU Bridge.</p>	<p>It is recommended that confirmation is provided on the design of the bridge parapet and how this affects a horse's view of traffic passing beneath the bridge.</p> <p>It is recommended that handrails are provided on the proposed bridge, although the impact this may have on the effective width should be considered. Note, the colour of any handrail should contrast with its surroundings, noting that <i>Inclusive Mobility</i> states that "colour/tonal contrasted handrails are essential to assist partially sighted users".</p> <p><b>Designers Response:</b></p>

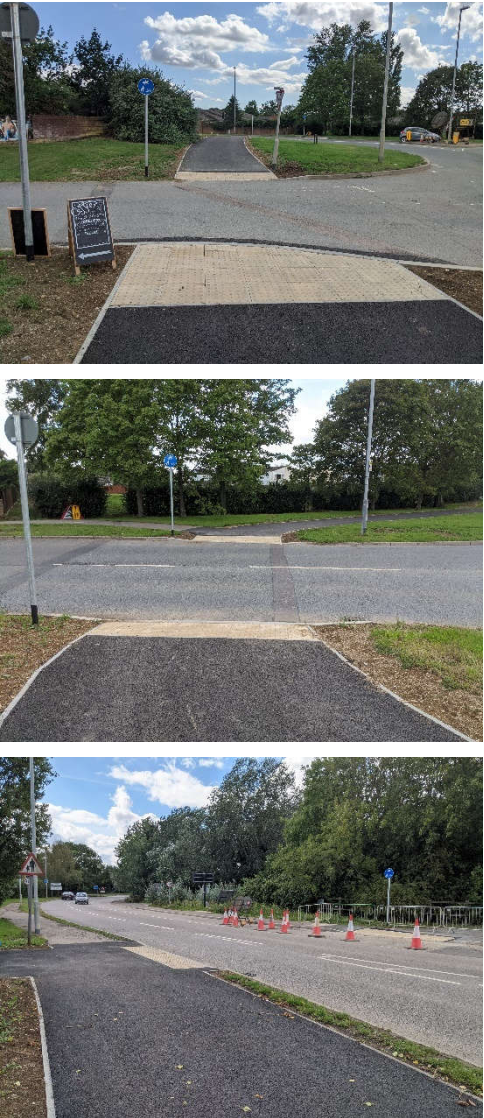
Ref.	Photos	Problem/Observation	Recommendation
S4.27

<p><u>Observation:</u> NMU 5.10 continues south of Bar Hill NMU Bridge and connects with NMU 5.7.</p> <p><u>Observation:</u> It is observed that tactile paving has been provided for all users crossing the arms of the roundabout.</p> <p><u>Observation:</u> It is noted that the appropriate markings for pedestrian and cycle users has not been provided.</p> <p><u>Problem:</u> It is noted that there is no separate crossing provision for equestrians.</p>	<p>It is recommended that the dropped kerb upstands are checked and altered to be no more than the permissible 6 mm.</p> <p>It is recommended that the appropriate markings (TSRGD Diagram 1023B, 1003B and 1009B) are provided at the dropped kerb crossings intended for use by pedestrian and cycle users.</p> <p>It is recommended that clarification is provided on the reasons why separate crossing provision has not been provided for equestrians. The BHS acknowledge that there may be circumstances where a variation from the standard design is appropriate, and that waiting pens are not always necessary and may be considered by site.</p> <p><b>Designers Response:</b></p>

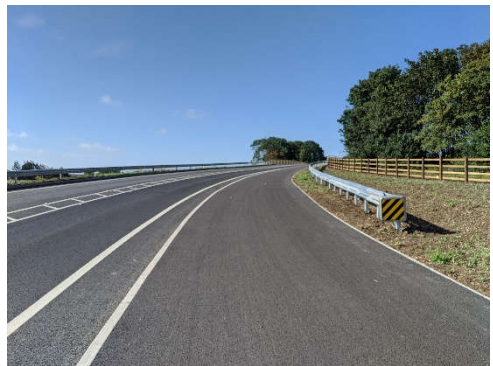
Ref.	Photos	Problem/Observation	Recommendation
S4.28

<p><u>Observation:</u> NMU 5.11, between the Oakington Road (east) Roundabout and Dry Drayton Bridge, was recorded on-site as 3.0 m wide with a 1.0 m spacing between the carriageway and the NMU route (hardstrip) and a varying verge width.</p>	<p>No recommendation.</p> <p><b>Designers Response:</b></p>
S4.29

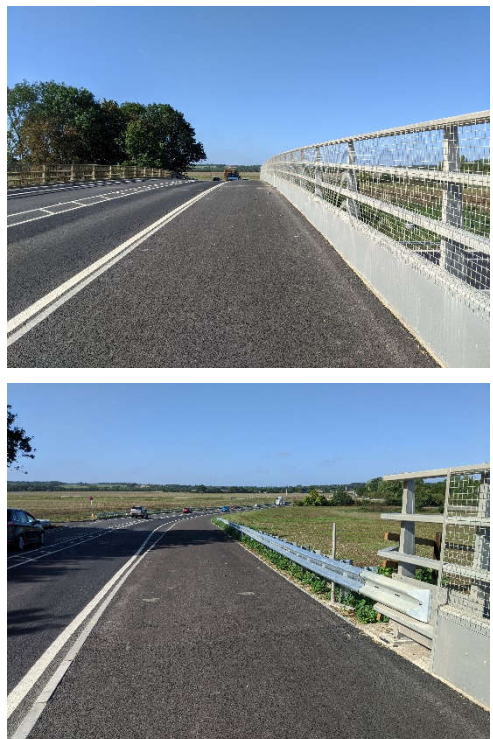
<p><u>Observation:</u> Subsequently, at the Dry Drayton Bridge the route is 3.3 m wide but the spacing between the carriageway and the NMU route reduces to approximately 0.3 m.</p> <p><u>Problem:</u> It is observed that the parapet heights are 1.8 m high, the desirable minimum parapet height where equestrians are to be accommodated.</p> <p>However, it was observed that the parapet did not include the appropriate infill on the parapet to obscure a horse's view of traffic passing beneath the bridge.</p>	<p>It is recommended that an infill is installed on the parapet i.e. a solid panelling fixed to the parapet railings. The British Horse Society guidance advises that the height of the infill should be 1.0 m with an uplift of 25 mm.</p> <p><b>Designers Response:</b></p>

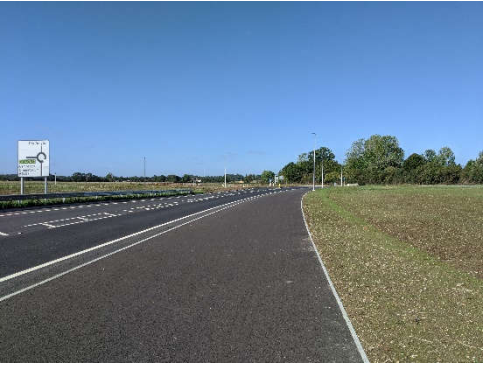
Ref.	Photos	Problem/Observation	Recommendation
S4.30

<p><u>Observation:</u> In turn NMU 5.13 provides a 4.0 m wide shared route, between Dry Drayton Bridge and the Oakington Road (west) roundabout, with a 0.8 m spacing between the carriageway and the NMU facility (hardstrip) and a varying verge width at the rear of the NMU route.</p>	<p>No recommendation. <b>Designers Response:</b></p>

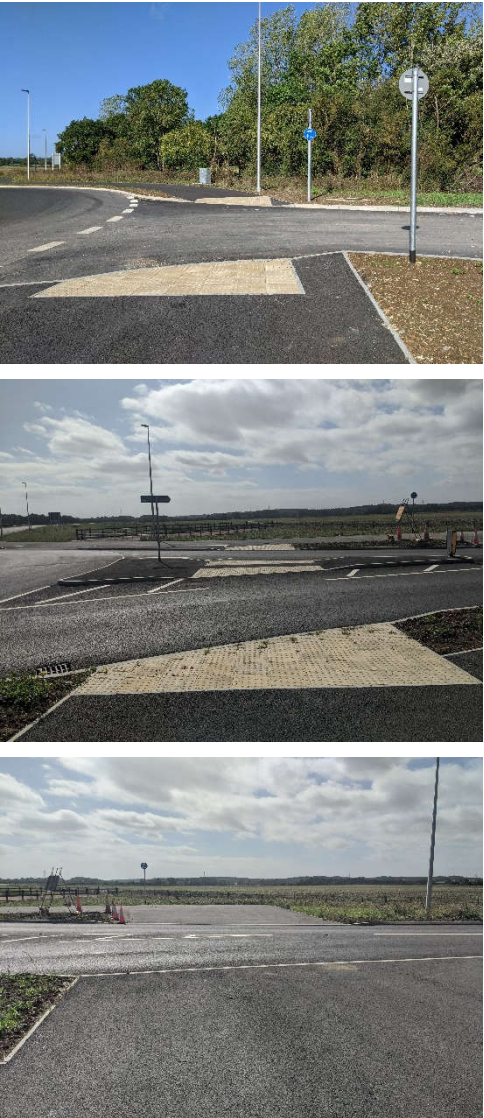
Ref.	Photos	Problem/Observation	Recommendation
S4.31

<p><u>Observation:</u> NMU 5.13 continues south and connects with NMU 5.14.</p> <p><u>Observation:</u> It is observed that tactile paving has been provided for all users cross the arm of Oakington Road Roundabout that provides maintenance access.</p> <p>It is noted that there is no separate crossing provision for equestrians at this location.</p> <p><u>Problem:</u> It is noted that there is separate crossing provision for equestrians on the Oakington Road arm of the roundabout. DMRB states that this should be a fenced, grassed holding area of 10.0 m wide by 5.0 m long.</p> <p><u>Observation:</u> It is noted that the appropriate markings for pedestrian and cycle users have not been provided.</p>	<p>It is recommended that the dropped kerb upstands are checked and altered to be no more than the permissible 6 mm.</p> <p>It is recommended that the appropriate markings (TSRGD Diagram 1023B, 1003B and 1009B) are provided at the dropped kerb crossings intended for use by pedestrian and cycle users.</p> <p>It is recommended, as per DMRB, that the holding areas for equestrians on the Oakington Road arm of the roundabout should be a fenced, grassed area of 10.0 m wide by 5.0 m long.</p> <p>It is recommended, as per DMRB, that a 10.0m band of high friction surfacing should be provided on the carriageway to prevent horses from slipping, and, where possible, this should be of the same colour as the carriageway.</p> <p>The BHS acknowledge that there may be circumstances where a variation from the standard design is appropriate, and that waiting pens are not always necessary and may be considered by site.</p> <p><b>Designers Response:</b></p>

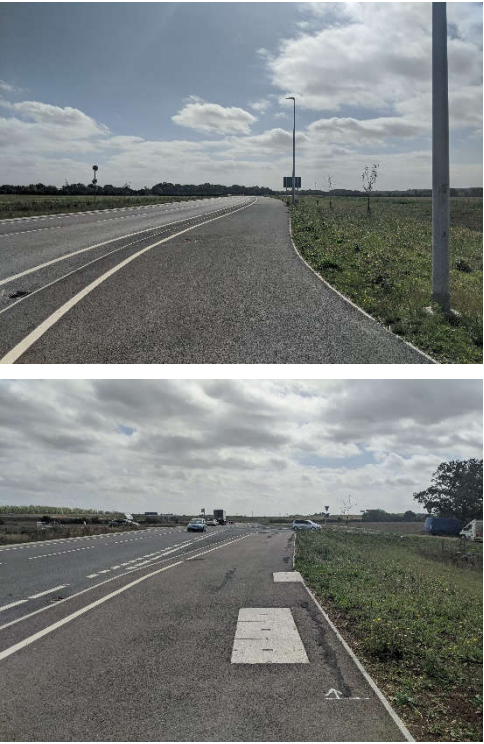
Ref.	Photos	Problem/Observation	Recommendation
S4.32

<p><u>Observation:</u> On-site observations confirm that NMU 5.14 is 4.0 m wide, and a 1.8 m separation (including a 1.0 m hardstrip), in line with guidance.</p>	<p>No recommendation.</p> <p><b>Designers Response:</b></p>

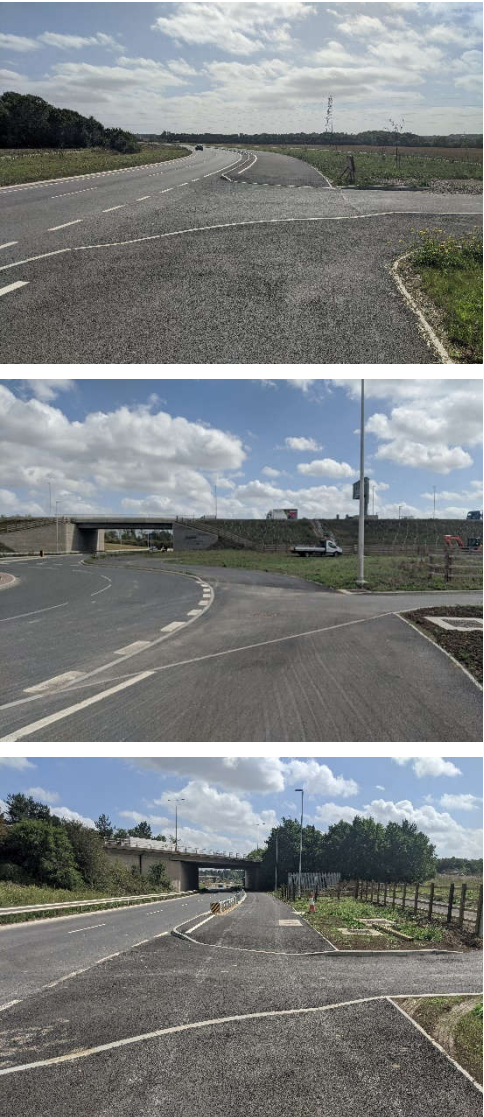
Ref.	Photos	Problem/Observation	Recommendation
S4.33

<p><u>Problem:</u> It is noted that tactile paving has not been provided at all the various side road accesses/junctions on NMU 5.14.</p>	<p>It is recommended that appropriate tactile paving and markings (TSRGD Diagram 1023B, 1003B and 1009B) are provided.</p> <p>It is recommended that the dropped kerb upstands are checked and altered, if necessary, to be no more than the permissible 6 mm.</p> <p><b>Designers Response:</b></p>

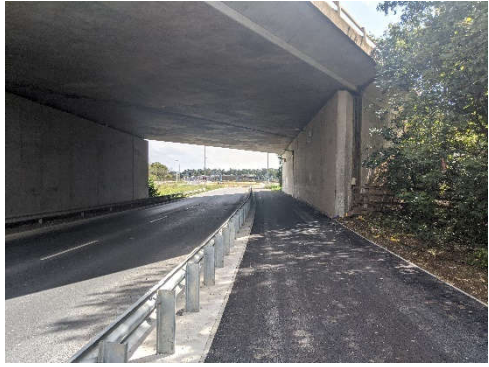
Ref.	Photos	Problem/Observation	Recommendation
S4.36

<p><u>Observation:</u> NMU 5.15, a continuation of NMU 5.14, narrows slightly where the route is straddled by the M11 to fit within the existing cross section. It is not anticipated that this will have an effect over this short distance.</p>	<p>No recommendation.</p> <p><b>Designers Response:</b></p>

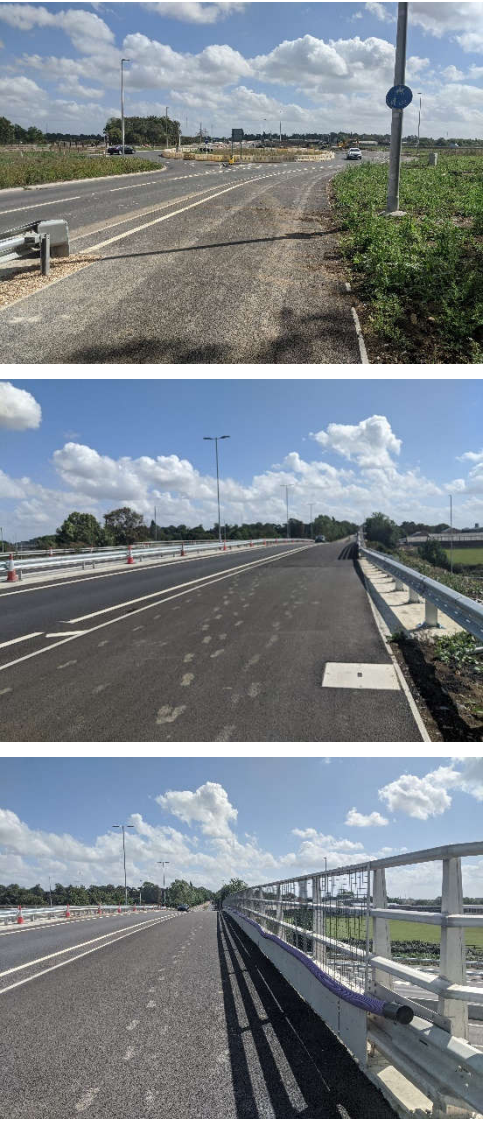
Ref.	Photos	Problem/Observation	Recommendation
S4.37

<p><u>Observation:</u> On-site observations confirm that NMU 5.16 is 4.0 m wide, and a varying separation (including a 1.0 m hardstrip).</p>	<p>No recommendation.  <b>Designers Response:</b></p>

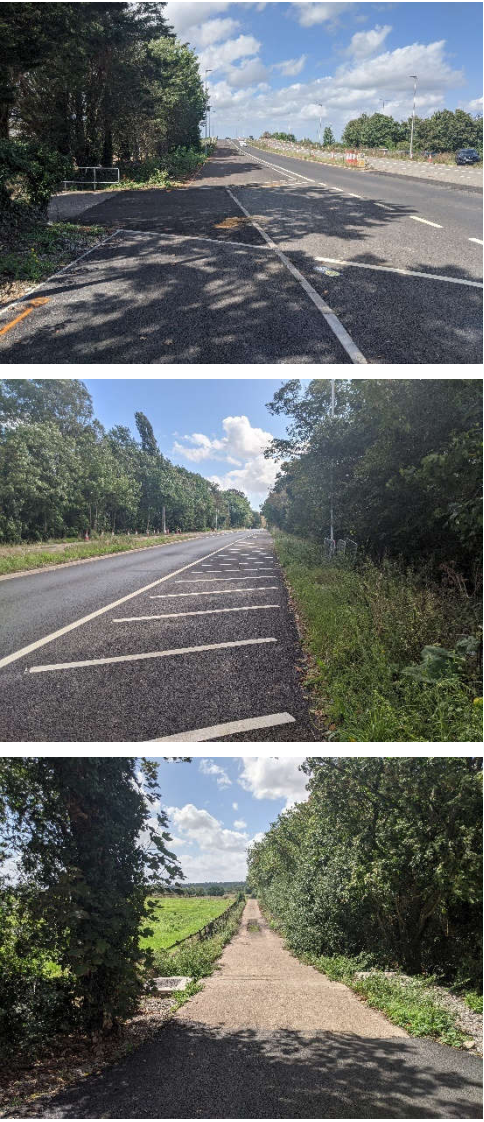
Ref.	Photos	Problem/Observation	Recommendation
S4.38

<p><u>Problem:</u> On-site observations confirm that the proposed connections to Footpath Girton 99/4 and 99/5 have not yet been constructed/completed.</p> <p>This should incorporate a Toucan crossing of the A1307, Huntingdon Road that would connect all three routes, although it is acknowledged that this is to be provided as part of the North-West Cambridge development plans.</p>	<p>It is recommended that connections with the proposed Toucan Crossing should be completed, and confirmation provided when and how this is to be achieved.</p> <p><b>Designers Response:</b></p>

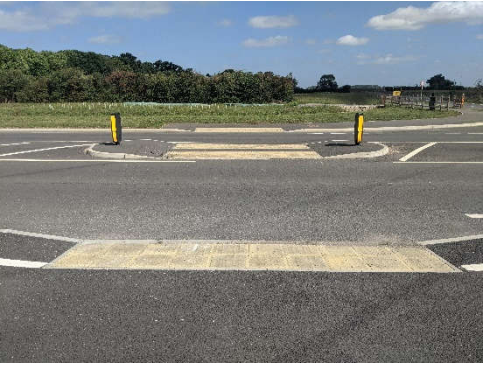
Ref.	Photos	Problem/Observation	Recommendation
S4.39

<p><u>Observation:</u> NMU route 5.17 provides a revised access to the Cambridge City Crematorium from the Local Access Road (NMU 5.14).</p> <p><u>Observation:</u> It is observed that tactile paving has been provided for users to cross between NMU 5.14 and NMU 5.17.</p> <p><u>Observation:</u> It is noted that the appropriate markings for pedestrian and cycle users has not been provided.</p>	<p>It is recommended that the dropped kerb upstands are checked and altered to be no more than the permissible 6 mm.</p> <p>It is recommended that the appropriate markings (TSRGD Diagram 1023B, 1003B and 1009B) are provided at the dropped kerb crossings intended for use by pedestrian and cycle users.</p> <p><b>Designers Response:</b></p>

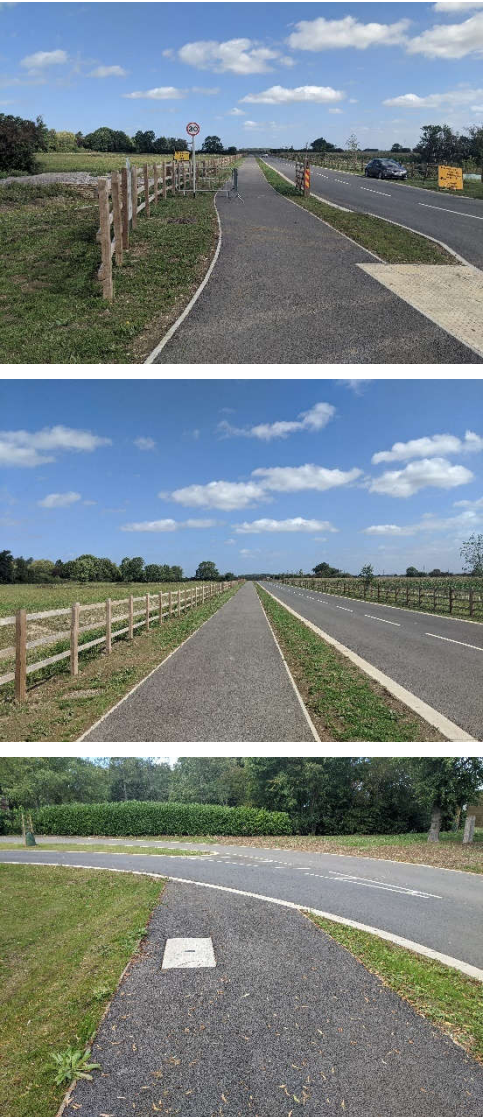
Ref.	Photos	Problem/Observation	Recommendation
S4.40

<p><u>Observation:</u> On-site observations confirm that NMU 5.17 is 2.2 m wide, with a 0.8 m separation.</p> <p>It is noted that NMU 5.17 was always intended to be a 2.0 m wide shared footway/cycleway, although it is noted that this does not conform to current standards.</p> <p><u>Problem:</u> NMU 5.17 was not observed as being signed.</p>	<p>It is recommended that appropriate signs are erected that advise that this is a route for use by pedal cycles and pedestrians only (TSRGD Diagram 956).</p> <p>It is also recommended that appropriate signage is erected directing users to the Crematorium, and similarly directing users coming from the Crematorium.</p> <p>It is recommended that appropriate tactile paving, markings (TSRGD Diagram 1023B, 1003B and 1009B) and signage are provided for users at the termination of the shared path where it intersects with the Crematorium access road.</p> <p><b>Designers Response:</b></p>

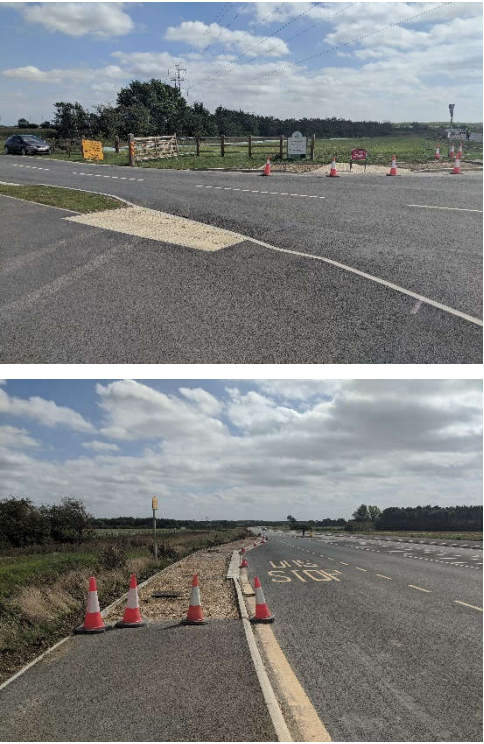
Ref.	Photos	Problem/Observation	Recommendation
S4.41

<p><u>Observation:</u> It is observed that tactile paving has been provided for users to cross between NMU 5.17 and the eastbound bus stop, and between the eastbound bus stop and NMU 5.14.</p> <p><u>Observation:</u> It is noted that the appropriate markings for pedestrian and cycle users has not been provided.</p>	<p>It is recommended that the dropped kerb upstands are checked and altered to be no more than the permissible 6 mm.</p> <p>It is recommended that the appropriate markings (TSRGD Diagram 1023B, 1003B and 1009B) are provided at the dropped kerb crossings intended for use by pedestrian and cycle users.</p> <p><b>Designers Response:</b></p>

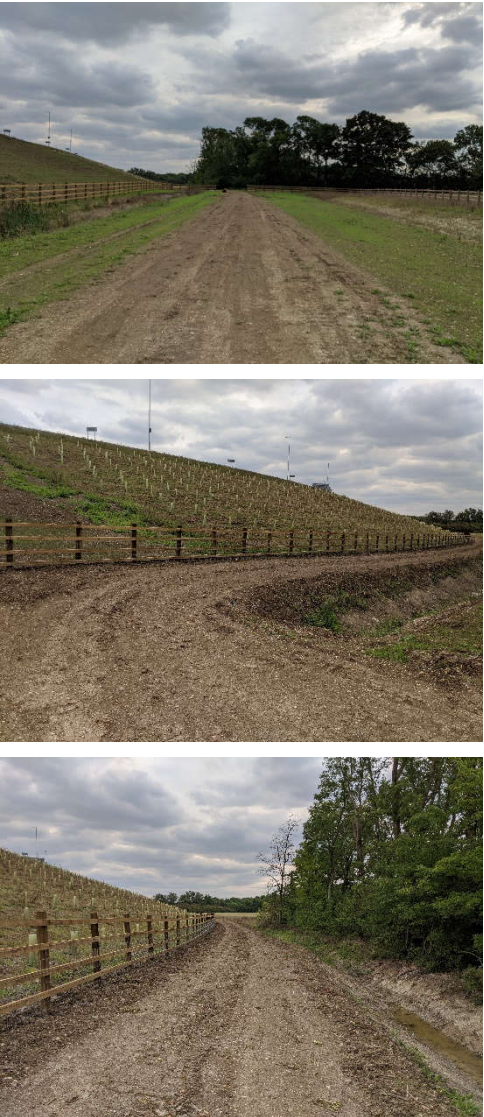
Ref.	Photos	Problem/Observation	Recommendation
S4.42

<p><u>Observation:</u> It was not possible to make the appropriate observations for NMU 5.18 as the route had not been completed.</p> <p>It is noted that this is to be a 4.5 m wide bridleway.</p>	<p>No recommendation.</p> <p><b>Designers Response:</b></p>
