# A14 Cambridge to Huntingdon Improvement Scheme

## POST CONSTRUCTION AUDIT - AUGUST 2020

PROJECT NUMBER: HA528983			DOCUMENT REF: HA528983-ACJV-HGN-SG_XX-RP-C-0003			
P01.1	First Issue	AKAK				
Revision	Purpose Description	Originated	Checked	Reviewed	Authorised	Date

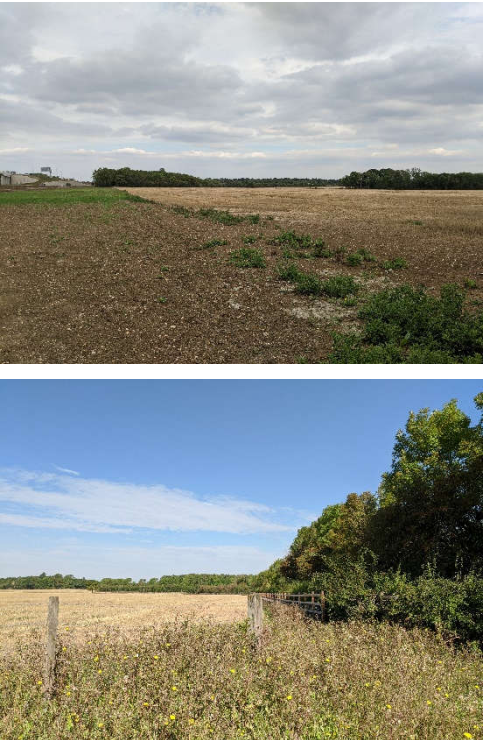
Ref.	Photos	Problem/Observation	Recommendation
S4.43

<p><u>Observation:</u> It was not possible to make the appropriate observations for NMU 5.19 as the route had not been constructed. Currently just fields.</p> <p>It is noted that this is to be a 4.5 m wide bridleway.</p>	<p>No recommendation.</p> <p><b>Designers Response:</b></p>

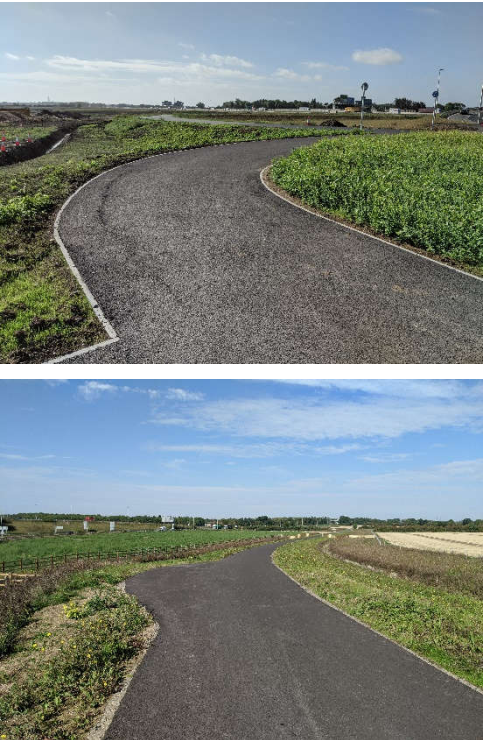
Ref.	Photos	Problem/Observation	Recommendation
S4.44

The top photograph shows a gravel path curving to the right, bordered by a white line on the left and green vegetation on the right. The bottom photograph shows a similar gravel path curving to the right, with a grassy area on the left and a field in the background.	<p><u>Observation:</u> On-site observations confirm that NMU 5.20 is 3.2 m to 3.7 m wide and is a shared bridleway/ accommodation track.</p>	<p>No recommendation.</p> <p><b>Designers Response:</b></p>

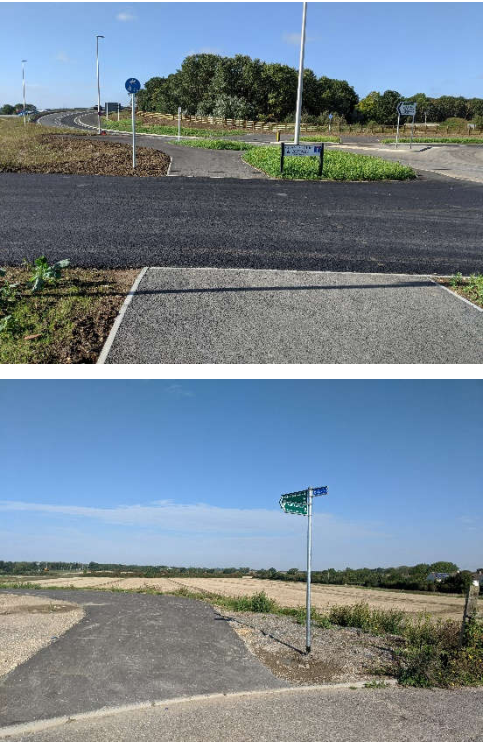
Ref.	Photos	Problem/Observation	Recommendation
S4.45

<p><u>Observation:</u> NMU 5.20 was observed as signed as a public bridleway at the Girton Accommodatrion Bridge side, but no signage observed at Oakington Road Roundabout.</p> <p>Drivers and other users may be confused when encountering each other.</p>	<p>It is recommended that consideration is given to designating this a 'quiet lane' and utilising <i>TSRGD</i> Diagram 884 and 885 – designated under section 268 of the Transport Act 2000.</p> <p>Additionally, it is recommended that consideration is given to the best means of reiterating that this section of the route is shared space.</p> <p><b>Designers Response:</b></p>
S4.46

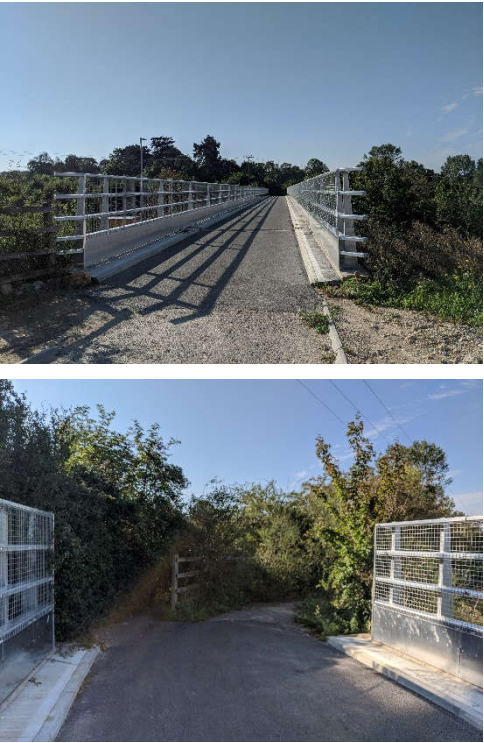
Ref.	Photos	Problem/Observation	Recommendation
S4.47

<p><u>Observation:</u> It was observed that the width of NMU 5.22 is 3.5 m between kerbs.</p> <p><u>Observation:</u> It is observed that the parapet heights are 1.8 m high, the desirable minimum parapet height where equestrians are to be accommodated.</p> <p>However, it was observed that the parapet did not include the appropriate infill on the parapet to obscure a horse's view of traffic passing beneath the bridge.</p>	<p>The proposed Girton Accommodation Bridge was proposed to be 4.5 m wide with a 1.8 m parapet and is specified as a bridleway in the Design Input Statement.</p> <p>It is recommended that an infill is installed on the parapets i.e. a solid panelling fixed to the parapet railings. The British Horse Society guidance advises that the height of the infill should be 1.0 m with an uplift of 25 mm.</p> <p><b>Designers Response:</b></p>

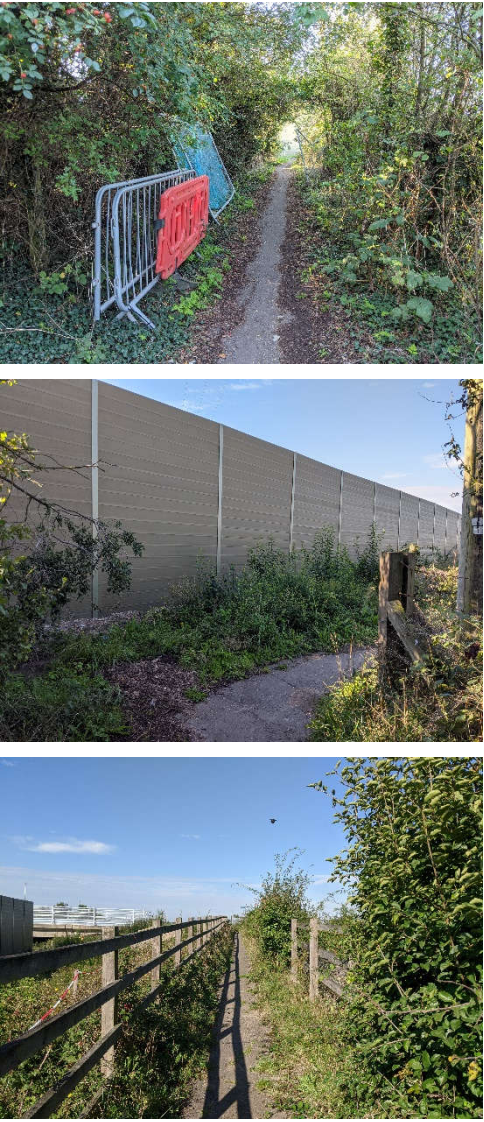
Ref.	Photos	Problem/Observation	Recommendation
S4.48

<p>The first photo shows a narrow dirt path through dense green foliage, with a blue and red metal barrier on the left. The second photo shows a concrete wall with a path leading to it. The third photo shows a path with a wooden fence on the left and dense vegetation on the right.</p>	<p><u>Observation:</u> It was observed that there has been no change to the existing path. It is noted that this is to convert the existing footpath to a shared pedestrian/ cycle track 2.5 m wide.</p>	<p>Confirmation is required on what changes are still to be made.</p> <p><b>Designers Response:</b></p>

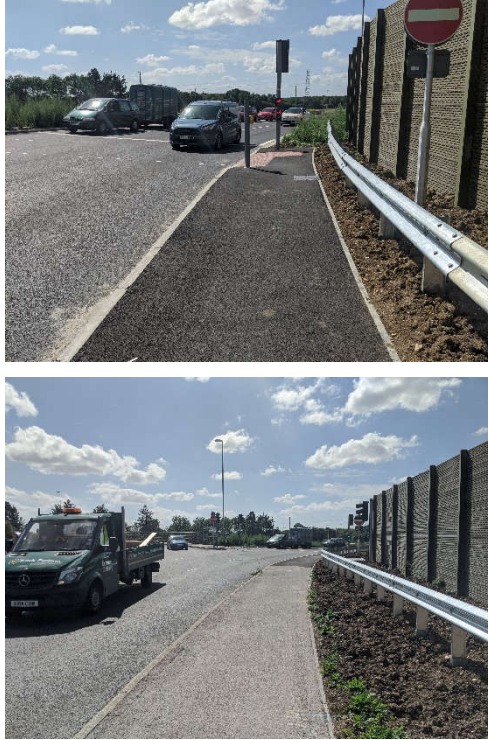
Ref.	Photos	Problem/Observation	Recommendation
S5.1

<p><u>Problem:</u> On-site observations confirm that the width of NMU 6.1 on the western side of Histon Junction has not increased beyond the 'existing' width, with no separation.</p> <p>It is anticipated that this route could experience significant NMU flows based on the recorded flows on the B1049, south of Histon Junction.</p>	<p>It is recommended that confirmation is provided on the reasons that the width of this route could not be increased to the expected 3.0 m width with the appropriate separation between the route and the carriageway (1.5 m for a 40mph road as recommended in guidance).</p> <p><b>Designers Response:</b></p>
