## Understanding river channel sensitivity to geomorphological changes

Literature review and understanding factors that influence river  
channel change

FRS17183/R1

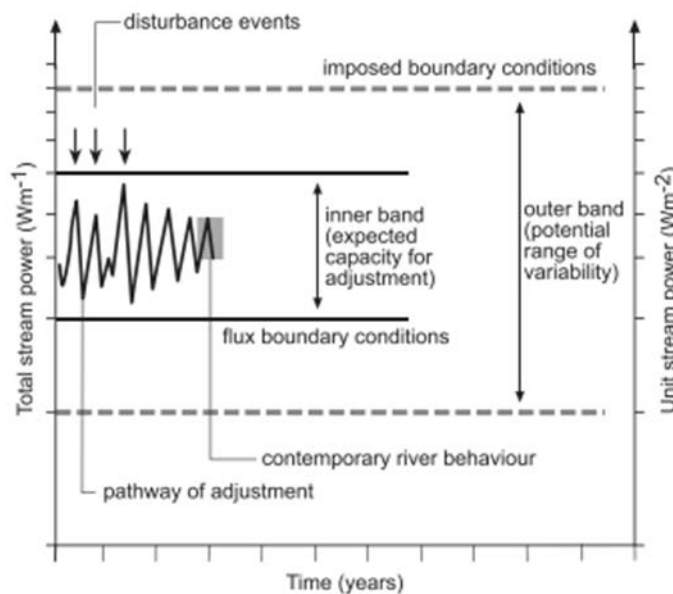
**Figure 2-2 Basic river evolution diagram, from Brierley and Fryirs (2016)**

Brierley and Fryirs (2005, 2016) present the river evolution diagram as a way of predicting future morphological change within a given fluvial system, based on stream power values (Figure 2.2). The dashed lines in Figure 2.2 represent controls imposed by geology (such as upstream catchment area, slope and valley confinement), which set boundaries on the range of total stream power values that do not change over time, and define the potential range of variability. This range bounds the types of channel morphologies that are able to form in that particular catchment context and valley setting. An inner band within that outer band reflects how the river behaves through minor adjustments to the channel and flood plain that occur in response to normal variability in stream power (that is, through water, sediment and vegetation interactions), defining the 'expected capacity for adjustment'. The pathway of adjustment within the expected capacity for adjustment reflects river behaviour according to a certain river type, which will fluctuate over time, dependent on prevailing influences of geology, hydrology and biology, and the nature of disturbance events. During and following disturbance, the amplitude and trajectory of the pathway of adjustment will be very different for different river types.

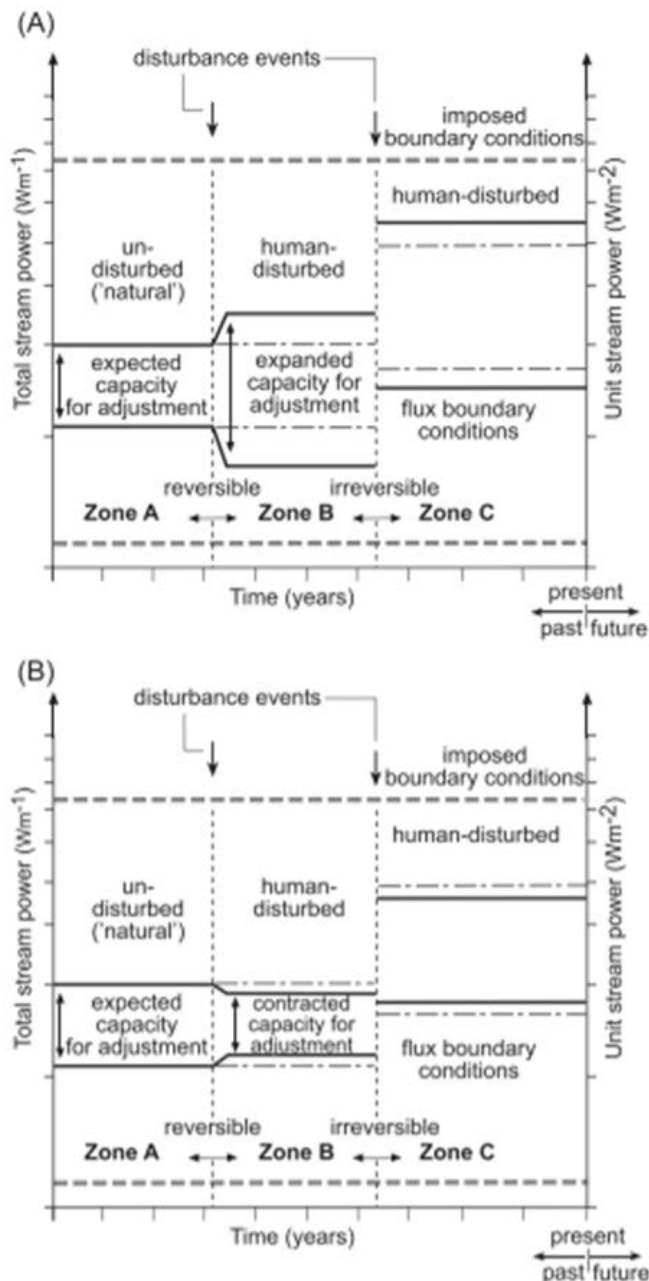
**Figure 2-3 River evolution diagram showing river response to disturbance events (a) disturbance events that expand the capacity for adjustment, (b) disturbance events that contract the capacity for adjustment, from Brierley and Fryirs (2016)**

Figure 2.3 uses the river evolution diagram to demonstrate the response of a river to disturbance events. An initial disturbance event may cause behavioural changes in a fluvial system that do not amount to a change in river type (shift from zone A to zone B). These changes may expand the expected capacity for adjustment (Figure 2.3a), or

contract it (Figure 2.3b). Structural and functional attributes of the river reach may be altered, but key defining attributes of the river type are maintained and, essentially, these behavioural adjustments are reversible. However, the initial disturbance event may impact the way in which the river responds to subsequent disturbances, by moving the river closer to or further away from a threshold of significant change, which increases or reduces its potential to change, respectively. In response to a subsequent disturbance, river change occurs, reflected by a shift in the position of the inner band from zones A or B, to zone C. This change is irreversible, as the river has changed its geomorphic type and is now in a different process domain, with altered stream processes, morphologies and capacity for adjustment.

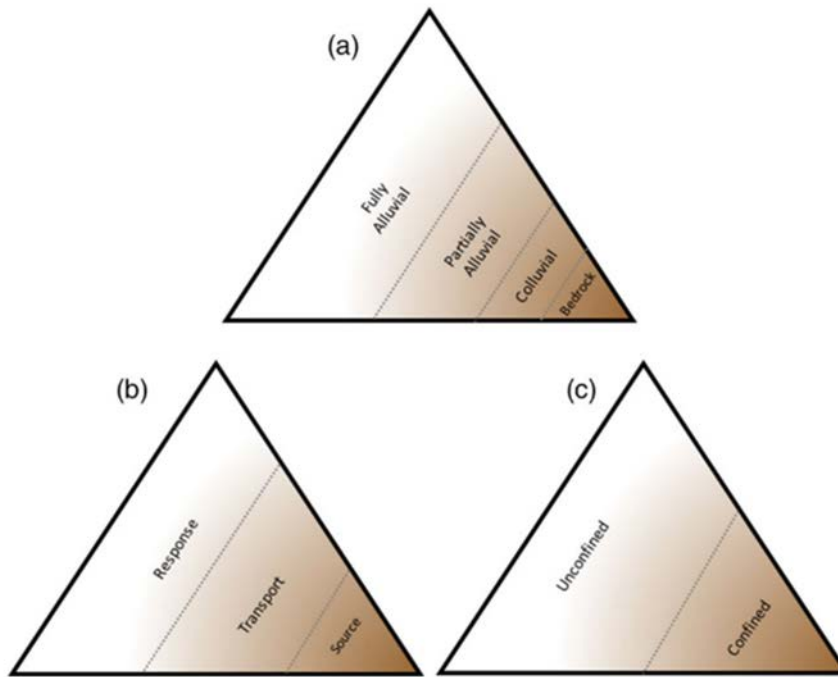
**Figure 2-5 The decreasing influence of geological factors with distance from the 'geology' corner in the stream evolution triangle, from Castro and Thorne (2019)**

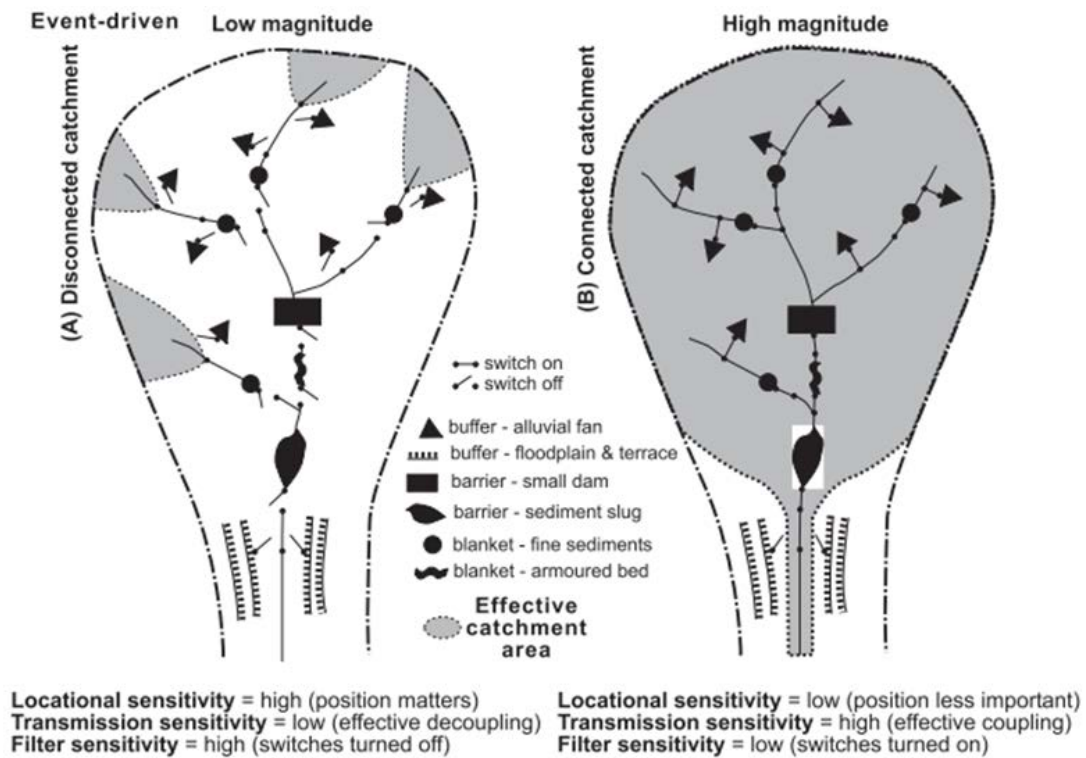
**Figure 2-9 Catchment scale (dis)connectivity showing (a) a disconnected and (b) a connected catchment, from Fryirs (2017)**

Fryirs (2017) presents a conceptual model at the catchment scale to represent how the spatial arrangement of blockages such as sediment slugs and dams in relation to the type of flood event can determine the amount of 'effective' catchment in operation (that is the 'connected' catchment that can contribute sediment to the 'catchment conveyor belt' (Figure 2.9). In Figure 2.9a, blockages throughout the catchment reduce catchment connectivity and the majority of the sediment cascade is inactive (switches off). This causes the 'effective catchment area' to be low. This is likely to represent a system experiencing high frequency, low magnitude flood events, which limit slope erosion and subsequent fluvial reworking. In Figure 2.9 (b), the catchment is highly connected with an active sediment cascade and large effective catchment area. This situation is likely to occur during a low frequency, high magnitude event, where existing blockages are breached and reworked.

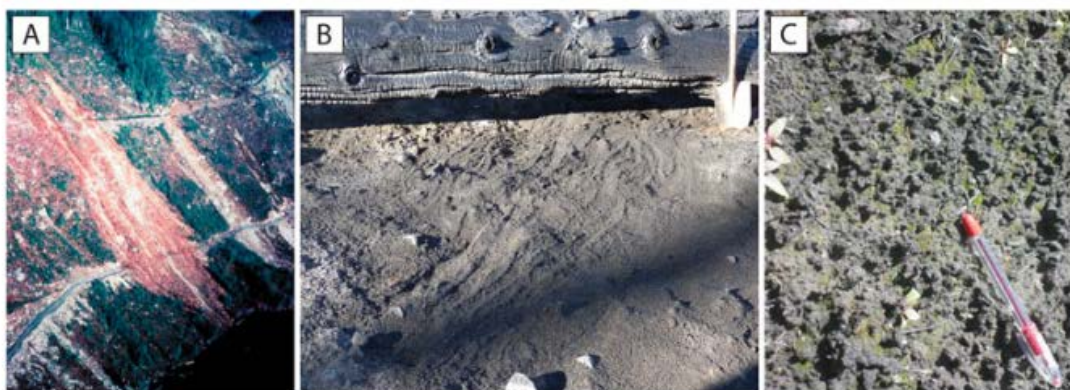
**Figure 2-15 (a) inappropriate forest management aggravating erosion, (b) in burned areas, reduced soil infiltration, water repellency, removal of surface cover and soil sealing causes increased run-off, (c) erosion on cleared forest floor, from Stoffel and Wildford (2011)**

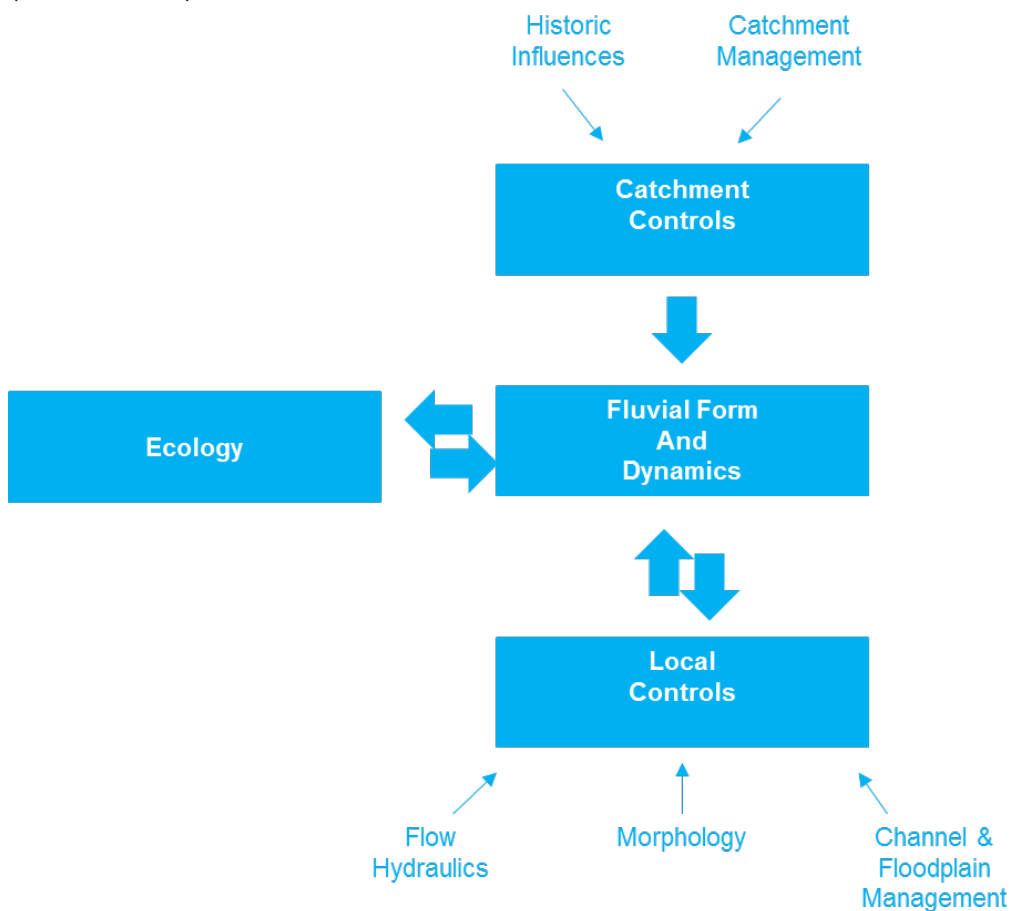
**Figure 2-16 Principal controls on the character and dynamics of fluvial systems**

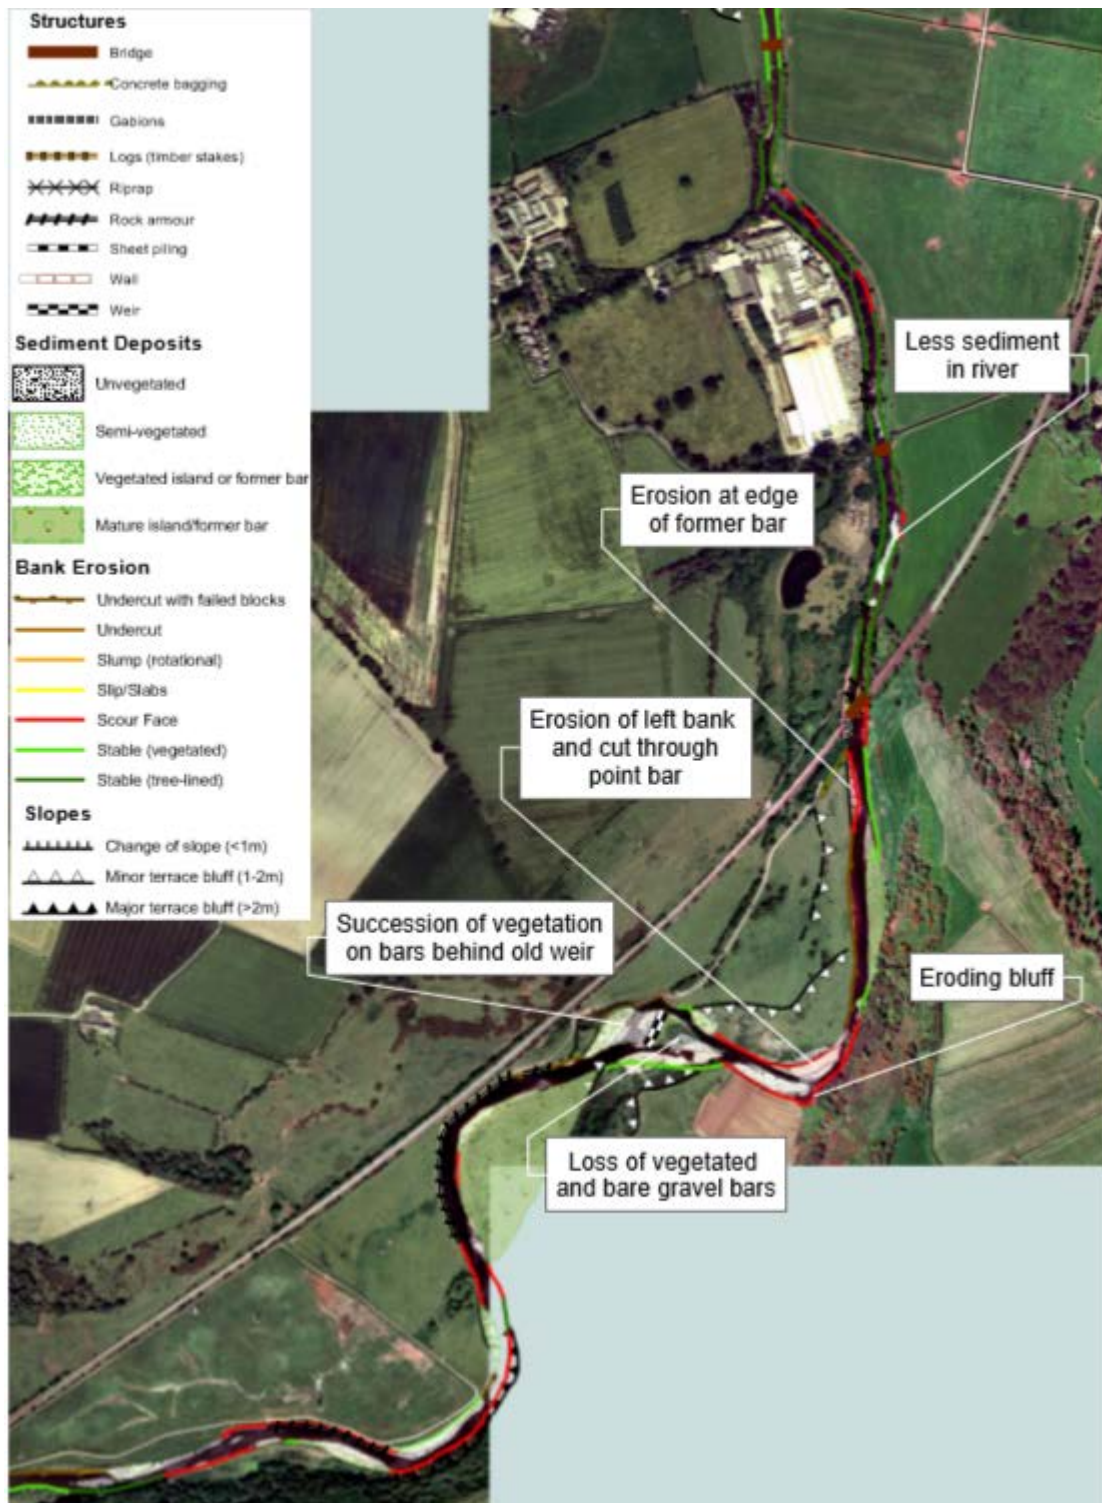
Figure 3-3 Post flood (2005) change at the former Cummersdale weir, from Jacobs (2007)

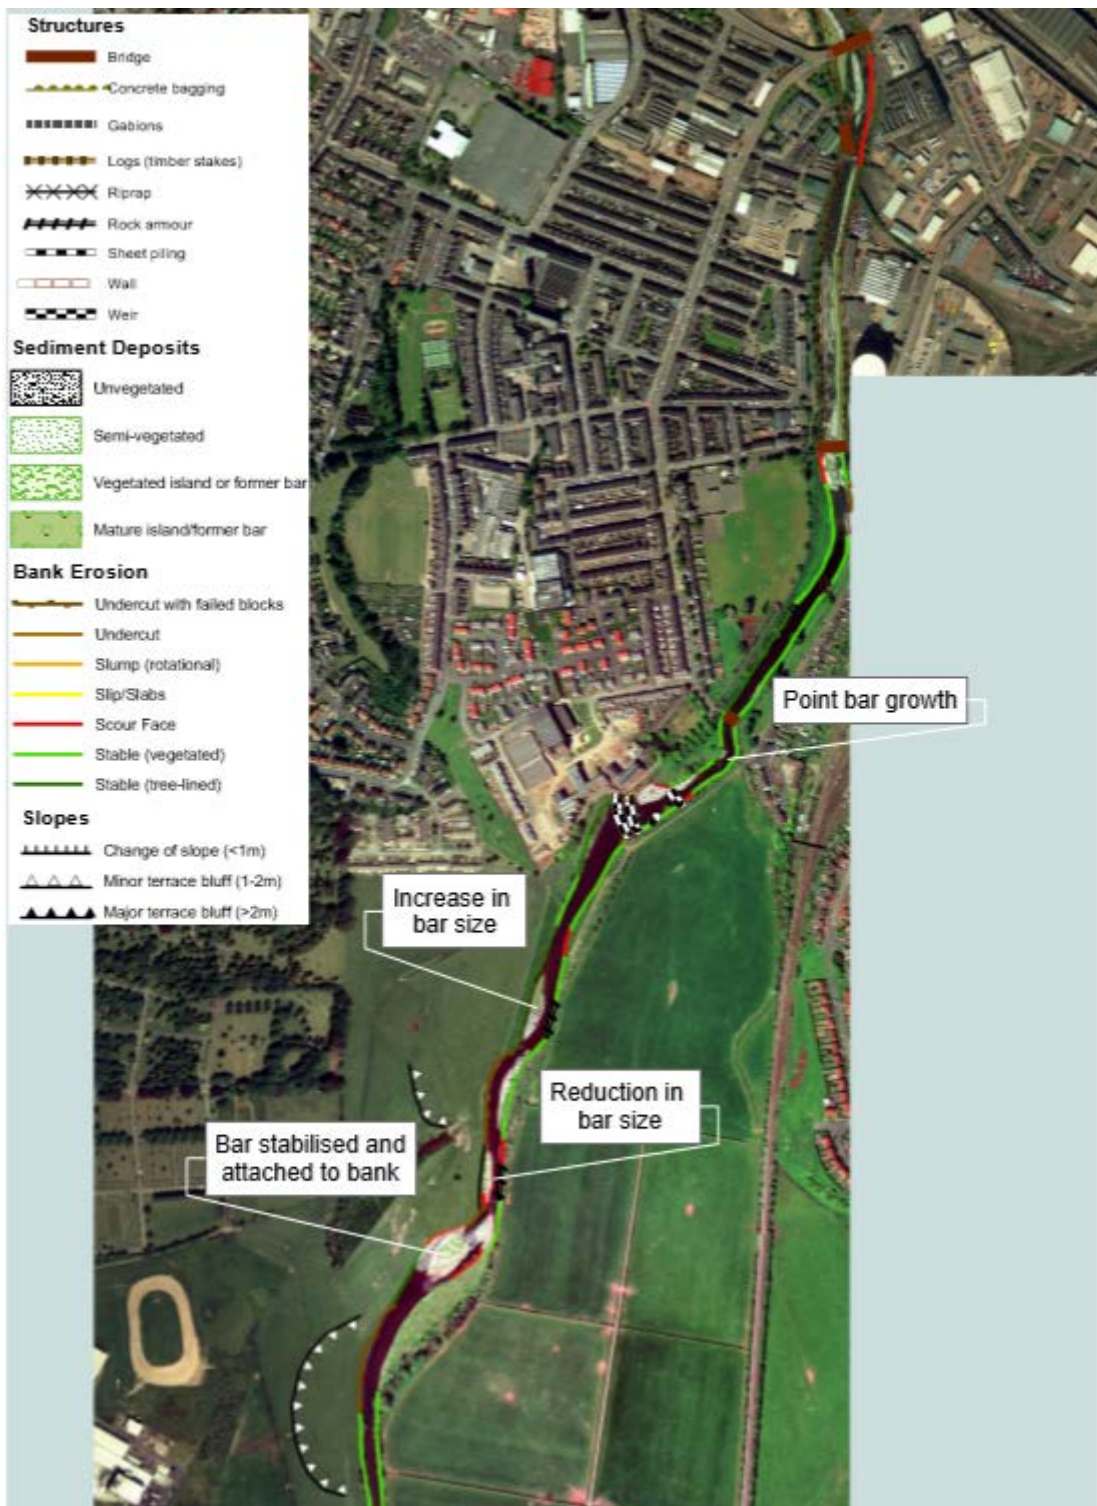
Figure 3-4 Post flood (2005) change upstream of Holme Head weir, from Jacobs (2007)

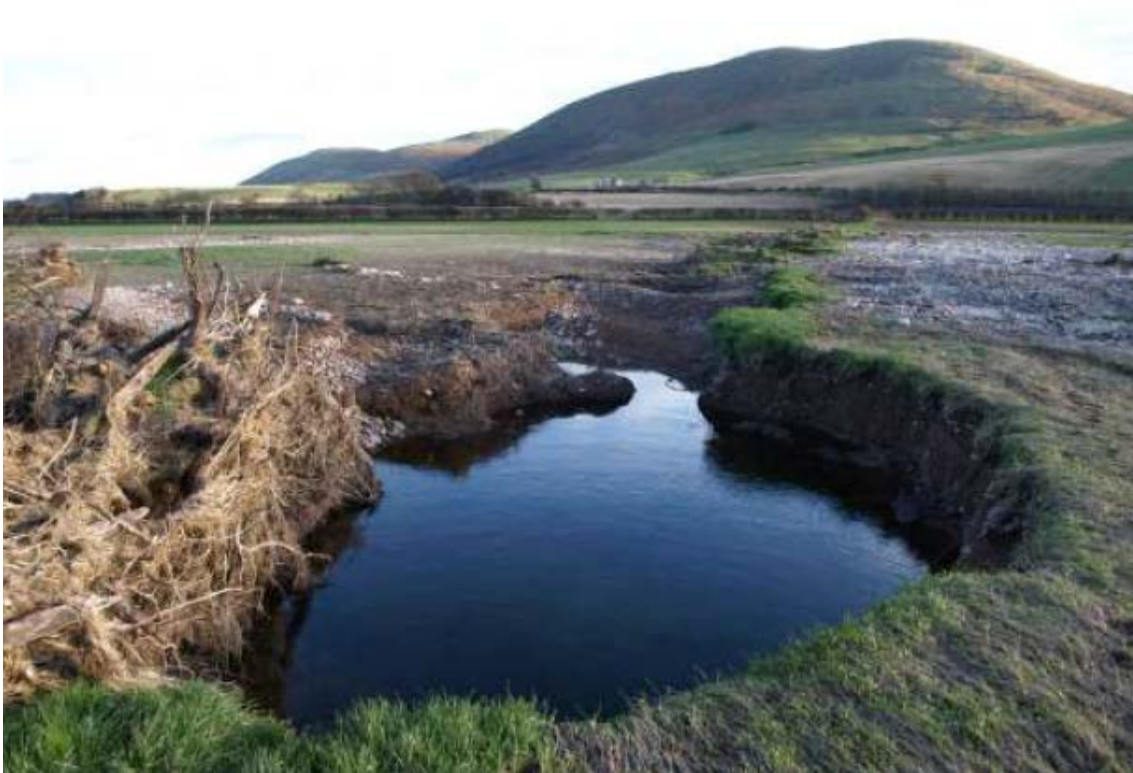
**Figure 3-5 Flood scour and gravel deposition associated with overflow of the River Glen near Kirknewton, from Oughton and others (2009)**

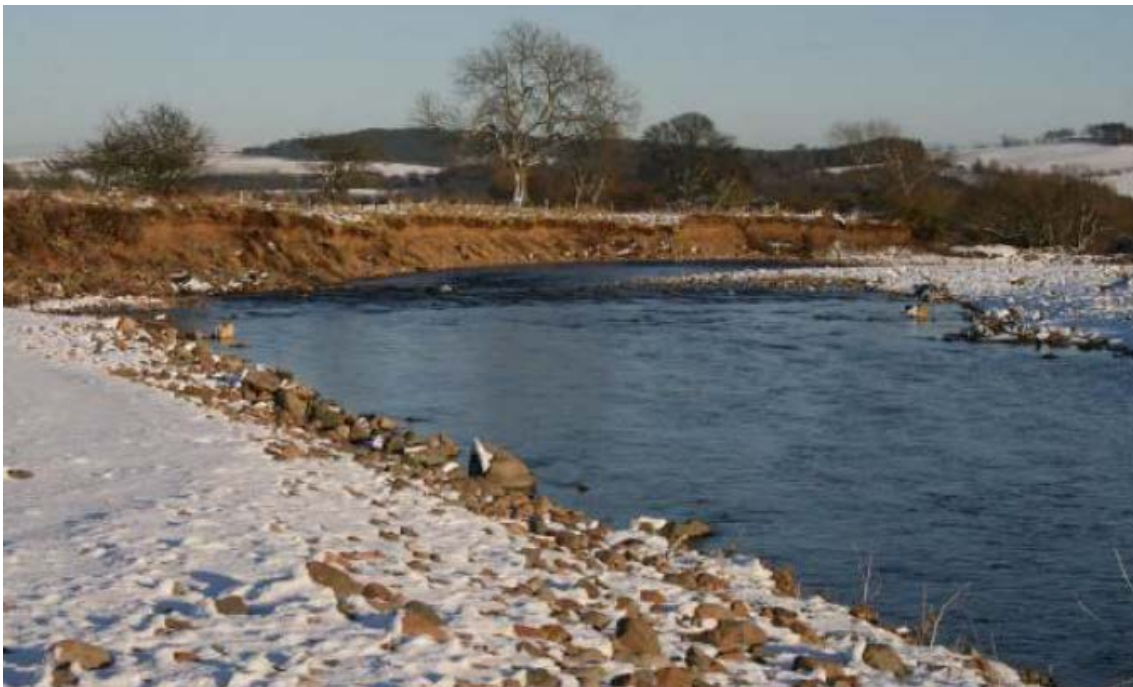
**Figure 3-6 Site of major bank erosion during the September 2008 flood – north bank of the Breamish downstream of Brandon Ford, from Oughton and others (2009)**

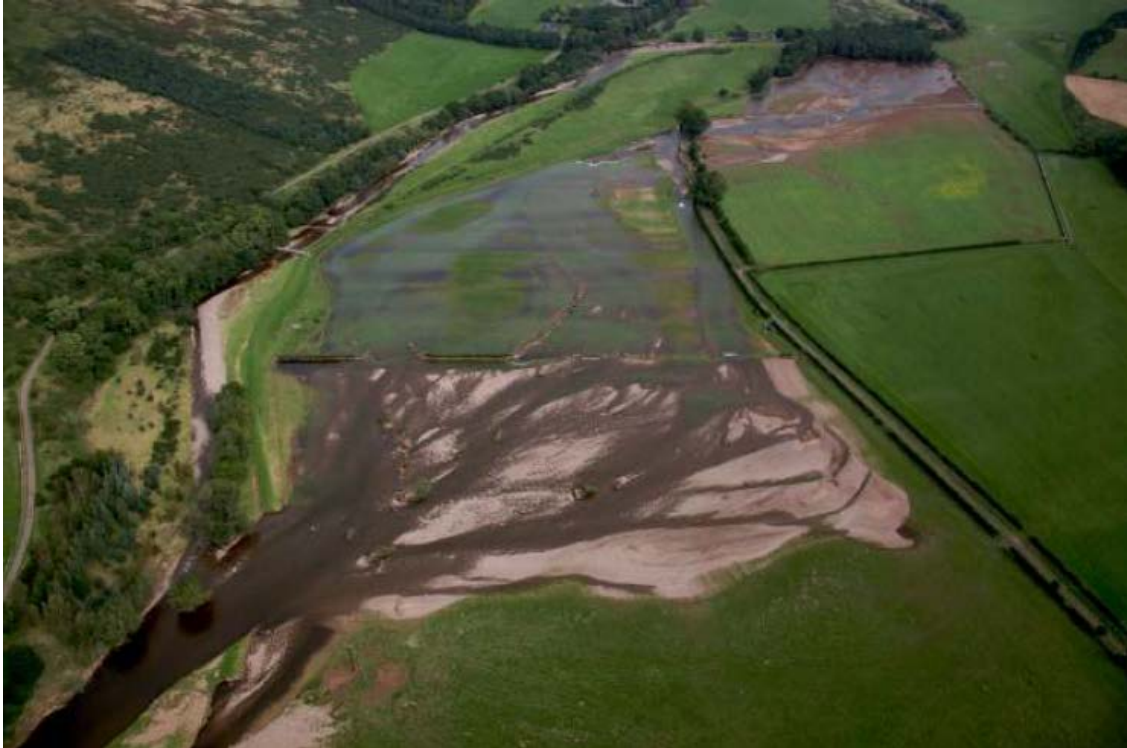
**Figure 3-7 Embankment breach and changed course of the River Glen at Kirknewton (before reinstatement of channel in pre-event course to left, from Oughton and others (2009))**

embankment, creating a crevasse-splay depositional feature on the flood plain (Figure 3.7). Floodwaters flowed in palaeochannels on the flood plain, flowing back into the main channel 900 m downstream near Lanton. In Figure 3.7, the intact embankment can be seen to prevent overbank flow from returning to the main channel in the next field downstream of the breach. Instead, flood water continued along the flood plain for a much greater distance, artificially extending the scale of the morphological response.

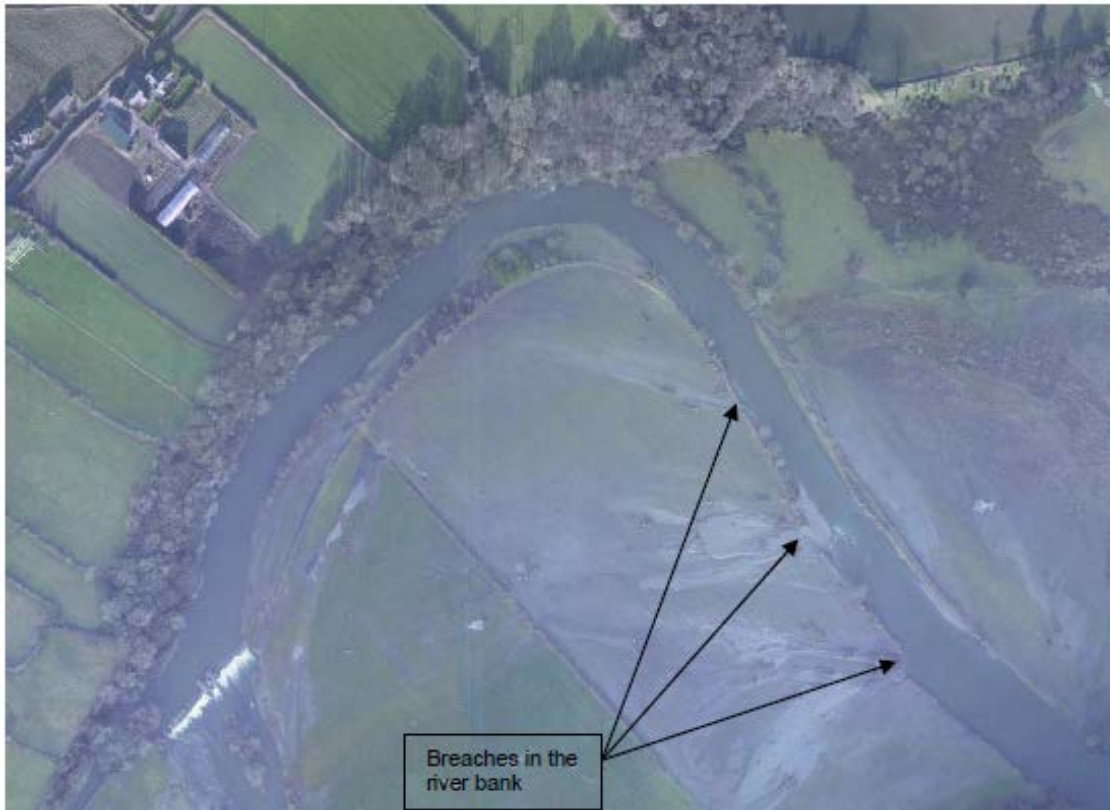
**Figure 3-9 Aerial photograph of the Stainburn Hall Farm site showing breaches in the left bank of the river at the upstream end of the site and coarse sediment splays radiating out from these breaches into the flood plain. Flow is from left to right in the photograph, from Jacobs (2010)**

The report concludes that the bank and flood plain erosion appears to have been caused by flow going out of bank in those locations and being routed across the neck of the large bend in the river. The main line of flow during the peak of the flood is almost perpendicular to the channel where the river crosses the valley floor from the left to the right valley side. The flood flow route could be natural or at least distorted, and possibly caused by human infrastructure.

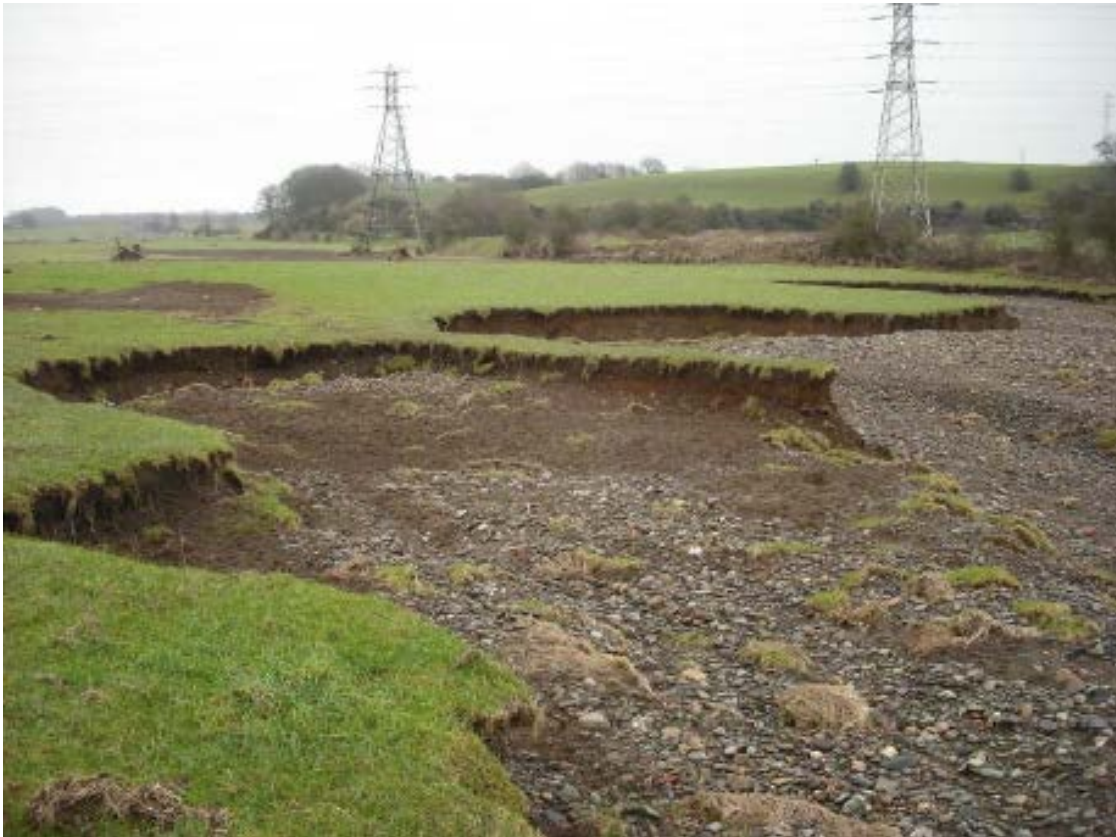
**Figure 3-10 Scars in the flood plain at the downstream end of the Stainburn Hall site, which reflect the up-flow migration of knickpoints, originating at the river bank, during the flood, from Jacobs (2010)**

bridge. Flow crossing the flood plain was deflected by the embankment of the former railway line and forced back into the channel. As the flow dropped back into the channel, locally high velocities appear to have been generated, initiating erosion of the river bank and the formation of several knickpoints, which retreated in an up-flow direction into the flood plain.

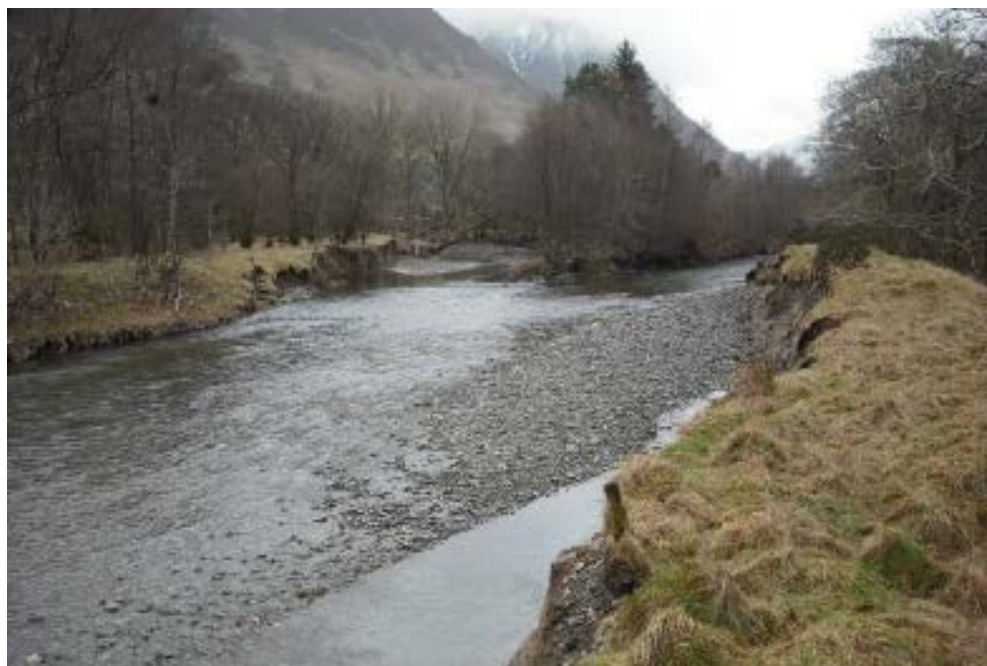
**Figure 3-12 View looking upstream at the upper end of the Brook Farm site. Erosion is visible along the left and right banks, from Jacobs (2010) 2015 to 2016 flood event**

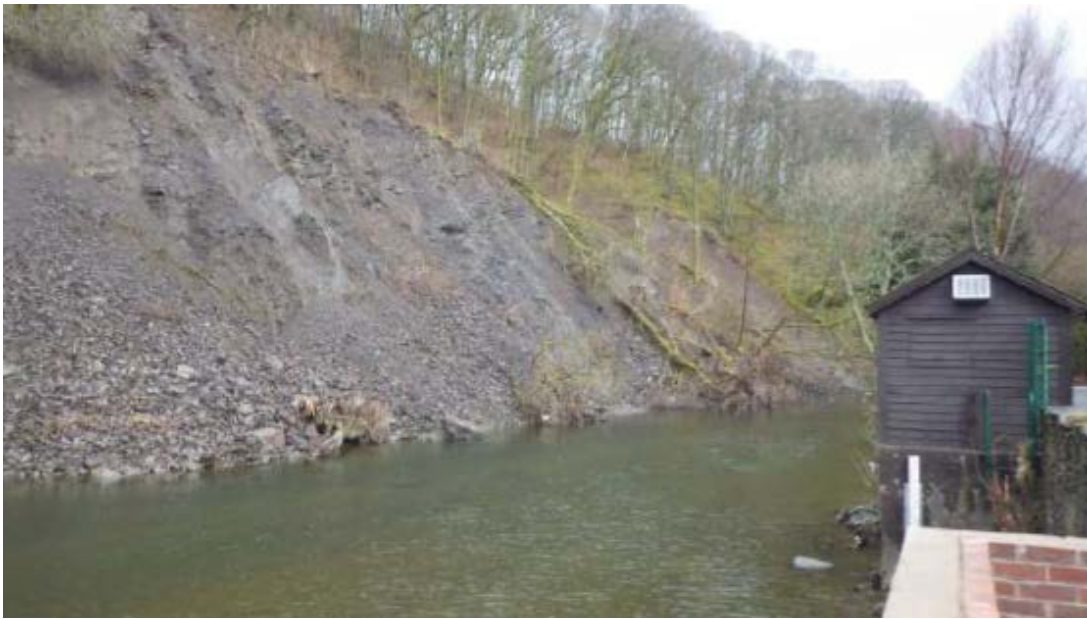
**Figure 3-15 Valley side erosion on the right bank, adjacent to the ‘Greta at Low Briery’ gauging station, from Wishart (2018)**

Wishart (2018) also suggests that the severity of erosion along the right bank in this reach may also reflect the supply of sediment from upstream. A large valley side failure occurred immediately upstream of this reach. This failure is likely to have occurred rapidly, as it was associated with the collapse of the weir, and would have led to a sudden increase in the volume of the flood flow due to the rapid addition of a massive amount of sediment, debris and water.

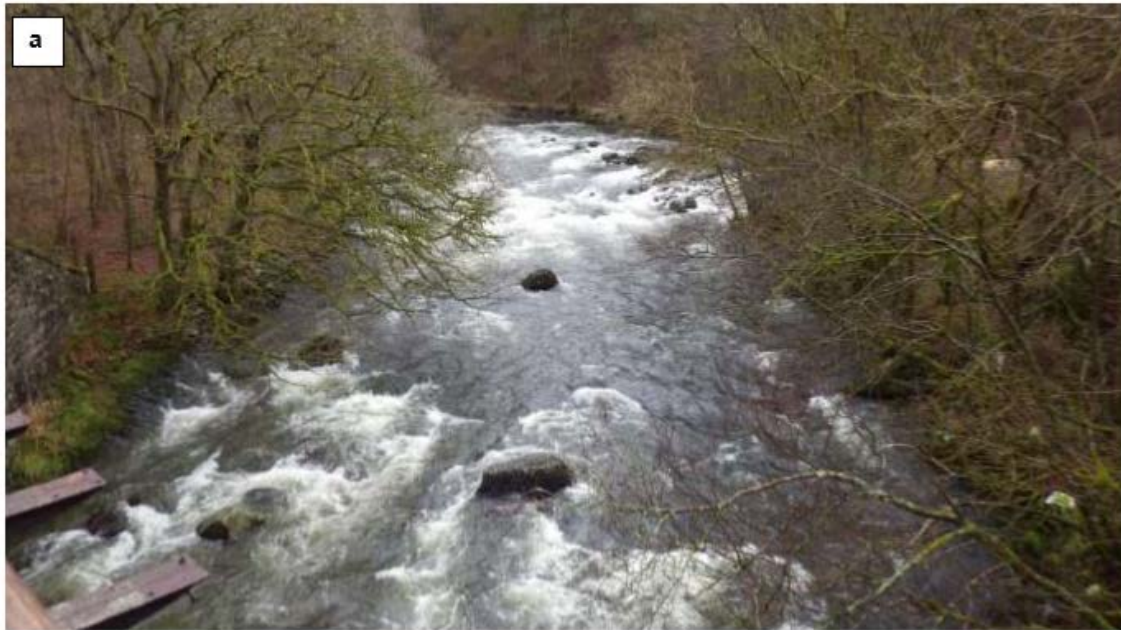
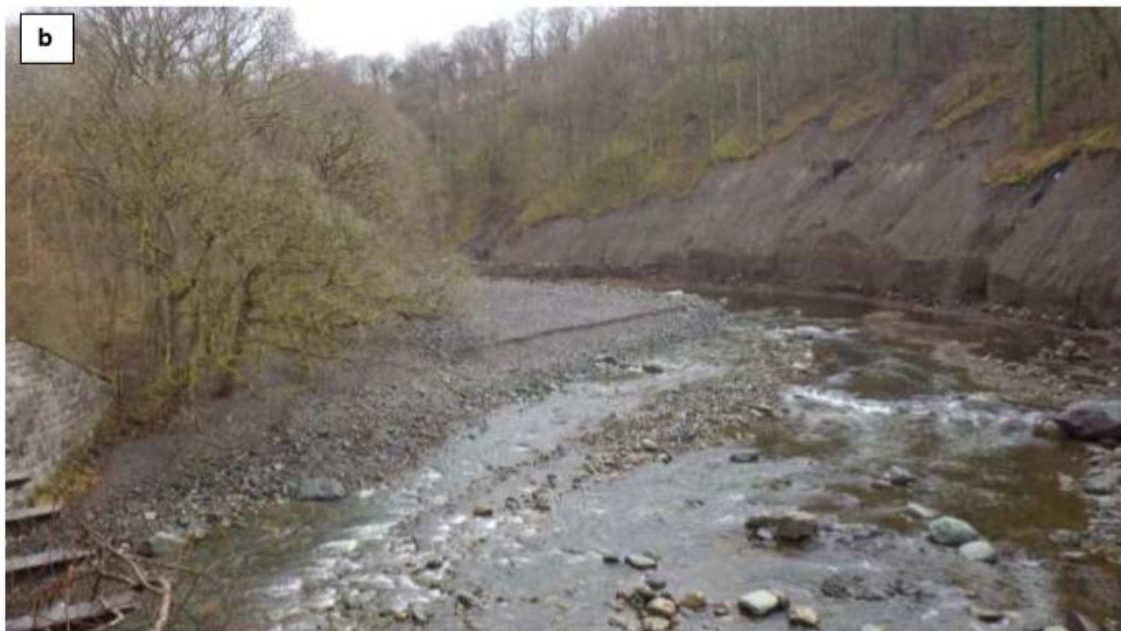
**Figure 3-16 Views of the weir site taken (a) before the flood in 2014 (18-02-2014) and (b) following the flood in 2016 (24-03-2016), from Wishart (2018)**

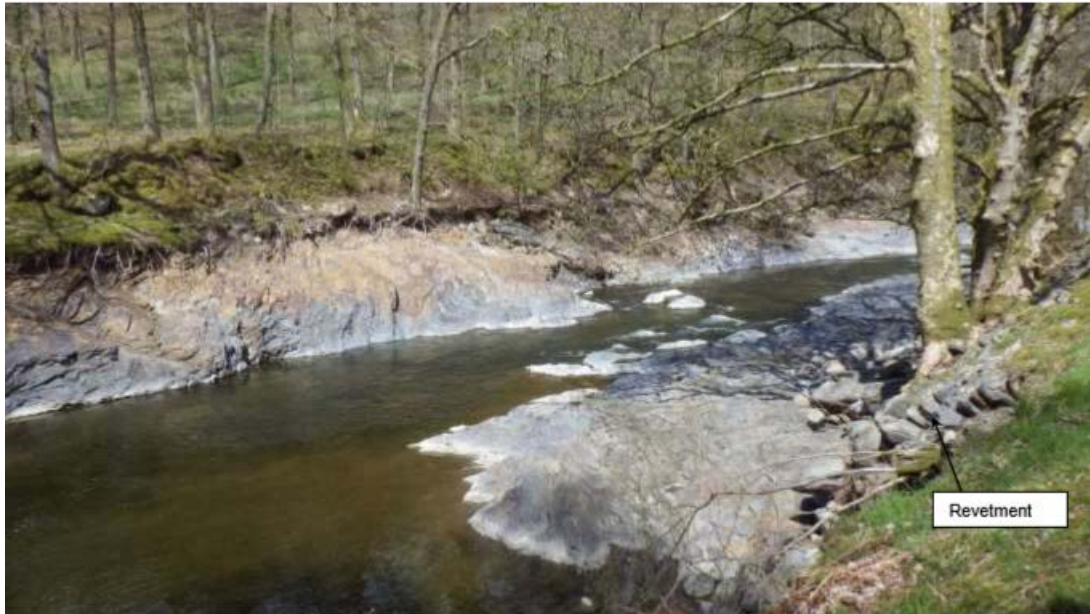
**Figure 3-17 Photograph illustrating the removal of the river bed in the upper half of reach 4, from Wishart (2018)**

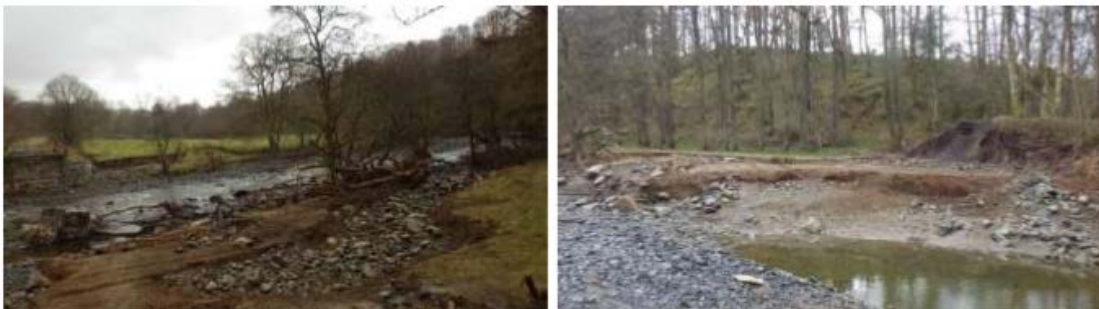
**Figure 3-18 Photographs illustrating the erosion of the right bank leading to erosion of the flood plain and the removal of a sizeable chunk of the railway embankment, from Wishart (2018)**

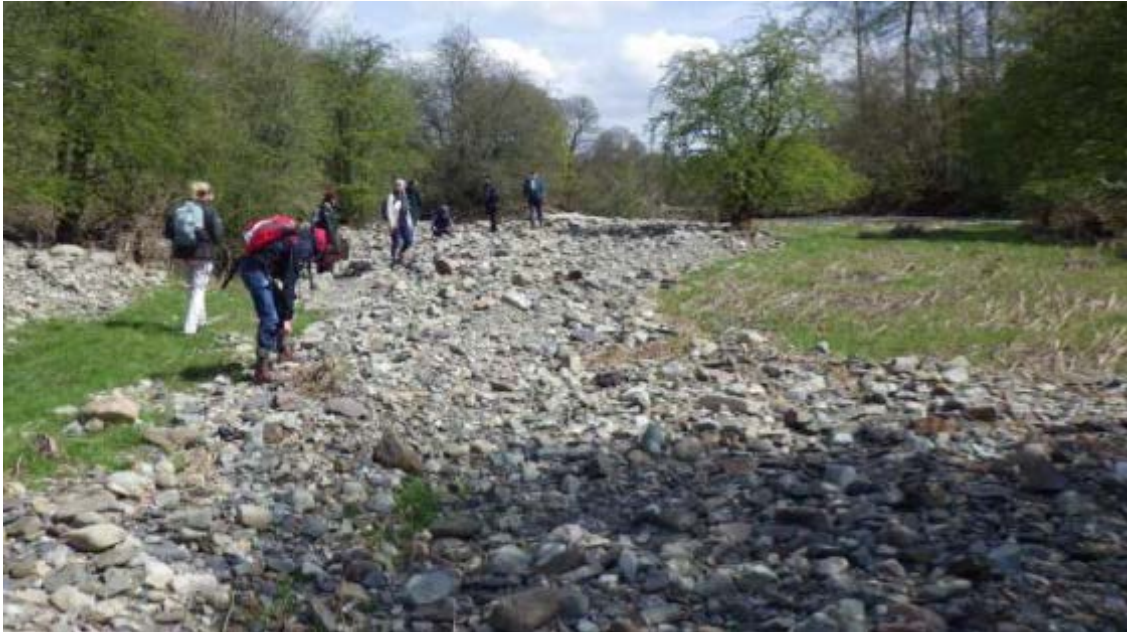
**Figure 3-19 Linear ridge of sediment deposited on the flood plain, from Wishart (2018)**

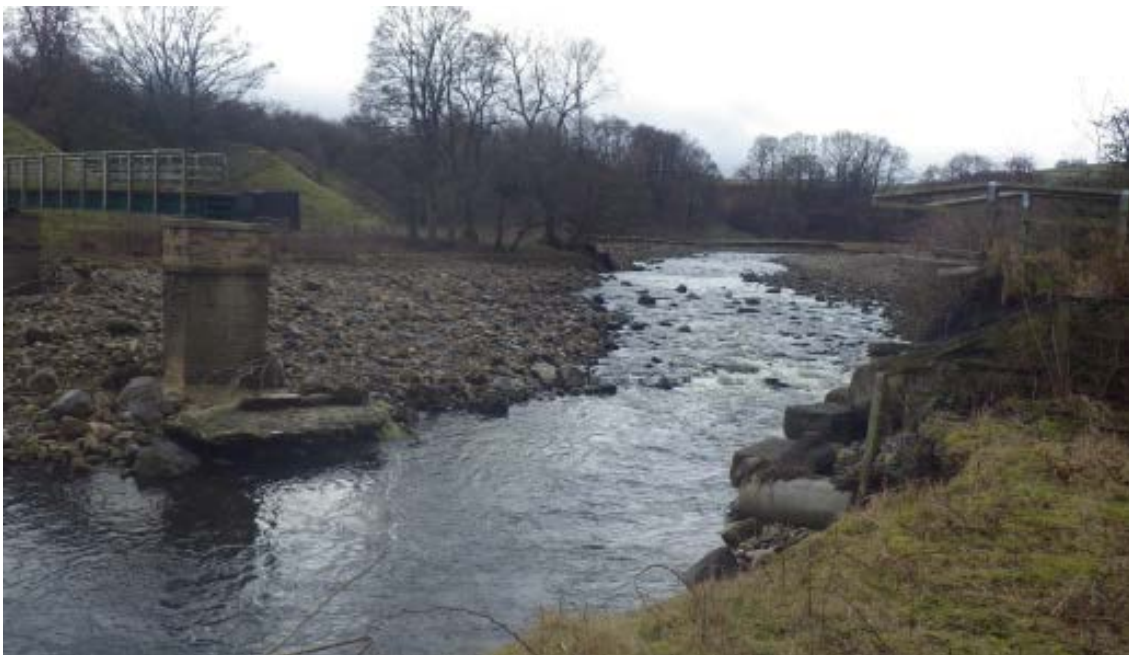
**Figure 3-20 View of the River Wear upstream from Kenneth's Bridge, from Wishart ('Case study: Geomorphological response to an artificial channel constriction')**

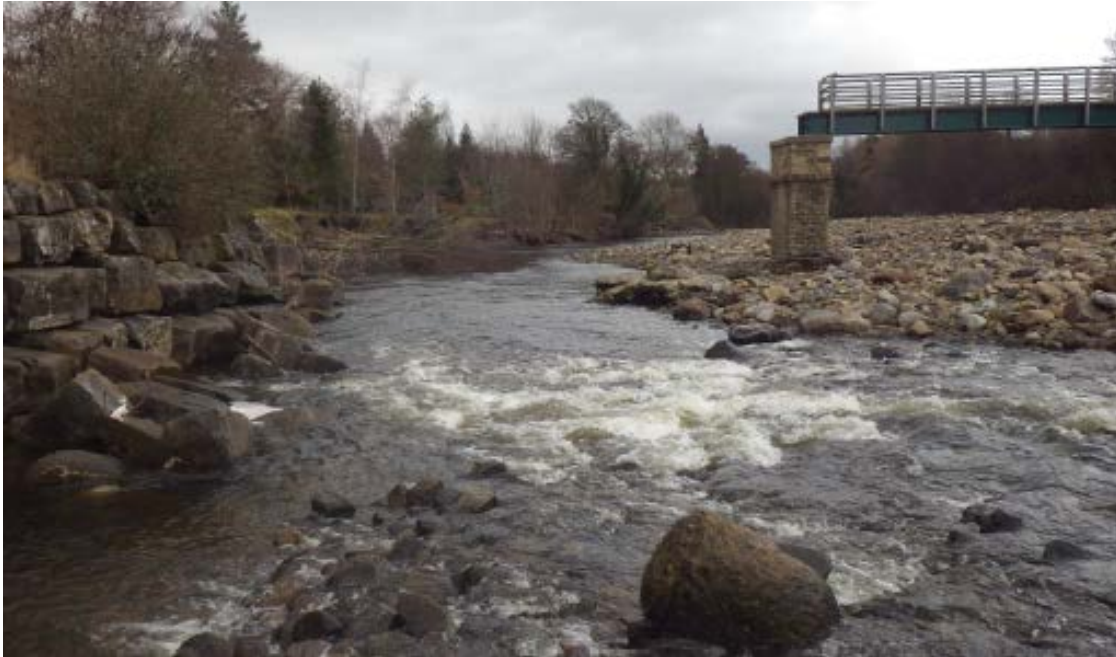
**Figure 3-21 View of the River Wear downstream from Kenneth's Bridge, from Wishart ('Case study: Geomorphological response to an artificial channel constriction')**

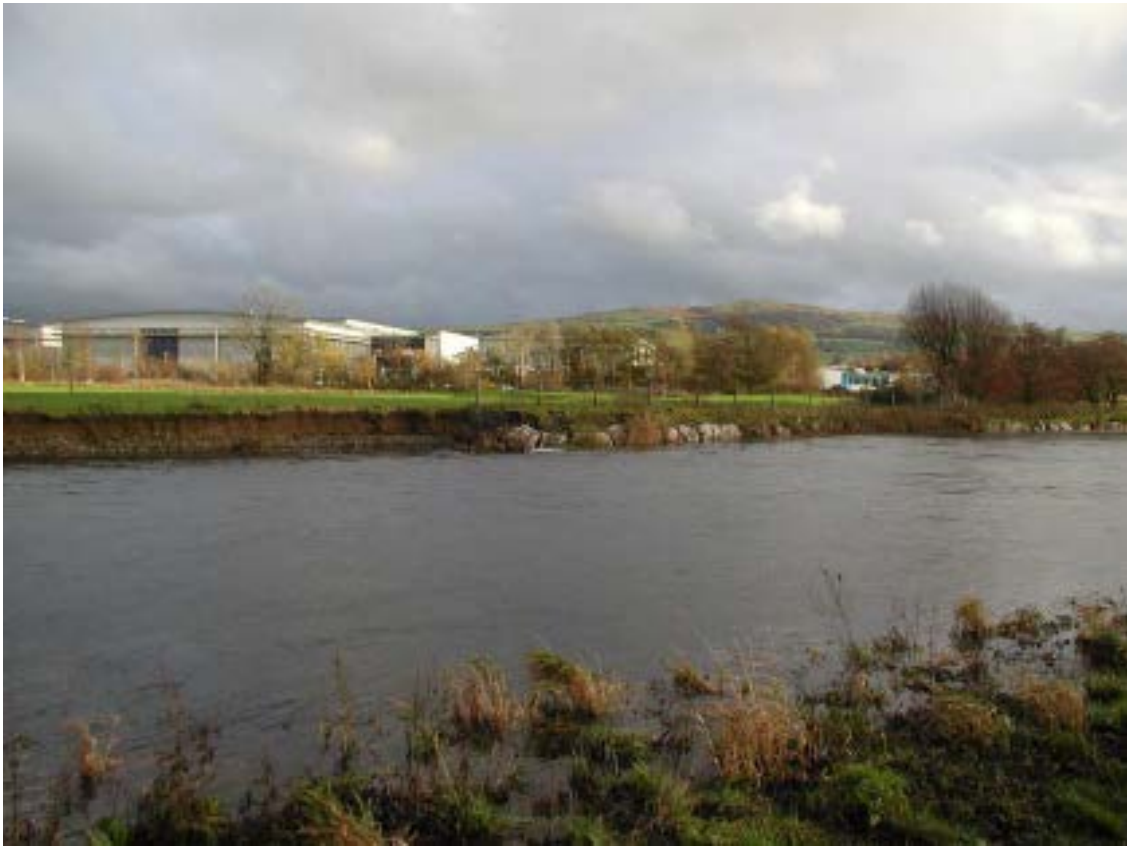
**Figure 3-22 Section of erosion on left bank of the River Kent, adjacent to Carus Green Gold course, from Cumbria County Council (2016c)**
