Appendix D: Method validation in the Kent, Stour and Wharfe catchments

FRS17183/R2 Appendix D

Various methods have been tested and evaluated to assess the ability to predict in-channel geomorphological activity at the reach scale, under both existing conditions and with future climate change (FRS17183/R1-R3).

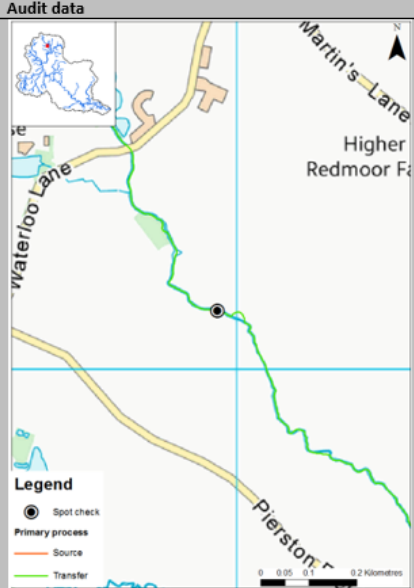
Figure D.1 Results validation: Stour 01

<p>Key process(es): Transfer</p> <p>Conclusion:</p> <ul style="list-style-type: none"> • Only one tested method available. The Half-yield method could not be used due to the lack RHS data in the area. • The audit classified the reach as passive meandering (i.e. minimal morphological activity). This suggests some deposition could occur, however sediment will also pass through the reach. • Based on this ST:REAM may not depict the correct process. 	Dominant process:	Transfer	Description:	Agricultural reach	Dominant bed material:	Gravel bed where undisturbed	Widening:	Present	Realignment:	Present	Resectioning:	Localised artificial form around STW near Silton and Waterloo Mill	Geomorphology:	Passive meandering	Evidence of incision/aggradation:	No	Floodplain connectivity:	Not recorded	Fine sediment:	Not recorded

<p>In the ST:REAM model, the reach is classified as depositional.</p>	<p>Not tested</p>

<p>No RHS sample point available for this reach.</p>
Dominant process:	Transfer																						
Description:	Agricultural reach																						
Dominant bed material:	Gravel bed where undisturbed																						
Widening:	Present																						
Realignment:	Present																						
Resectioning:	Localised artificial form around STW near Silton and Waterloo Mill																						
Geomorphology:	Passive meandering																						
Evidence of incision/aggradation:	No																						
Floodplain connectivity:	Not recorded																						
Fine sediment:	Not recorded

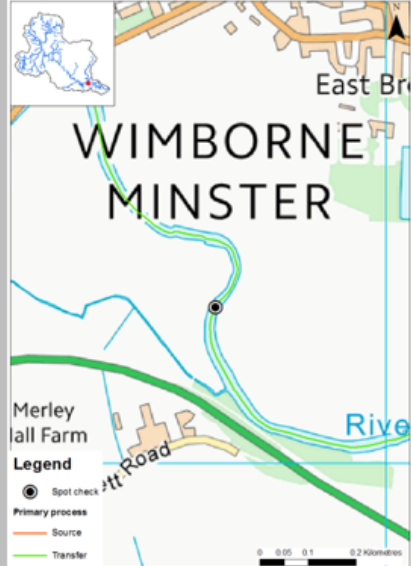
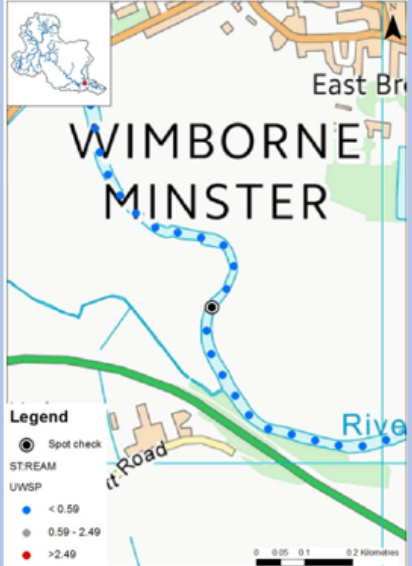
Figure D.6 Results validation: Stour 06

<p>Key process(es): Transfer</p> <p>Conclusion:</p> <ul style="list-style-type: none"> • Only two tested methods available – both display different processes. ST:REAM classifies the reach as depositional, whereas the Half-yield method classifies the reach as stable. • The audit classified the reach as transfer – however, past dredging is likely to have disrupted past processes. • Based on this the Half-Yield results are most closely aligned to the existing conditions. 	Dominant process:	Transfer	Description:	A31 to Wimbourne Minster	Dominant bed material:	Gravel	Widening:	Not recorded	Realignment:	Not recorded	Resectioning:	Not recorded	Dredging:	Dredged extensively in the late 20 th C, not fully recovered	Geomorphology:	Passive meandering and sinuous	Evidence of incision/aggradation:	Not recorded	Floodplain connectivity:	Not recorded	Fine sediment:	Vegetated berms u/s of weir, medium term store of fines	<p>In the ST:REAM model, the reach is classified as depositional.</p>	<p>Not tested.</p>	<p>In the Half-yield method, there is one suitable RHS data point located upstream of the spot check location.</p> <p>The RHS point is classified as stable in terms of the Performance Factor ($P = -0.15$) and Effectiveness Index ($E = -0.12$). This indicates that there is a balance in sediment yield between the in-channel and overtopping flows.</p>
Dominant process:	Transfer																								
Description:	A31 to Wimbourne Minster																								
Dominant bed material:	Gravel																								
Widening:	Not recorded																								
Realignment:	Not recorded																								
Resectioning:	Not recorded																								
Dredging:	Dredged extensively in the late 20 th C, not fully recovered																								
Geomorphology:	Passive meandering and sinuous																								
Evidence of incision/aggradation:	Not recorded																								
Floodplain connectivity:	Not recorded																								
Fine sediment:	Vegetated berms u/s of weir, medium term store of fines

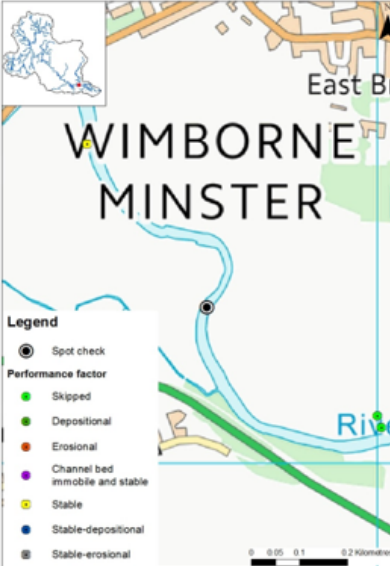
Reach: Stour_06, Watercourse: River Stour, OS NGR: 400646, 099325																									
Audit data	ST:REAM	CAESAR-Lisflood	Half-yield

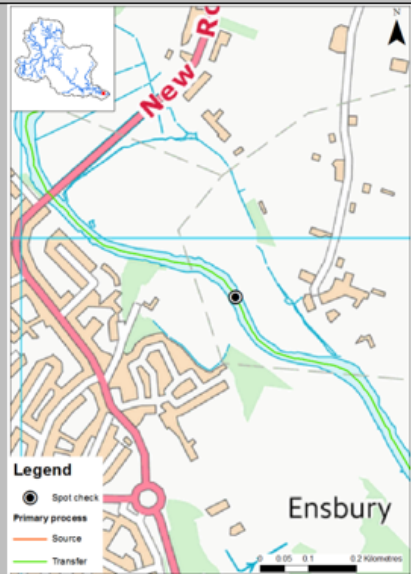
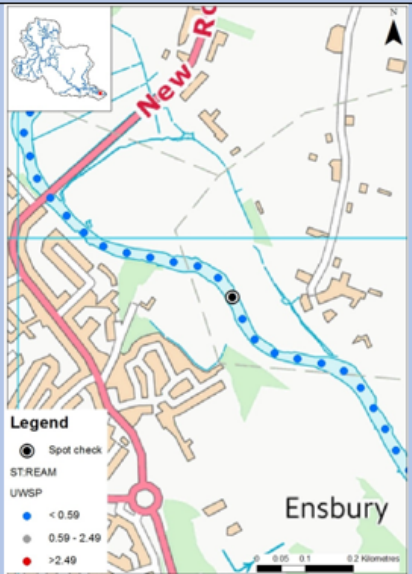
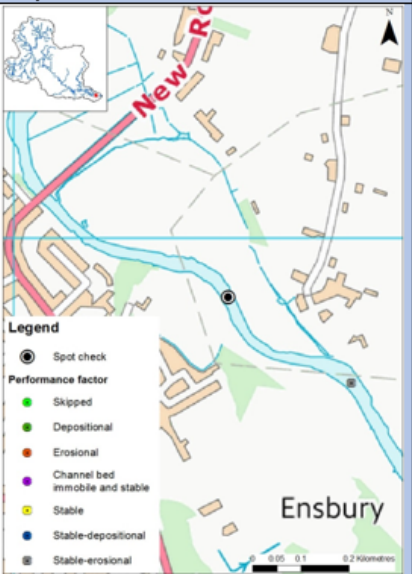
Figure D.7 Results validation: Stour 07

<table><tr><td>Dominant process:</td><td>Transfer</td></tr><tr><td>Dredging</td><td>Present (1980s) – triggered knickpoint erosion</td></tr><tr><td>Artificial features:</td><td>Bed check weirs installed to reduce knickpoint erosion after extreme dredging</td></tr><tr><td>Geomorphology</td><td>Passive meandering with weir pools associated with gravel bars</td></tr></table>

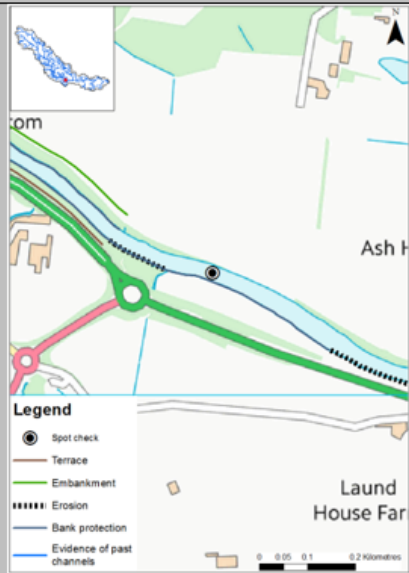
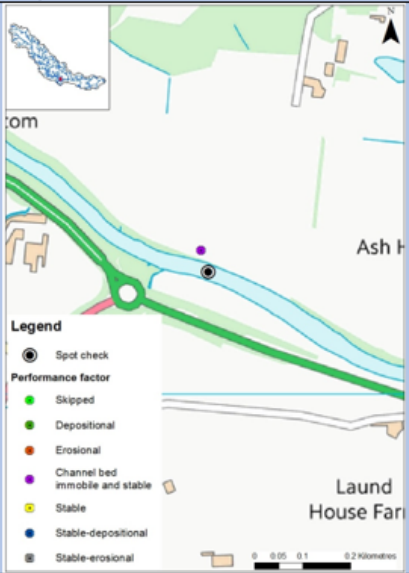
Figure D.15 Results validation: Wharfe 07

<p>Key process(es): Transfer</p> <p>Conclusion:</p> <ul style="list-style-type: none"> • Only two tested methods available. • The audit classified the reach as transfer. • Based on this Half-Yield depicts the correct process. ST:REAM does not depict the correct process as the reach was calculated to be depositional in nature. 	Dominant bank material:	Fines, with some sand	Dominant bank structure:	Cohesive	Dominant bank erosion process:	Geotechnical, with some burrowing	Acceleration of erosion occurring:	No	Evidence of incision:	No	Evidence of aggradation:	No	Dominant bed material:	Coarse gravel, with some fine gravel and cobbles	Dominant biotope:	Glide with some riffles	Dominant deposition:	Macroscale, unstable and stable silt deposits

<p>In the ST:REAM model, the reach is classified as depositional.</p>	<p>Not tested.</p>

<p>In the Half-yield method, there is one suitable RHS data point within the vicinity of the spot check location.</p> <p>In the Half-yield method the reach is calculated to have an immobile and stable channel bed. This indicates that the channel will act as a transfer reach for smaller sediment sizes and potentially depositional for fines. Channel banks might also be subject to erosion in high energy reaches.</p>
Dominant bank material:	Fines, with some sand																				
Dominant bank structure:	Cohesive																				
Dominant bank erosion process:	Geotechnical, with some burrowing																				
Acceleration of erosion occurring:	No																				
Evidence of incision:	No																				
Evidence of aggradation:	No																				
Dominant bed material:	Coarse gravel, with some fine gravel and cobbles																				
Dominant biotope:	Glide with some riffles																				
Dominant deposition:	Macroscale, unstable and stable silt deposits

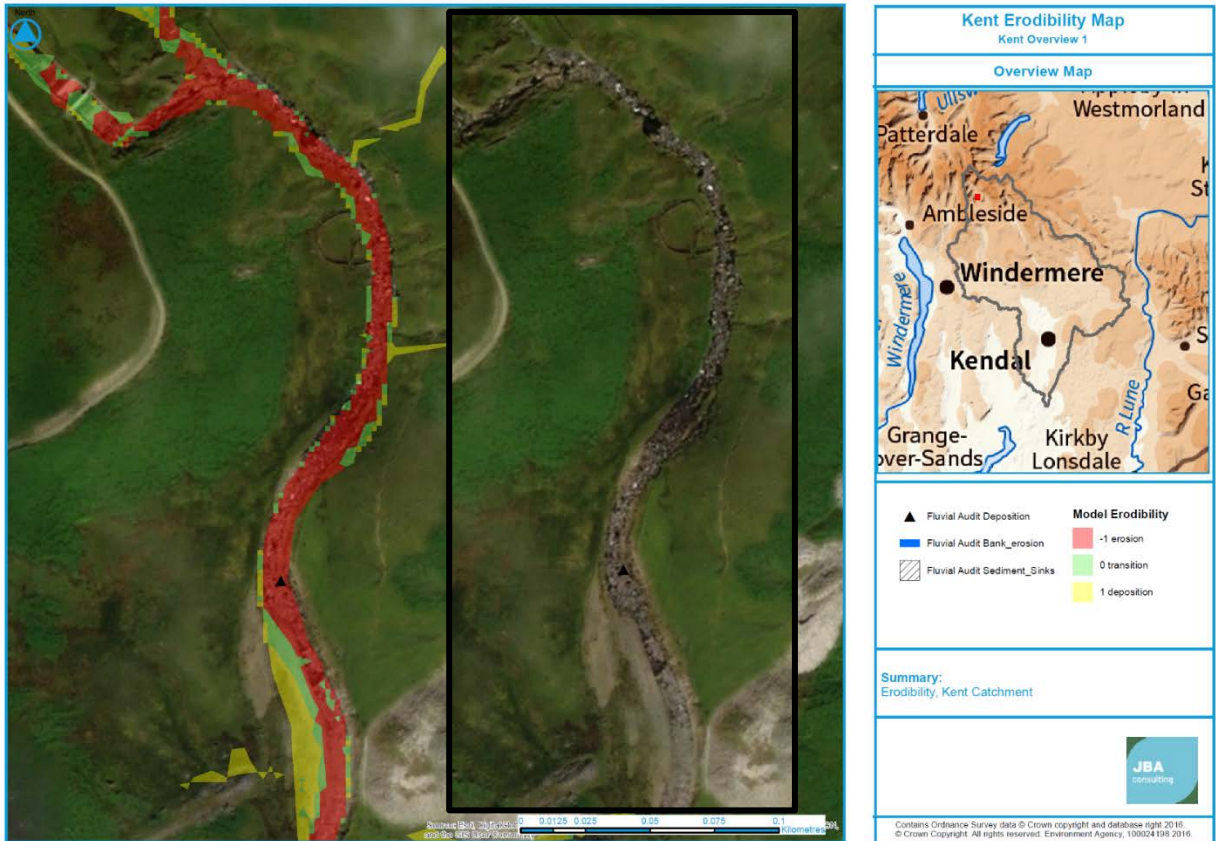
Figure D-22 Kent - complex erosion and deposition area with photo inset right

Figure D-22 represents an area in which the fluvial audit has only recorded a point location of deposition. This is close to the patch of yellow in the modelled maps, although clearly visible from the inset photo is a depositional bar that is more aligned with the model than the fluvial audit, suggesting some limitations in the survey. In this instance, SSDM could be said to have improved reach scale mapping compared to the audit.

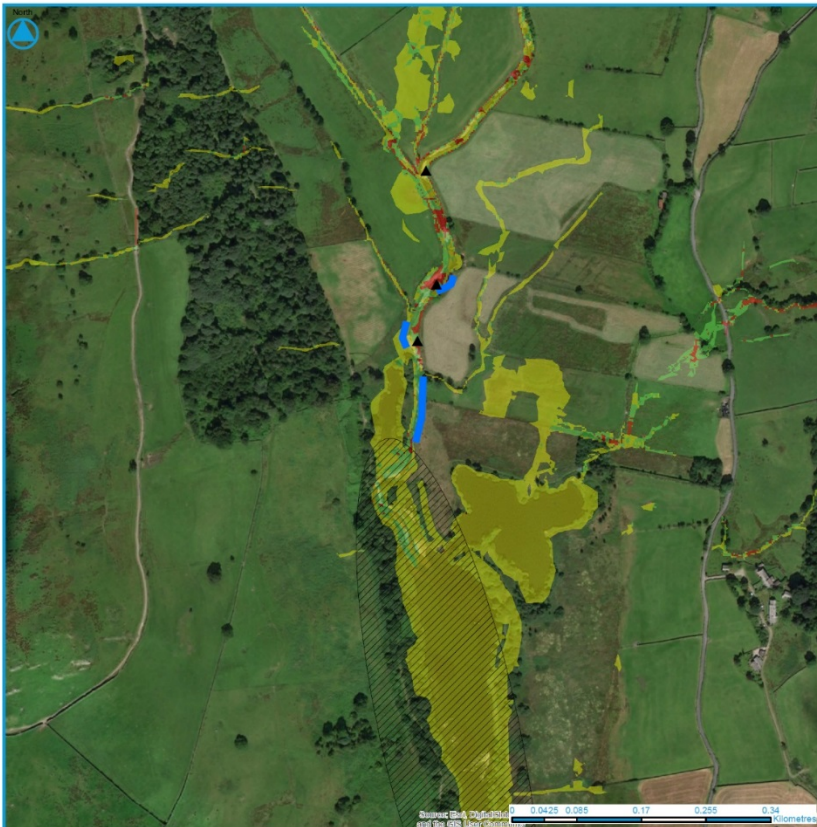
Figure D-25 Kent - Erosion and depositional zones mostly captured by model

Figure D-25 highlights that the model can capture complex reaches of sediment movement quite accurately in comparison with the fluvial audit observations, especially where tree coverage is less.

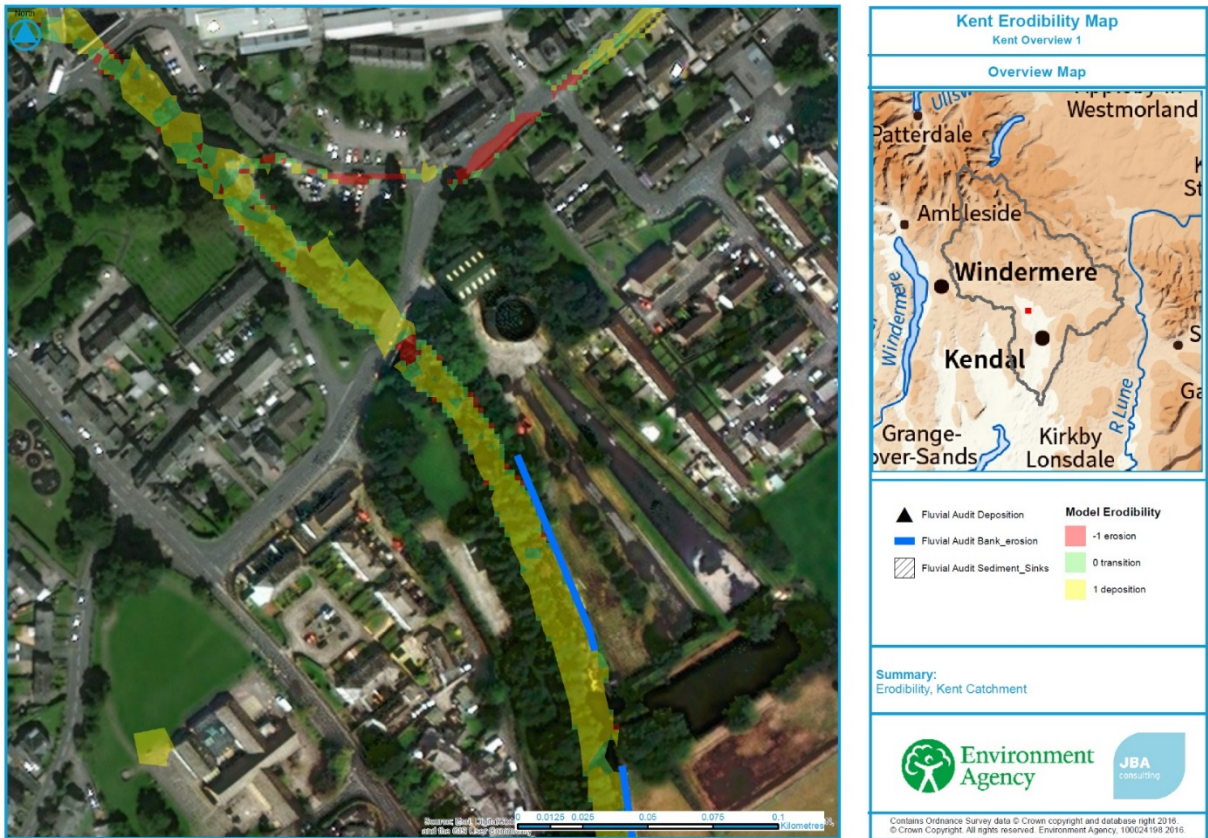
Figure D-27 Kent - Bank erosion predicted

Figure D-27 shows agreement with the audit in that there are red pixels illustrating bank erosion close to the left bank where there is less tree cover. Discrepancies between the model and data would again be removed by filtering out the wooded areas.

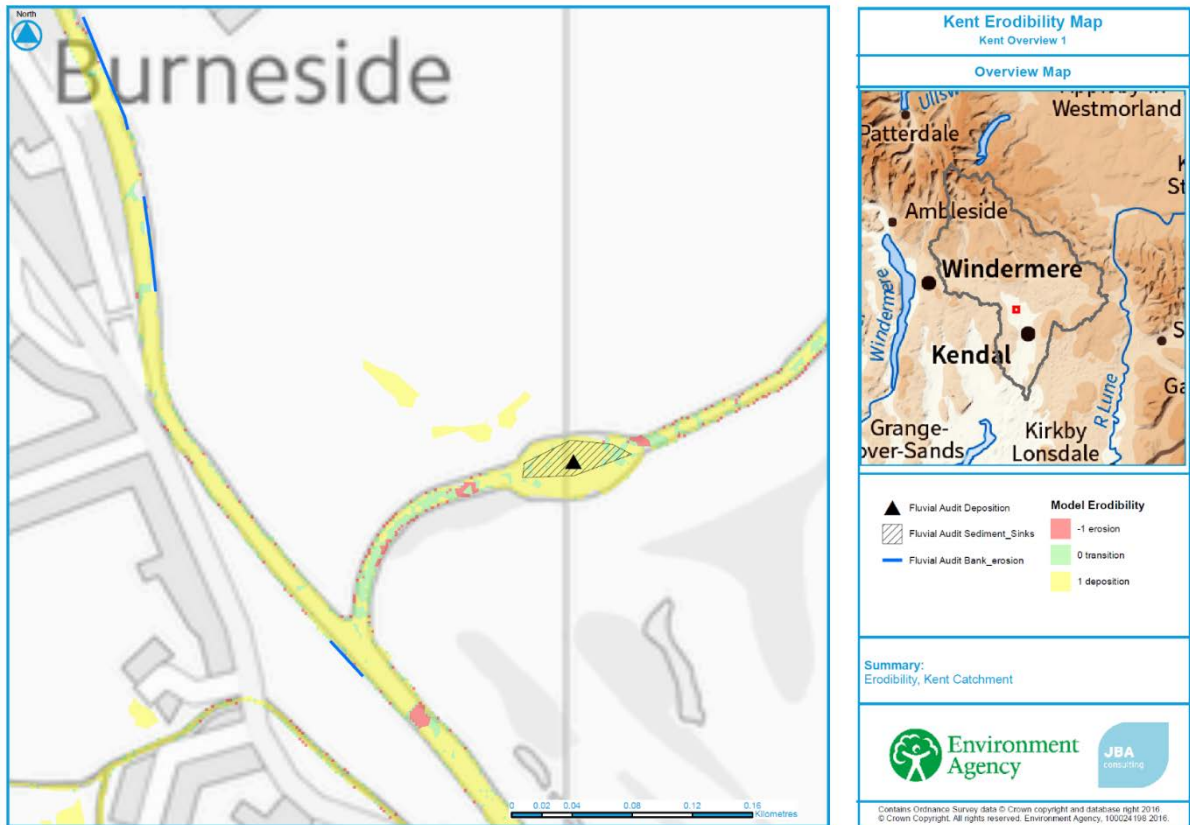
Figure D-29 Kent - Depositional areas identified correctly, with some areas of bank erosion downstream of Burneside

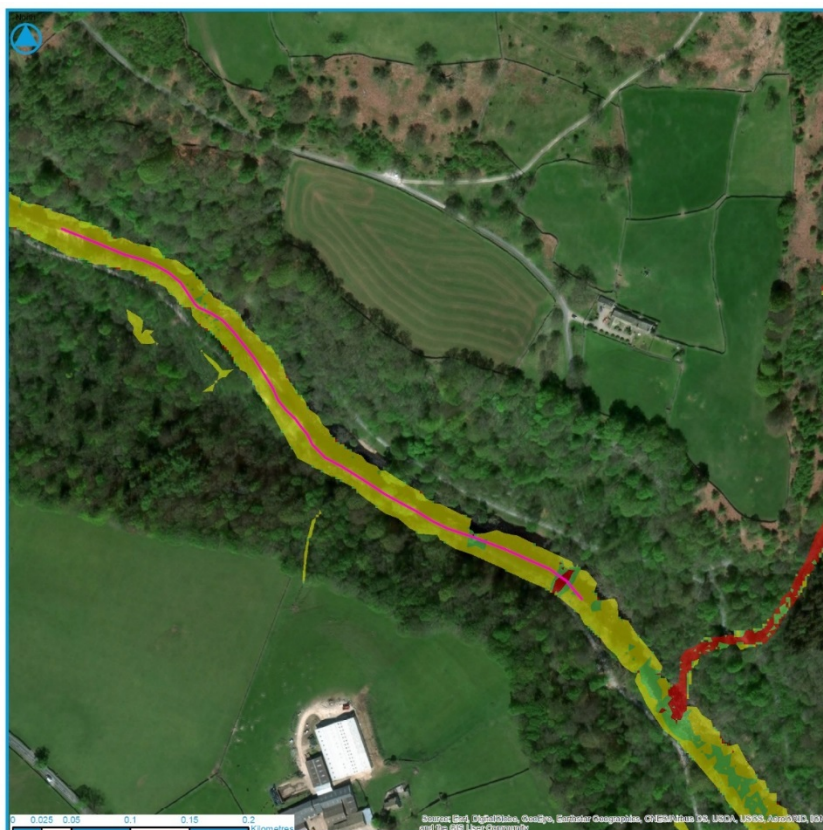
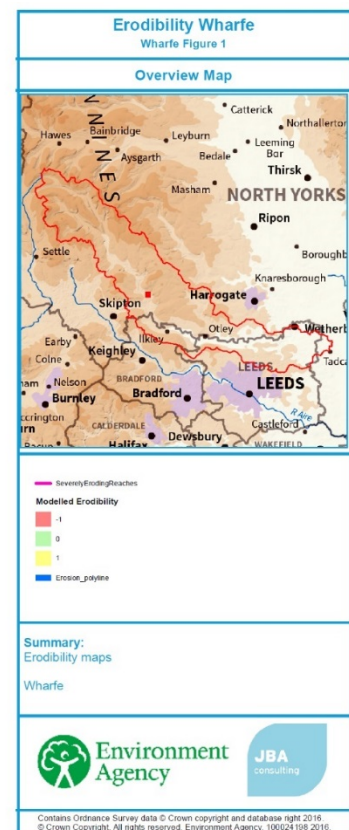
Figure D-34 Wharfe severely eroded reach 52 RP 30

The first map (Figure D-34) is zoomed into reach 52, halfway along the Wharfe catchment, using the erodibility maps based on the 30-year return period (3.33% AEP). It is evident that there are some areas of agreement near the south-eastern end of the reach, where erosion is predicted (red zones). Here the river is reasonably wide, and it suggests that shear stresses based on a larger flow may be necessary in order to represent the potential for channel erosion.

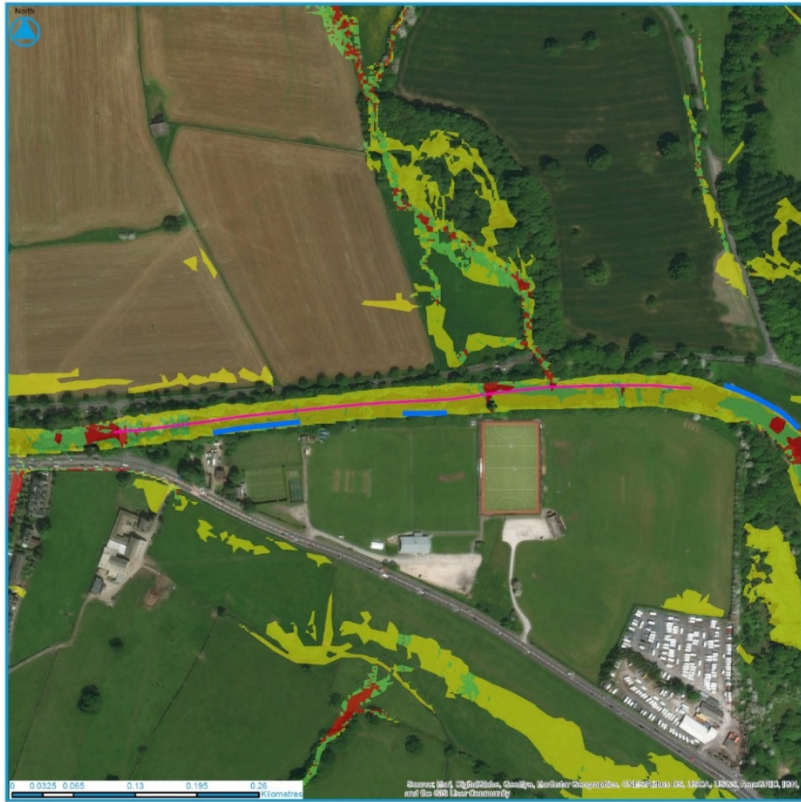
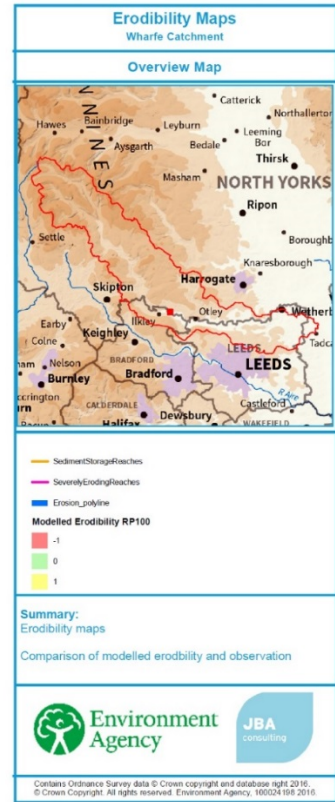
Figure D-37 Wharfe severely eroded reach 58 using RP100

Figure D-37 also shows SSDM prediction of red erosion zones within this reach flagged as having significant erosion.

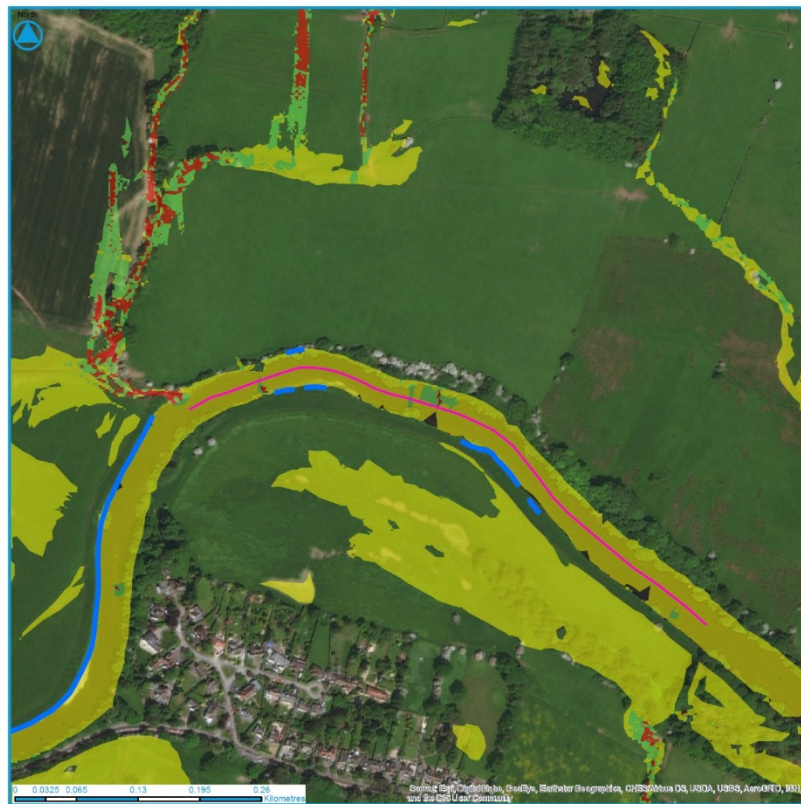
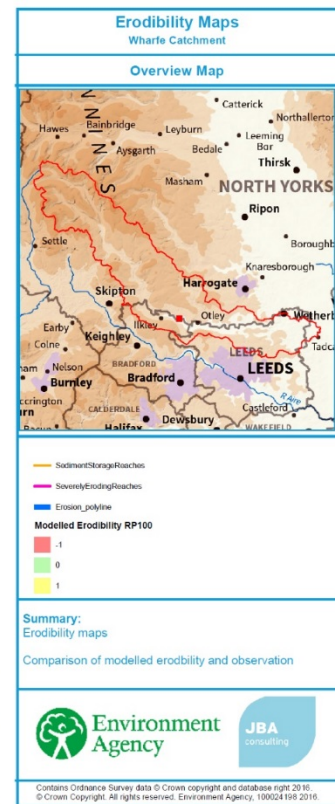
Figure D-38 Wharfe severely eroded reach 61 with inset RP100

This reach (61) shows less agreement with the audit, with some patches of predicted erosion to the west and centre of the reach. There are some high shear stresses in the

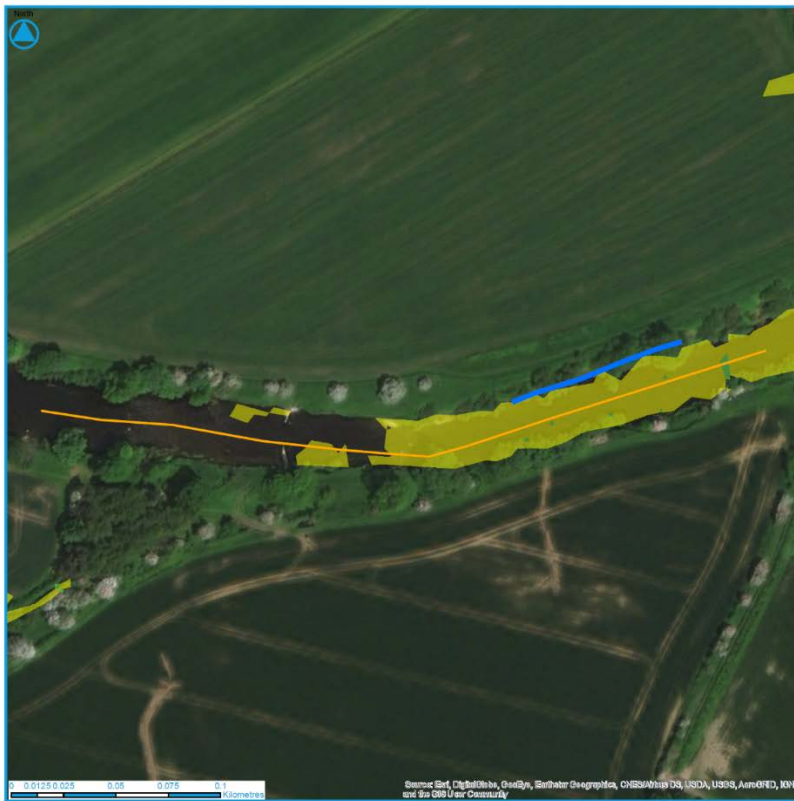
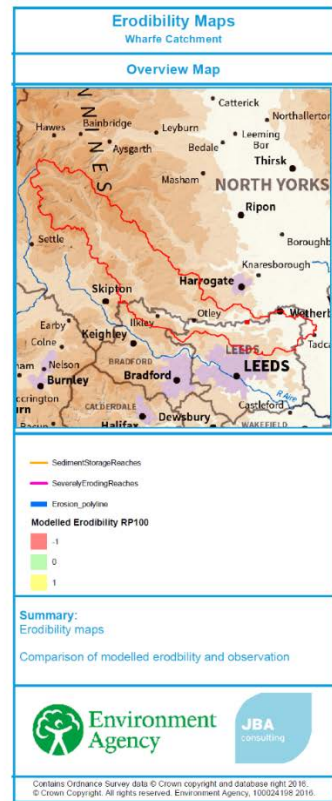
Figure D-42 Wharfe storage reach 85 for RP100

Reach 85 is identified as a storage reach and the model outputs for RP100 match this observation. The short reach of bank erosion is not captured, although the next figure shows this is well captured for another reach.

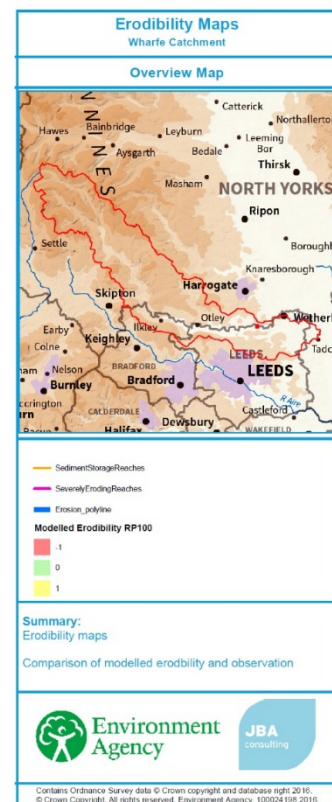
Figure D-43 Wharfe storage reach 96 for RP100

Reach 96 is highlighted as a storage dominated reach and this is captured by the model. In addition, the red areas of higher shear near the banks match well with the blue line, showing observed bank erosion.
