February 2021

## Air Quality and Dust Monitoring Monthly Report - February 2021

Three Rivers District Council

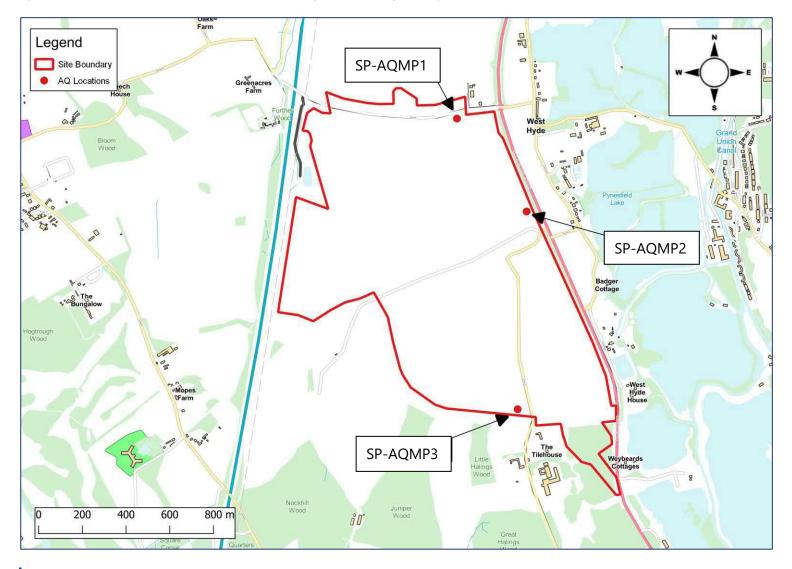
Figure 1: Three Rivers District Council Worksites and Monitoring locations during February 2021

- 1.1.2 Figure 1 in Appendix A indicates the current worksite together with the dust monitoring locations for February 2021.
- 1.1.3 This summary should be read in conjunction with the overview monitoring report available from <a href="www.gov.uk/government/collections/monitoring-the-environmental-effects-of-hs2">www.gov.uk/government/collections/monitoring-the-environmental-effects-of-hs2</a>, which highlights: the applicable standards and guidance, as well as the air quality and dust monitoring methodologies to be implemented by nominated undertakers throughout construction.

- 1.1.4 The current phase of works at the South Portal site commenced within TRDC in July 2017 and is currently ongoing. The South Portal site as presented in Appendix A, Figure 1, includes the following ongoing activities:

- 1.1.5 Three (3) dust monitors are installed around the worksite, where earthworks, construction and trackout activities are underway. This site returned a medium dust risk rating.

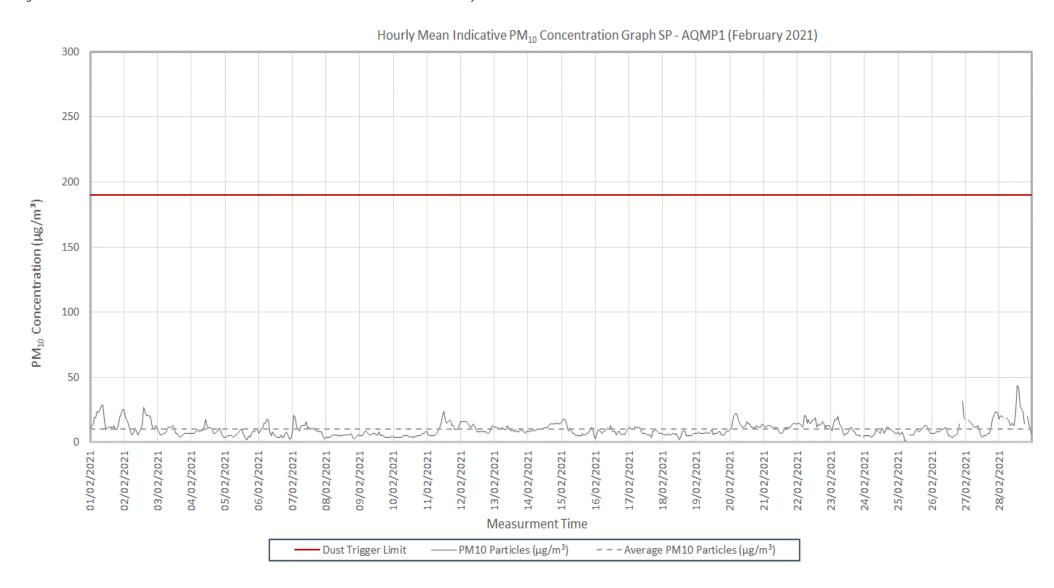
Figure 2: Continuous dust 1-hour mean indicative PM<sub>10</sub> concentration for SP-AQMP1 for February 2021

- 1.1.6 Dust monitoring locations and results for February 2021 are presented in Appendix B, Table 1, together with a line chart of monthly data from each dust monitor, presented in Figures 2, 3 and 4. All continuous dust monitoring is undertaken using indicative monitors. Despite being Environment Agency (MCERTS) certified, indicative monitors carry a higher level of uncertainty than reference monitors, and therefore cannot be strictly compared with Air Quality Standards for human health and the environment. The purpose of the monitoring undertaken is to ensure the effectiveness of the on-site mitigation.

- 1.1.7 The trigger level for  $PM_{10}$  concentrations of 190  $\mu$ g/m³, measured as a 1-hour mean, in accordance with the updated guidance document 'Guidance on Monitoring in the Vicinity of Demolition and Construction Sites (October 2018)' has been applied.

- 1.1.8 There were six (6) dust trigger alerts recorded during the monitoring period (February 2021).

Monitoring Site ID	Period of trigger alert & Concentration recorded	Investigation	Outcomes / Resolution / Remedial measures		
			implemented		
	06/02/2021 18:01 – 19:00: 214 μg/m³				
	18/02/2021 07:01 – 08:00: 190 μg/m³	On investigation, the trigger alerts are likely due to wind whipping of nearby (within 3m) loose earth	Concentrations at this monitor are to be closely monitored and good housekeeping measures (in line with the Code of Construction Practice) continue to be implemented across all works.		
SP-AQMP2	10/02/2021 23:01 – 00:00: 200 μg/m³	mounds and monitor being located immediately			
	11/02/2021 01:01 -03:00: 221 μg/m³ (x2 alerts)	beside site-vehicle haul route.			
	11/02/2021 05:01 – 06:00: 251 µg/m³

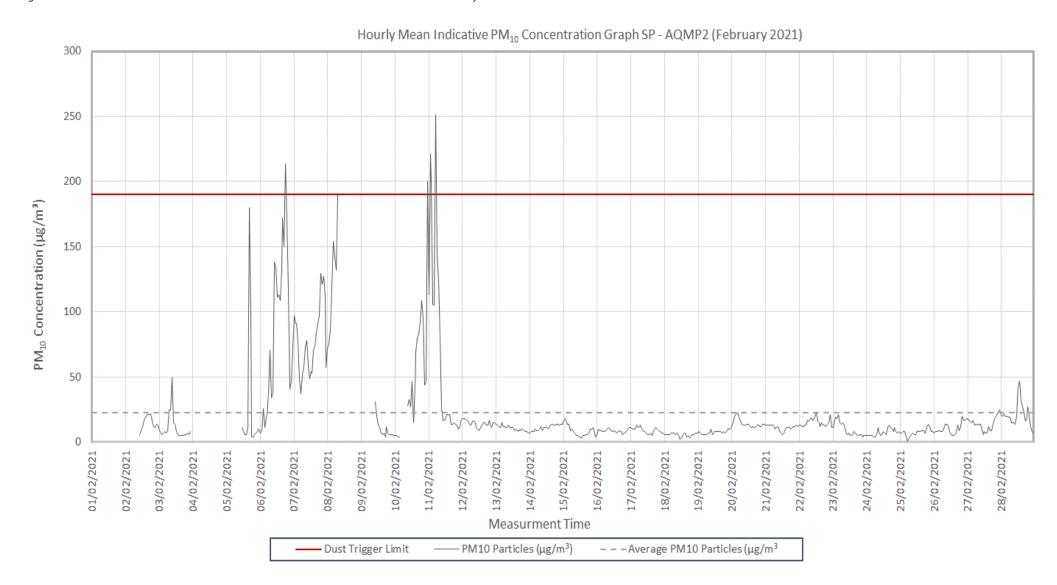
Figure 3: Continuous dust 1-hour mean indicative PM<sub>10</sub> concentration for SP-AQMP2 for February 2021

Trigger alerts are presented in Appendix B, Table 2. All other results were in line with expected ranges.
- 1.1.9 Data capture for monitors SP-AQMP2 and SP-AQMP3 was below 90% for the month of February 2021. Missing data was due to technical issues and/or loss of power due to renewable energy power loss (insufficient sunlight/wind). Technical issues have been or are in the process of being resolved and an alternative power source is currently being explored to resolve the intermittent solar power issue.
- 1.1.10 There were no (0) complaints, relating to dust or air quality, received during the reporting period (February 2021).
