Construction noise and vibration Monthly Report – February 2021

London Borough of Camden

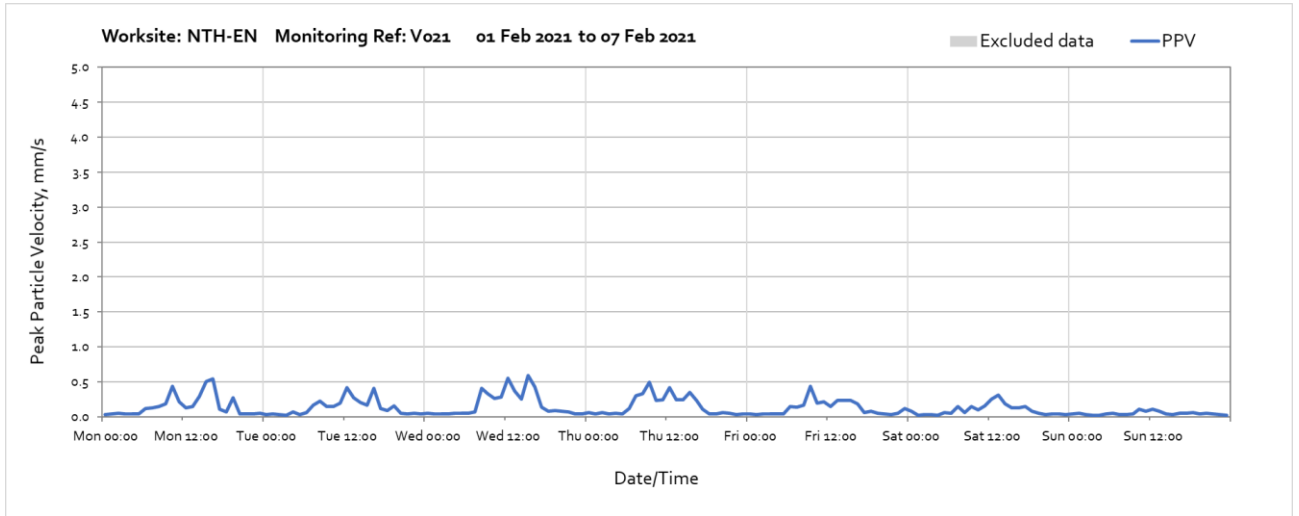
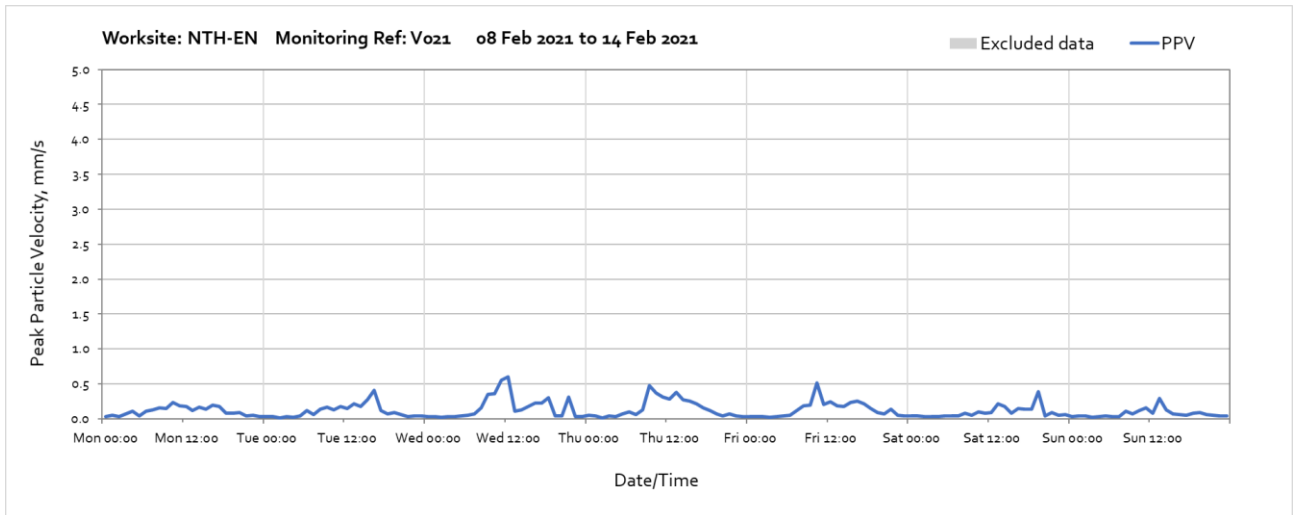
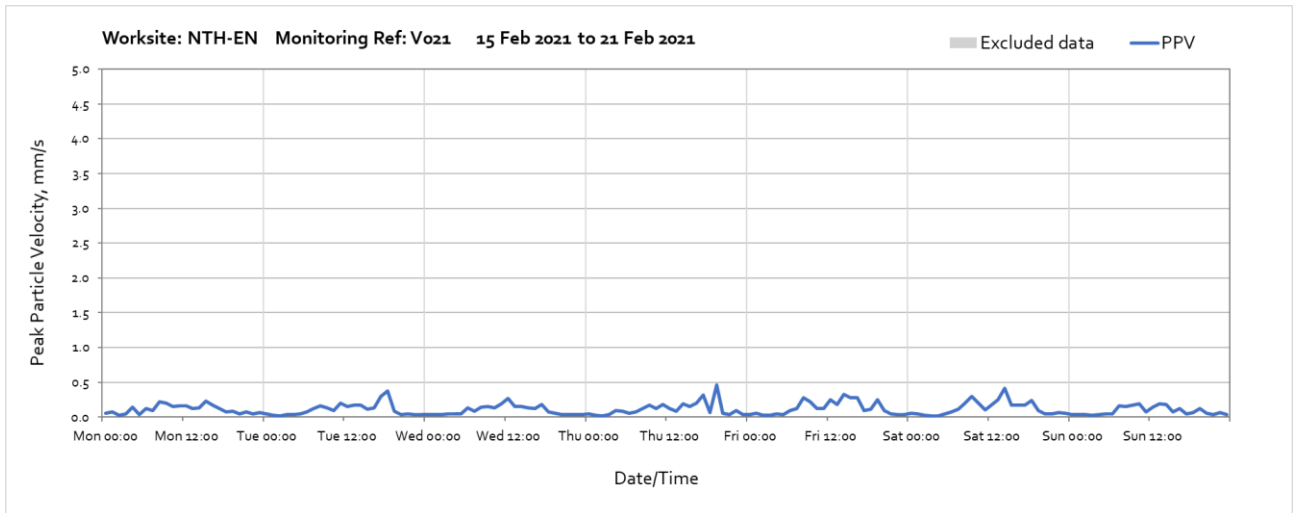
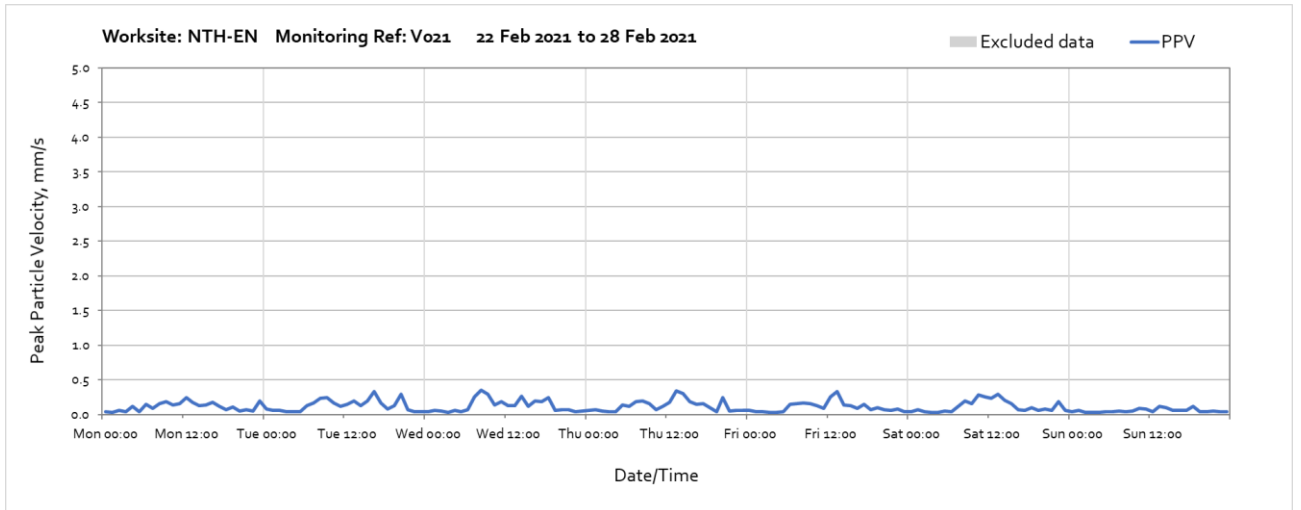
Worksite: NTH-EN – Monitoring Ref: V021

The following graphs show the hourly measured peak particle velocity PPV recorded during the monitoring period. The graphs show the resultant PPV due to vibration components on three orthogonal axis x, y and z. Where high values of PPV were caused by local interference with the vibration monitor, which are not representative of HS2 construction works, these values have been greyed out in the following charts and have been excluded to calculate values in Table 4 of the main report.
