PHASE 1 DESK STUDY AND PHASE 2 INTRUSIVE INVESTIGATION; INTERPRETATIVE REPORT

Northstowe Phase 2 – Phase 2B

Report No 10018973-ARC-XX-XX-RP-YY-0004-03-Ph2B interpretative report

SUBJECT
Northstowe Phase 3B: Hydrogeological assessment of
groundwater levels due to a reduction in recharge

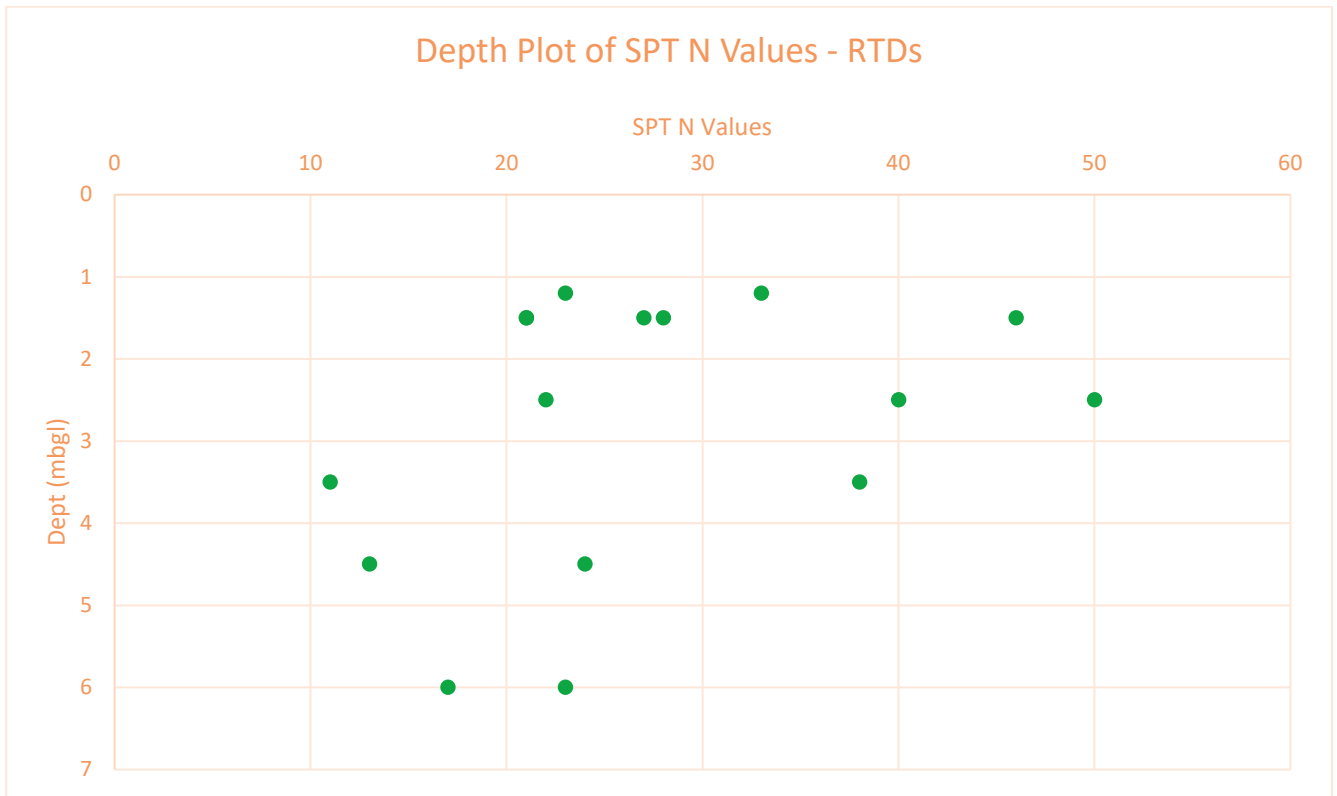
Figure 4.5 Depth Plot of SPT N Values – RTDs

SPT testing undertaken within the RTDs recorded SPT N-values of between 11 and 50 indicating medium dense to dense consistencies. In general, no clear trend is observed within the dataset, which highlights the variability of the RTDs. Figure 4.5 below displays the relationship between depth and SPT N-value.

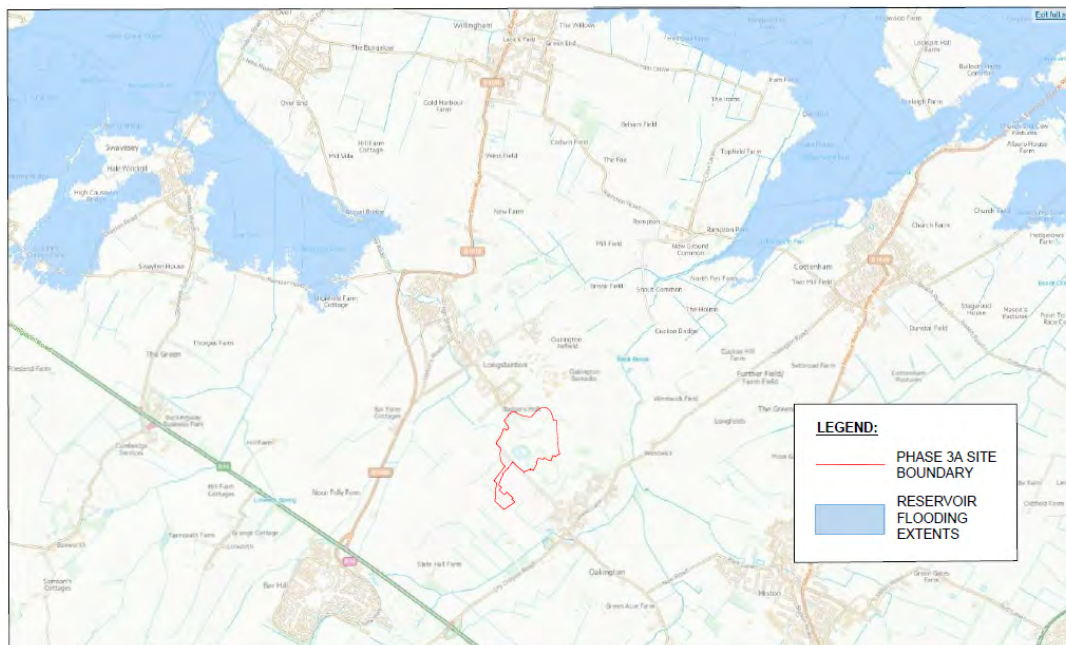
Figure 17: Risk of Flooding from Reservoirs (EA)

- 4.6.1 Ordnance Survey mapping indicates there are no significant bodies of water (lakes, reservoirs, or canals), retained above natural groundwater level, upstream of the Phase 3A site. The site is not in an area potentially affected by reservoir flooding, as indicated on the Environment Agency Risk of Flooding from Reservoirs online map (**Figure 17**).

- 4.6.2 It is therefore considered that the potential for flooding from artificial sources is **low**.

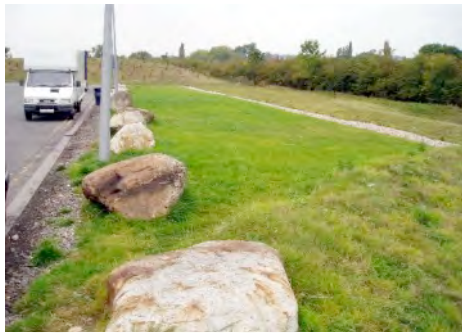
FILTER STRIPS

Filter strips are uniformly graded and gently sloping strips of grass or other dense vegetation that are designed to treat runoff from adjacent impermeable areas by promoting sedimentation, filtration and infiltration.

Location and Use on Site: Highways will drain via filter-strips into larger conveyance swales bordering the site.

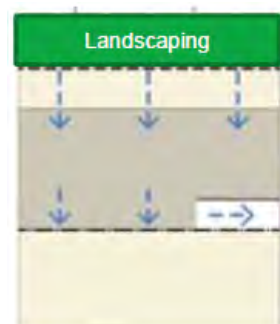
<p>TANKED BLANKET</p>	<p>INFILTRATION</p>
------------------------------	----------------------------

A tanked infiltration blanker allows for surface water flows to be attenuated before being discharged off site. An infiltration blanket can be used under a landscaped area, and has a suitable void ratio and depth to cater for storm volumes up to Q100 + 30% Climate Change.
