## **Construction noise and vibration Monthly Report – March 2021**

**London Borough of Ealing**

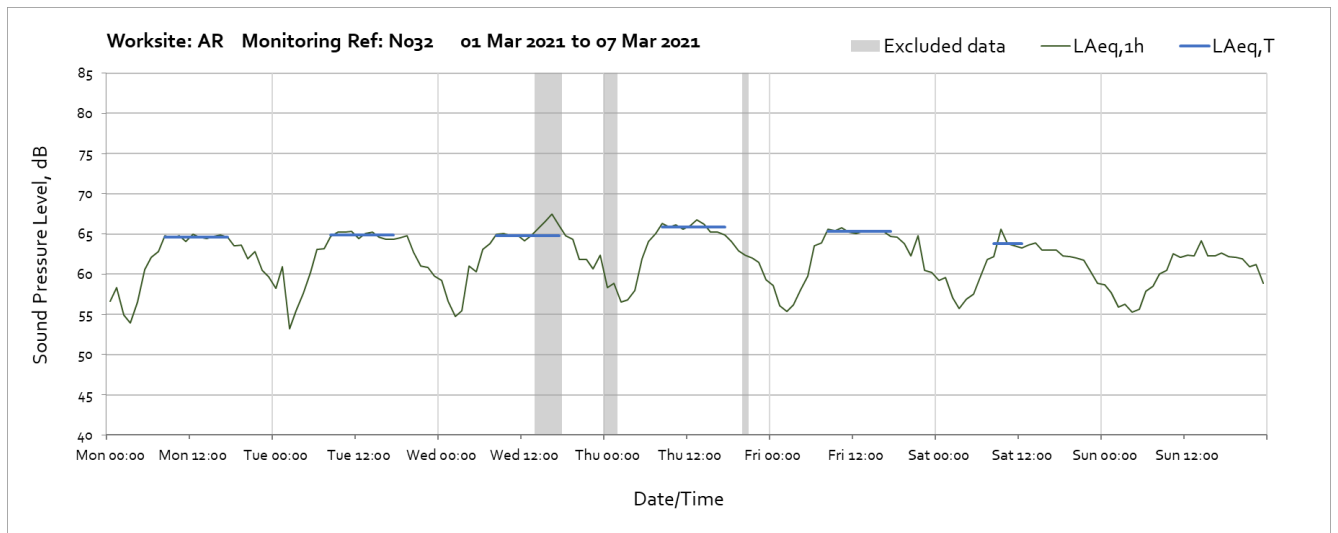
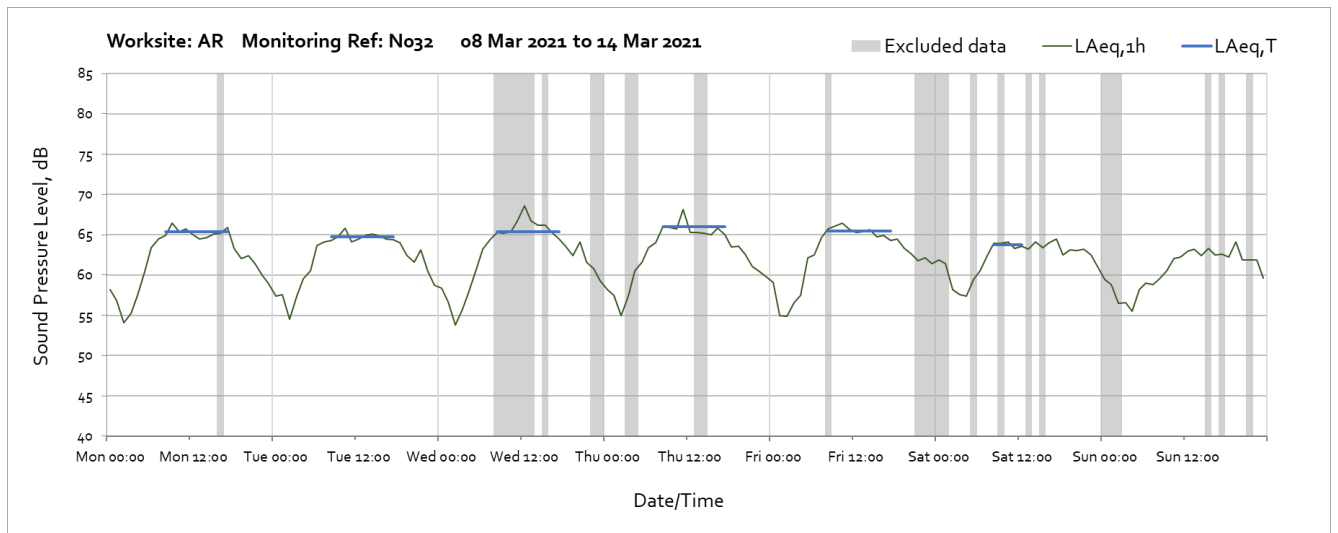
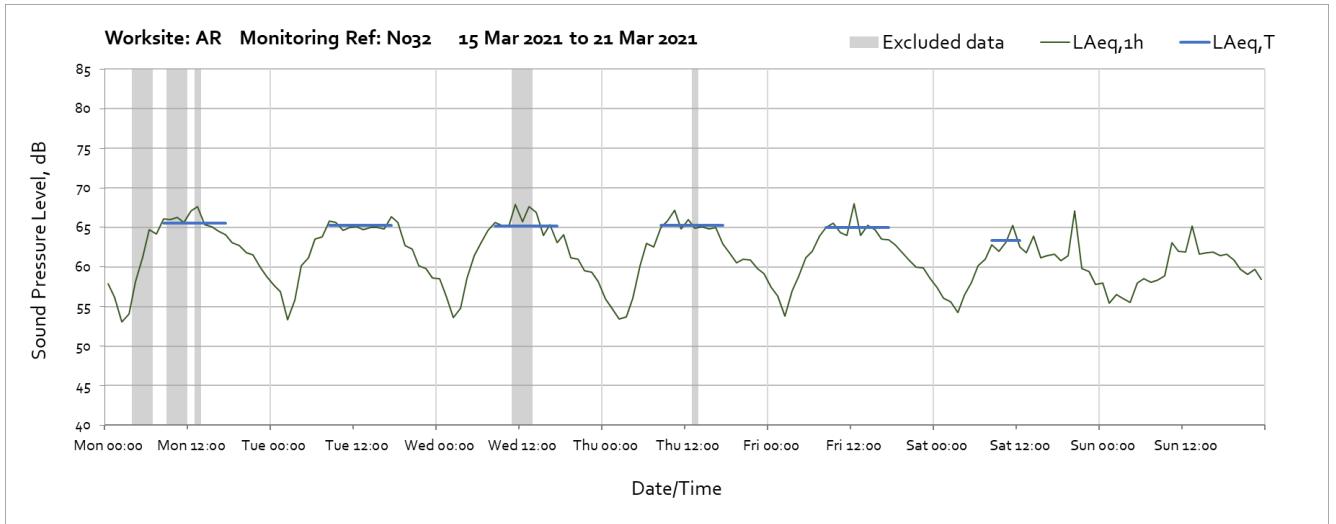
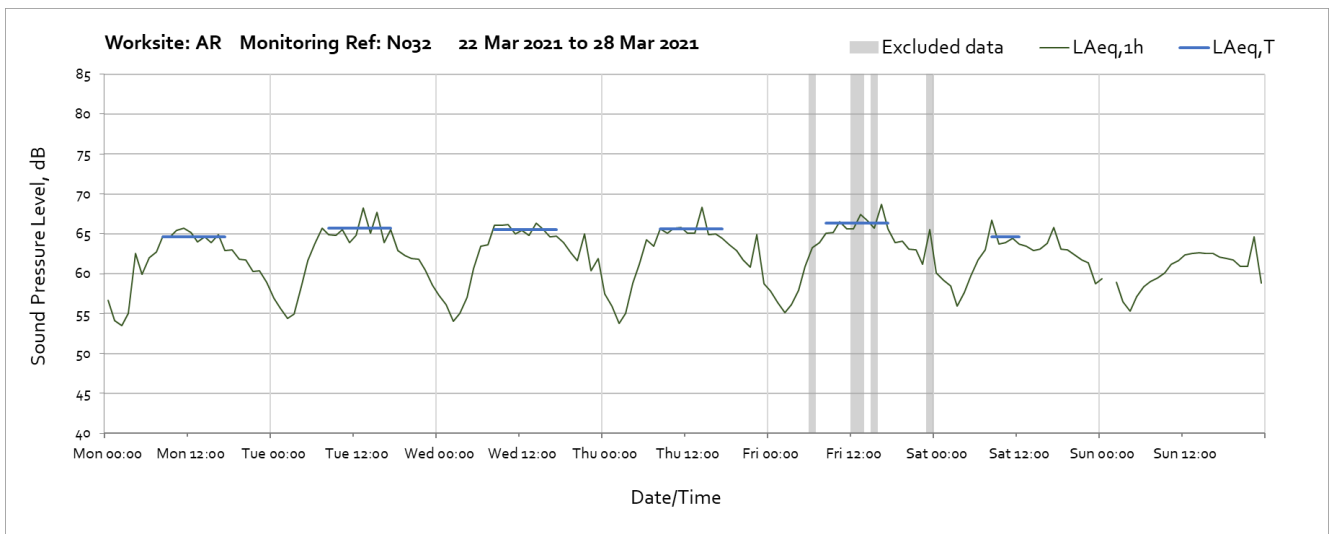
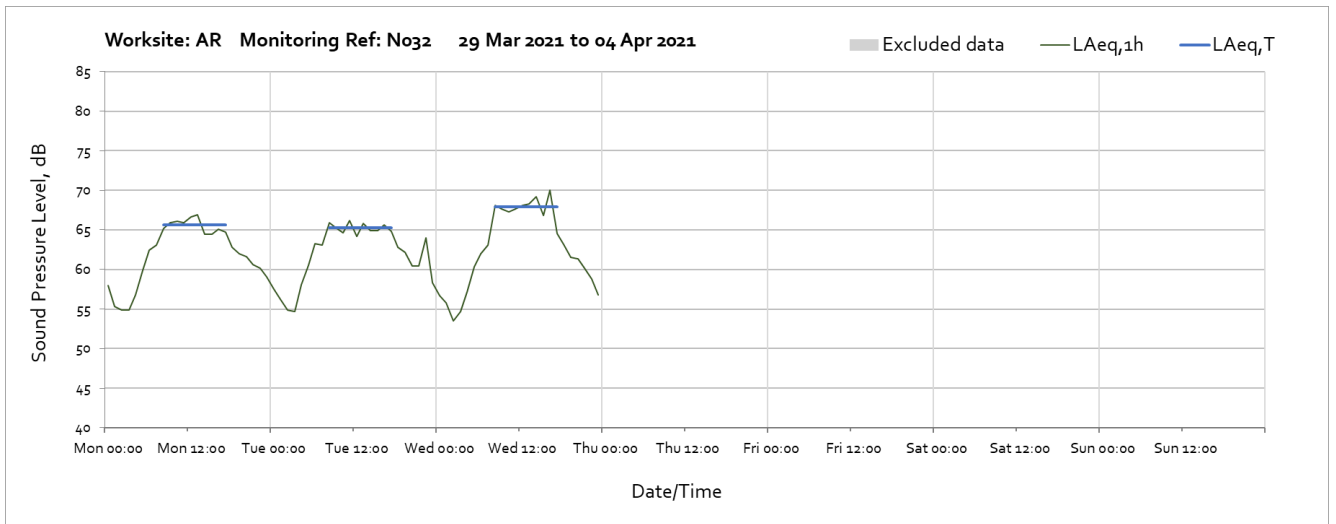
### Worksite: Atlas Road worksite (AR) – Monitoring Ref: N032

Note: Missing data at 01:00 on Sunday 28<sup>th</sup> March 2021 was due to the clocks going forward at the start of British Summer Time.

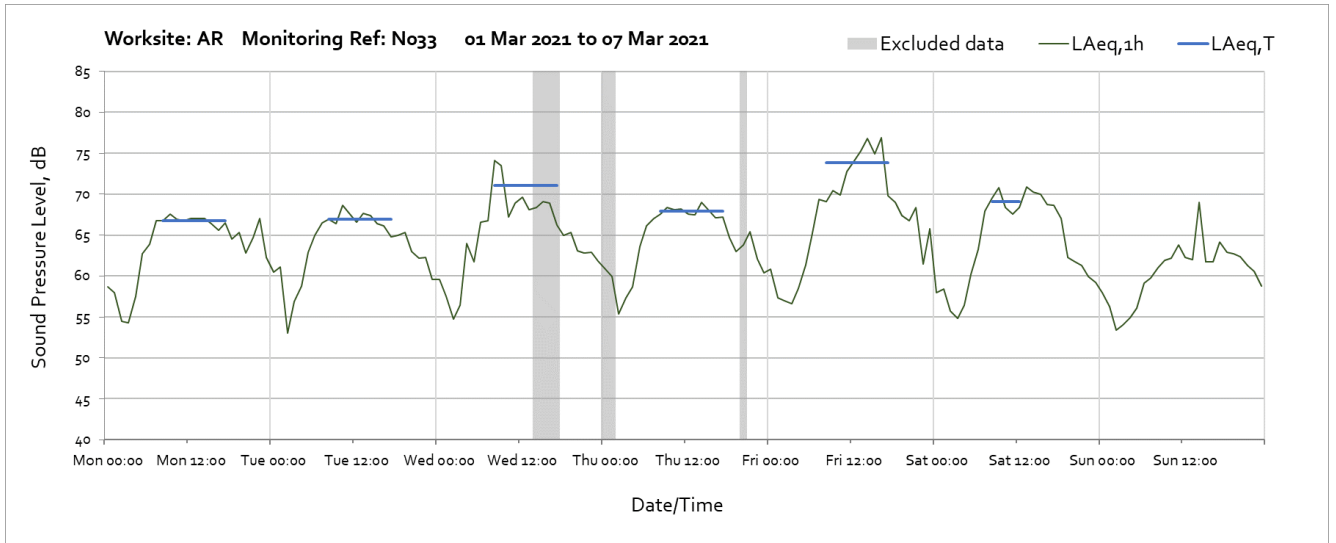
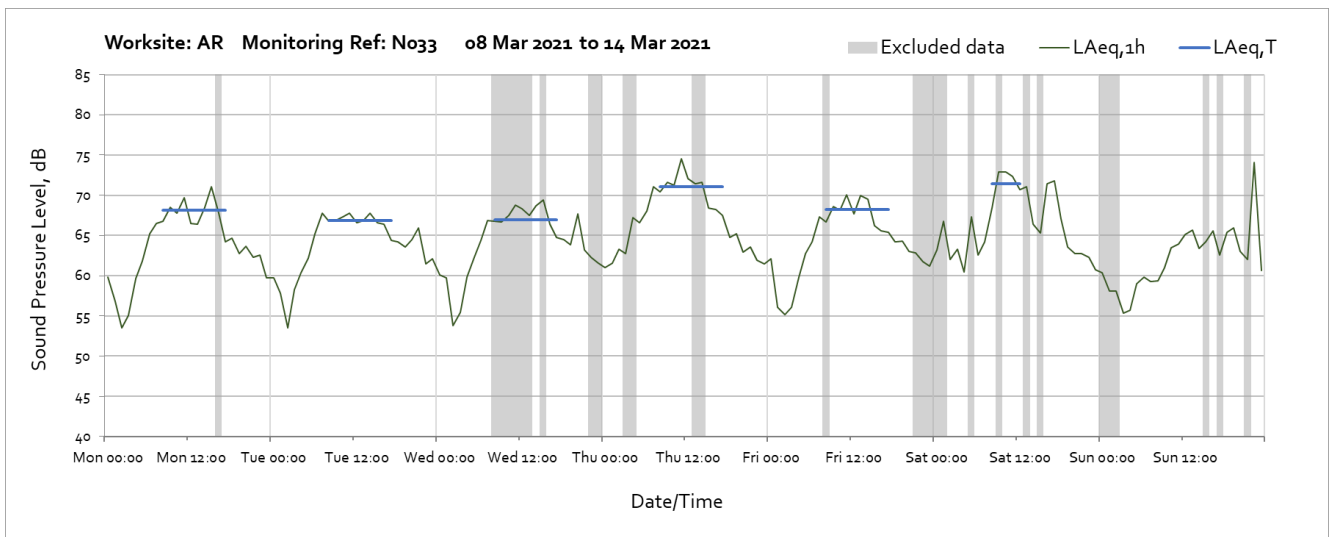
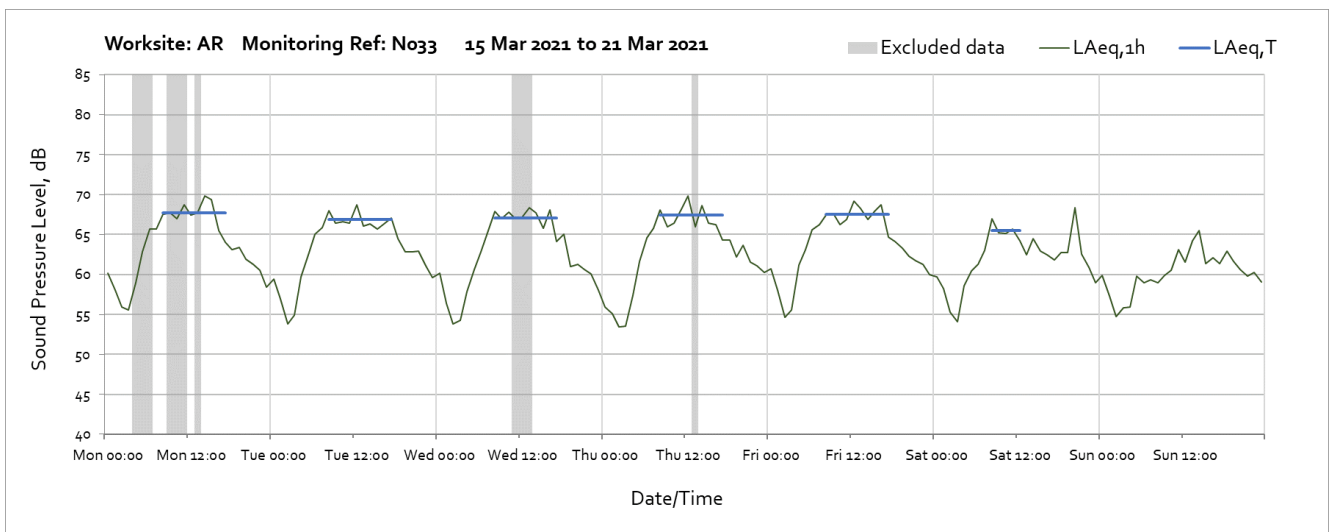
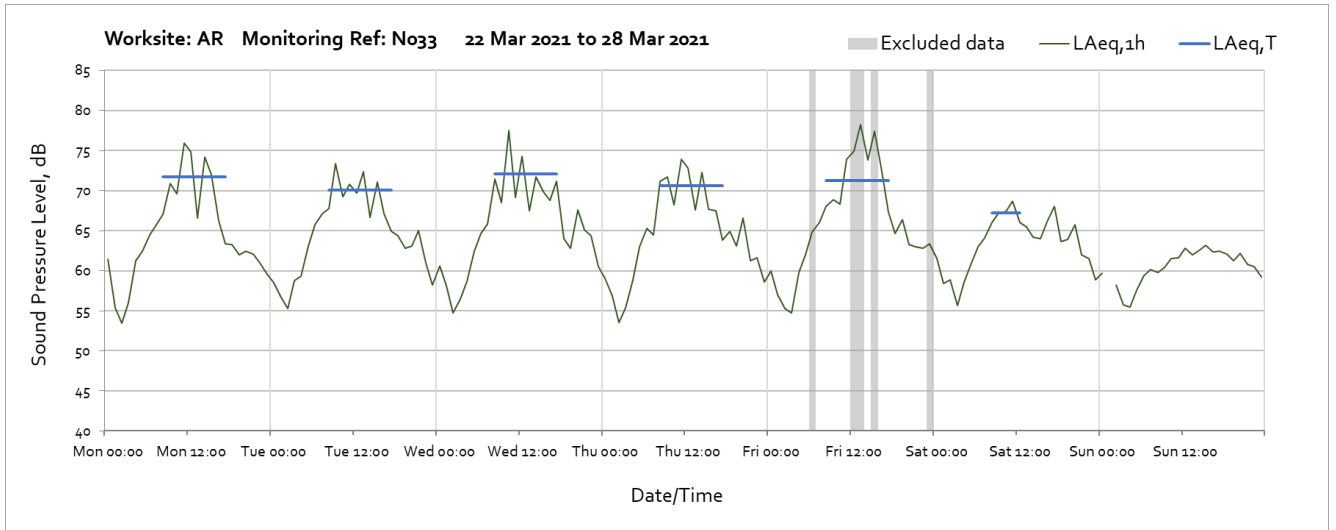
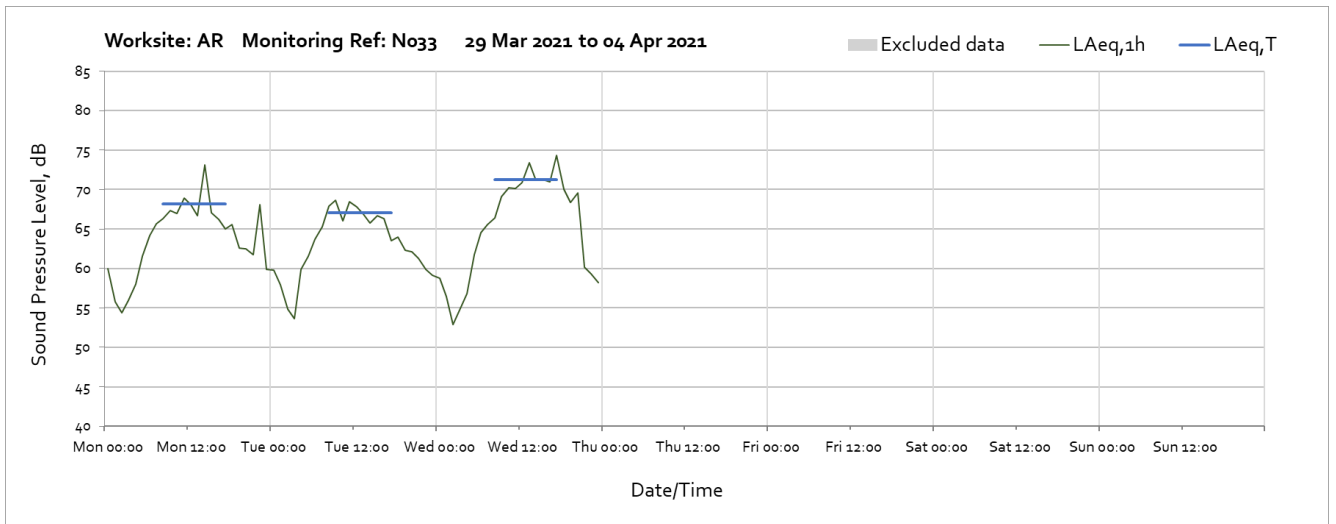
## Worksite: Atlas Road worksite (AR) – Monitoring Ref: N033

Note: Missing data at 01:00 on Sunday 28<sup>th</sup> March 2021 was due to the clocks going forward at the start of British Summer Time.

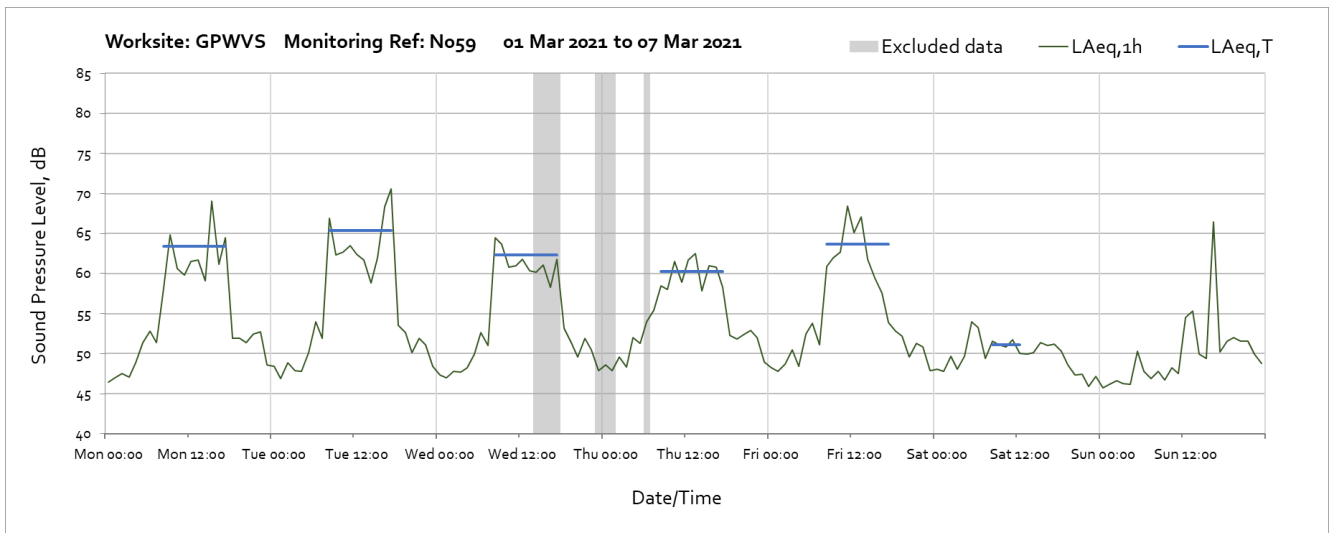
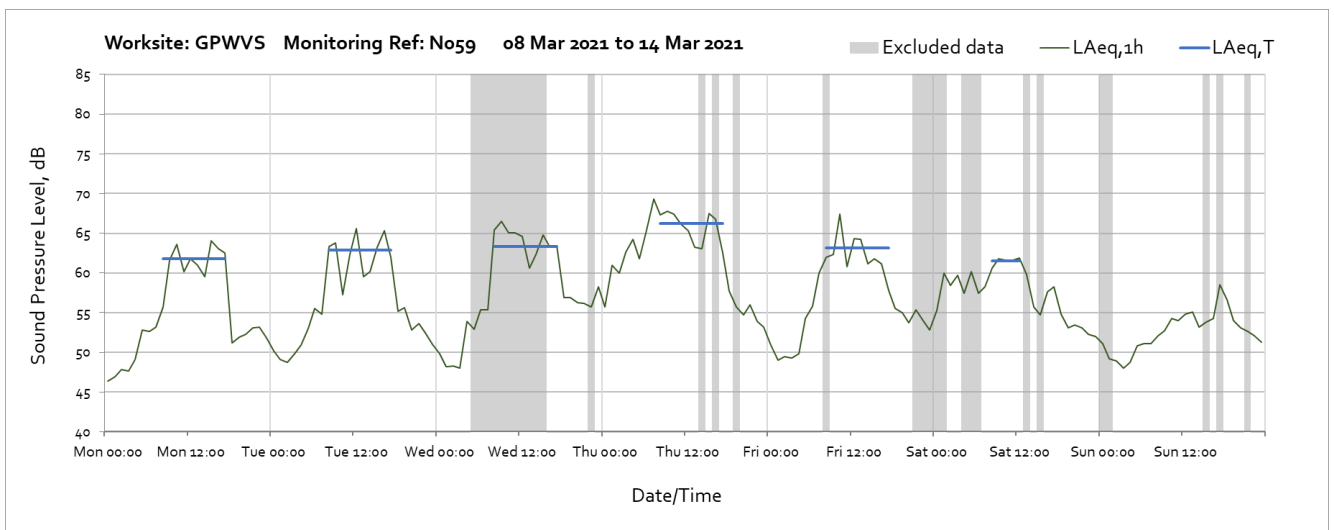
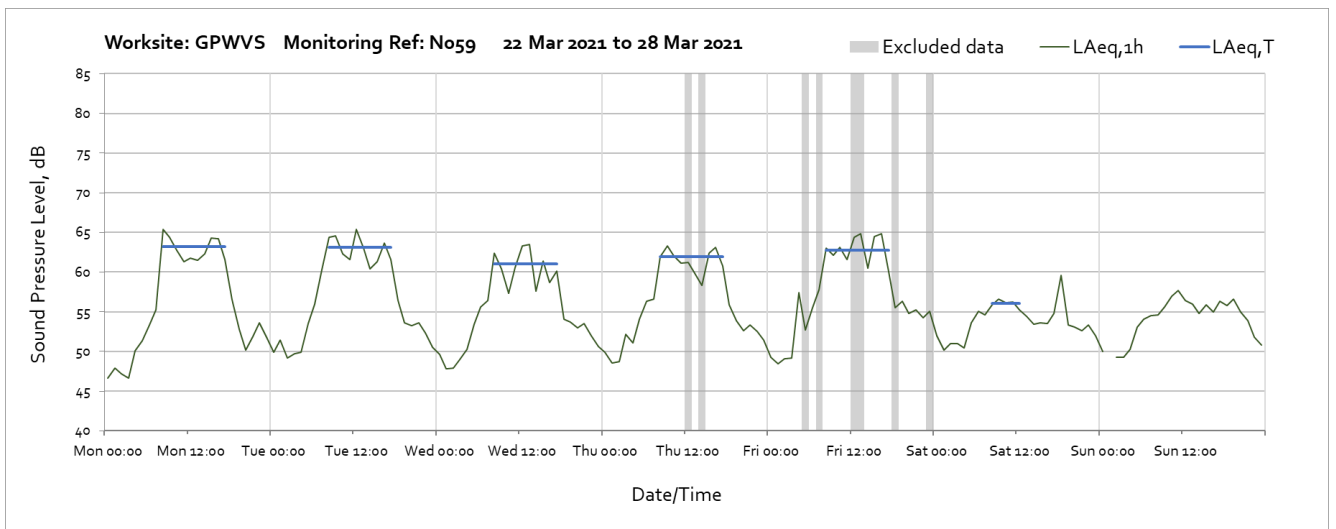
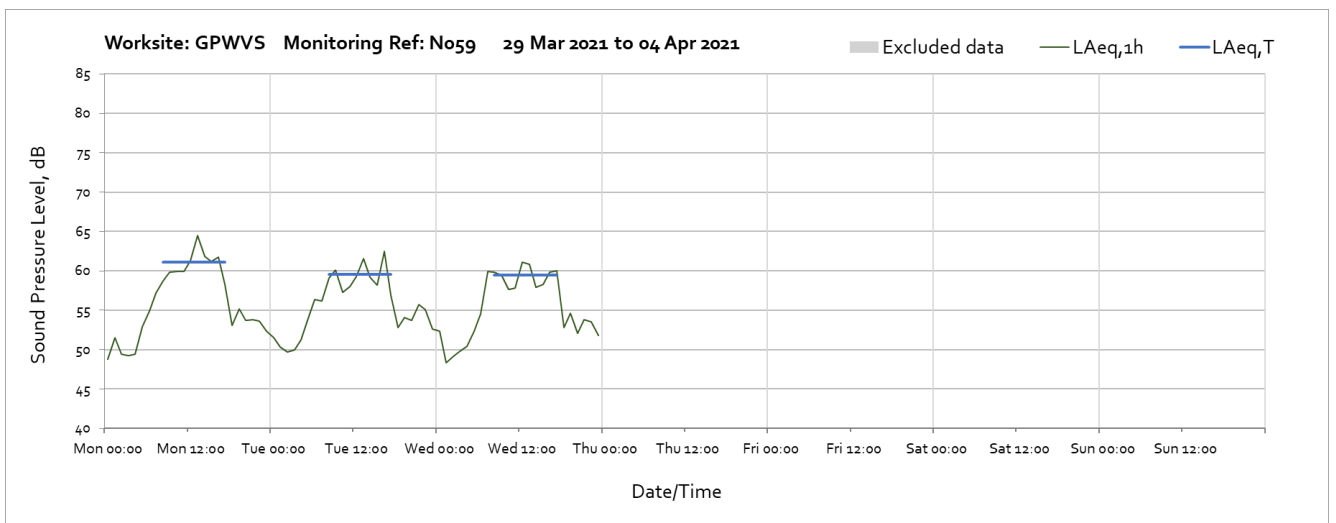
**Worksite: Green Park Way Vent Shaft (GPWVS) – Monitoring Ref: N059**

Note: Missing data between 23:00 on Tuesday 16<sup>th</sup> and 11:00 on Wednesday 17<sup>th</sup> March 2021 was due to a power supply issue which was rectified on Wednesday 17<sup>th</sup> March 2021.

Note: Missing data at 01:00 on Sunday 28<sup>th</sup> March 2021 was due to the clocks going forward at the start of British Summer Time.

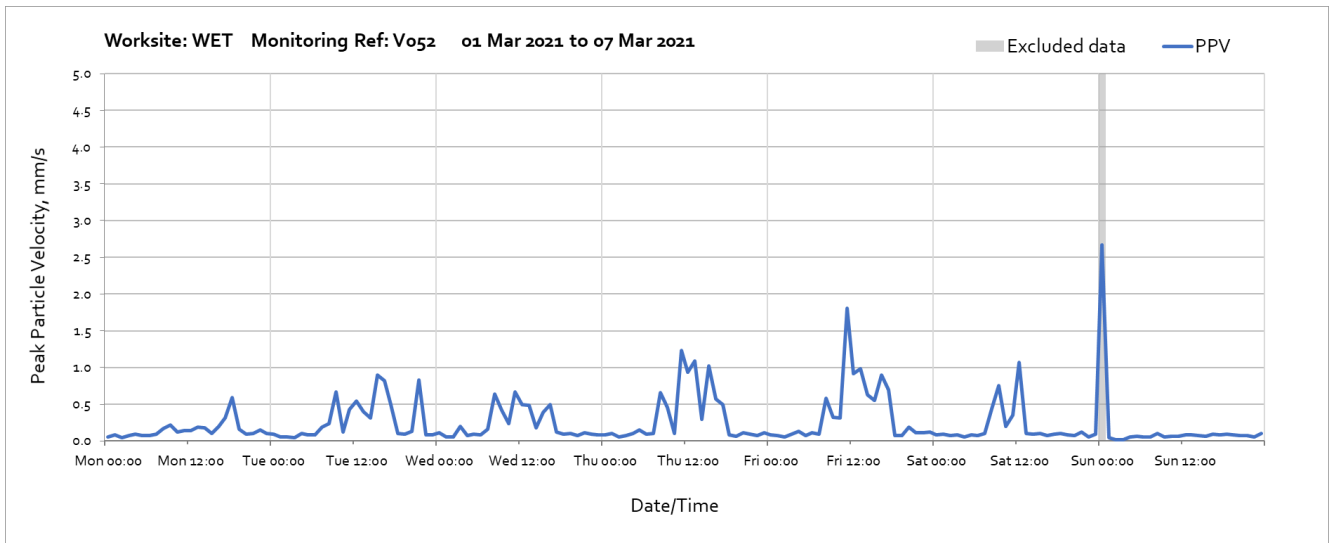
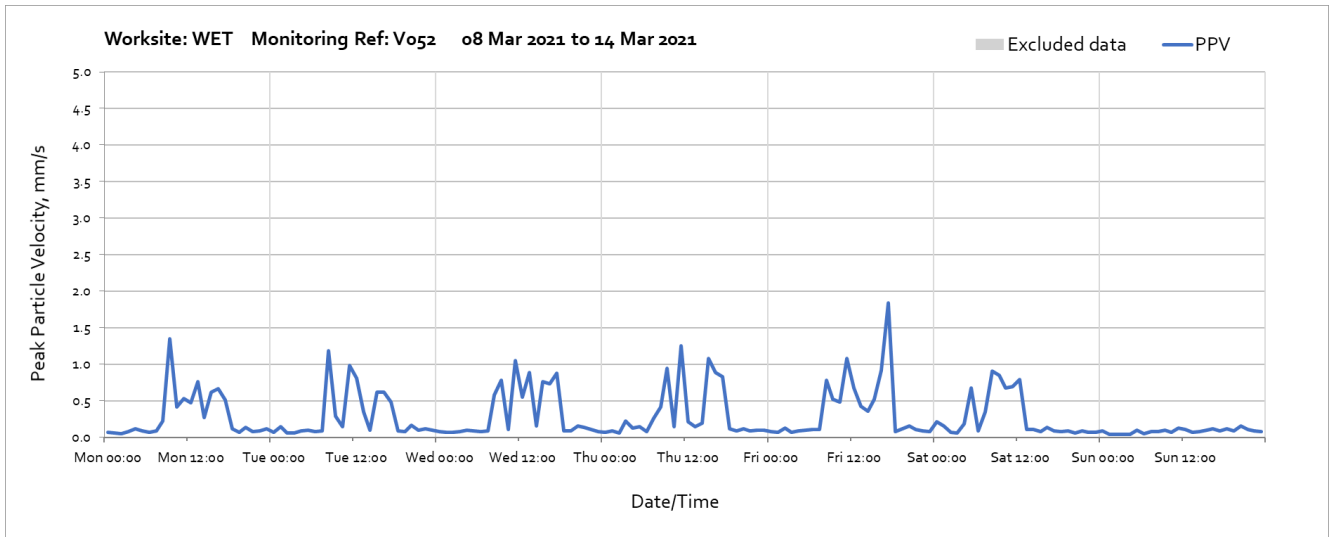
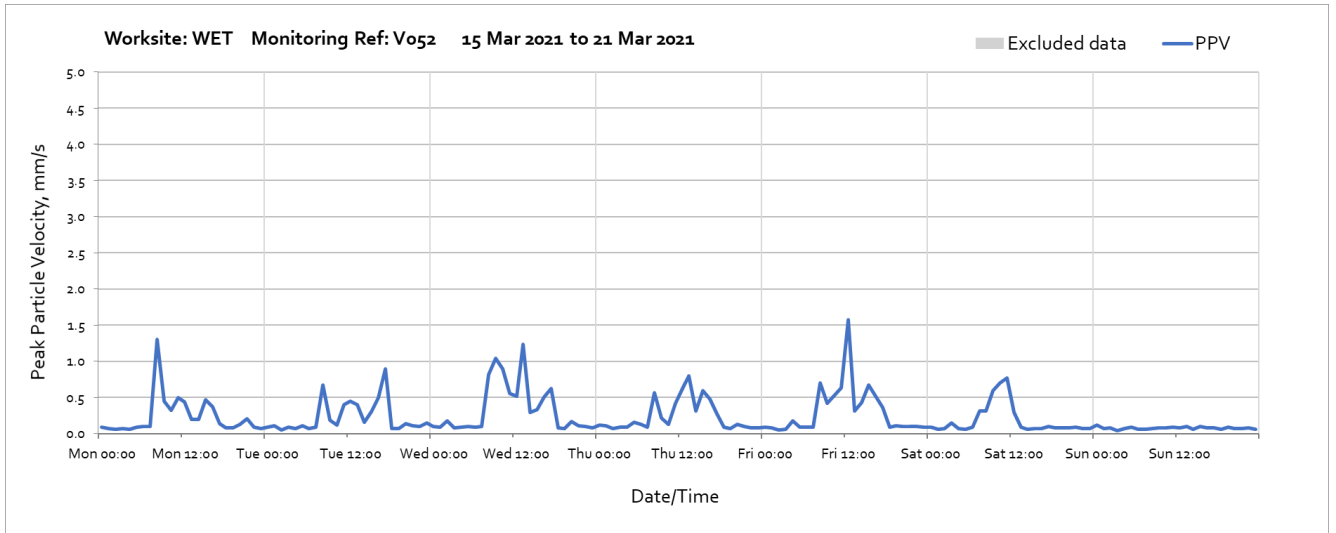
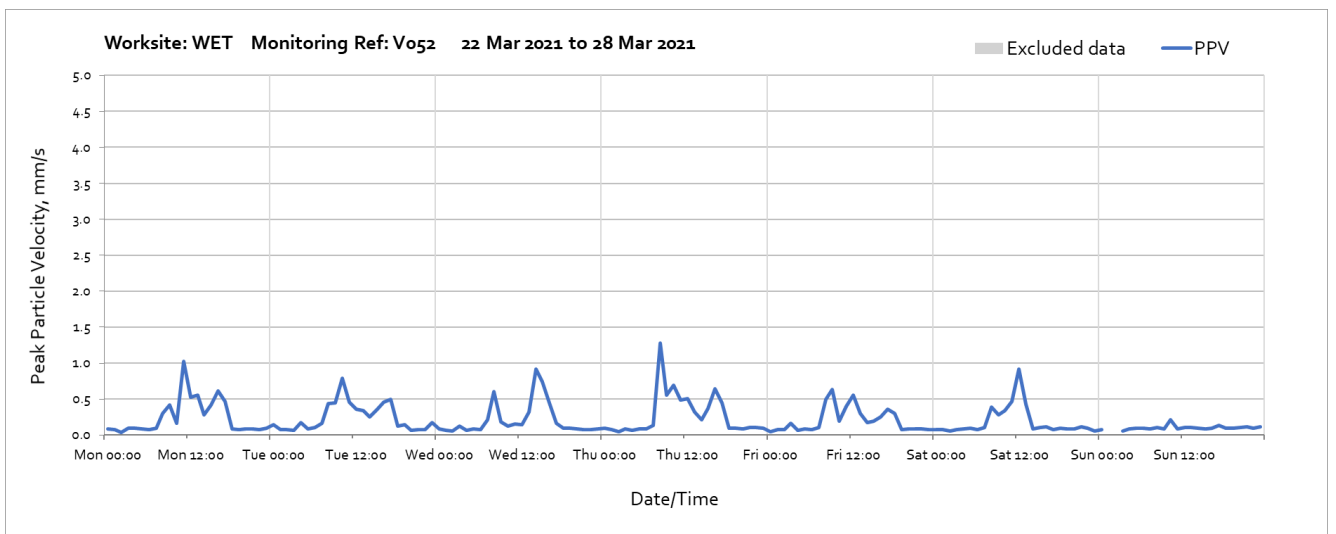
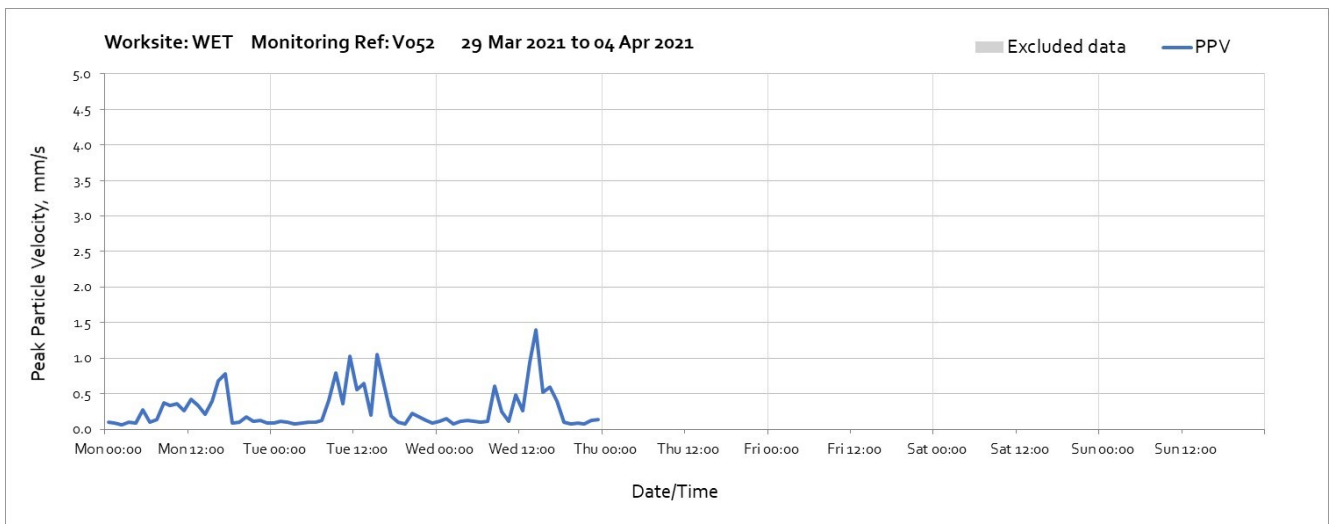
### Worksite: Willesden Euro Terminal (WET) – Monitoring Ref: V052

Note: High vibration levels measured at 00:00 on Sunday 7<sup>th</sup> March 2021 was not related to HS2 construction vibration.

Note: Missing data at 01:00 on Sunday 28<sup>th</sup> March 2021 was due to the clocks going forward at the start of British Summer Time.
